**REPORT NUMBER: SPNCAP-MGA-2019-020**

**NEW CAR ASSESSMENT PROGRAM (NCAP)  
Side Impact Pole Test**

**TOYOTA MOTOR MANUFACTURING, KENTUCKY, INC.  
2019 Toyota Avalon XLE 4-Door Sedan  
NHTSA No.: O20195108**

**FINAL REPORT**

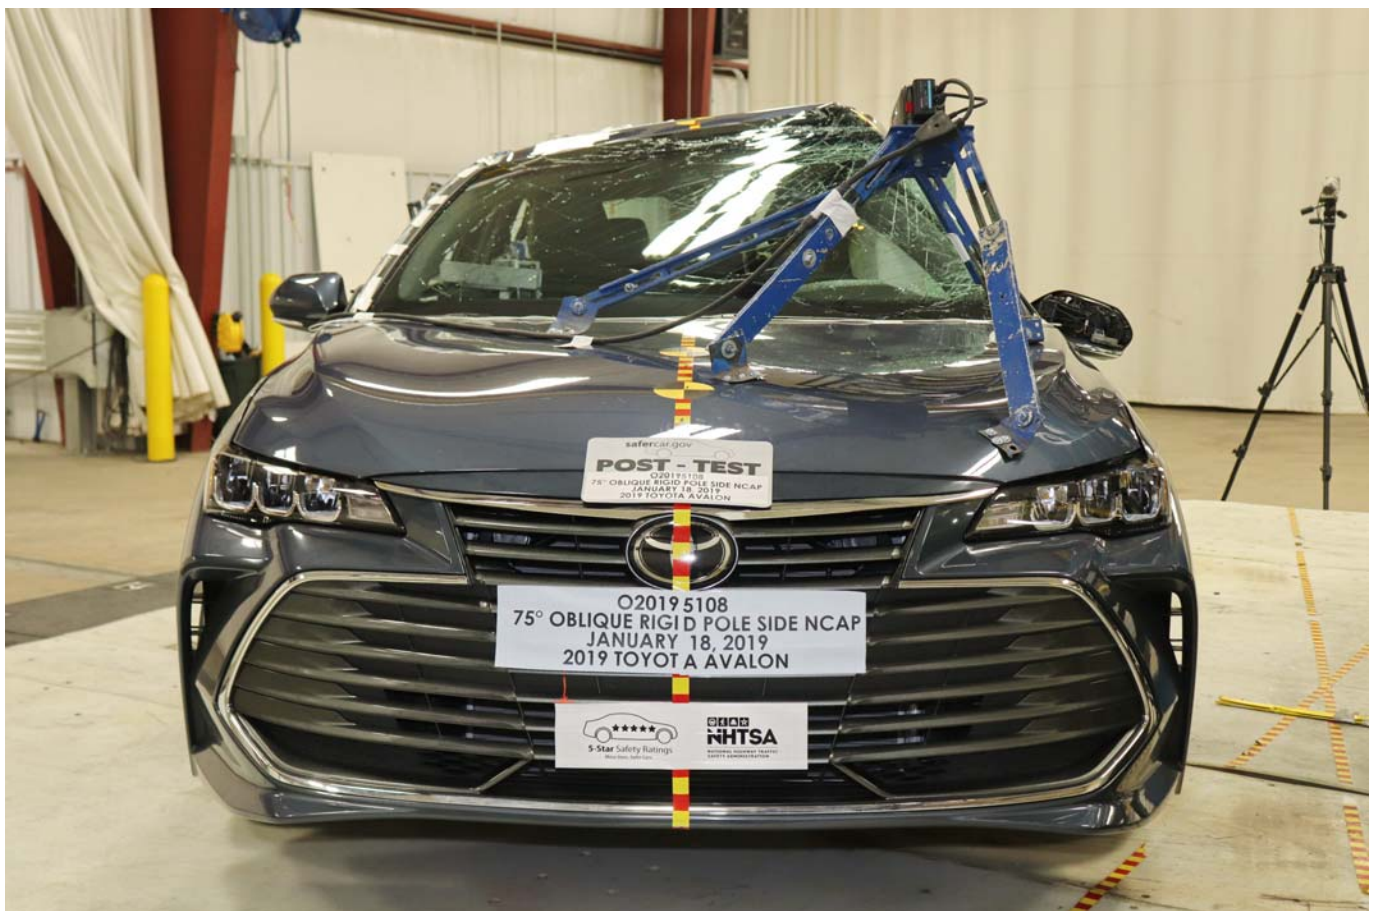
Photo No. 004 - Post-Test Frontal View of Test Vehicle

| Critical Areas of Performance | Observations and Conclusions |
|---|---|
| Windshield Damage | Cracked |

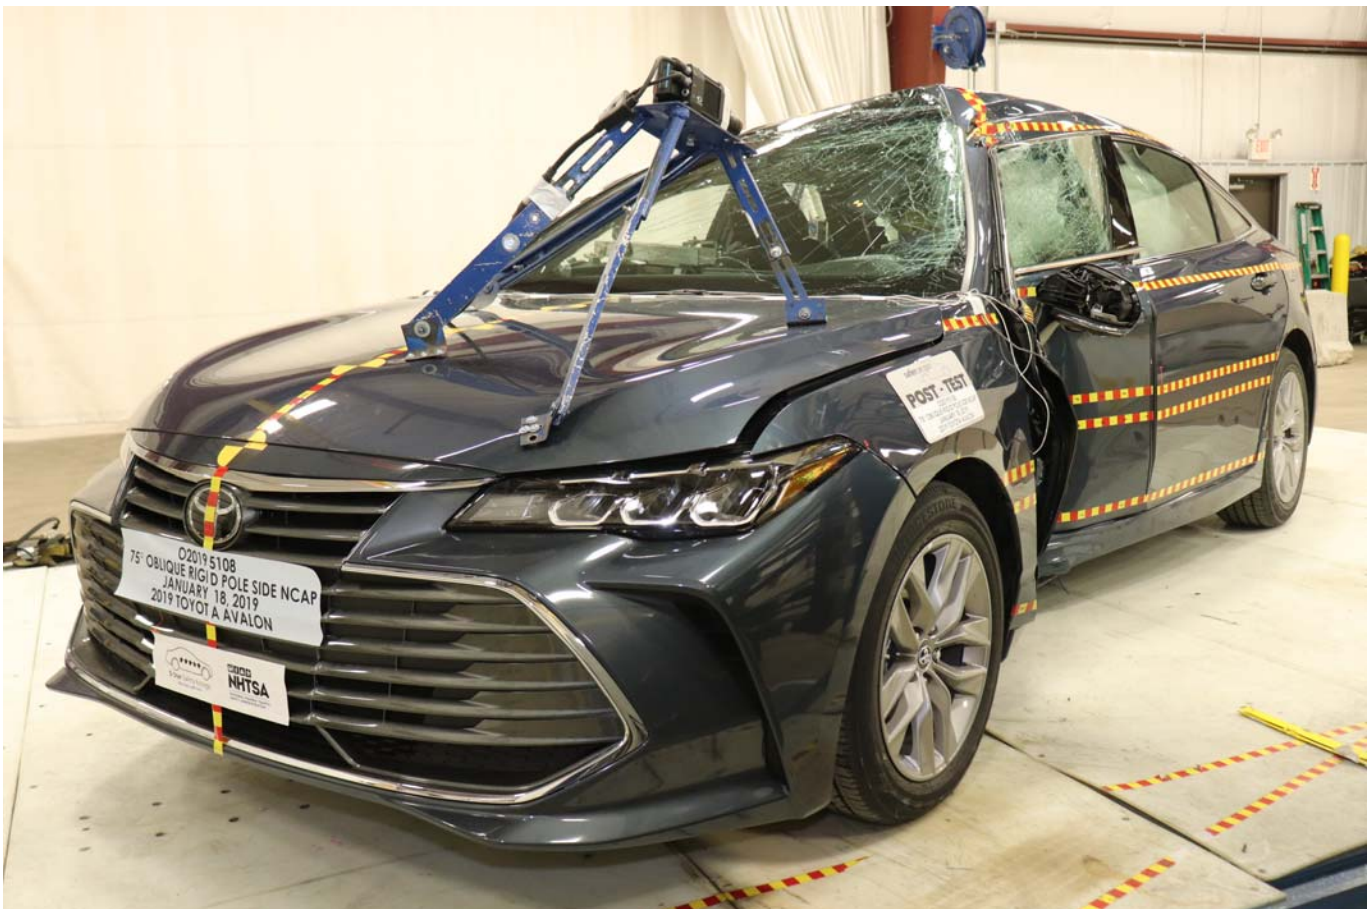
Photo No. 006 - Post-Test Left Front Three-Quarter View of Test Vehicle

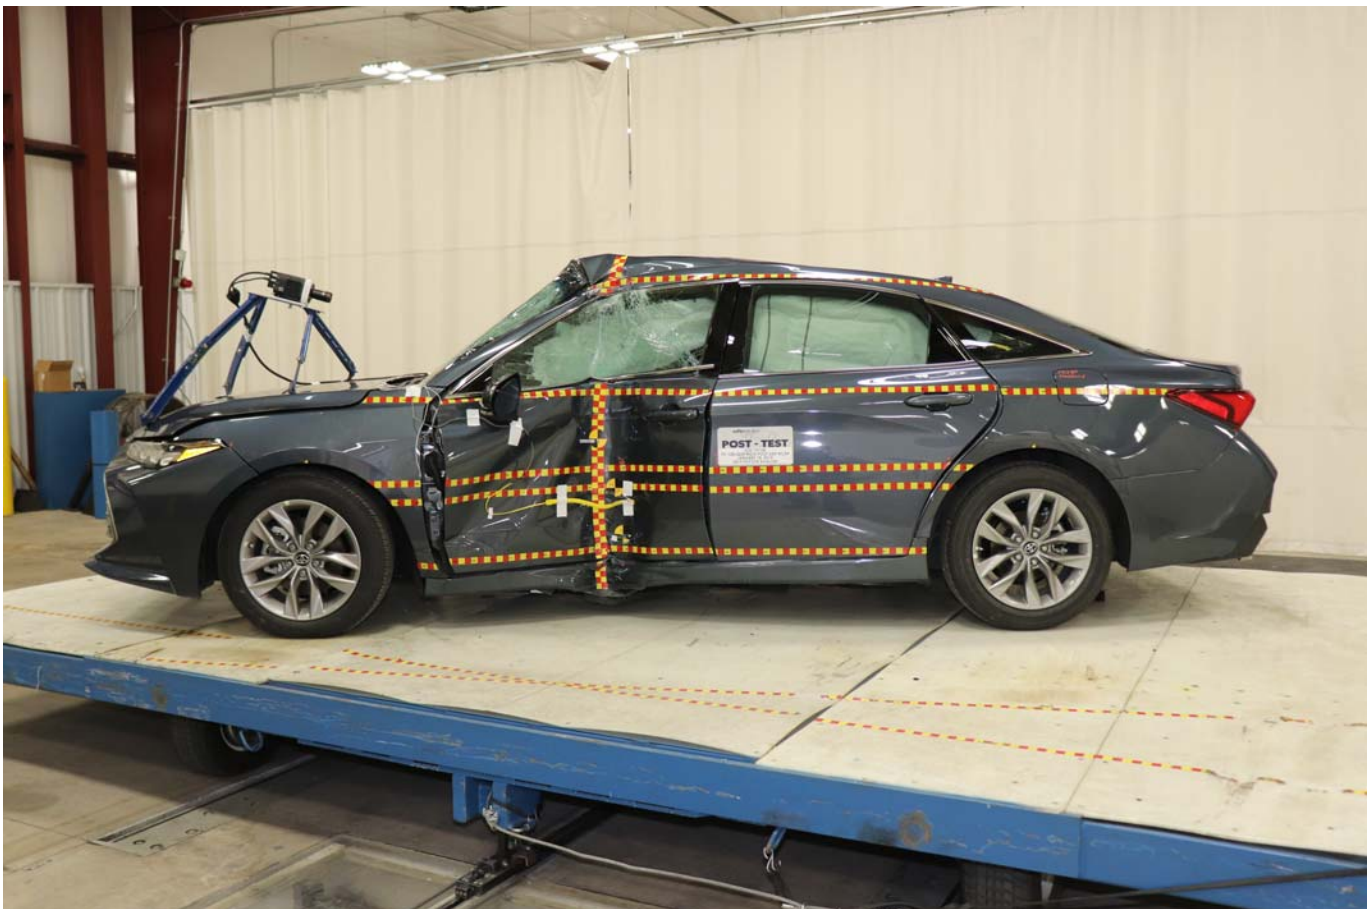
Photo No. 008 - Post-Test Left Side View of Test Vehicle

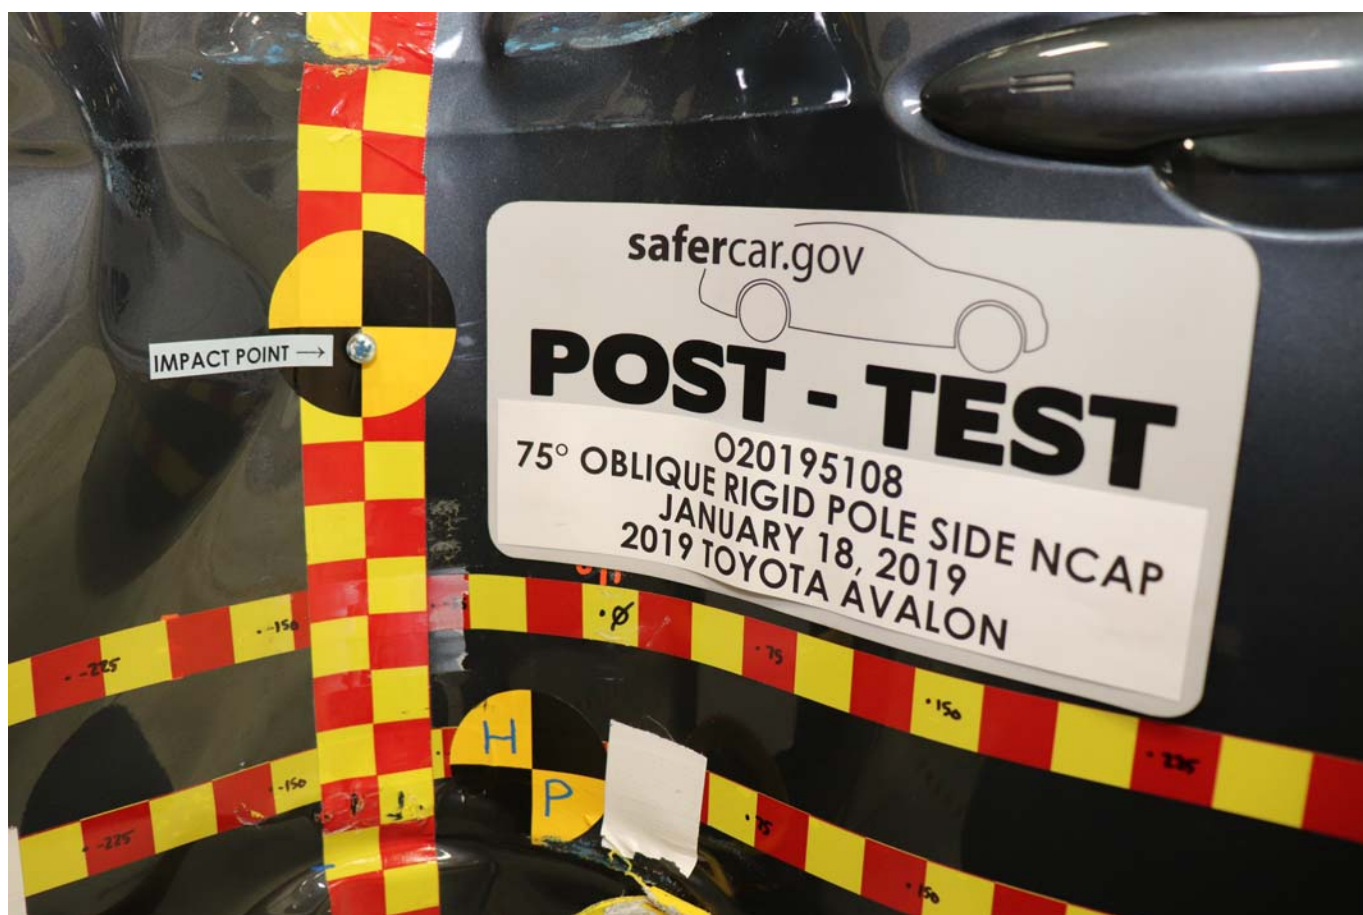
Photo No. 020 - Post-Test Close-Up View of Impact Point Target Showing Impact Location

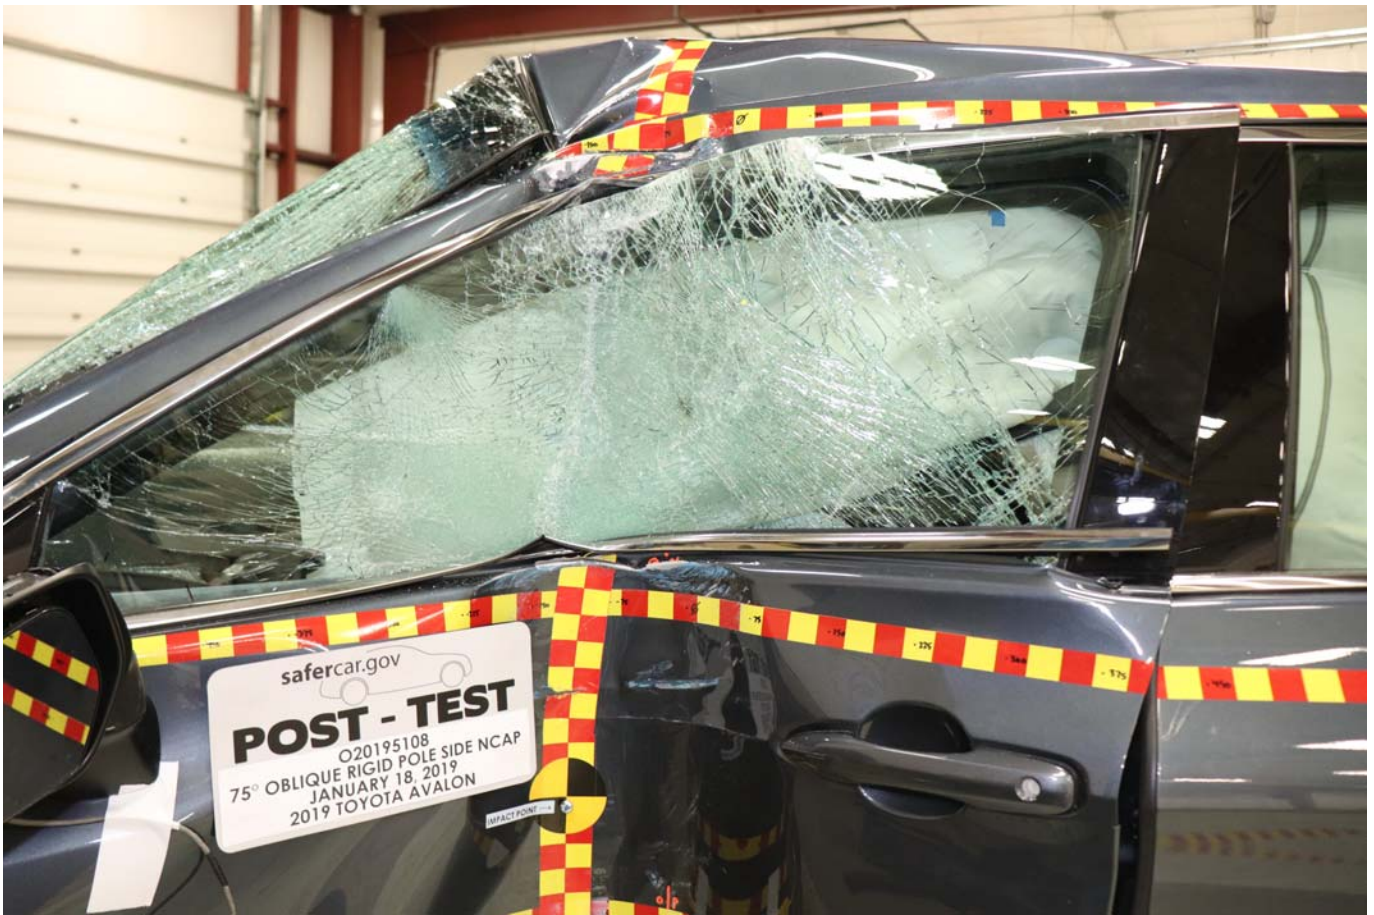
Photo No. 025 - Post-Test Left Side View of Dummy Shoulder and Door Top View

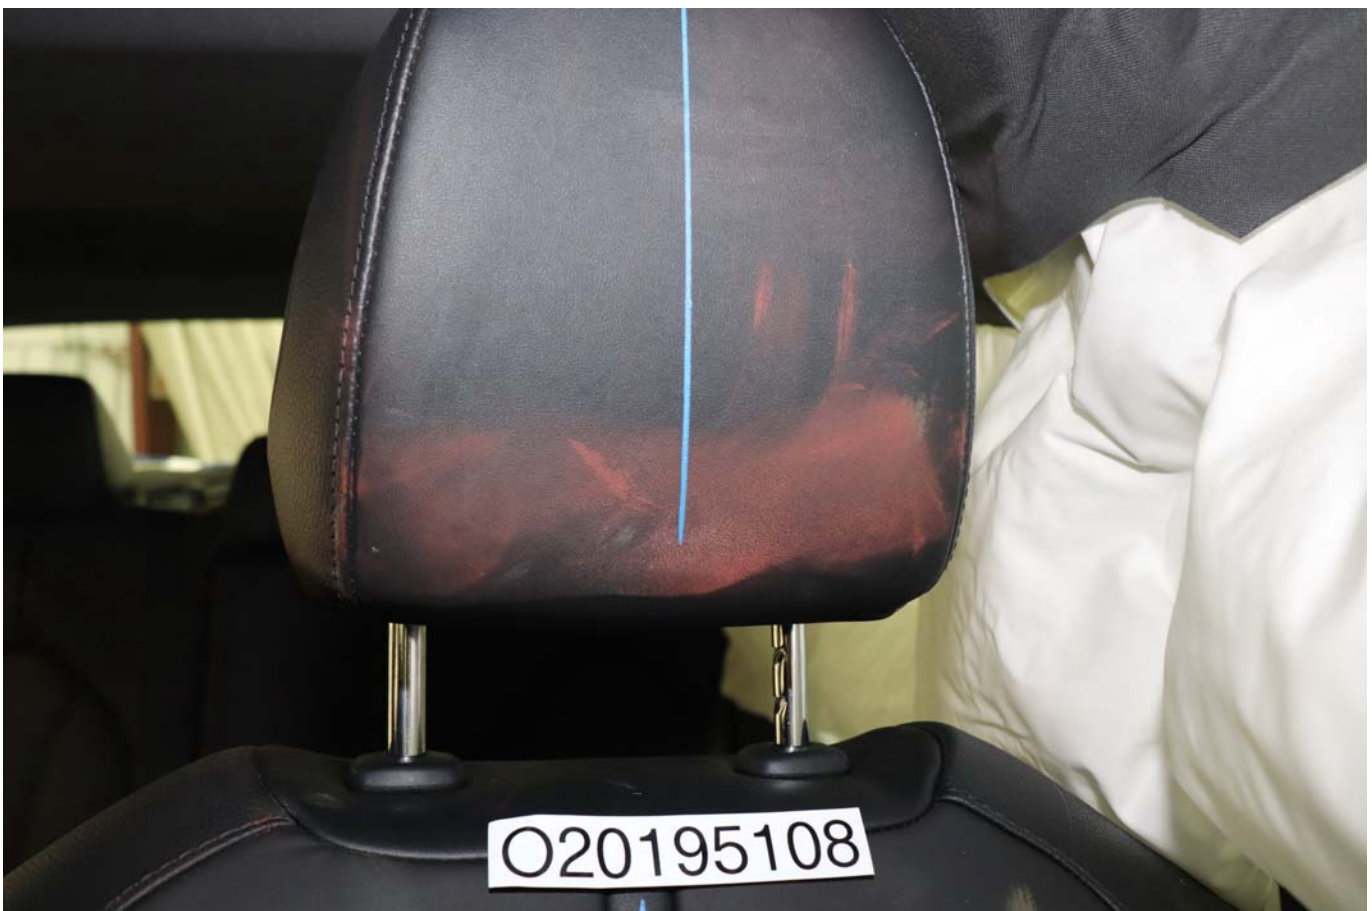
Photo No. 046 - Post-Test Dummy Close-Up Head Contact with Vehicle Interior View

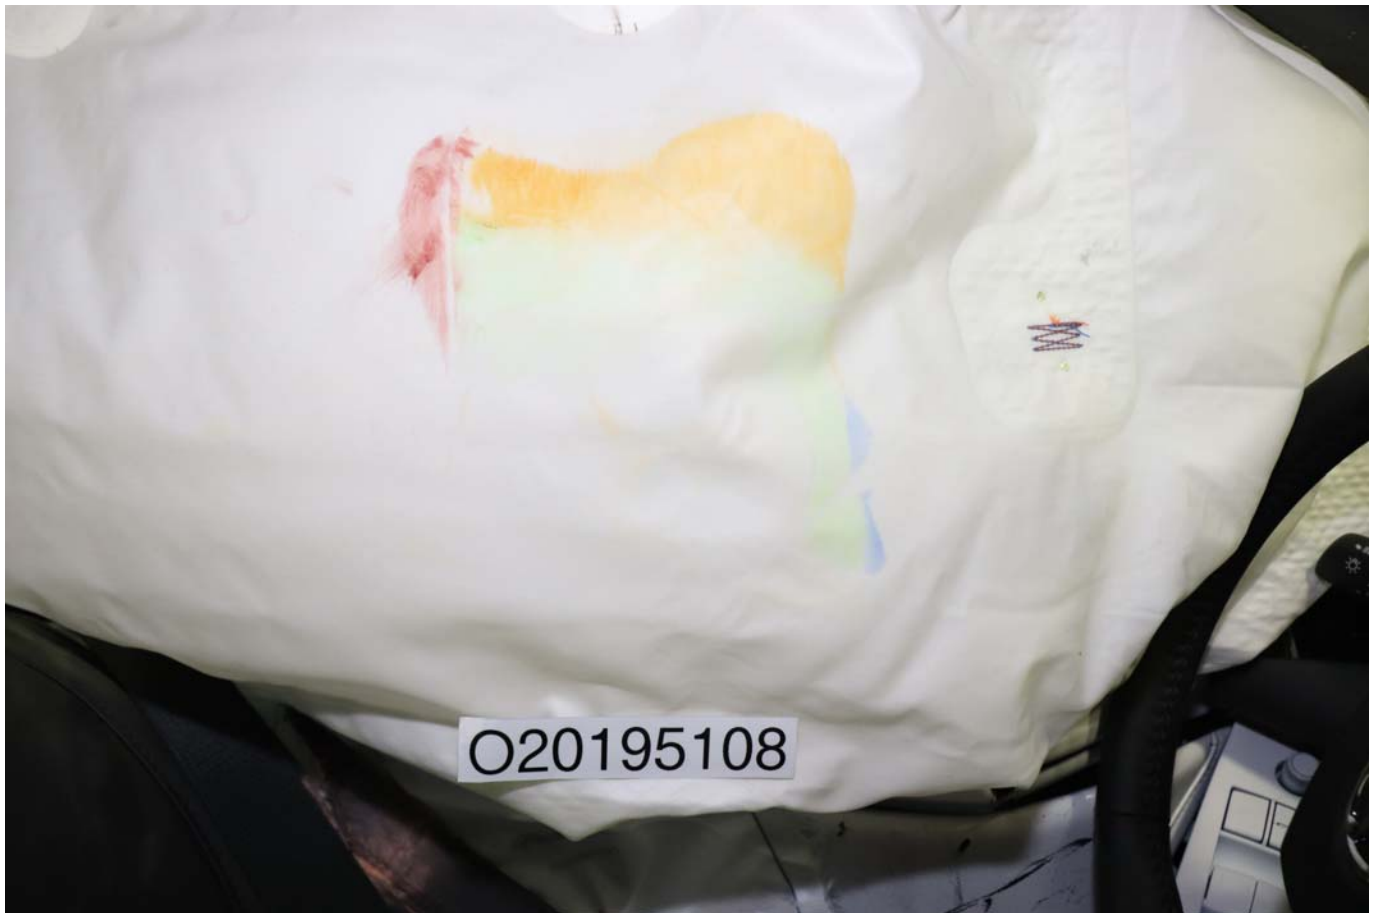
Photo No. 047 - Post-Test Dummy Close-Up Head Contact with Side Air Bag View

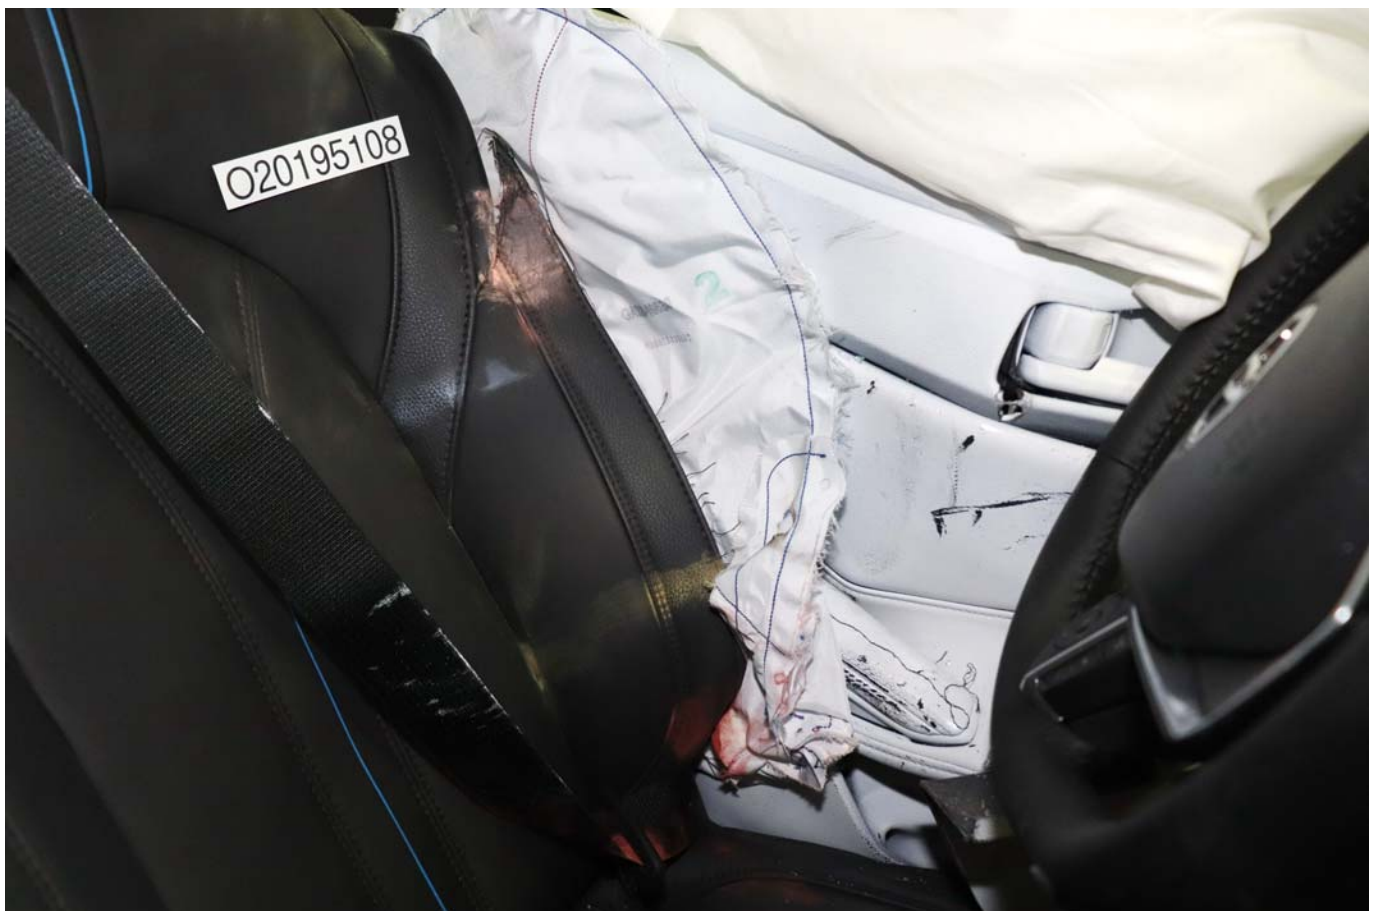
Photo No. 048 - Post-Test Dummy Close-Up Torso Contact with Vehicle Interior View

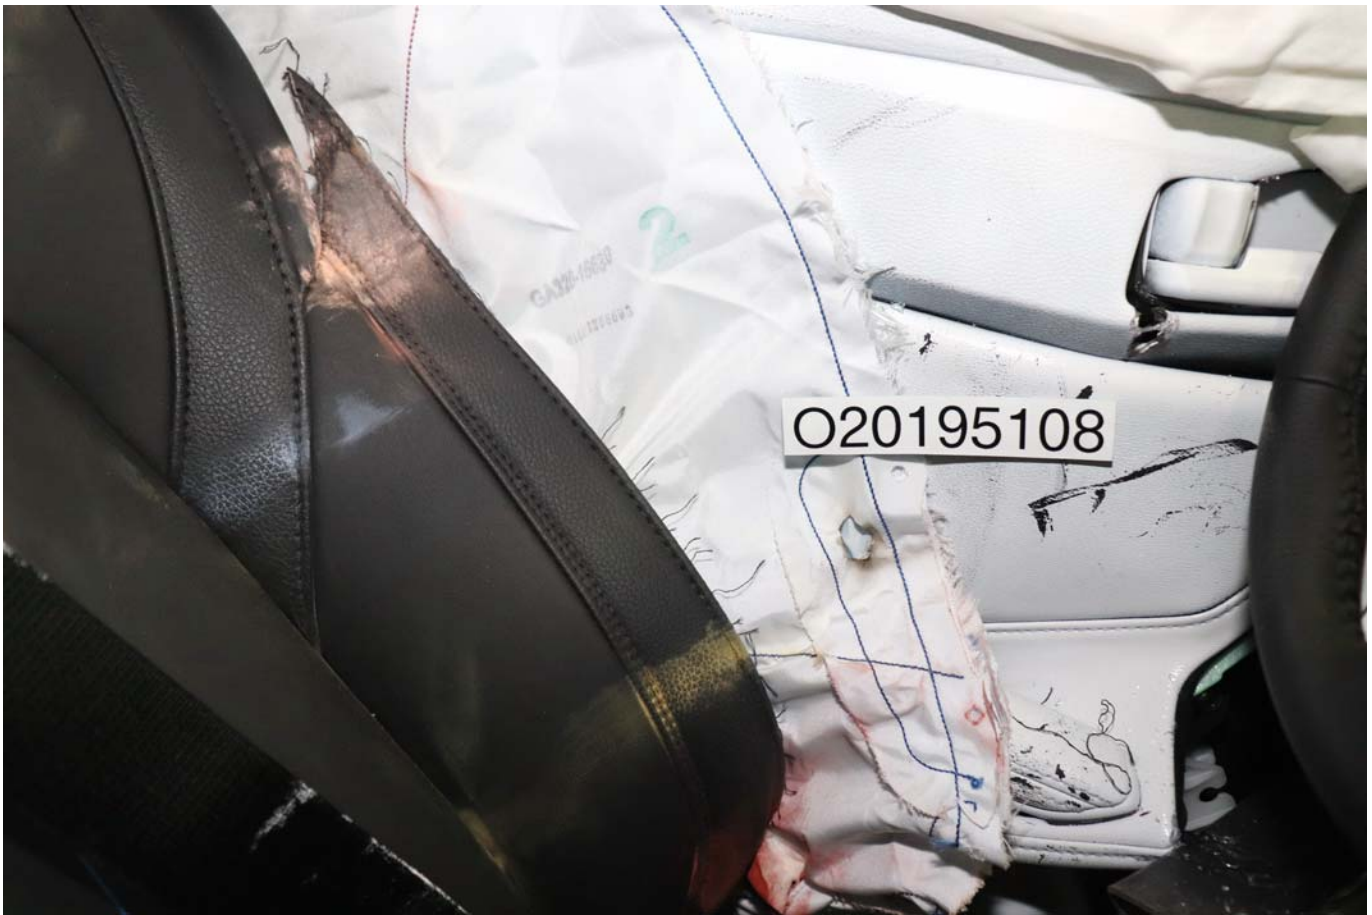
Photo No. 049 - Post-Test Dummy Close-Up Torso Contact with Side Air Bag View

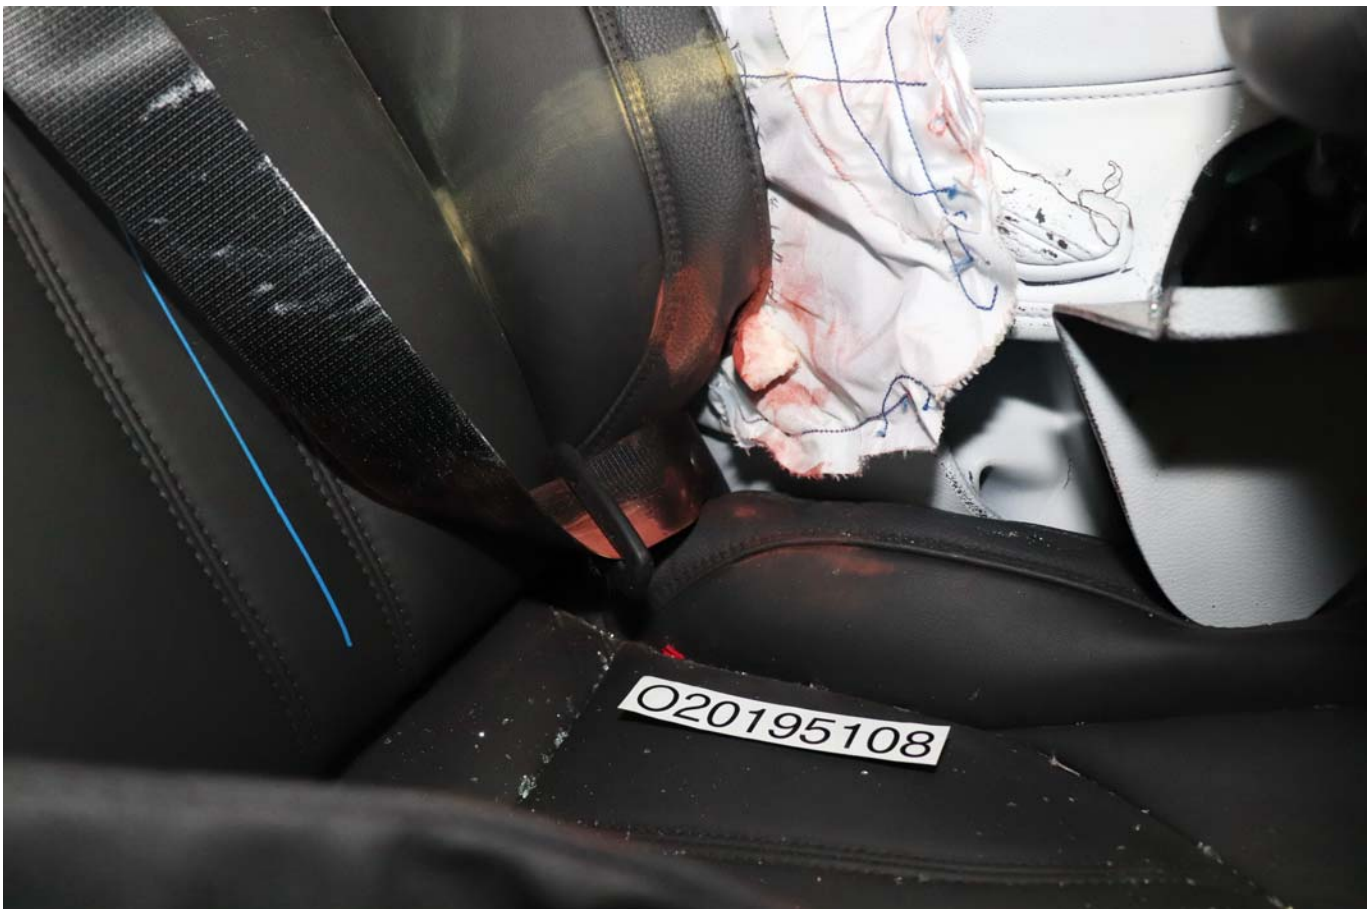
Photo No. 050 - Post-Test Dummy Close-Up Pelvis Contact with Vehicle Interior View

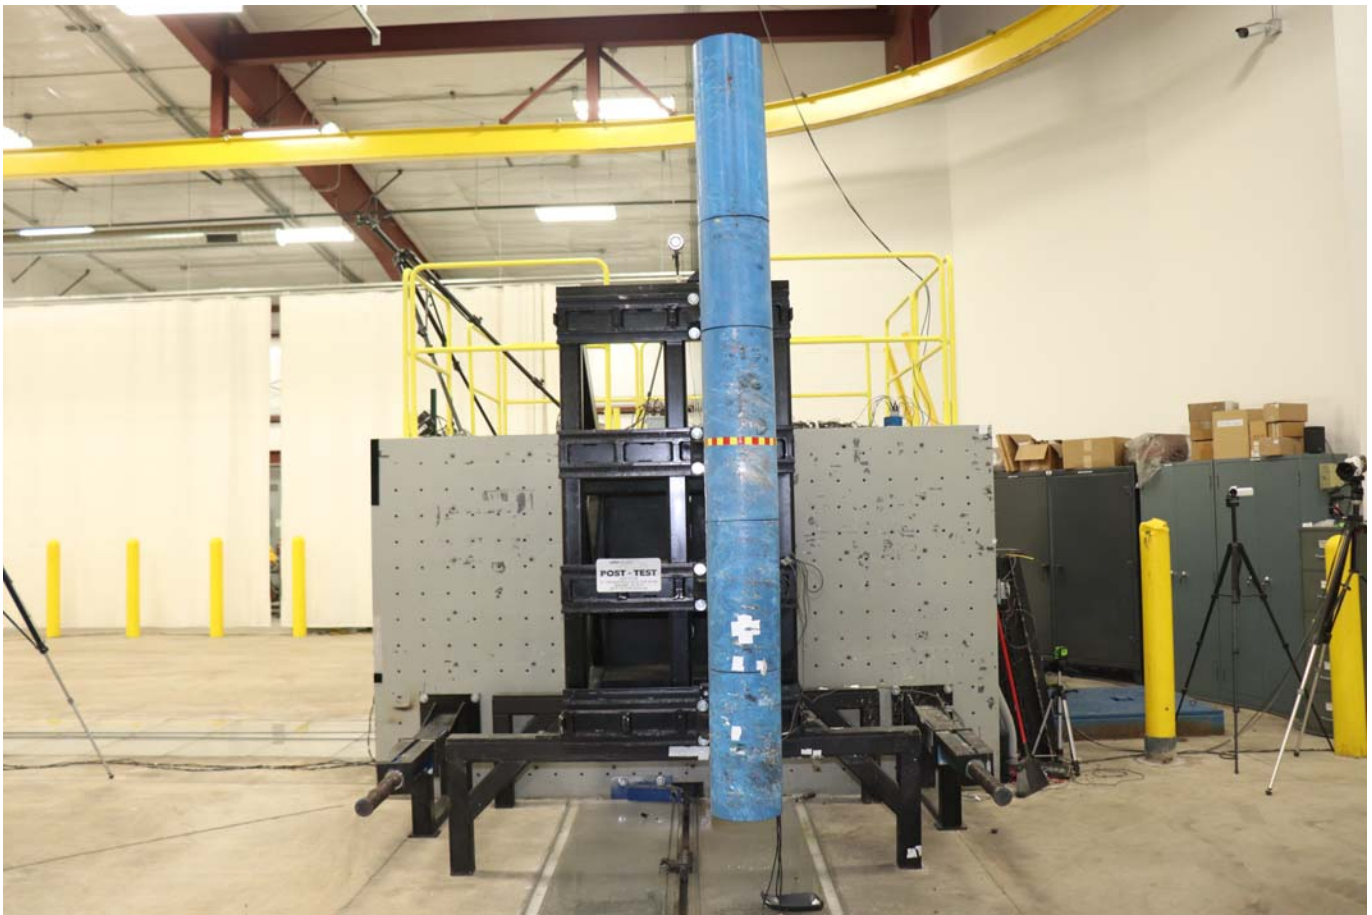
Photo No. 058 - Post-Test Pole Barrier Front View

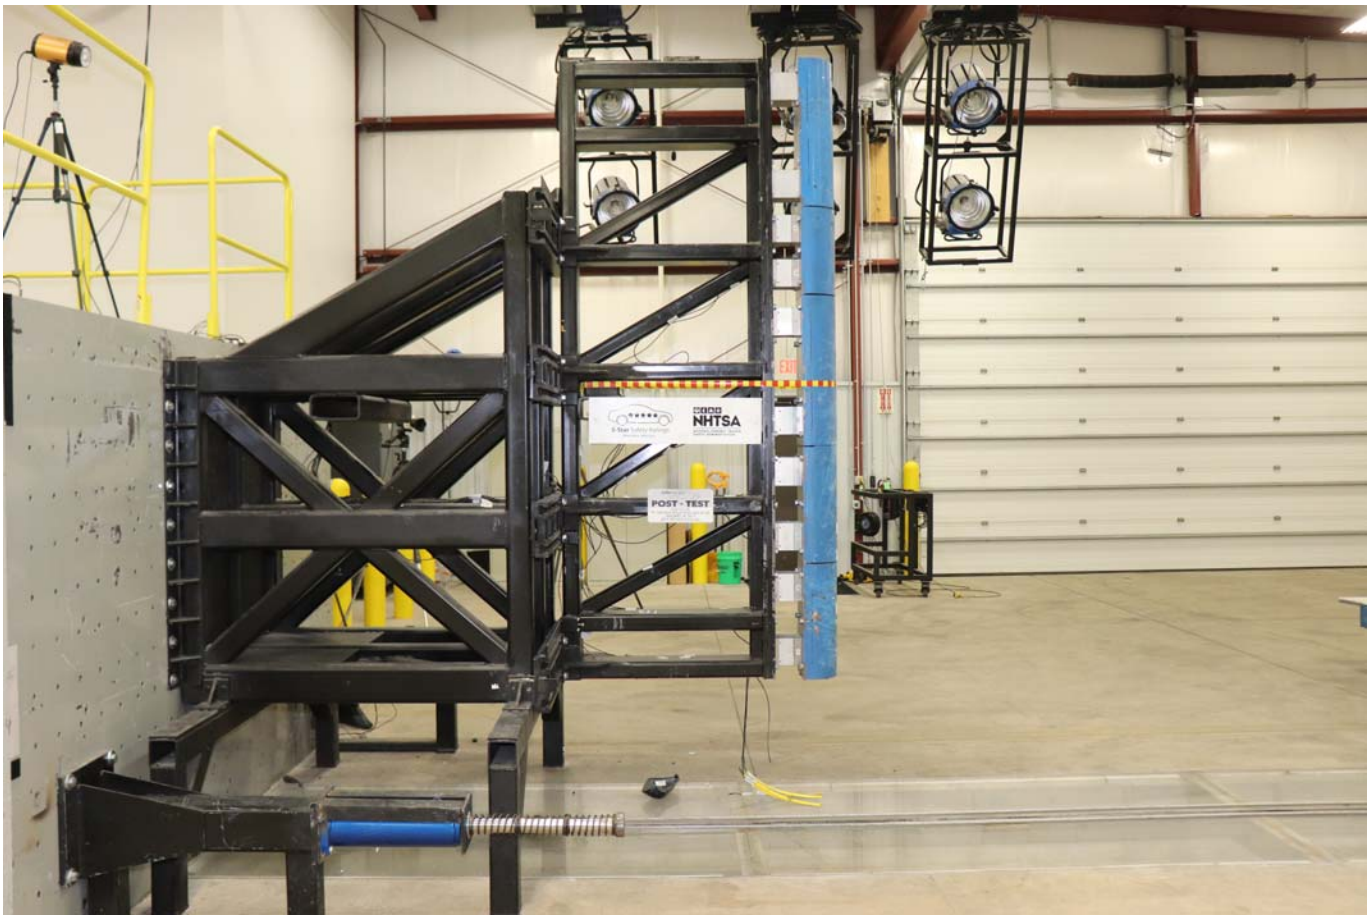
Photo No. 060 - Post-Test Pole Barrier Side View

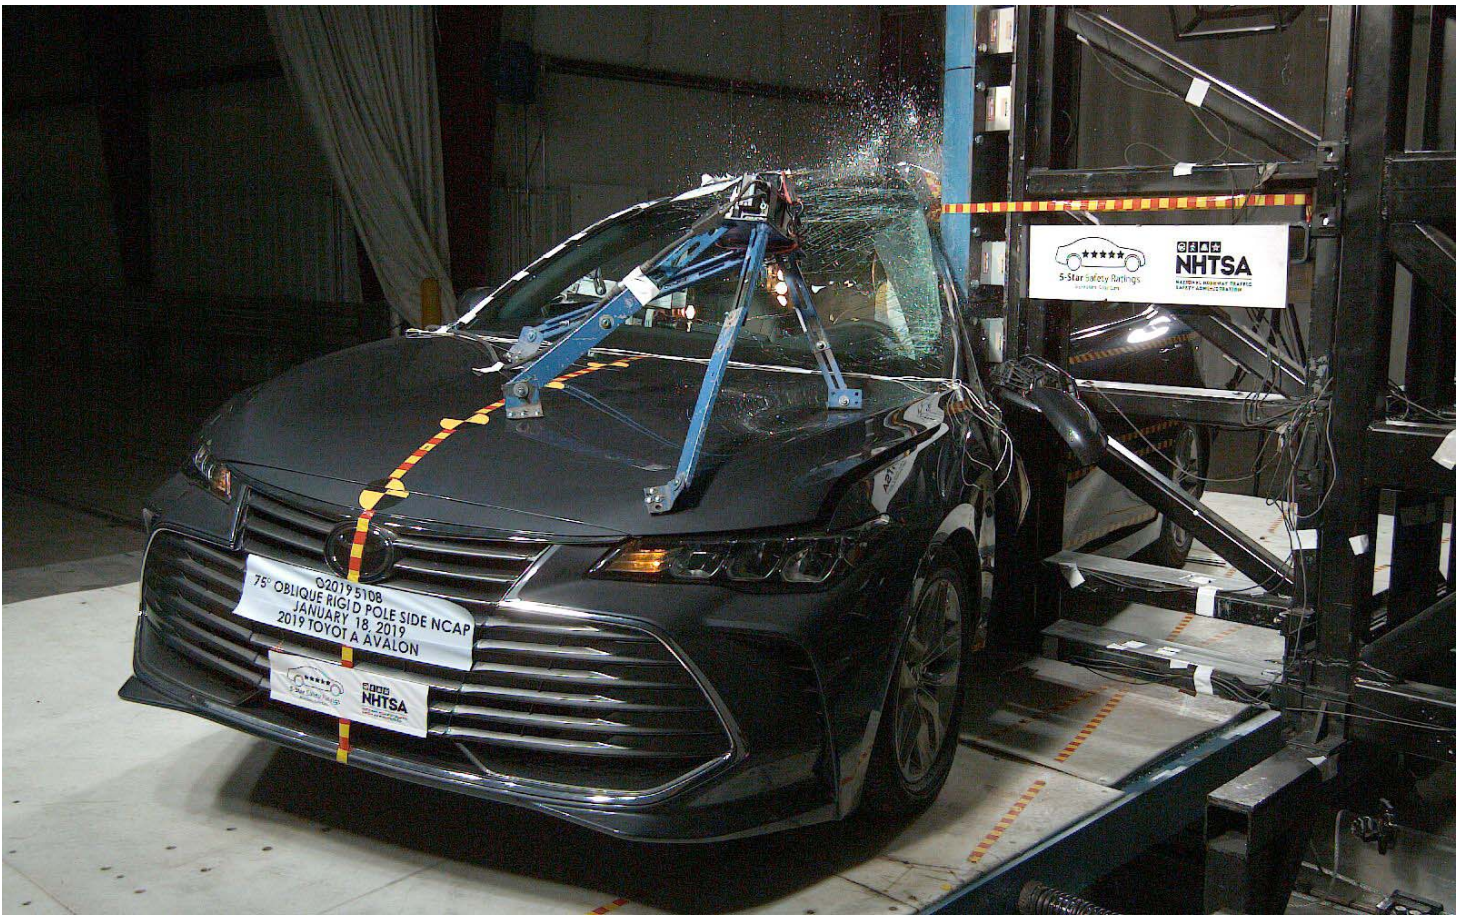
Photo No. 068 - Impact Event

A rigid pole side impact test was conducted on a 2019 Toyota Avalon XLE 4-Door Sedan. The subject vehicle was towed into the rigid pole at an angle of 75° and a velocity of 32.10 km/h. The test was conducted by MGA Research Corporation in Burlington, Wisconsin on January 18, 2019. Pre-test and post-test photographs of the test vehicle and side impact dummy (SID-IIs) are included in Appendix A of this report.

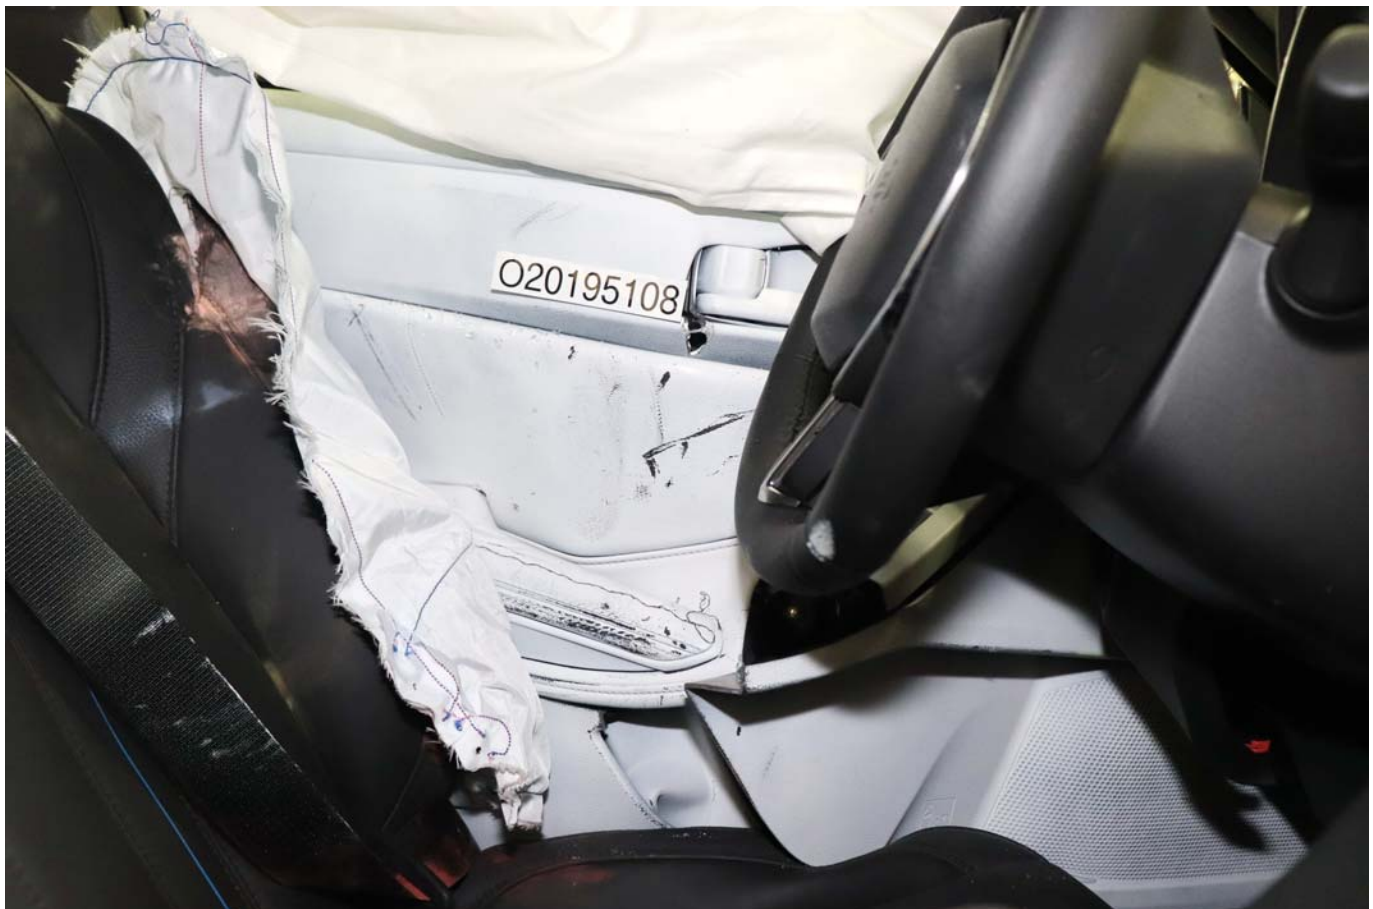
Photo No. 071 - Post-Test View of Shattered Vehicle Inner Door Panel
