REPORT NUMBER: SPNCAP-MGA-2019-022

**NEW CAR ASSESSMENT PROGRAM (NCAP)
Side Impact Pole Test**

**TOYOTA MOTOR MANUFACTURING, KENTUCKY, INC.
2019 Lexus ES 350 4-Door Sedan
NHTSA No.: O20195105**

**MGA RESEARCH CORPORATION
5000 Warren Road
Burlington, WI 53105**

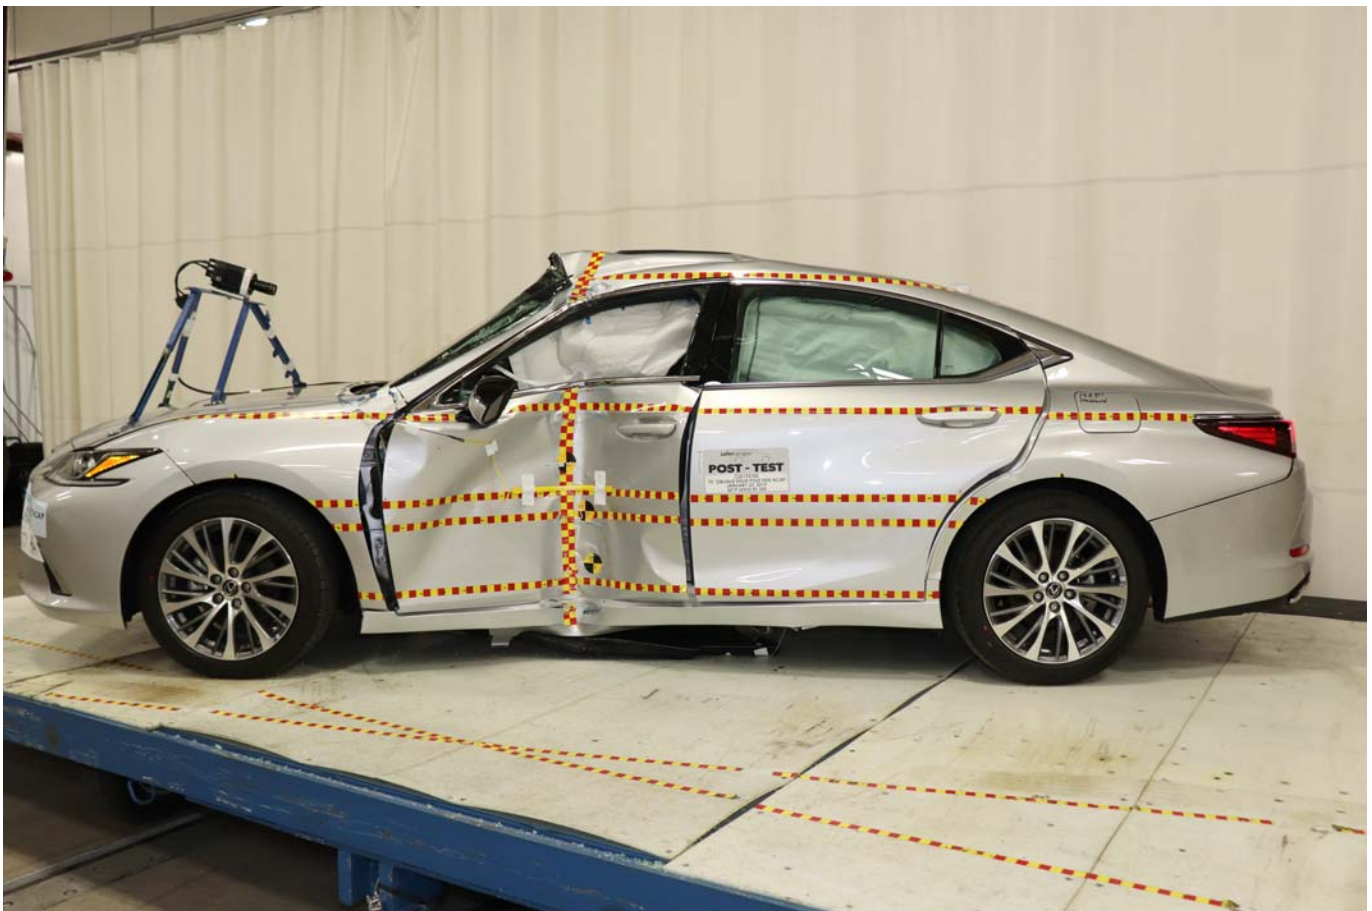
Photo No. 008 - Post-Test Left Side View of Test Vehicle

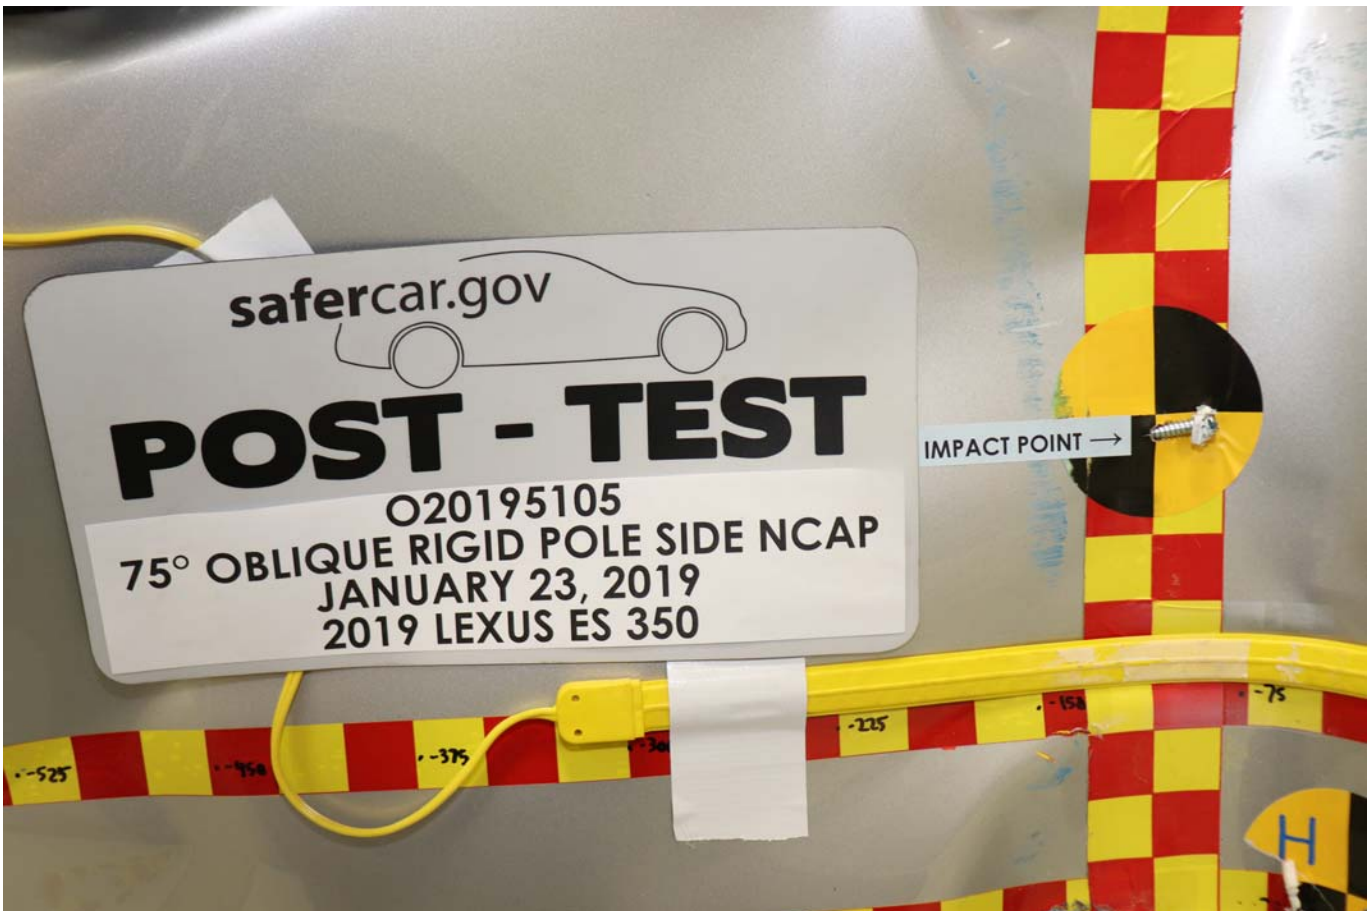
Photo No. 020 - Post-Test Close-Up View of Impact Point Target Showing Impact Location

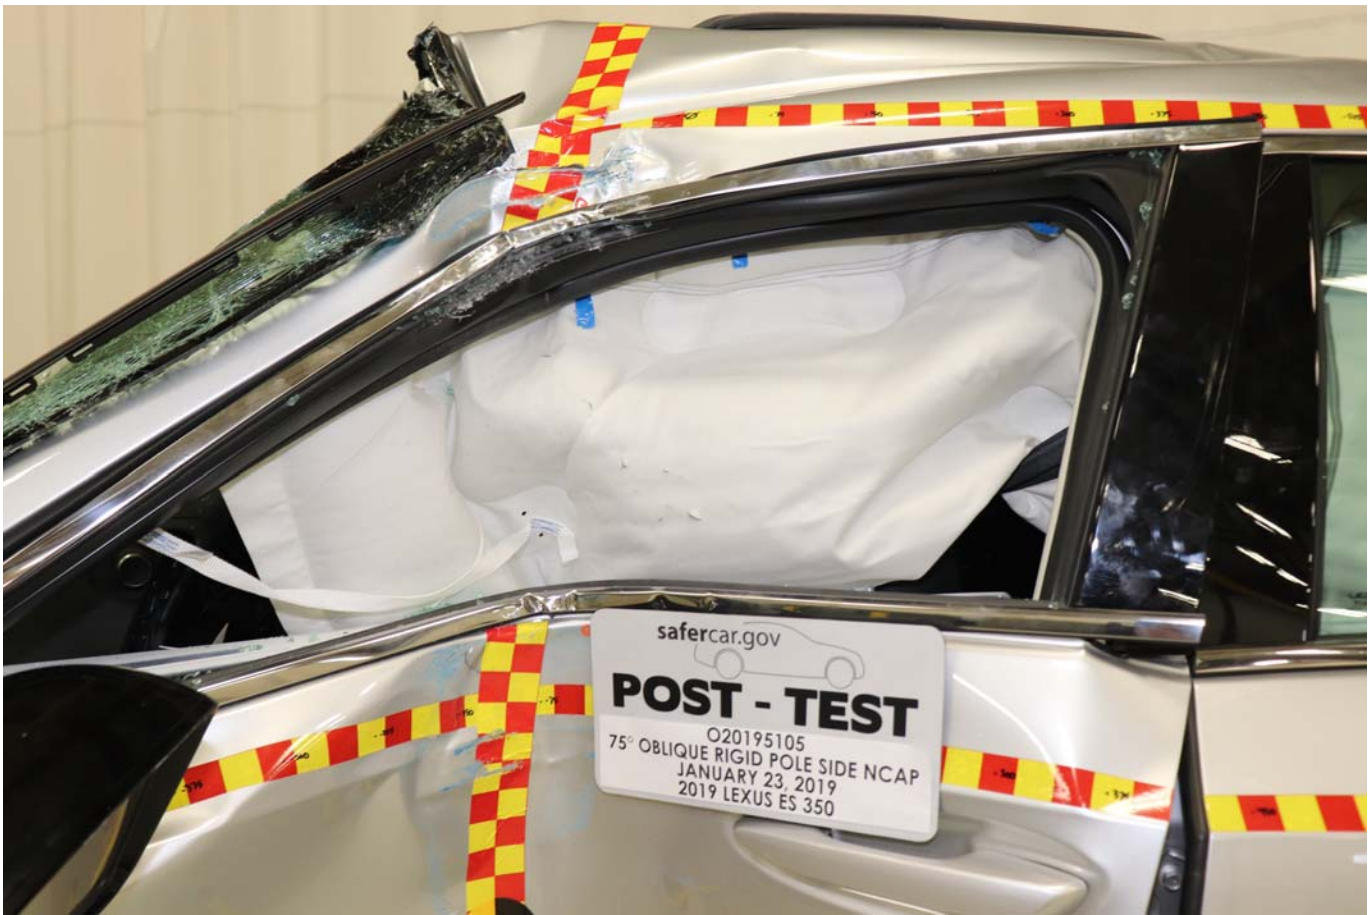
Photo No. 025 - Post-Test Left Side View of Dummy Shoulder and Door Top View

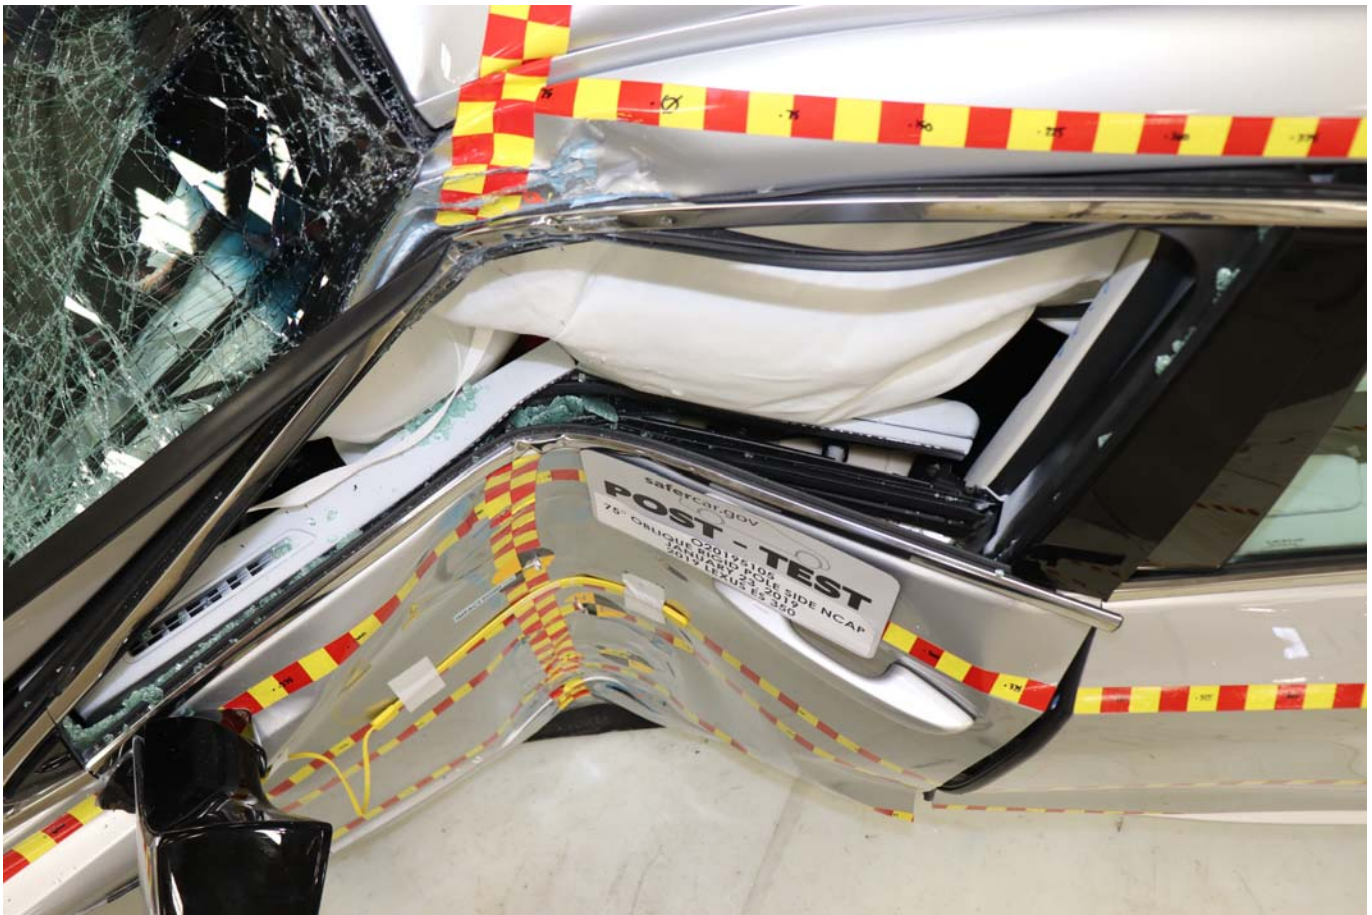
Photo No. 041 - Post-Test Dummy and Door Clearance View

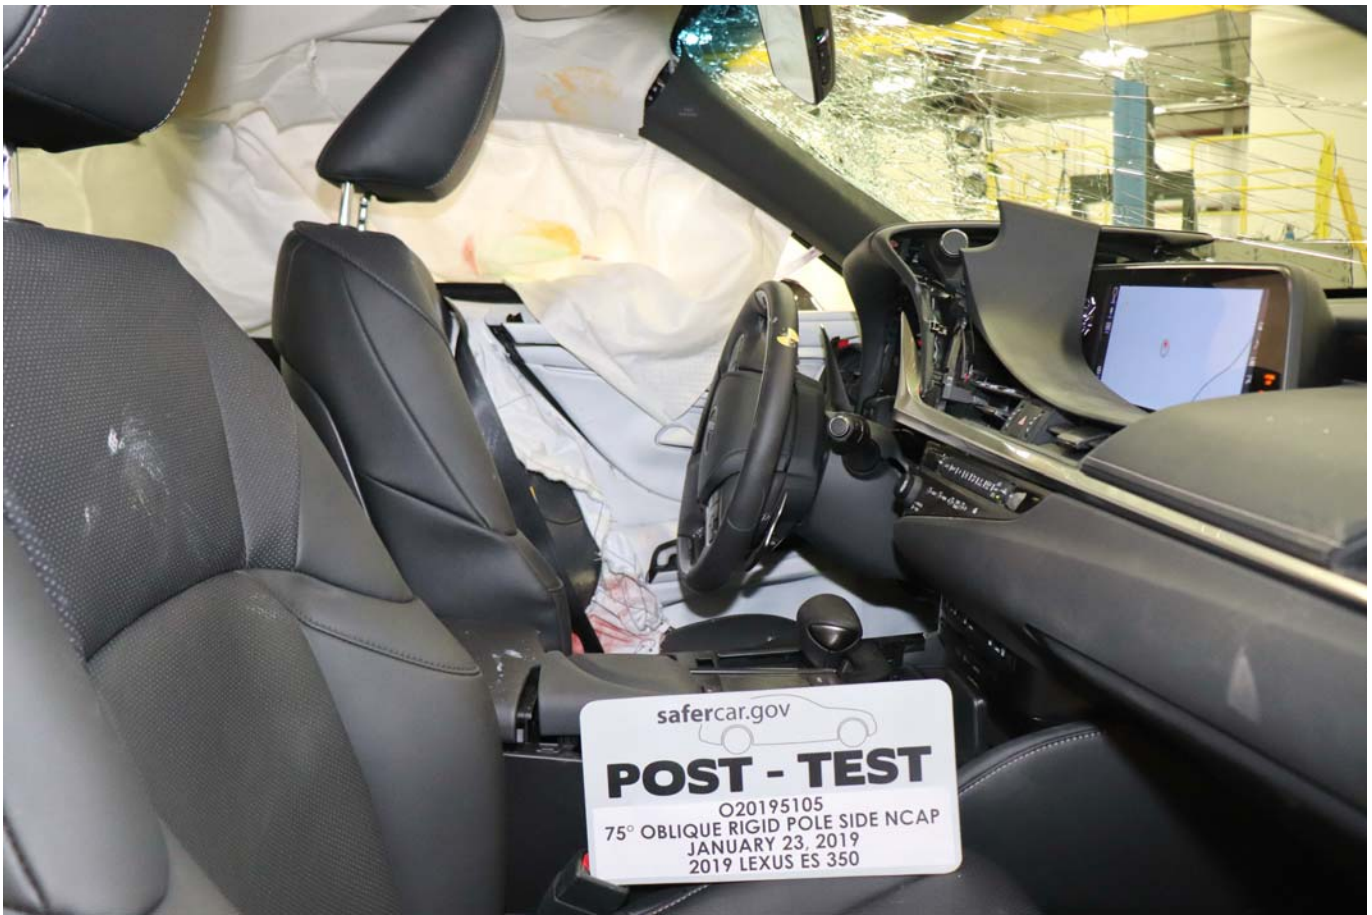
Photo No. 045 - Post-Test Inner Door Panel View Showing Dummy Contact Location

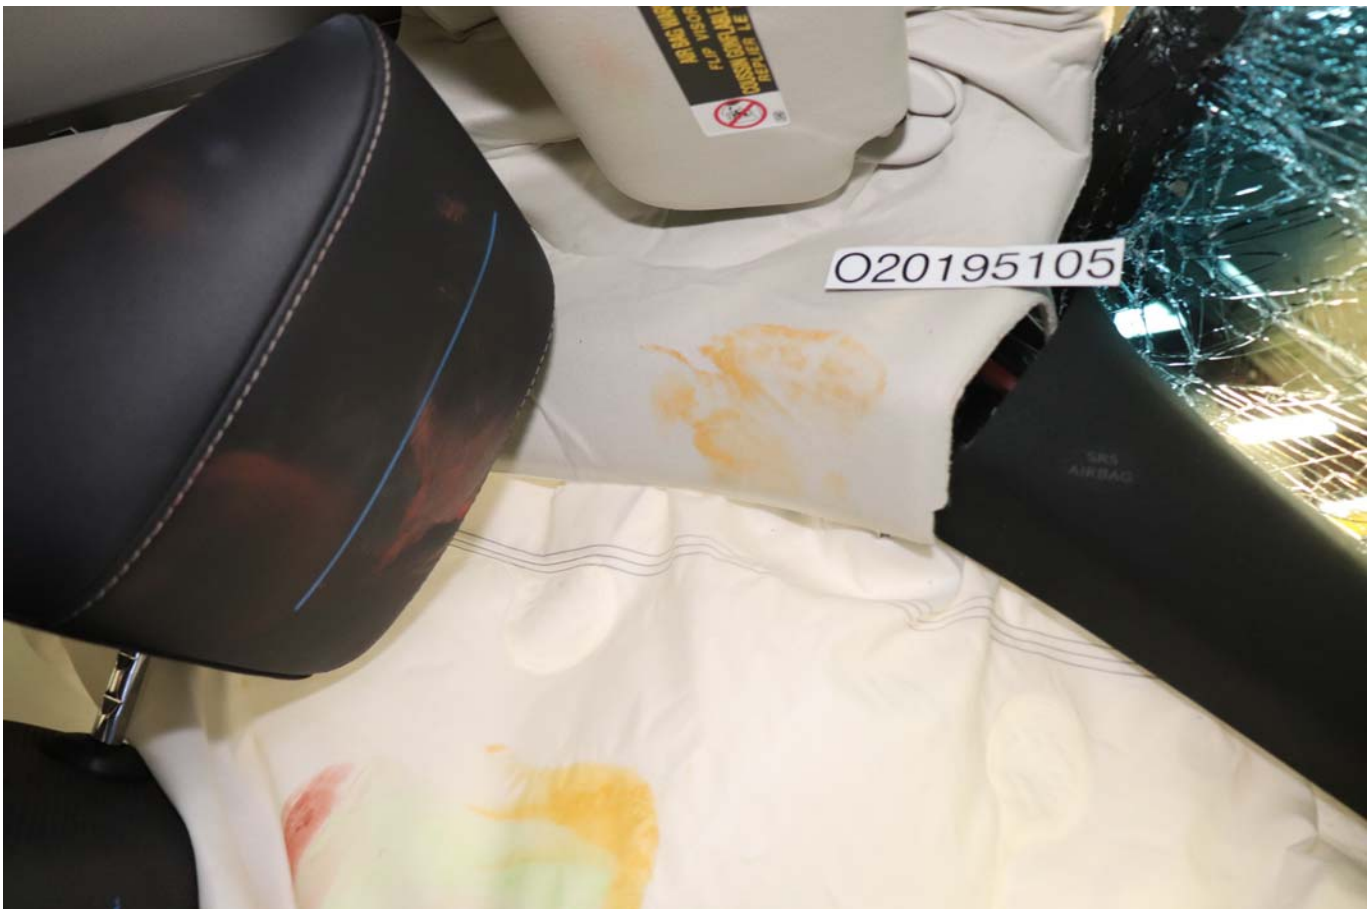
Photo No. 046 – Dummy contact with headliner occurred during removal from vehicle.

Photo No. 046 - Post-Test Dummy Close-Up Head Contact with Vehicle Interior View

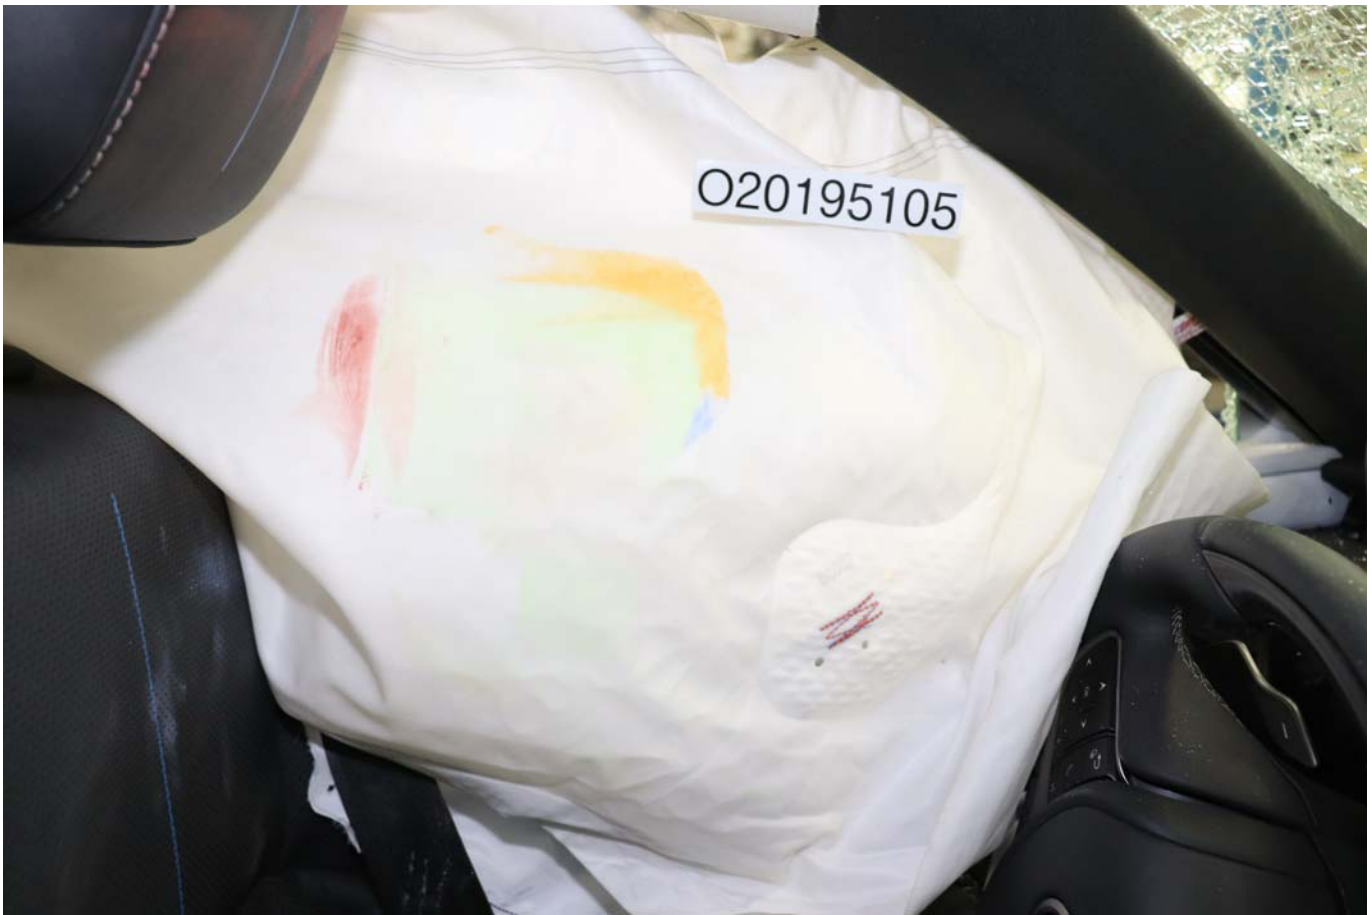
Photo No. 047 - Post-Test Dummy Close-Up Head Contact with Side Air Bag View

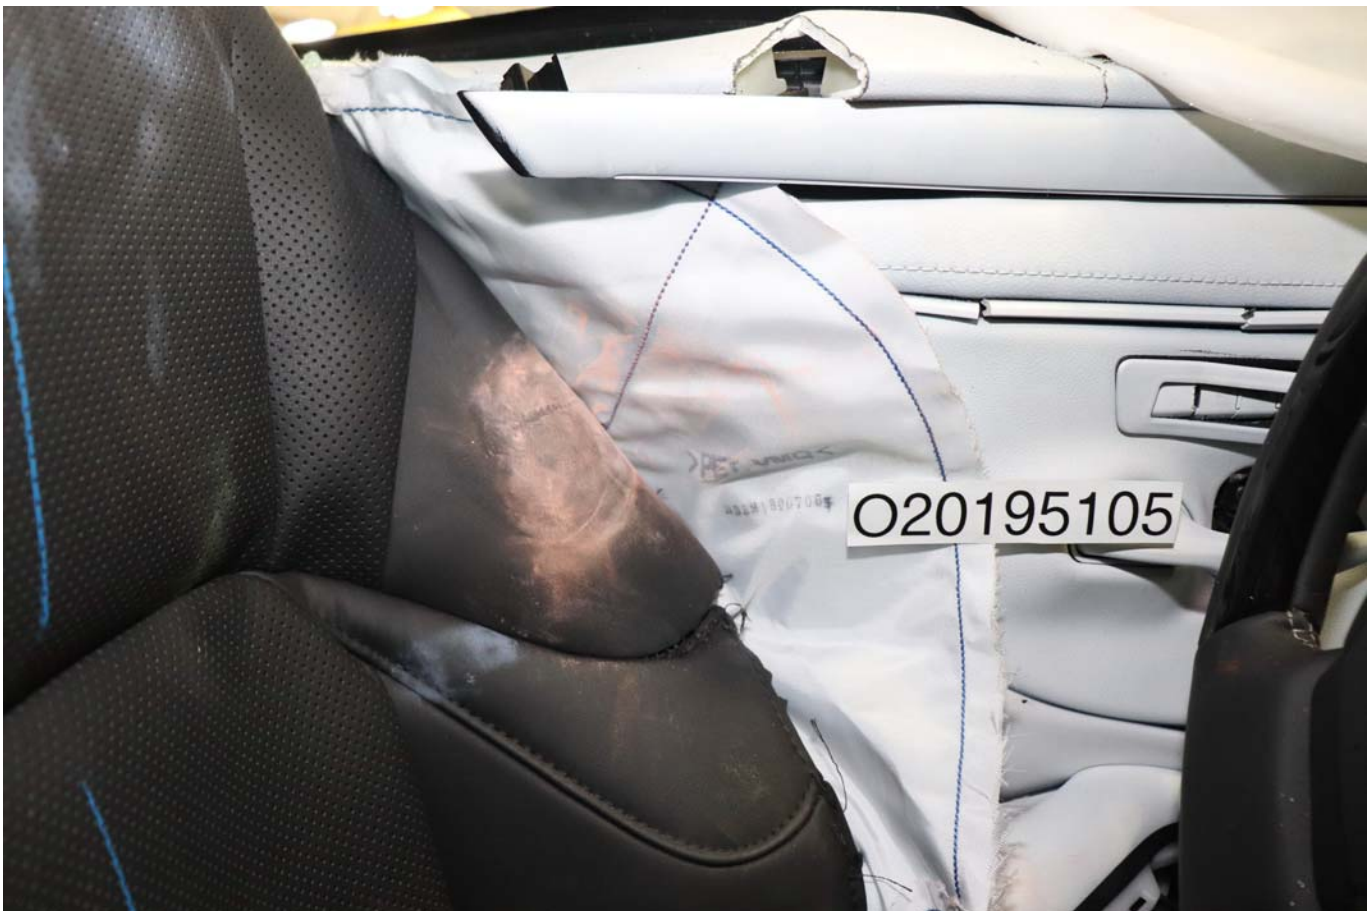
Photo No. 048 - Post-Test Dummy Close-Up Torso Contact with Vehicle Interior View

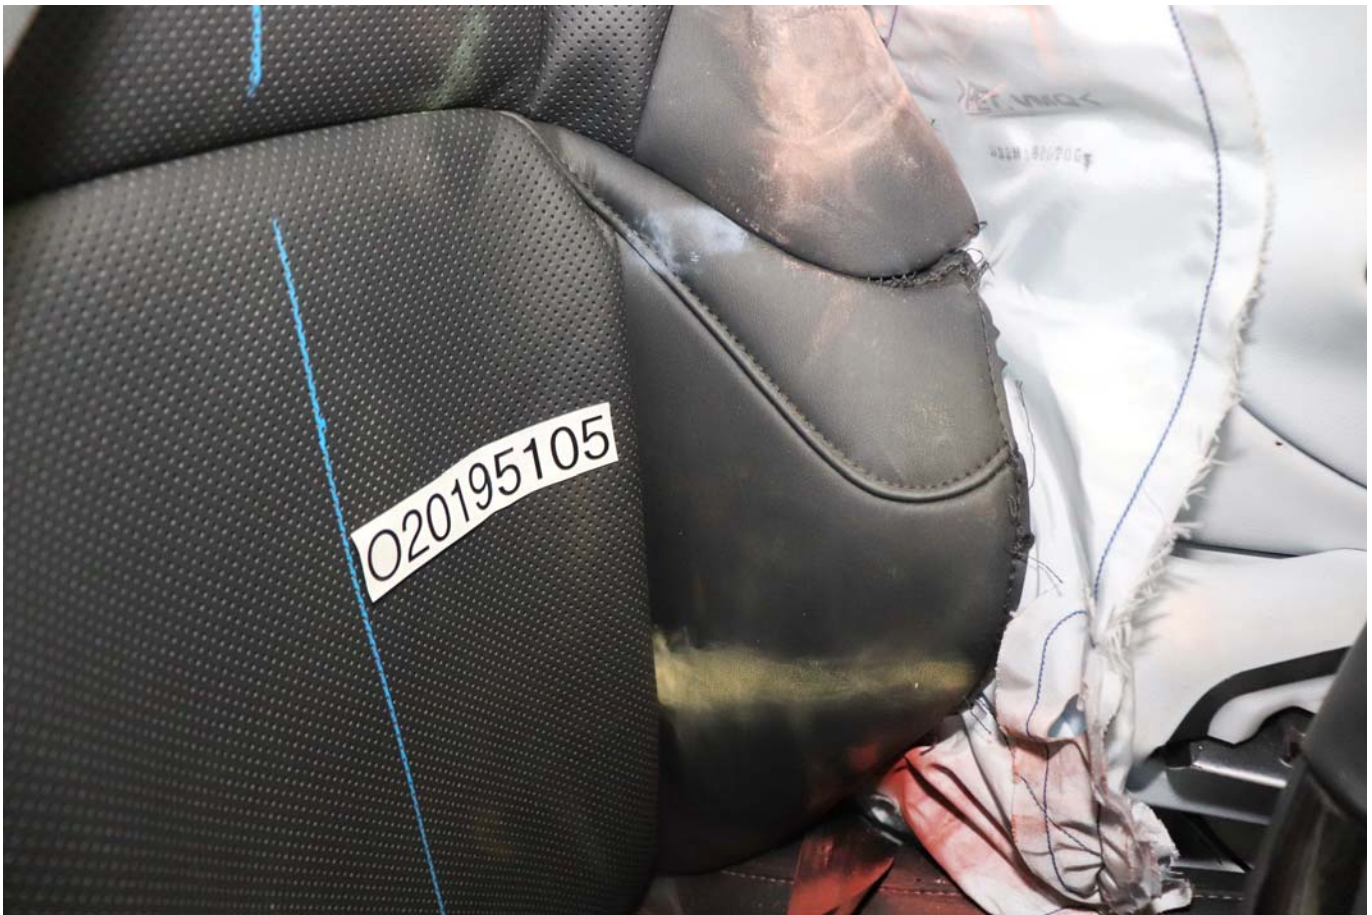
Photo No. 049 - Post-Test Dummy Close-Up Torso Contact with Side Air Bag View

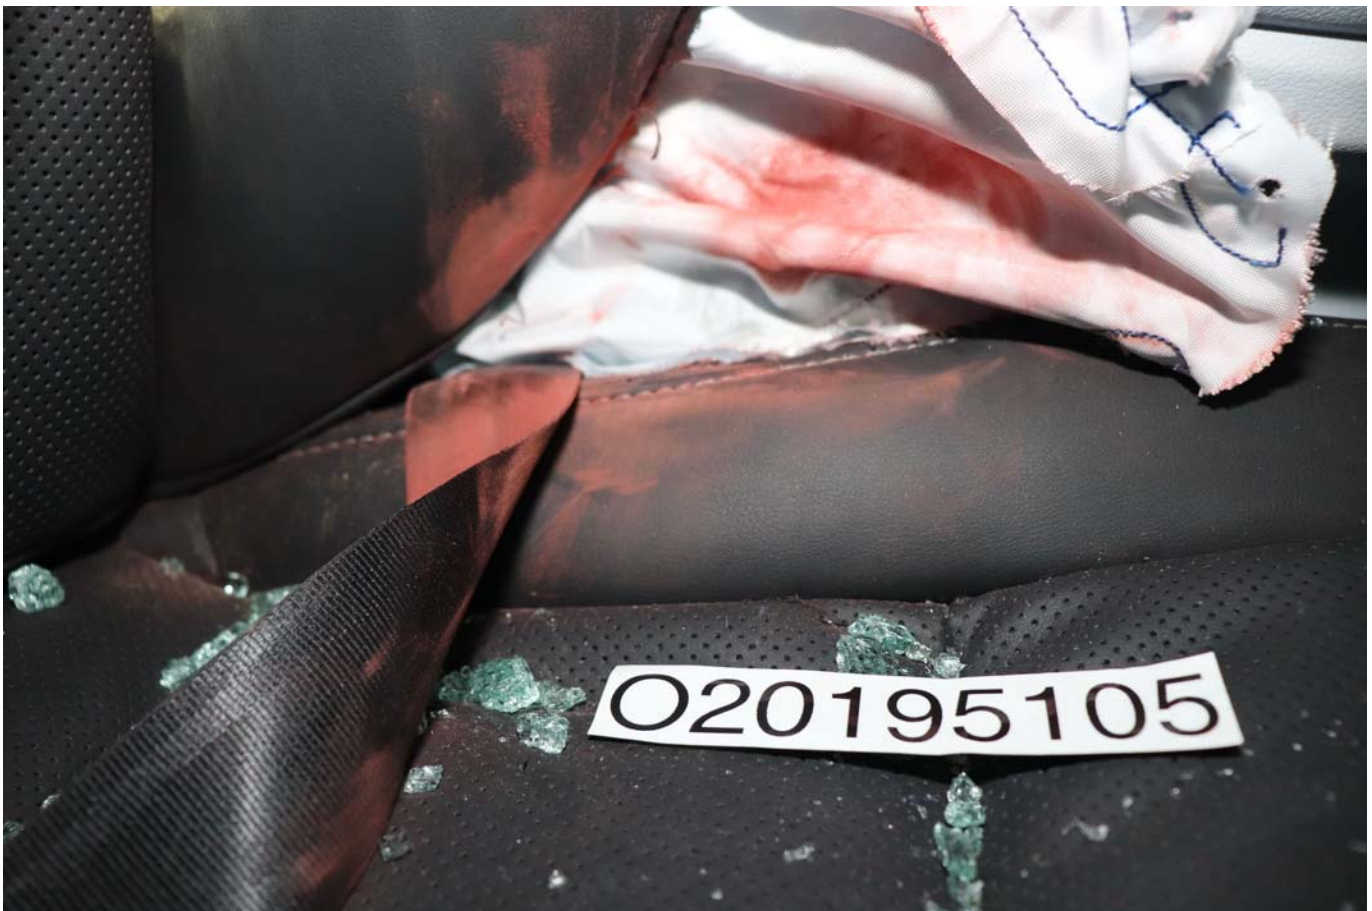
Photo No. 050 - Post-Test Dummy Close-Up Pelvis Contact with Vehicle Interior View

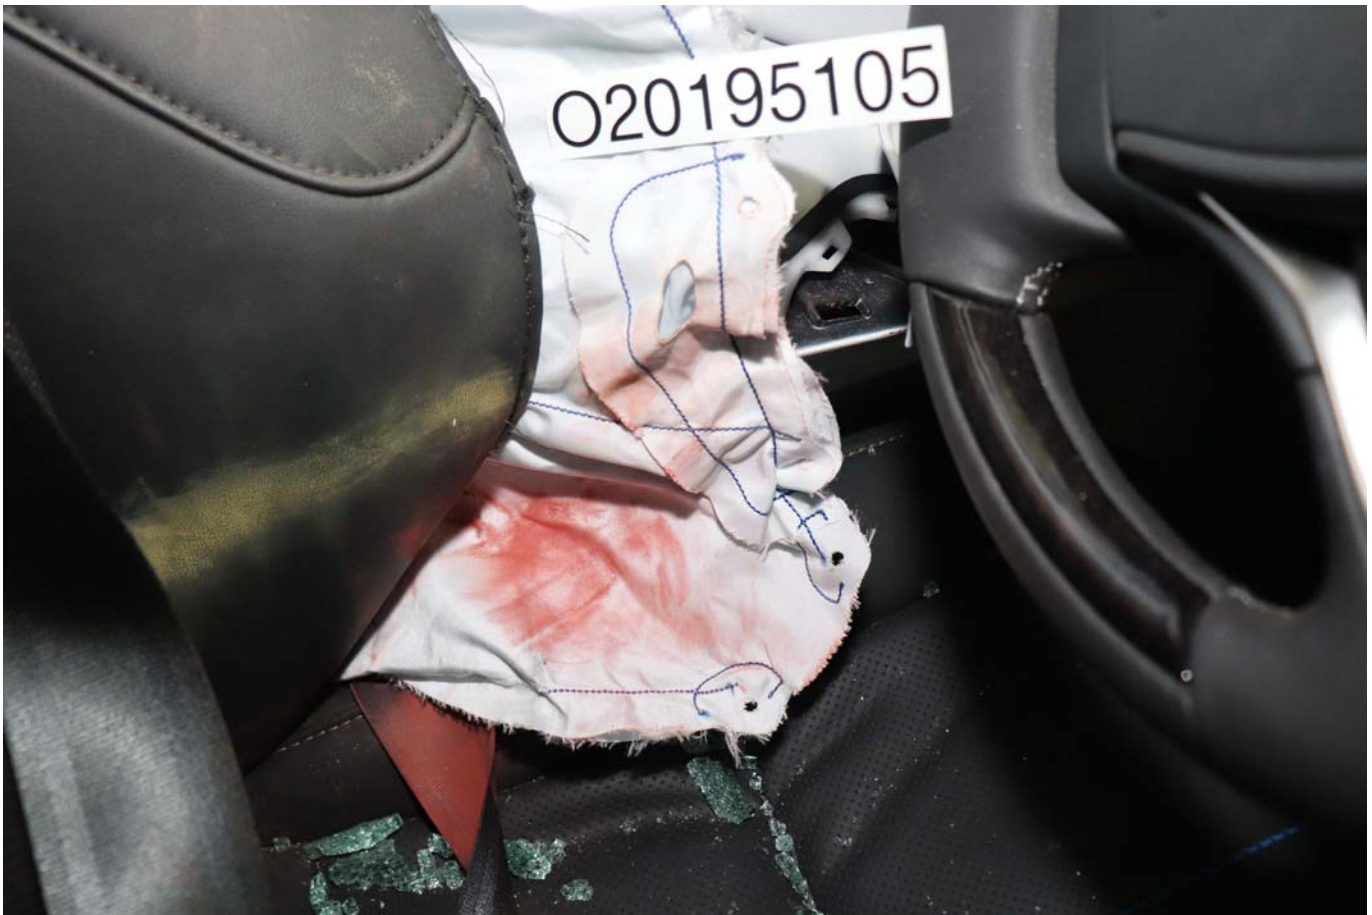
Photo No. 051 - Post-Test Dummy Close-Up Pelvis Contact with Side Air Bag View

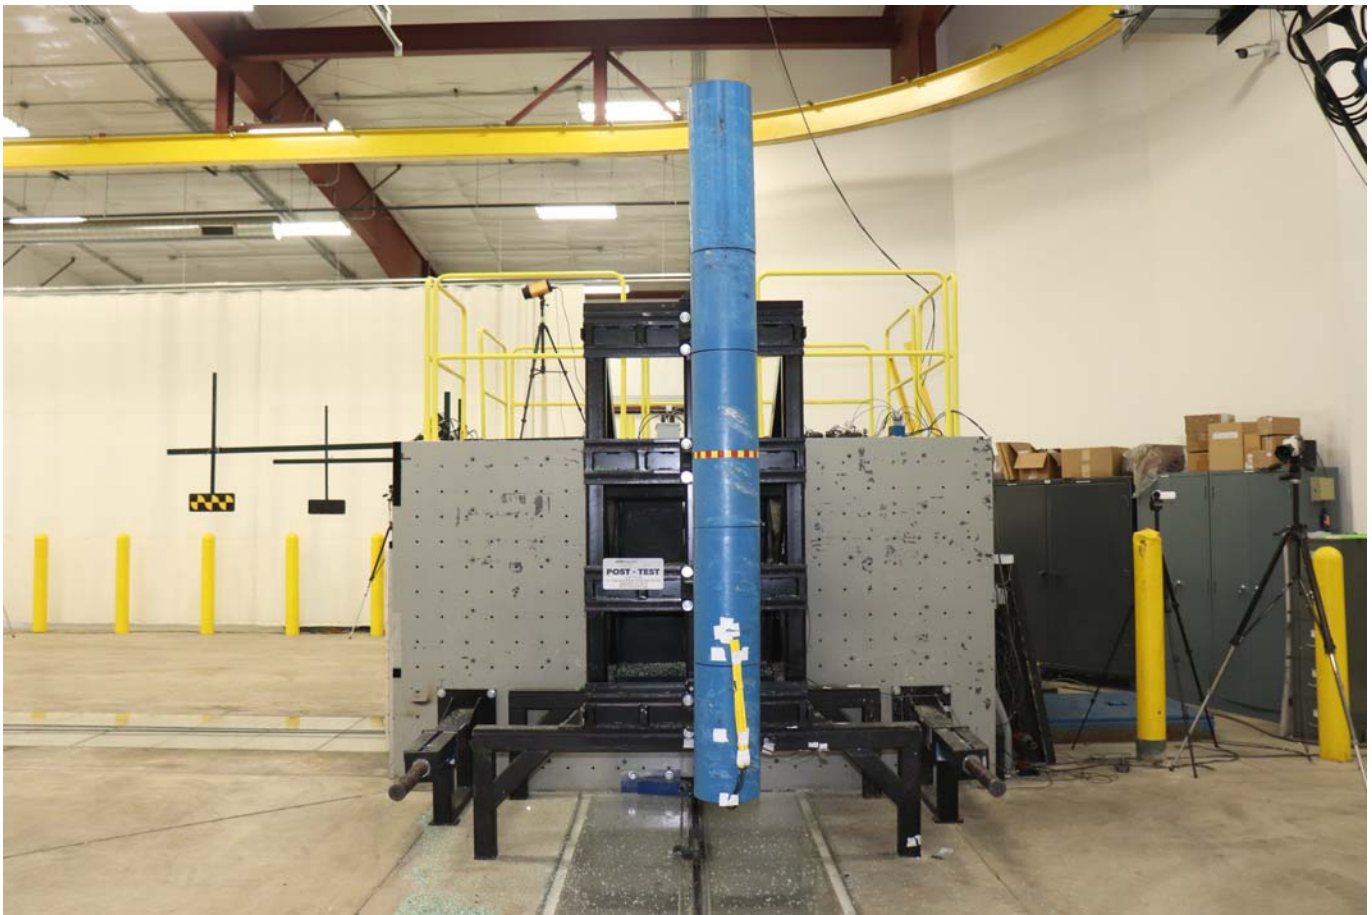
Photo No. 058 - Post-Test Pole Barrier Front View

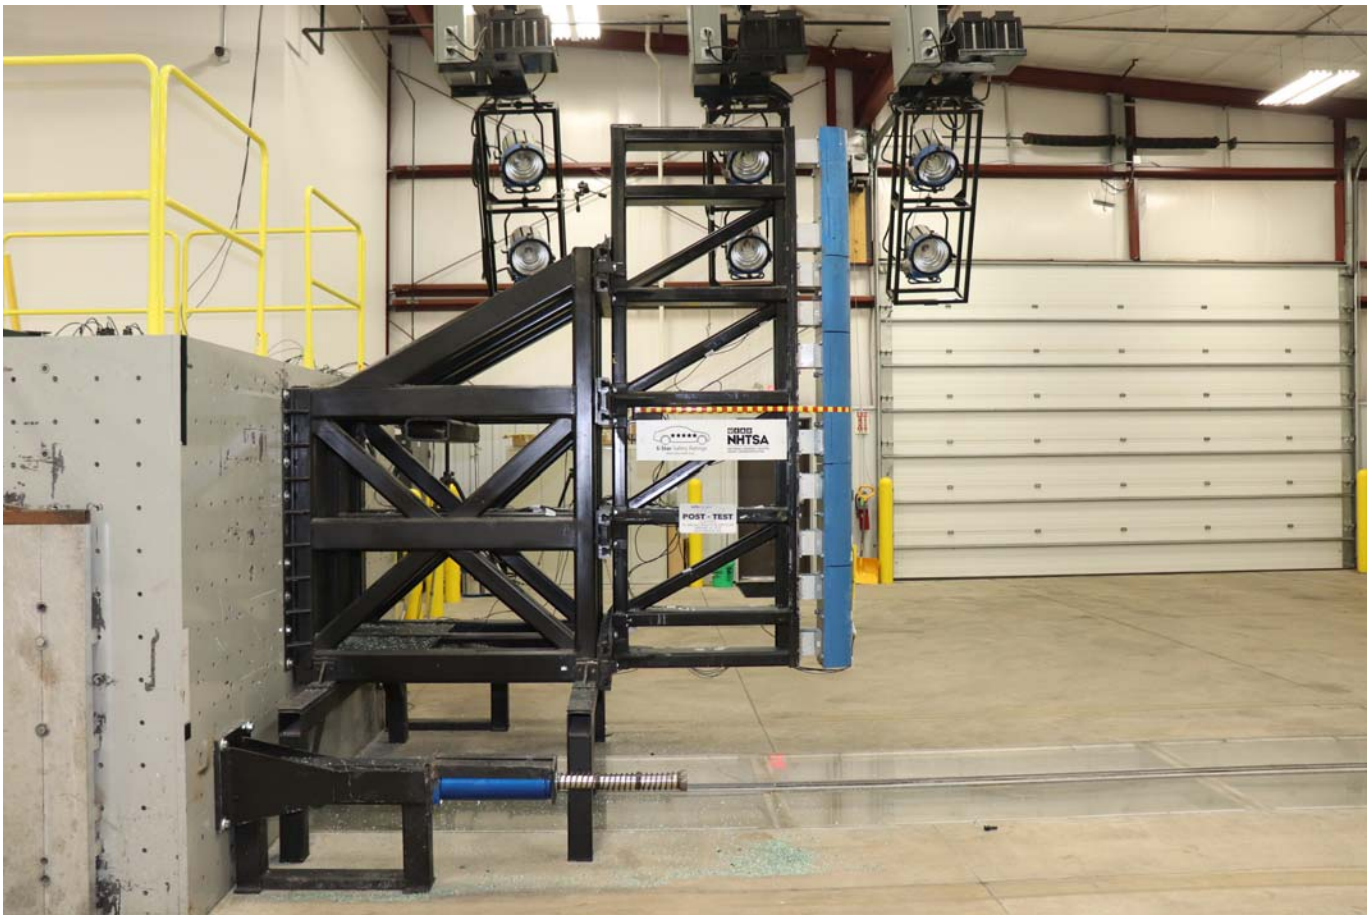
Photo No. 060 - Post-Test Pole Barrier Side View

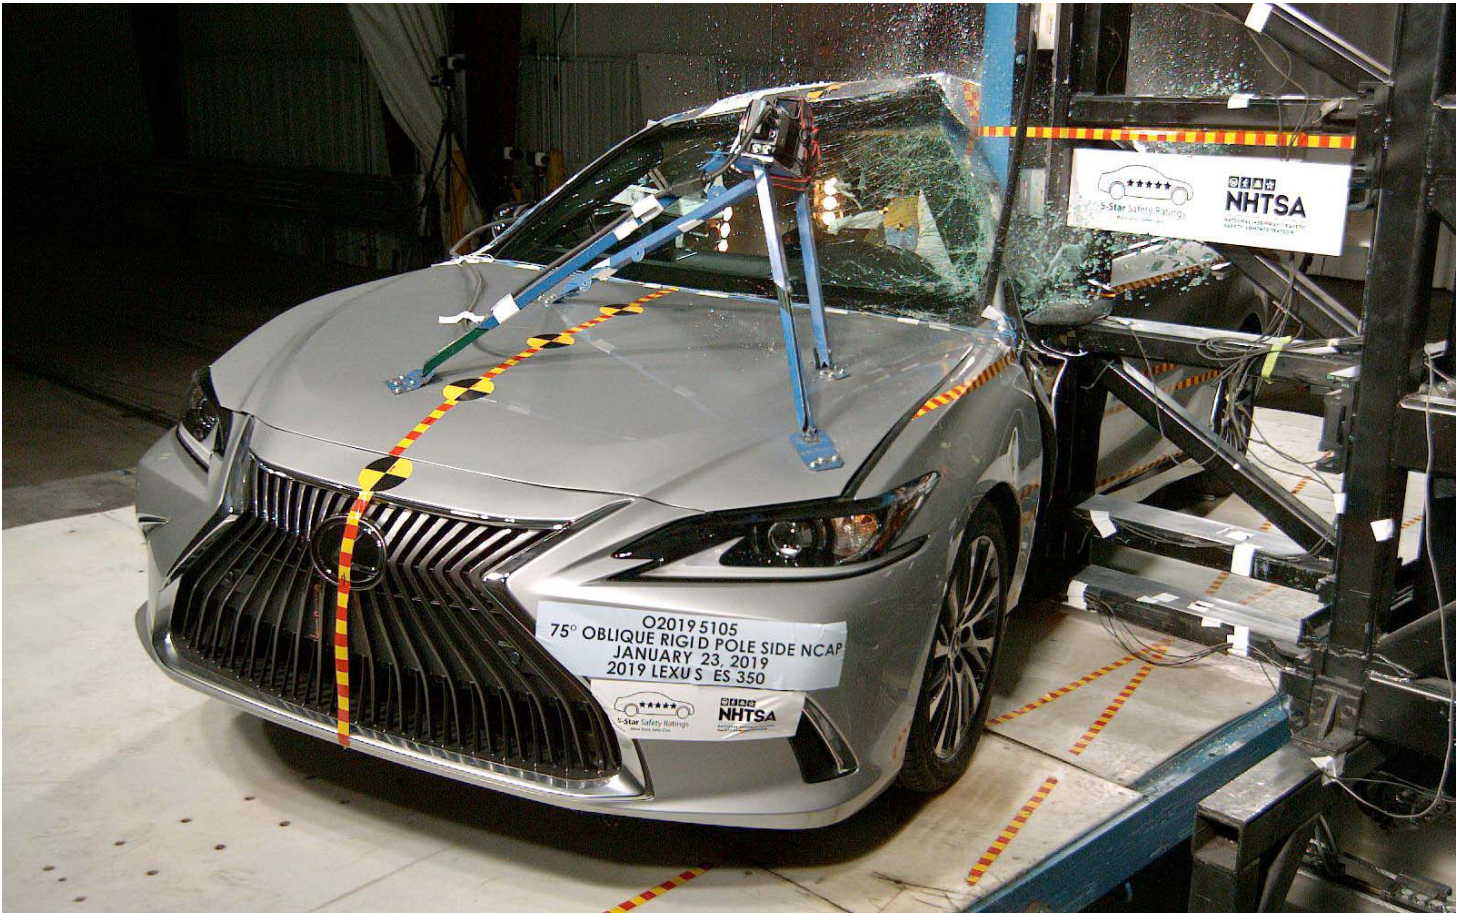
Photo No. 068 - Impact Event
