REPORT NUMBER: NCAP-MGA-2019-024

**NEW CAR ASSESSMENT PROGRAM (NCAP)
Frontal Barrier Impact Test**

**AUDI AG
2019 Audi Q8 Premium Plus 5-Door SUV
NHTSA No.: O20195800**

**MGA RESEARCH CORPORATION
5000 Warren Road
Burlington, WI 53105**

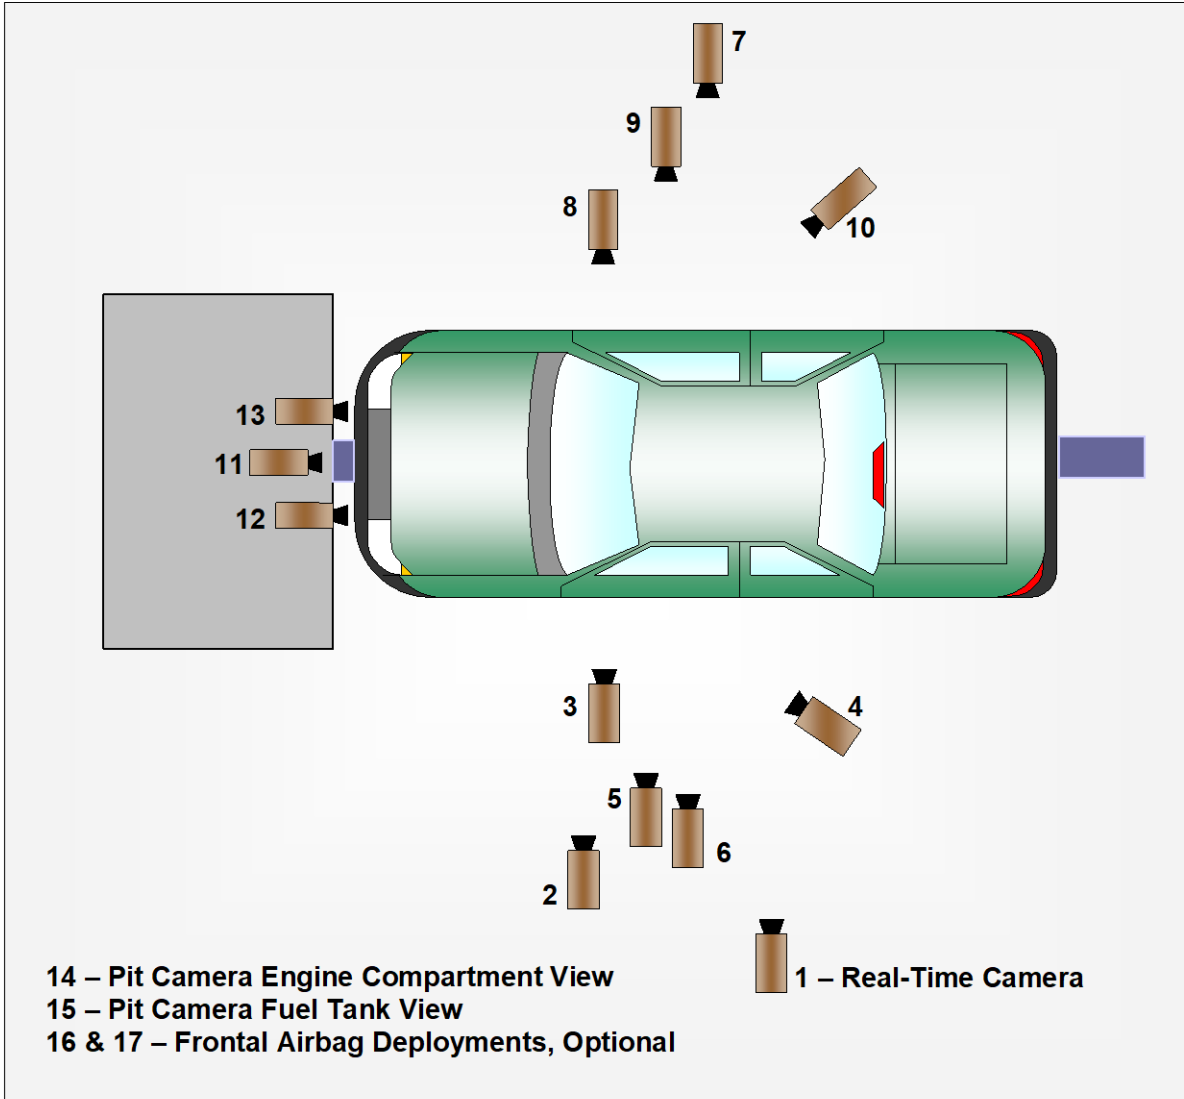
CAMERA POSITIONS FOR FRONTAL IMPACTS

Two (2) real-time cameras and fourteen (14) high-speed cameras were used to document the frontal barrier impact event. Camera locations and other pertinent camera information can be found in this report.

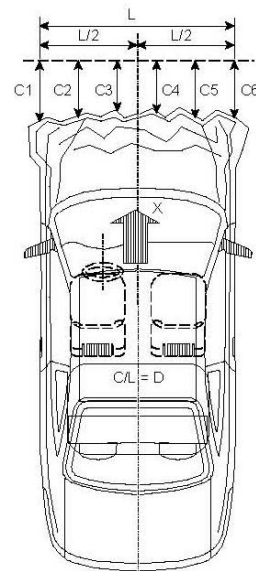
Midpoint of Damage: Centerline

Damage Region Length (mm): 1360

Impact Mode: Frontal

No.	Measurement Description	Units	Pre-Test	Post-Test	Difference
C1	Crush zone 1 at left side	mm	4844	4461	383
C2	Crush zone 2 at left side	mm	4940	4394	546
C3	Crush zone 3 at left side	mm	4958	4334	624
C4	Crush zone 4 at right side	mm	4958	4391	567
C5	Crush zone 5 at right side	mm	4940	4461	479
C6	Crush zone 6 at right side	mm	4844	4460	384
L	C1 TO C6	mm	1360	1384	-24

The maximum static crush of the vehicle was 624 mm located to the left of the vehicle centerline and both the driver and passenger side doors remained closed during the impact event and were operable after the impact.

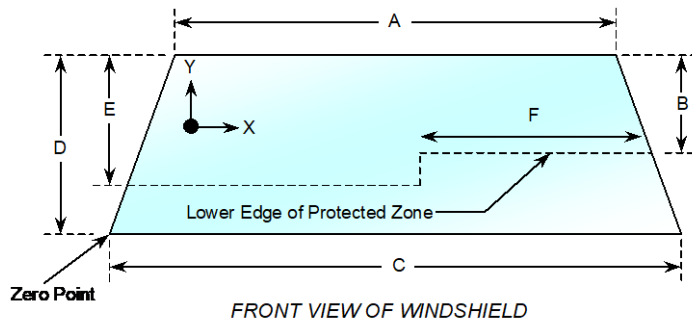
WINDSHIELD PERIPHERY MEASUREMENTS

Measurement	Pre-Test (mm)	Post-Test (mm)	% of Retention
Left Side	2230	2230	100.0
Right Side	2230	2230	100.0
Total	4460	4460	100.0

Item	Units	Value
A	mm	1244
B	mm	376
C	mm	1628
D	mm	794
E	mm	461
F	mm	520

AREA OF PROTECTED ZONE FAILURES - NONE

There was 100 percent windshield retention and no intrusion into the protected zone of the windshield during the event. There was no Stoddard Solvent leakage after the event or during any phase of the static rollover.

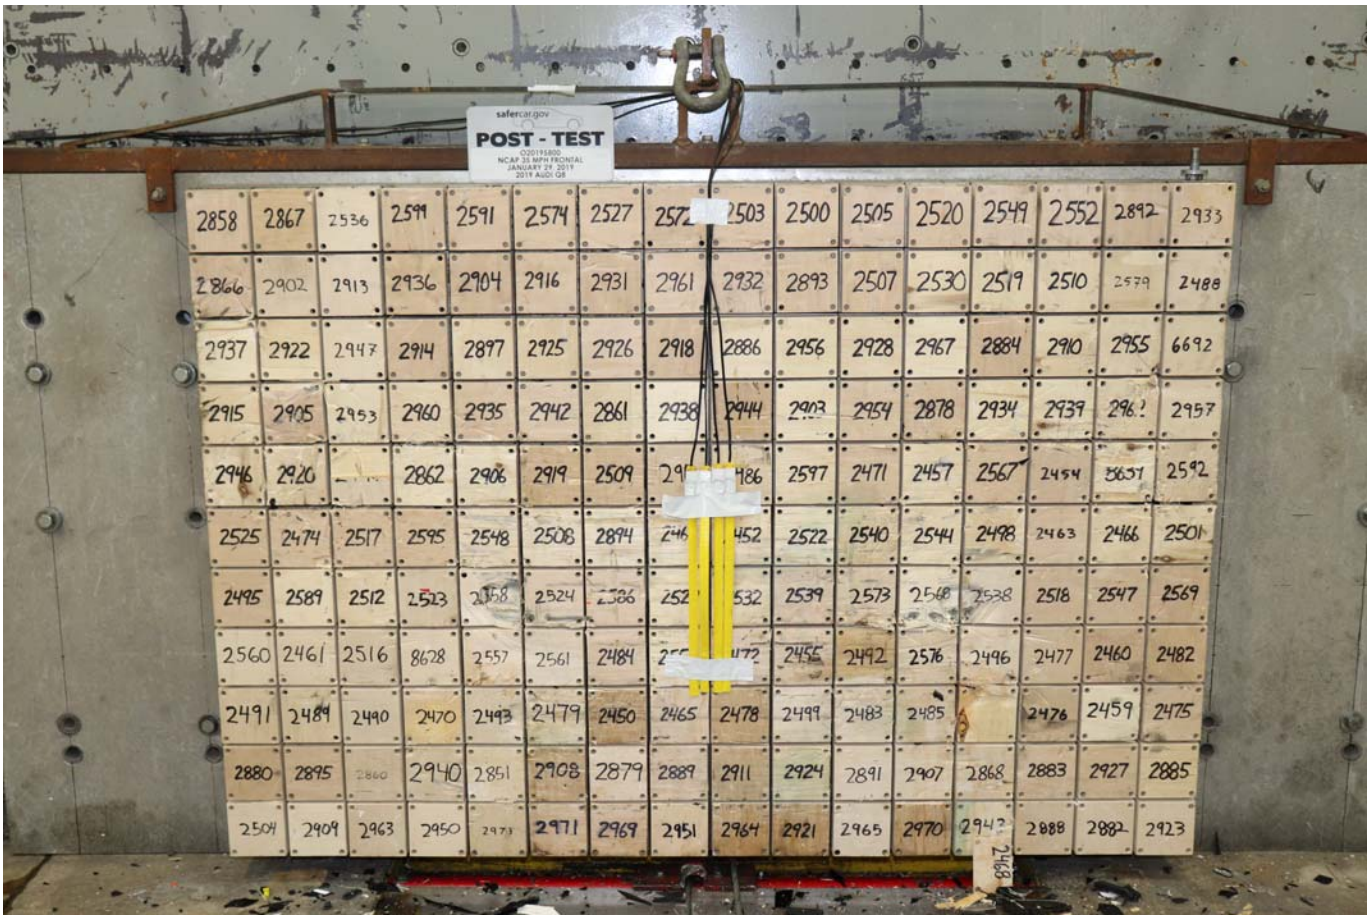
Photo No. 003 - Post-Test Load Cell Wall

A load cell barrier consisting of 176 load cells was impacted by a 2019 Audi Q8 Premium Plus 5-Door SUV at a velocity of 56.21 km/h. The test was performed at MGA Research Corporation on January 29, 2019. Pre-test and post-test photographs of the vehicle and dummies can be found in Appendix A.

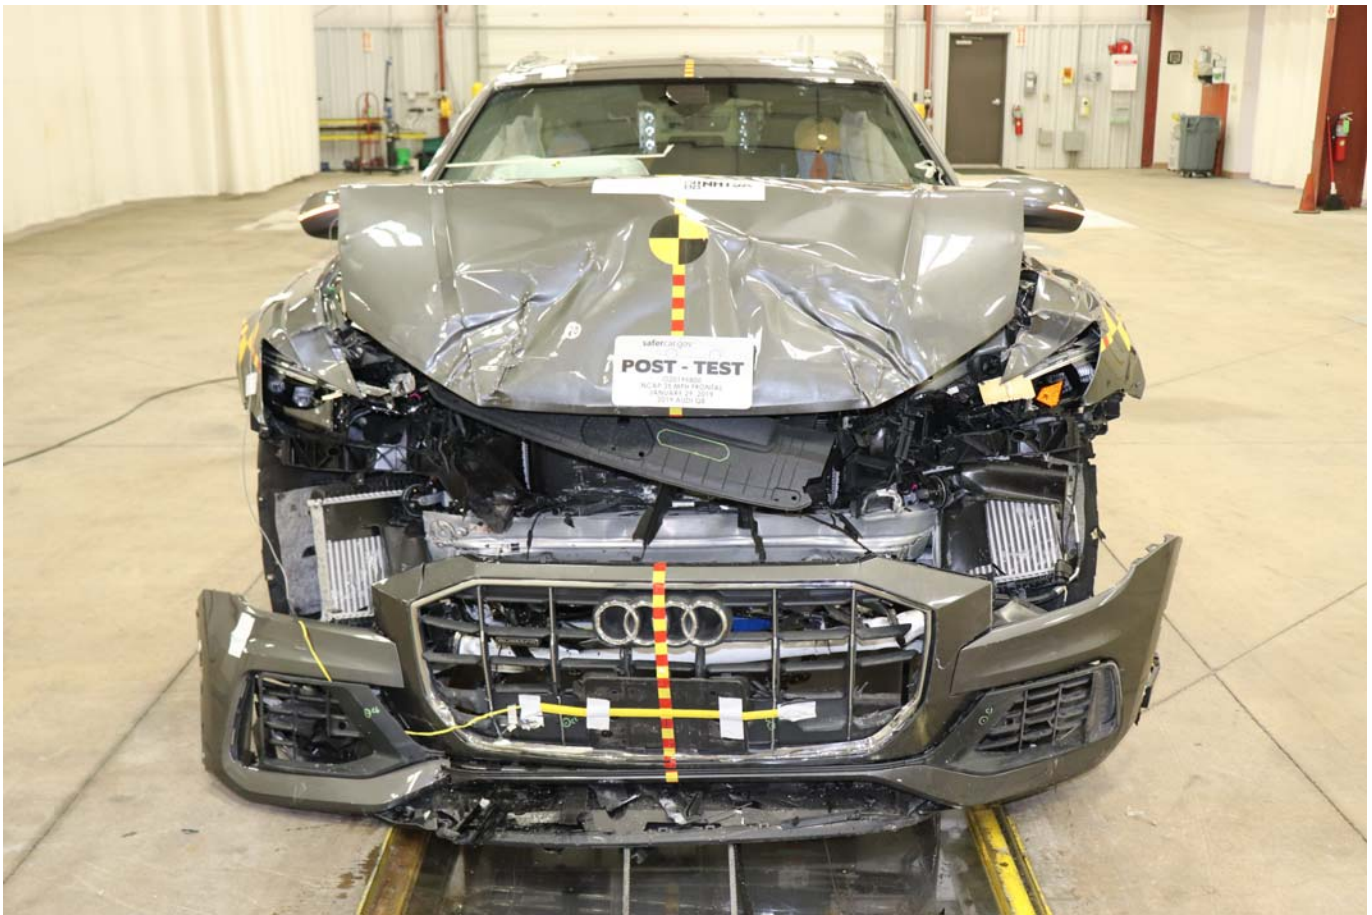
Photo No. 009 - Post-Test Front View of Test Vehicle

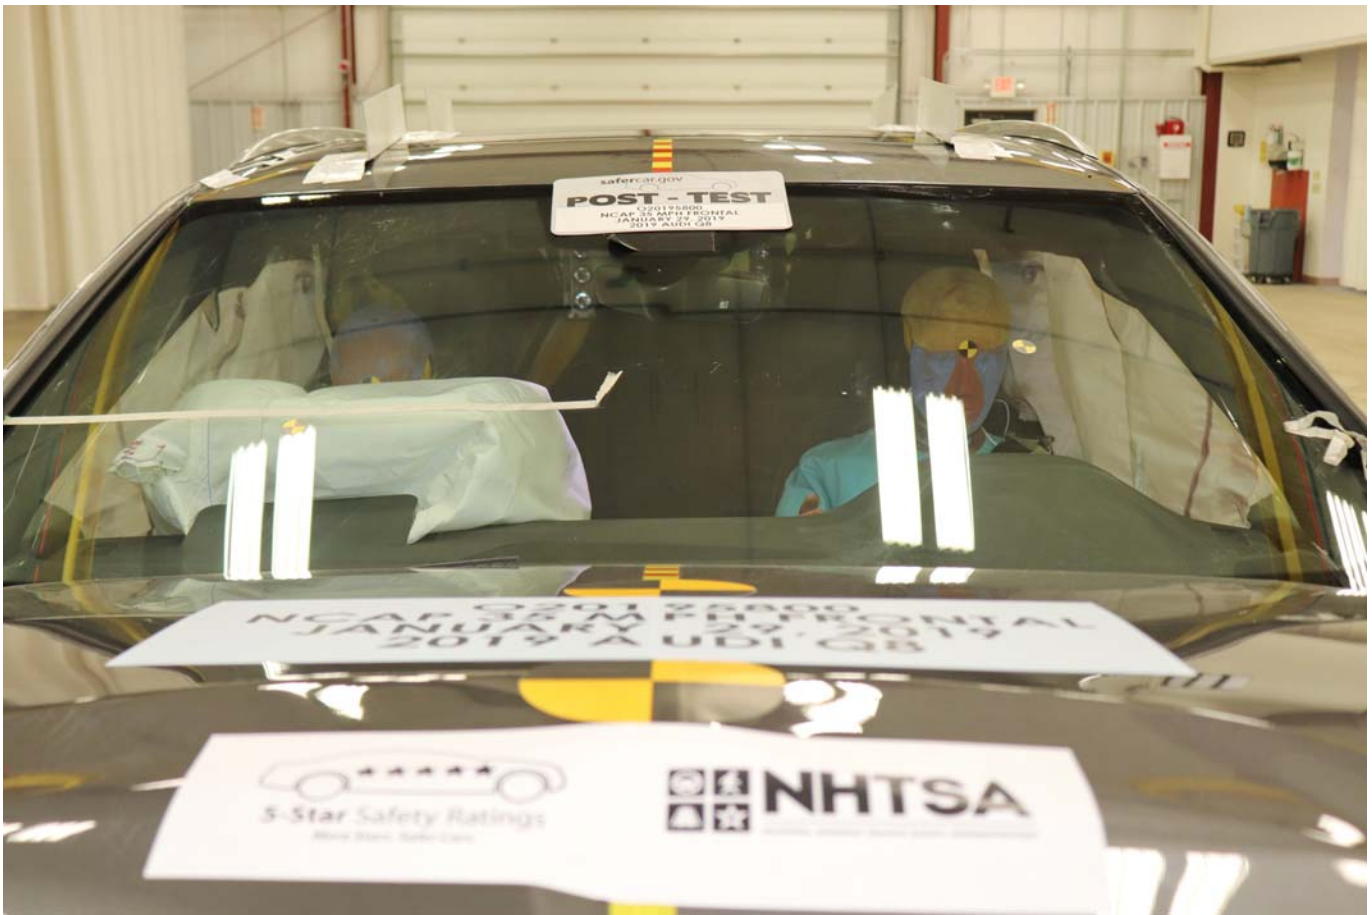
Photo No. 019 - Post-Test Windshield View

Critical Areas of Performance	Observations and Conclusions
Windshield Damage	Cracked
Window Damage	None
Other Notable Effects	None

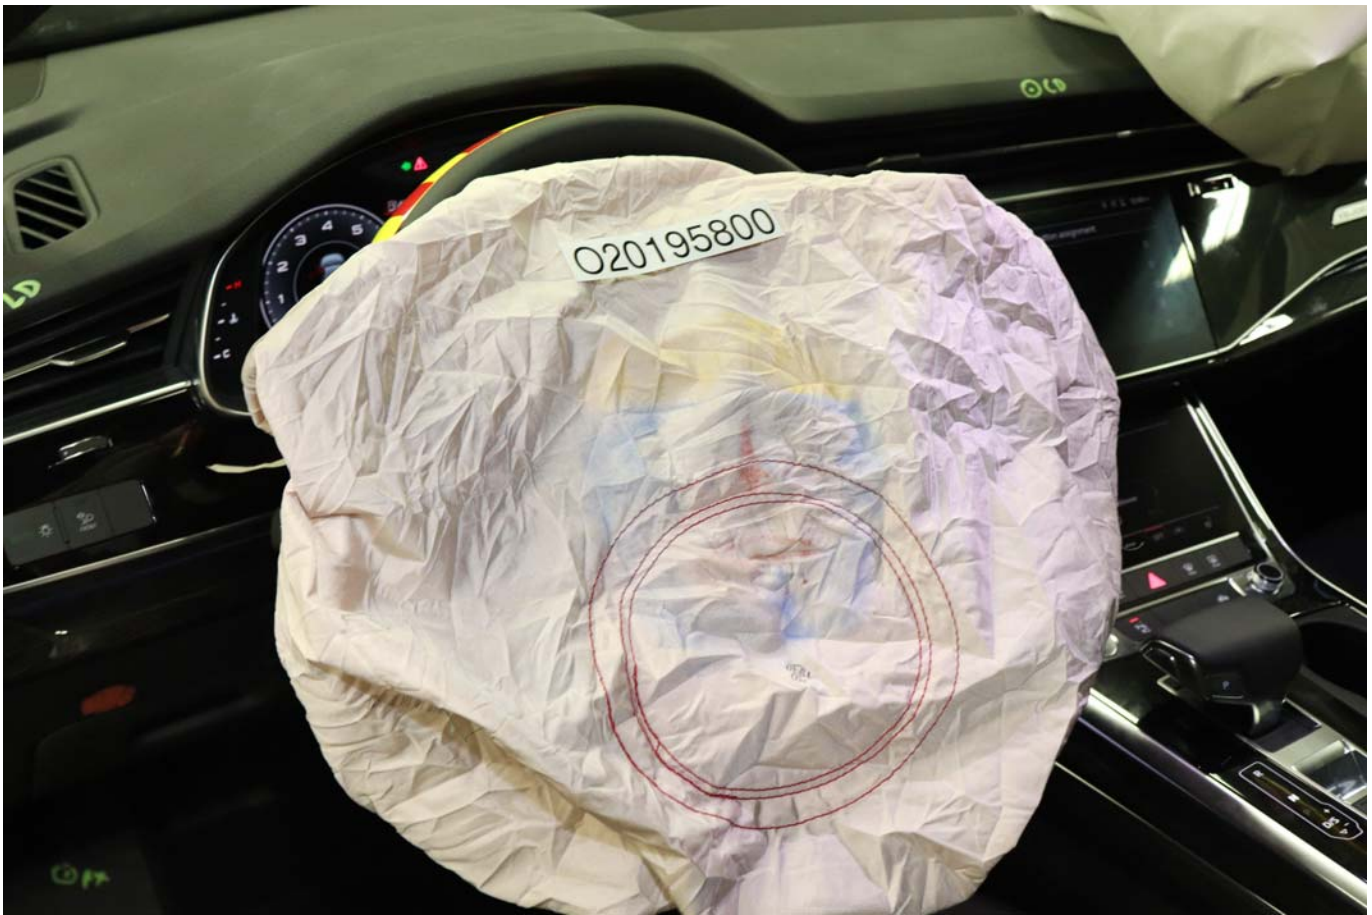
Photo No. 047 - Post-Test Driver Dummy Contact with Airbag

The driver's visible contact points were as follows: The driver's head contacted the airbag. The driver's head also contacted the headrest.

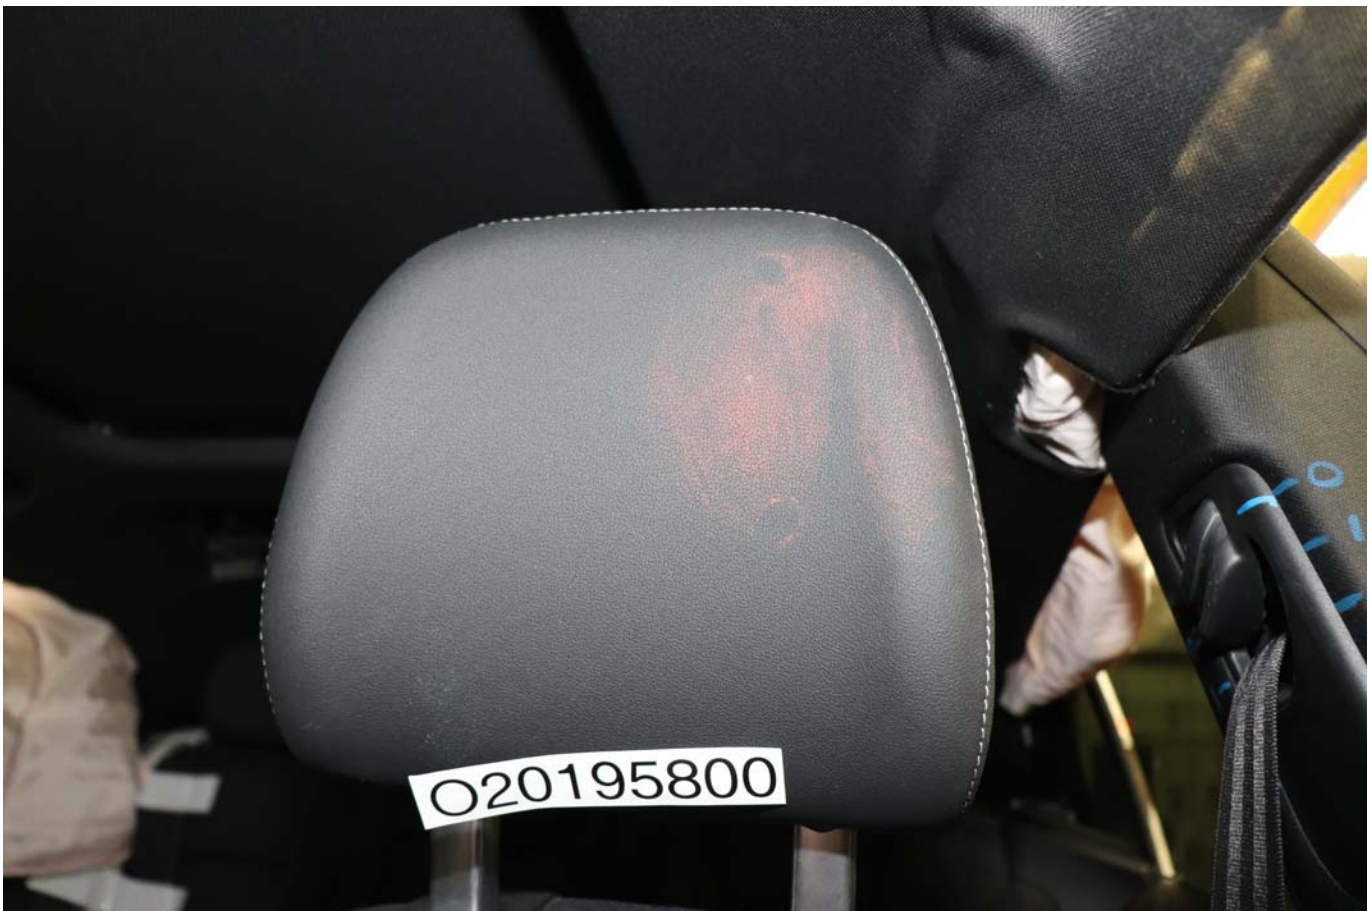
Photo No. 048 - Post-Test Driver Dummy Contact with Headrest

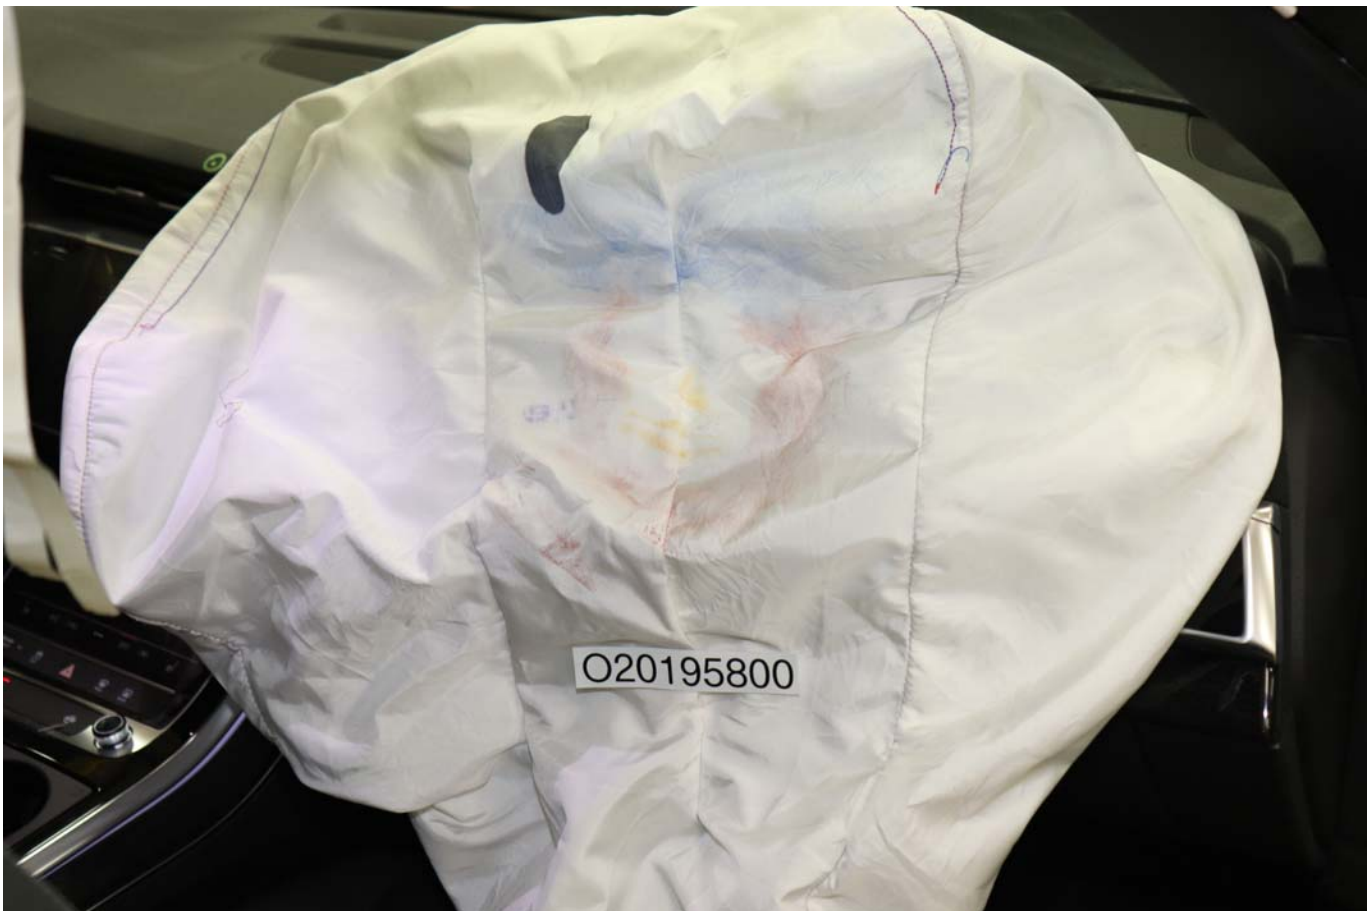
Photo No. 068 - Post-Test Passenger Dummy Contact with Airbag

The passenger's visible contact points were as follows: The passenger's head contacted the airbag. The passenger's head also contacted the headrest.

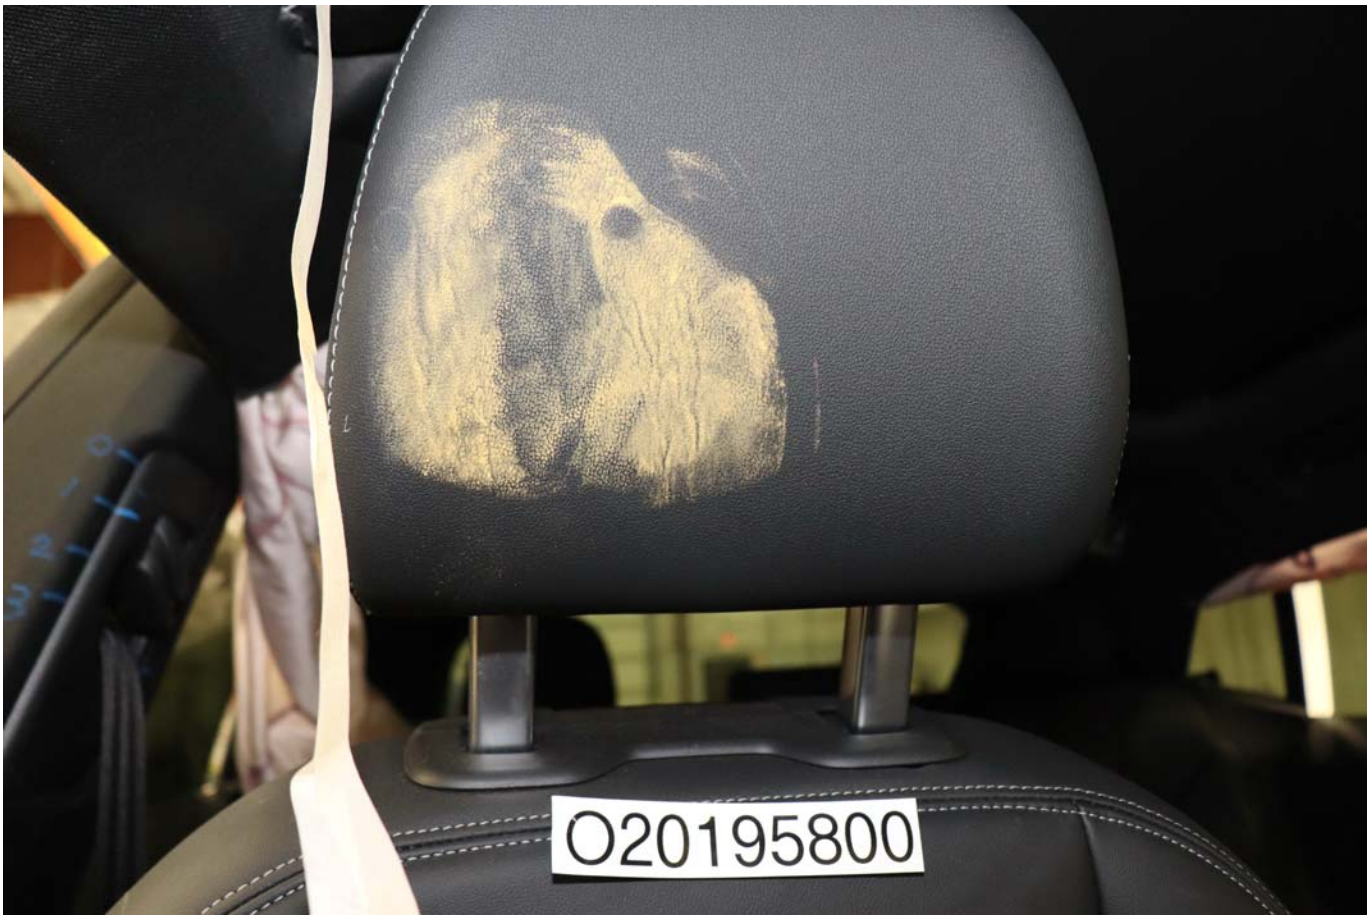
Photo No. 069 - Post-Test Passenger Dummy Contact with Headrest
