**REPORT NUMBER: SINCAP-MGA-2019-026**

**NEW CAR ASSESSMENT PROGRAM (NCAP)  
Moving Deformable Barrier Side Impact Test**

**AUDI AG  
2019 Audi Q8 Premium 5-Door SUV  
NHTSA No.: O20195802**

**MGA RESEARCH CORPORATION  
5000 Warren Road  
Burlington, WI 53105**

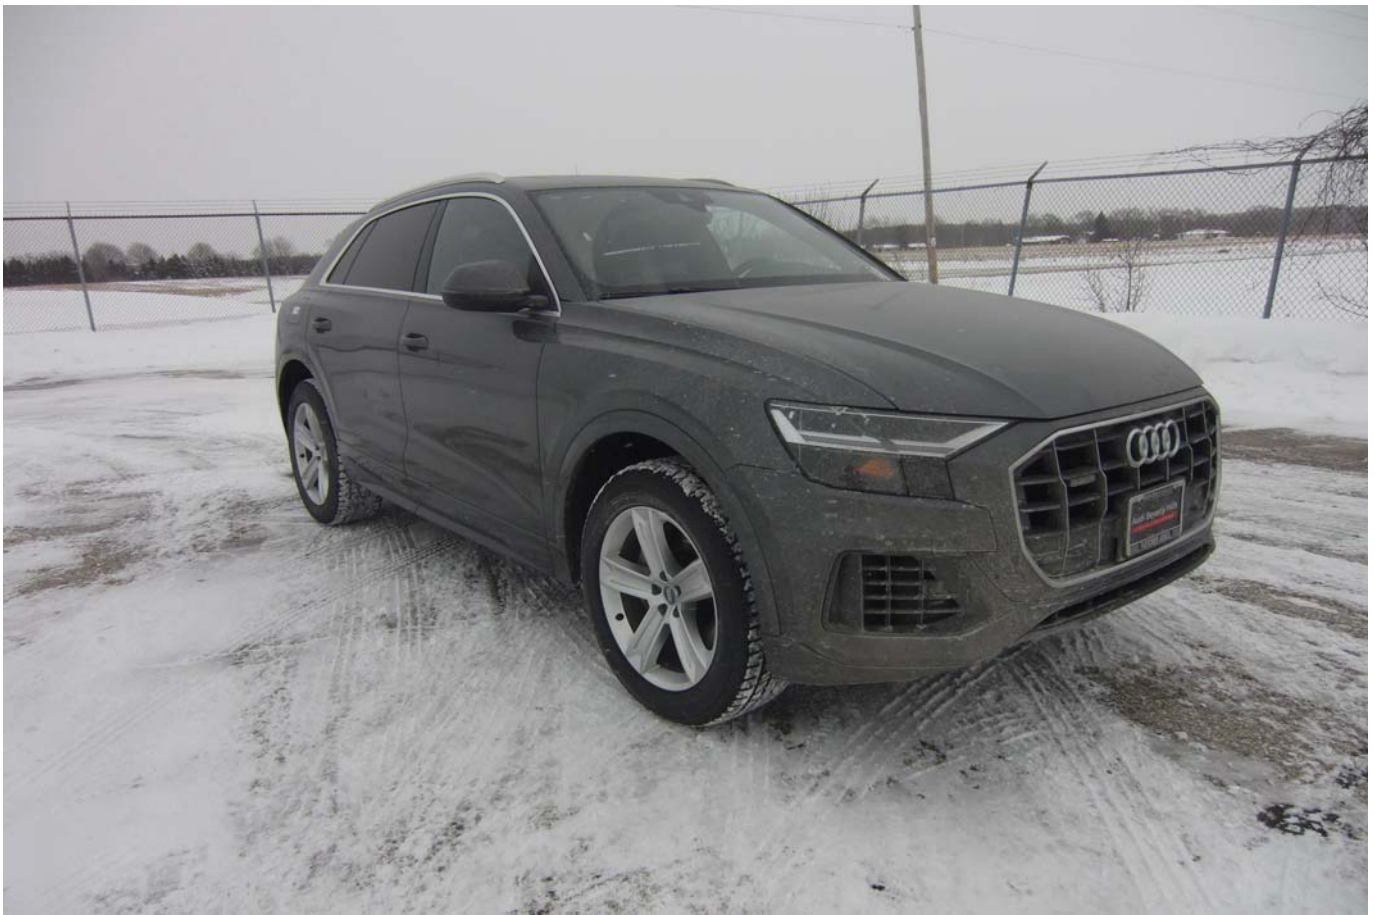
Photo No. 001 - As Delivered Right Front Three-Quarter View of Test Vehicle

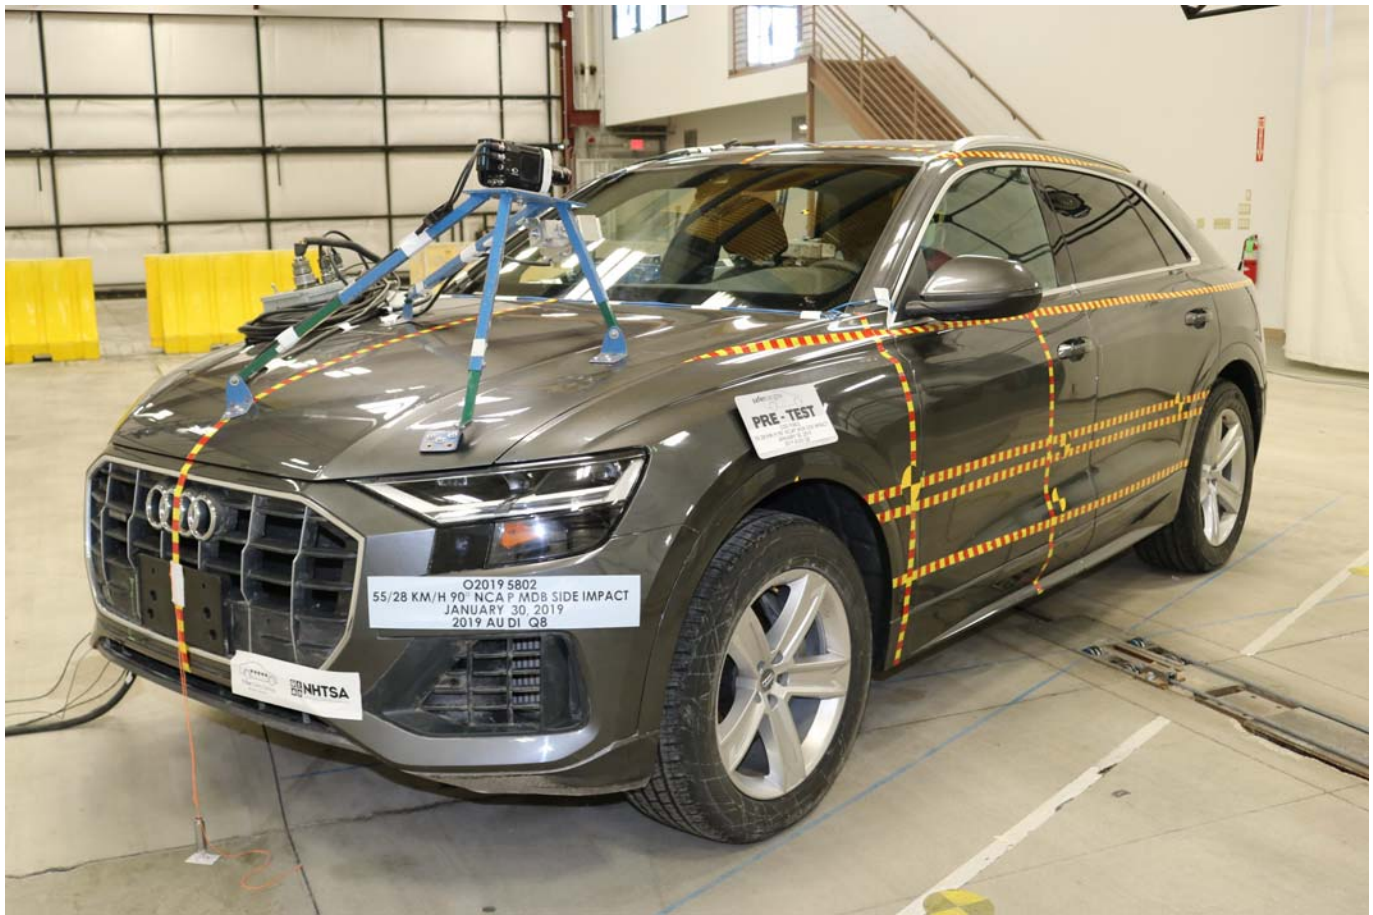
Photo No. 005 - Pre-Test Left Front Three-Quarter View of Test Vehicle

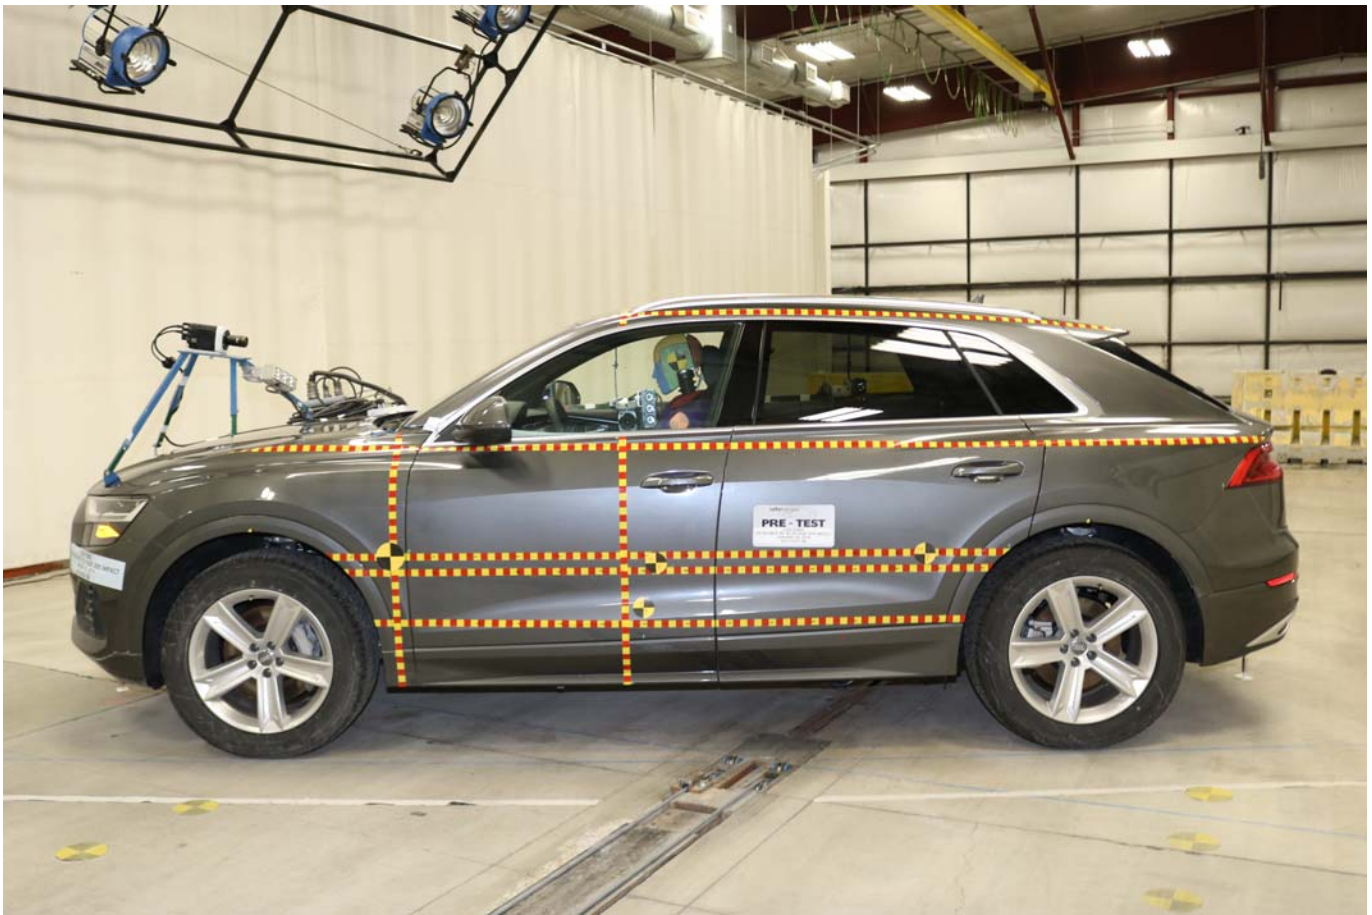
Photo No. 007 - Pre-Test Left Side View of Test Vehicle

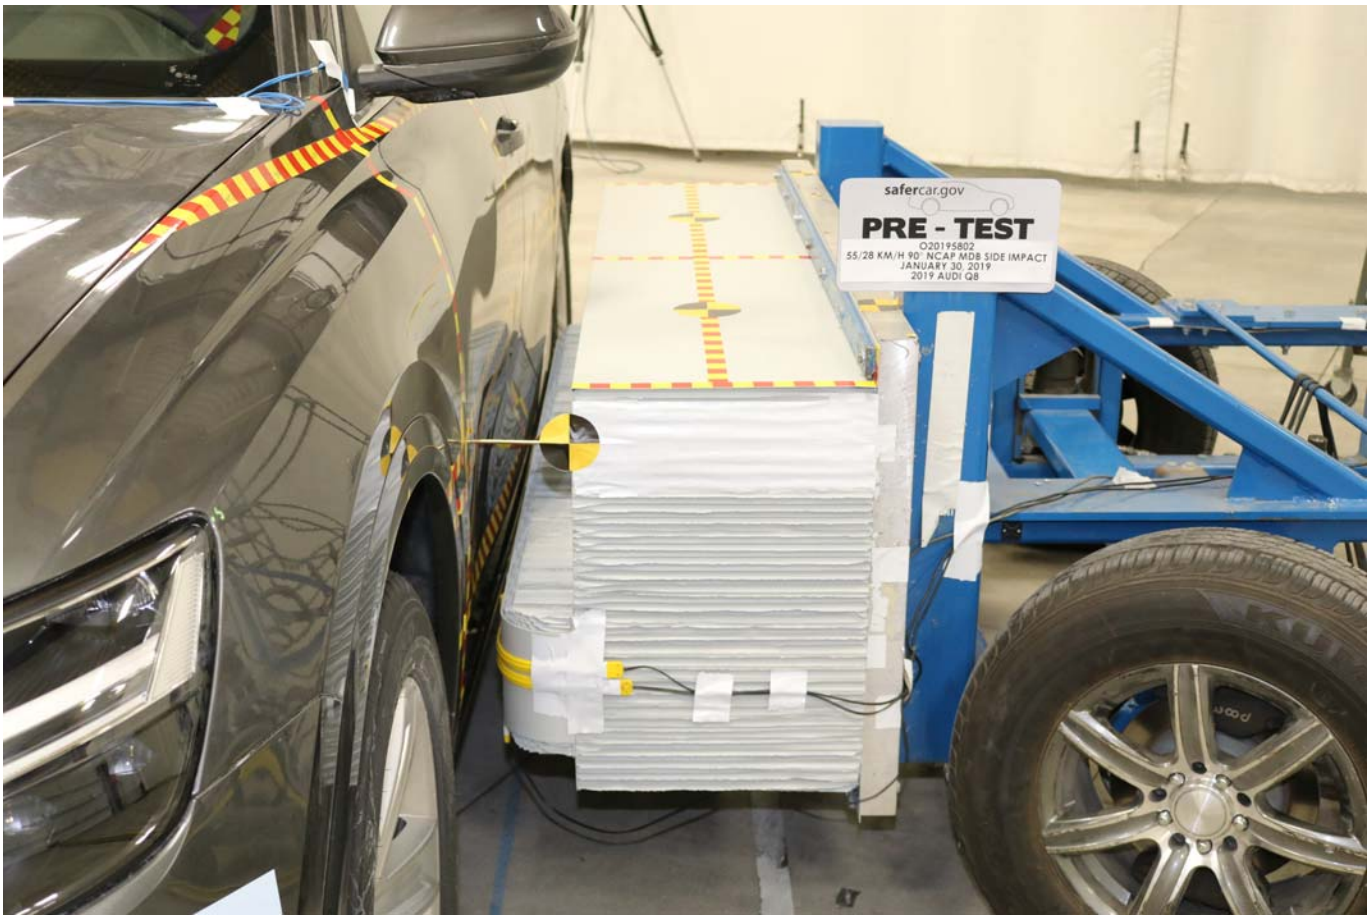
Photo No. 017 - Pre-Test Left Side View of MDB Positioned Against Side of Test Vehicle

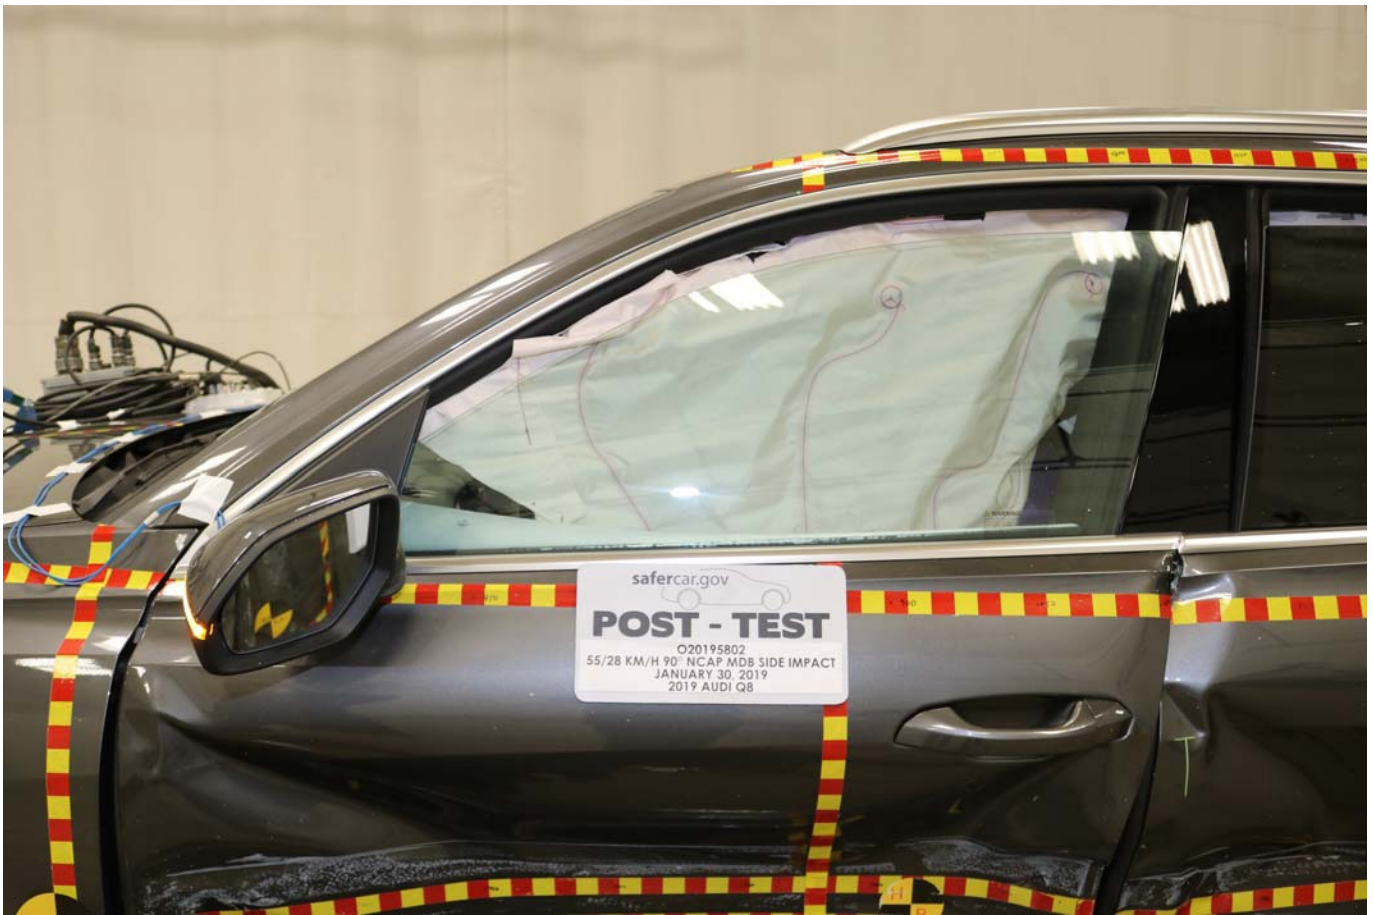
Photo No. 029 - Post-Test Left Side View of Driver Dummy Shoulder and Door Top View

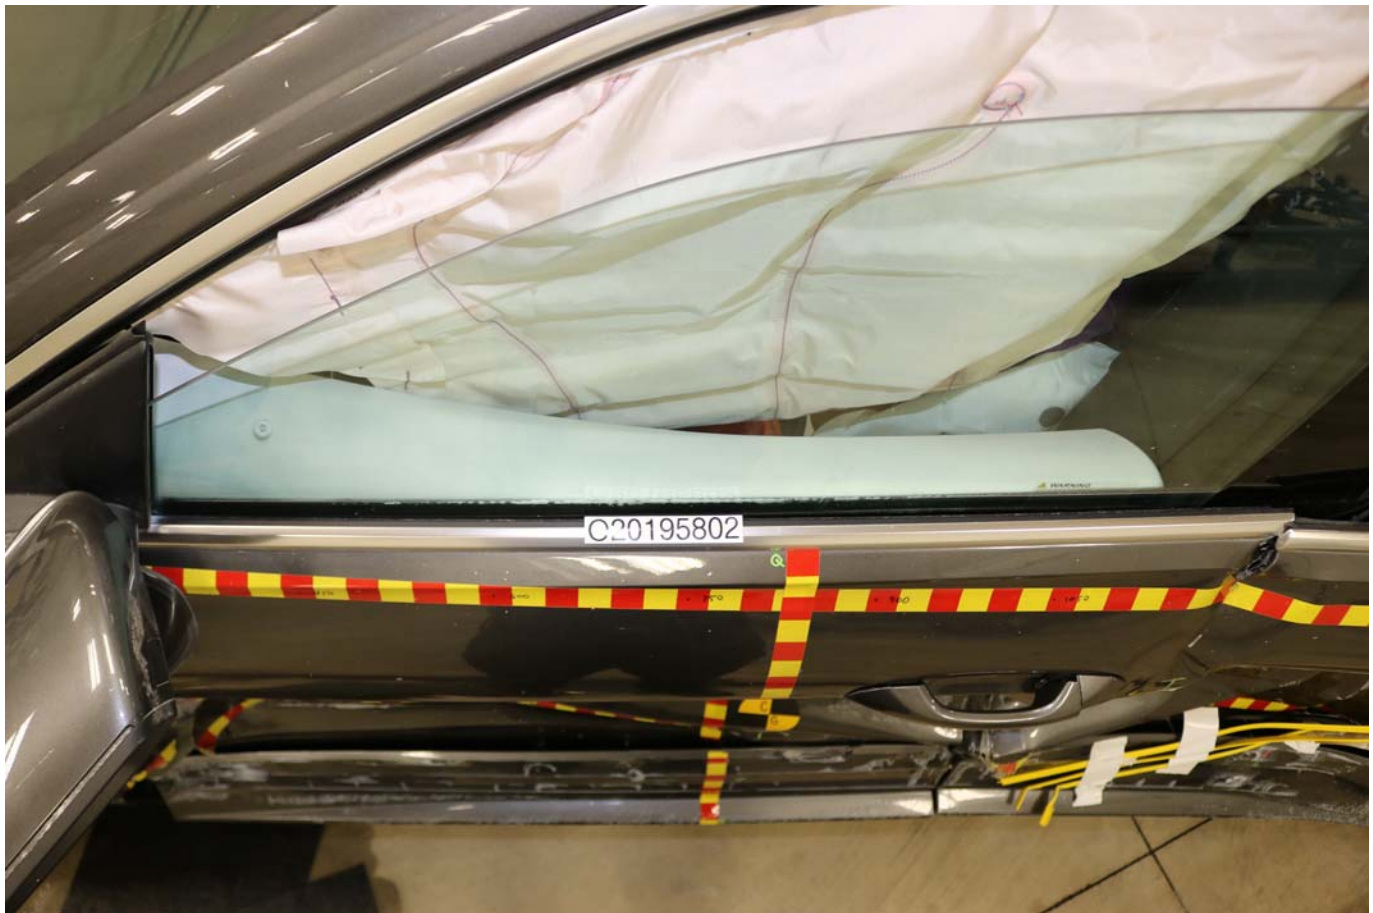
Photo No. 043 - Post-Test Driver Dummy and Door Clearance View

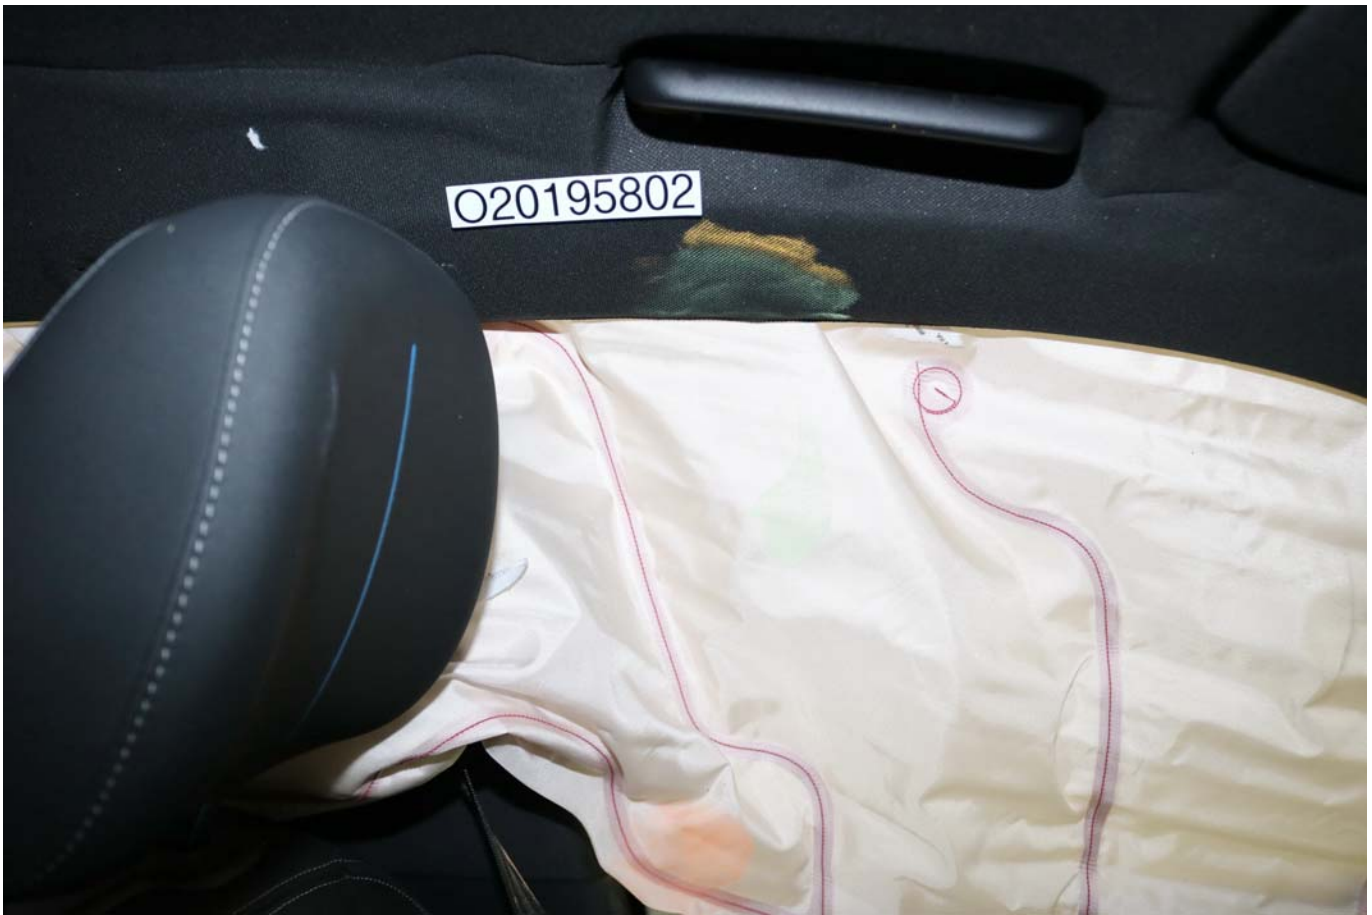
Photo No. 049 - Post-Test Driver Dummy Close-up Head Contact with Side Airbag View

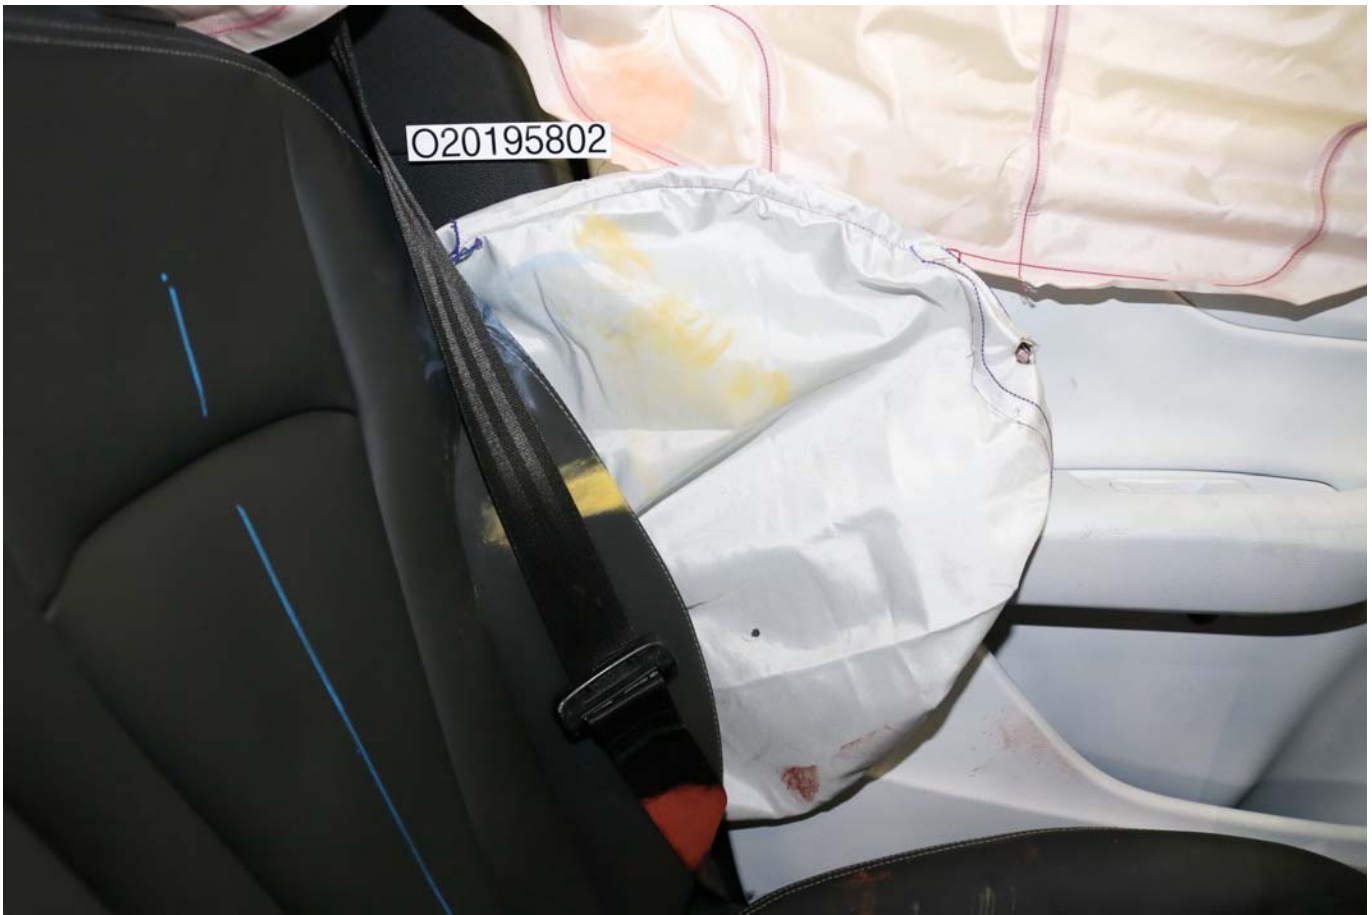
Photo No. 051 - Post-Test Driver Dummy Close-up Torso Contact with Side Airbag View

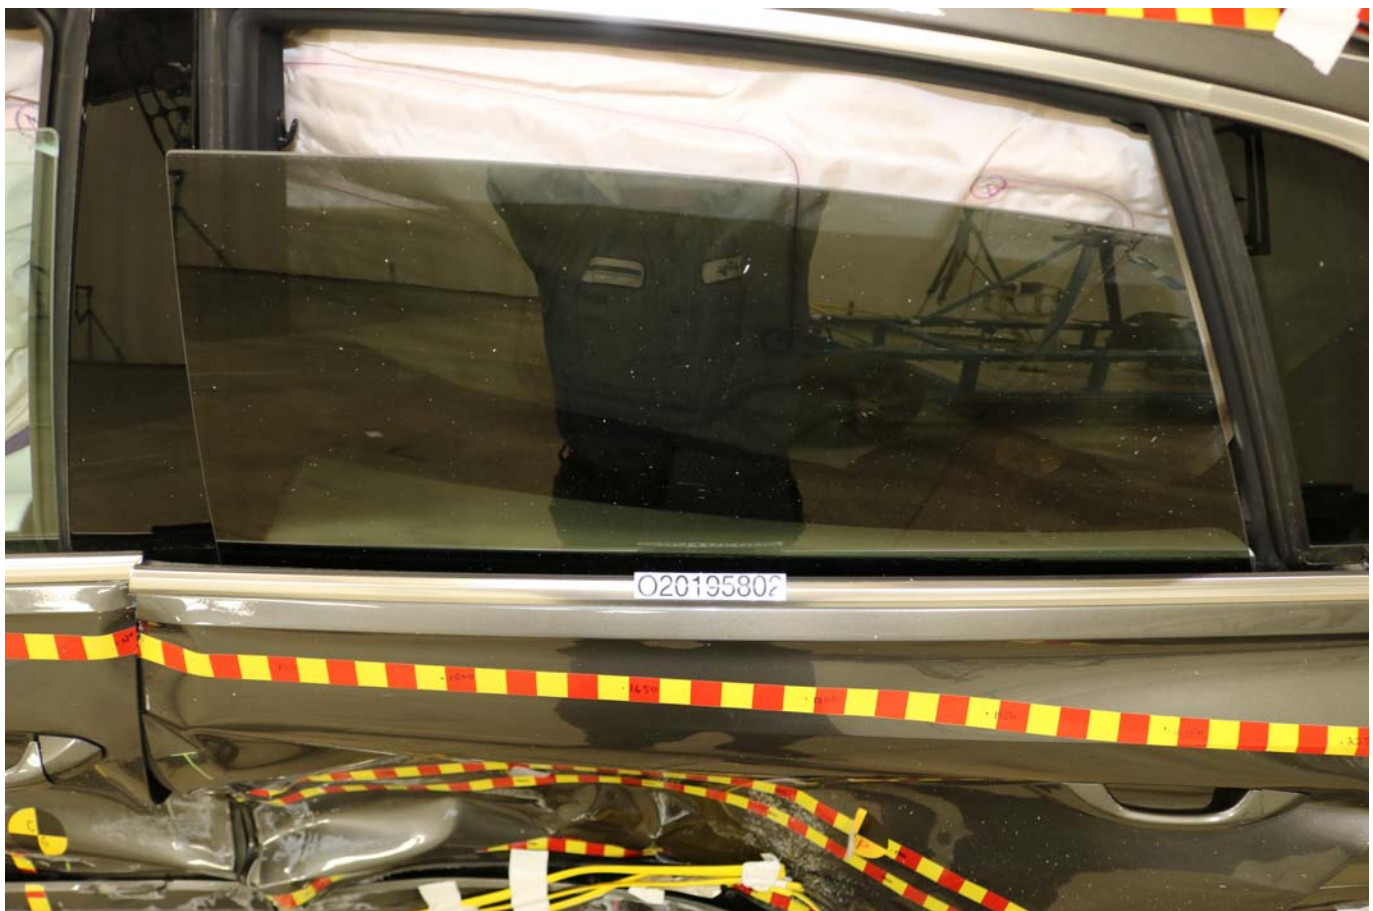
Photo No. 070 - Post-Test Rear Passenger Dummy and Door Clearance View

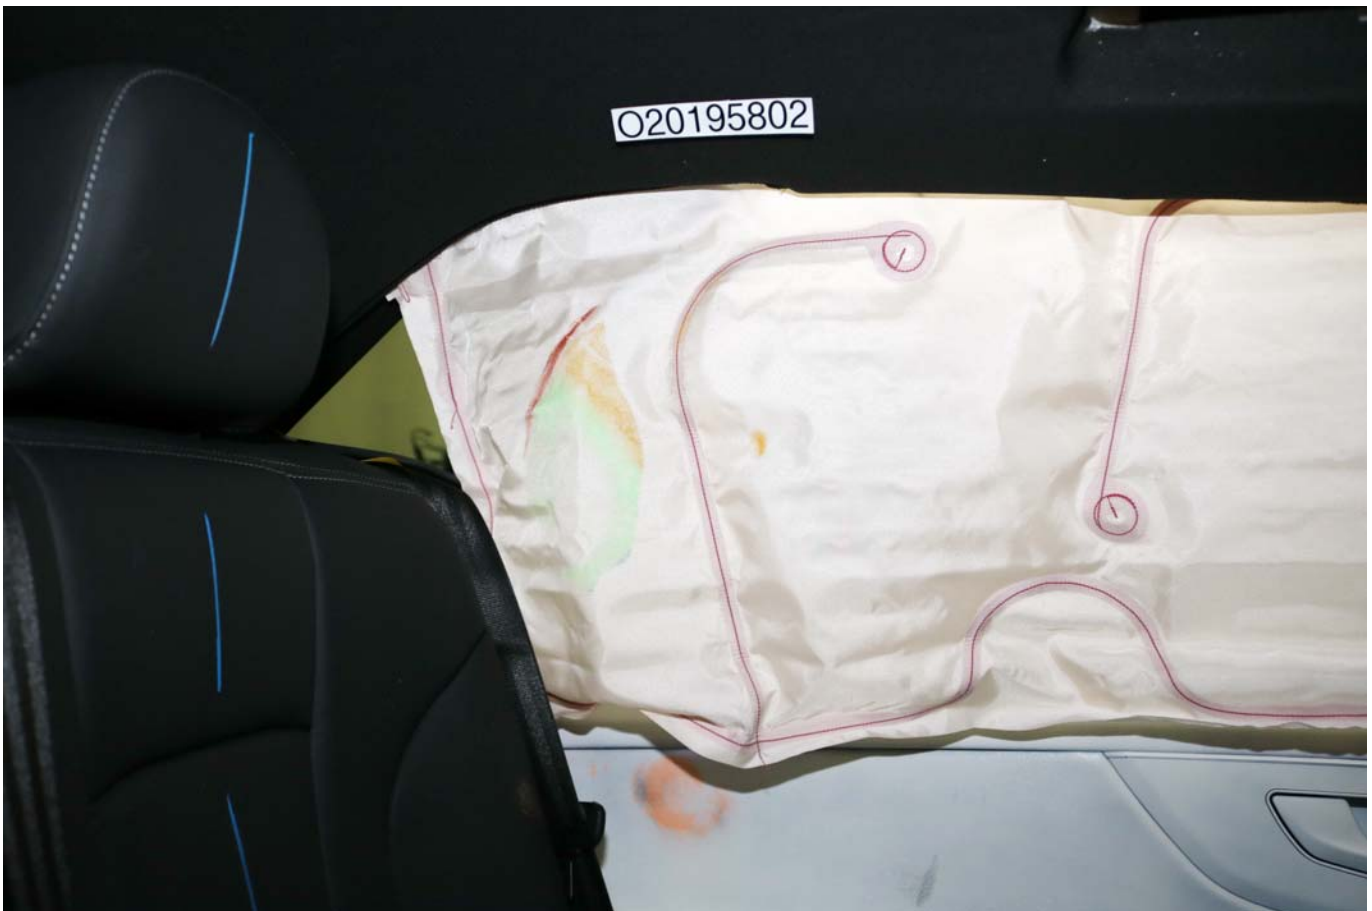
Photo No. 076 - Post-Test Rear Passenger Dummy Close-up Head Contact with Side Airbag View

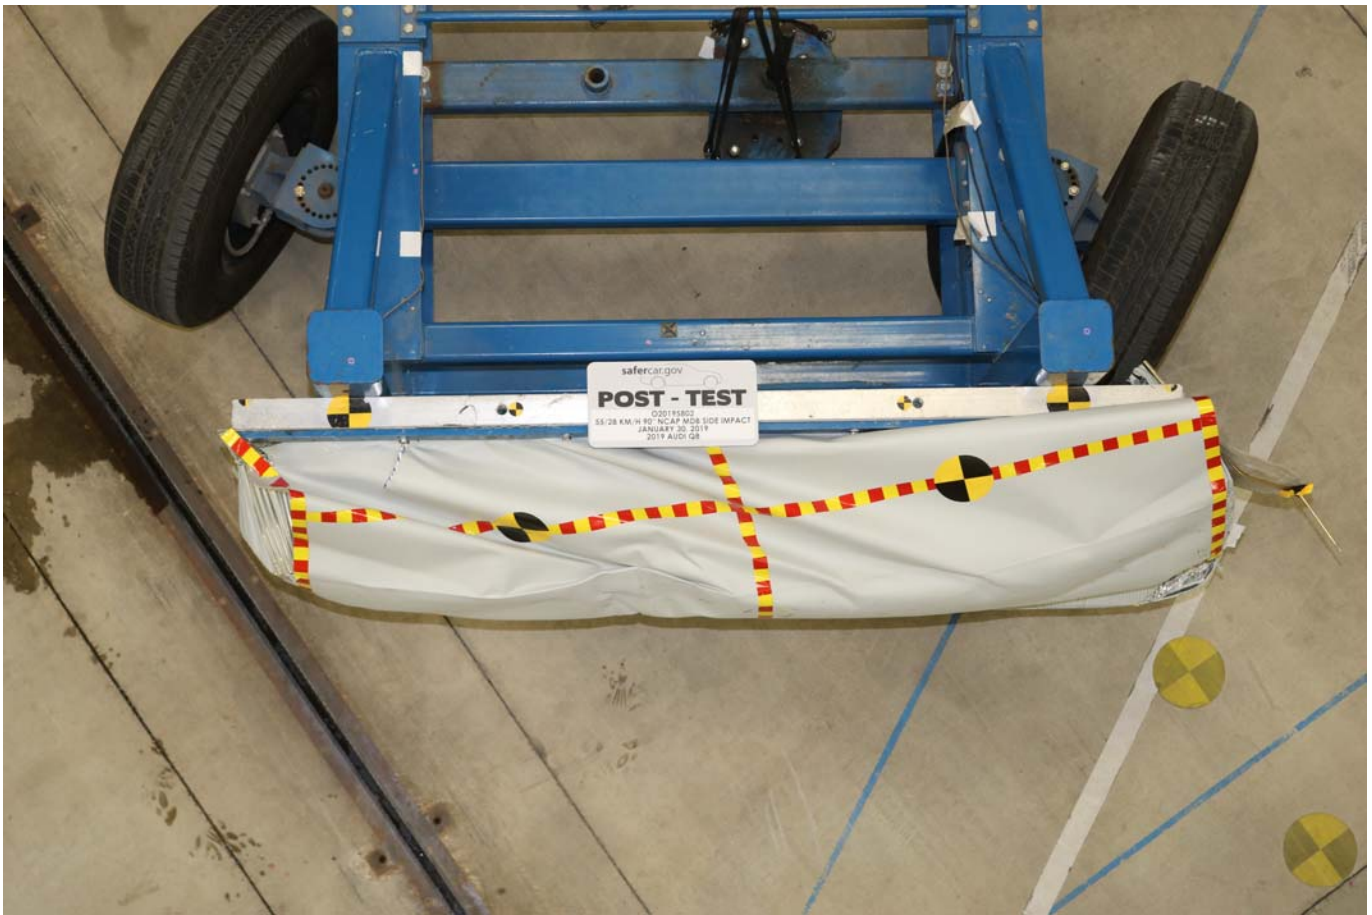
Photo No. 087 - Post-Test Top View of MDB Impactor Face

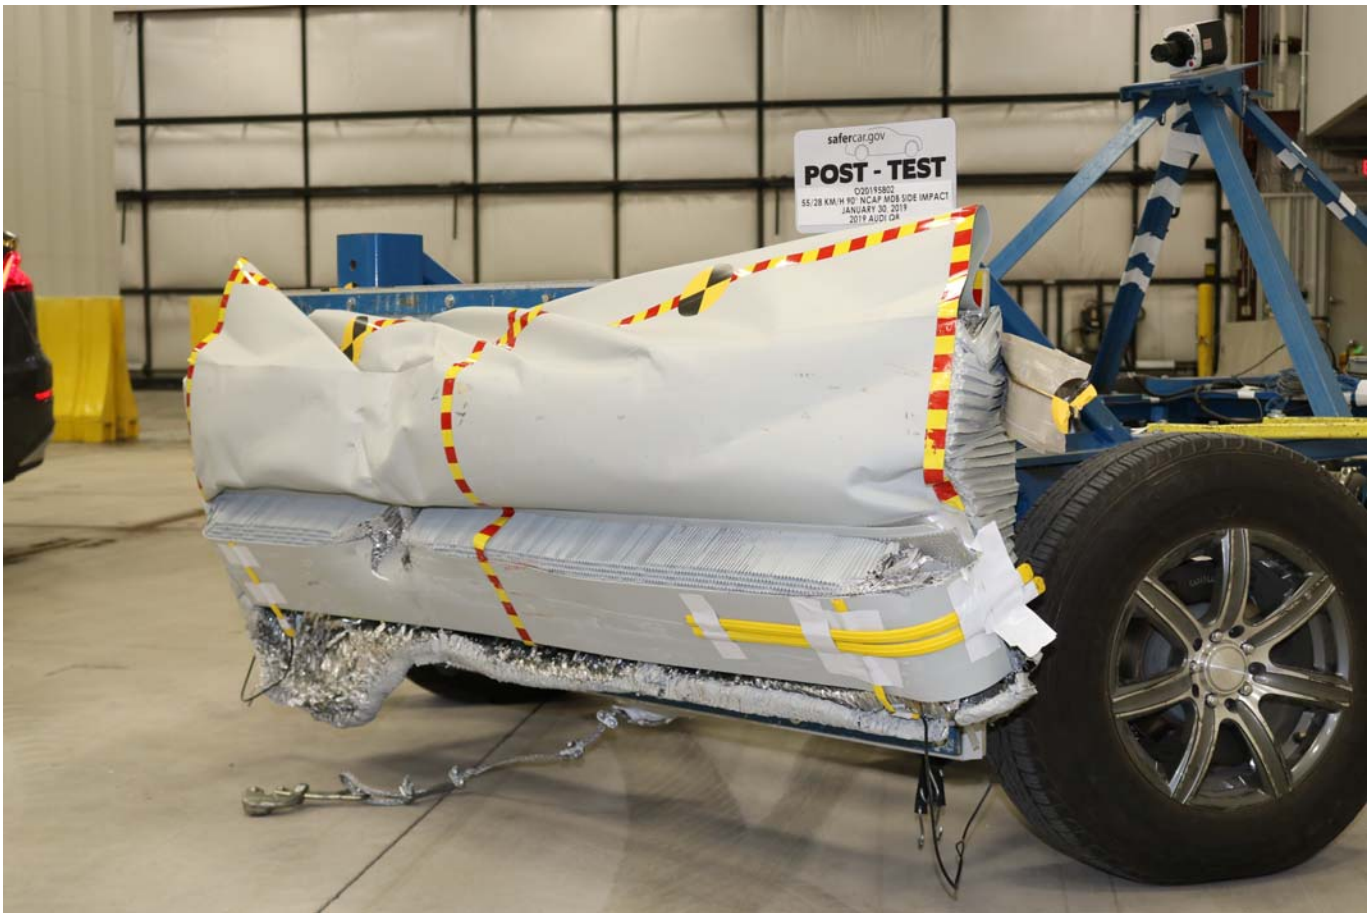
Photo No. 089 - Post-Test Left Side View of MDB Impactor Face

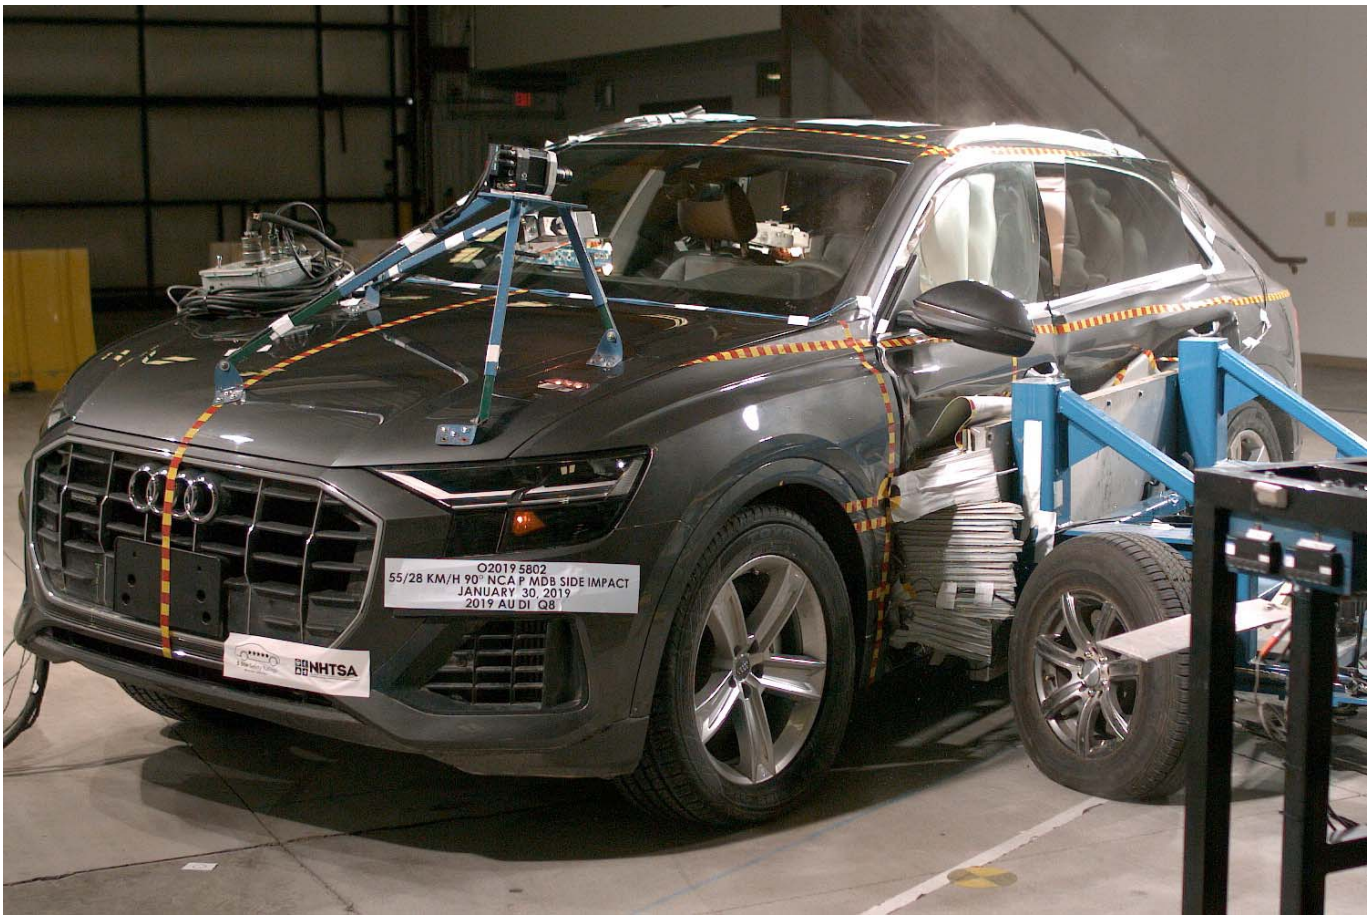
Photo No. 101 - Impact Event
