**REPORT NUMBER: NCAP-CAL-19-003**

**NEW CAR ASSESSMENT PROGRAM (NCAP)  
FRONTAL BARRIER IMPACT TEST**

**Volkswagen de Mexico S.A. de C.V.  
2019 Volkswagen Jetta  
Four Door Sedan**

**NHTSA No: M20195800**

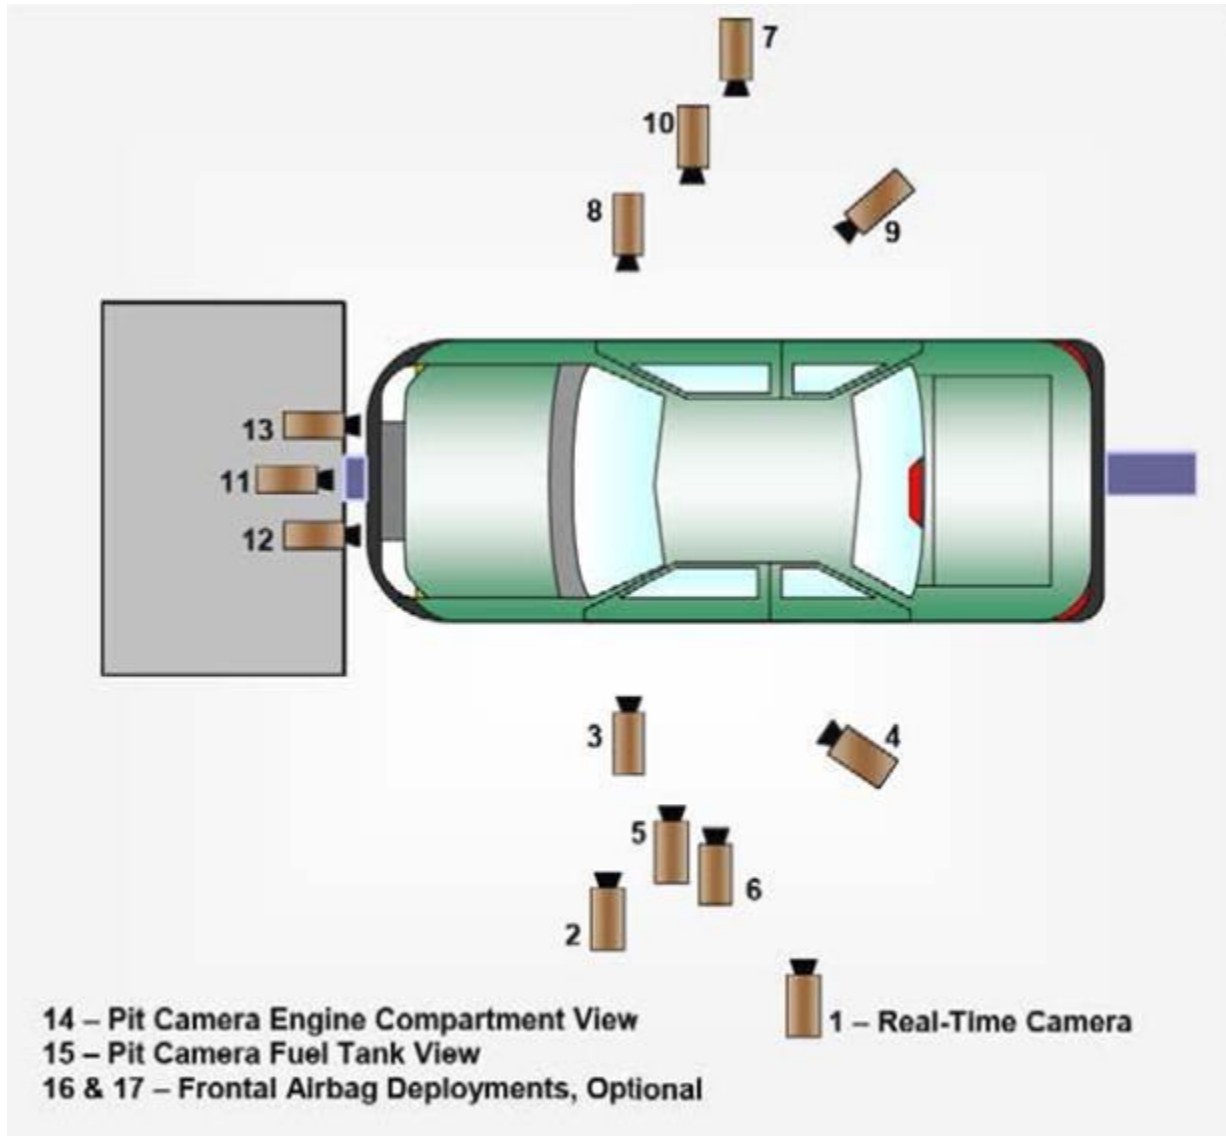
**CAMERA POSITIONS FOR FRONTAL IMPACTS**

Top View

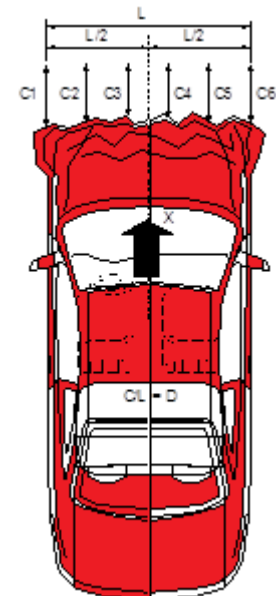
**CRUSH PROFILE**

Collision Deformation Classification: 12FDEW2  
Midpoint of Damage: C3  
Damage Region Length (mm): 1325  
Impact Mode: Frontal

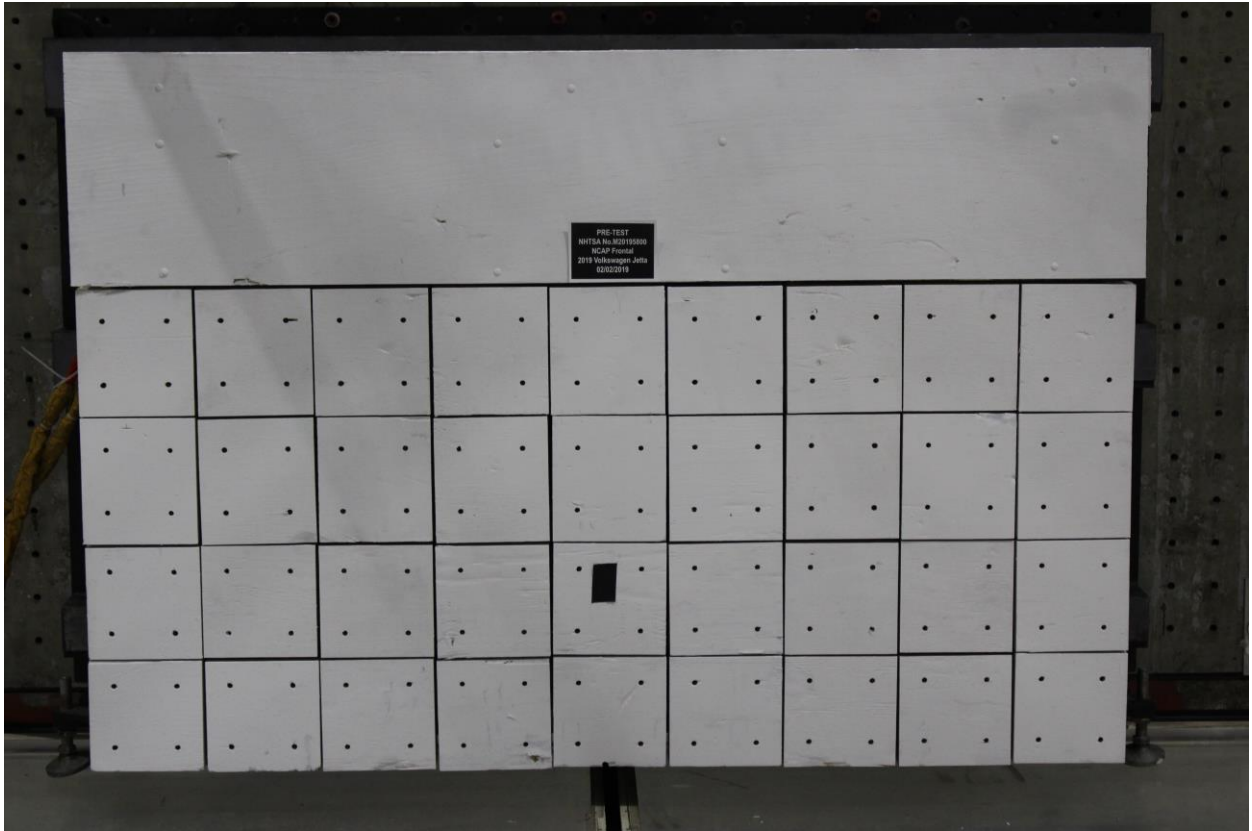
Figure A-2: Pre-Test Load Cell Wall

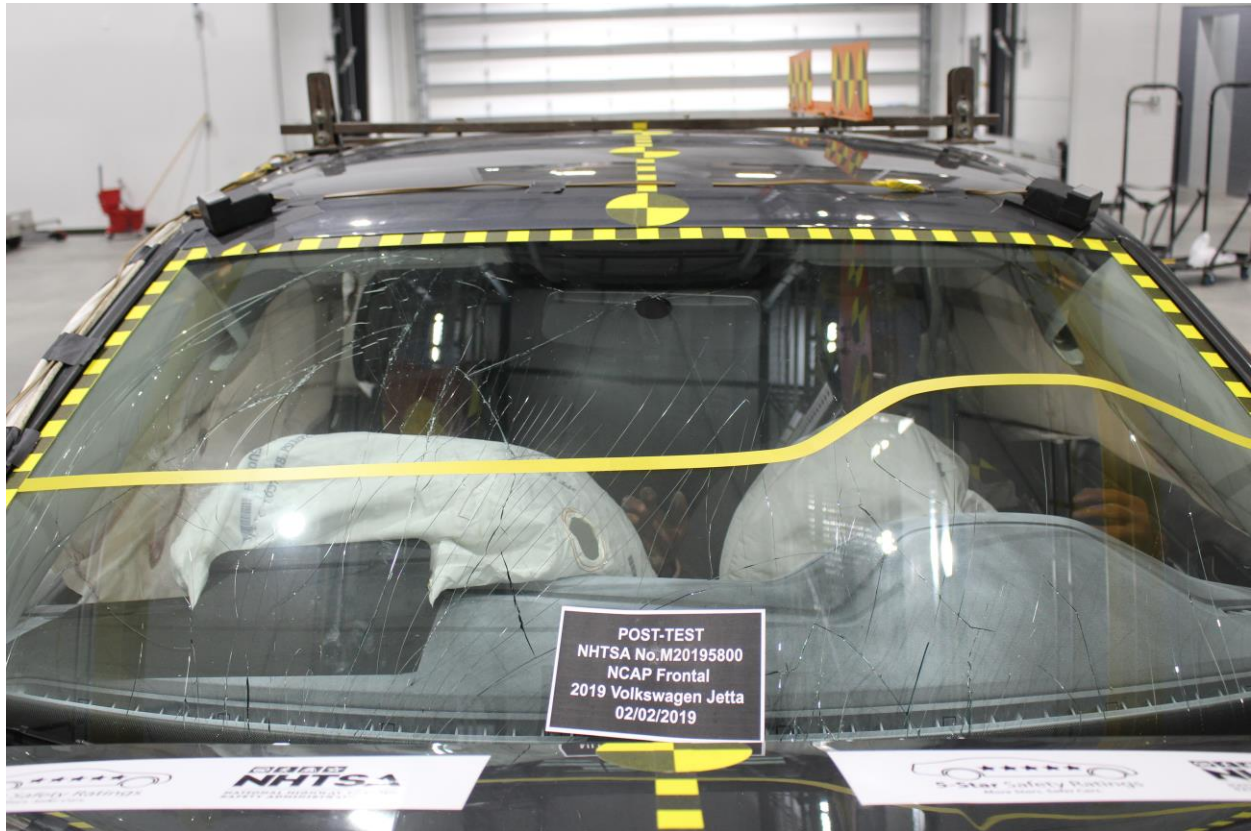
**Figure A-19: Post-Test Windshield View**

Critical Areas of Performance	Observations and Conclusions
Windshield Damage	Cracks throughout
Window Damage	None
Other Notable Effects	None

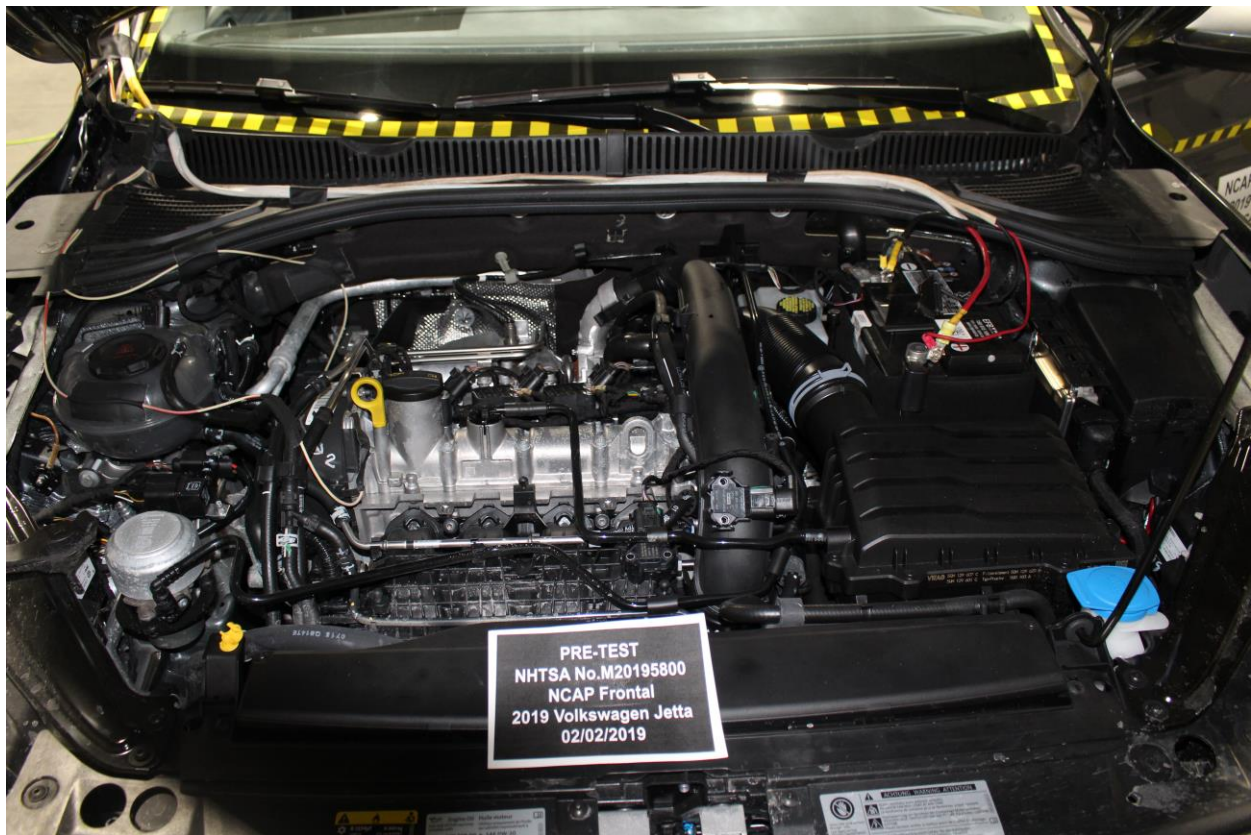
**Figure A-20: Pre-Test Engine Compartment View**

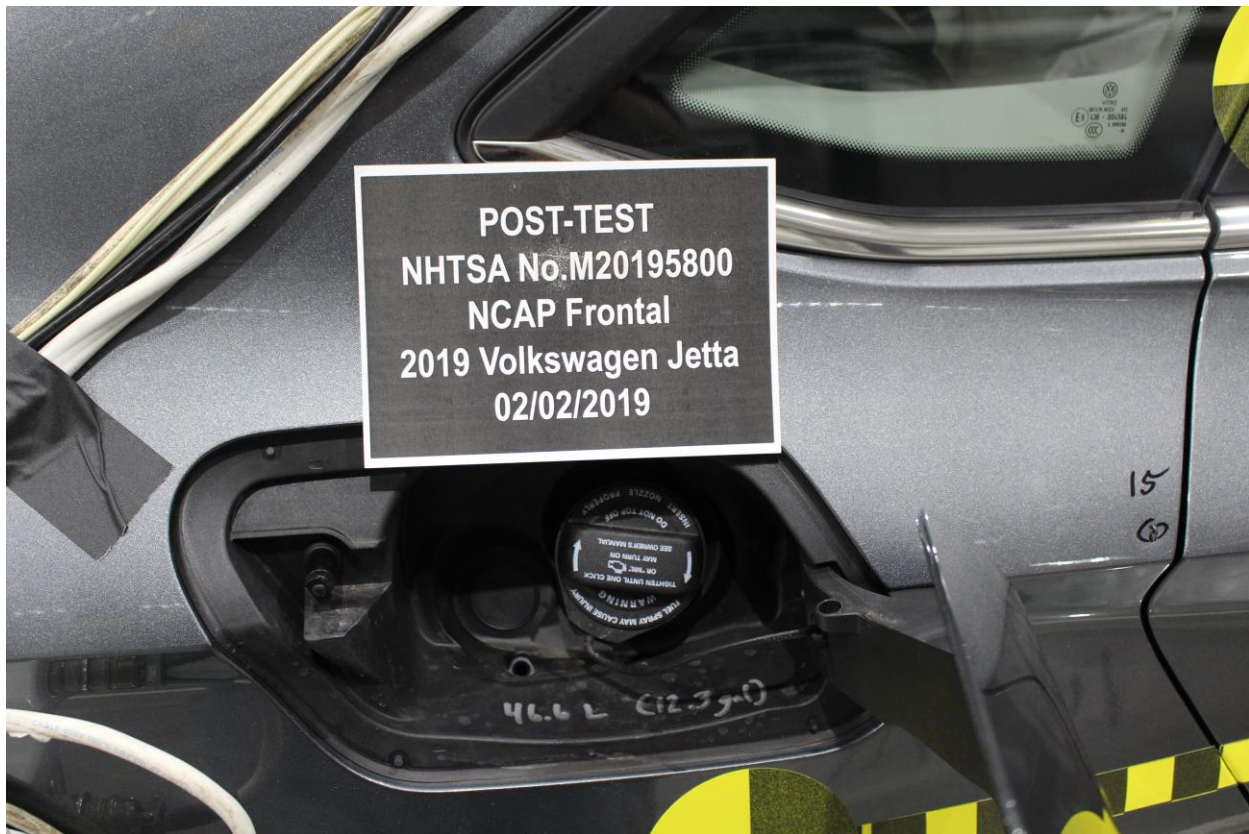
**Figure A-23: Post-Test Fuel Filler Cap View**

There was 100 percent windshield retention and no intrusion into the protected zone of the windshield during the event. There was a total of 0.0 grams of stoddard solvent leakage after the event and including all phases of the static rollover. The maximum static crush of the test vehicle was 380 mm at C2 to the left side of front bumper. During and after the impact event, the driver's and passenger's side doors were closed and operational.

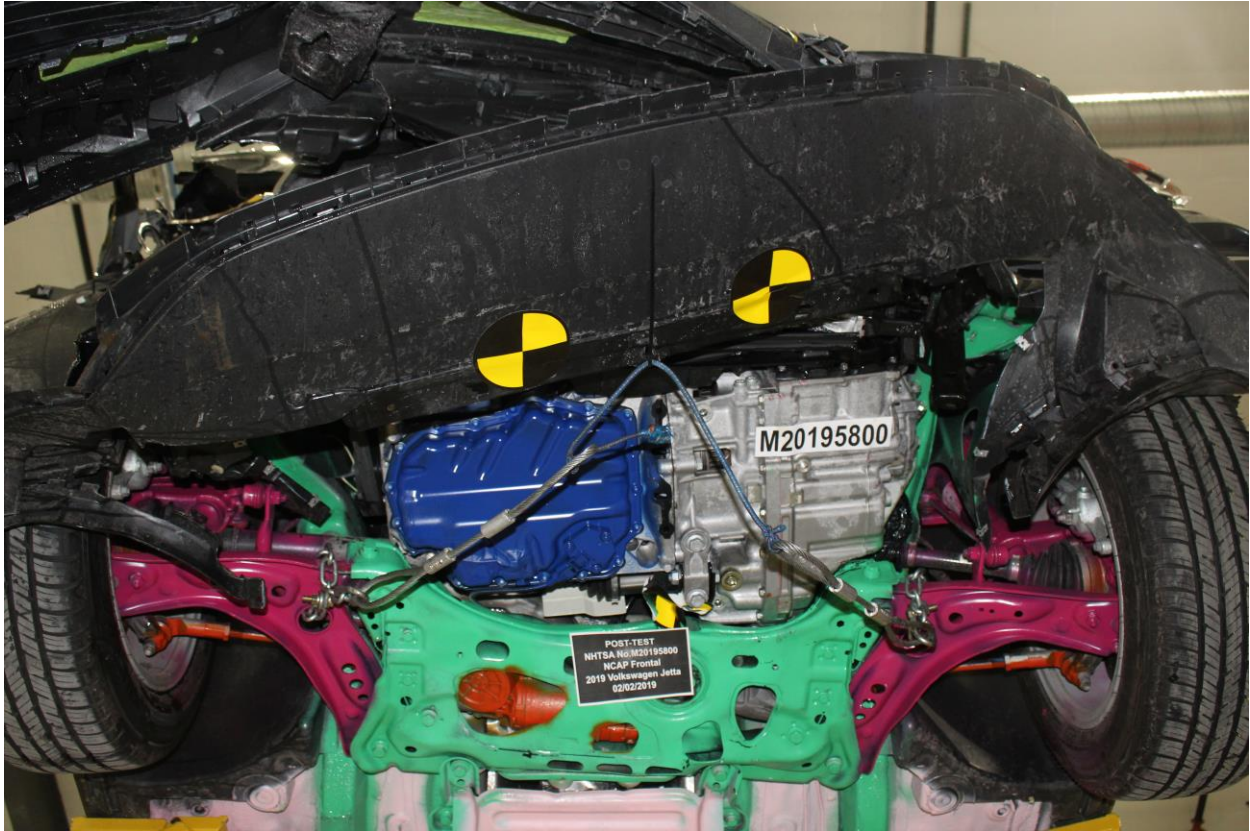
Figure A-25: Post-Test Front Underbody View

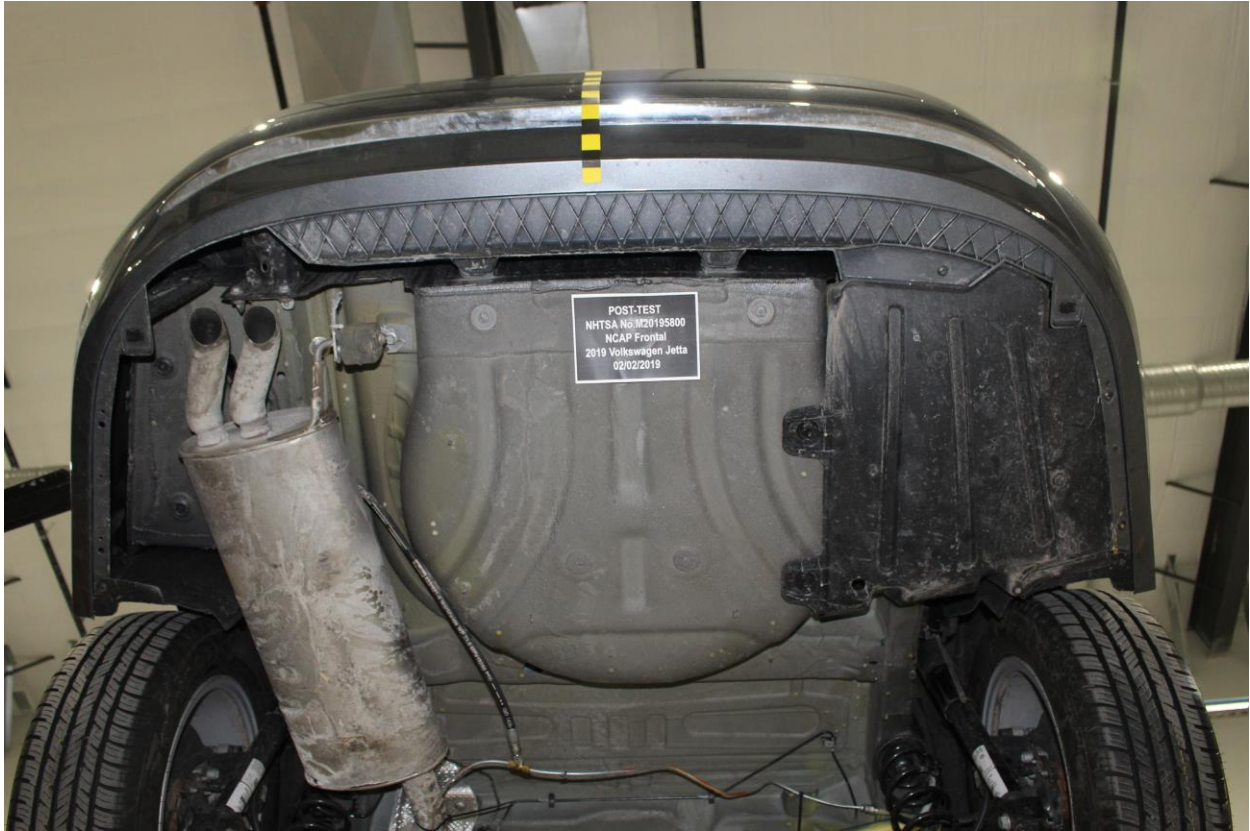
**Figure A-27: Post-Test Rear Underbody View**

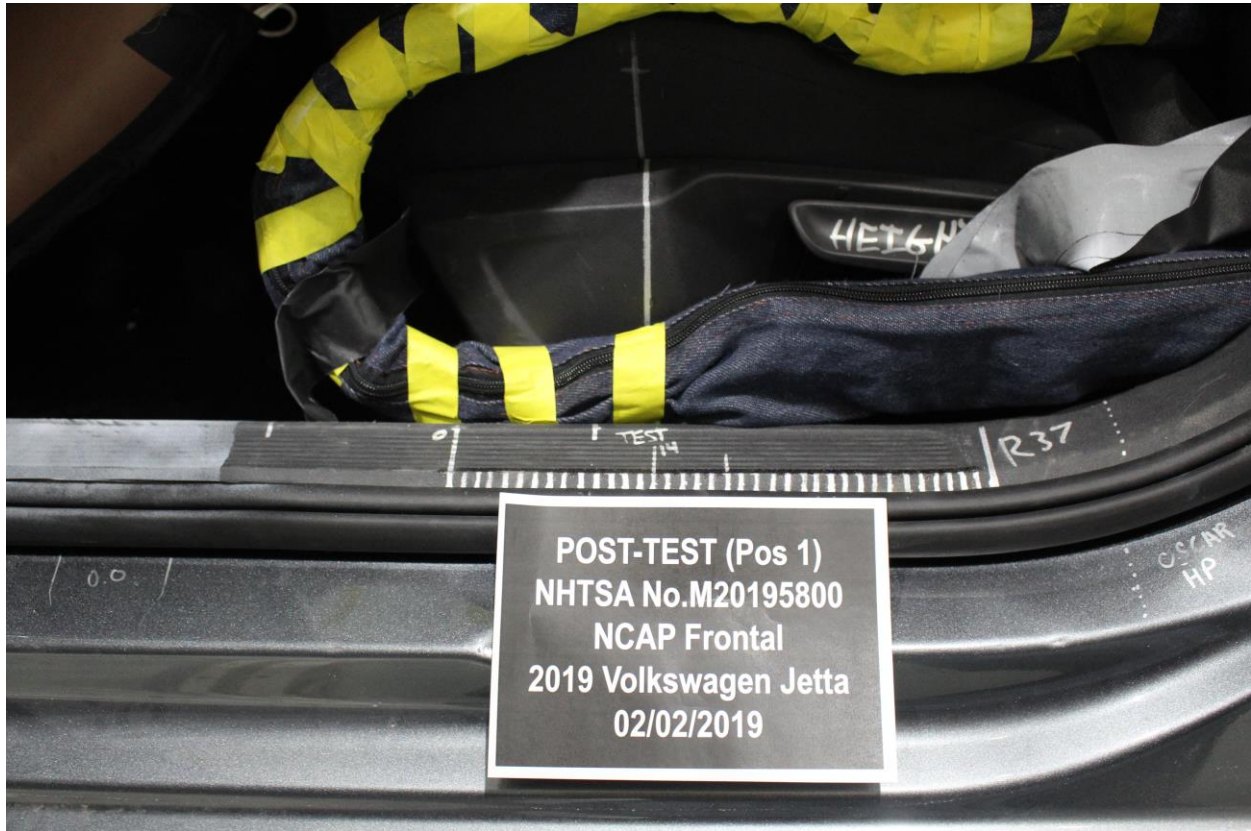
**Figure A-37: Post-Test Driver's Seat Fore-Aft Markings**

Description	Driver	Passenger
Locked / Unlocked Doors	Unlocked	Unlocked
Front Door Opening	Closed & Operational	Closed & Operational
Rear Door Opening	Closed & Operational	Closed & Operational
Seat Track Shift (mm)	0	0
Seat Back Failure	No	No
Glazing Damage	None	None

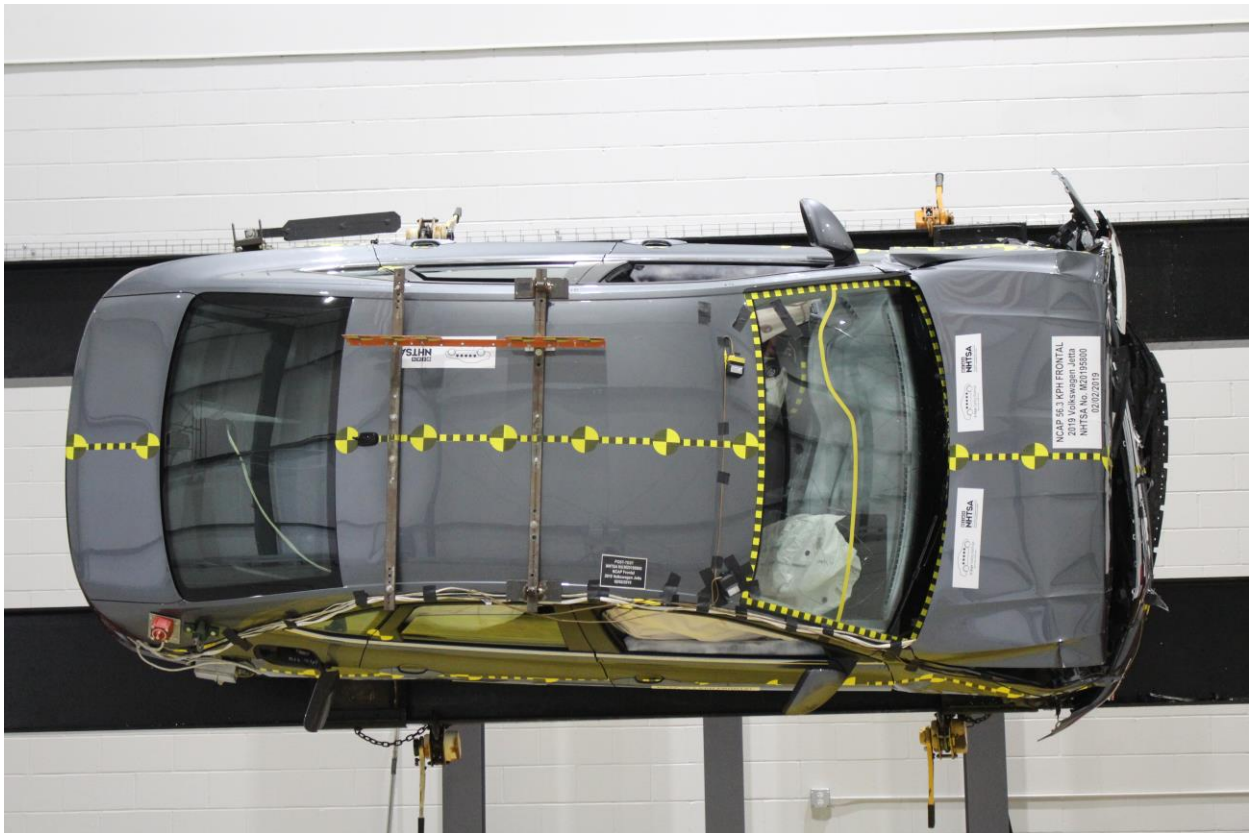
**Figure A-74: Vehicle at 90° on Static Rollover Device**

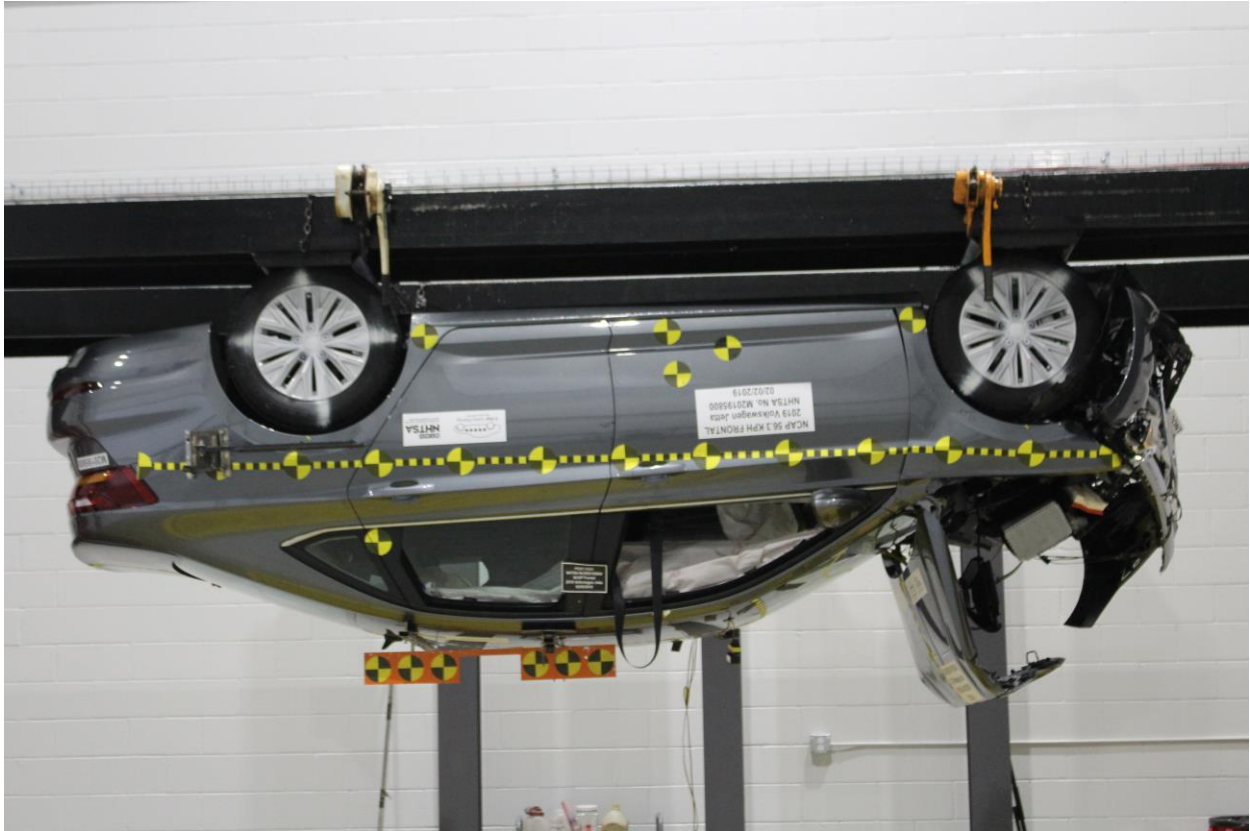
**Figure A-75: Vehicle at 180° on Static Rollover Device**

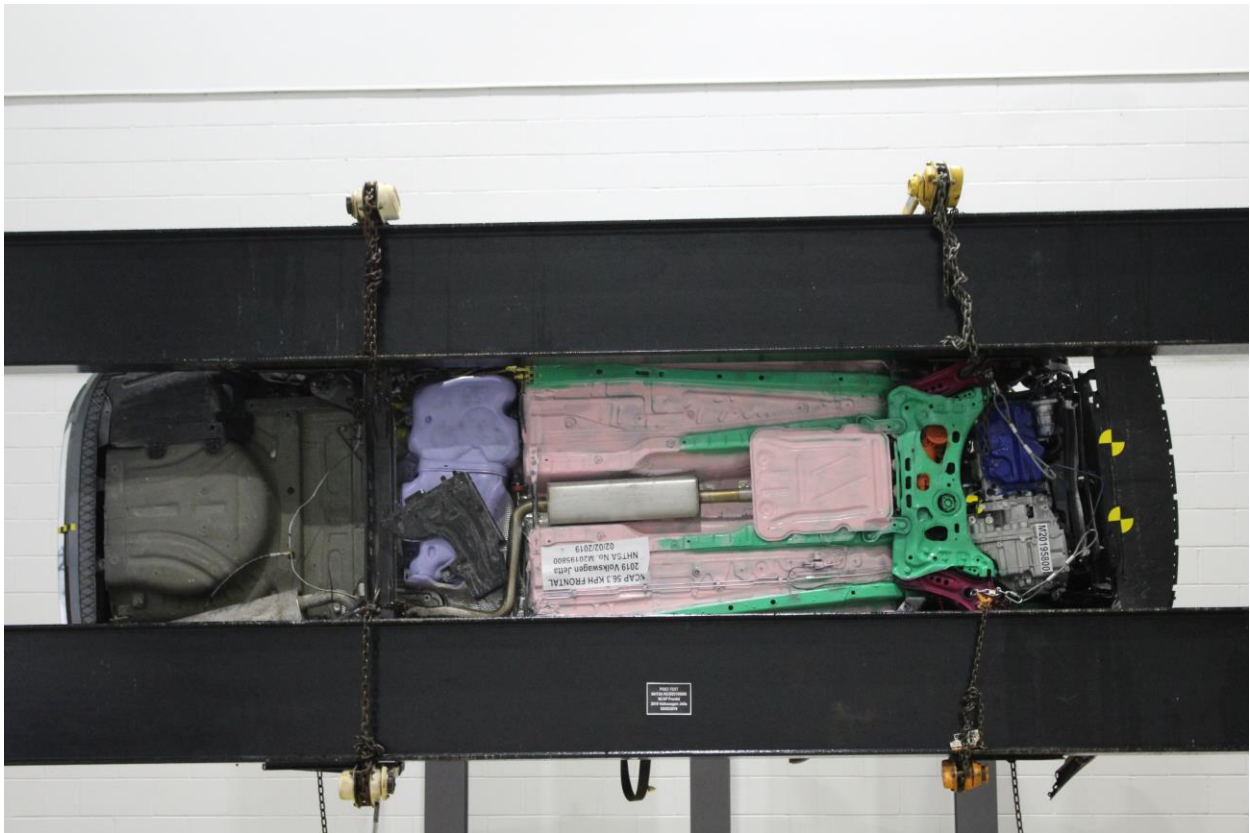
**Figure A-76: Vehicle at 270° on Static Rollover Device**

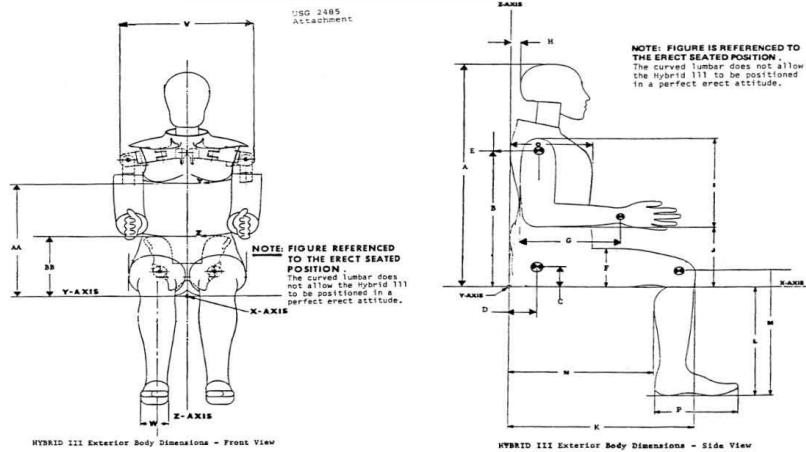
Symbol	Description	Specification (in)		Result (in)	Pass/Fail
A	Sitting Height	34.6	35.0	34.7	Pass
B	Shoulder Pivot Height	19.9	20.5	20.2	Pass
C	H-Point Height	3.3	3.5	3.4	Pass
D	H-Point from Backline	5.3	5.5	5.4	Pass
E	Shoulder Pivot from Backline	3.3	3.7	3.5	Pass
F	Thigh Clearance	5.5	6.1	5.8	Pass
G	Back of Elbow to Wrist Pivot	11.4	12.0	11.8	Pass
H	Head Back to Backline	1.6	1.8	1.7	Pass
I	Shoulder to Elbow Length	13.0	13.6	13.4	Pass
J	Elbow Rest Height	7.5	8.3	8.1	Pass
K	Buttock to Knee Length	22.8	23.8	23.0	Pass
L	Popliteal Height	16.9	17.9	17.3	Pass
M	Knee Pivot Height	19.1	19.7	19.4	Pass
N	Buttock Popliteal Length	17.8	18.8	18.3	Pass
O	Chest Depth without Jacket	8.4	9.0	8.6	Pass
P	Foot Length (right)	9.9	10.5	10.2	Pass
V	Shoulder Breadth	16.3	17.2	16.7	Pass
W	Foot Breadth	3.6	4.2	3.8	Pass
Y	Chest Circumference with Jacket	38.2	39.4	38.9	Pass
Z	Waist Circumference	32.9	34.1	33.7	Pass
AA	Reference Location (Chest Circumference)	16.9	17.1	17.0	Pass

BB	Reference Location (Waist Circumference)	8.9	9.1	9.0	Pass

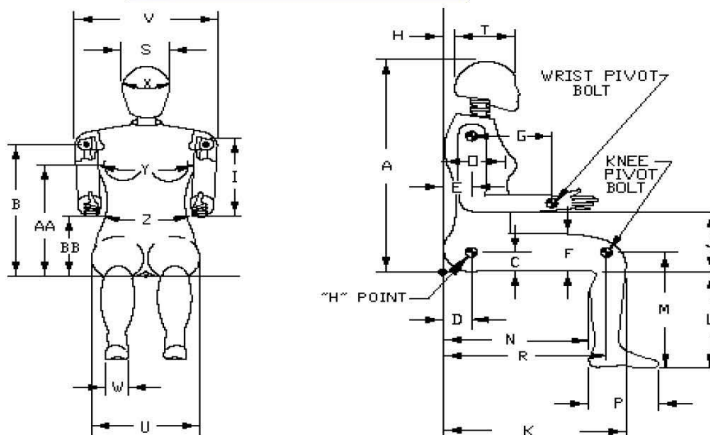
Symbol	Description	Specification (mm)		Result (mm)	Pass/Fail
A	Sitting Height	775	800	789	Pass
B	Shoulder Pivot Height	432	457	446	Pass
C	H-Point Height	81	86	83	Pass
D	H-Point from Backline	145	150	147	Pass
E	Shoulder Pivot from Backline	69	84	76	Pass
F	Thigh Clearance	119	135	124	Pass
G	Back of Elbow to Wrist Pivot	244	259	250	Pass
H	Head Back to Backline	43	48	46	Pass
I	Shoulder to Elbow Length	277	297	289	Pass
J	Elbow Rest Height	183	203	188	Pass
K	Buttock to Knee Length	521	546	541	Pass
L	Popliteal Height	356	376	363	Pass
M	Knee Pivot Height	394	419	398	Pass
N	Buttock Popliteal Length	414	439	424	Pass
O	Chest Depth without Jacket	175	191	185	Pass
P	Foot Length (right)	219	234	225	Pass
R	Buttock To Knee Pivot Length	457	483	473	Pass
S	Head Breadth	137	147	141	Pass
T	Head Depth	178	188	182	Pass
U	Hip Breadth	300	315	304	Pass
V	Shoulder Breadth	351	366	362	Pass
W	Foot Breadth	79	94	86	Pass
X	Head Circumference	528	549	535	Pass

Y	Chest Circumference with Jacket	851	881	854	Pass
Z	Waist Circumference	460	790	773	Pass
AA	Reference Location (Chest Circumference)	333	358	345	Pass
BB	Reference Location (Waist Circumference)	160	170	165	Pass

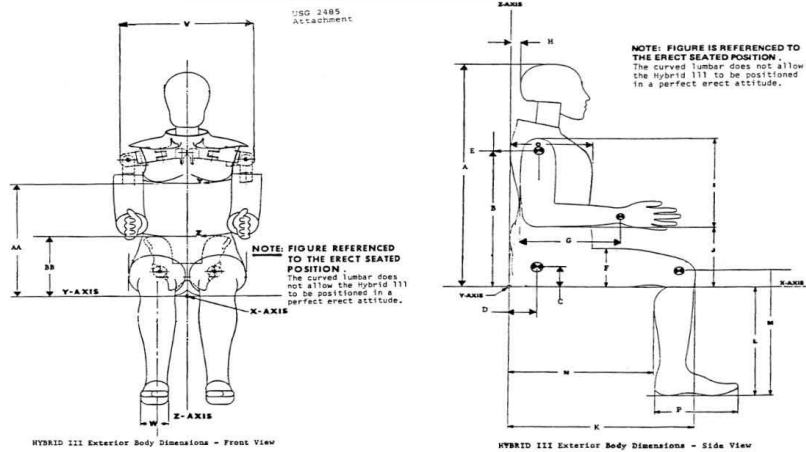
Symbol	Description	Specification (in)		Result (in)	Pass/Fail
A	Sitting Height	34.6	35.0	34.7	Pass
B	Shoulder Pivot Height	19.9	20.5	20.1	Pass
C	H-Point Height	3.3	3.5	3.4	Pass
D	H-Point from Backline	5.3	5.5	5.4	Pass
E	Shoulder Pivot from Backline	3.3	3.7	3.5	Pass
F	Thigh Clearance	5.5	6.1	5.8	Pass
G	Back of Elbow to Wrist Pivot	11.4	12.0	11.9	Pass
H	Head Back to Backline	1.6	1.8	1.7	Pass
I	Shoulder to Elbow Length	13.0	13.6	13.4	Pass
J	Elbow Rest Height	7.5	8.3	8.1	Pass
K	Buttock to Knee Length	22.8	23.8	23.0	Pass
L	Popliteal Height	16.9	17.9	17.3	Pass
M	Knee Pivot Height	19.1	19.7	19.4	Pass
N	Buttock Popliteal Length	17.8	18.8	18.5	Pass
O	Chest Depth without Jacket	8.4	9.0	8.6	Pass
P	Foot Length (right)	9.9	10.5	10.2	Pass
V	Shoulder Breadth	16.3	17.2	16.7	Pass
W	Foot Breadth	3.6	4.2	3.8	Pass
Y	Chest Circumference with Jacket	38.2	39.4	38.9	Pass
Z	Waist Circumference	32.9	34.1	33.7	Pass
AA	Reference Location (Chest Circumference)	16.9	17.1	17.0	Pass

BB	Reference Location (Waist Circumference)	8.9	9.1	9.0	Pass

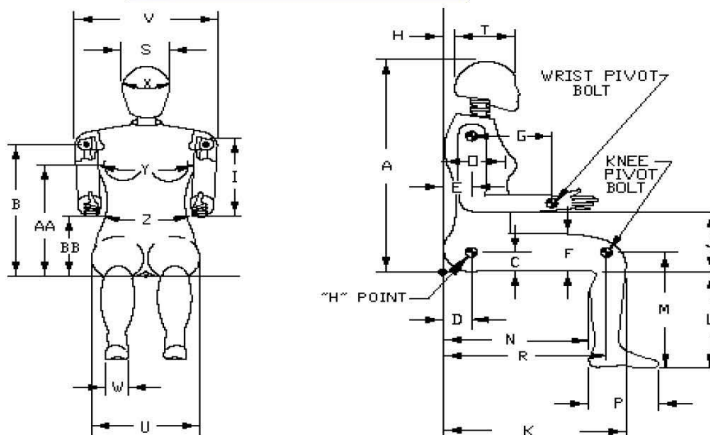
Symbol	Description	Specification (mm)		Result (mm)	Pass/Fail
A	Sitting Height	775	800	789	Pass
B	Shoulder Pivot Height	432	457	446	Pass
C	H-Point Height	81	86	84	Pass
D	H-Point from Backline	145	150	147	Pass
E	Shoulder Pivot from Backline	69	84	76	Pass
F	Thigh Clearance	119	135	124	Pass
G	Back of Elbow to Wrist Pivot	244	259	251	Pass
H	Head Back to Backline	43	48	45	Pass
I	Shoulder to Elbow Length	277	297	289	Pass
J	Elbow Rest Height	183	203	188	Pass
K	Buttock to Knee Length	521	546	541	Pass
L	Popliteal Height	356	376	363	Pass
M	Knee Pivot Height	394	419	398	Pass
N	Buttock Popliteal Length	414	439	424	Pass
O	Chest Depth without Jacket	175	191	185	Pass
P	Foot Length (right)	219	234	225	Pass
R	Buttock To Knee Pivot Length	457	483	473	Pass
S	Head Breadth	137	147	141	Pass
T	Head Depth	178	188	182	Pass
U	Hip Breadth	300	315	308	Pass
V	Shoulder Breadth	351	366	362	Pass
W	Foot Breadth	79	94	86	Pass
X	Head Circumference	528	549	535	Pass

Y	Chest Circumference with Jacket	851	881	861	Pass
Z	Waist Circumference	460	790	773	Pass
AA	Reference Location (Chest Circumference)	333	358	345	Pass
BB	Reference Location (Waist Circumference)	160	170	165	Pass
