REPORT NUMBER: NCAP-MGA-2019-029

**NEW CAR ASSESSMENT PROGRAM (NCAP)
Frontal Barrier Impact Test**

**NISSAN MOTOR CO., LTD.
2019 Nissan Murano S AWD 5-Door SUV
NHTSA No.: M20195209**

**MGA RESEARCH CORPORATION
5000 Warren Road
Burlington, WI 53105**

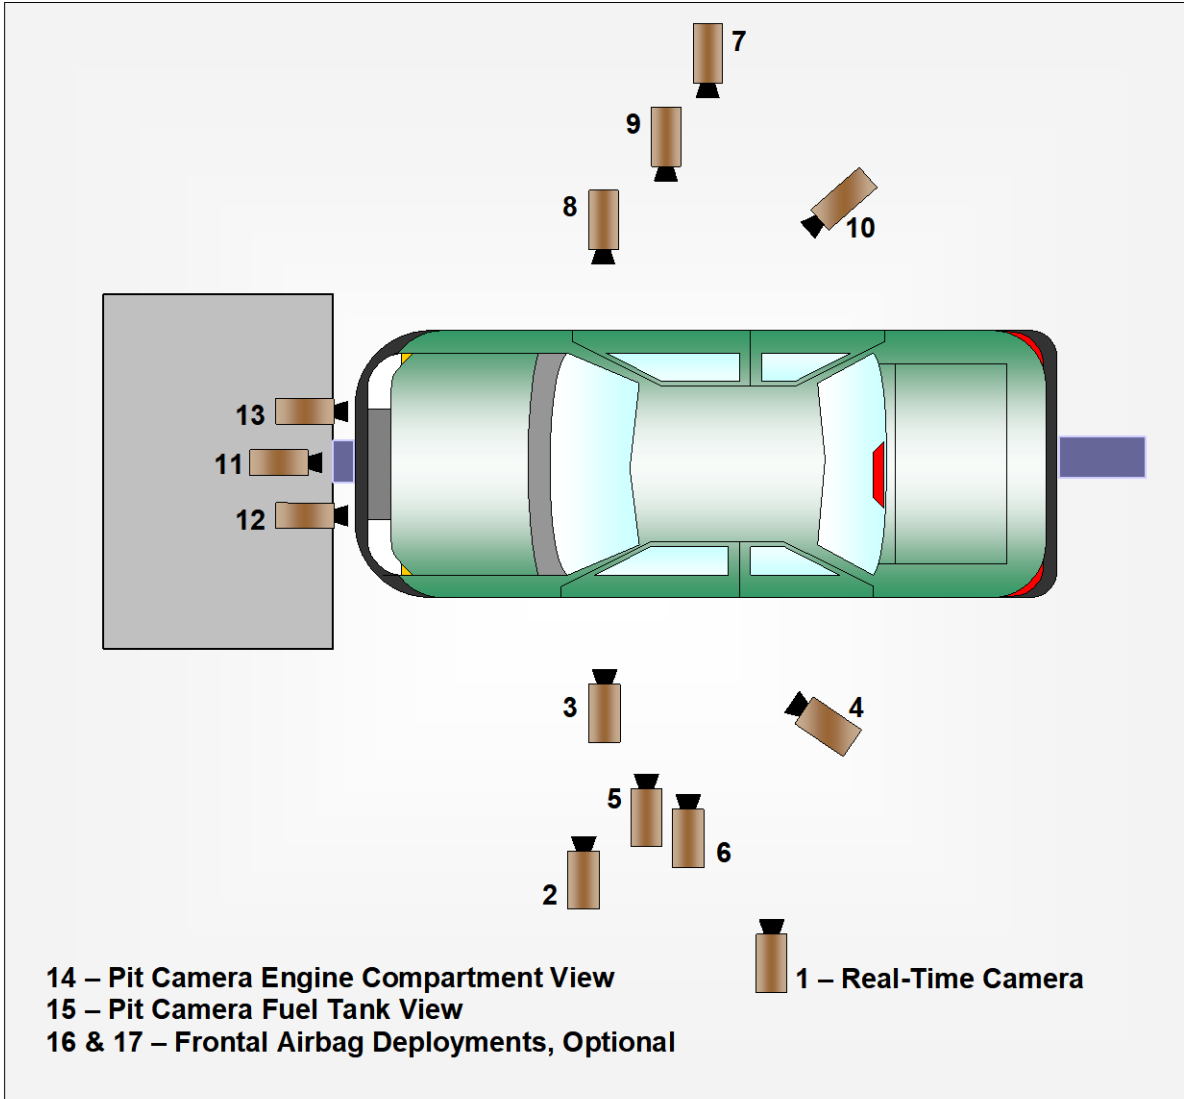
CAMERA POSITIONS FOR FRONTAL IMPACTS

Two (2) real-time cameras and fourteen (14) high-speed cameras were used to document the frontal barrier impact event. Camera locations and other pertinent camera information can be found in this report.

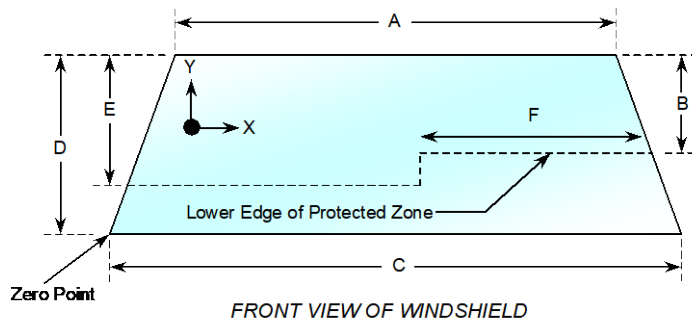
WINDSHIELD PERIPHERY MEASUREMENTS

Measurement	Pre-Test (mm)	Post-Test (mm)	% of Retention
Left Side	2308	2308	100.0
Right Side	2308	2308	100.0
Total	4616	4616	100.0

Item	Units	Value
A	mm	1278
B	mm	534
C	mm	1398
D	mm	970
E	mm	535
F	mm	405

AREA OF PROTECTED ZONE FAILURES - NONE

There was 100 percent windshield retention and no intrusion into the protected zone of the windshield during the event. There was no Stoddard Solvent leakage after the event or during any phase of the static rollover.
