REPORT NUMBER: SPNCAP-MGA-2019-030

**NEW CAR ASSESSMENT PROGRAM (NCAP)
Side Impact Pole Test**

**NISSAN MOTOR CO., LTD.
2019 Nissan Murano S 5-Door SUV
NHTSA No.: M20195210**

**MGA RESEARCH CORPORATION
5000 Warren Road
Burlington, WI 53105**

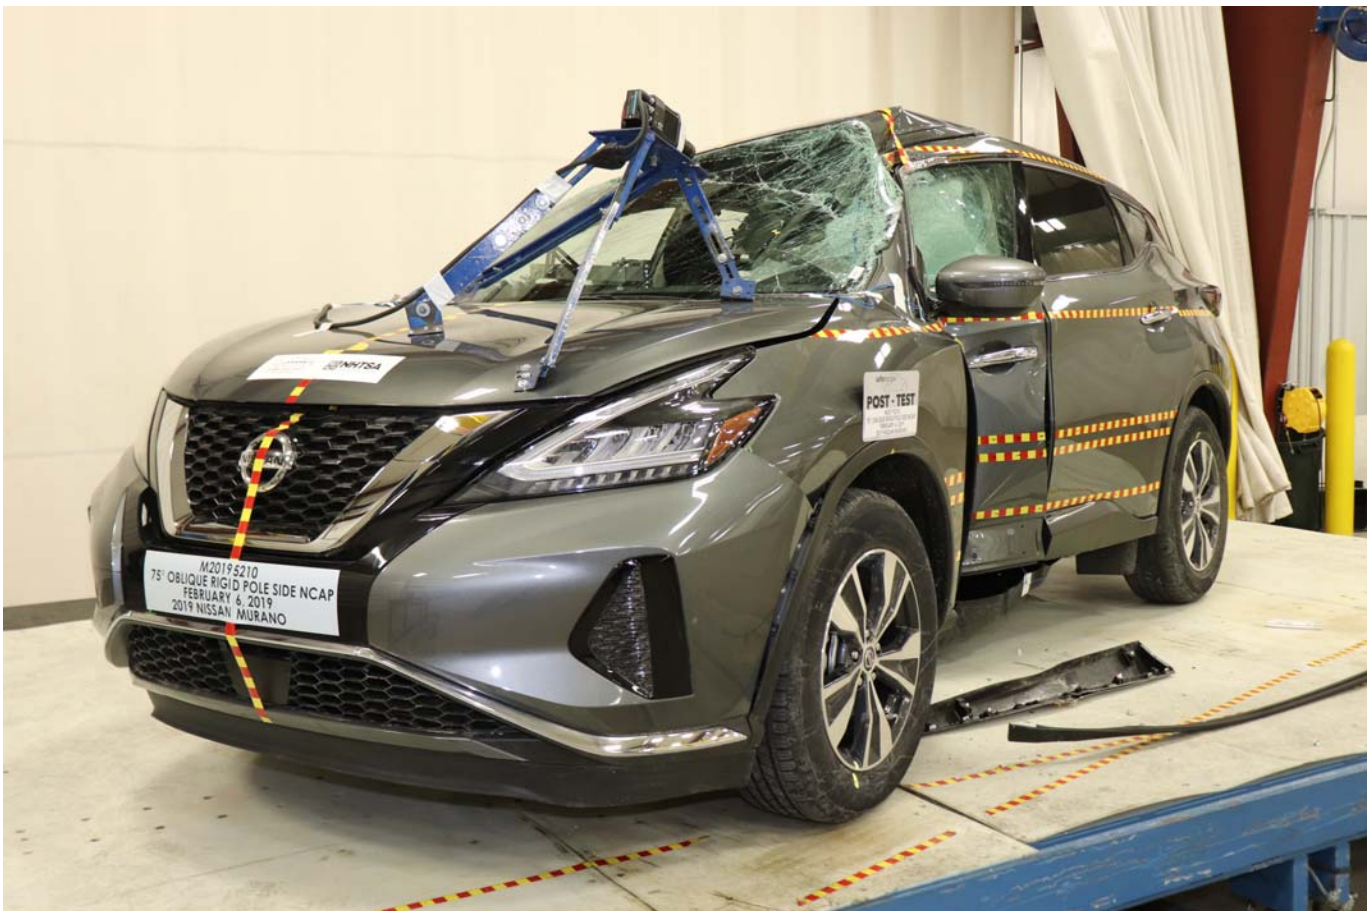
Photo No. 006 - Post-Test Left Front Three-Quarter View of Test Vehicle

Critical Areas of Performance	Observations and Conclusions
Pillar Performance	No Separation
Sill Separation	None
Windshield Damage	Cracked
Side Window Damage	Left Front Window Cracked
Other Notable Effects	None

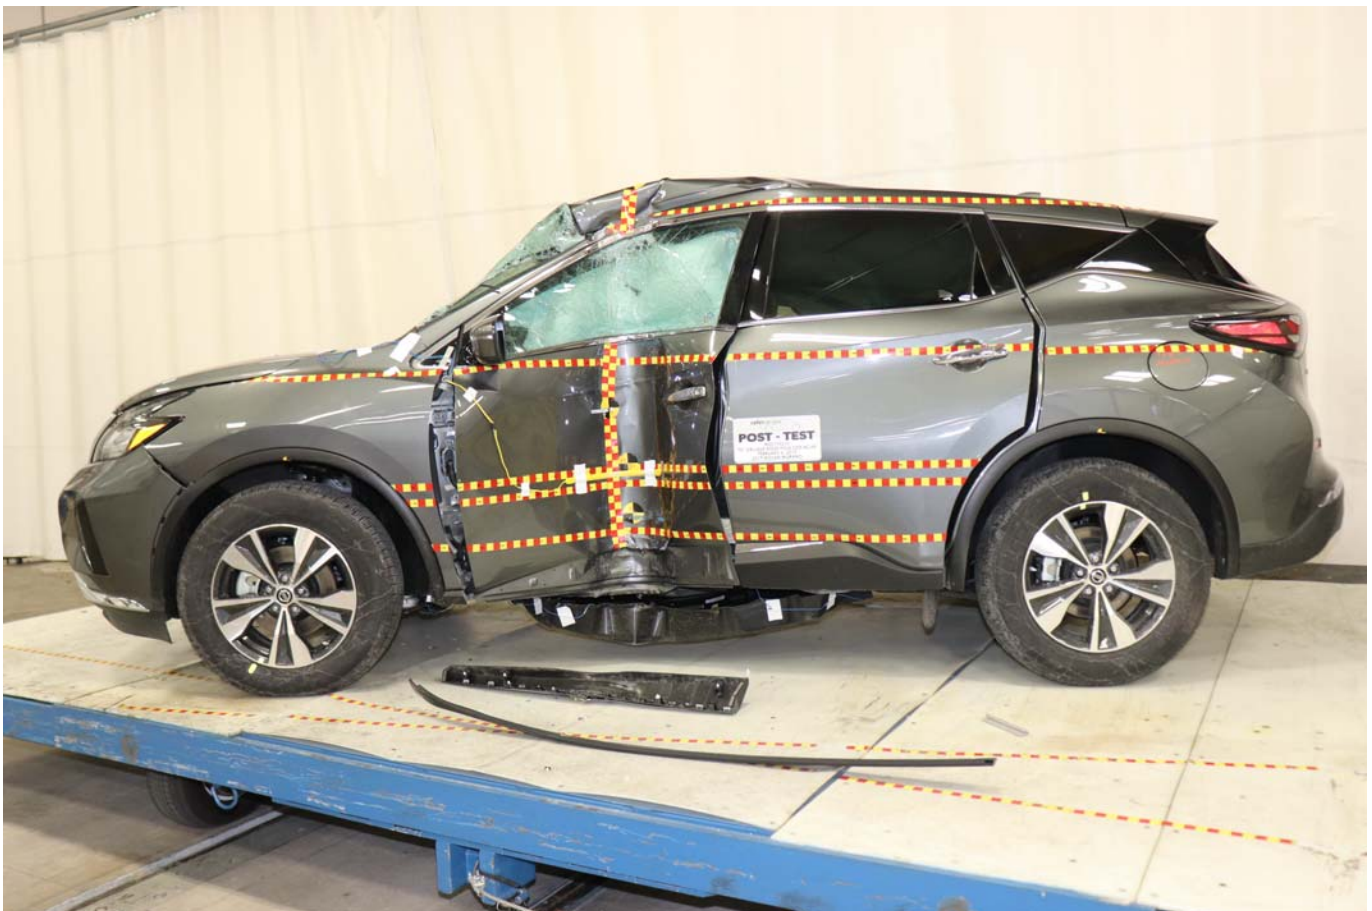
Photo No. 008 - Post-Test Left Side View of Test Vehicle

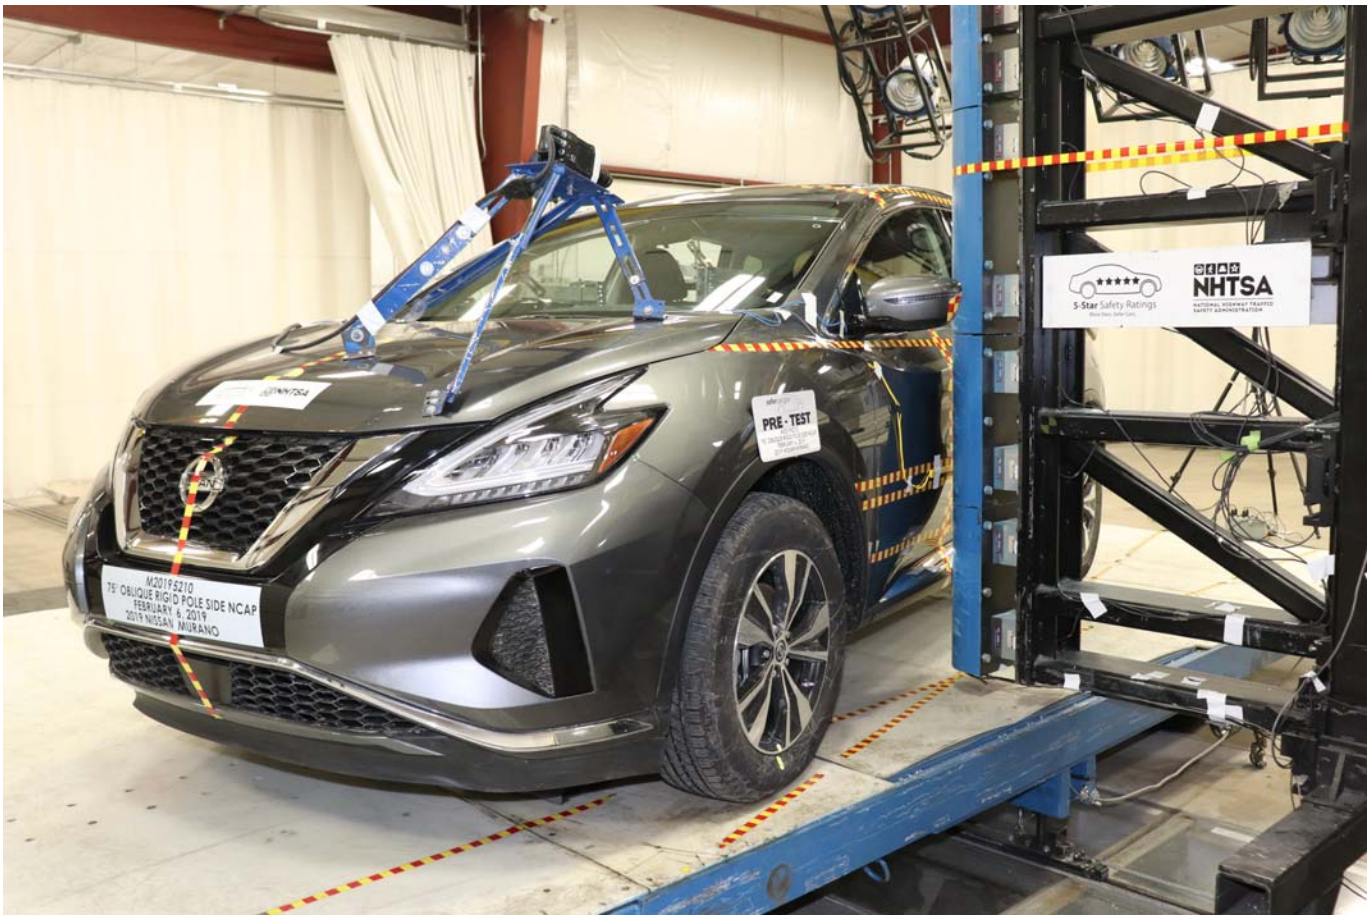
Photo No. 017 - Pre-Test Left Side View of Pole Positioned Against Side of Vehicle

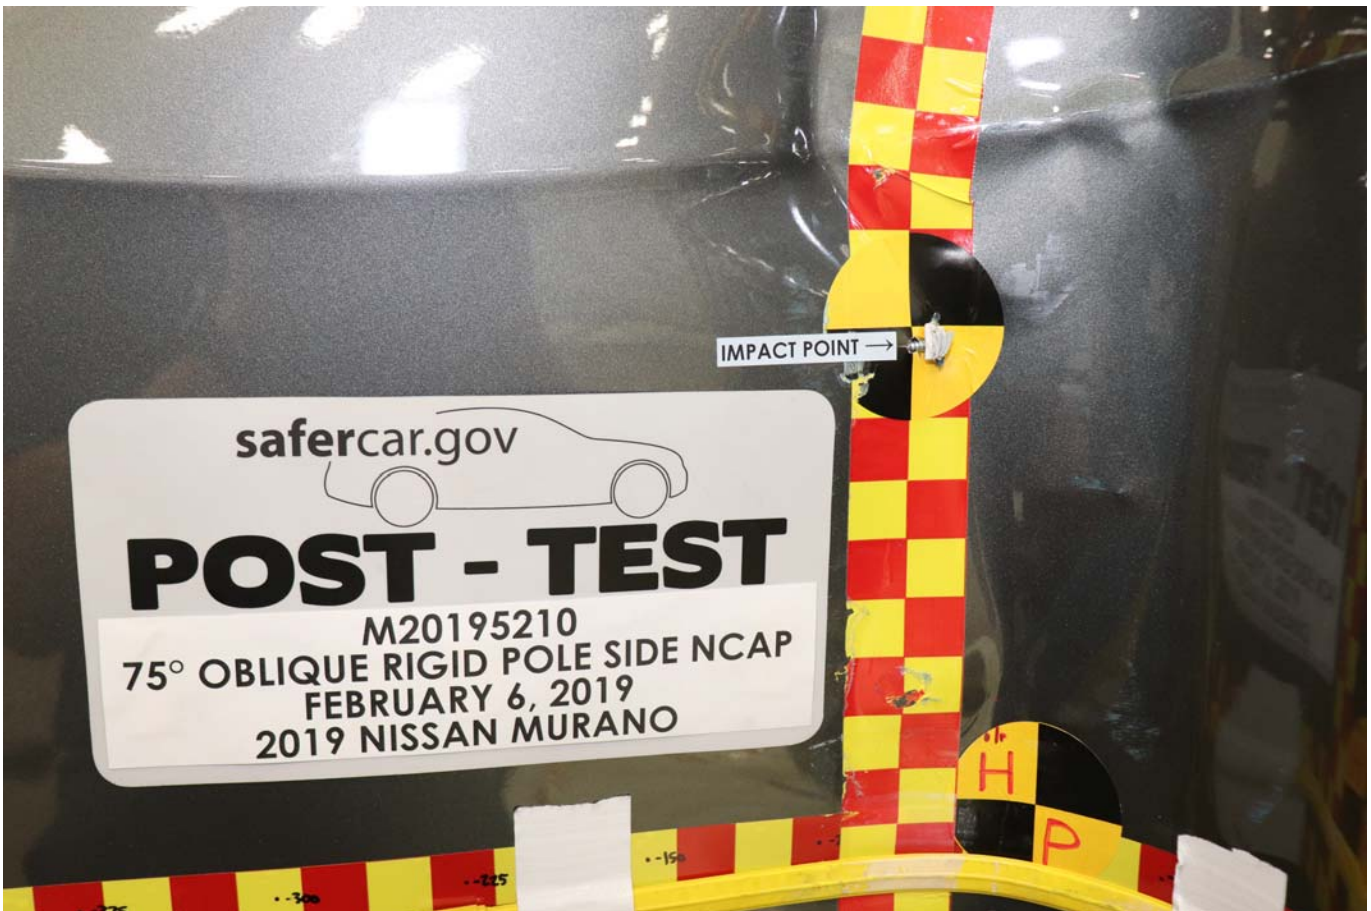
Photo No. 020 - Post-Test Close-Up View of Impact Point Target Showing Impact Location

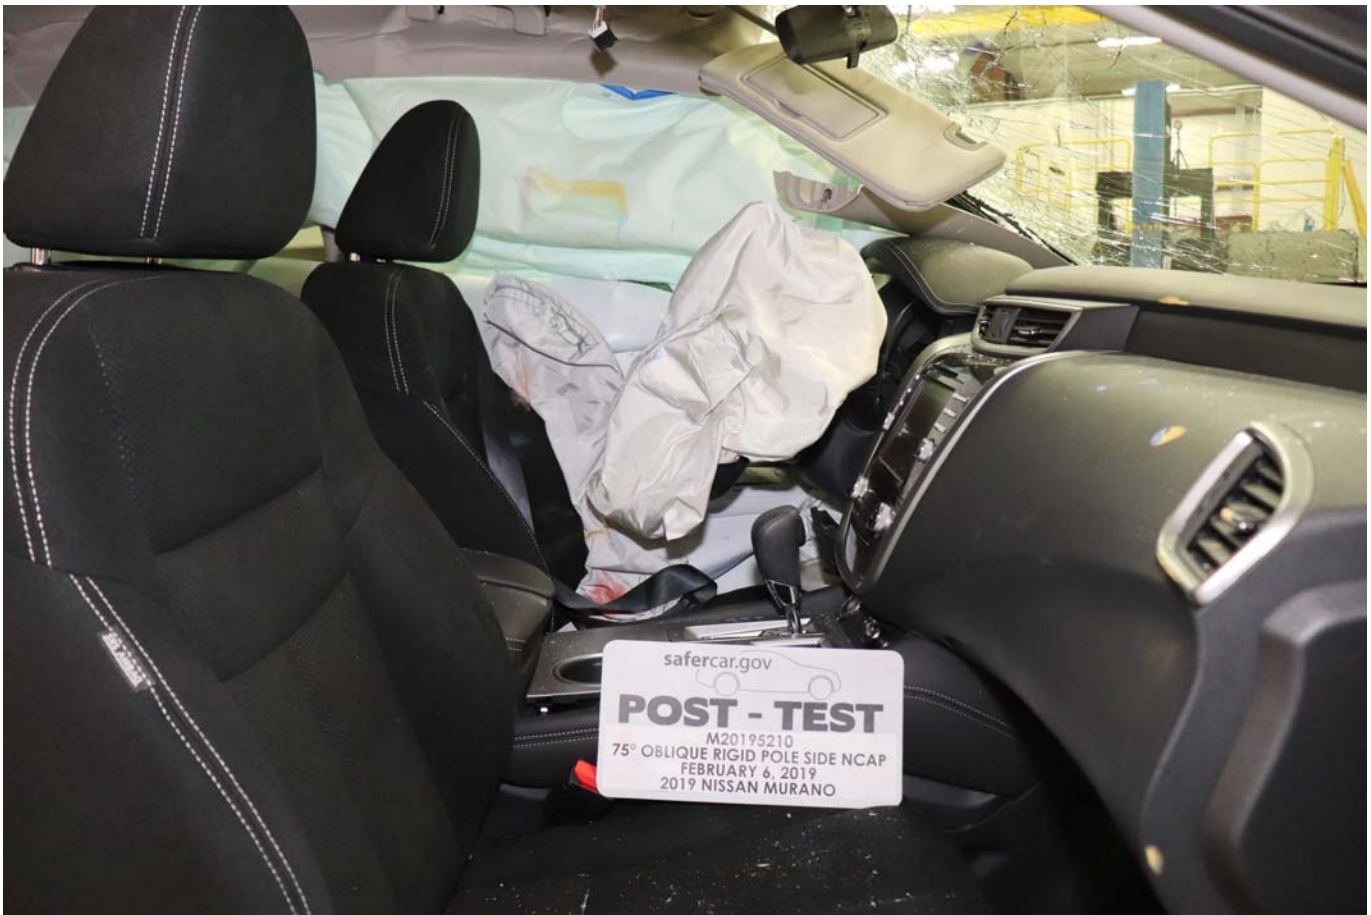
Photo No. 045 - Post-Test Inner Door Panel View Showing Dummy Contact Location

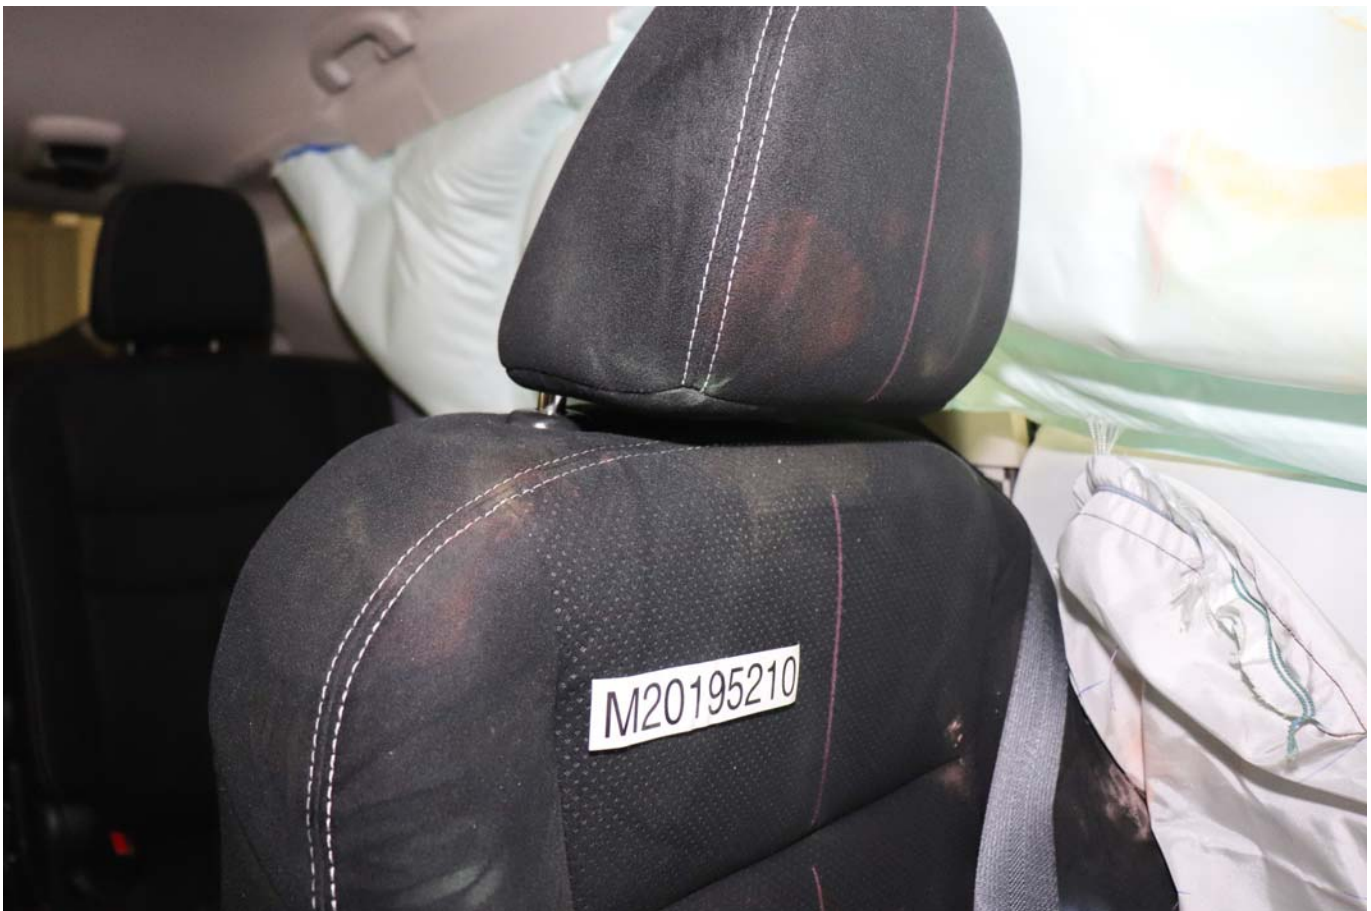
Photo No. 046 - Post-Test Dummy Close-Up Head Contact with Vehicle Interior View

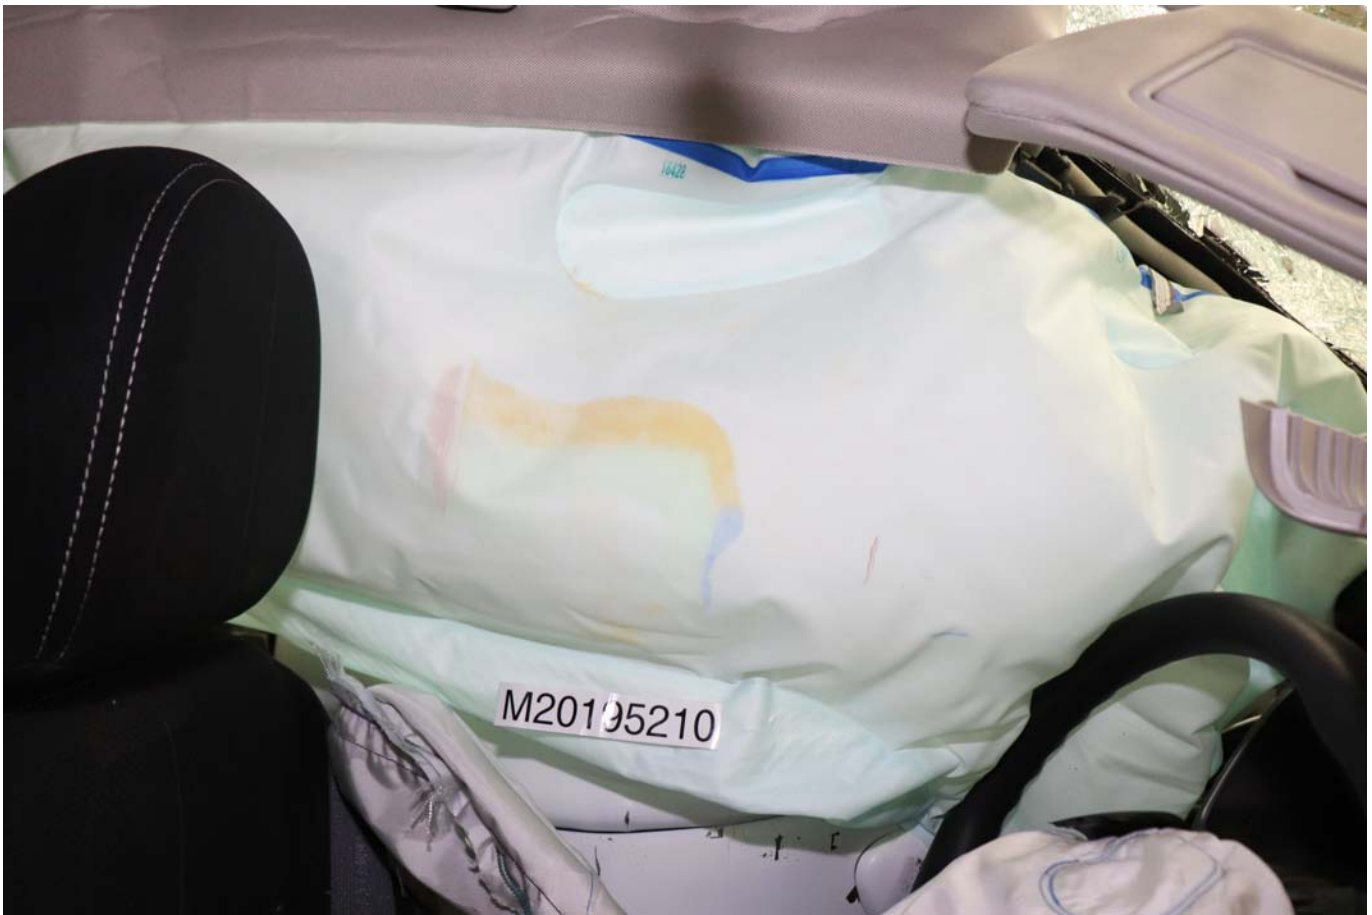
Photo No. 047 - Post-Test Dummy Close-Up Head Contact with Side Air Bag View

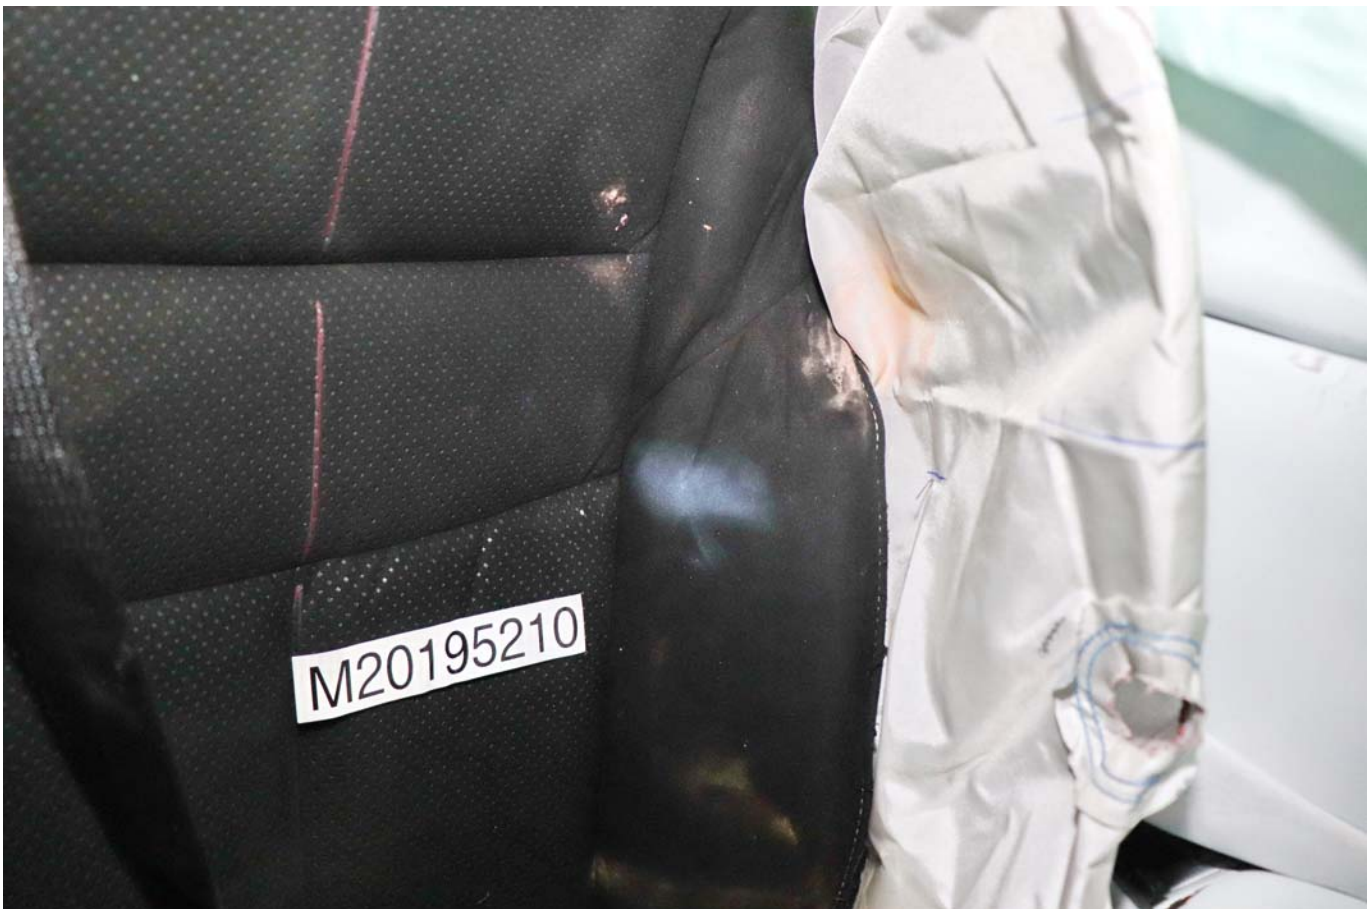
Photo No. 048 - Post-Test Dummy Close-Up Torso Contact with Vehicle Interior View

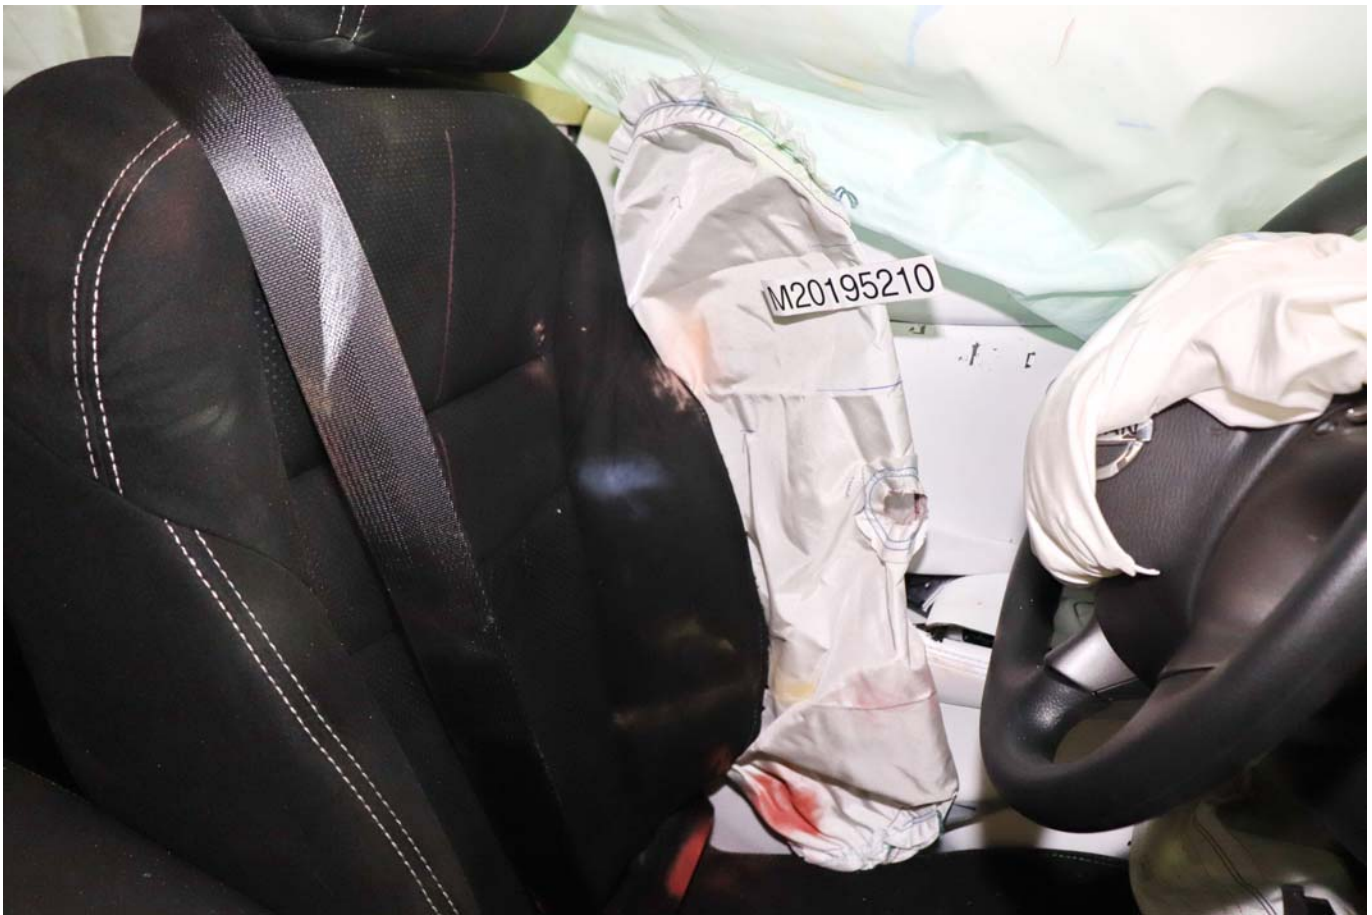
Photo No. 049 - Post-Test Dummy Close-Up Torso Contact with Side Air Bag View

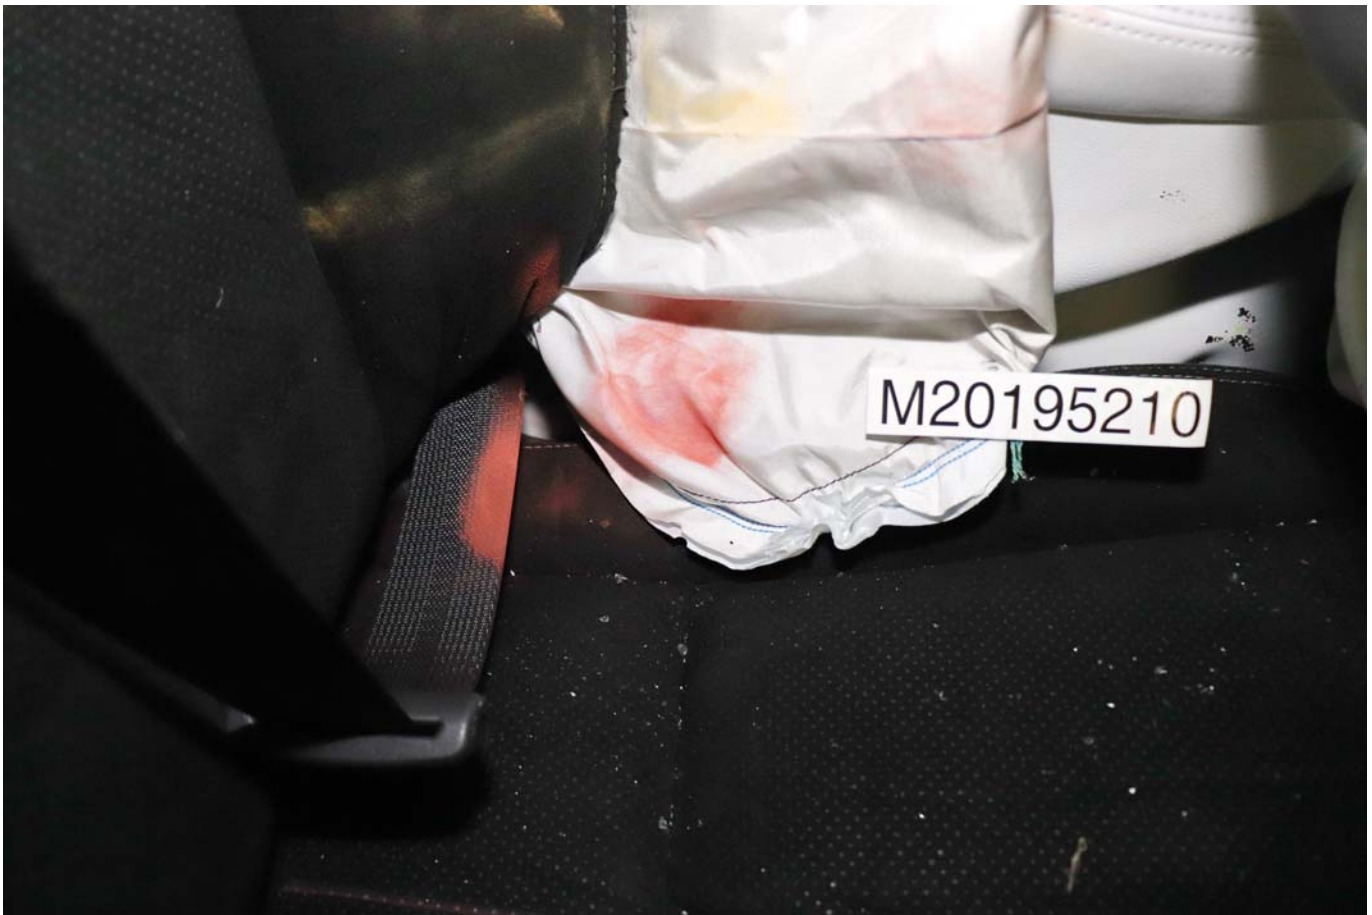
Photo No. 051 - Post-Test Dummy Close-Up Pelvis Contact with Side Air Bag View

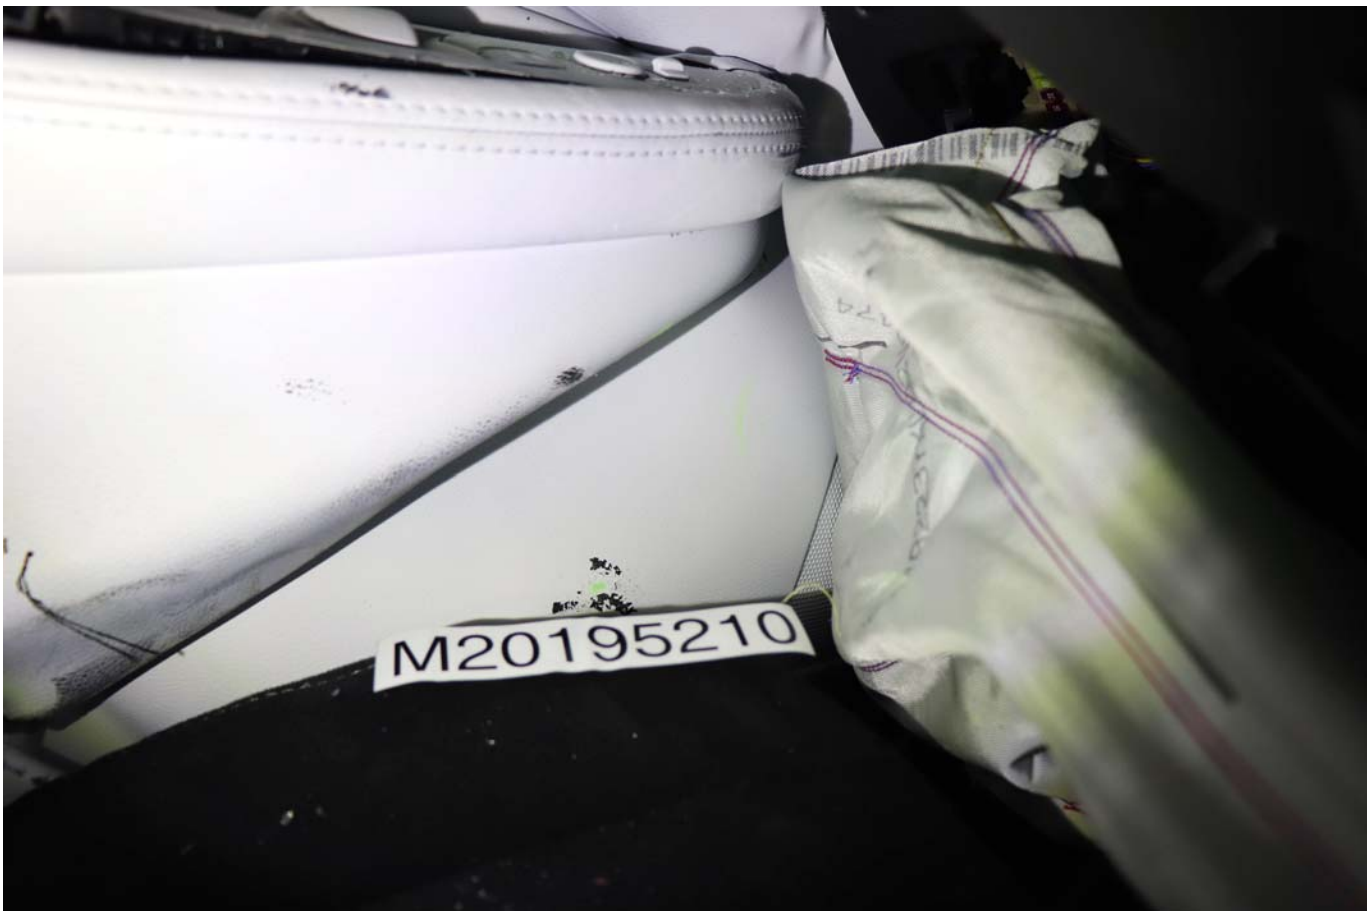
Photo No. 052 - Post-Test Dummy Close-Up Knee Contact with Vehicle Interior View

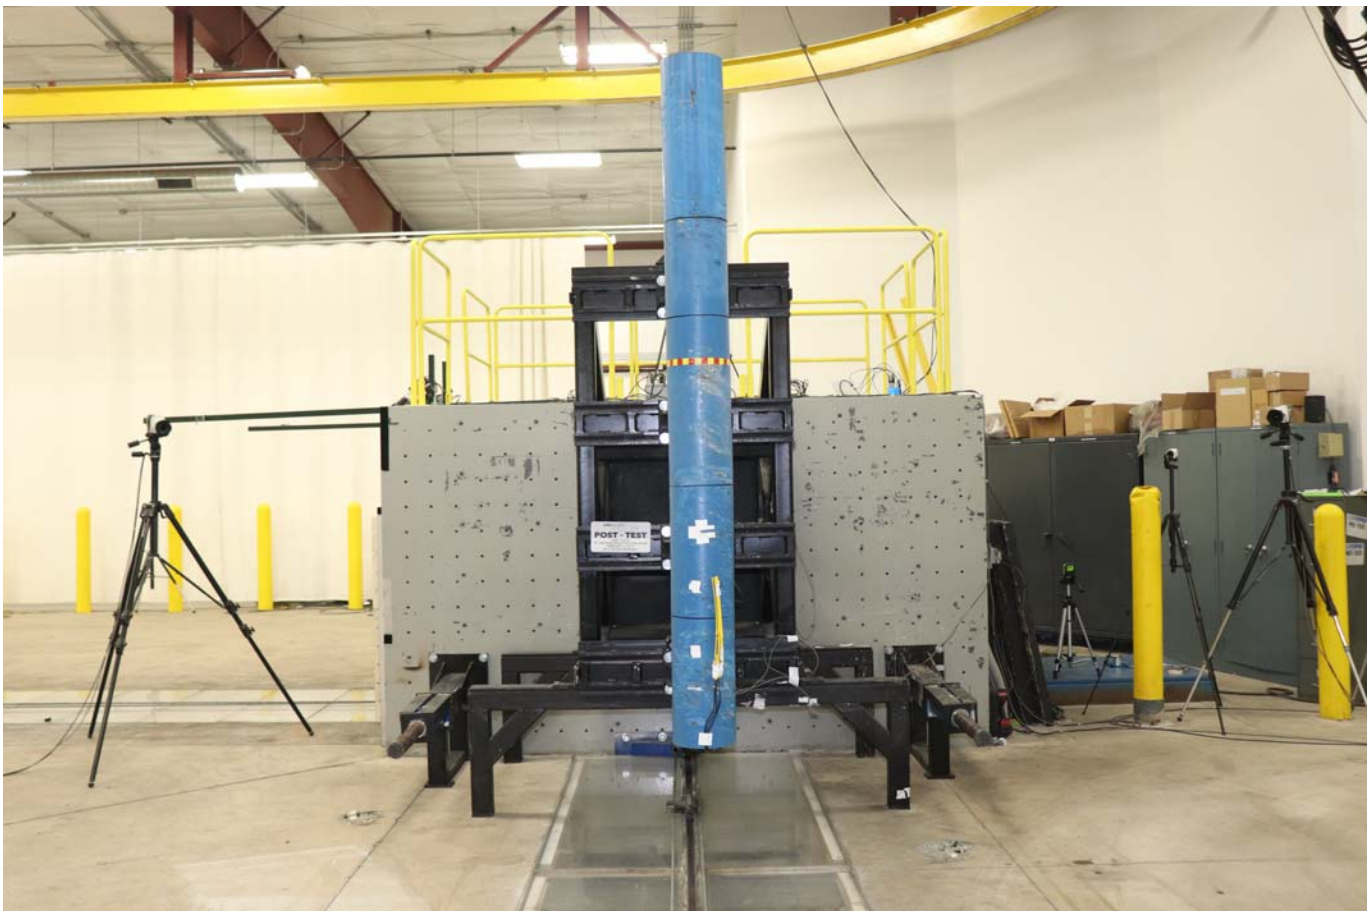
Photo No. 058 - Post-Test Pole Barrier Front View

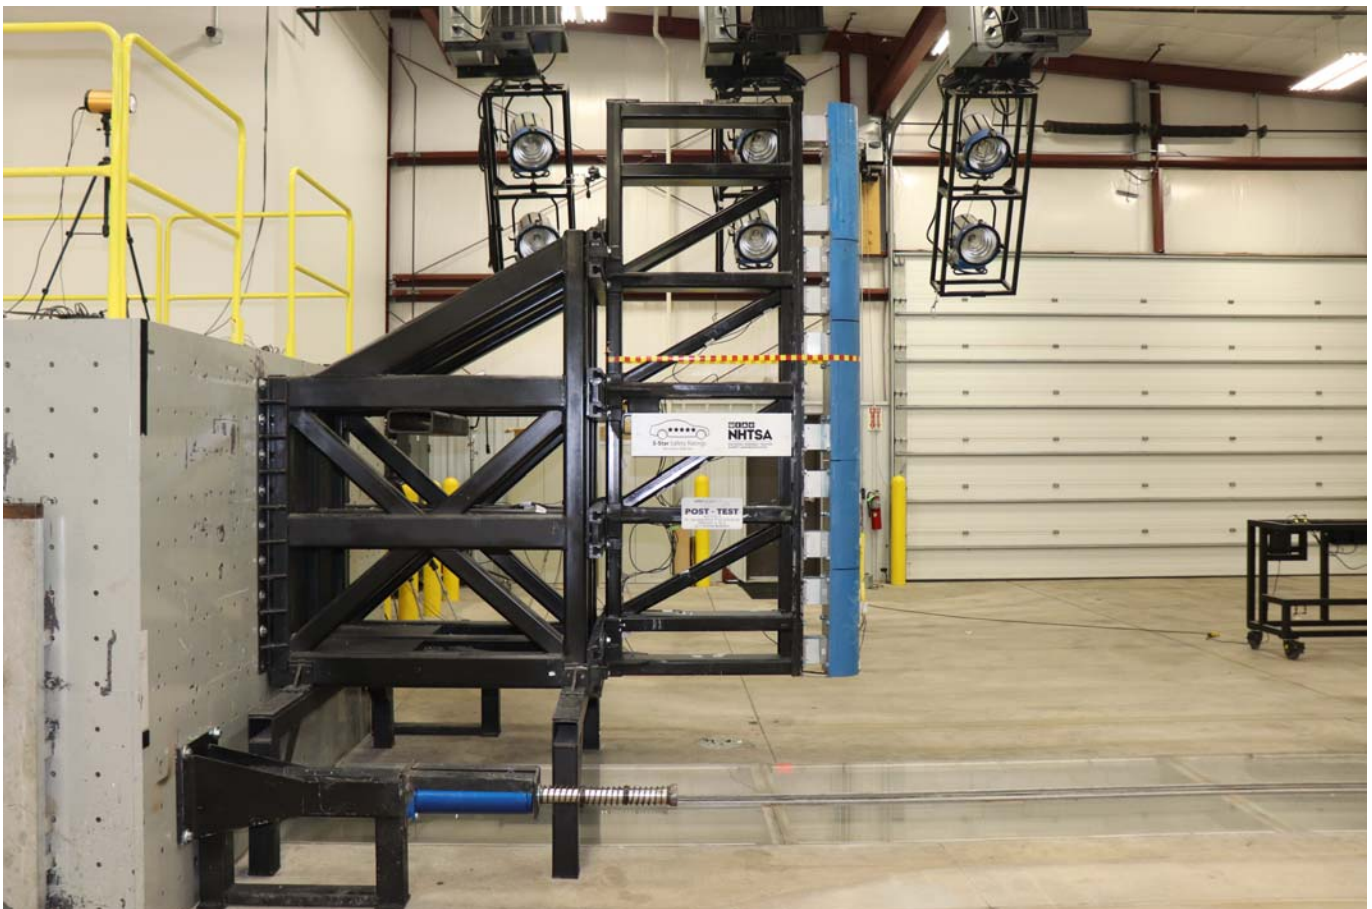
Photo No. 060 - Post-Test Pole Barrier Side View

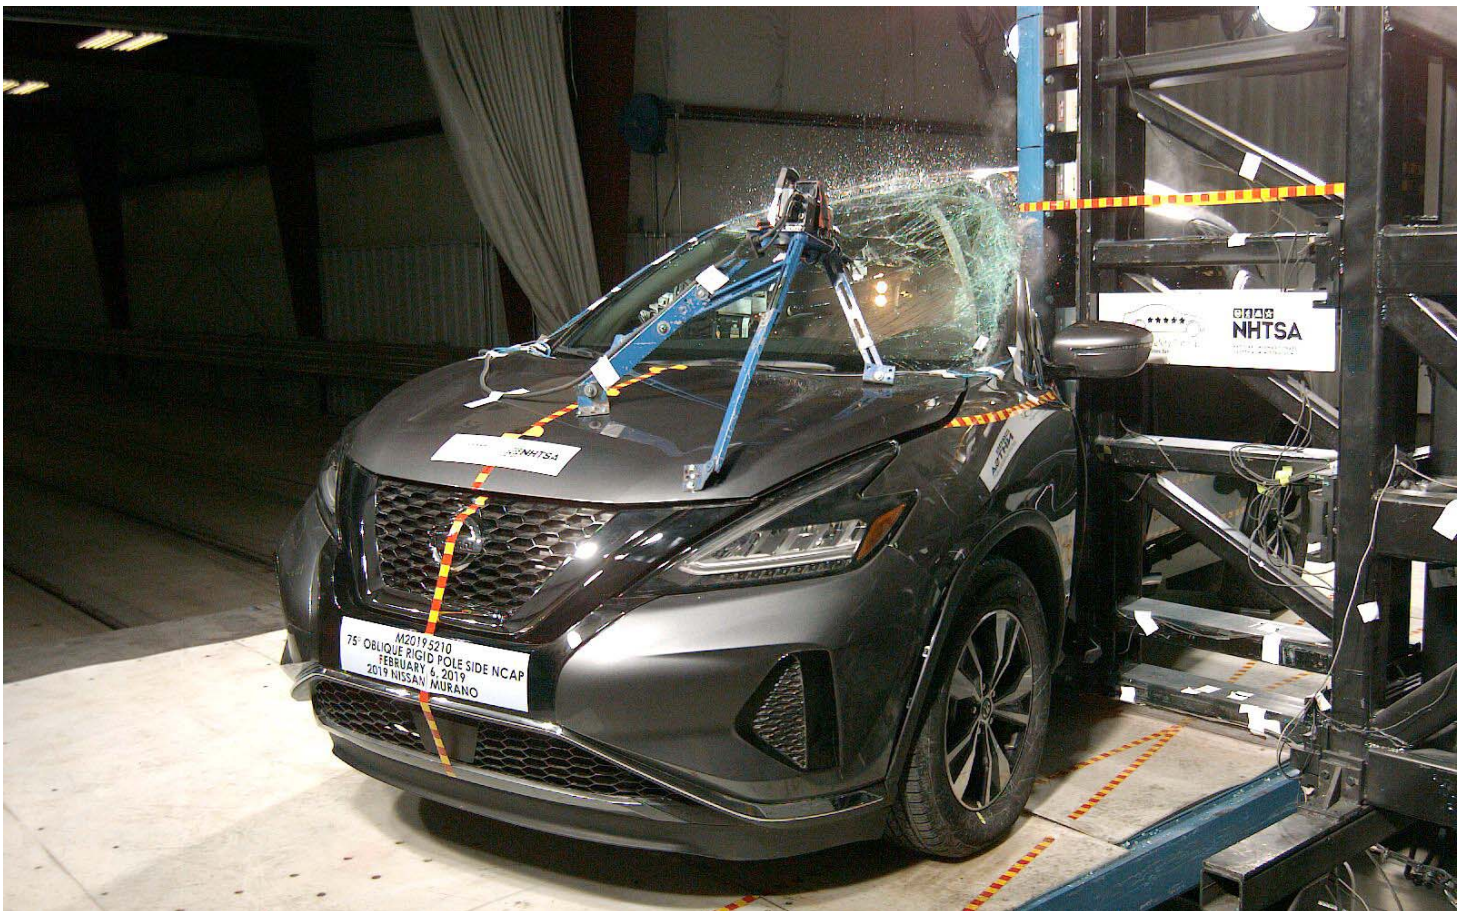
Photo No. 068 - Impact Event

A rigid pole side impact test was conducted on a 2019 Nissan Murano S 5-Door SUV. The subject vehicle was towed into the rigid pole at an angle of 75° and a velocity of 32.17 km/h. The test was conducted by MGA Research Corporation in Burlington, Wisconsin on February 6, 2019. Pre-test and post-test photographs of the test vehicle and side impact dummy (SID-IIs) are included in Appendix A of this report.

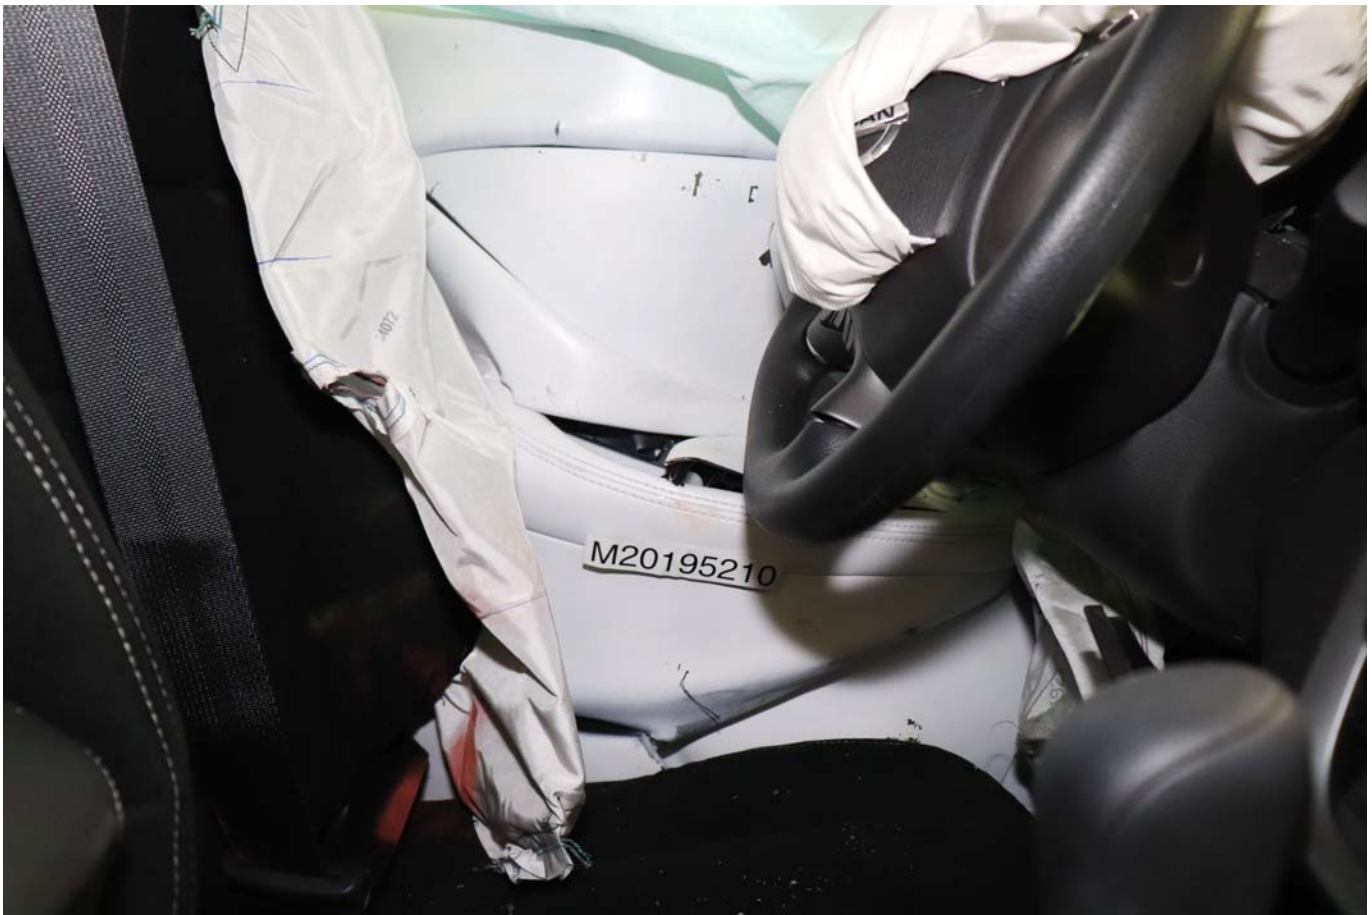
Photo No. 071 - Post-Test View of Shattered Vehicle Inner Door Panel
