**REPORT NUMBER: NCAP-CAL-19-004**

**NEW CAR ASSESSMENT PROGRAM (NCAP)  
FRONTAL BARRIER IMPACT TEST**

**KIA Motors Mexico S.A. de C.V  
2019 KIA Forte  
Four Door Sedan**

**FINAL REPORT**

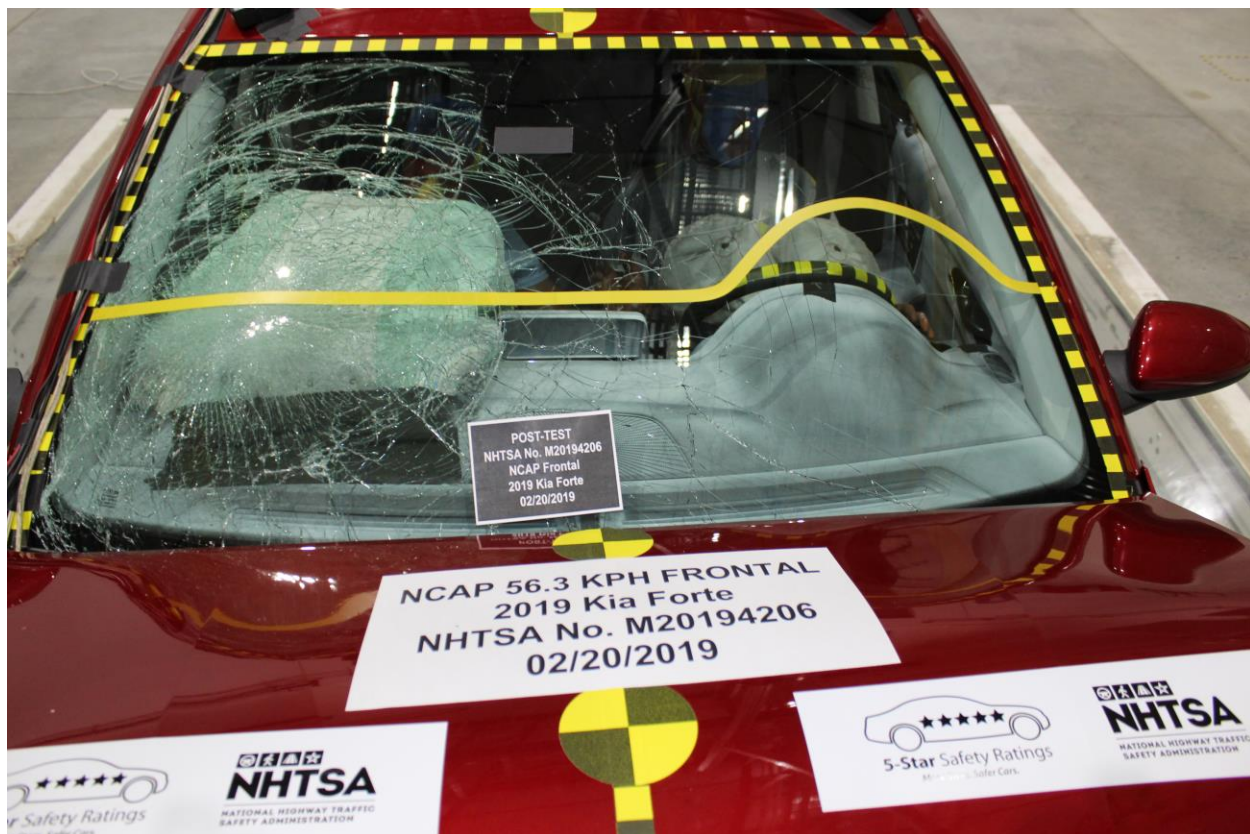
Figure A-19: Post-Test Windshield View

| Critical Areas of Performance | Observations and Conclusions |
|---|---|
| Windshield Damage | Cracked from air bag deployment |

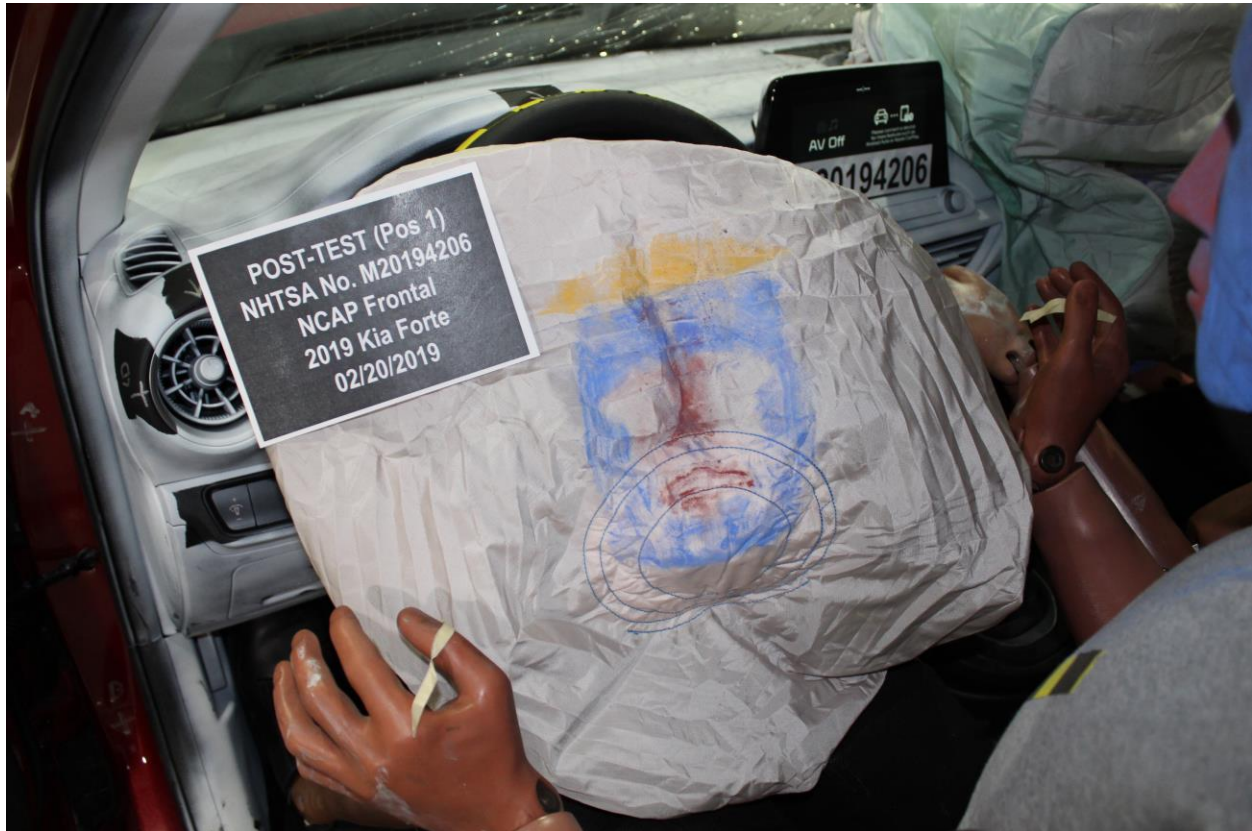
**Figure A-47: Post-Test Driver Dummy Contact With Airbag**

The driver's visible contact points were as follows: The driver's head contacted the frontal airbag and then the head restraint. The upper torso contacted the frontal airbag. The right side knee contacted the driver side steering column.

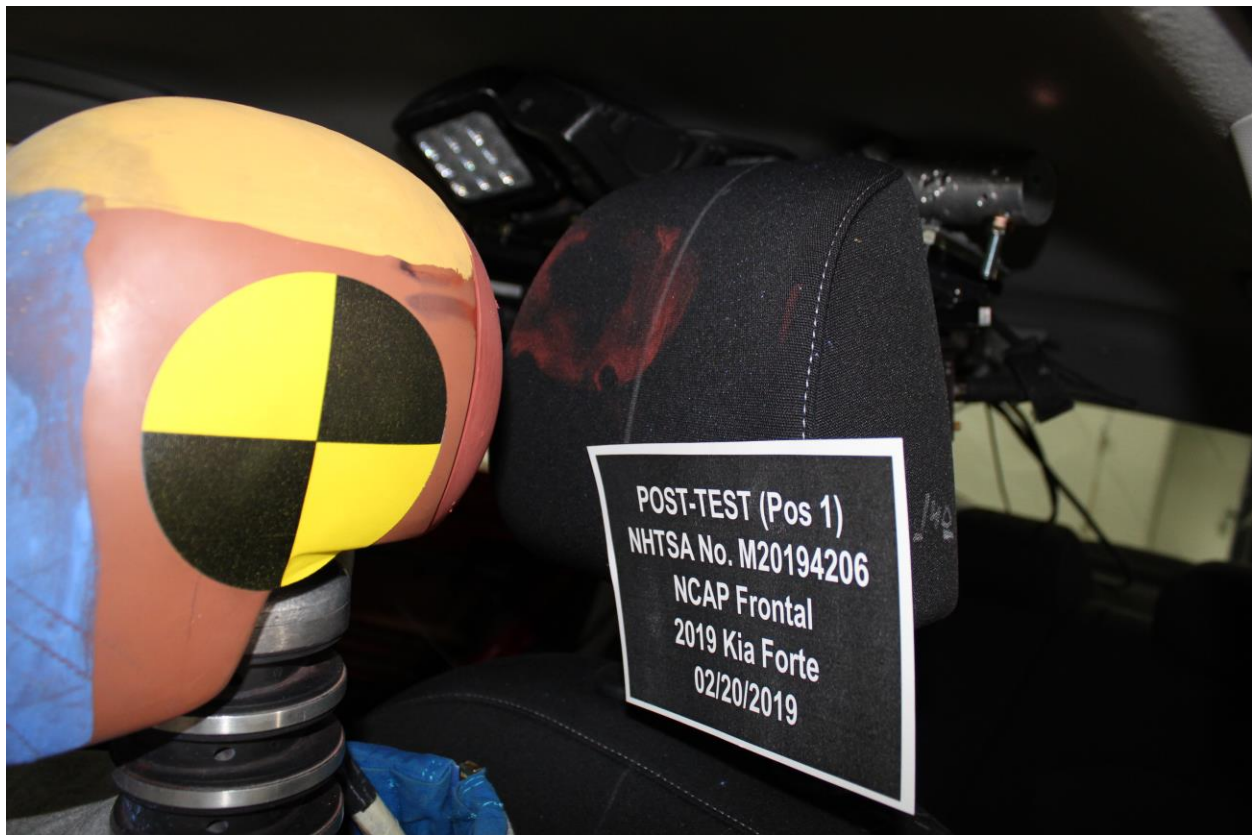
**Figure A-48: Post-Test Driver Dummy Contact With Headrest**
