**REPORT NUMBER: SINCAP-CAL-19-007**

**NEW CAR ASSESSMENT PROGRAM (NCAP)  
MOVING DEFORMABLE BARRIER SIDE IMPACT TEST**

**FCA US LLC  
2019 Ram 1500 Quad Cab  
Four Door Truck**

**NHTSA No: M20190317**

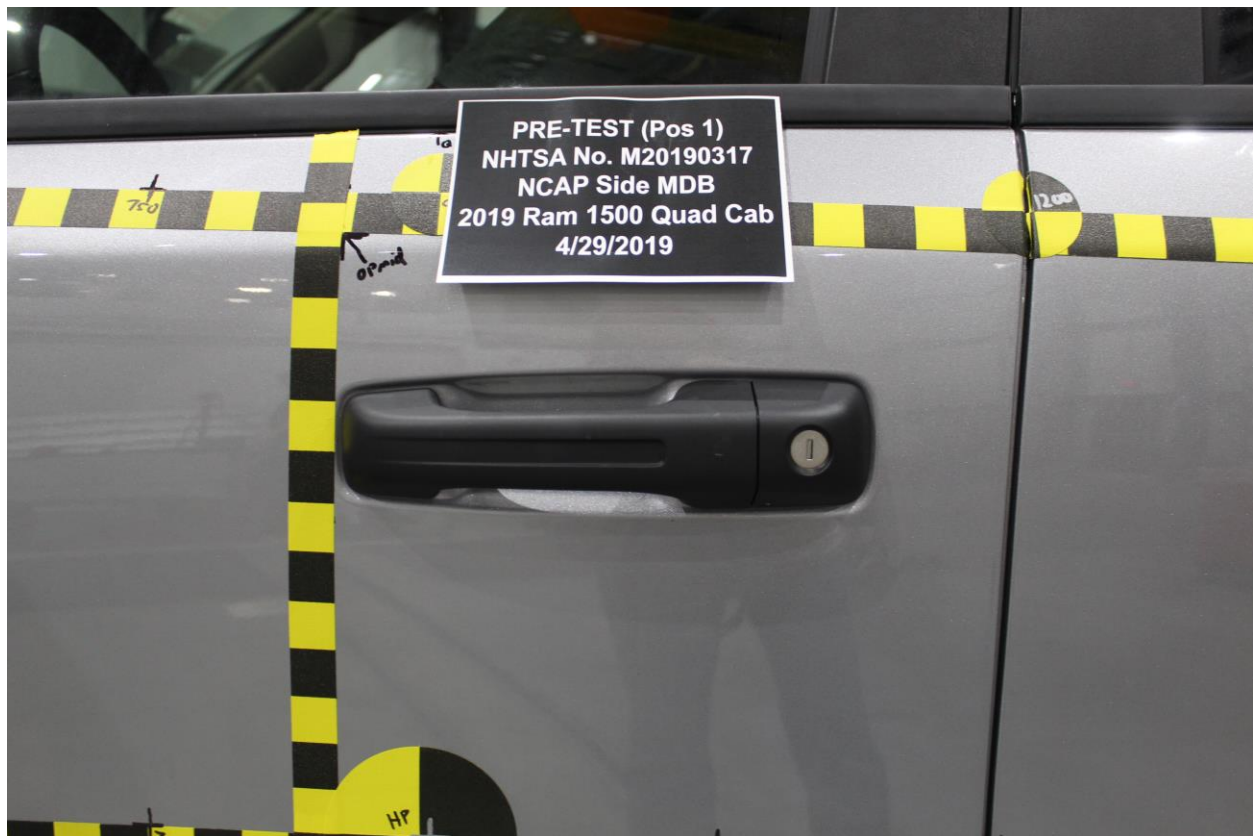
Figure A-21: Pre-Test Left Front Door Latch Close-Up

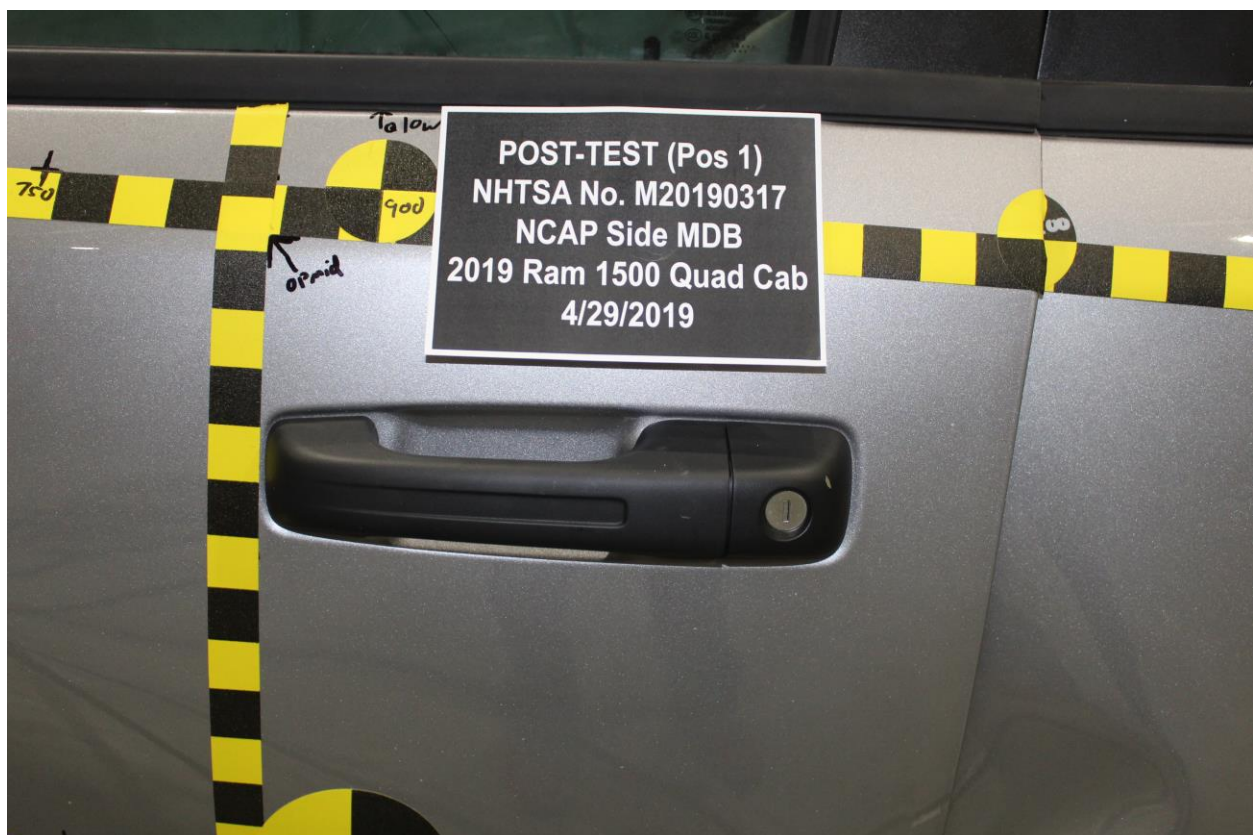
Figure A-22: Post-Test Left Front Door Latch Close-Up

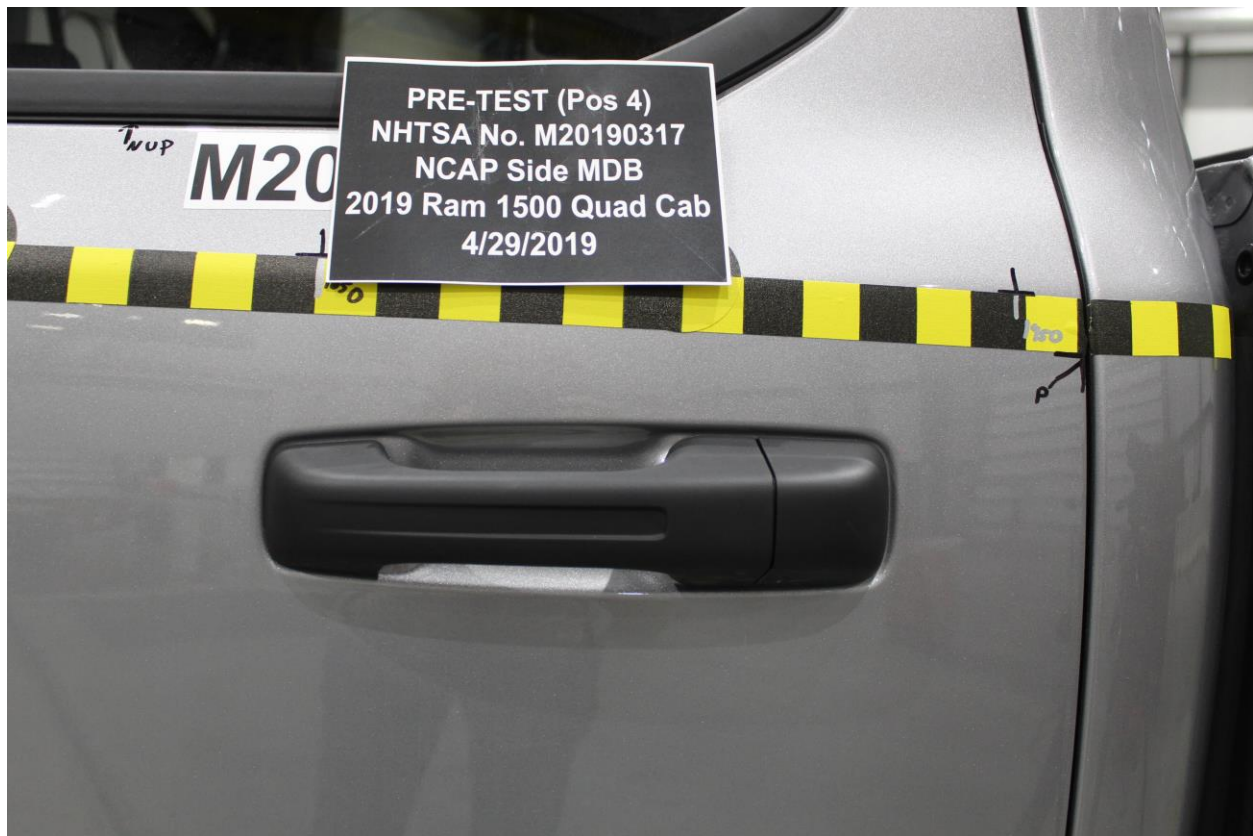
Figure A-23: Pre-Test Left Rear Door Latch Close-Up

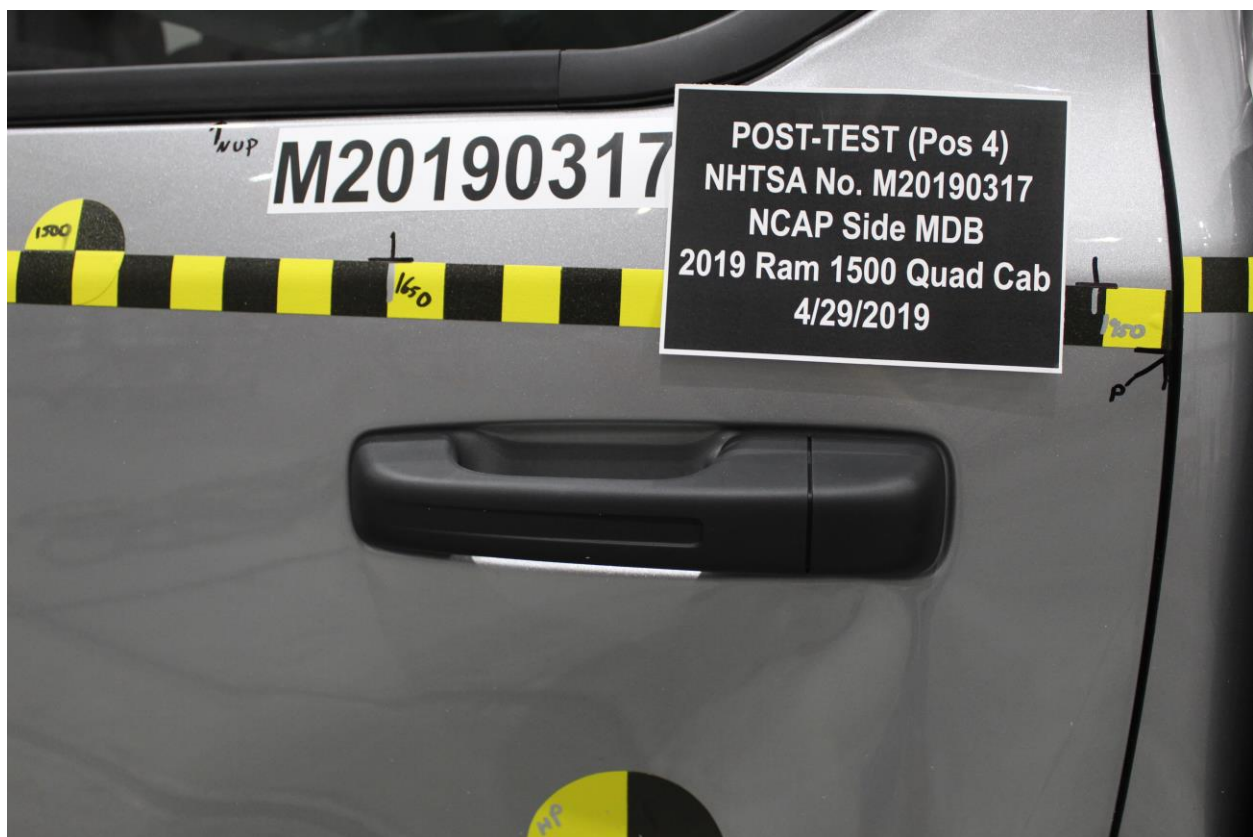
Figure A-24: Post-Test Left Rear Door Latch Close-Up
