**REPORT NUMBER: 301-KAR-19-001**  
**SAFETY COMPLIANCE TESTING FOR FMVSS 301R**  
**FUEL SYSTEM INTEGRITY – REAR IMPACT**  
**79.3 KM/H 70% OVERLAP REAR IMPACT**

**SUBARU CORPORATION**  
**2019 SUBARU FORESTER 5-DOOR MPV**

**NHTSA NUMBER: C20195502**

**PREPARED BY:**  
**APPLUS+ IDIADA KARCO ENGINEERING, LLC.**  
**9270 HOLLY ROAD**  
**ADELANTO, CA 92301**

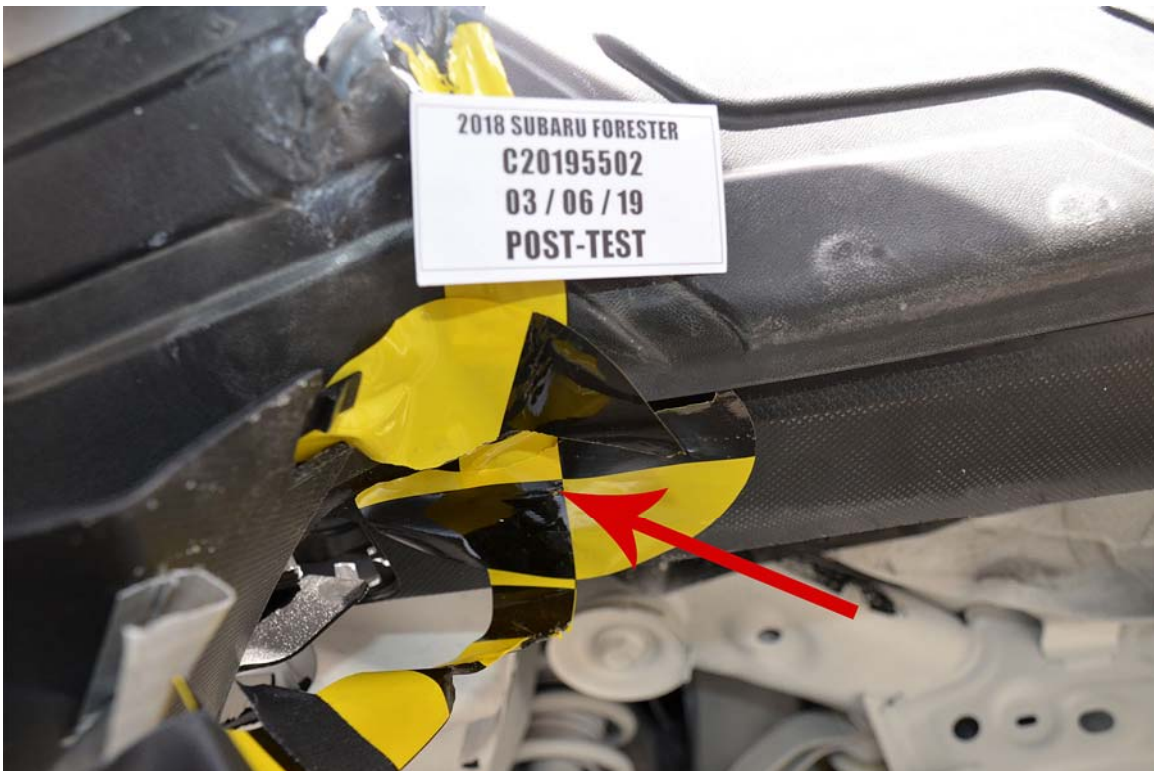
FIGURE 22. Post-Test Close-Up View of Impact Point Target

**IMPACT POINT LOCATION DATA**

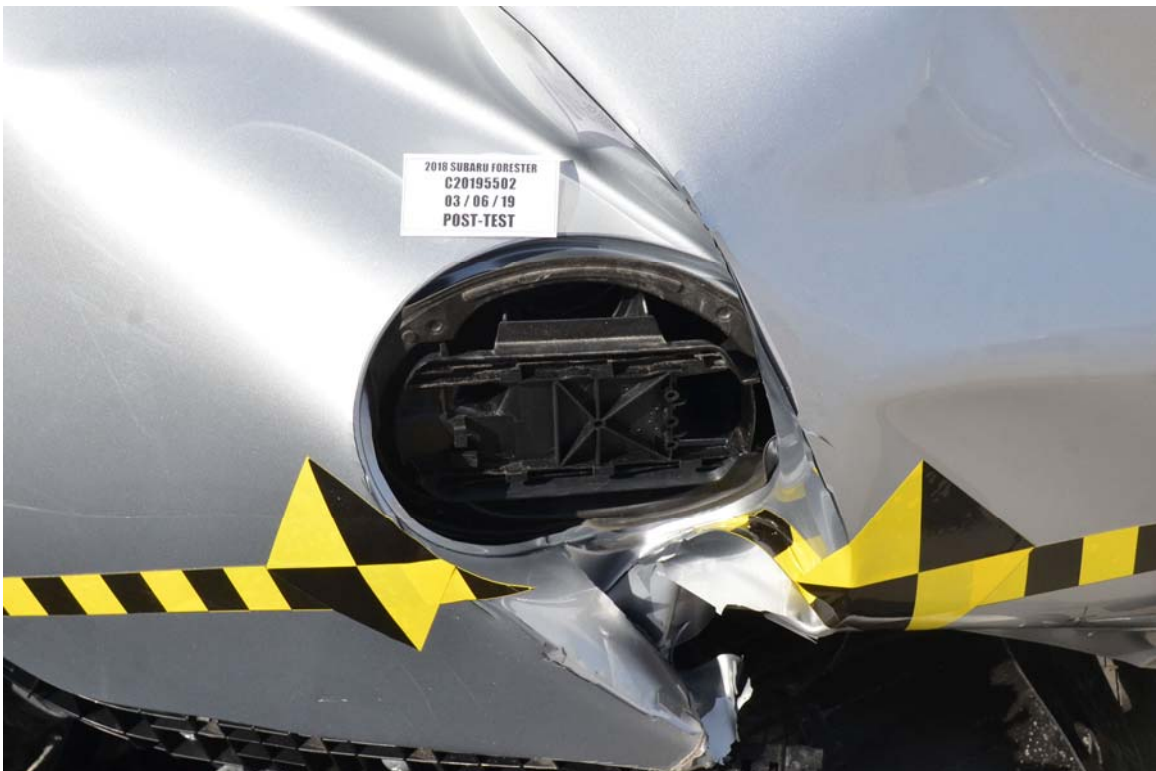
FIGURE 24. Post-Test View of Fuel Filler Cap

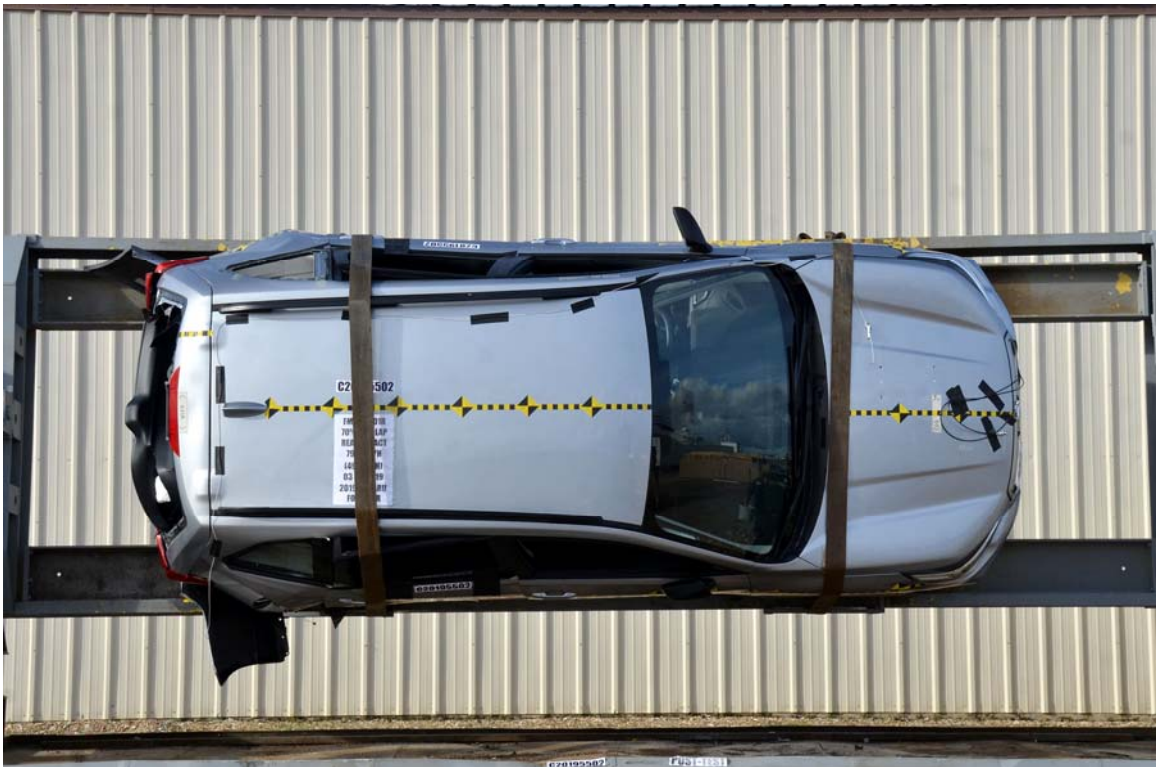
FIGURE 32. Test Vehicle at 90° on FMVSS 301 Static Rollover Device

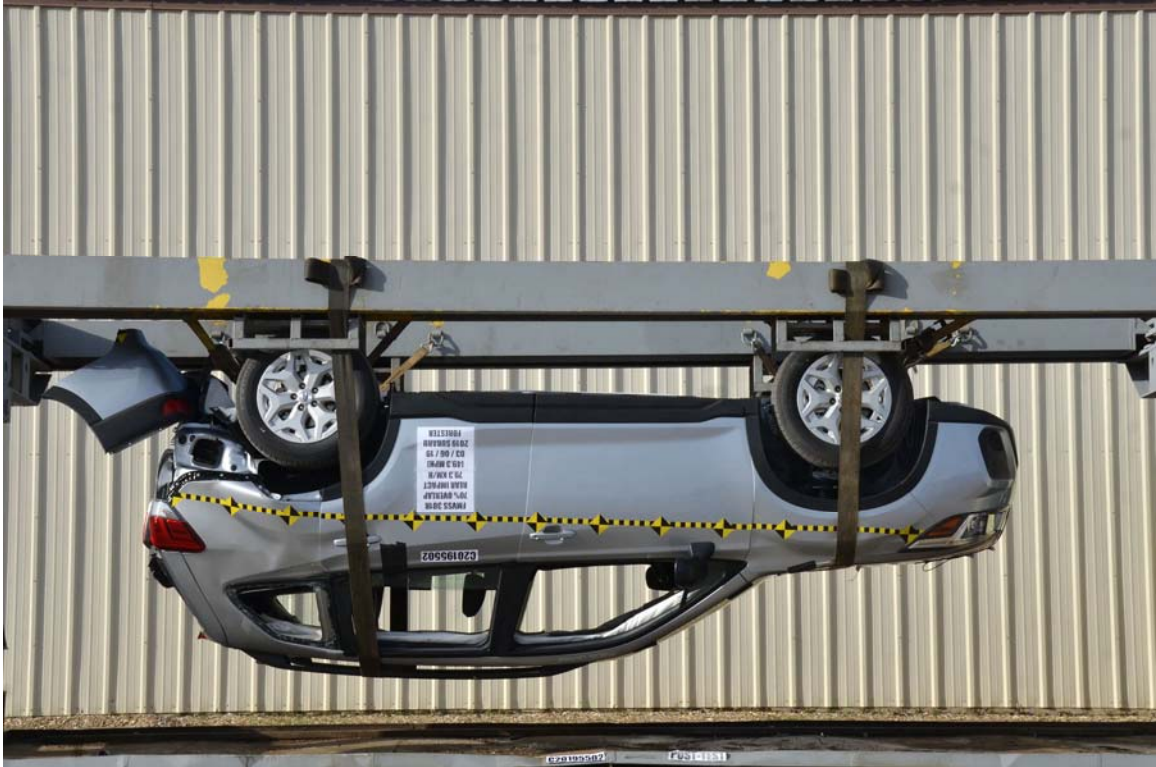
FIGURE 33. Test Vehicle at 180° on FMVSS 301 Static Rollover Device

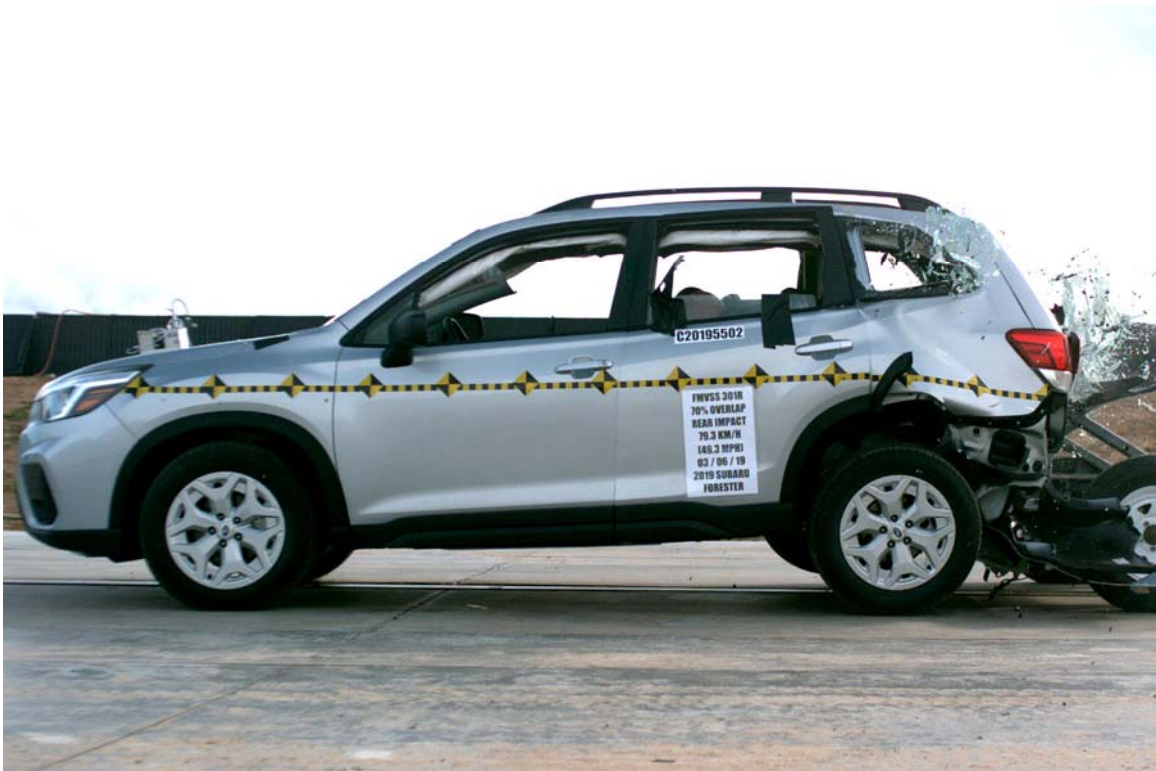
FIGURE 36. Impact Event
