REPORT NUMBER: NCAP-MGA-2019-042

**NEW CAR ASSESSMENT PROGRAM (NCAP)
Frontal Barrier Impact Test**

**FCA US LLC
2019 Jeep Grand Cherokee Laredo 4x4 5-Door SUV
NHTSA No.: M20190308**

**MGA RESEARCH CORPORATION
5000 Warren Road
Burlington, WI 53105**

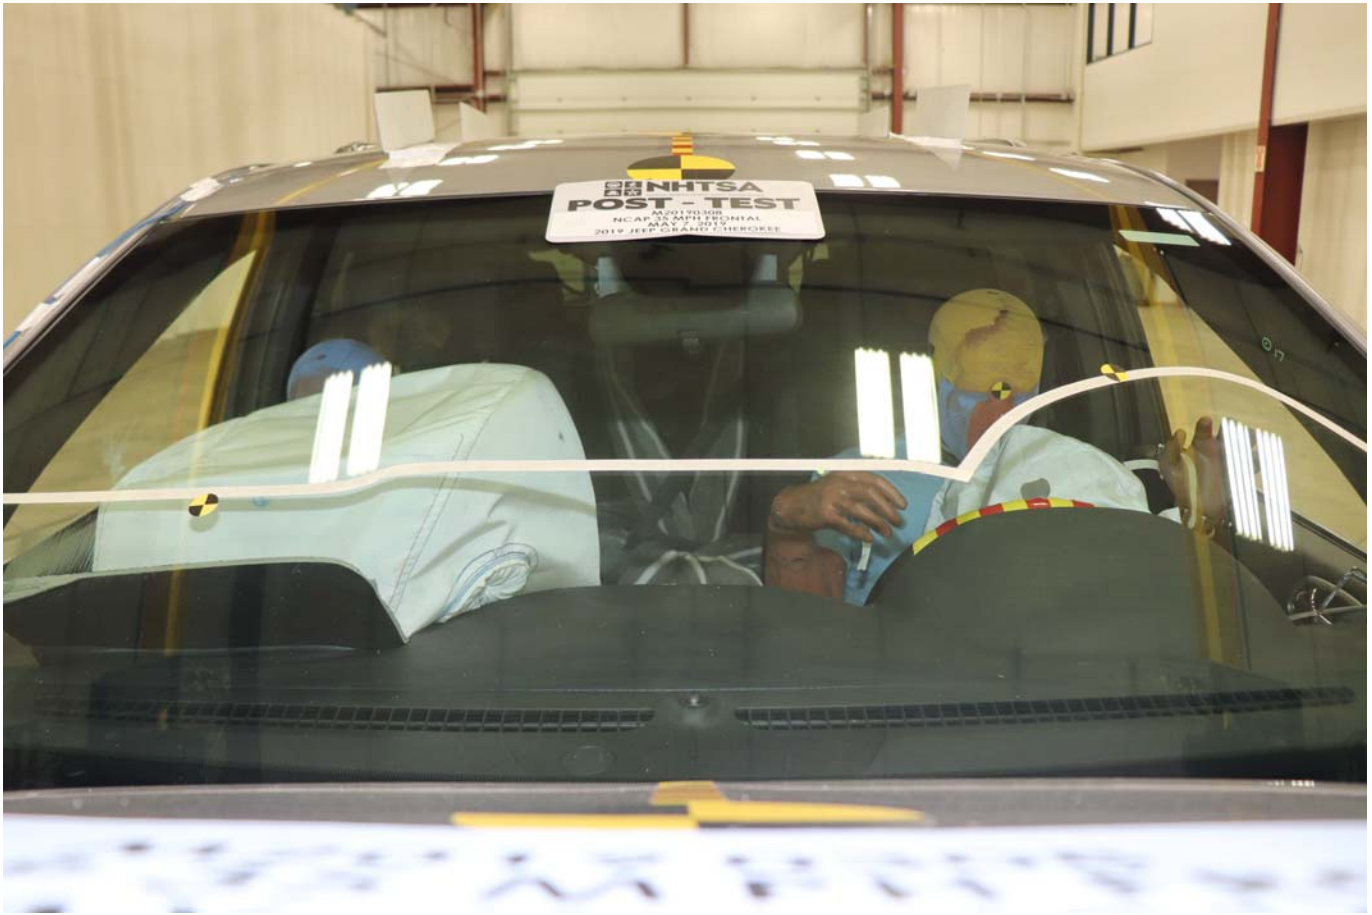
Photo No. 019 - Post-Test Windshield View

There was 100 percent windshield retention and no intrusion into the protected zone of the windshield during the event. There was no Stoddard Solvent leakage after the event or during any phase of the static rollover.

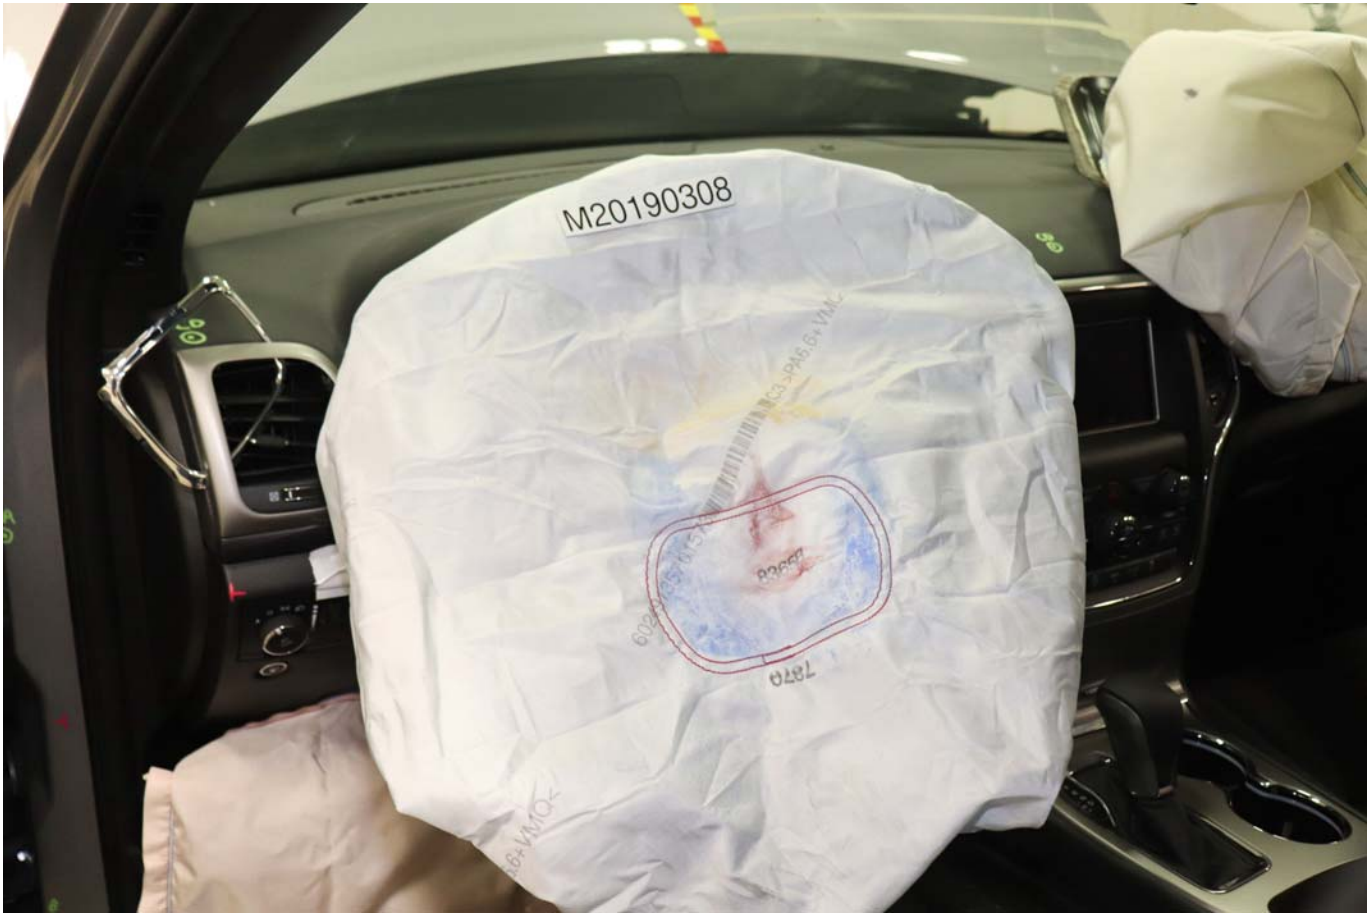
Photo No. 047 - Post-Test Driver Dummy Contact with Airbag

The driver's visible contact points were as follows: The driver's head contacted the airbag. The driver's head also contacted the headrest. The driver's knees contacted the knee airbag. The passenger's visible contact points were as follows: The passenger's head contacted the airbag. The passenger's head also contacted the headrest. The passenger's knees contacted the glove box.
