REPORT NUMBER: SINCAP-KAR-19-027

**NEW CAR ASSESSMENT PROGRAM (NCAP)
MOVING DEFORMABLE BARRIER SIDE IMPACT TEST**

**HONDA OF CANADA MFG
2019 HONDA CR-V LX 5-DOOR MPV**

NHTSA No: M20195302

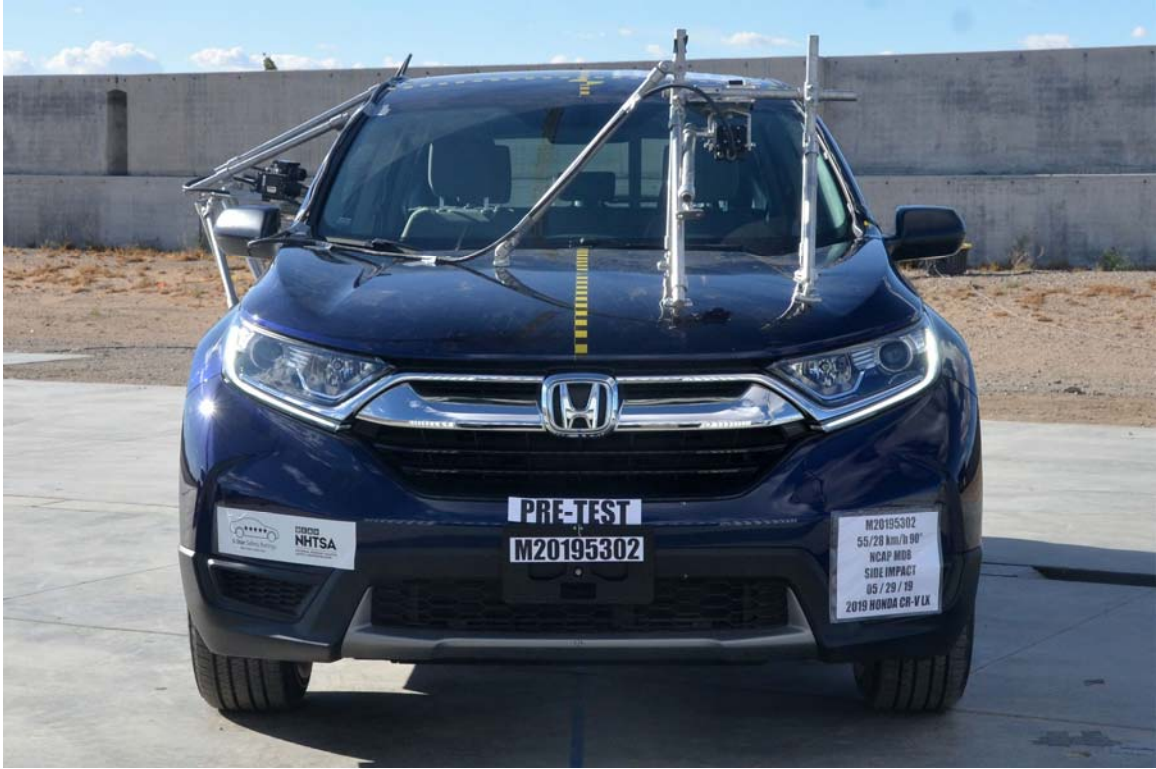
FIGURE 3. Pre-Test Frontal View of Test Vehicle

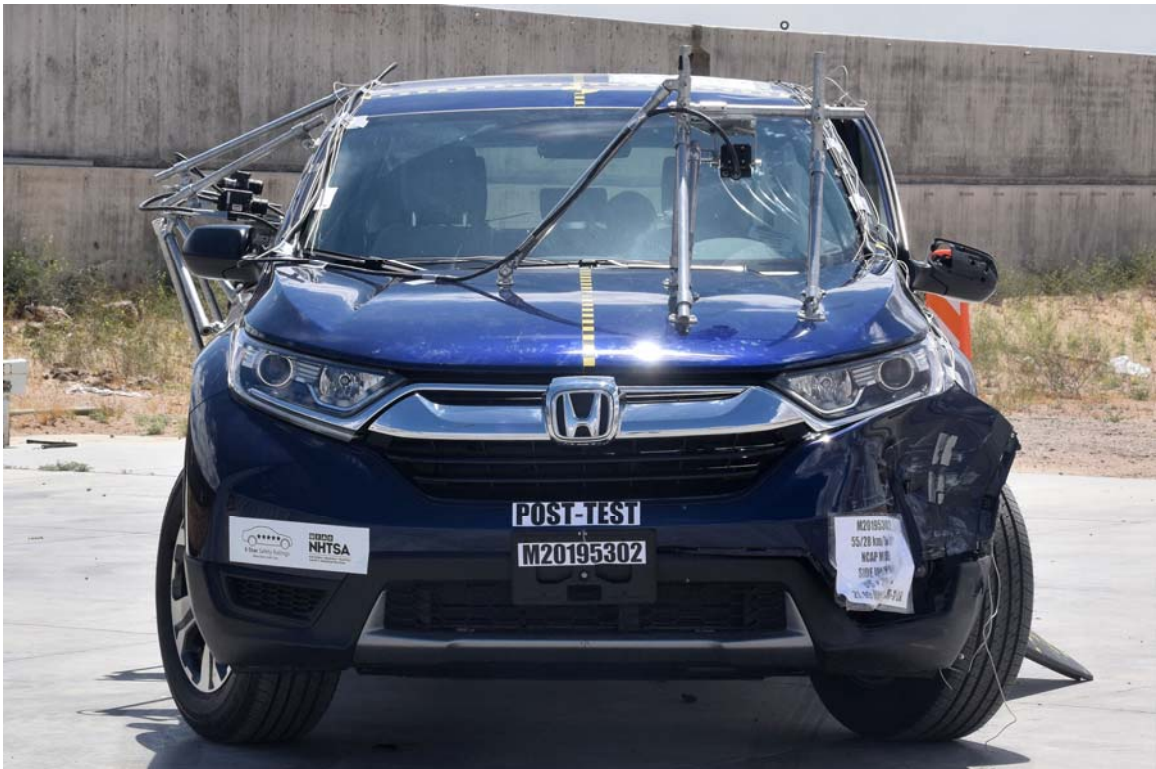
FIGURE 4. Post-Test Frontal View of Test Vehicle

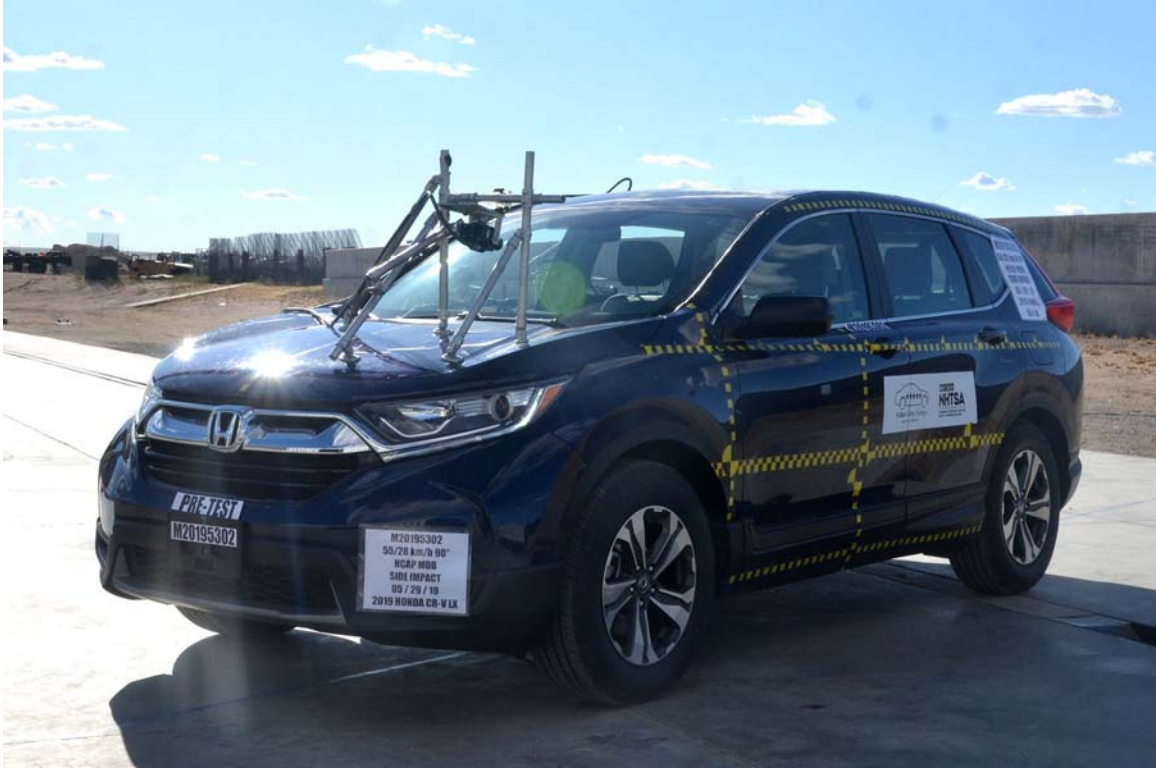
FIGURE 5. Pre-Test Left Front $\frac{3}{4}$ View of Test Vehicle

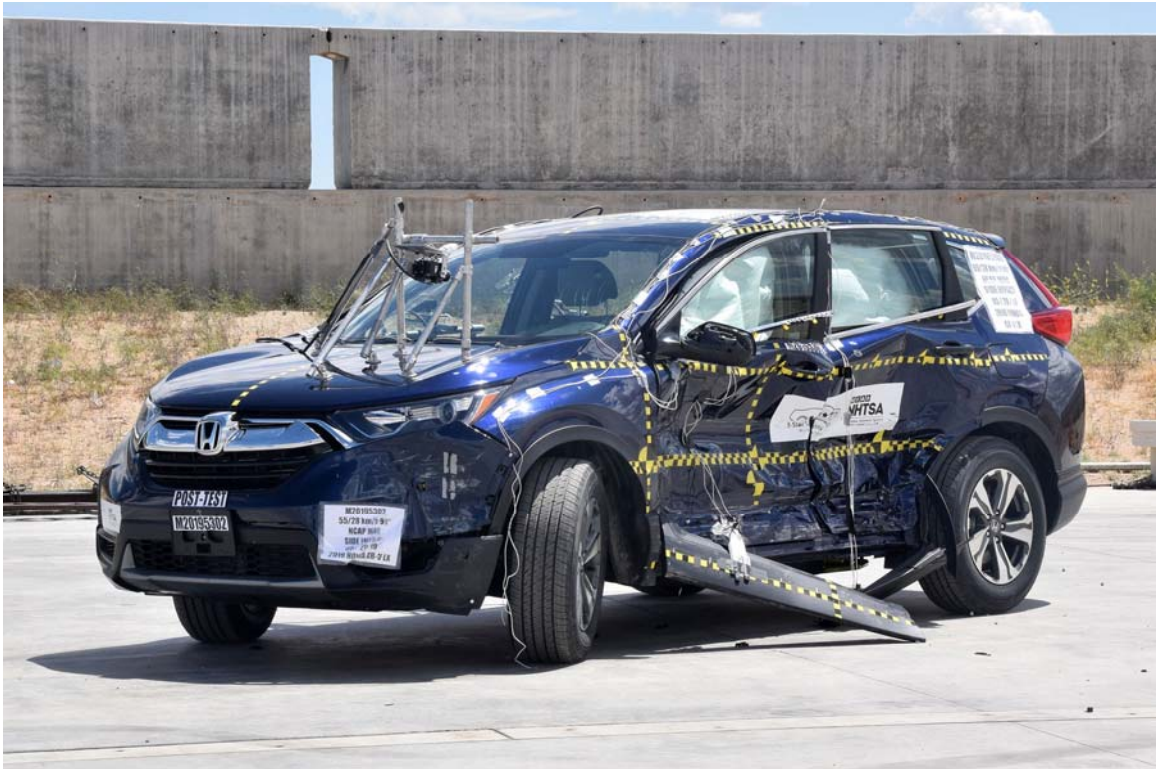
FIGURE 6. Post-Test Left Front $\frac{3}{4}$ View of Test Vehicle

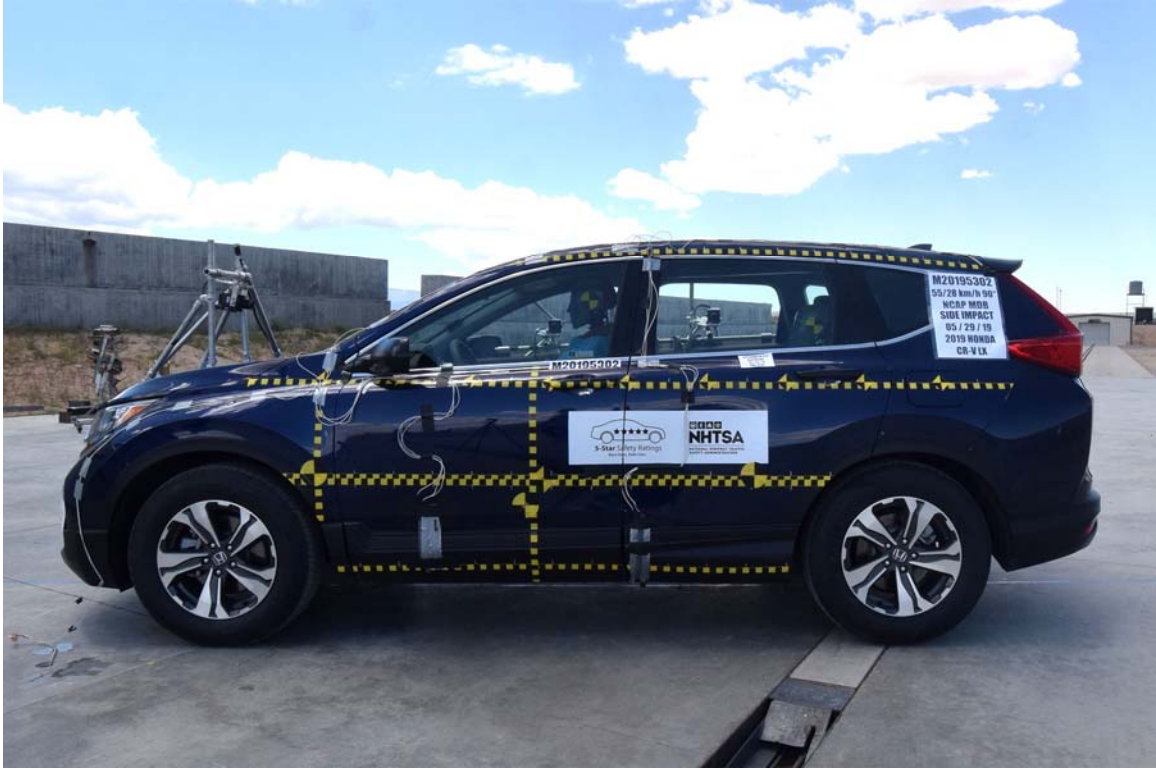
FIGURE 7. Pre-Test Left Side View of Test Vehicle

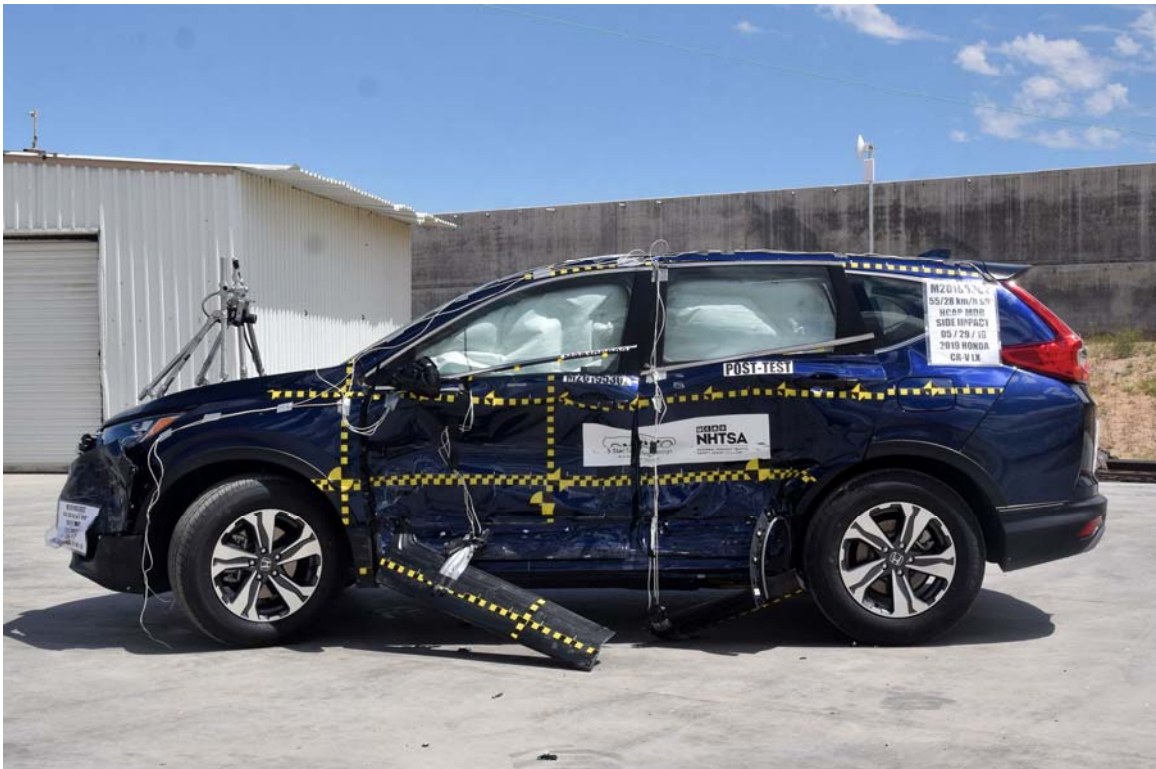
FIGURE 8. Post-Test Left Side View of Test Vehicle

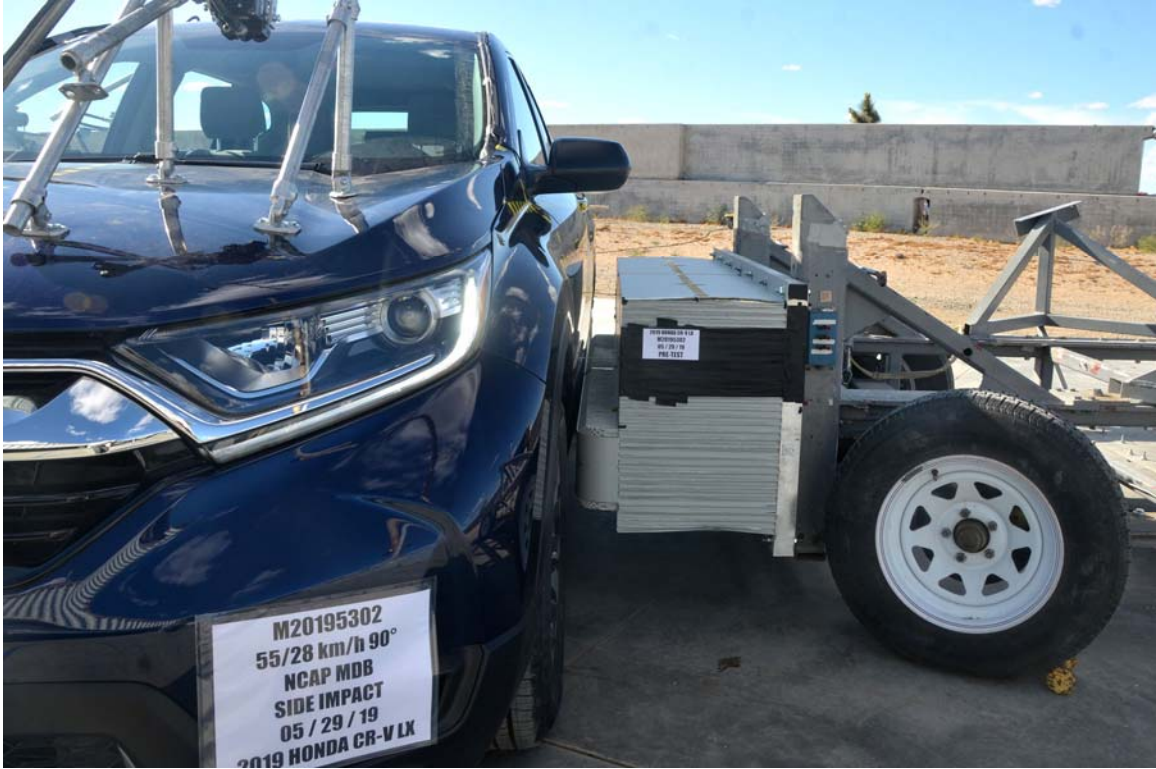
FIGURE 17. Pre-Test Left Side View of MDB Positioned Against Side of Test Vehicle

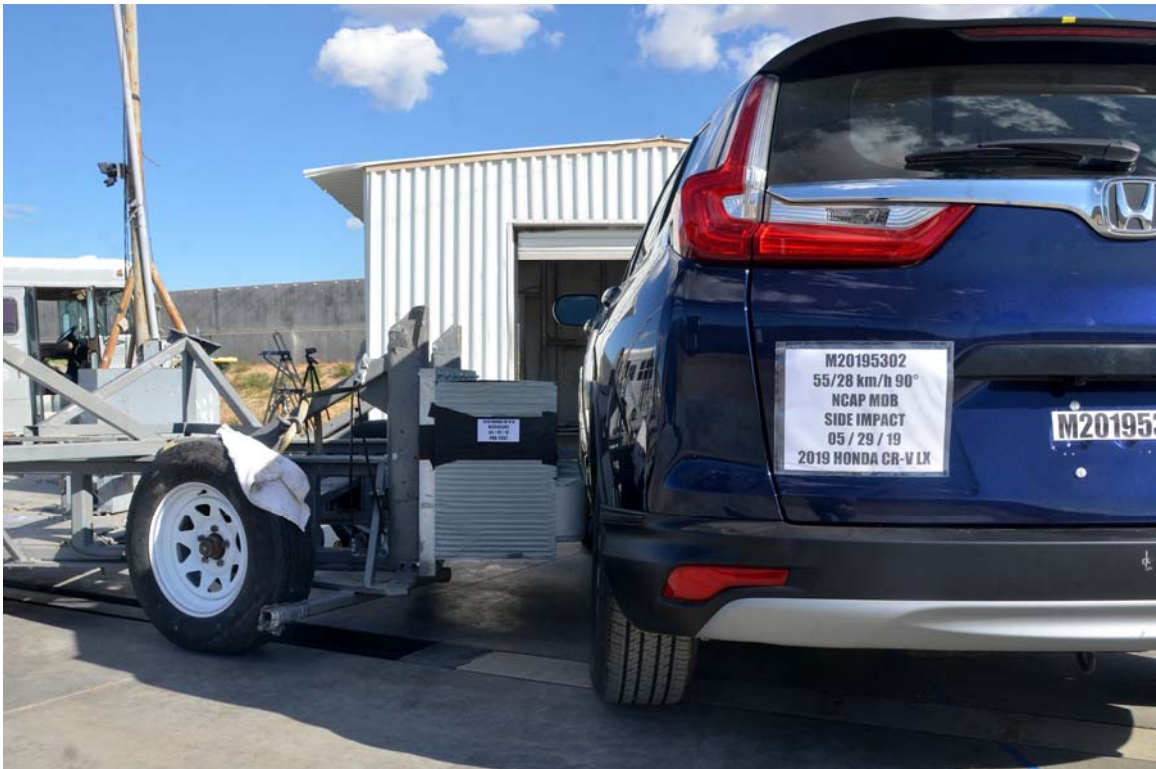
FIGURE 18. Pre-Test Right Side View of MDB Positioned Against Side of Test Vehicle

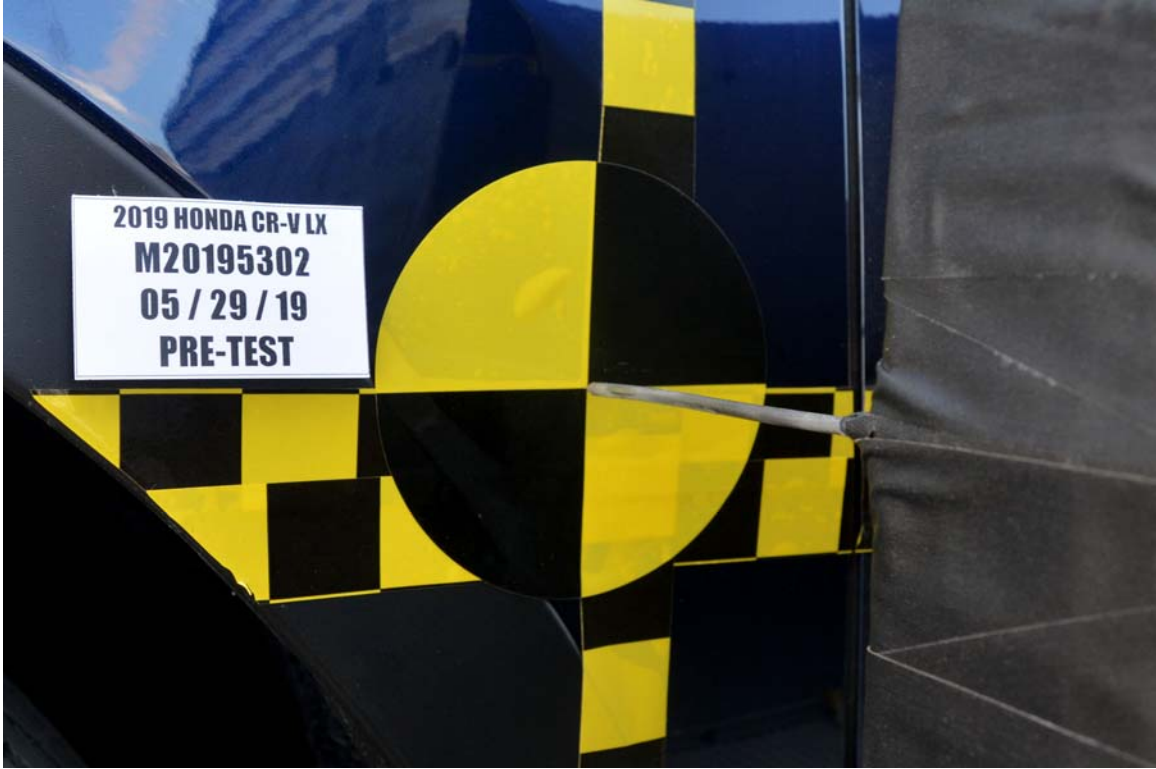
FIGURE 19. Pre-Test Close-Up View of Impact Point Target

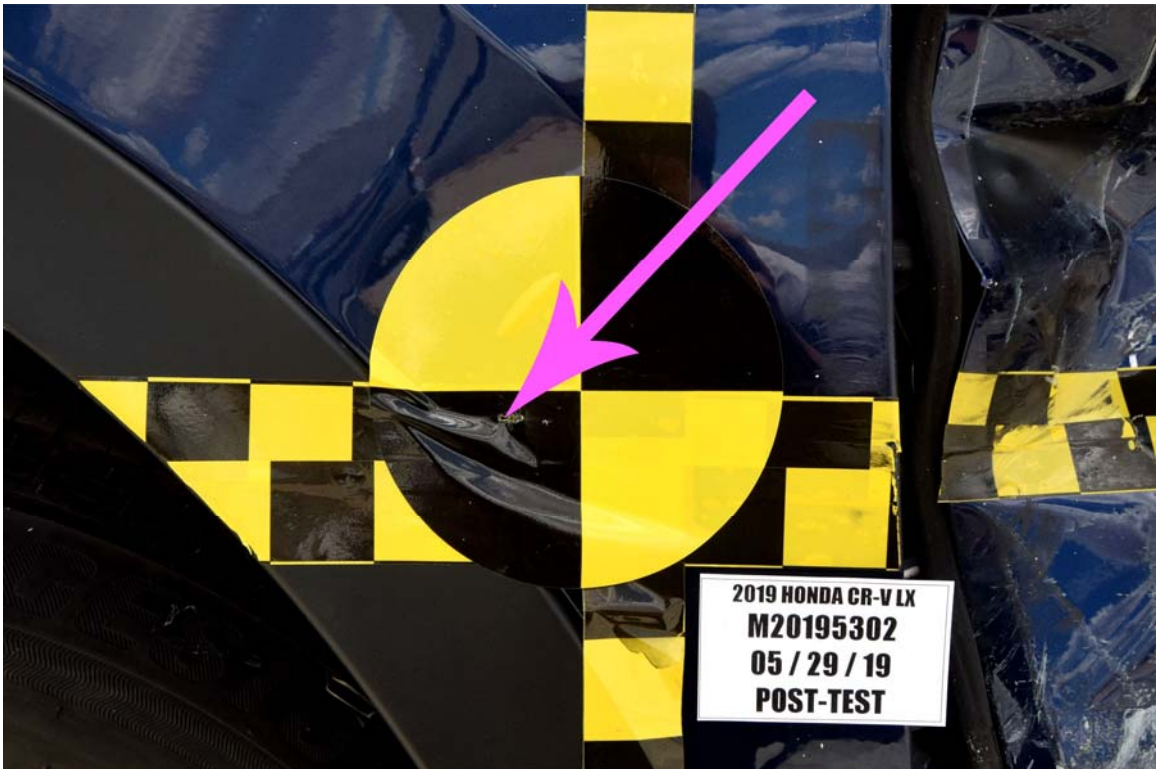
FIGURE 20. Post-Test Close-Up View of Impact Point Target

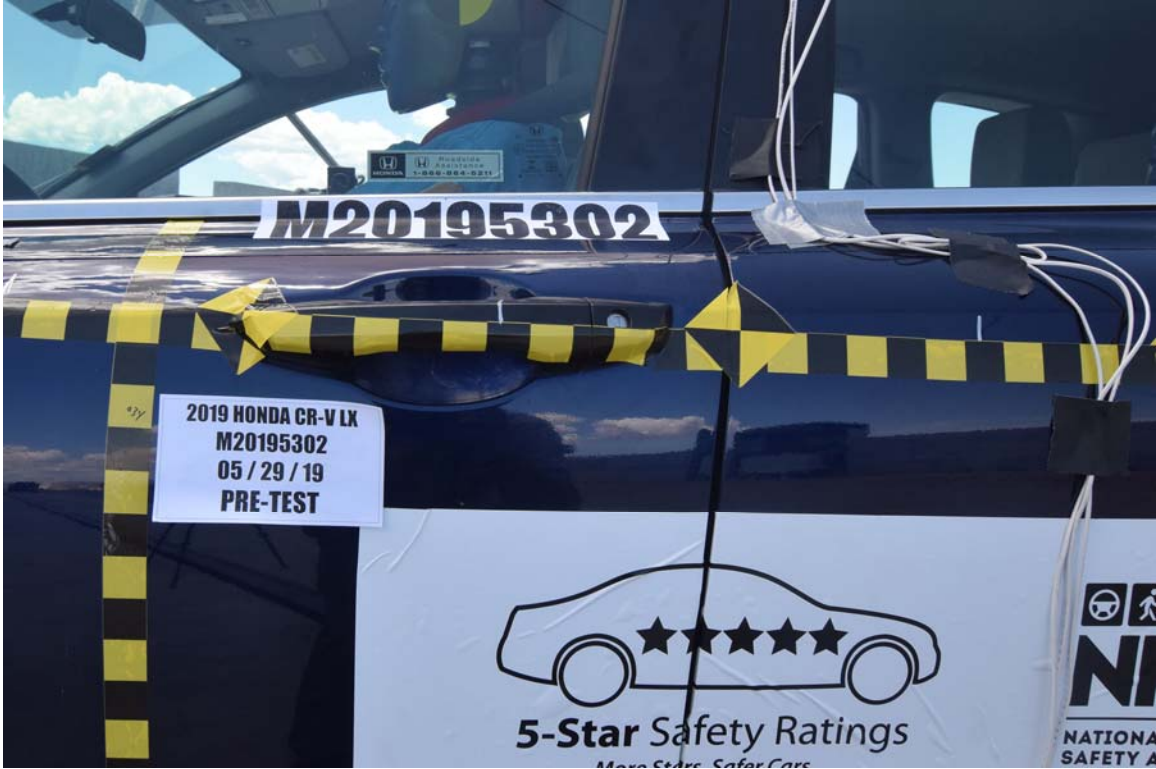
FIGURE 21. Pre-Test Left Front Door Latch Close-Up

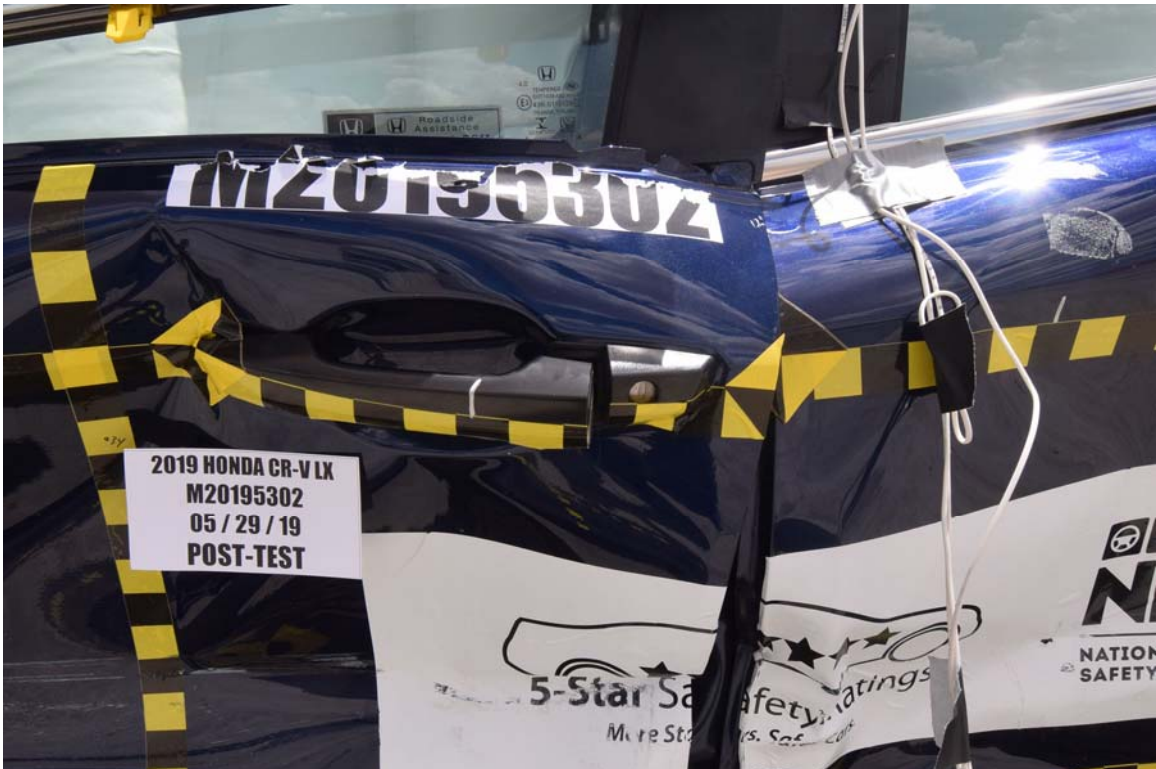
FIGURE 22. Post-Test Left Front Door Latch Close-Up

The doors on the struck side of the vehicle remained closed and latched. There was no separation at the hinges or latches. The doors on the non-struck side remained closed and latched. There was no ATD value that exceeded its limit. The Left Front Sill Y channel failed at 8.8 ms and the Left Mid A-Post Y channel failed at 11.1 ms.

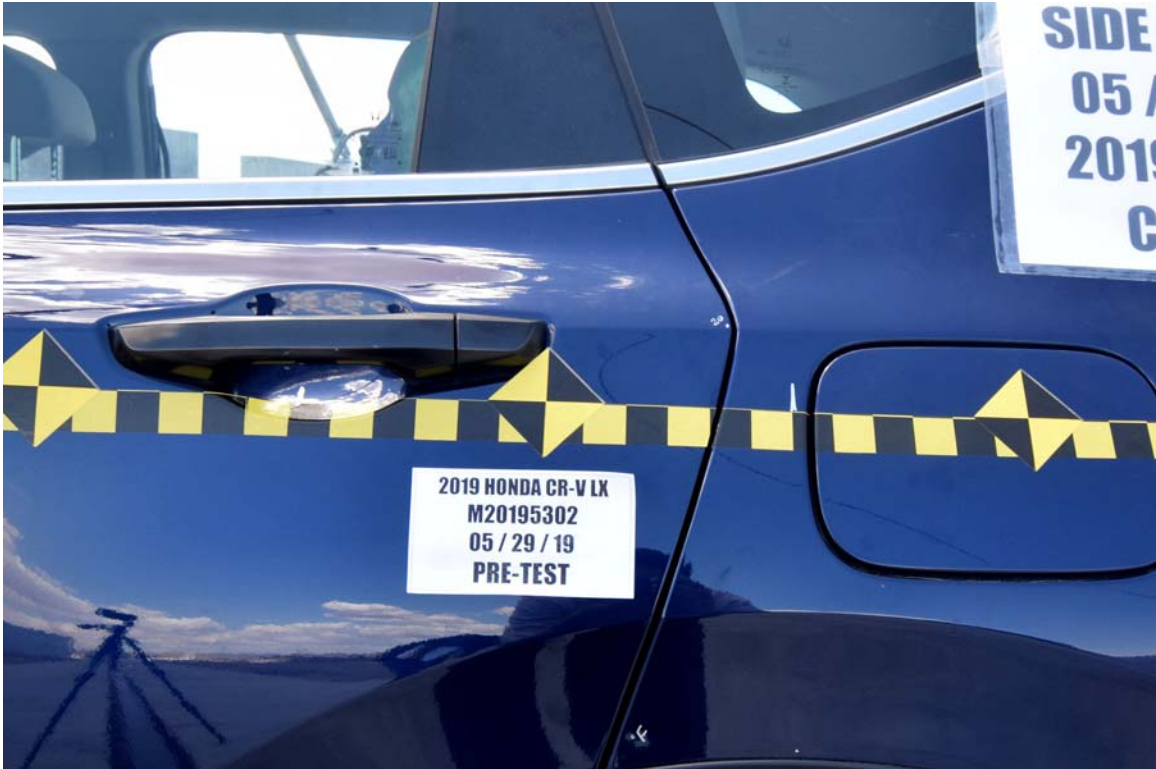
FIGURE 23. Pre-Test Left Rear Door Latch Close-Up

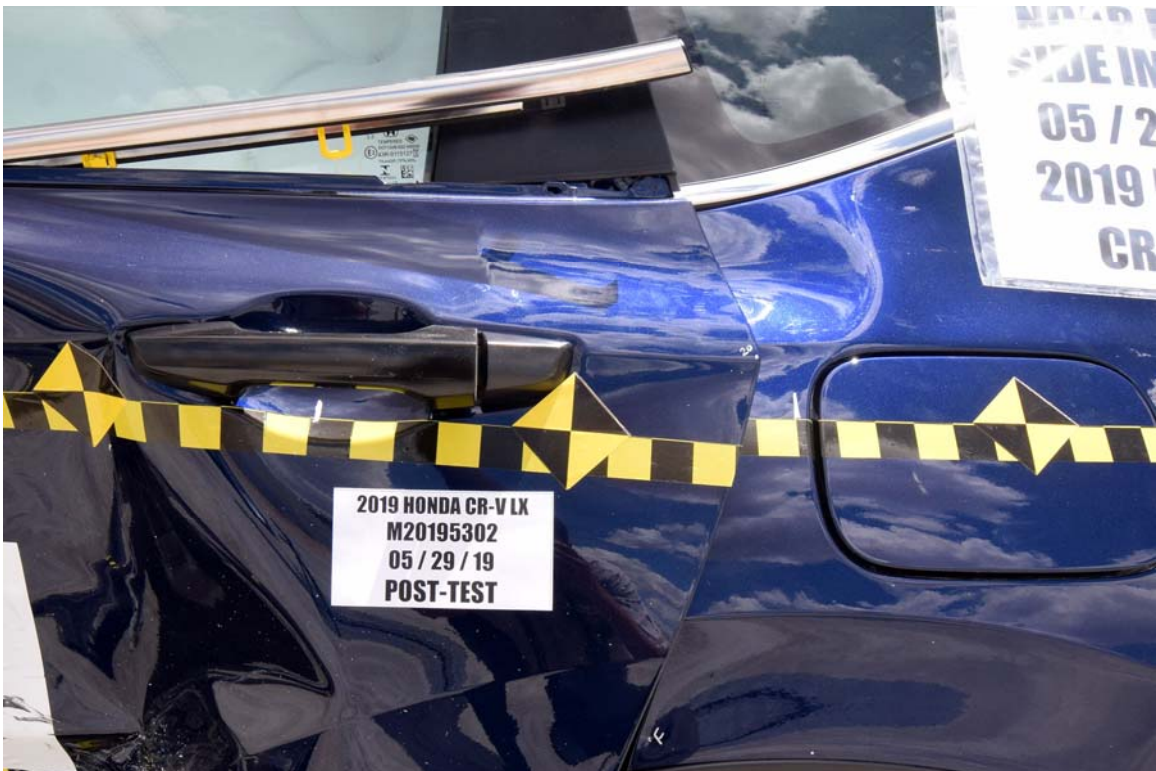
FIGURE 24. Post-Test Left Rear Door Latch Close-Up

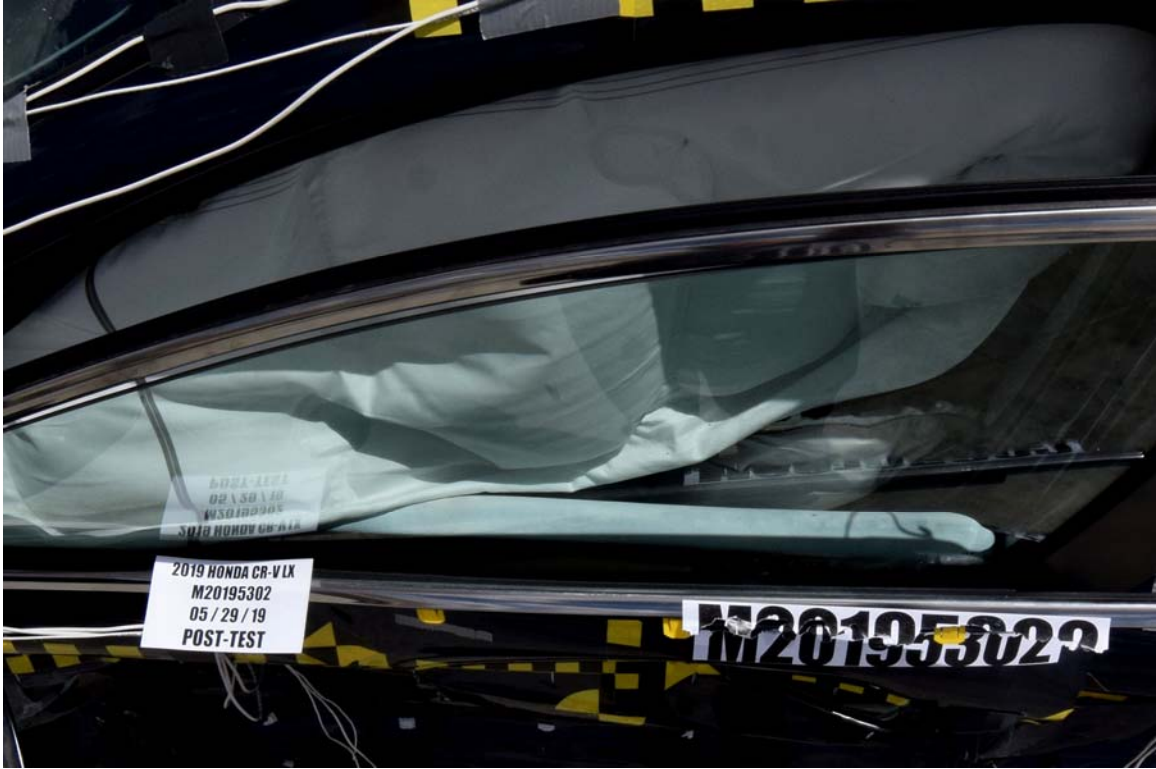
FIGURE 43. Post-Test Driver Dummy and Door Clearance View

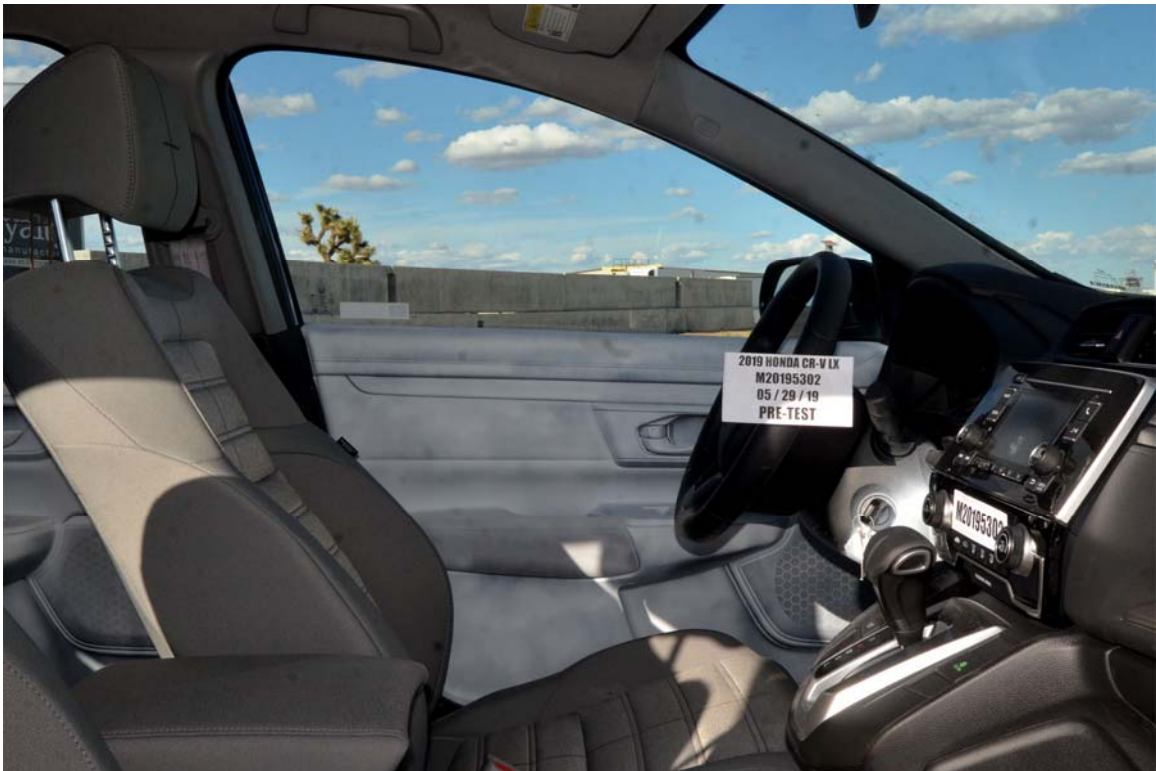
FIGURE 46. Pre-Test Driver Inner Door Panel View

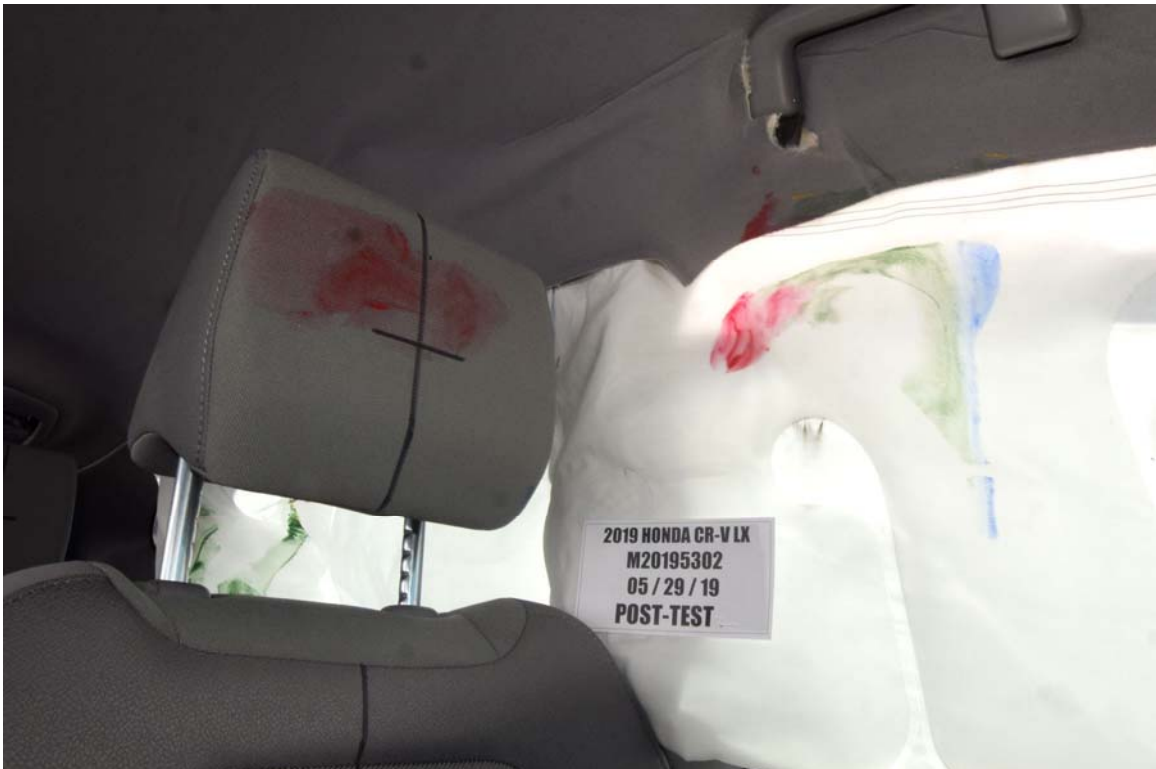
FIGURE 48. Post-Test Driver Dummy Close-Up Head Contact
with Vehicle Interior View

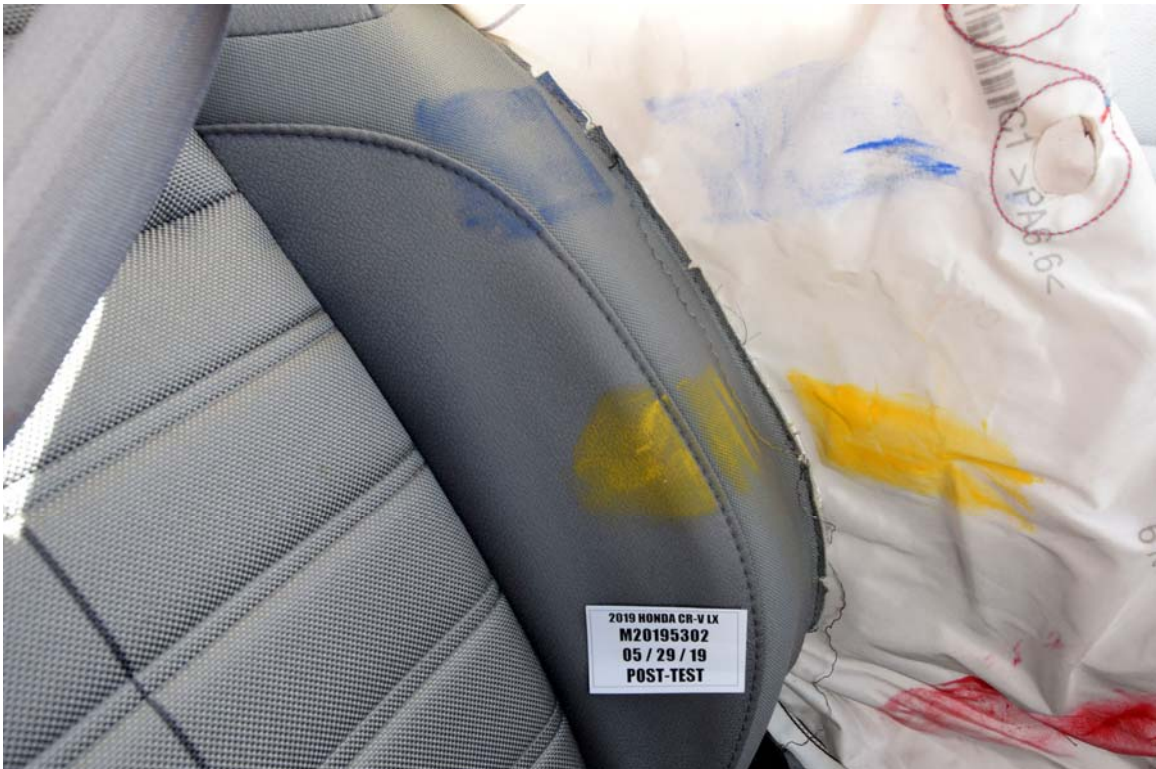
FIGURE 50. Post-Test Driver Dummy Close-Up Torso Contact with Vehicle Interior View

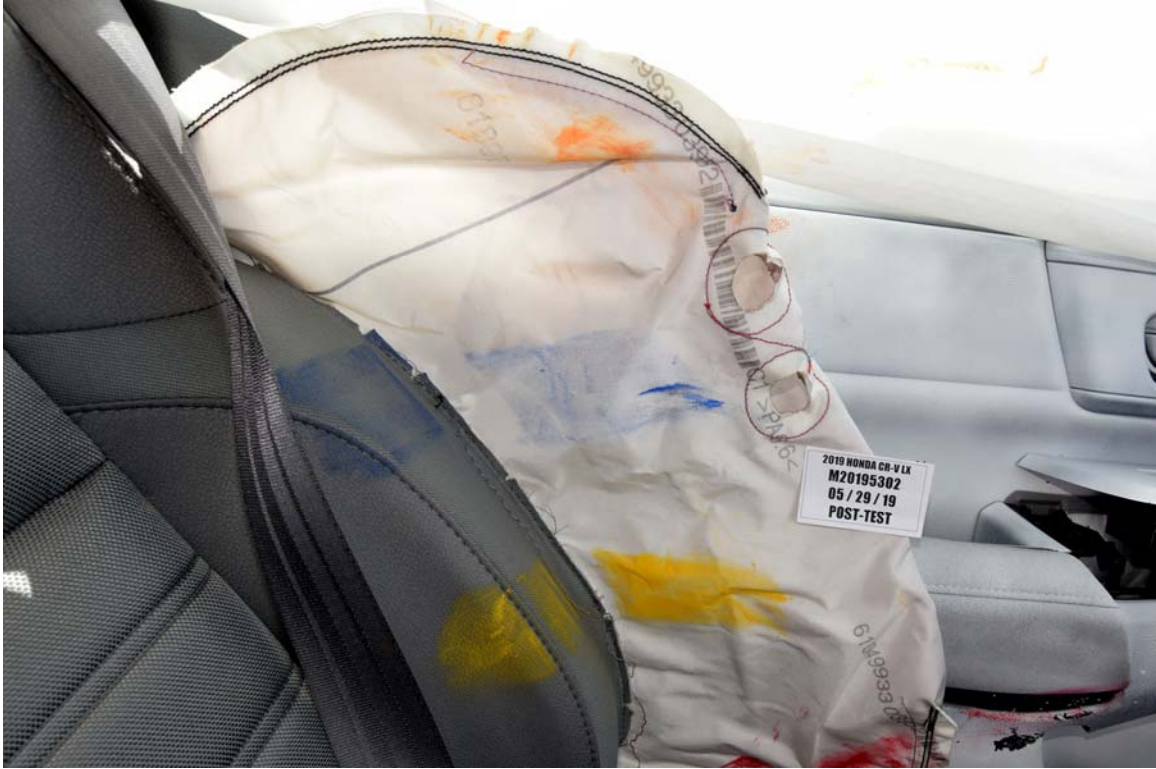
FIGURE 51. Post-Test Driver Dummy Close-Up Torso Contact with Side Airbag View

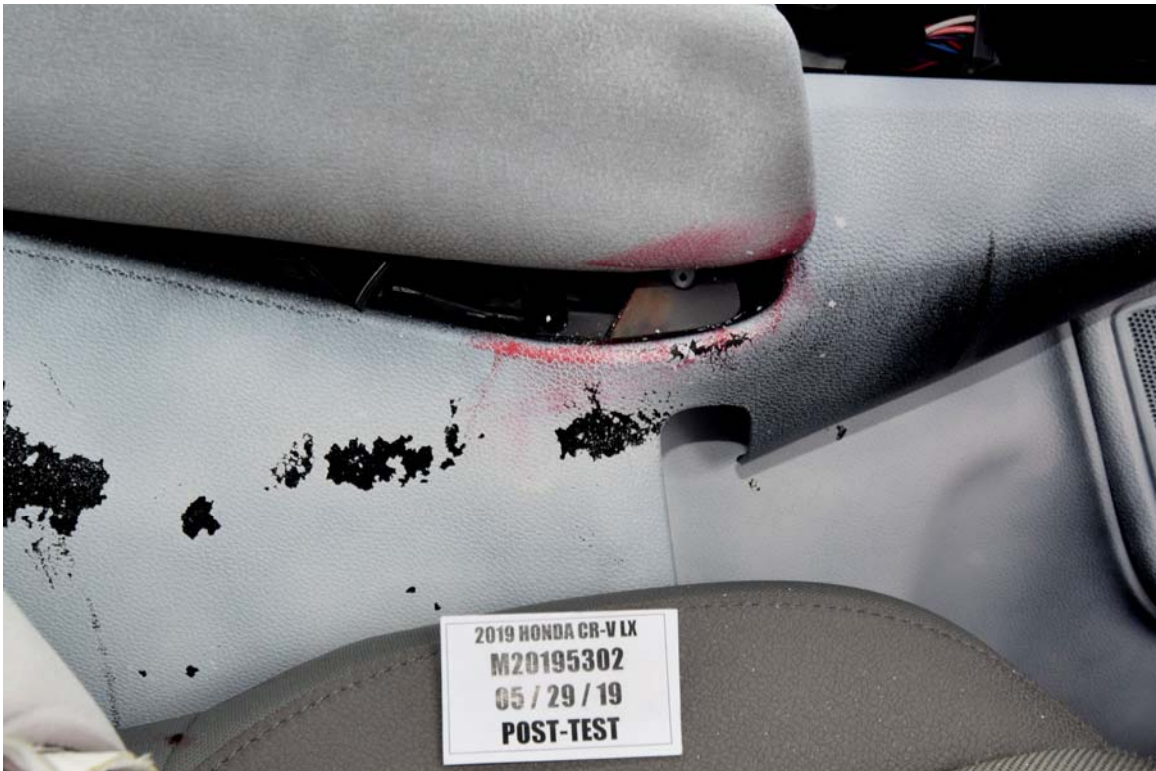
FIGURE 52. Post-Test Driver Dummy Close-Up Pelvis Contact with Vehicle Interior View

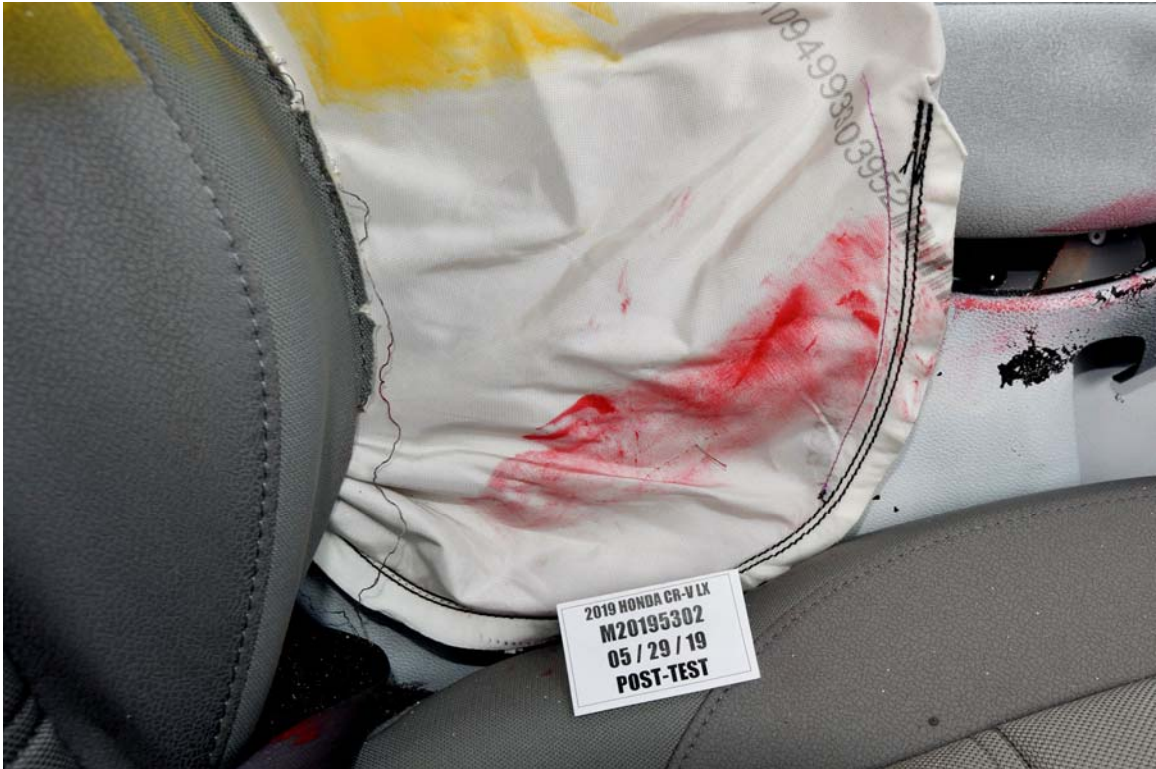
FIGURE 53. Post-Test Driver Dummy Close-Up Pelvis Contact with Side Airbag View

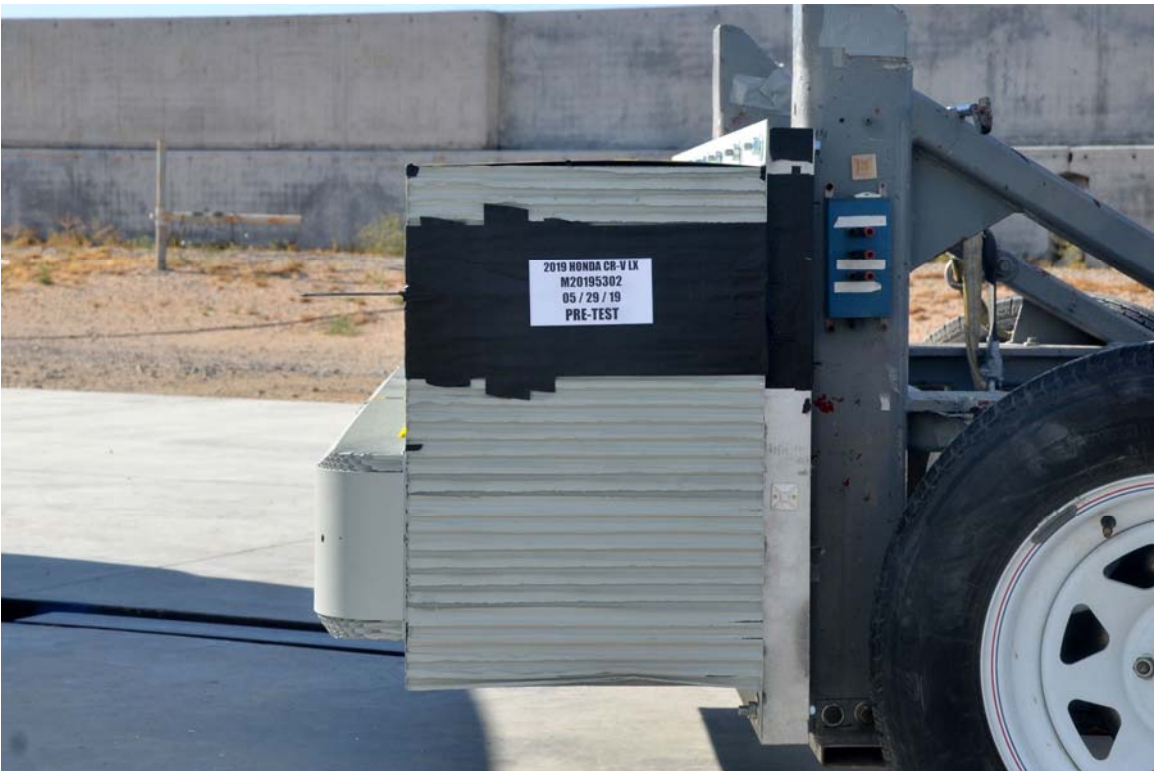
FIGURE 88. Pre-Test Left Side View of MDB Impactor Face
