**REPORT NUMBER: SPNCAP-MGA-19-050**

**NEW CAR ASSESSMENT PROGRAM (NCAP)  
Side Impact Pole Test**

**FORD MOTOR CO.  
2019 Ford F-250 SuperCab XL Truck  
NHTSA No.: M20190209**

**FINAL REPORT**

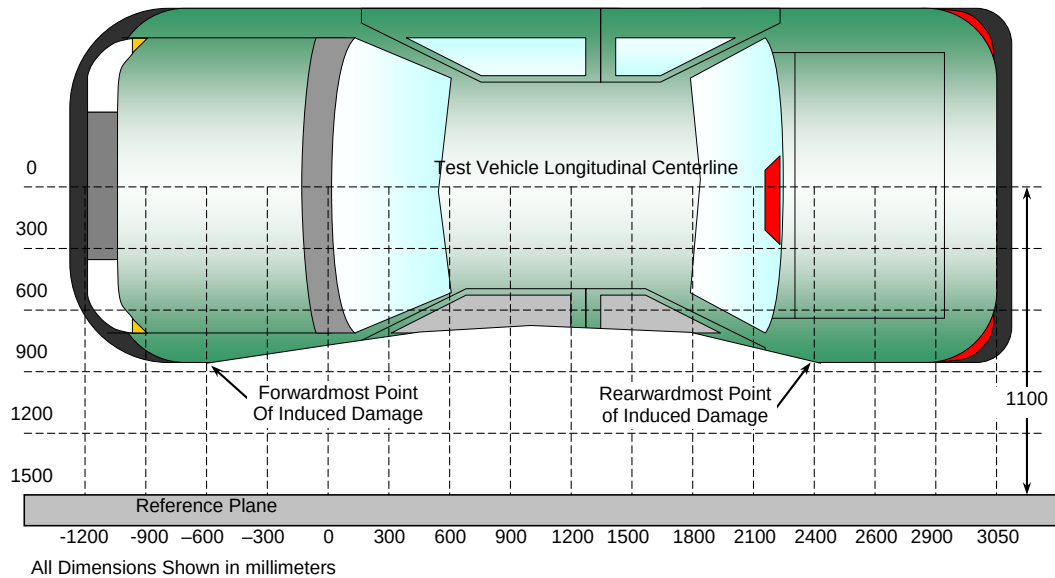
**DATA SHEET NO. 11**  
**VEHICLE DAMAGE PROFILE DISTANCES**

**TOP VIEW**

**VEHICLE DAMAGE PROFILE DISTANCES**

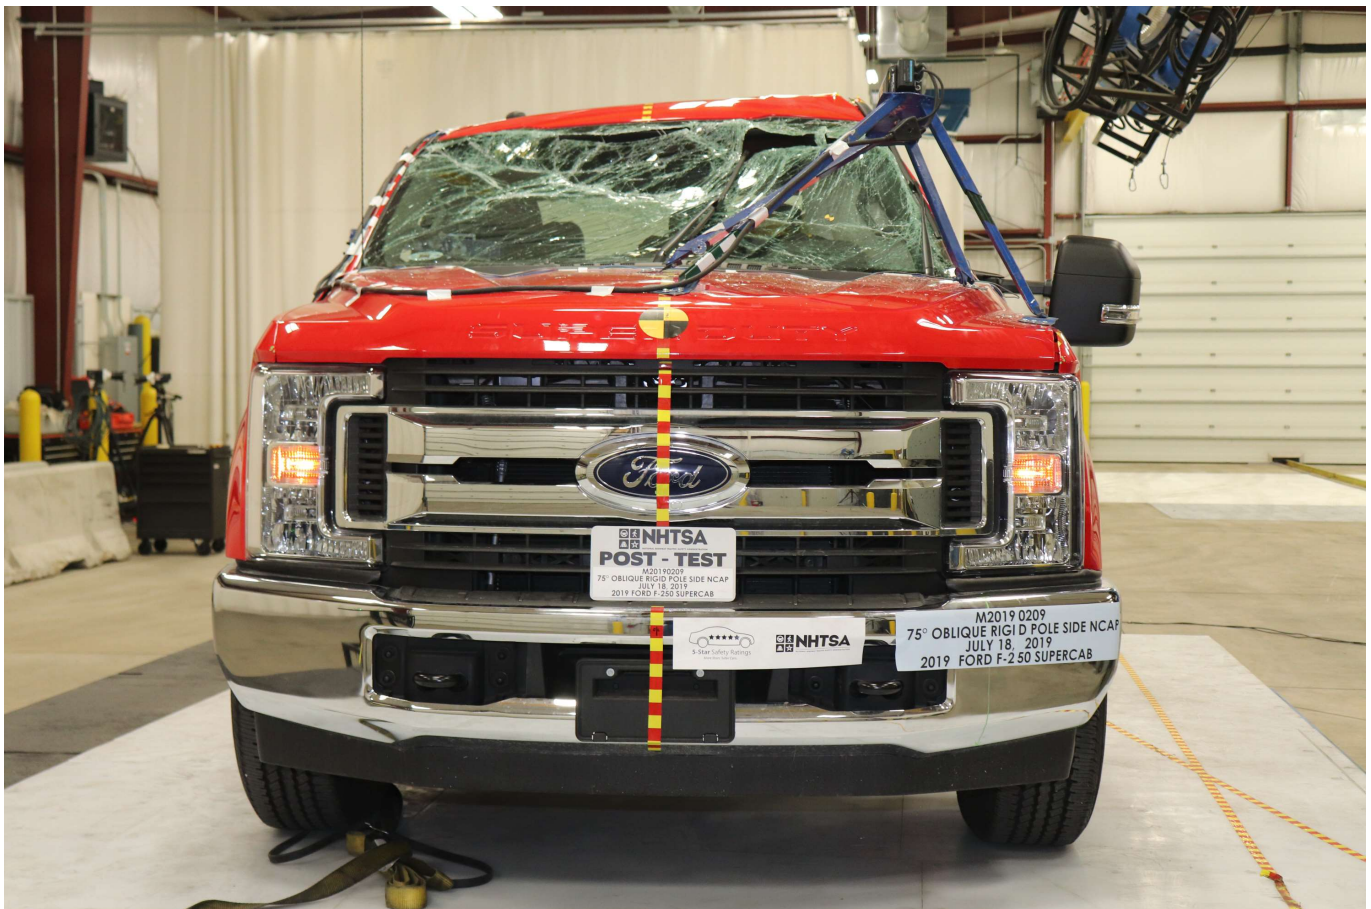
Photo No. 004 - Post-Test Frontal View of Test Vehicle

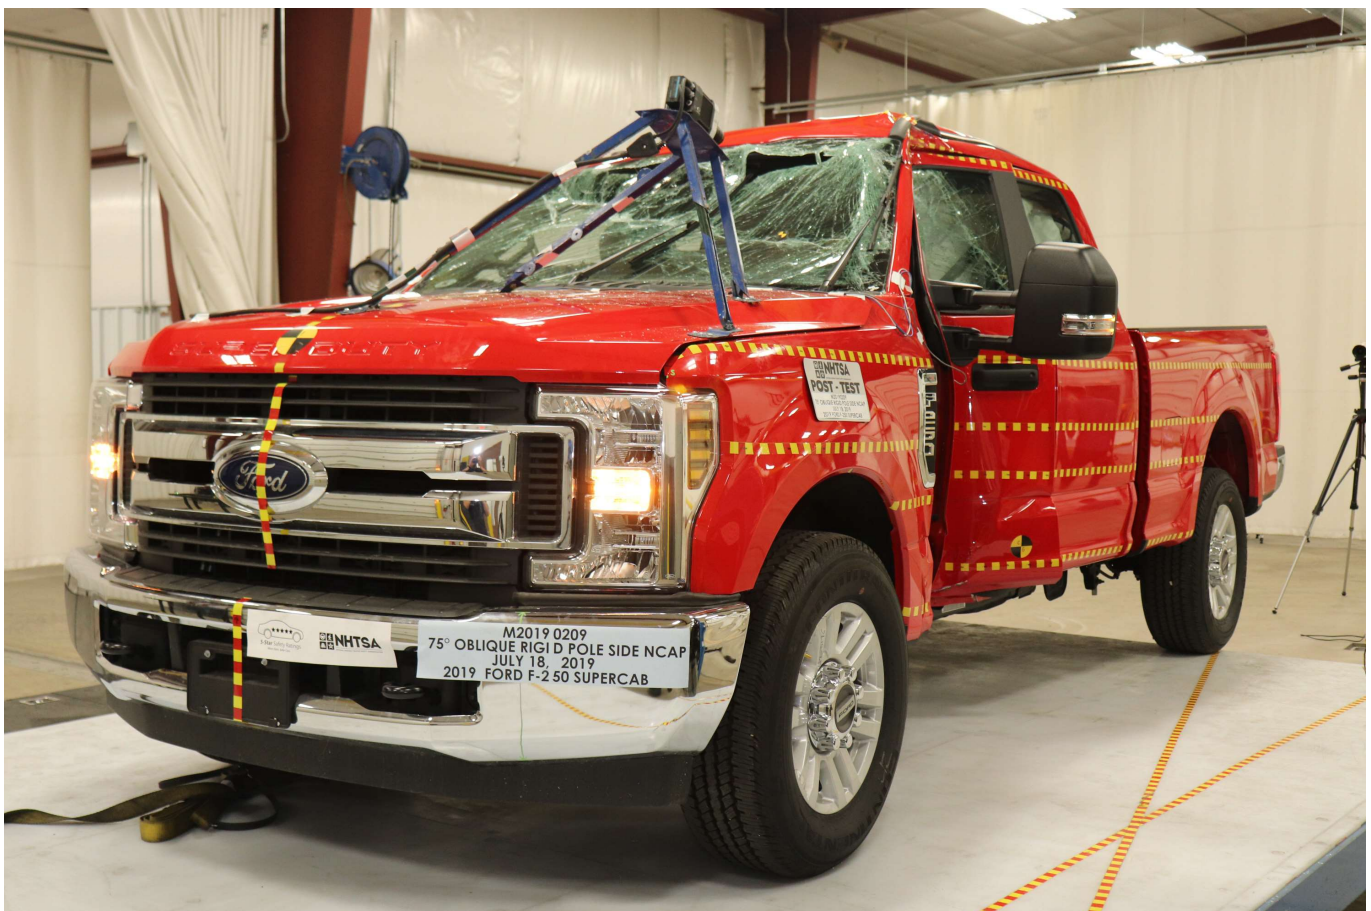
Photo No. 006 - Post-Test Left Front Three-Quarter View of Test Vehicle

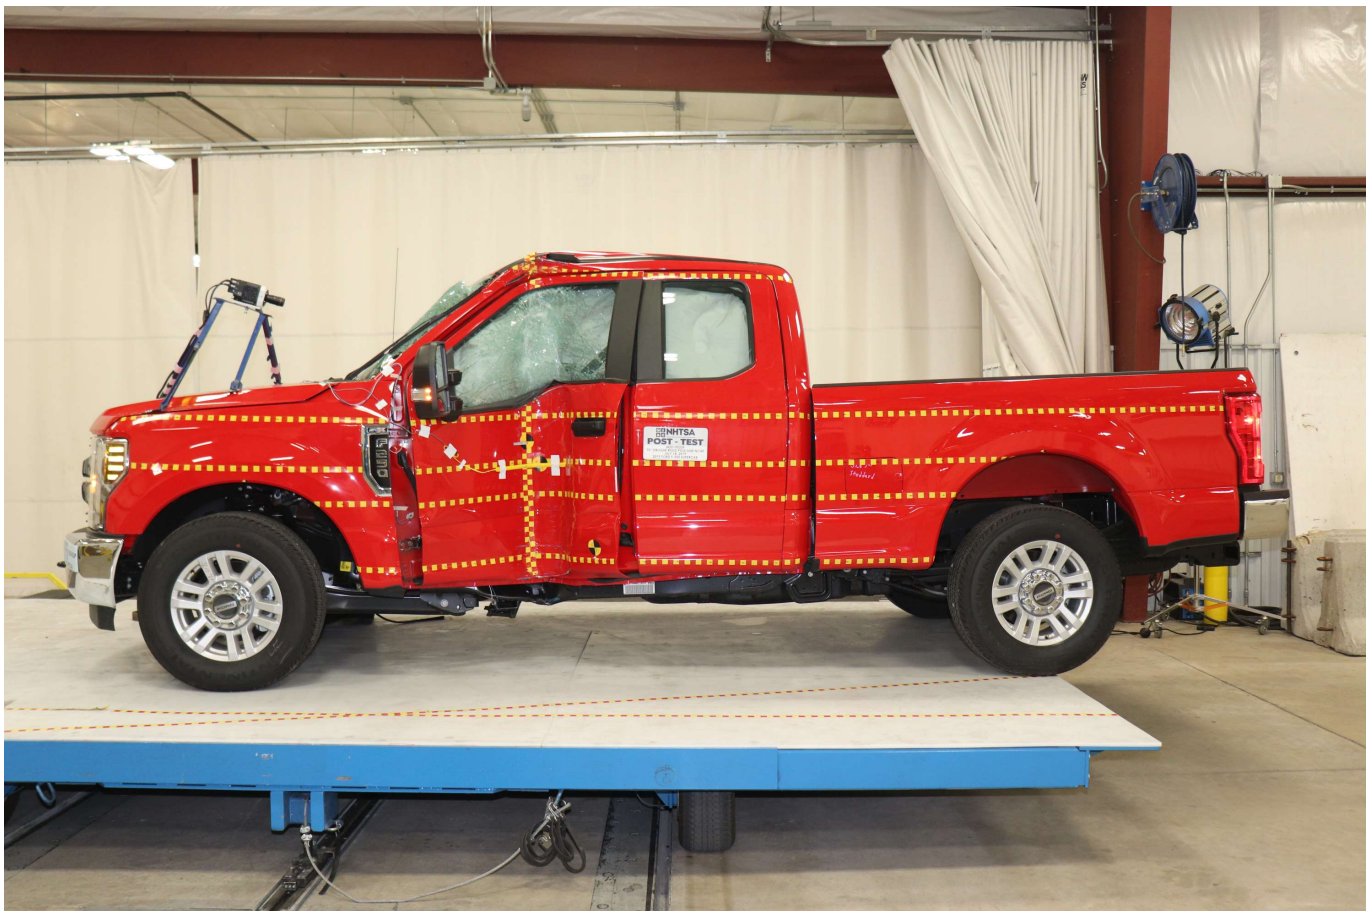
Photo No. 008 - Post-Test Left Side View of Test Vehicle

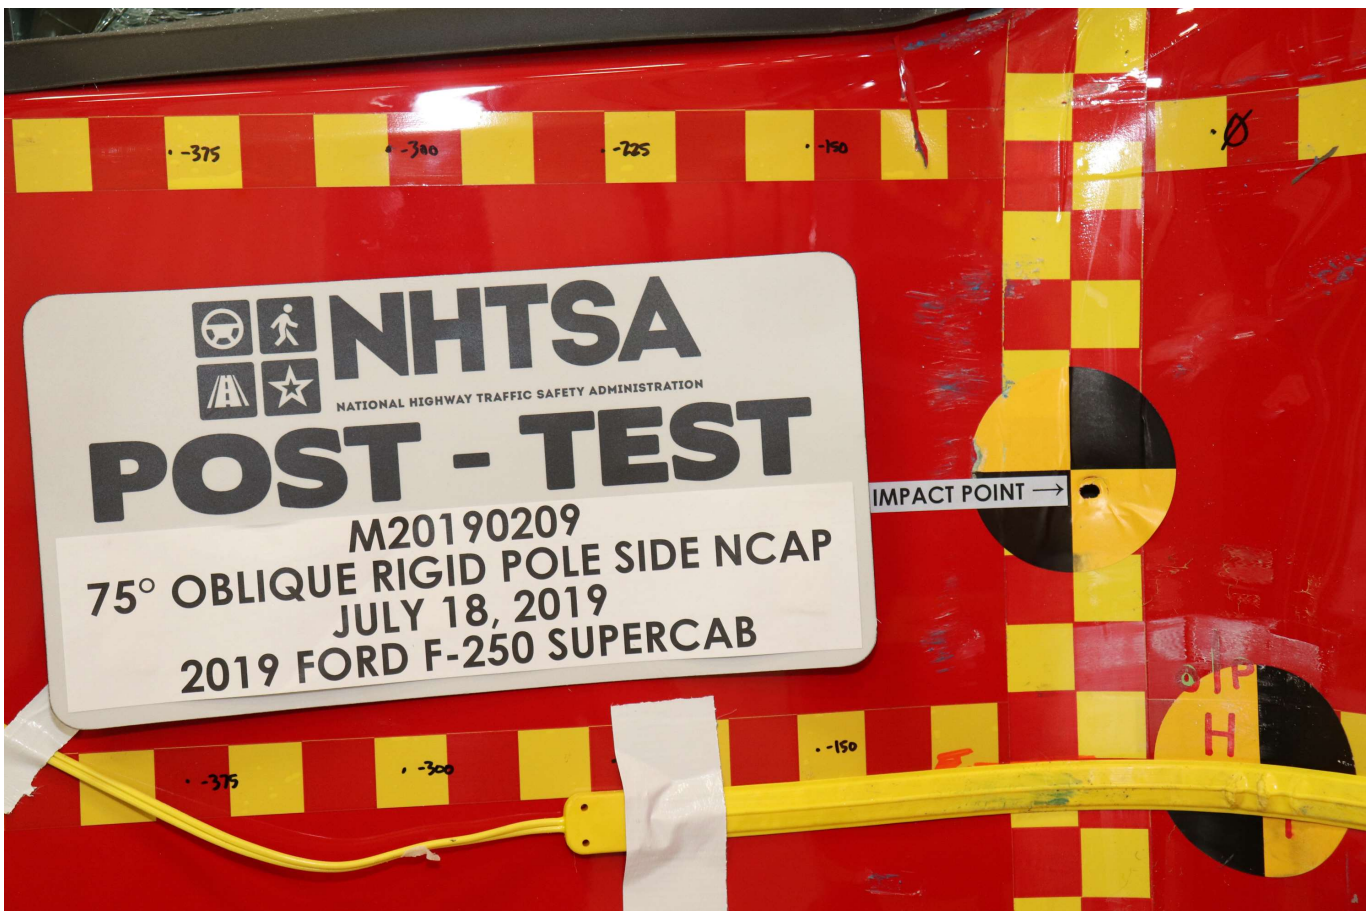
Photo No. 020 - Post-Test Close-Up View of Impact Point Target Showing Impact Location

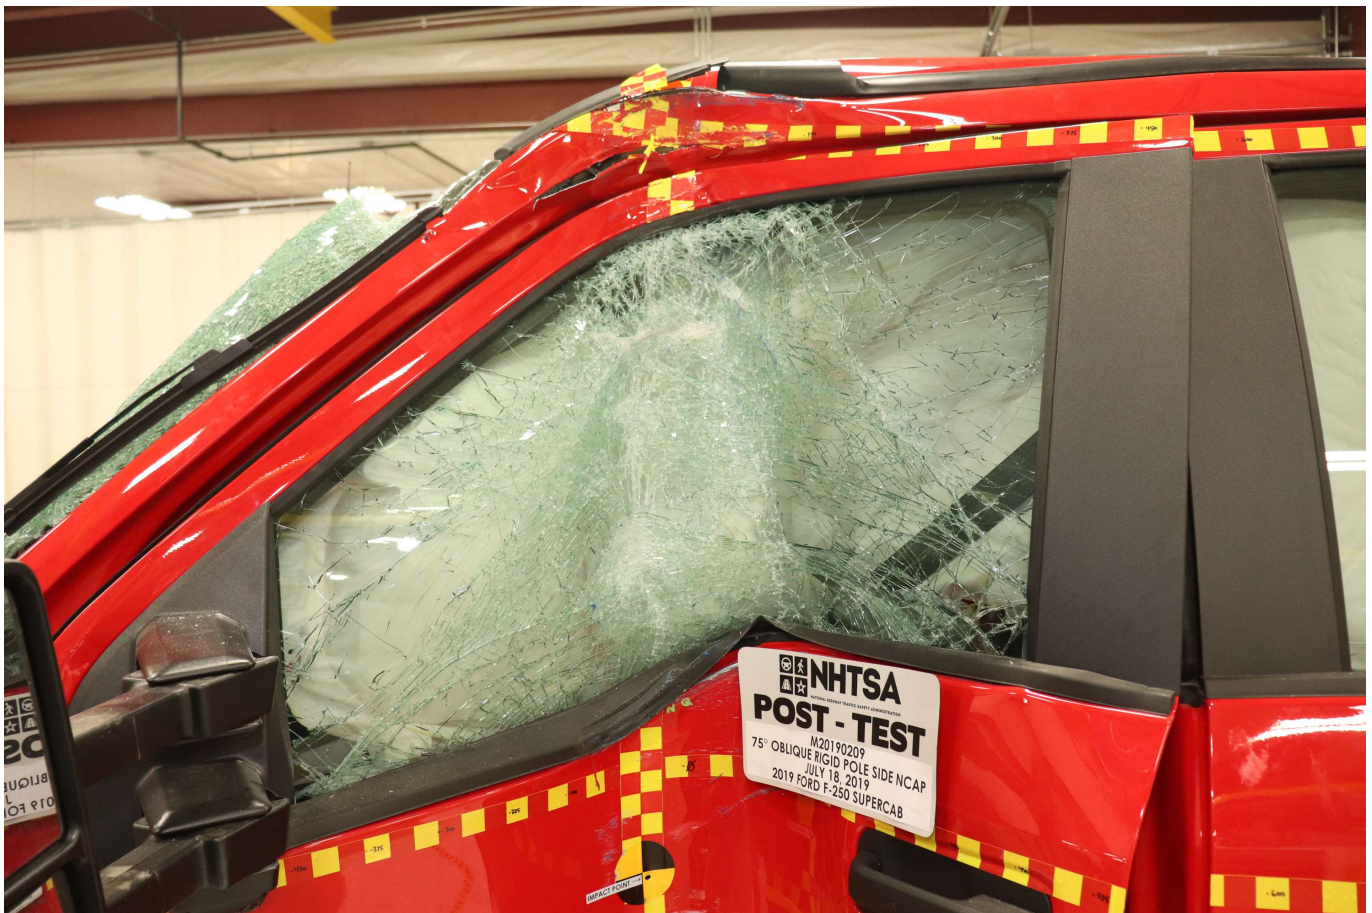
Photo No. 025 - Post-Test Left Side View of Dummy Shoulder and Door Top View

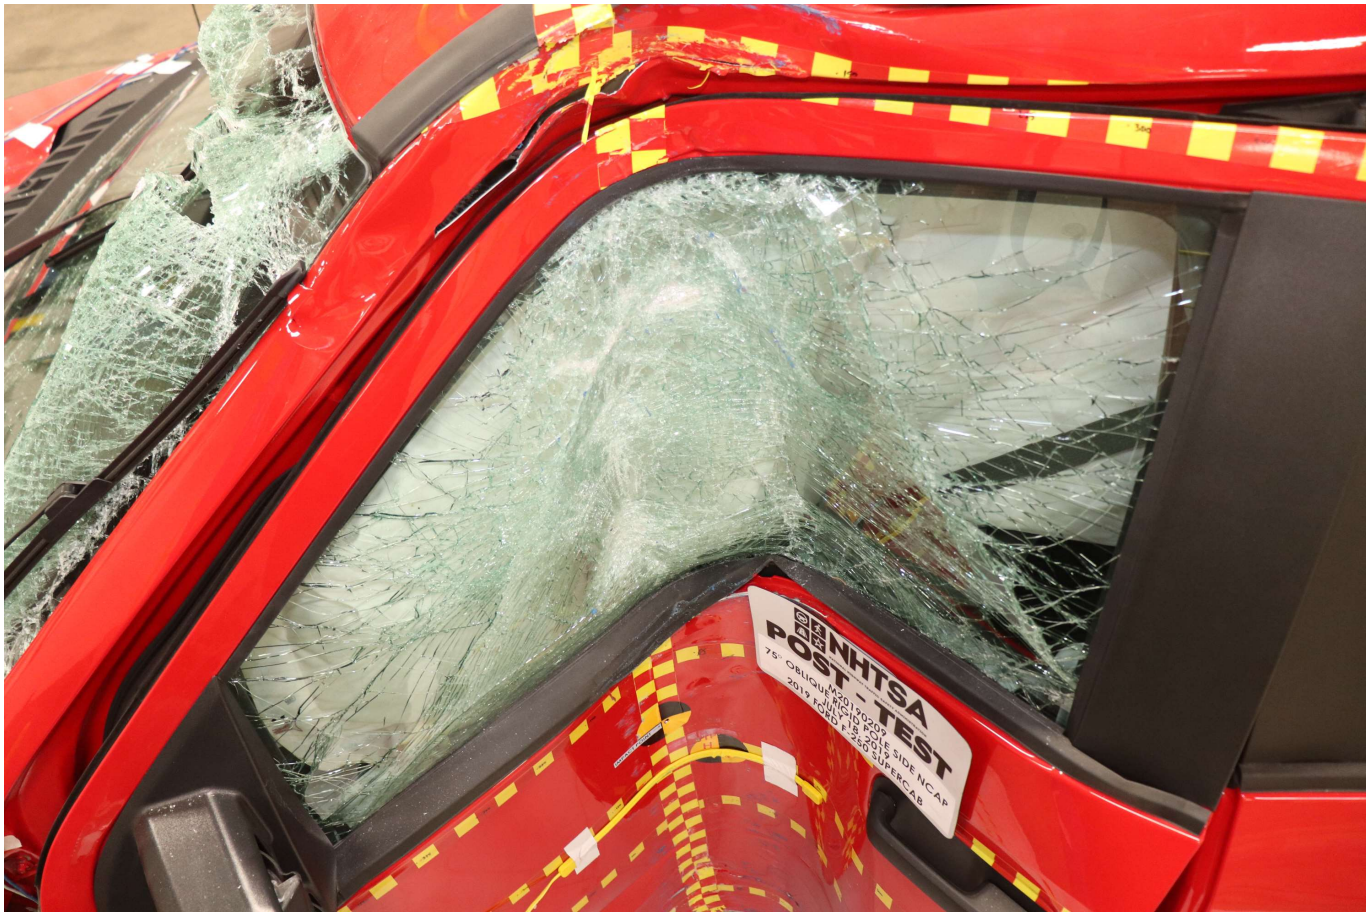
Photo No. 041 - Post-Test Dummy and Door Clearance View

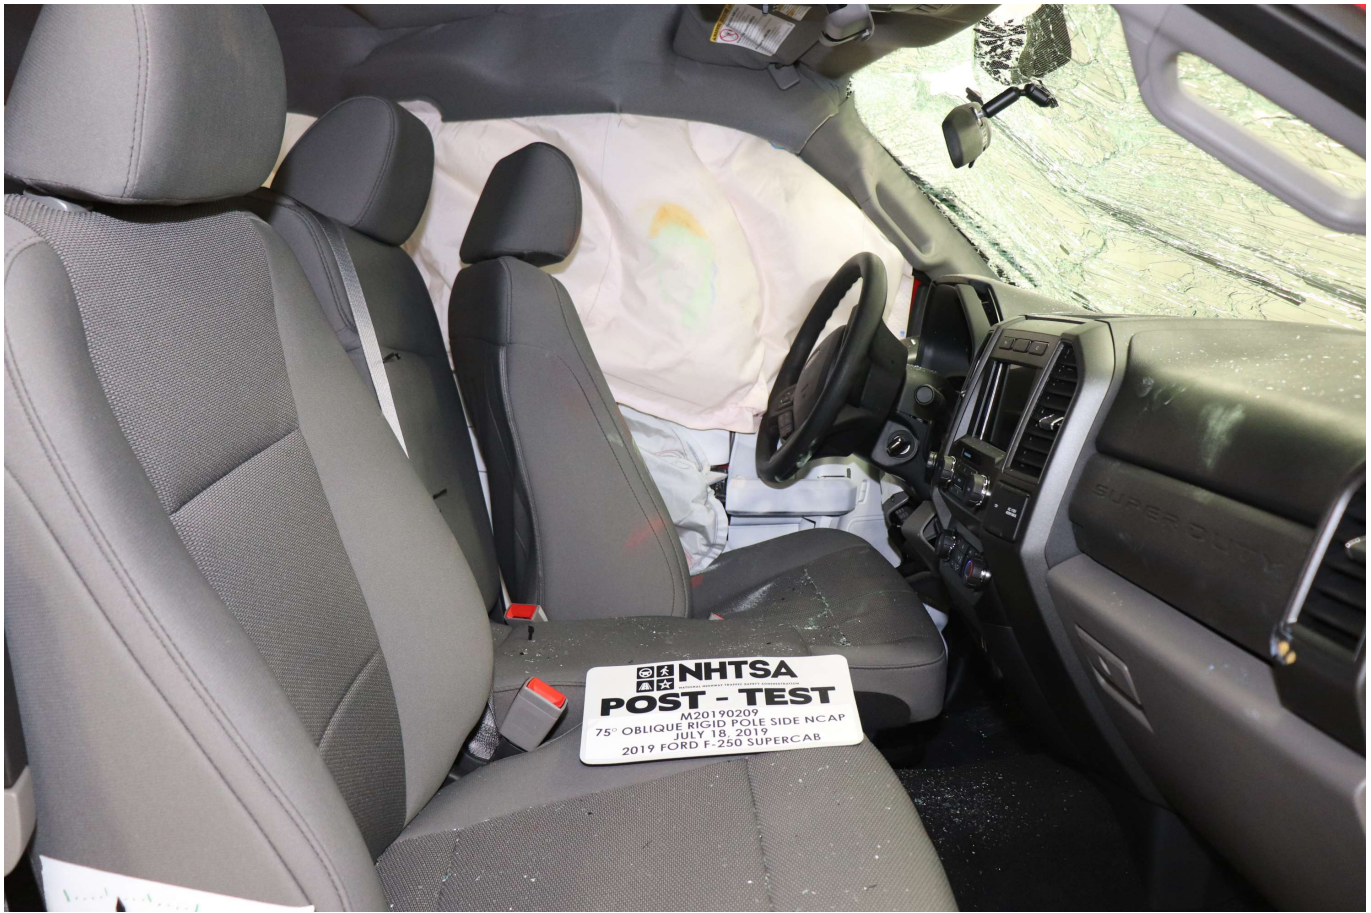
Photo No. 045 - Post-Test Inner Door Panel View Showing Dummy Contact Location

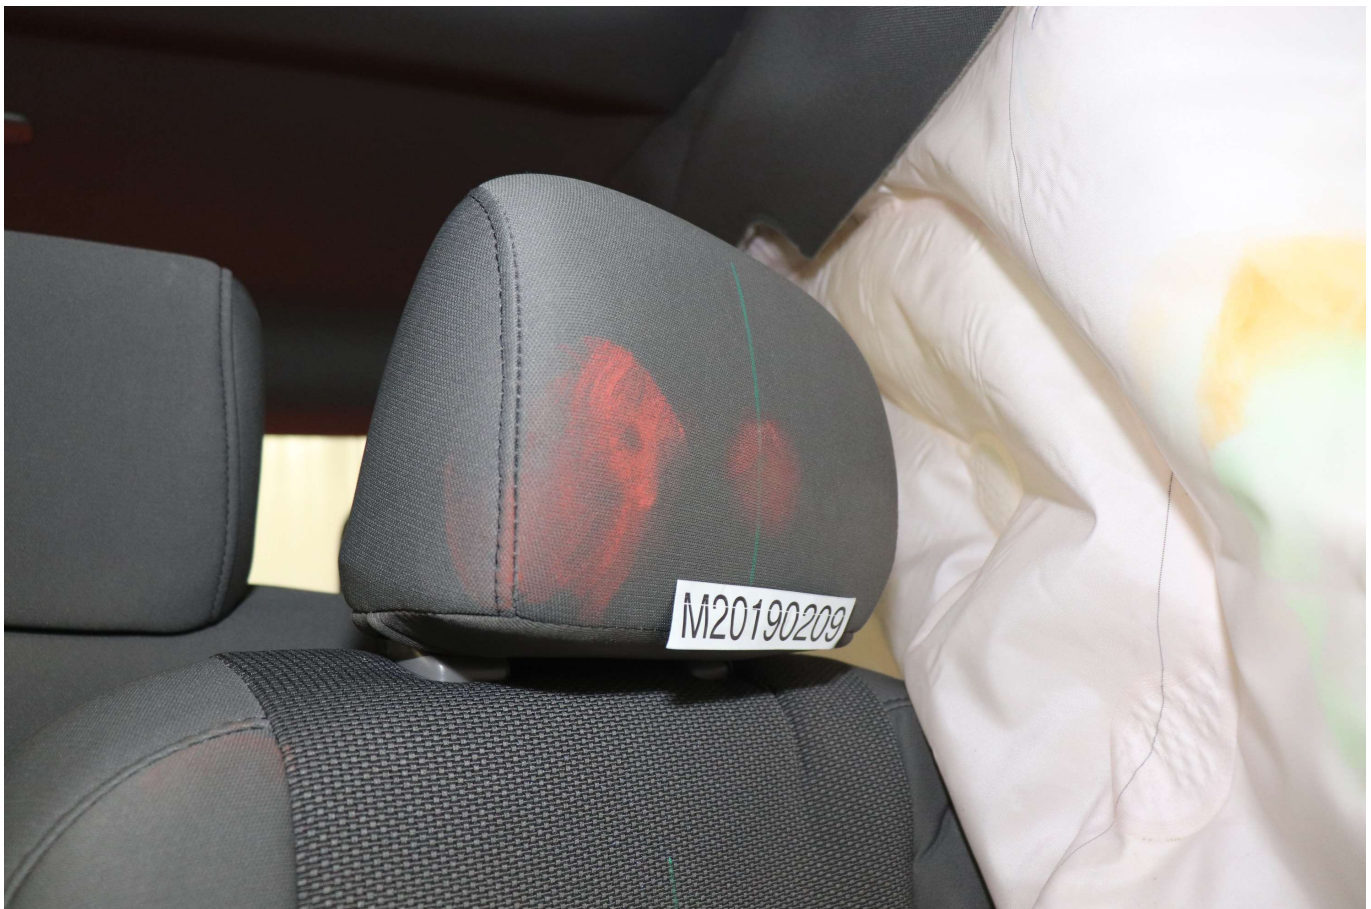
Photo No. 046 - Post-Test Dummy Close-Up Head Contact with Vehicle Interior View

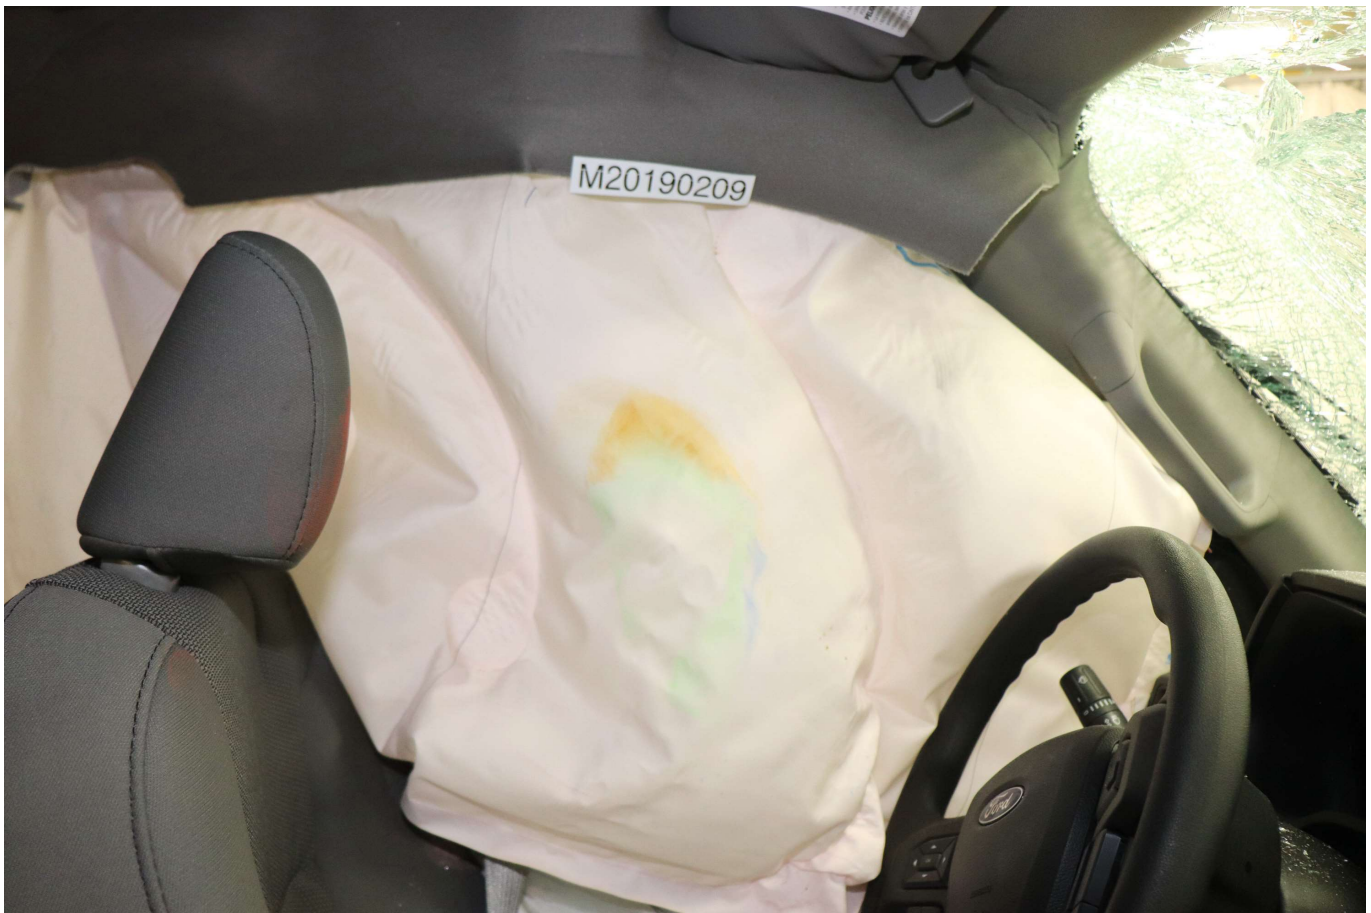
Photo No. 047 - Post-Test Dummy Close-Up Head Contact with Side Air Bag View

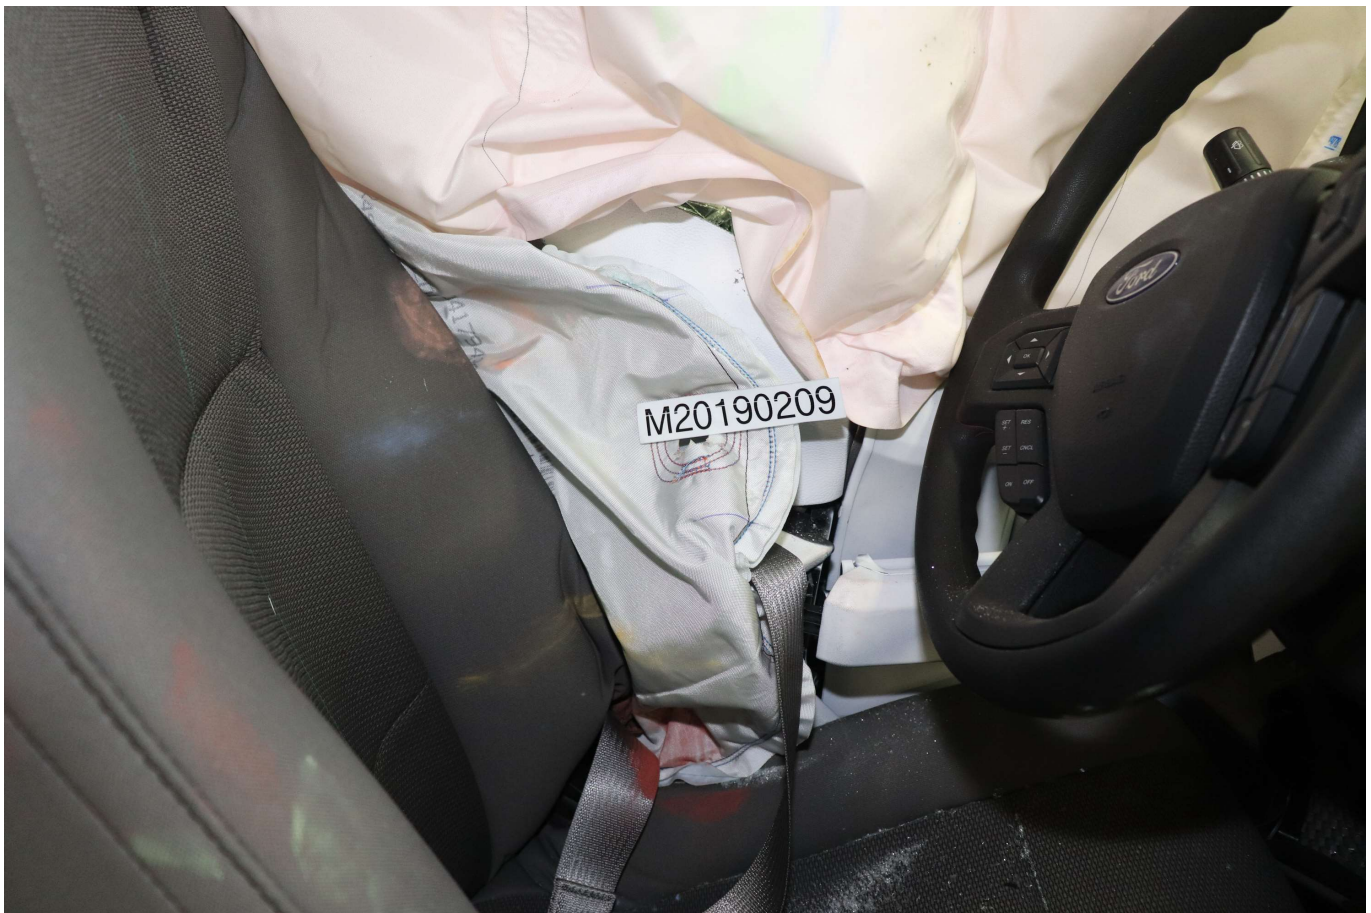
Photo No. 049 - Post-Test Dummy Close-Up Torso Contact with Side Air Bag View

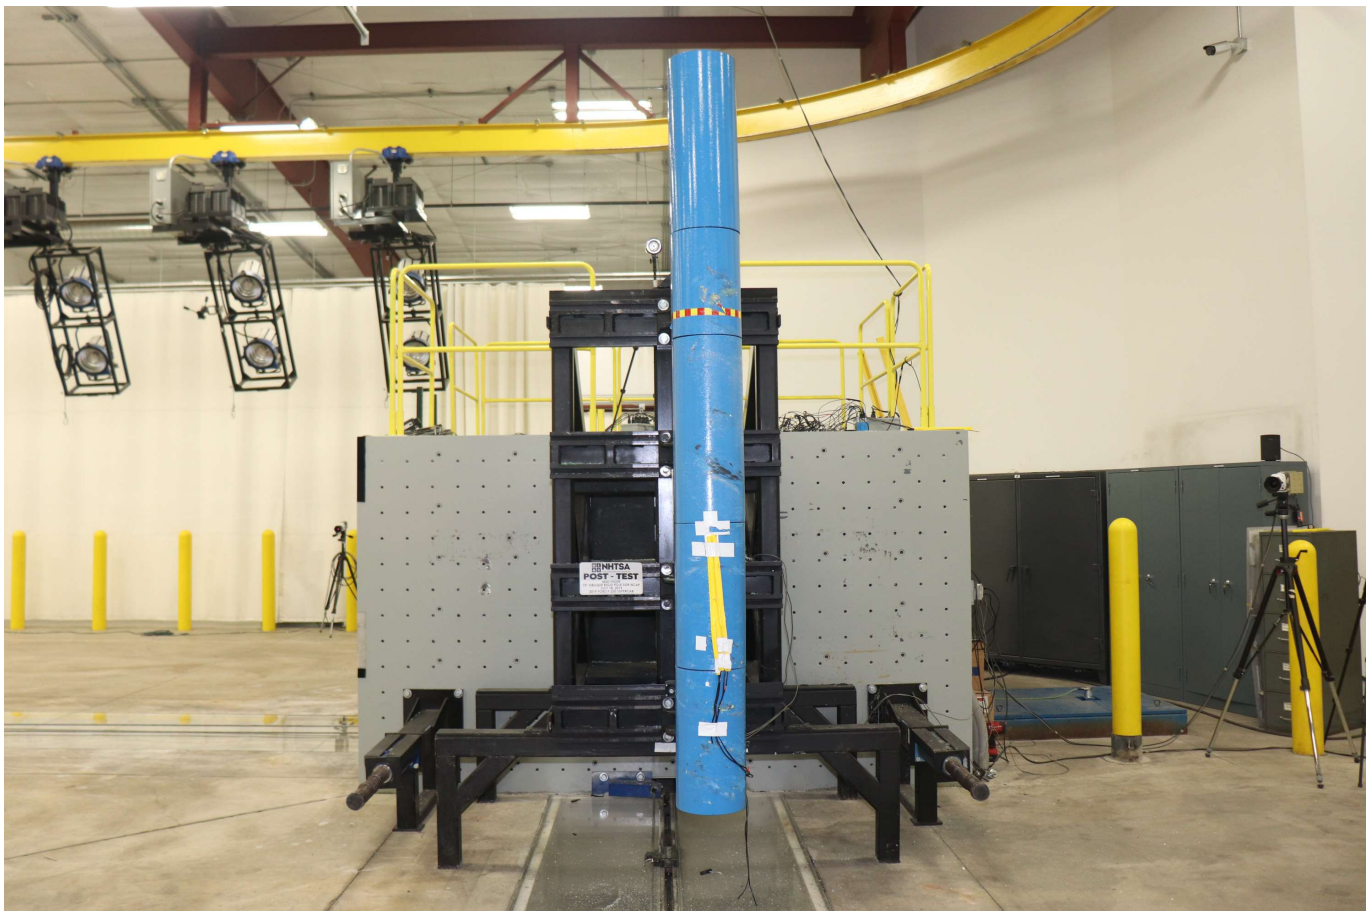
Photo No. 058 - Post-Test Pole Barrier Front View

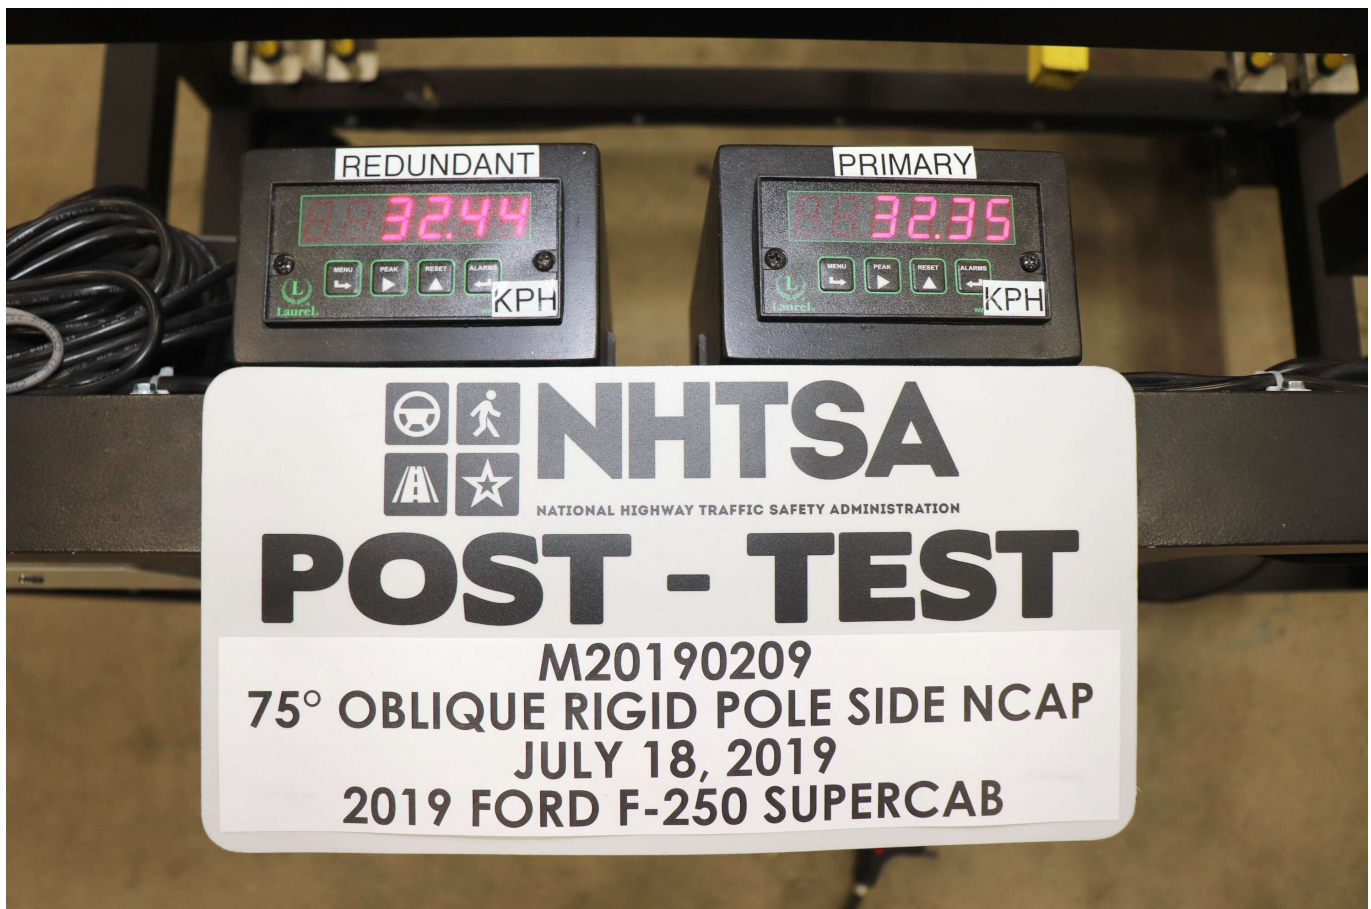
Photo No. 062 - Post-Test Primary and Redundant Speed Trap Read-Out

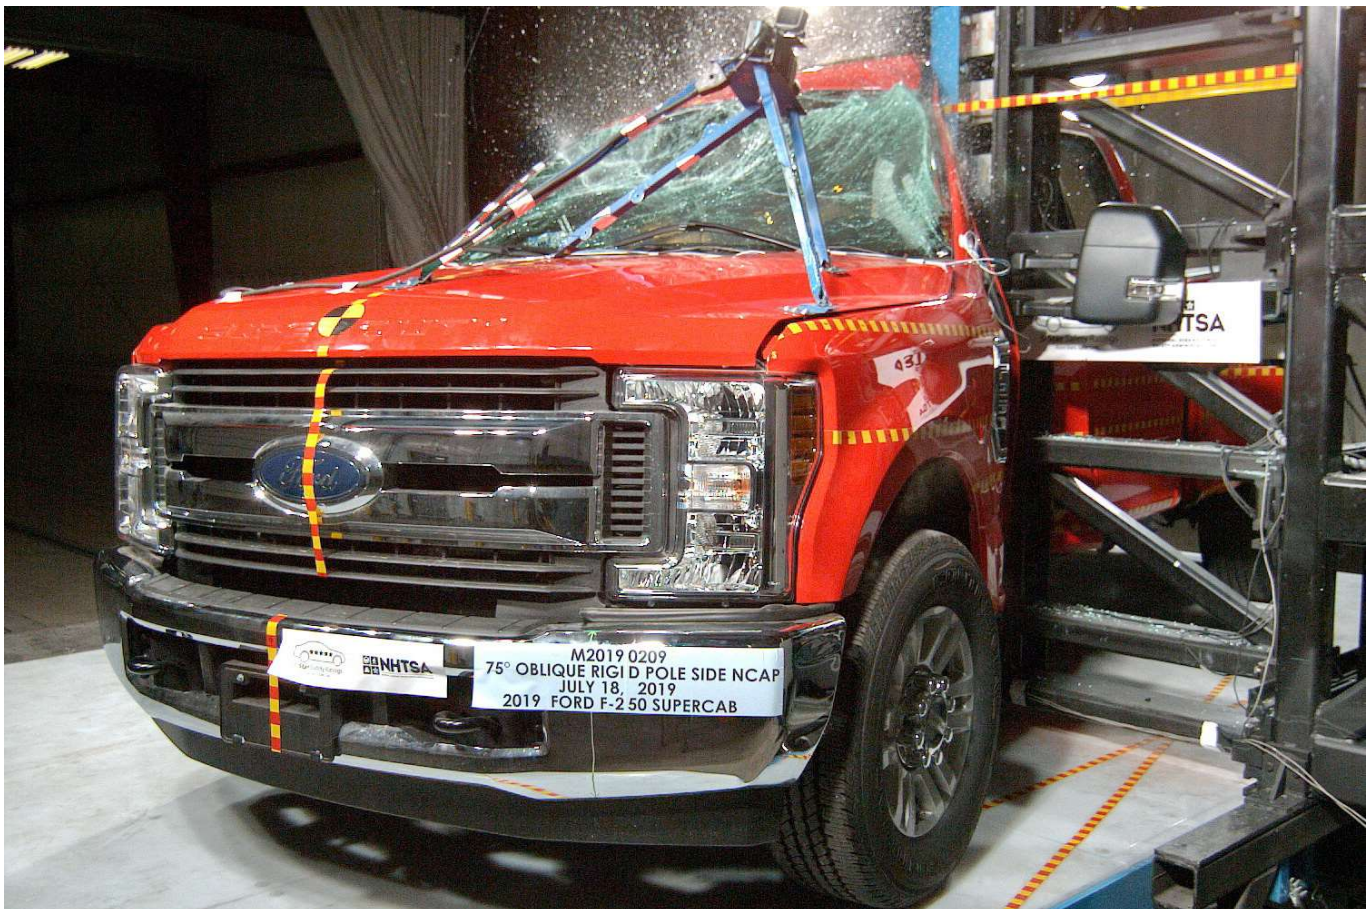
Photo No. 068 - Impact Event

A rigid pole side impact test was conducted on a 2019 Ford F-250 SuperCab XL Truck. The subject vehicle was towed into the rigid pole at an angle of 75° and a velocity of 32.35 km/h. The test was conducted by MGA Research Corporation in Burlington, Wisconsin on July 18, 2019. Pre-test and post-test photographs of the test vehicle and side impact dummy (SID-IIs) are included in Appendix A of this report.
