**REPORT NUMBER: NCAP-CAL-19-009**

**NEW CAR ASSESSMENT PROGRAM (NCAP)  
FRONTAL BARRIER IMPACT TEST**

**General Motors LLC  
2019 Chevrolet Silverado 2500 Crew Cab  
Truck**

**NHTSA No: M20190114**

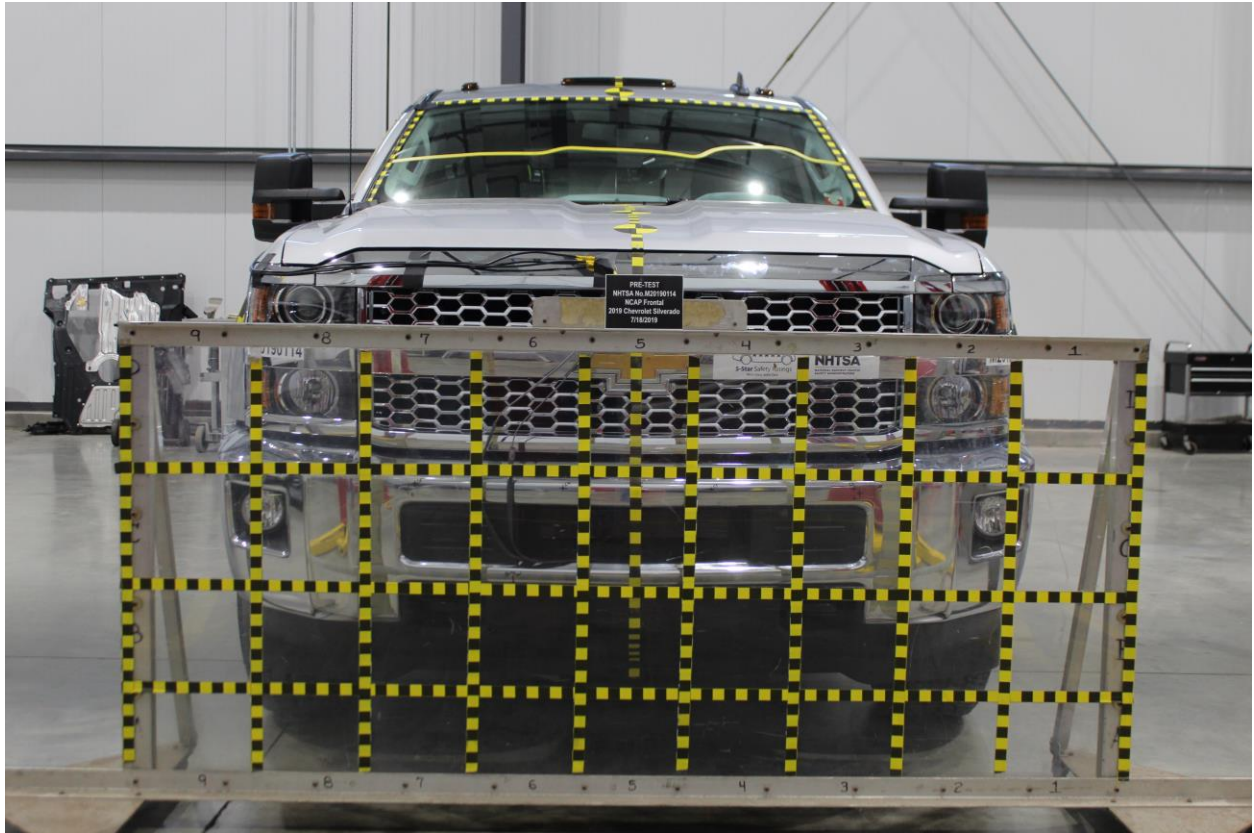
Figure A-1: Load Cell Location

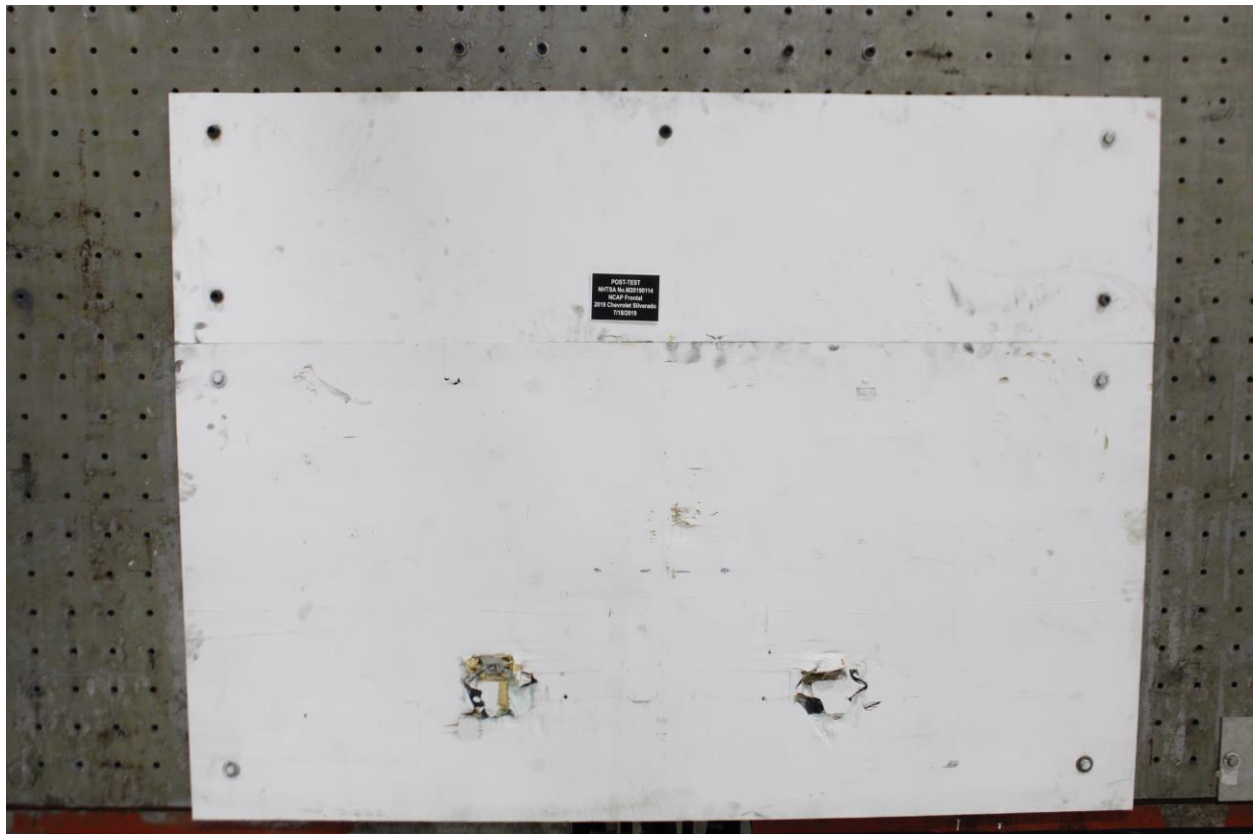
Figure A-3: Post-Test Load Cell Wall

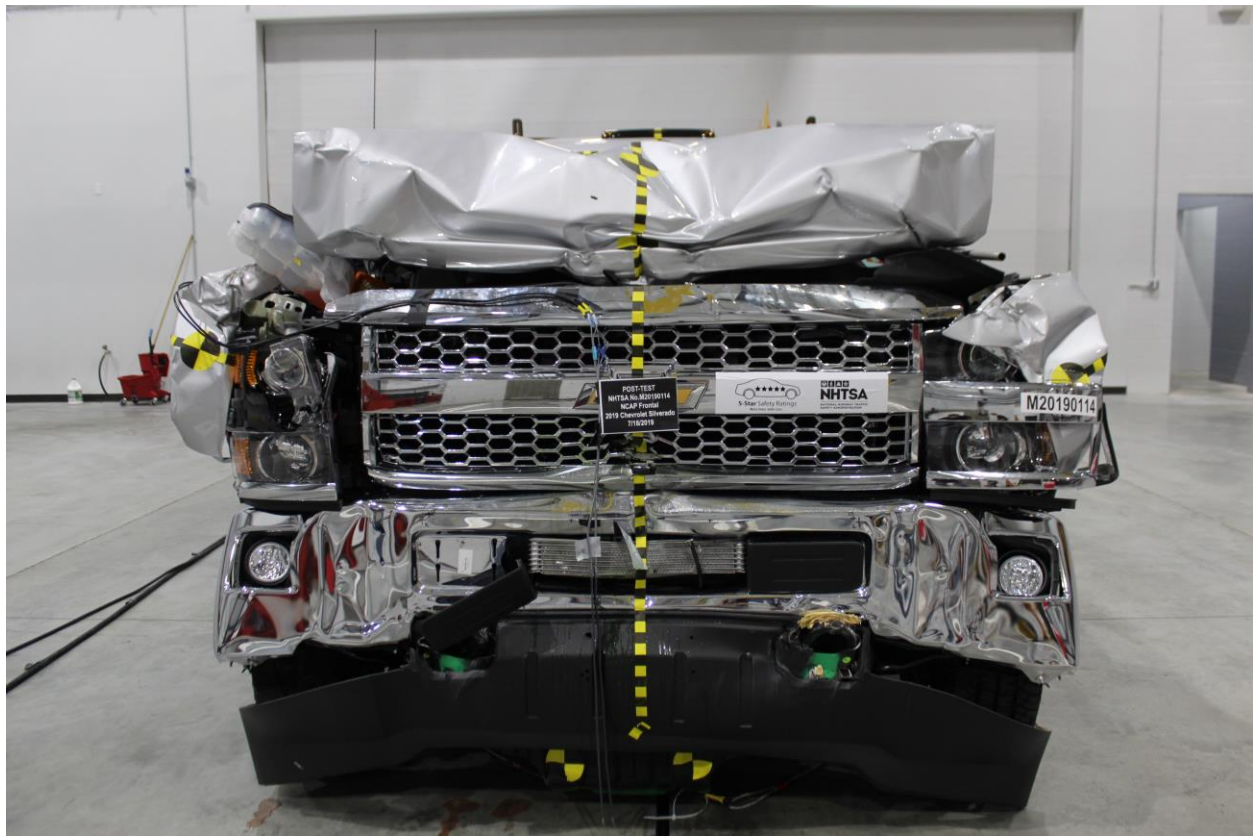
**Figure A-9: Post-Test Front View of Test Vehicle**

A ridged fixed barrier was impacted by a 2019 Chevrolet Silverado 2500 Crew Cab Truck at a velocity of 56.34 km/h. The test was performed at Calspan Corporation's Transportation Test Operations facility in Buffalo, New York on July 18, 2019. Pre- and post-test photographs of the vehicle and dummies to document the test can be found in Appendix A. One real-time camera and 14 high-speed cameras were used to document the frontal barrier impact event. Camera locations and other pertinent camera information can be found in Data Sheet 6 of this report.

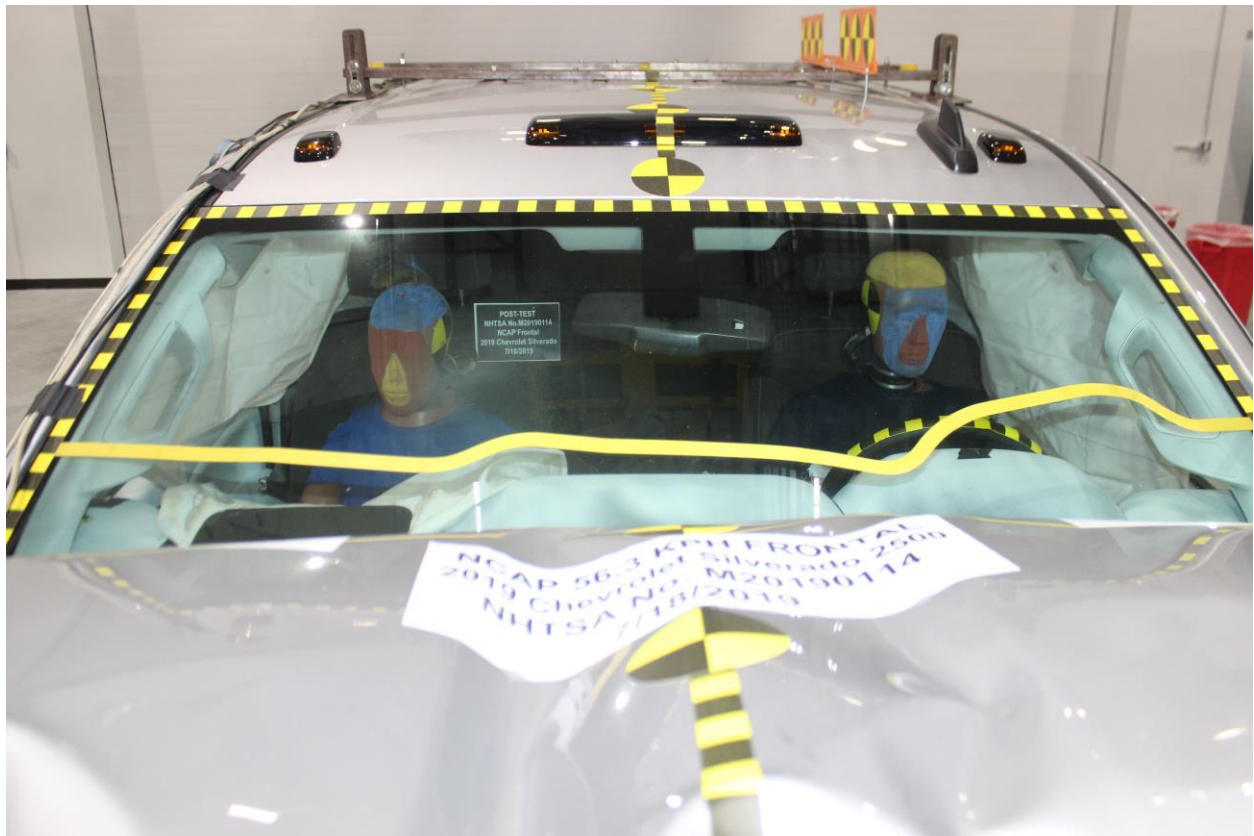
**Figure A-19: Post-Test Windshield View**

There was 100 percent windshield retention and no intrusion into the protected zone of the windshield during the event. There was a total of 0.0 grams of stoddard solvent leakage after the event and including all phases of the static rollover. The maximum static crush of the test vehicle was 675 mm at the vehicles centerline. During and after the impact event, the driver's and passenger's side doors were closed and operational.

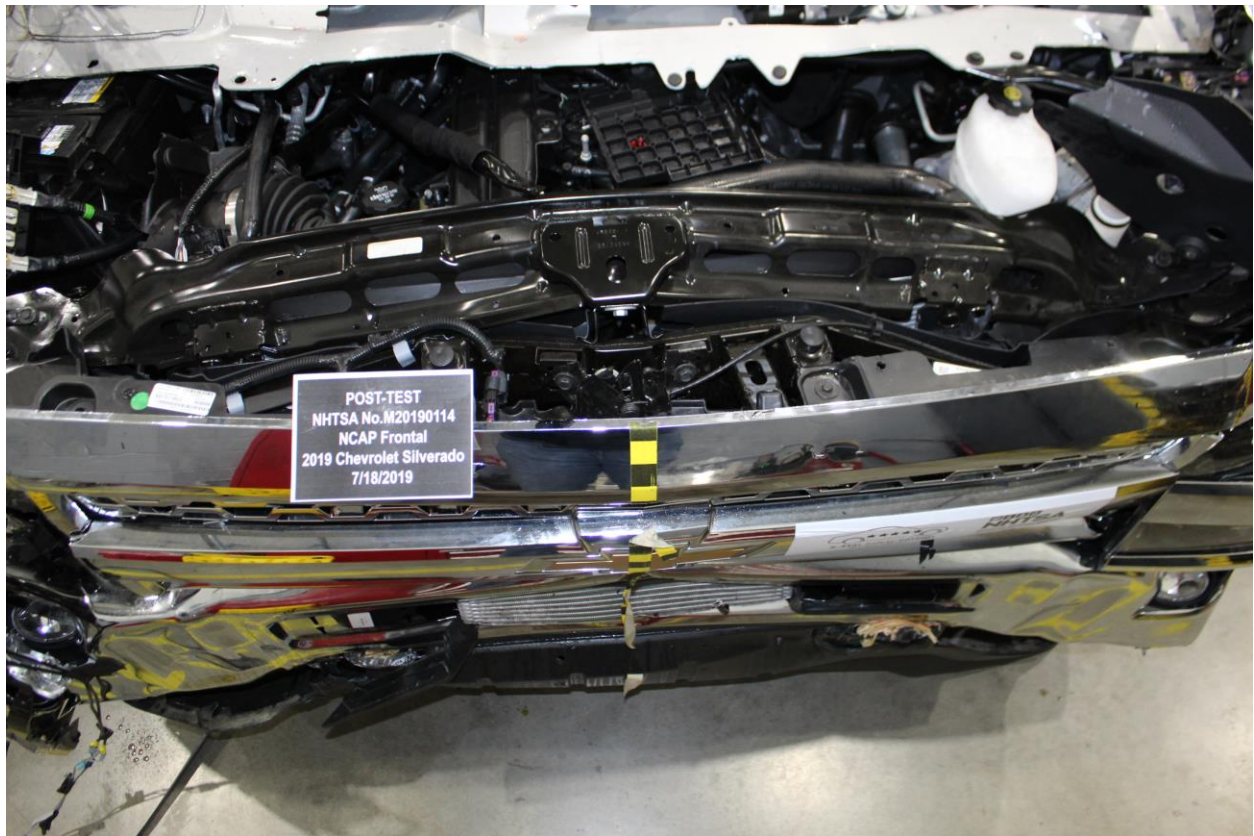
**Figure A-21: Post-Test Engine Compartment View**

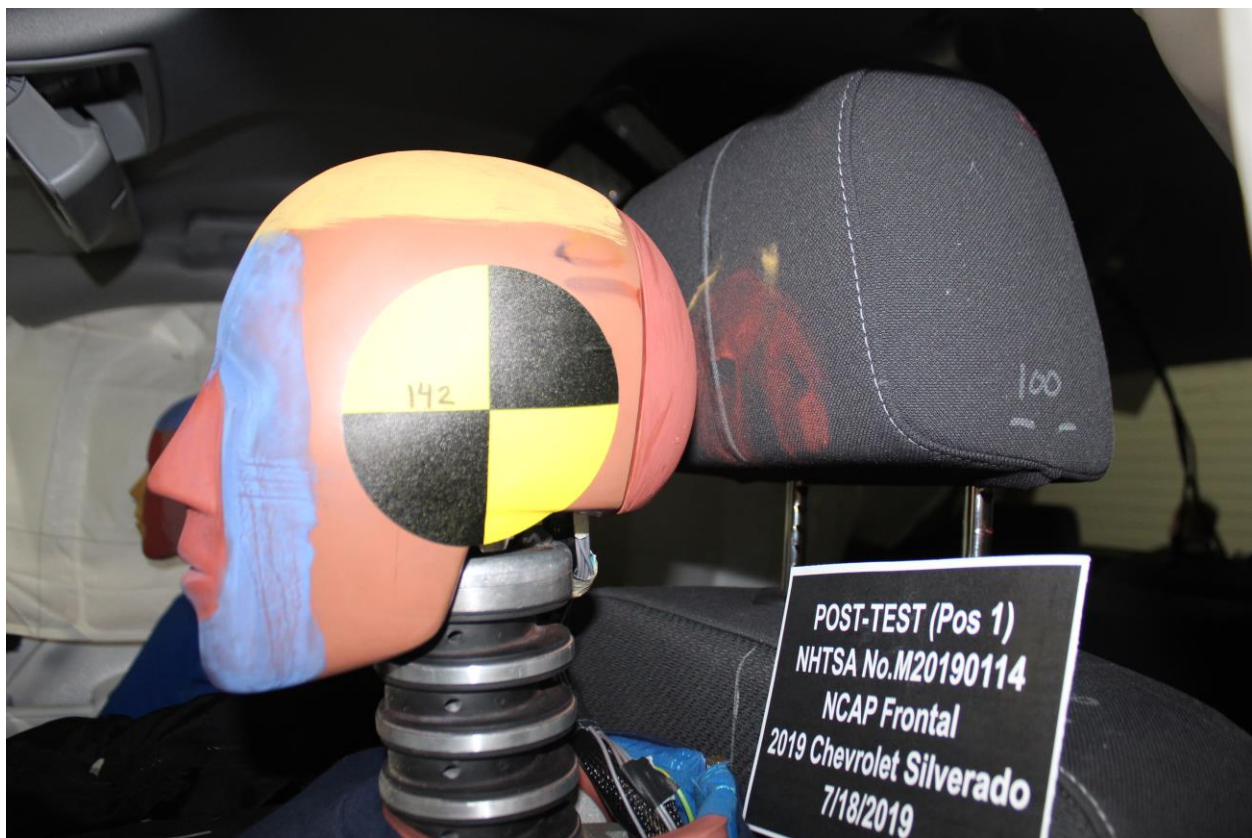
**Figure A-48: Post-Test Driver Dummy Contact With Headrest**

The driver's visible contact points were as follows: The driver's head contacted the frontal airbag and then the head restraint. The upper torso contacted the frontal airbag. Both knees contacted the knee bolster.

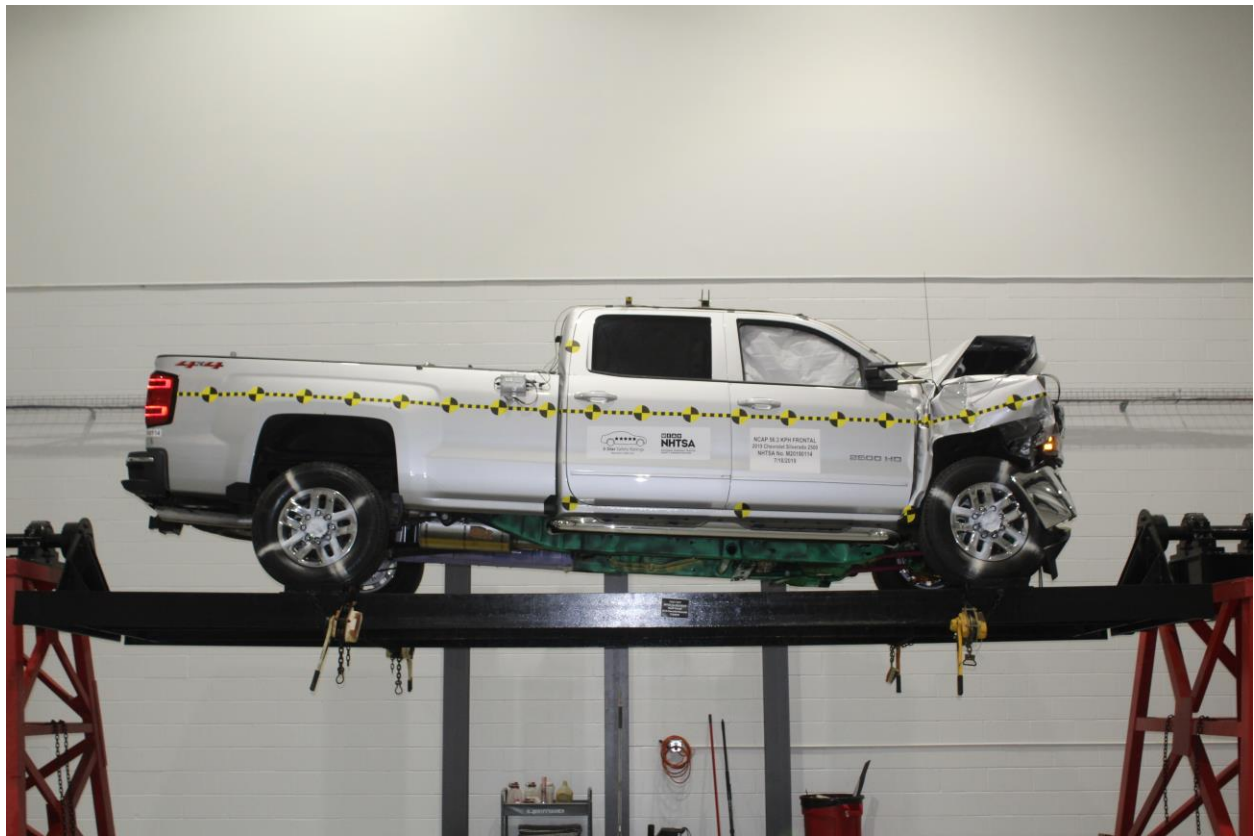
**Figure A-73: Vehicle at 0° on Static Rollover Device**

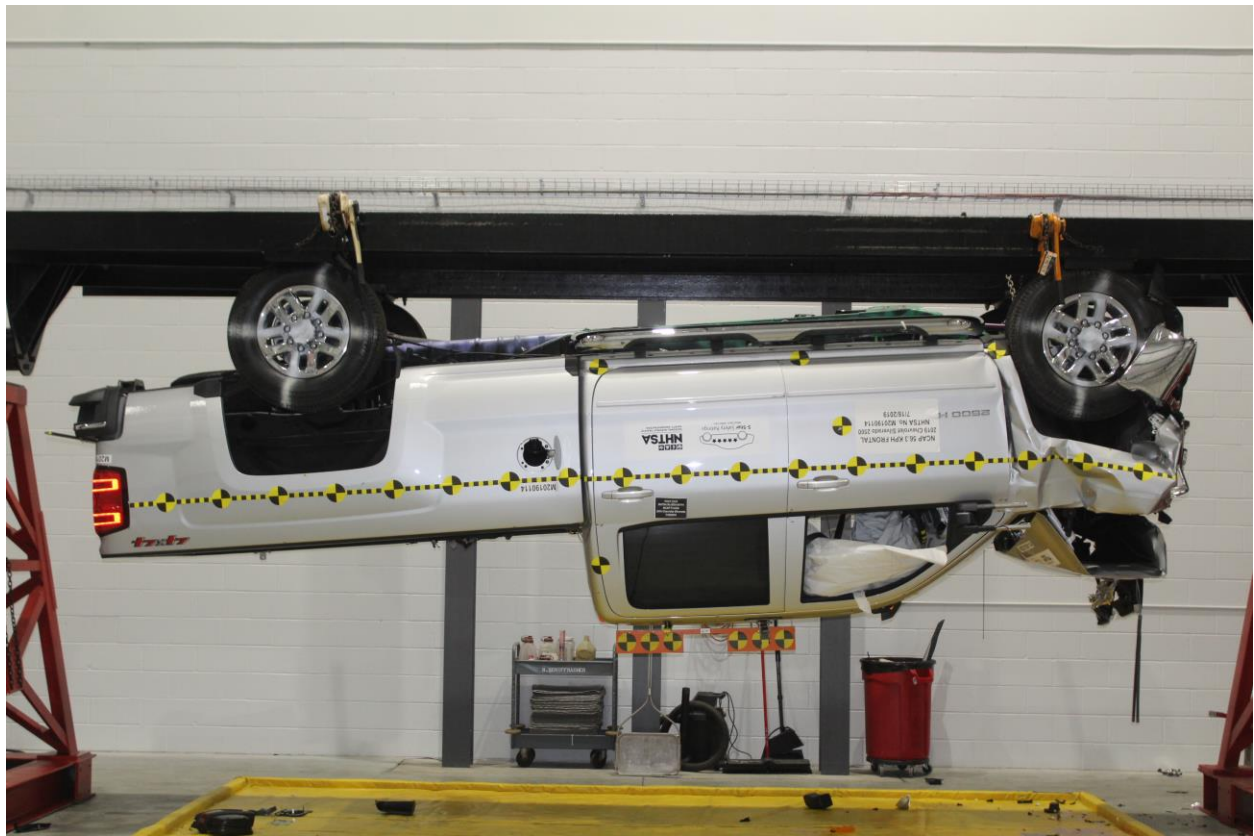
**Figure A-75: Vehicle at 180° on Static Rollover Device**
