**REPORT NUMBER: SINCAP-MGA-20-001**

**NEW CAR ASSESSMENT PROGRAM (NCAP)  
Moving Deformable Barrier Side Impact Test**

**TOYOTA MOTOR CORPORATION  
2020 Toyota Corolla LE 4-Door Sedan  
NHTSA No.: O20205100**

**MGA RESEARCH CORPORATION  
5000 Warren Road  
Burlington, WI 53105**

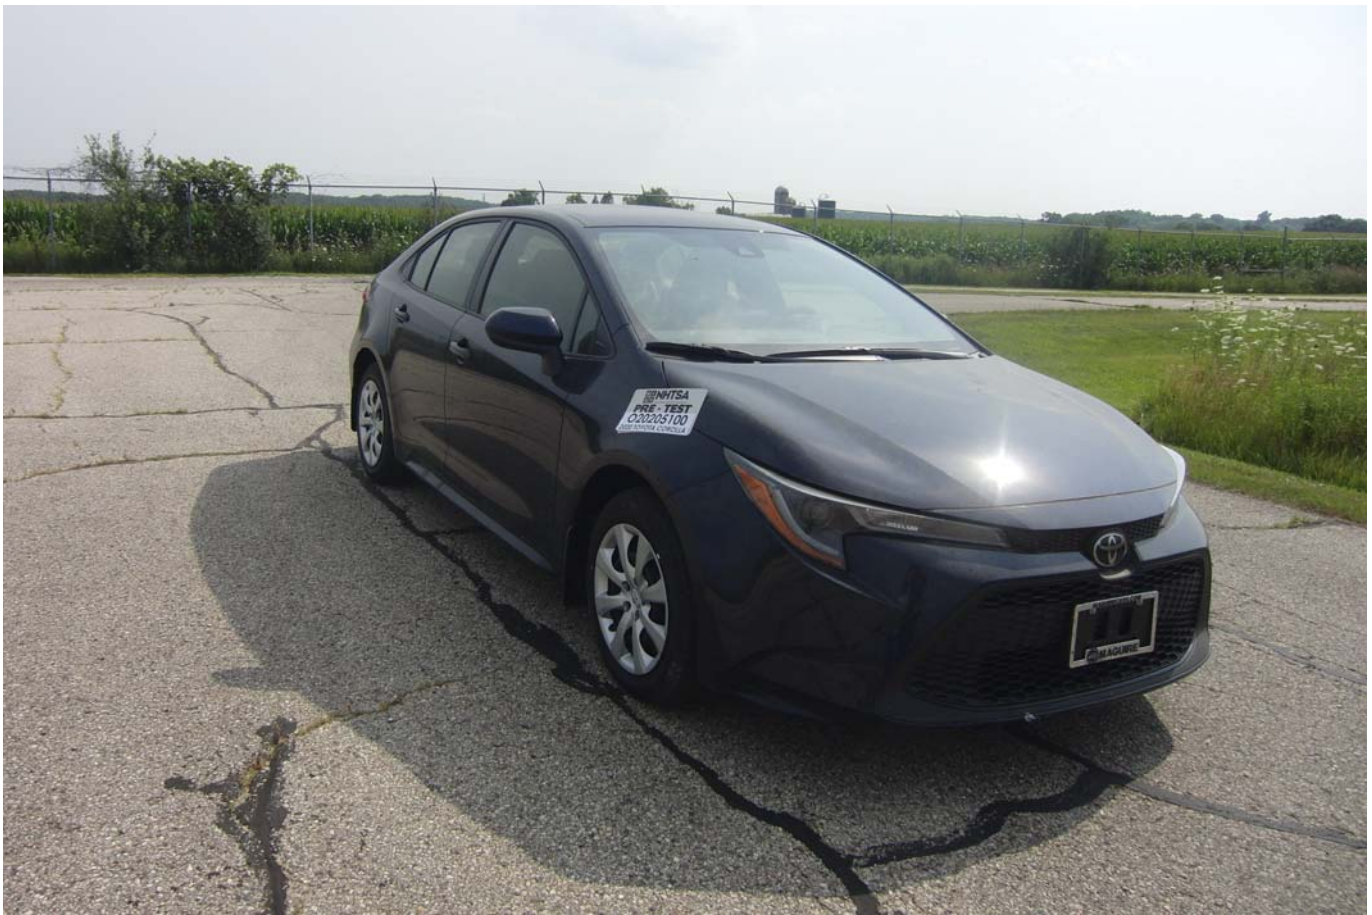
Photo No. 001 - As Delivered Right Front Three-Quarter View of Test Vehicle

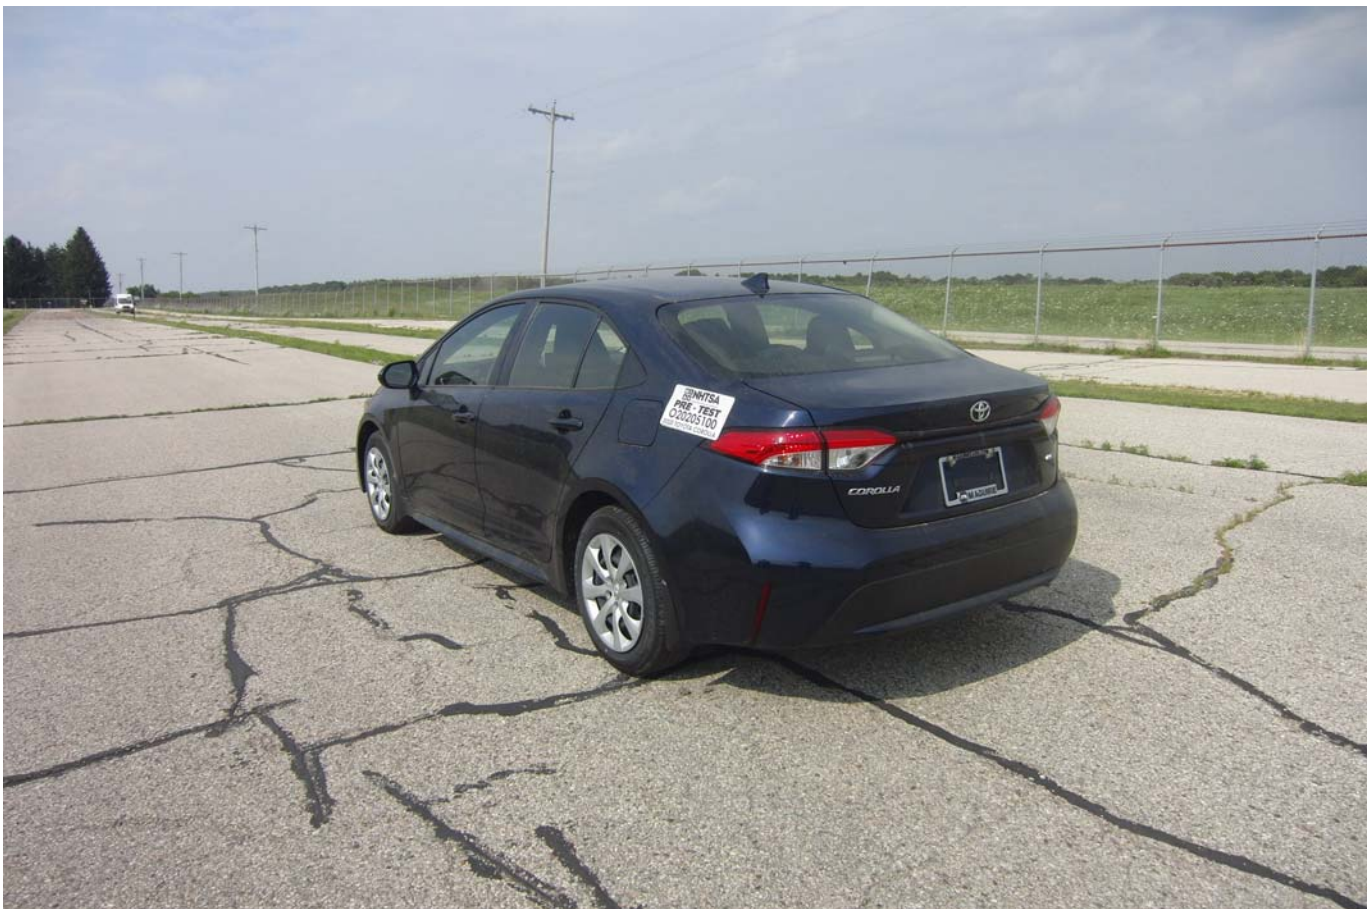
Photo No. 002 - As Delivered Left Rear Three-Quarter View of Test Vehicle

| | | <u>Page No.</u> |
|---|---|---|
| Photo No. 002 | As Delivered Left Rear Three-Quarter View of Test Vehicle | A-1 |

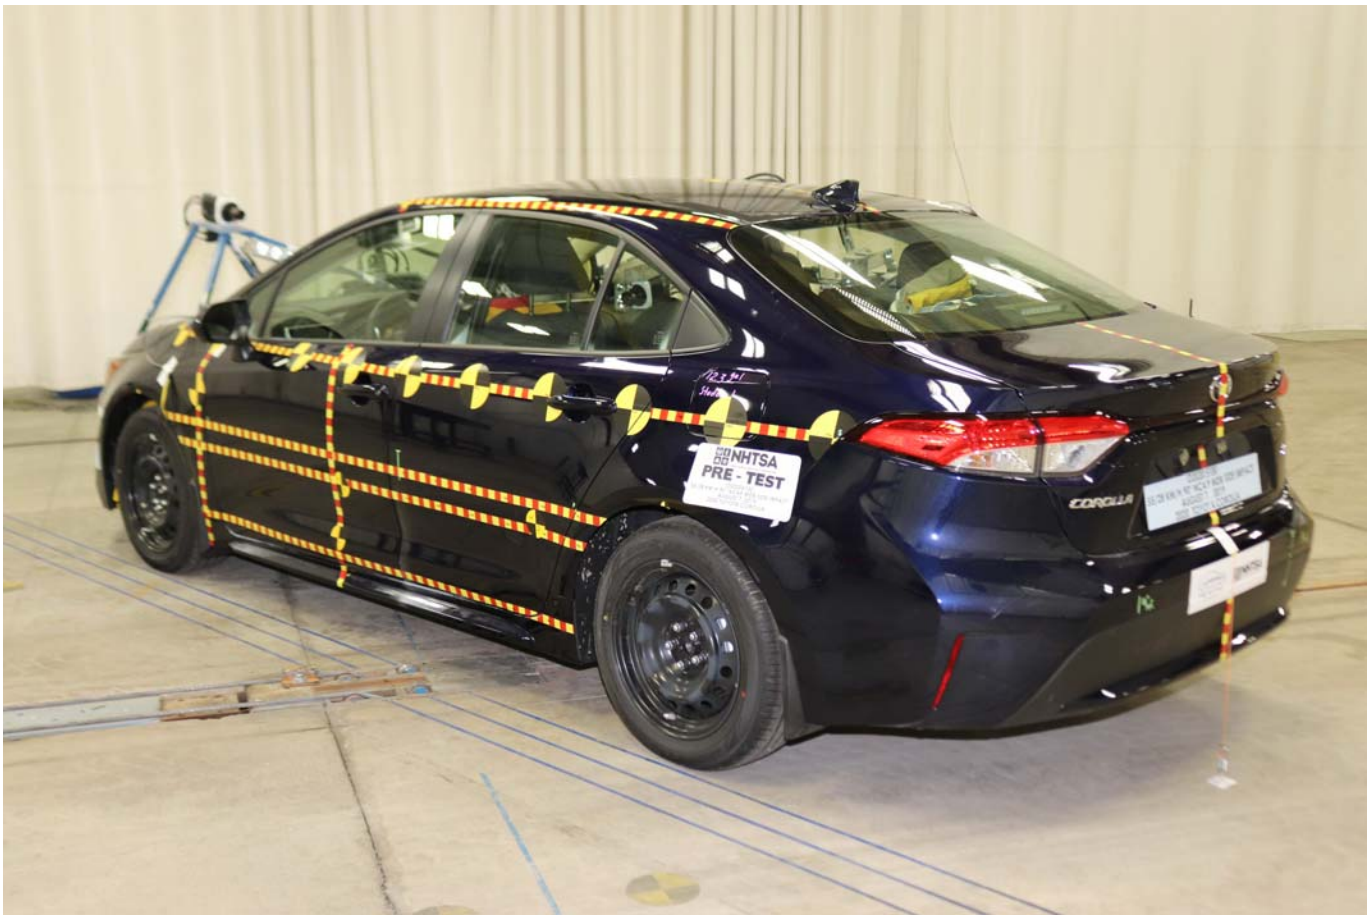
Photo No. 009 - Pre-Test Left Three-Quarter Rear View of Test Vehicle

| | | <u>Page No.</u> |
|---|---|---|
| Photo No. 009 | Pre-Test Left Three-Quarter Rear View of Test Vehicle | A-5 |

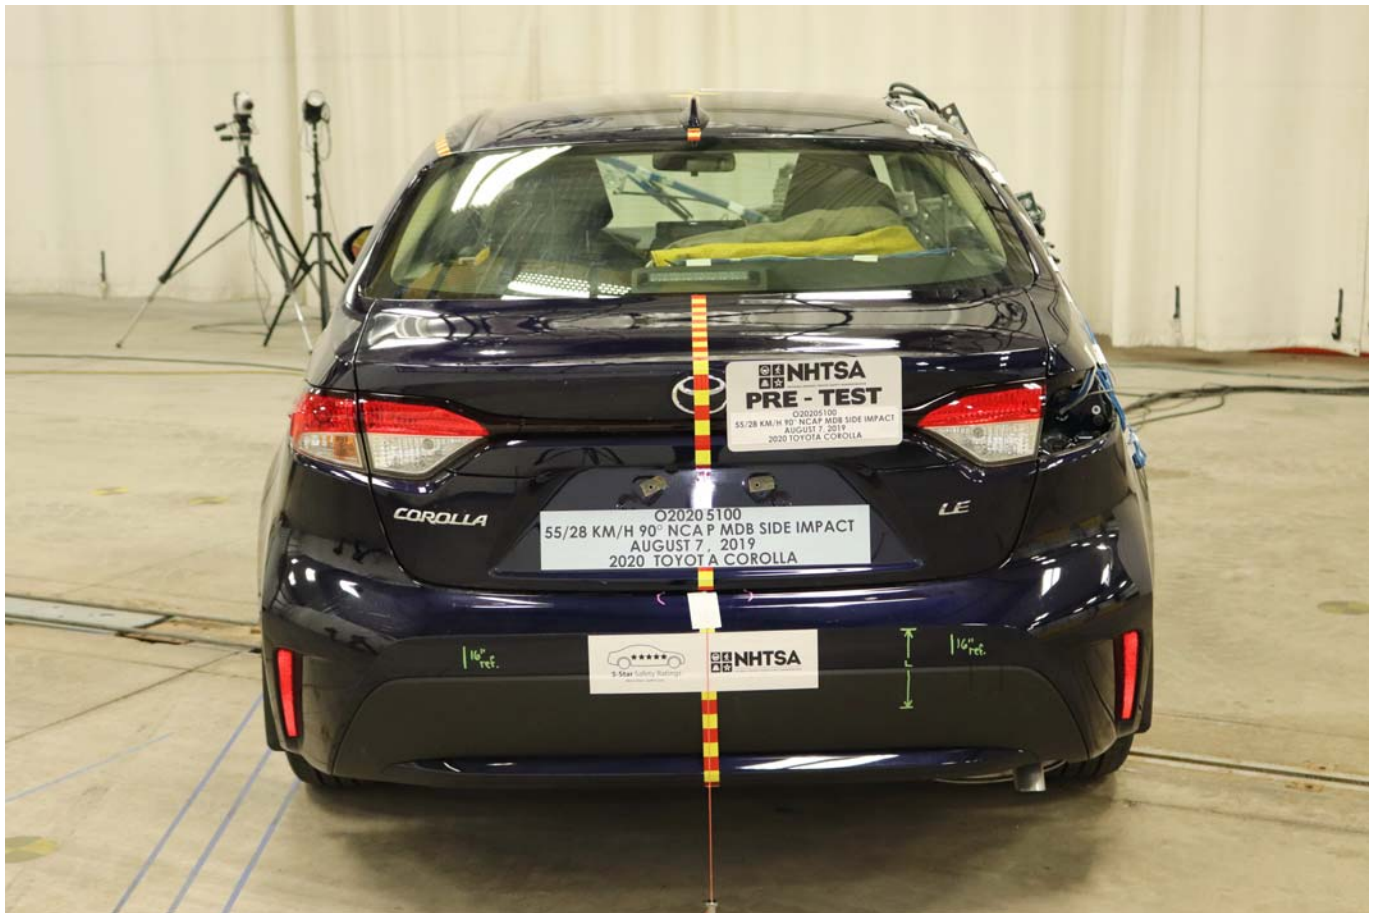
Photo No. 011 - Pre-Test Rear View of Test Vehicle

| | | <u>Page No.</u> |
|---|---|---|
| Photo No. 011 | Pre-Test Rear View of Test Vehicle | A-6 |

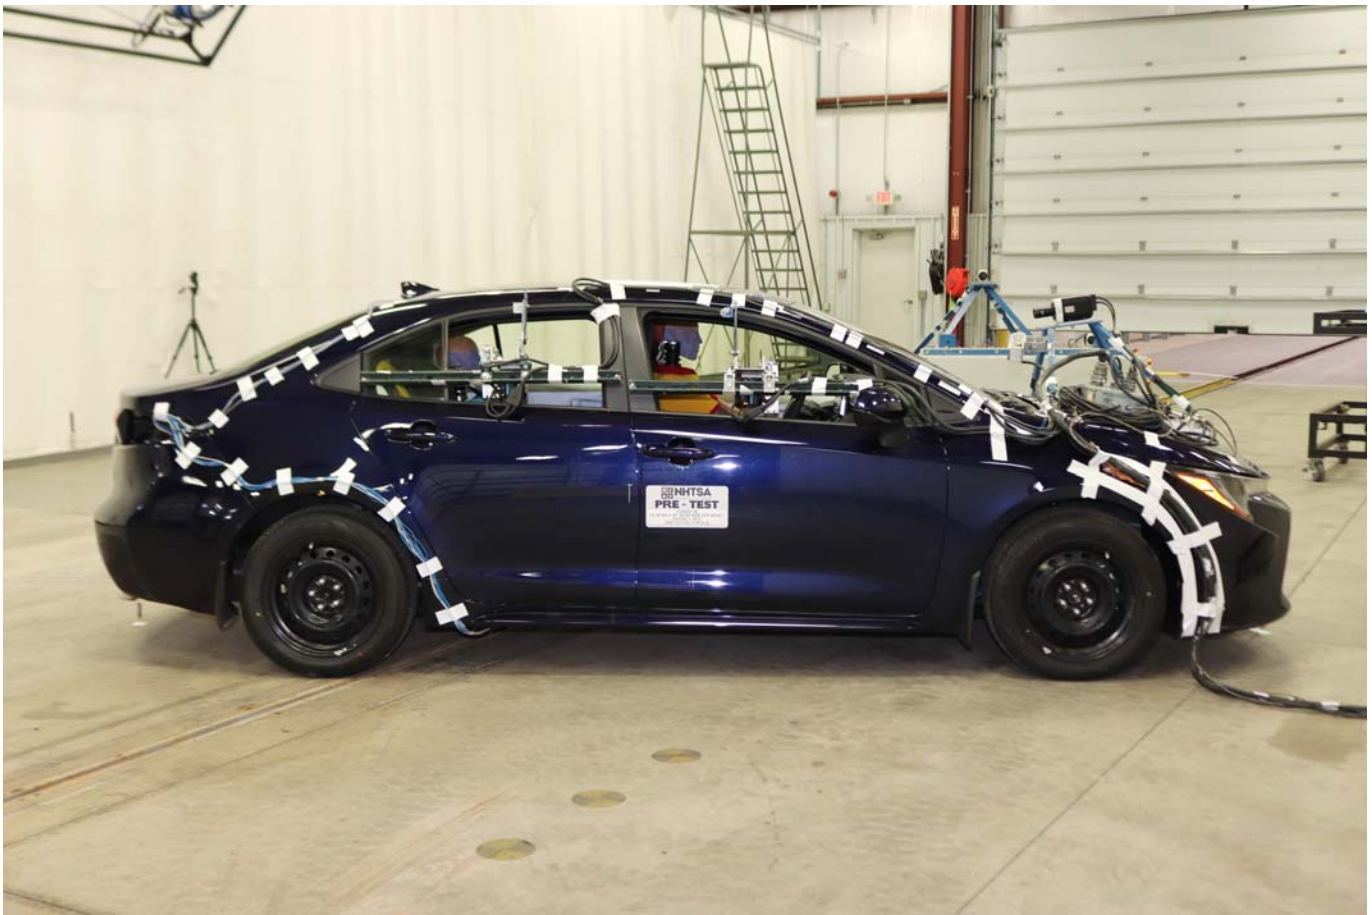
Photo No. 013 - Pre-Test Right Side View of Test Vehicle

| | | <u>Page No.</u> |
|---|---|---|
| Photo No. 013 | Pre-Test Right Side View of Test Vehicle | A-7 |

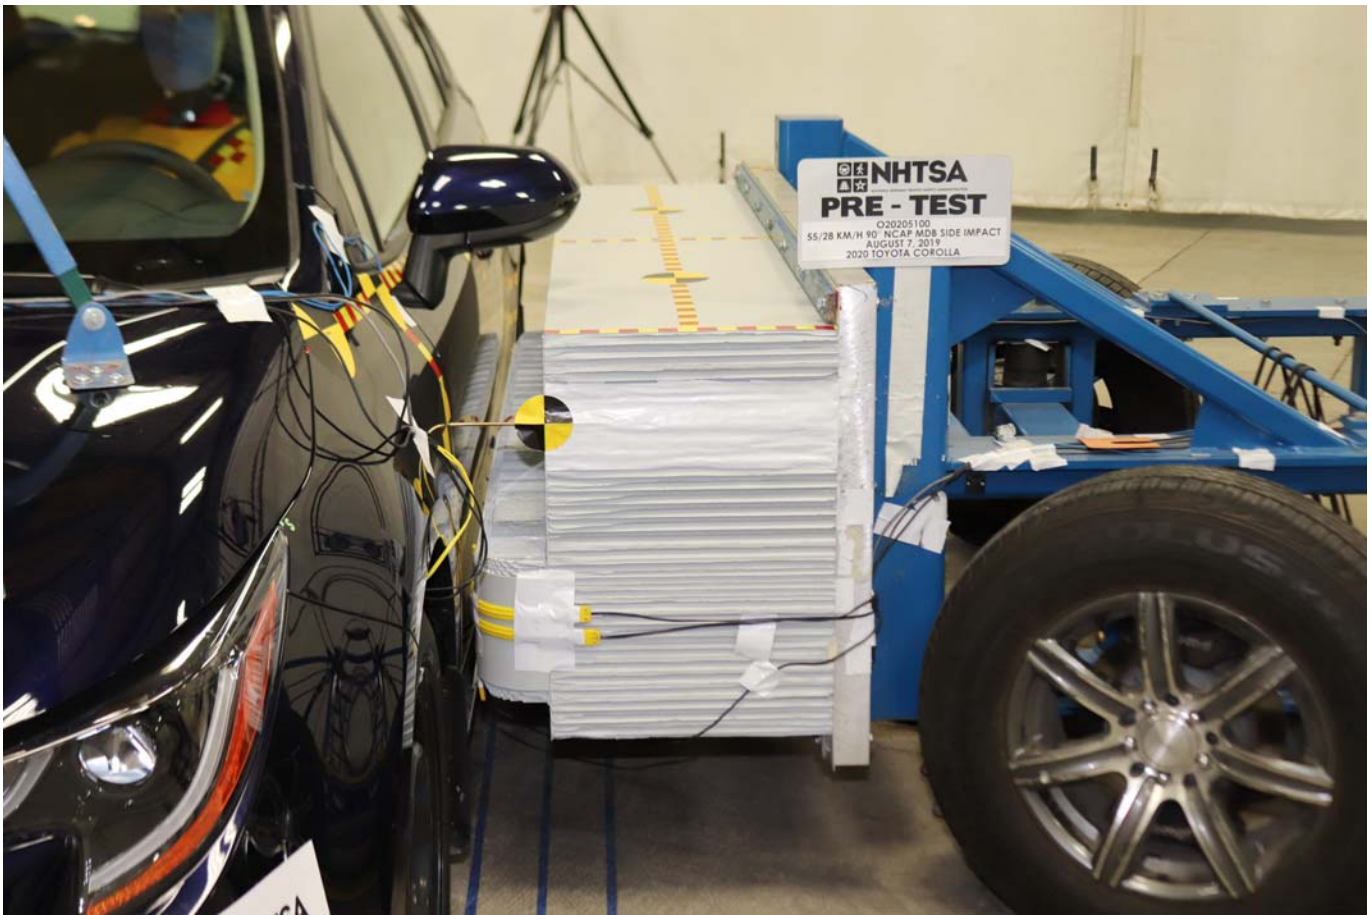
Photo No. 017 - Pre-Test Left Side View of MDB Positioned Against Side of Test Vehicle

| | | <u>Page No.</u> |
|---|---|---|
| Photo No. 017 | Pre-Test Left Side View of MDB Positioned Against Side of Test Vehicle | A-9 |

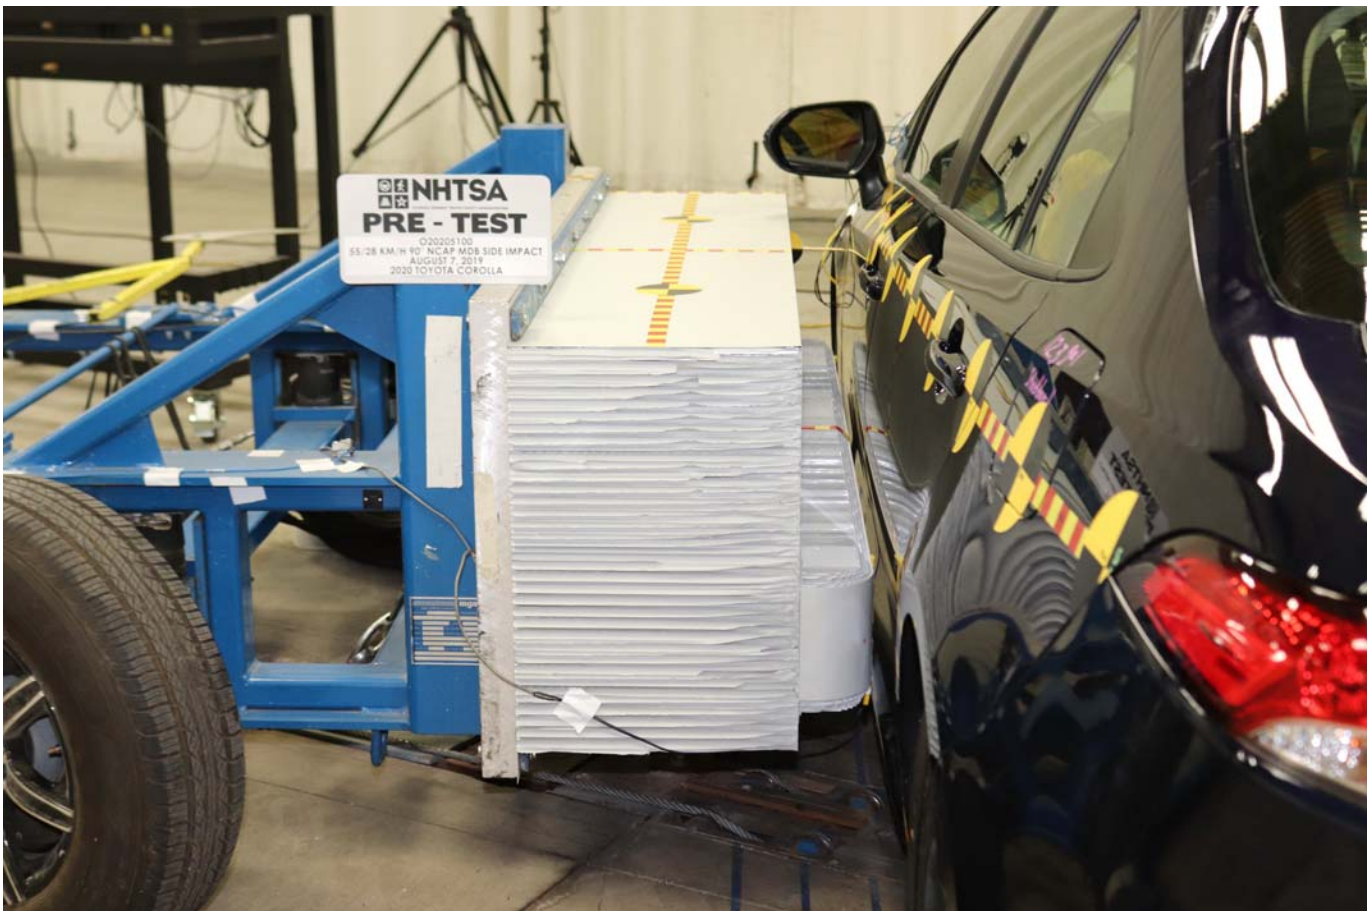
Photo No. 018 - Pre-Test Right Side View of MDB Positioned Against Side of Test Vehicle

| | | <u>Page No.</u> |
|---|---|---|
| Photo No. 018 | Pre-Test Right Side View of MDB Positioned Against Side of Test Vehicle | A-9 |

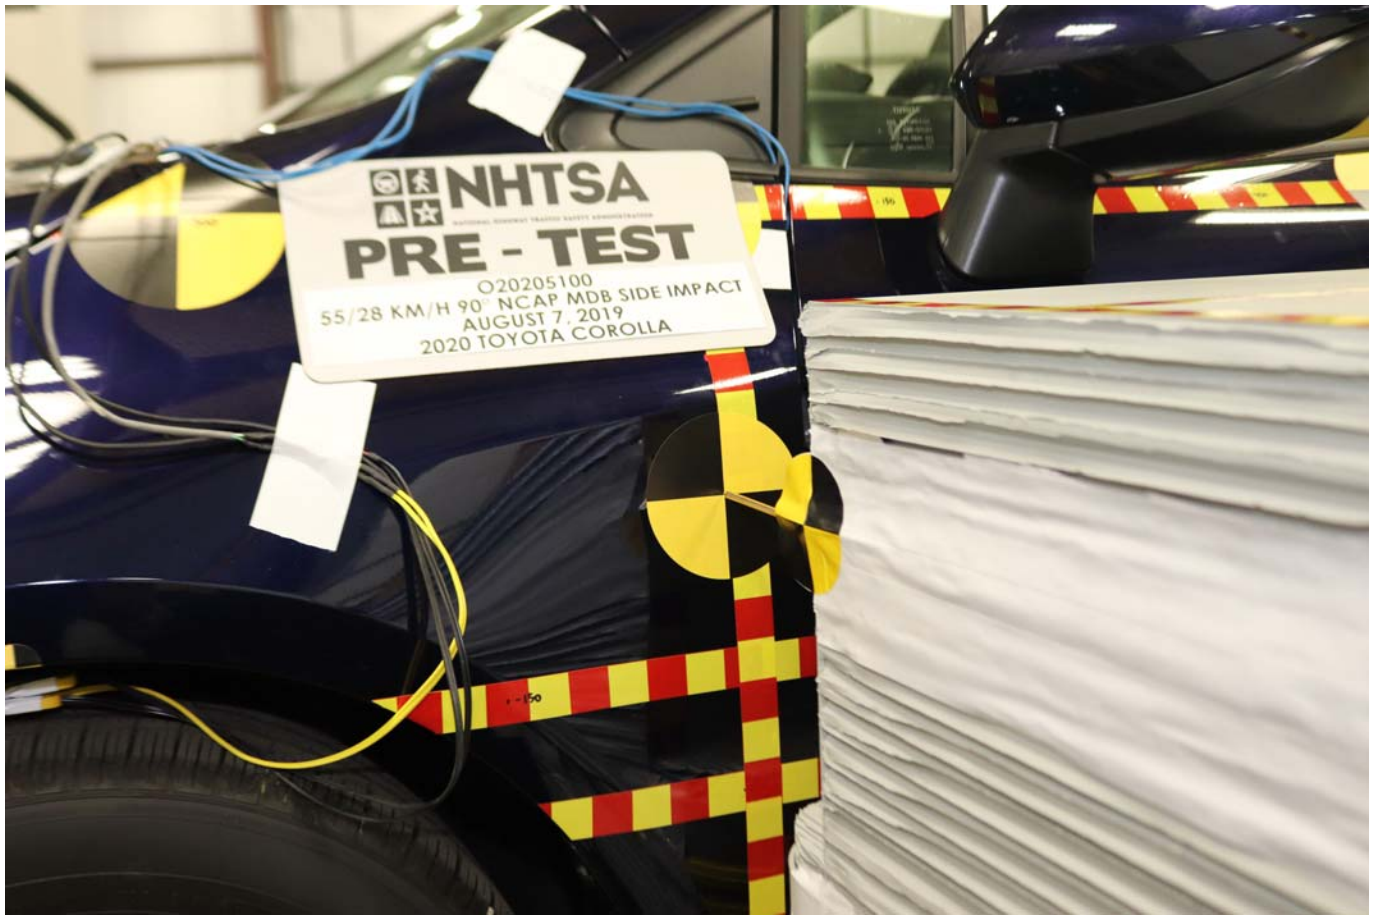
Photo No. 019 - Pre-Test Close-Up View of Impact Point Target

| | | <u>Page No.</u> |
|---|---|---|
| Photo No. 019 | Pre-Test Close-Up View of Impact Point Target | A-10 |

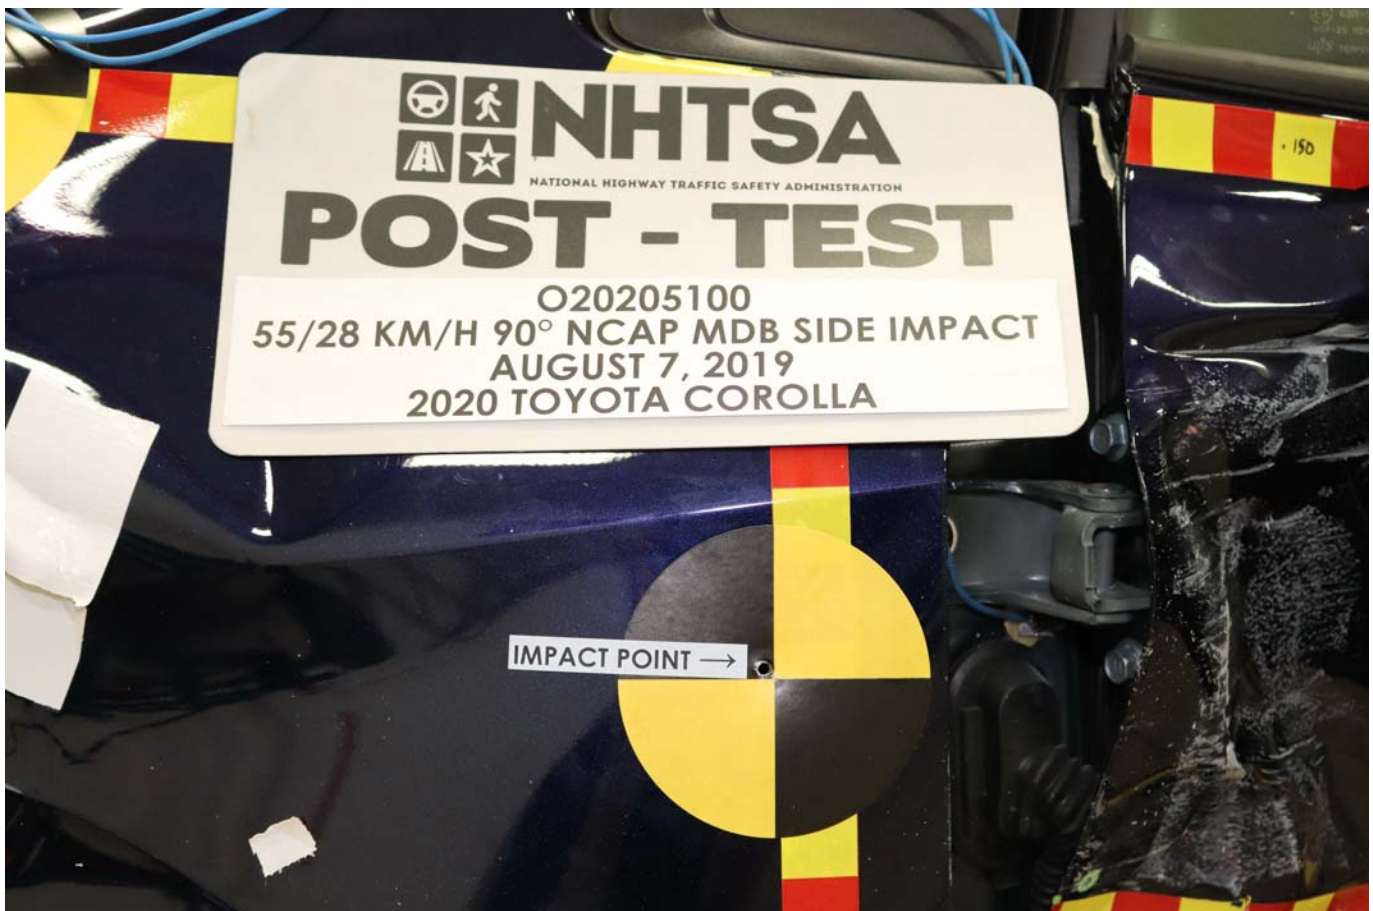
Photo No. 020 - Post-Test Close-Up View of Impact Point Target

| | | <u>Page No.</u> |
|---|---|---|
| Photo No. 020 | Post-Test Close-Up View of Impact Point Target | A-10 |

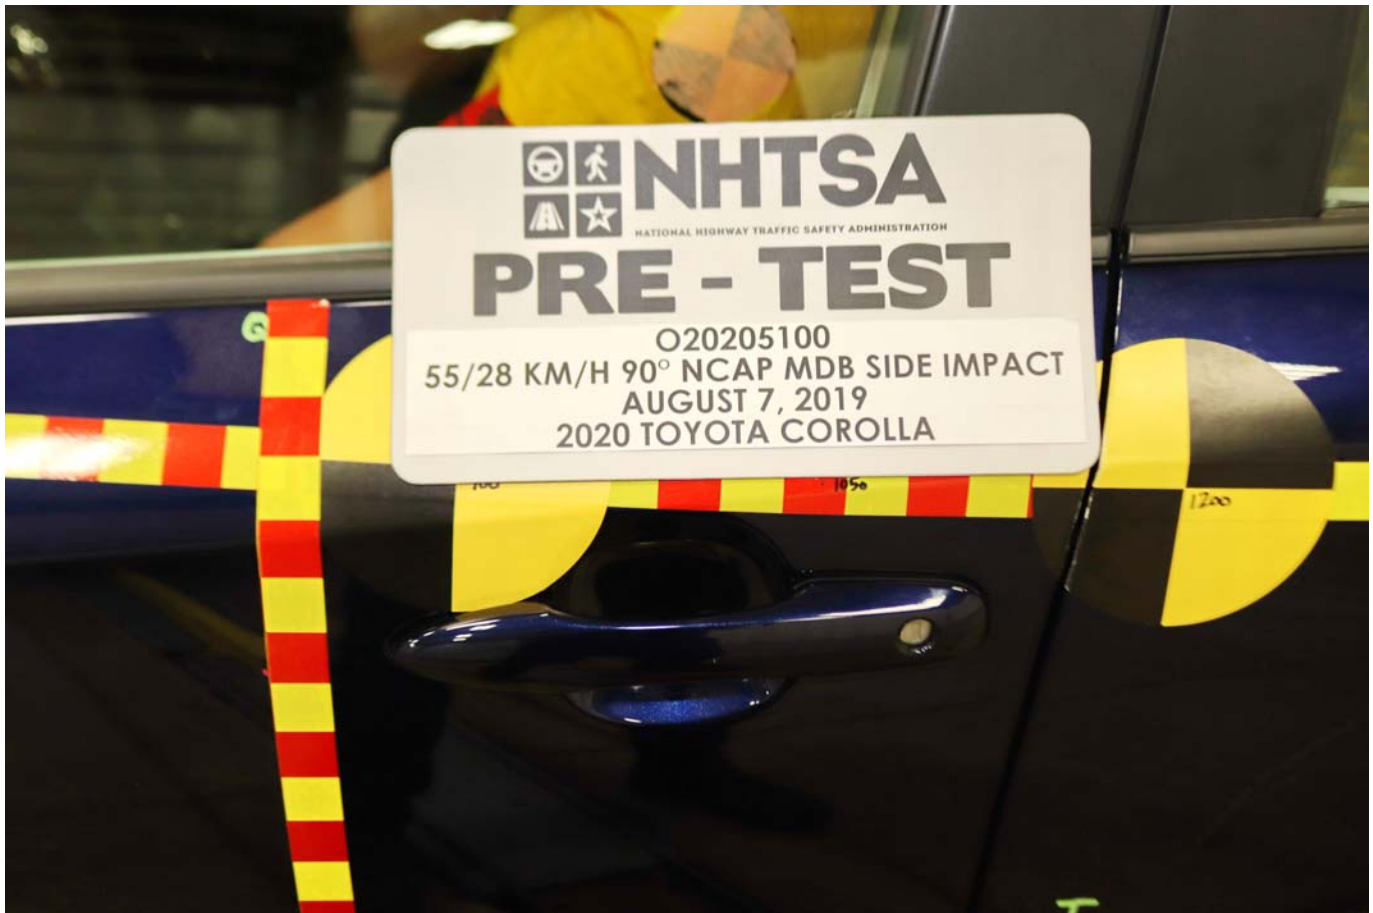
Photo No. 021 - Pre-Test Left Front Door Latch Close-Up

| | | <u>Page No.</u> |
|---|---|---|
| Photo No. 021 | Pre-Test Left Front Door Latch Close-Up | A-11 |

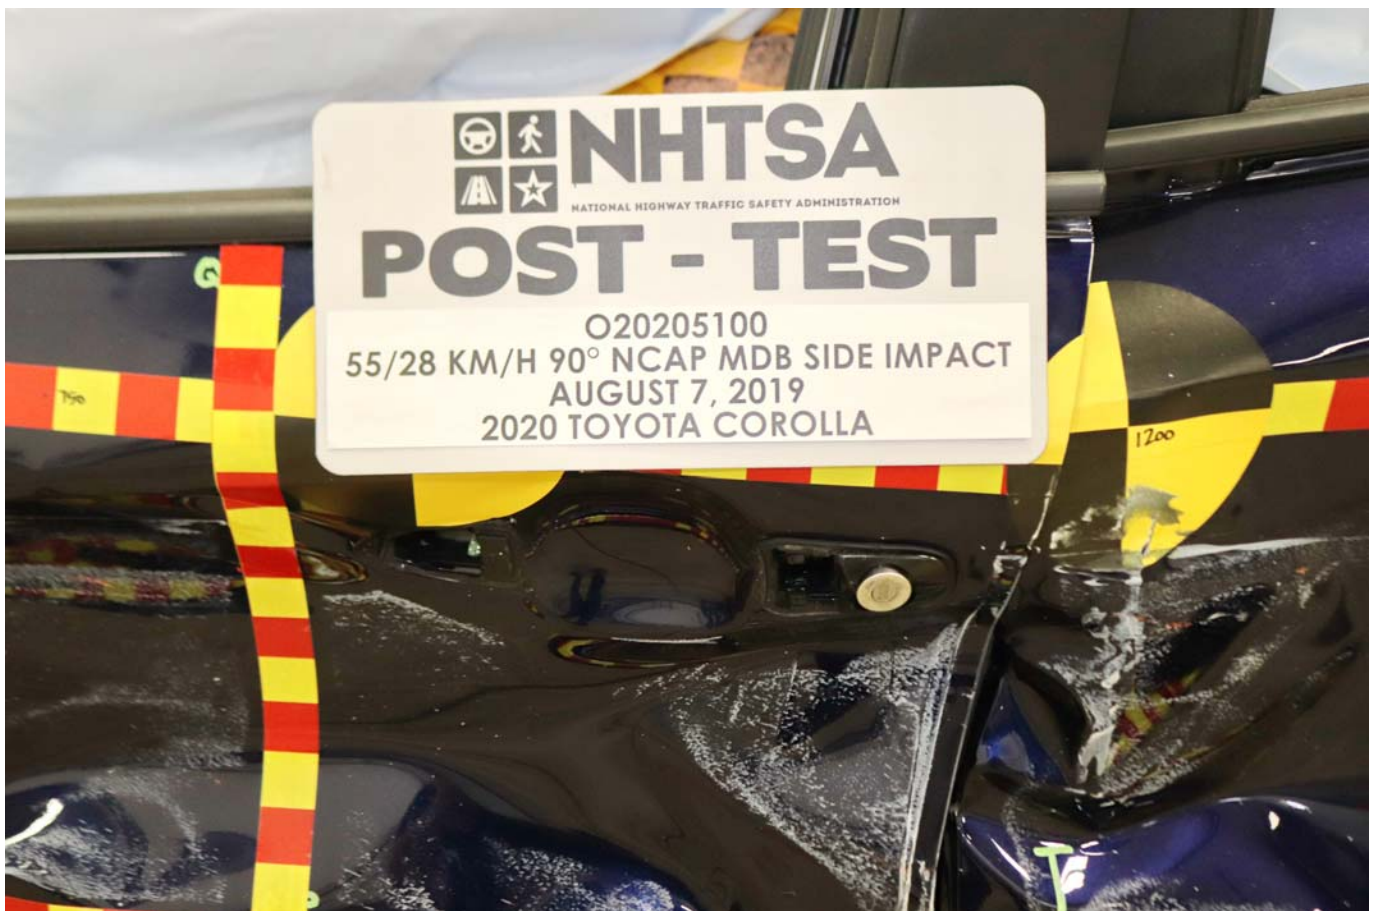
Photo No. 022 - Post-Test Left Front Door Latch Close-Up

The doors on the struck side of the vehicle did not separate from the body at the hinges or latches and the opposite doors did not open during the side impact event.

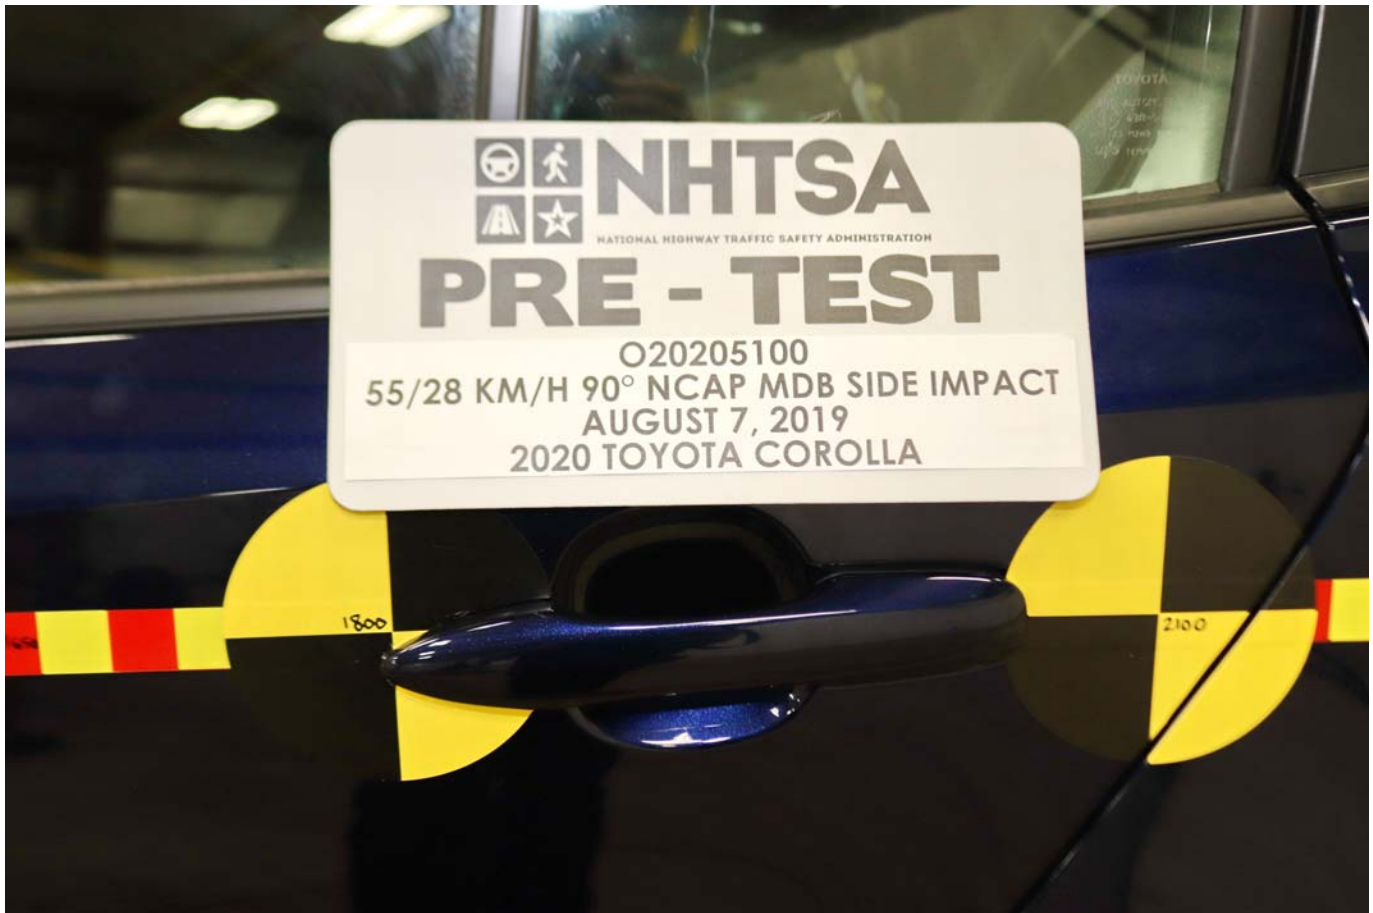
Photo No. 023 - Pre-Test Left Rear Door Latch Close-Up

| | | <u>Page No.</u> |
|---|---|---|
| Photo No. 023 | Pre-Test Left Rear Door Latch Close-Up | A-12 |

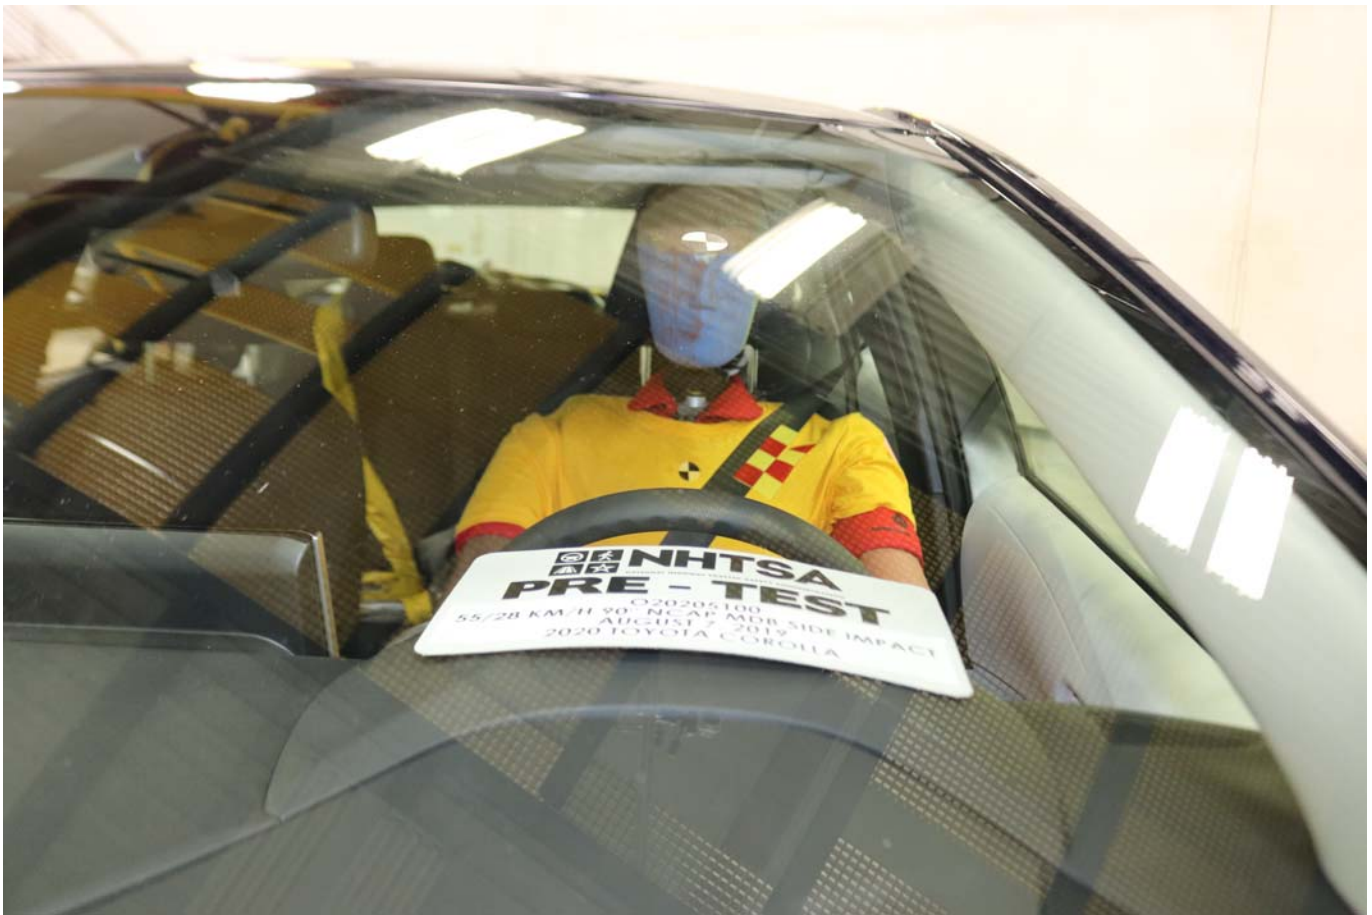
Photo No. 025 - Pre-Test Front Close-Up View of Driver Dummy

| | | <u>Page No.</u> |
|---|---|---|
| Photo No. 025 | Pre-Test Front Close-Up View of Driver Dummy | A-13 |

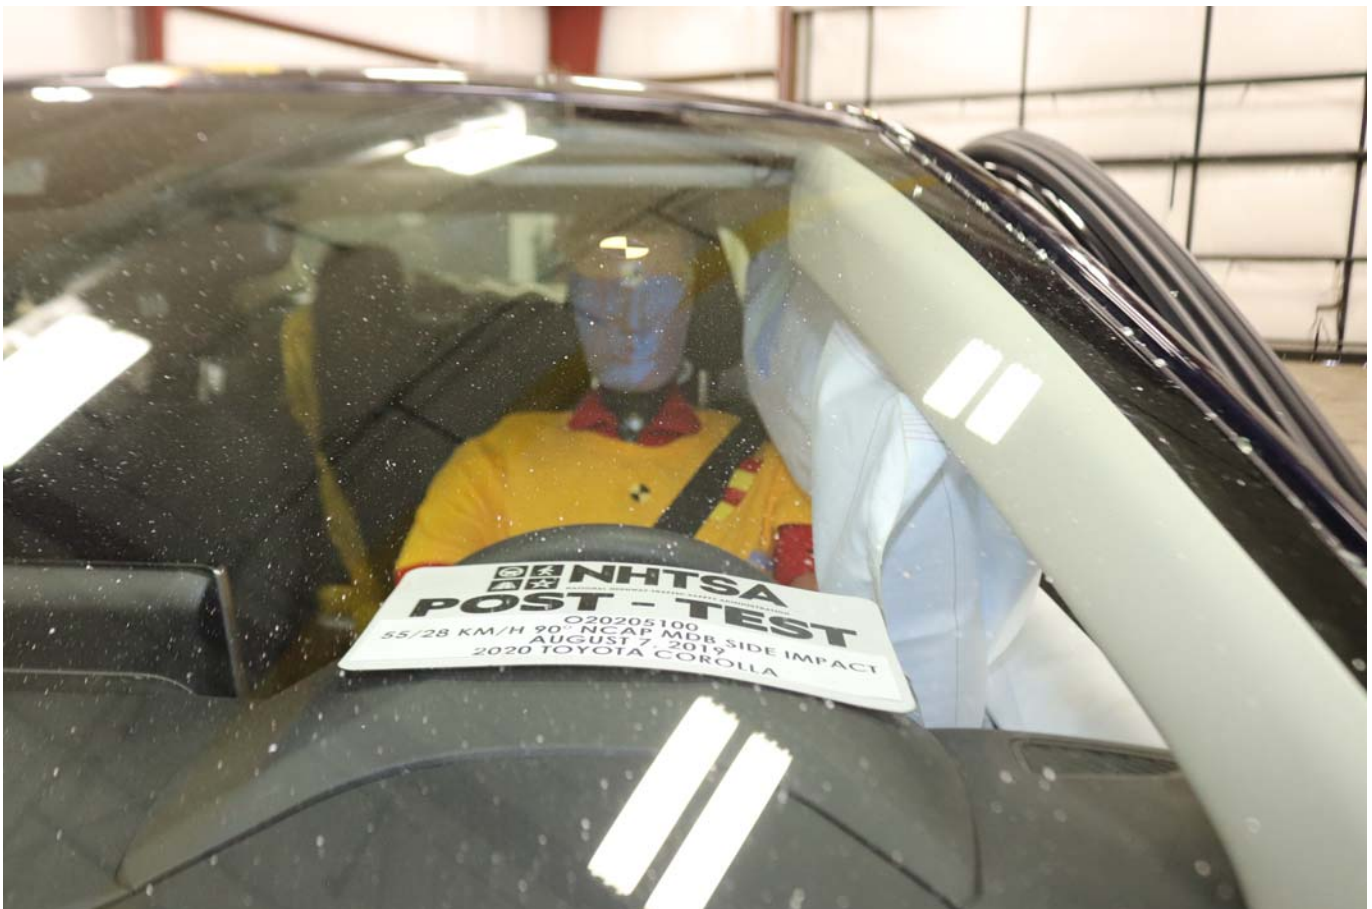
Photo No. 026 - Post-Test Front Close-Up View of Driver Dummy

| | | <u>Page No.</u> |
|---|---|---|
| Photo No. 026 | Post-Test Front Close-Up View of Driver Dummy | A-13 |

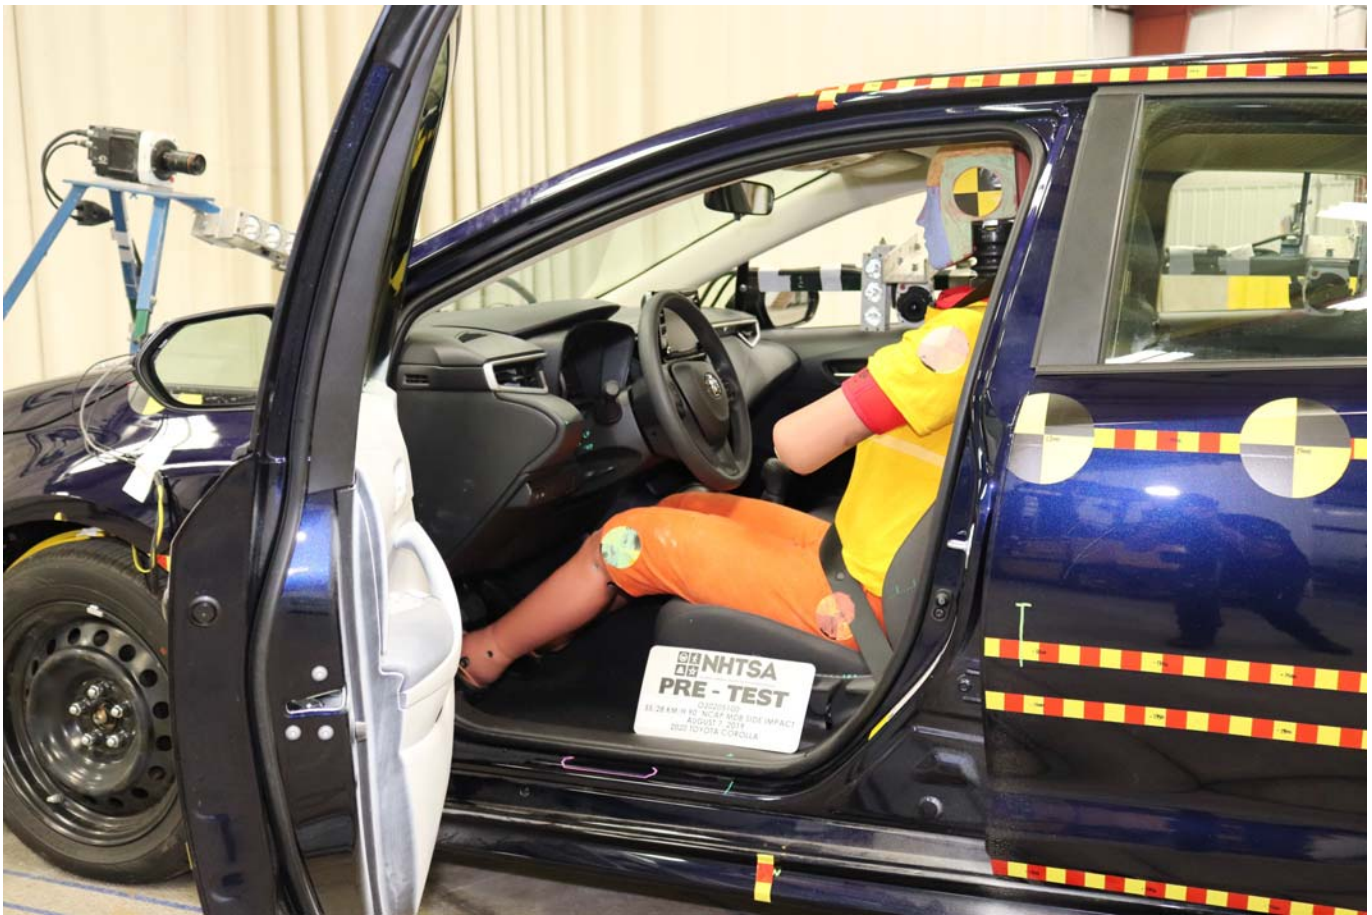
Photo No. 027 - Pre-Test Left Side View of Driver Dummy Showing Belt and Chalking

| | | <u>Page No.</u> |
|---|---|---|
| Photo No. 027 | Pre-Test Left Side View of Driver Dummy Showing Belt and Chalking | A-14 |

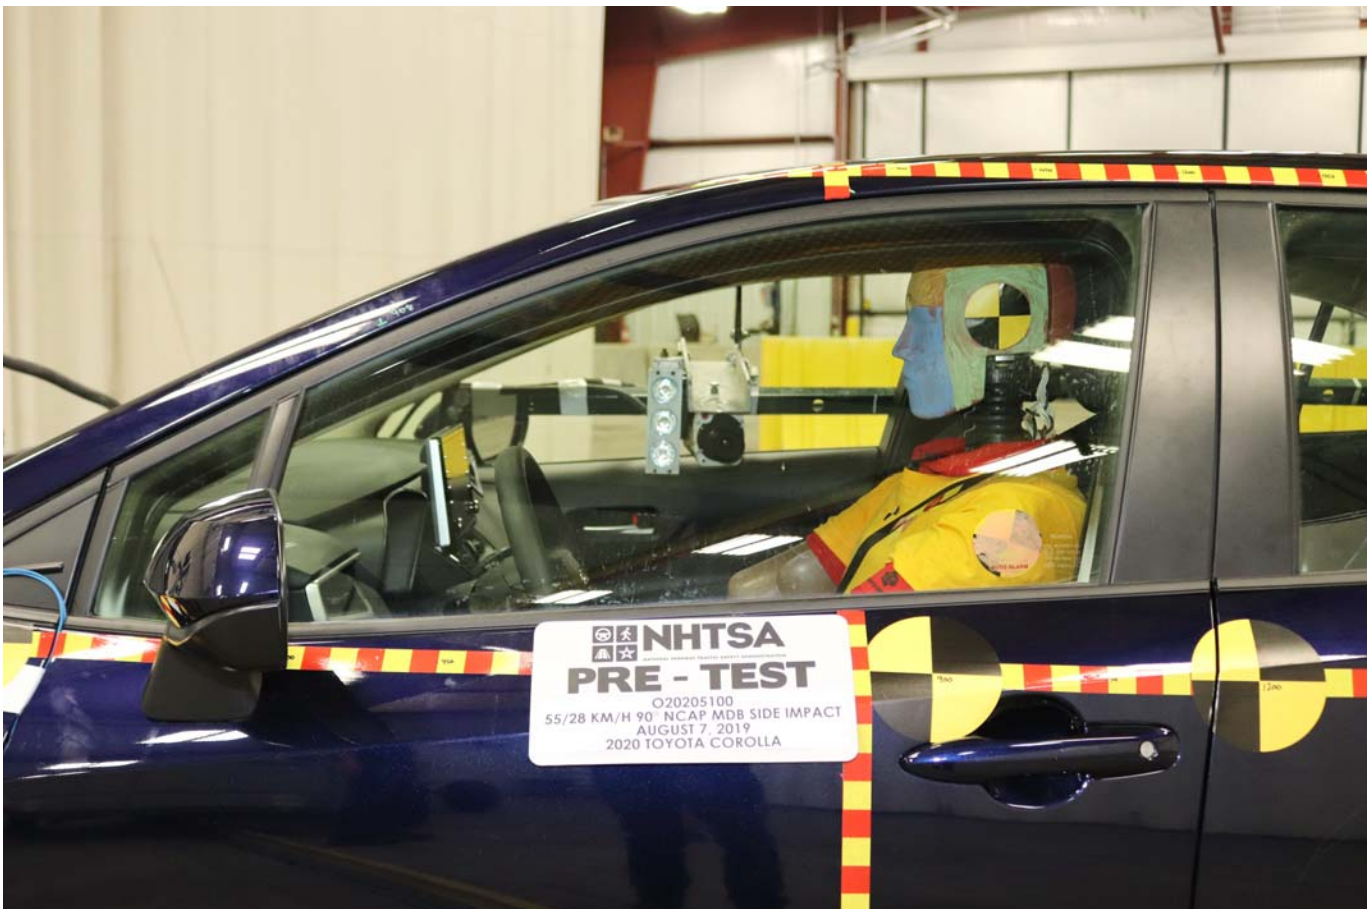
Photo No. 028 - Pre-Test Left Side View of Driver Dummy Shoulder and Door Top View

| | | <u>Page No.</u> |
|---|---|---|
| Photo No. 028 | Pre-Test Left Side View of Driver Dummy Shoulder and Door Top View | A-14 |

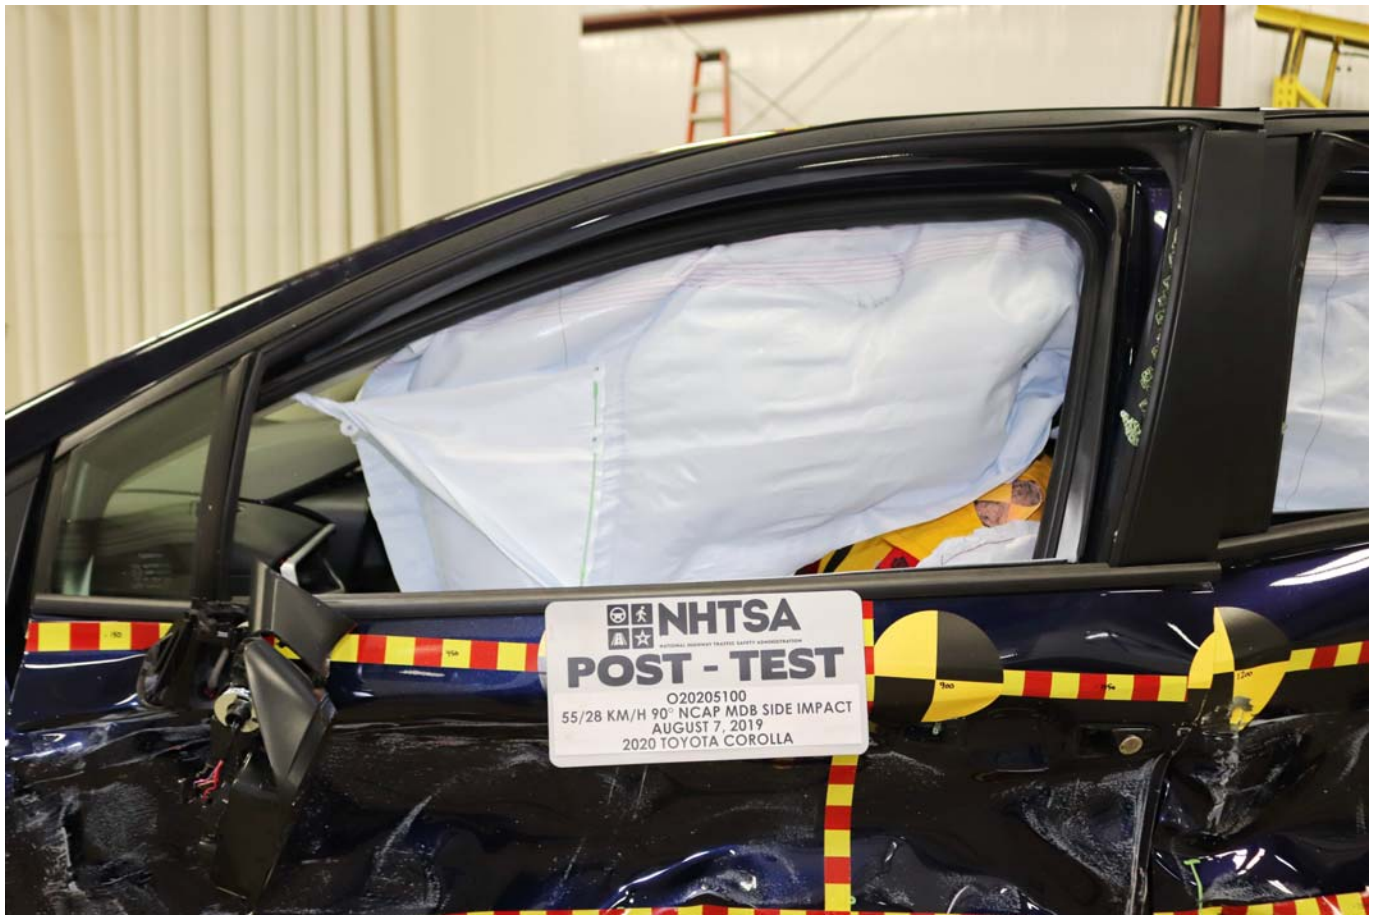
Photo No. 029 - Post-Test Left Side View of Driver Dummy Shoulder and Door Top View

| | | <u>Page No.</u> |
|---|---|---|
| Photo No. 029 | Post-Test Left Side View of Driver Dummy Shoulder and Door Top View | A-15 |
