**REPORT NUMBER: SINCAP-MGA-20-001**

**NEW CAR ASSESSMENT PROGRAM (NCAP)  
Moving Deformable Barrier Side Impact Test**

**TOYOTA MOTOR CORPORATION  
2020 Toyota Corolla LE 4-Door Sedan  
NHTSA No.: O20205100**

**MGA RESEARCH CORPORATION  
5000 Warren Road  
Burlington, WI 53105**

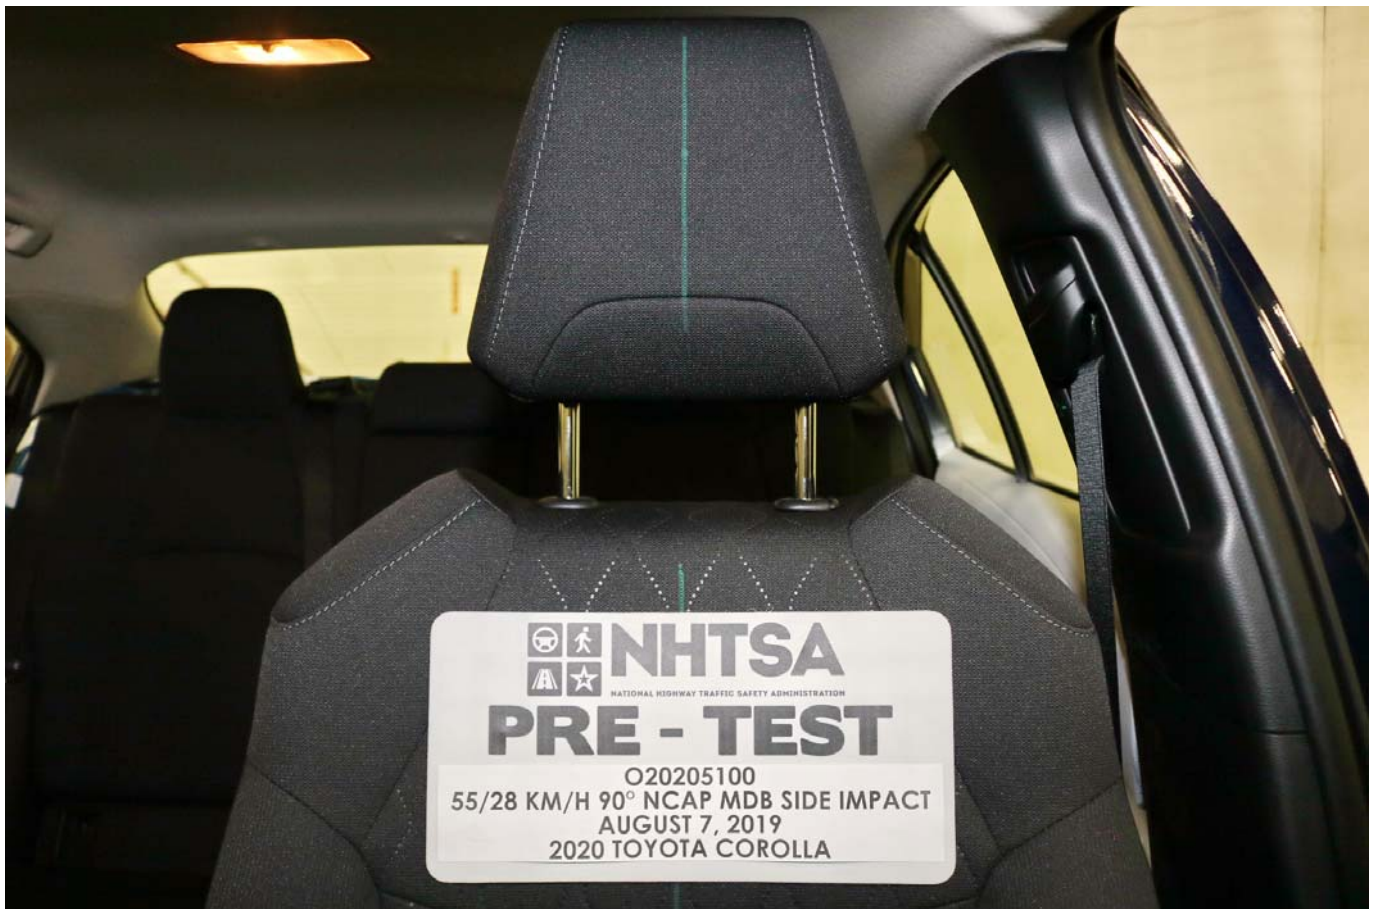
Photo No. 030 - Pre-Test Frontal View of Driver Seat Back Prior to Dummy Positioning

| | | <u>Page No.</u> |
|---|---|---|
| Photo No. 030 | Pre-Test Frontal View of Driver Seat Back Prior to Dummy Positioning | A-15 |

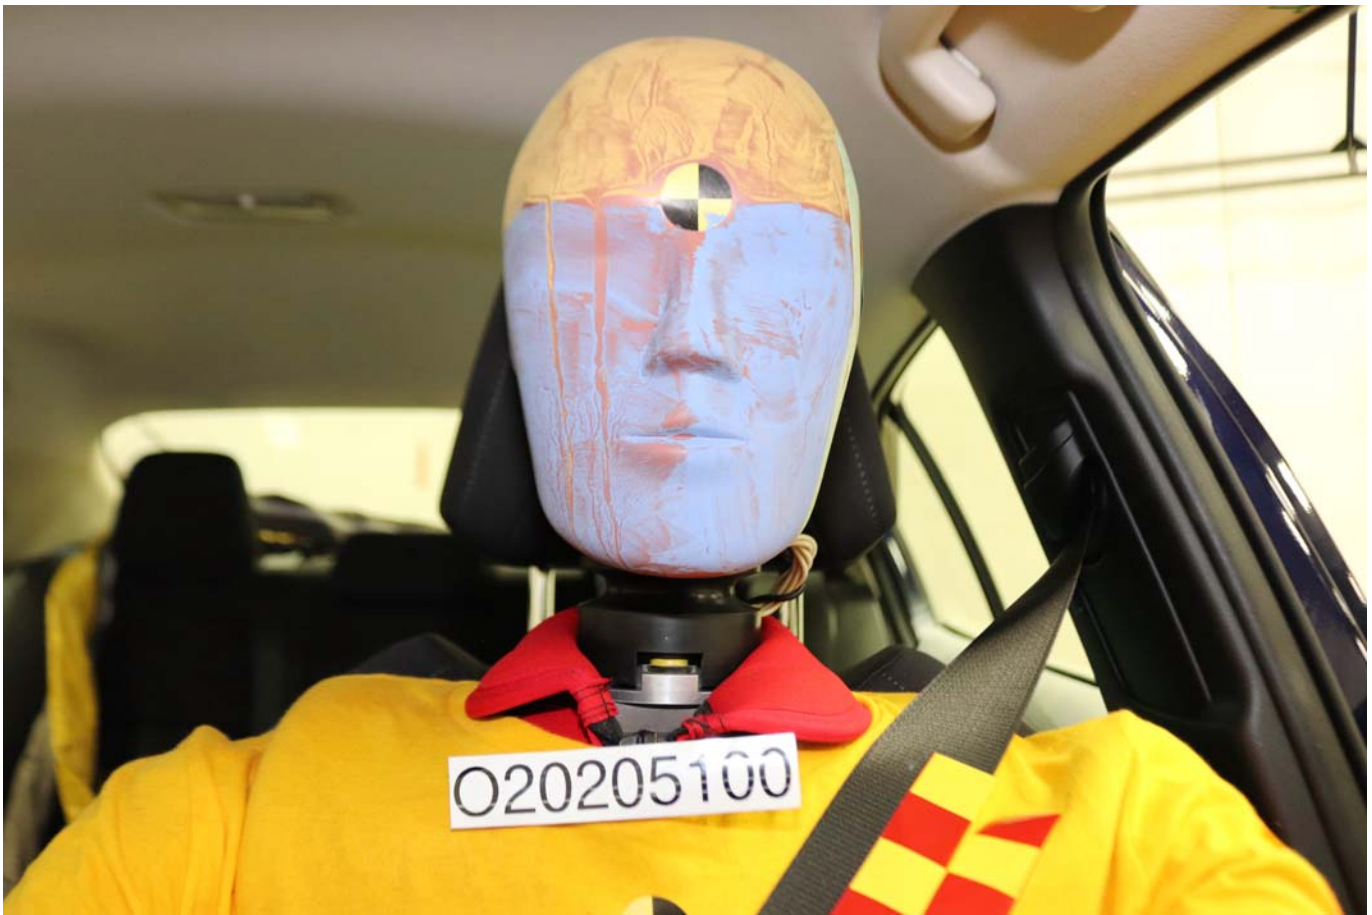
Photo No. 031 - Pre-Test Frontal View of Driver Dummy Head and Shoulders in Relation to Head Restraint

| | | <u>Page No.</u> |
|---|---|---|
| Photo No. 031 | Pre-Test Frontal View of Driver Dummy Head and Shoulders in Relation to Head Restraint | A-16 |

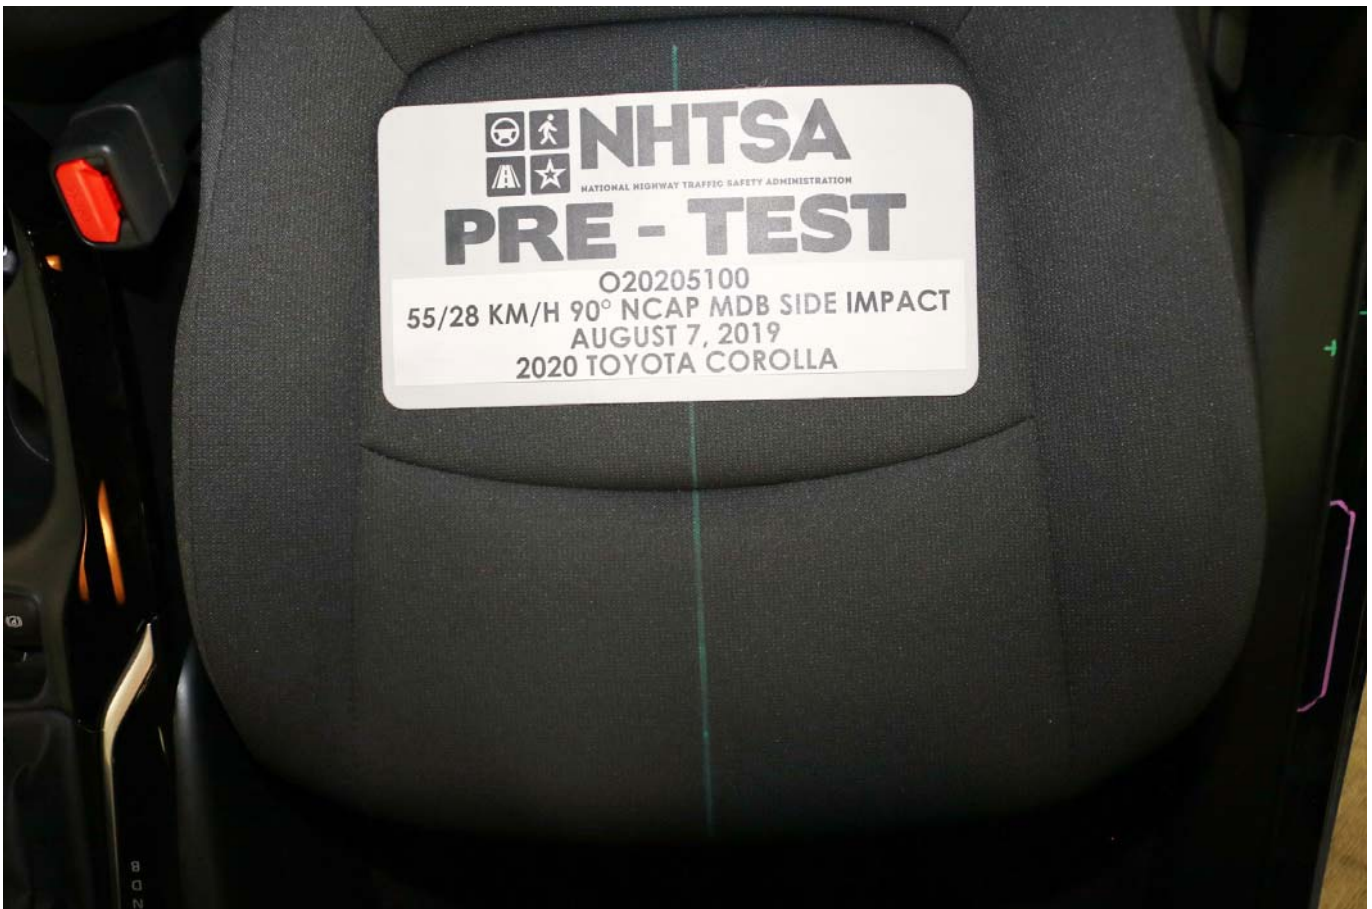
Photo No. 032 - Pre-Test Frontal View of Driver Seat Pan Prior to Dummy Positioning

| | | <u>Page No.</u> |
|---|---|---|
| Photo No. 032 | Pre-Test Frontal View of Driver Seat Pan Prior to Dummy Positioning | A-16 |

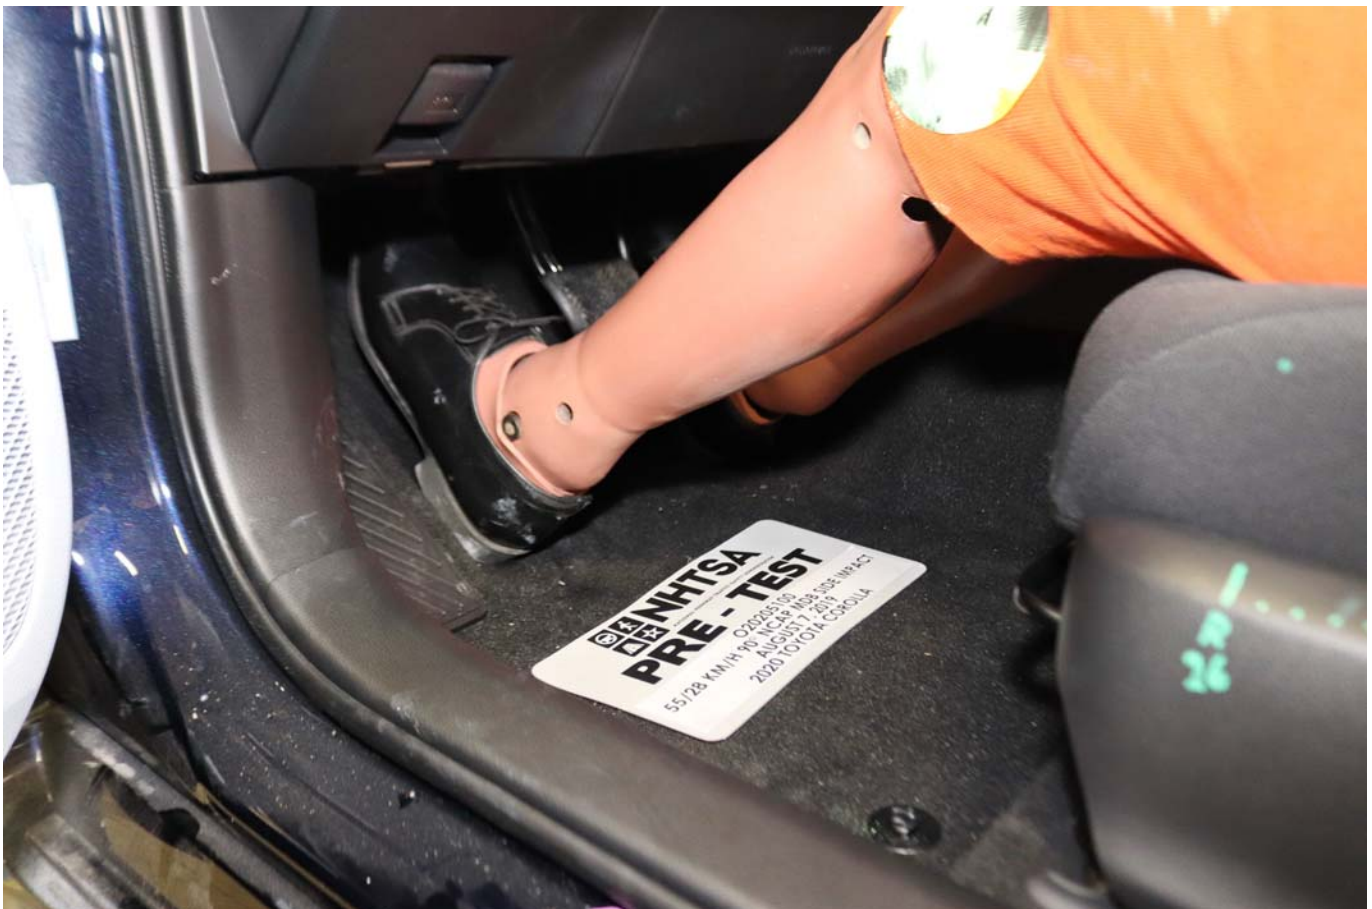
Photo No. 034 - Pre-Test Placement of Driver Dummy Feet

| | | <u>Page No.</u> |
|---|---|---|
| Photo No. 034 | Pre-Test Placement of Driver Dummy's Feet | A-17 |

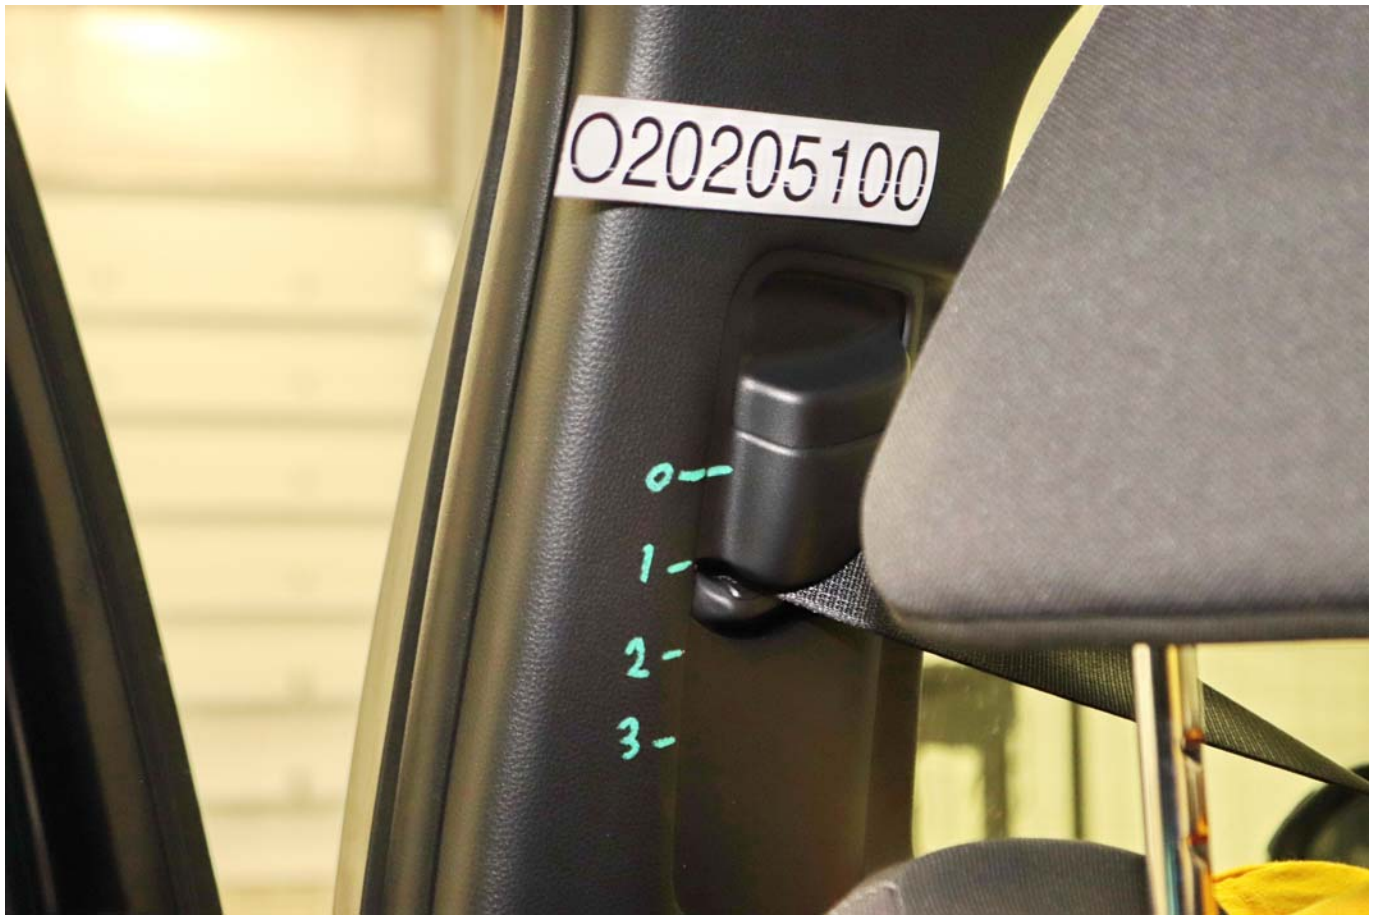
Photo No. 035 - Pre-Test View of Belt Anchorage for Driver Dummy

| | | <u>Page No.</u> |
|---|---|---|
| Photo No. 035 | Pre-Test View of Belt Anchorage for Driver Dummy | A-18 |

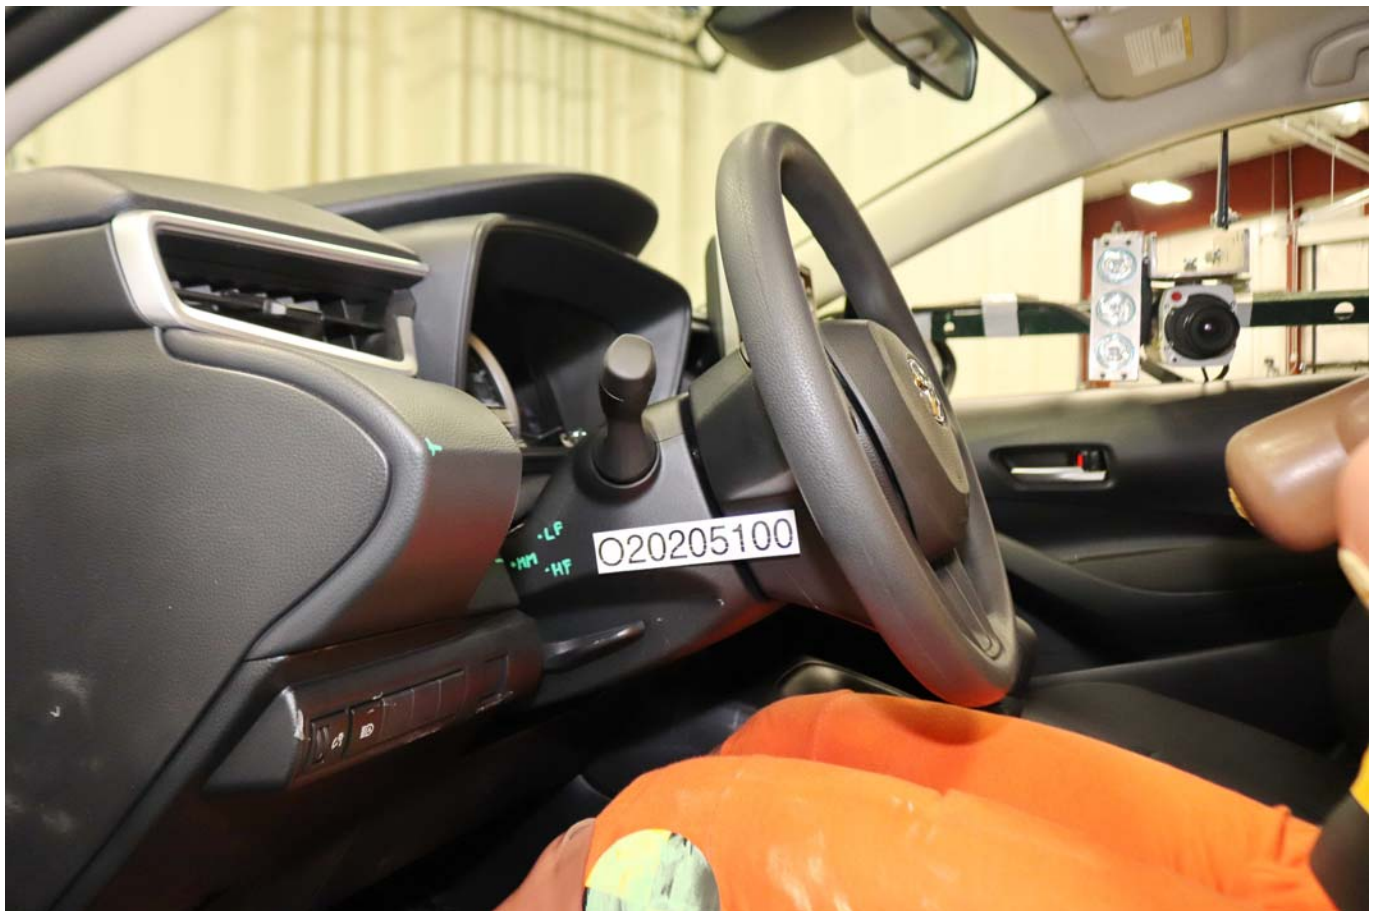
Photo No. 036 - Pre-Test Left Side View of Steering Wheel

| | | <u>Page No.</u> |
|---|---|---|
| Photo No. 036 | Pre-Test Left Side View of Steering Wheel | A-18 |

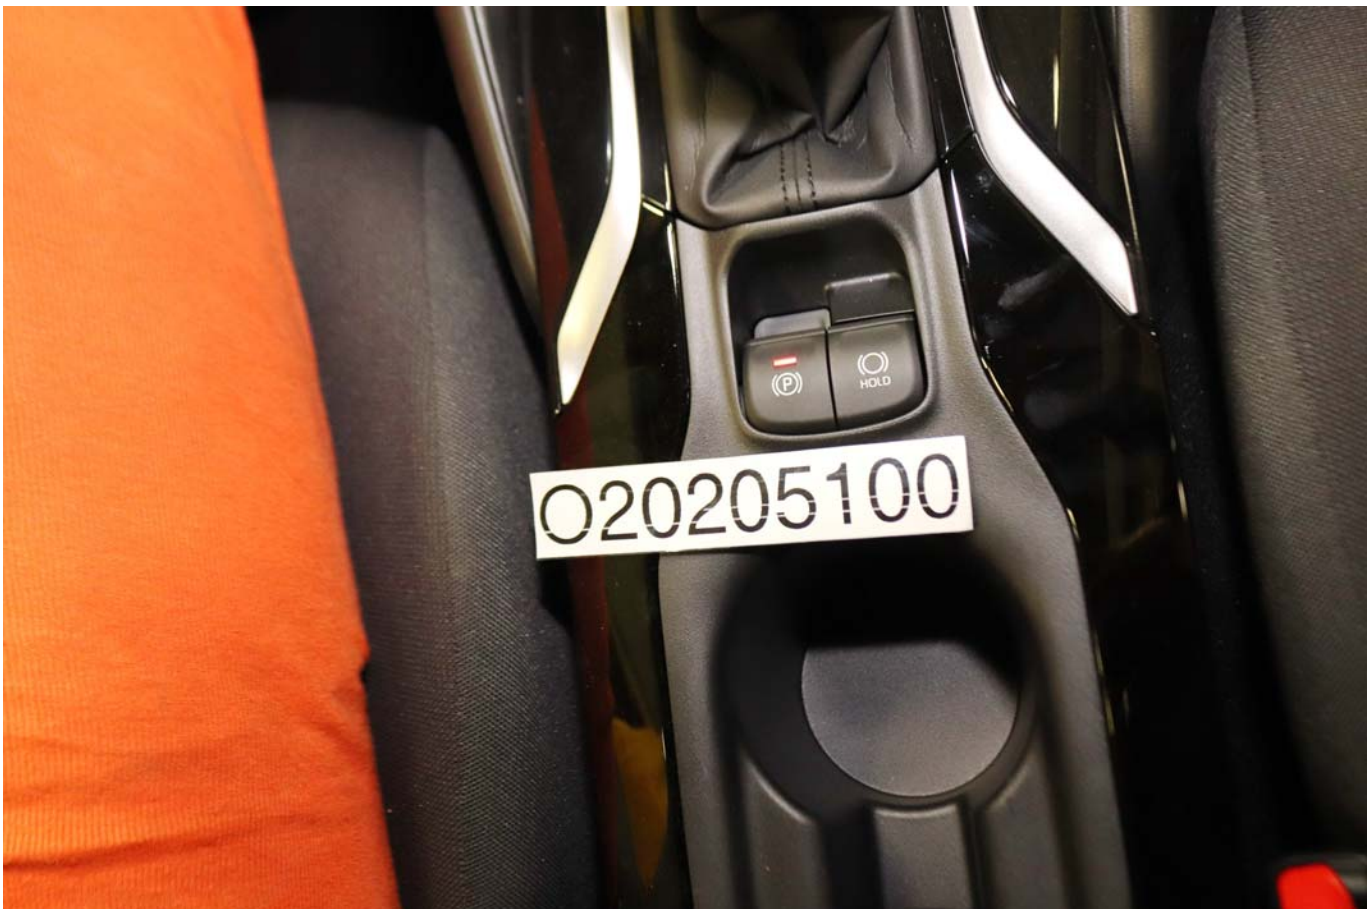
Photo No. 038 - Pre-Test View of Parking Brake

| | | <u>Page No.</u> |
|---|---|---|
| Photo No. 038 | Pre-Test View of Parking Brake | A-19 |

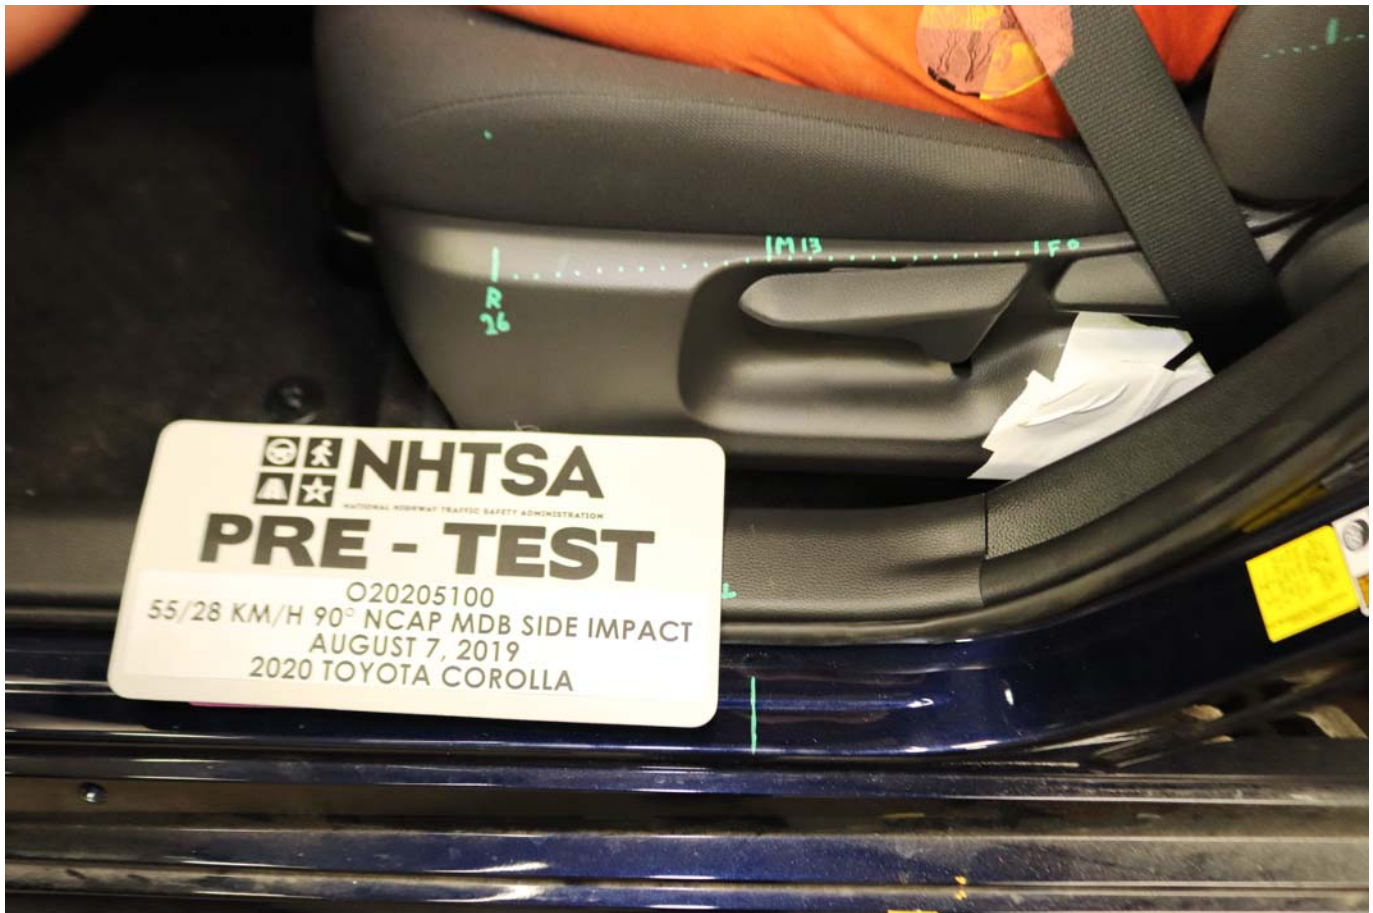
Photo No. 039 - Pre-Test Close-Up Left Side View of Driver Seat Track

| | | <u>Page No.</u> |
|---|---|---|
| Photo No. 039 | Pre-Test Close-Up Left Side View of Driver Seat Track | A-20 |

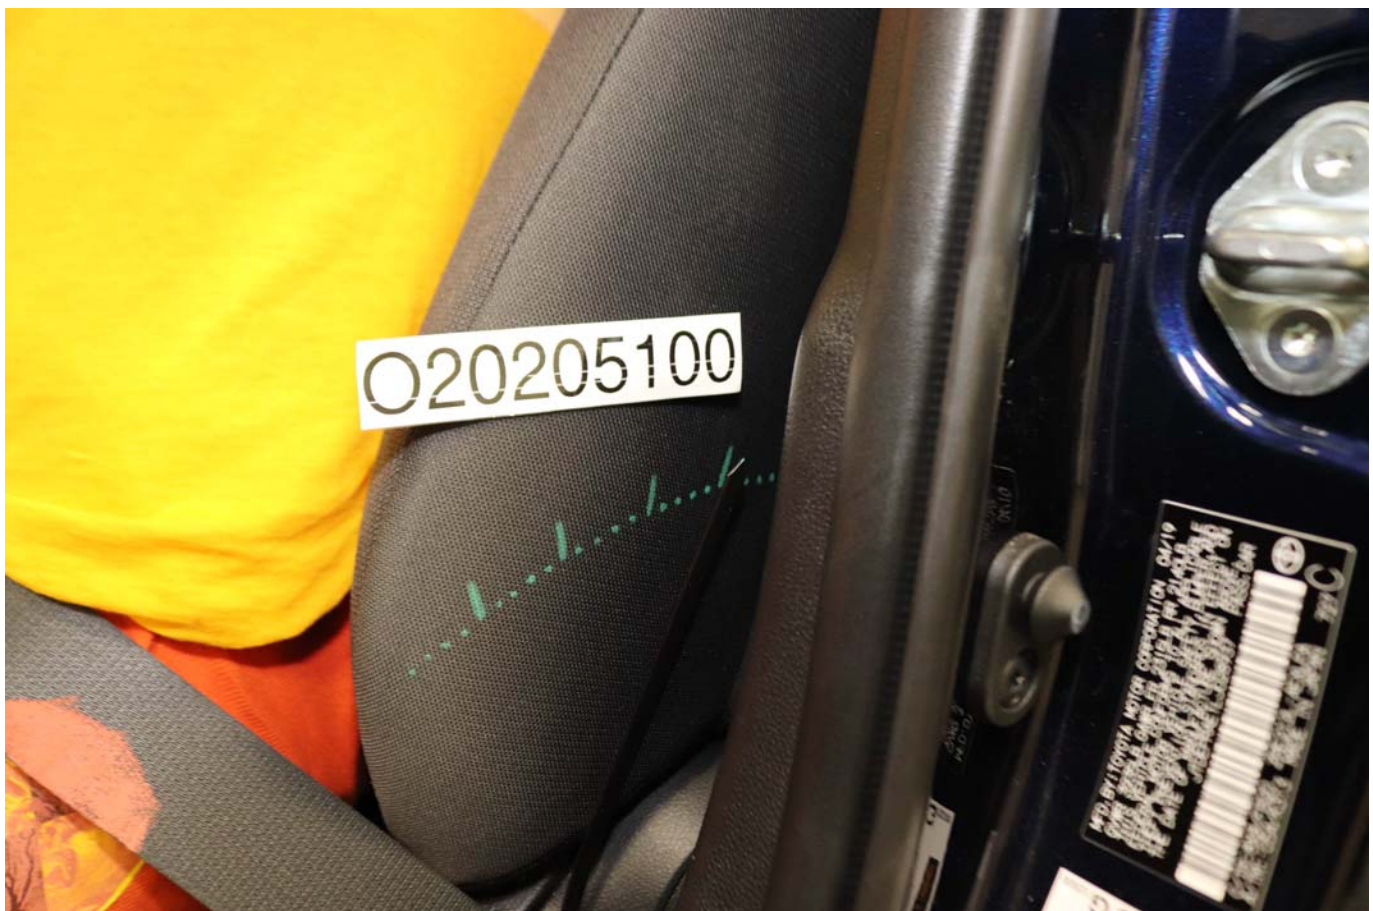
Photo No. 040 - Pre-Test Close-Up Left Side View of Driver Seat Back

| | | <u>Page No.</u> |
|---|---|---|
| Photo No. 040 | Pre-Test Close-Up Left Side View of Driver Seat Back | A-20 |

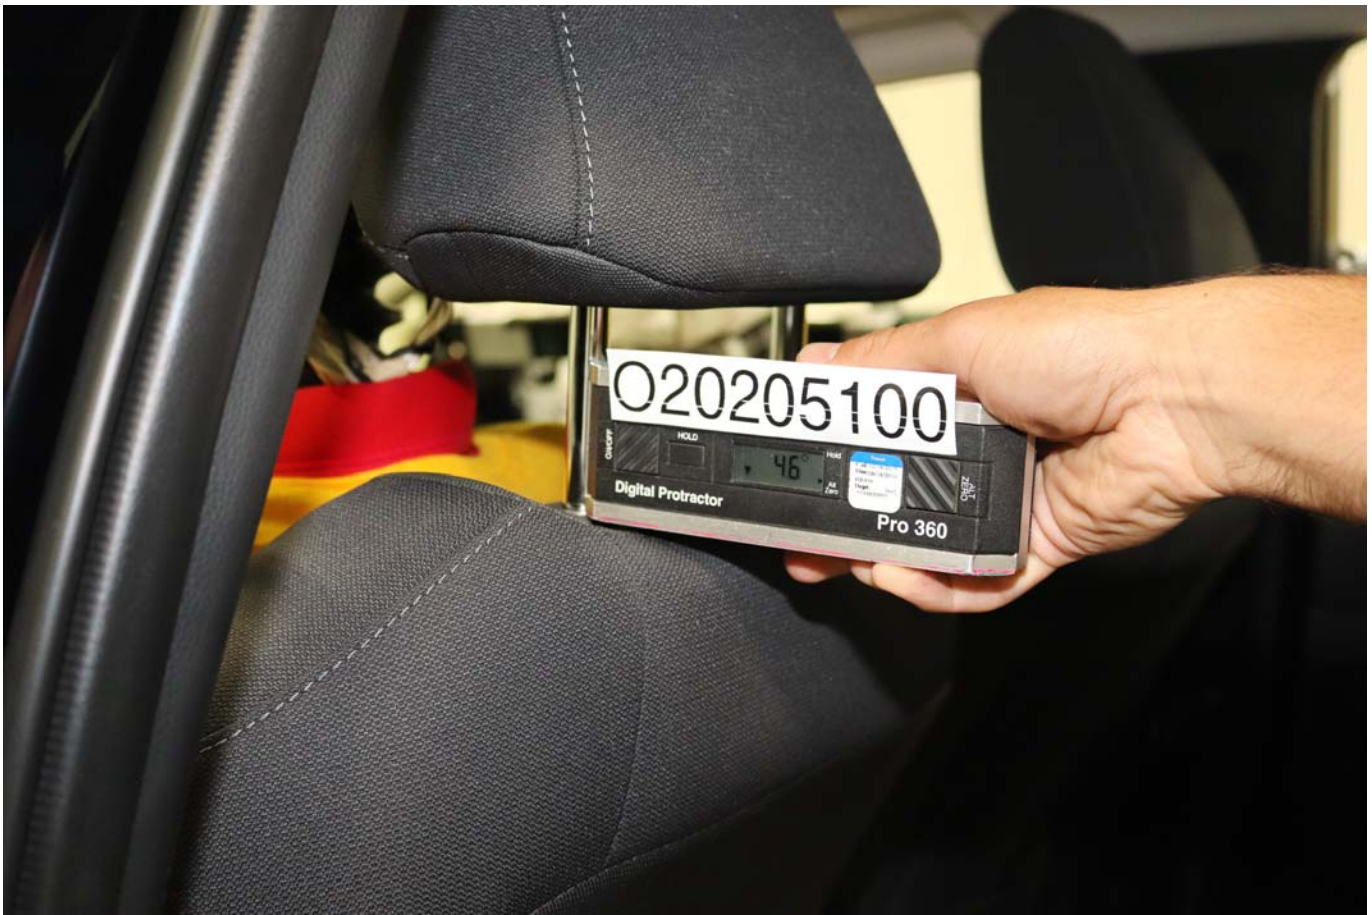
Photo No. 041 - Pre-Test Close-Up View of Driver Seat Back or Head Restraint

| | | <u>Page No.</u> |
|---|---|---|
| Photo No. 041 | Pre-Test Close-Up View of Driver Seat Back or Head Restraint | A-21 |

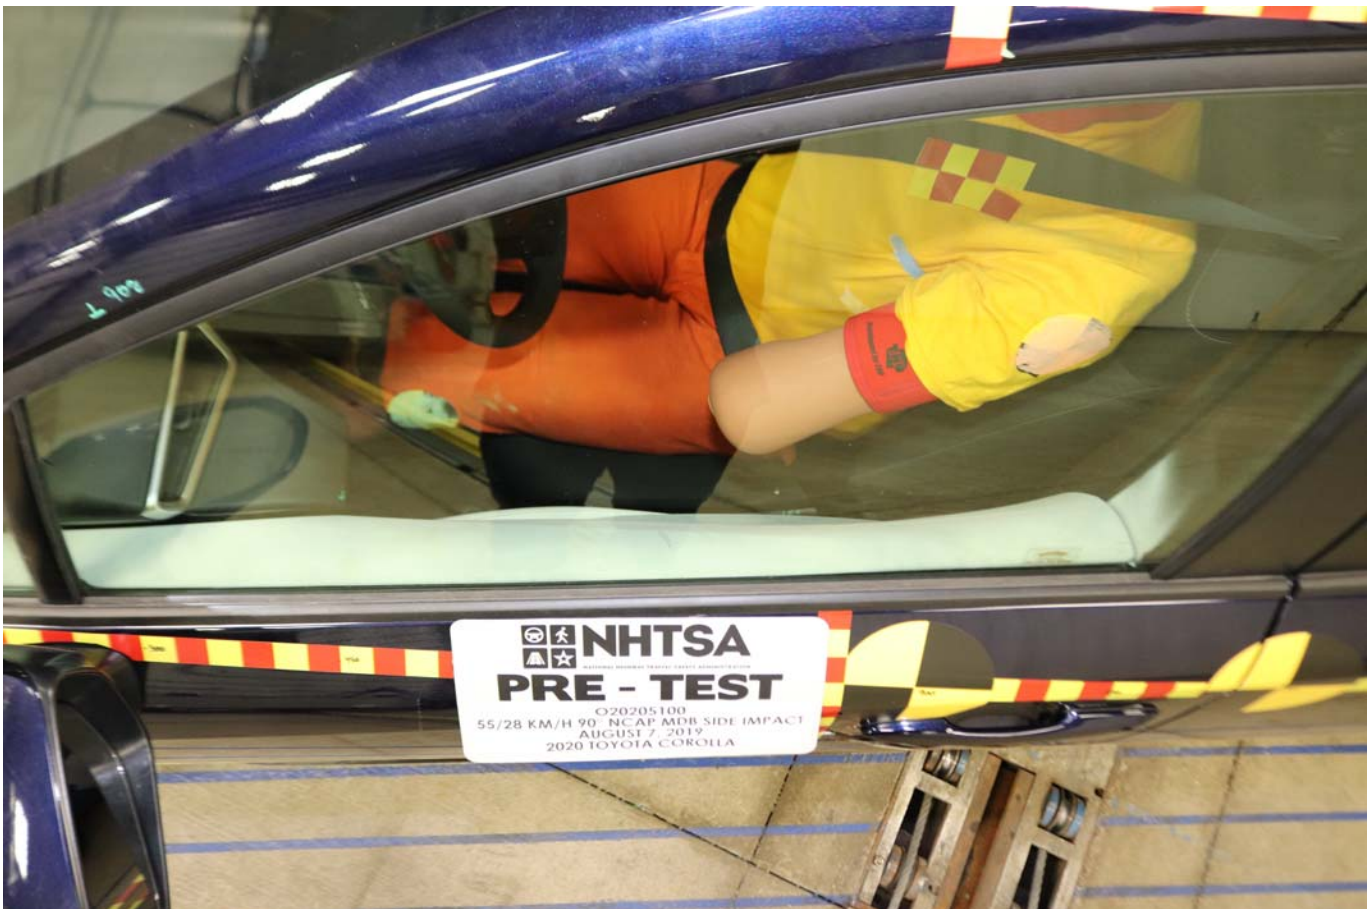
Photo No. 042 - Pre-Test Driver Dummy and Door Clearance View

| | | <u>Page No.</u> |
|---|---|---|
| Photo No. 042 | Pre-Test Driver Dummy and Door Clearance View | A-21 |

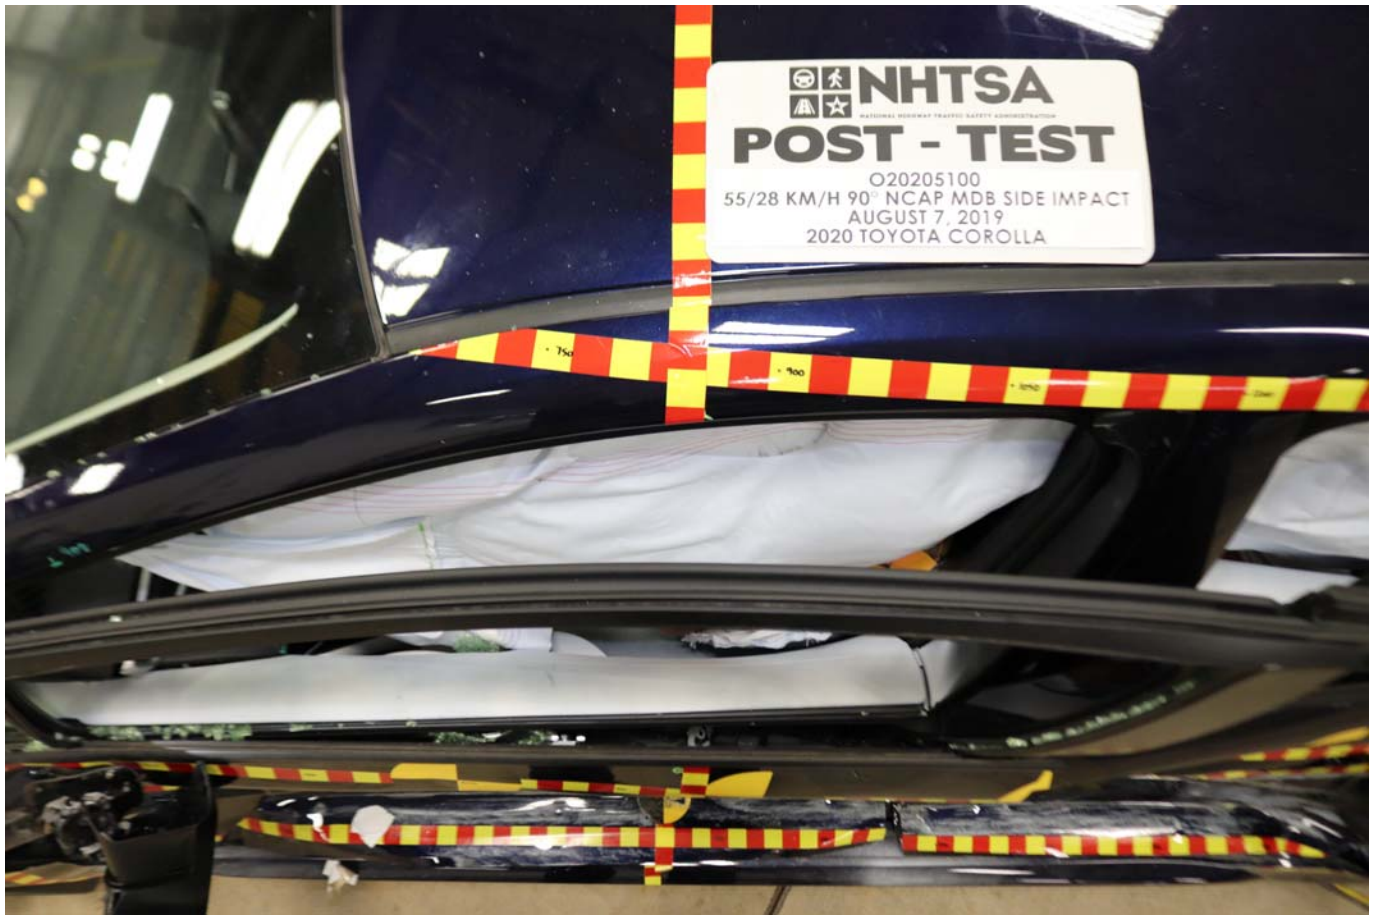
Photo No. 043 - Post-Test Driver Dummy and Door Clearance View

| | | <u>Page No.</u> |
|---|---|---|
| Photo No. 043 | Post-Test Driver Dummy and Door Clearance View | A-22 |

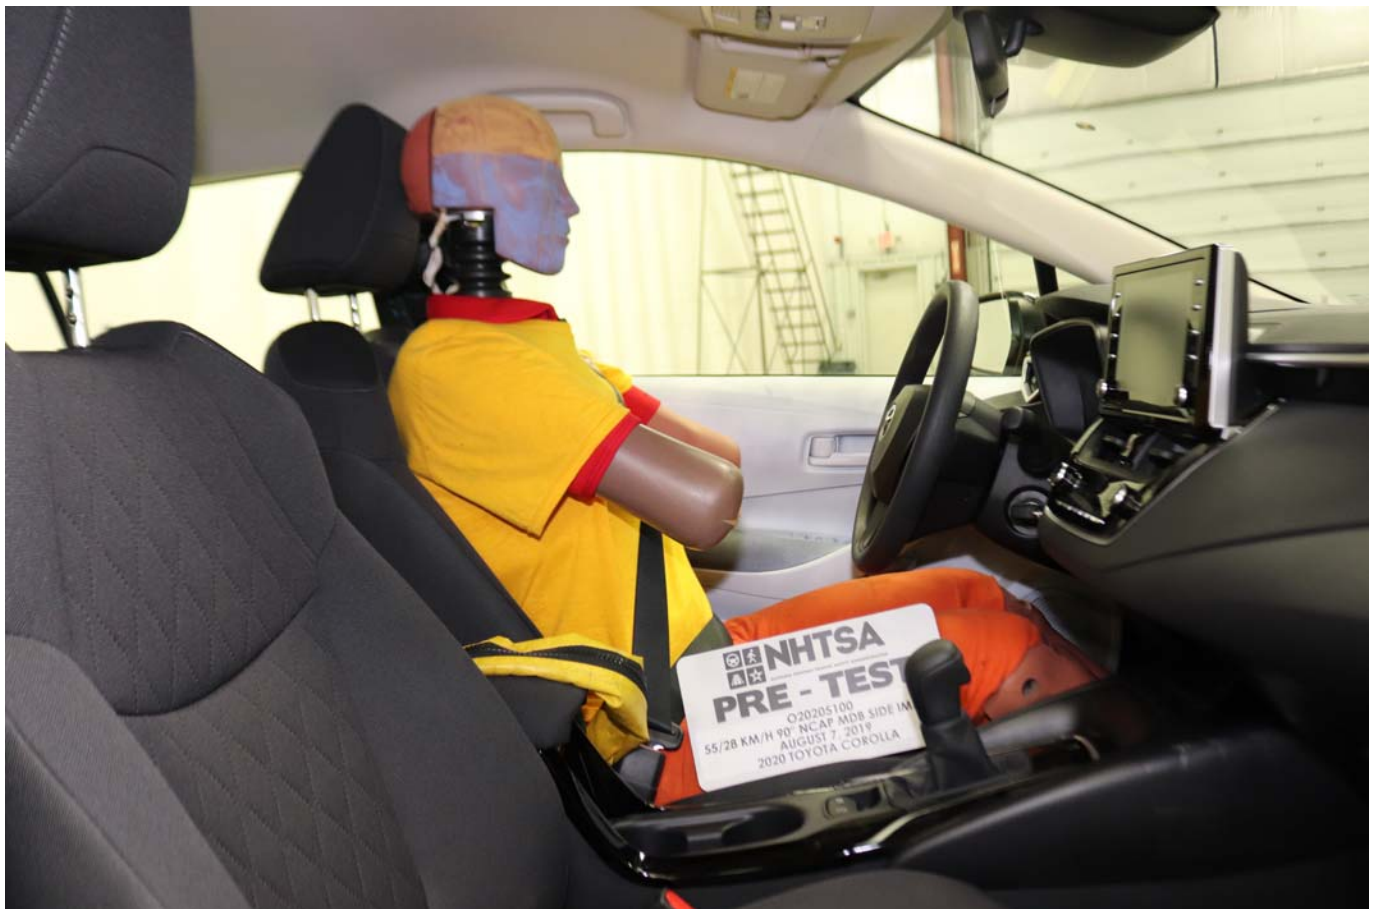
Photo No. 044 - Pre-Test Right Side View of Driver Dummy and Front Seat of Occupant Compartment

| | | <u>Page No.</u> |
|---|---|---|
| Photo No. 044 | Pre-Test Right Side View of Driver Dummy and Front Seat of Occupant Compartment | A-22 |

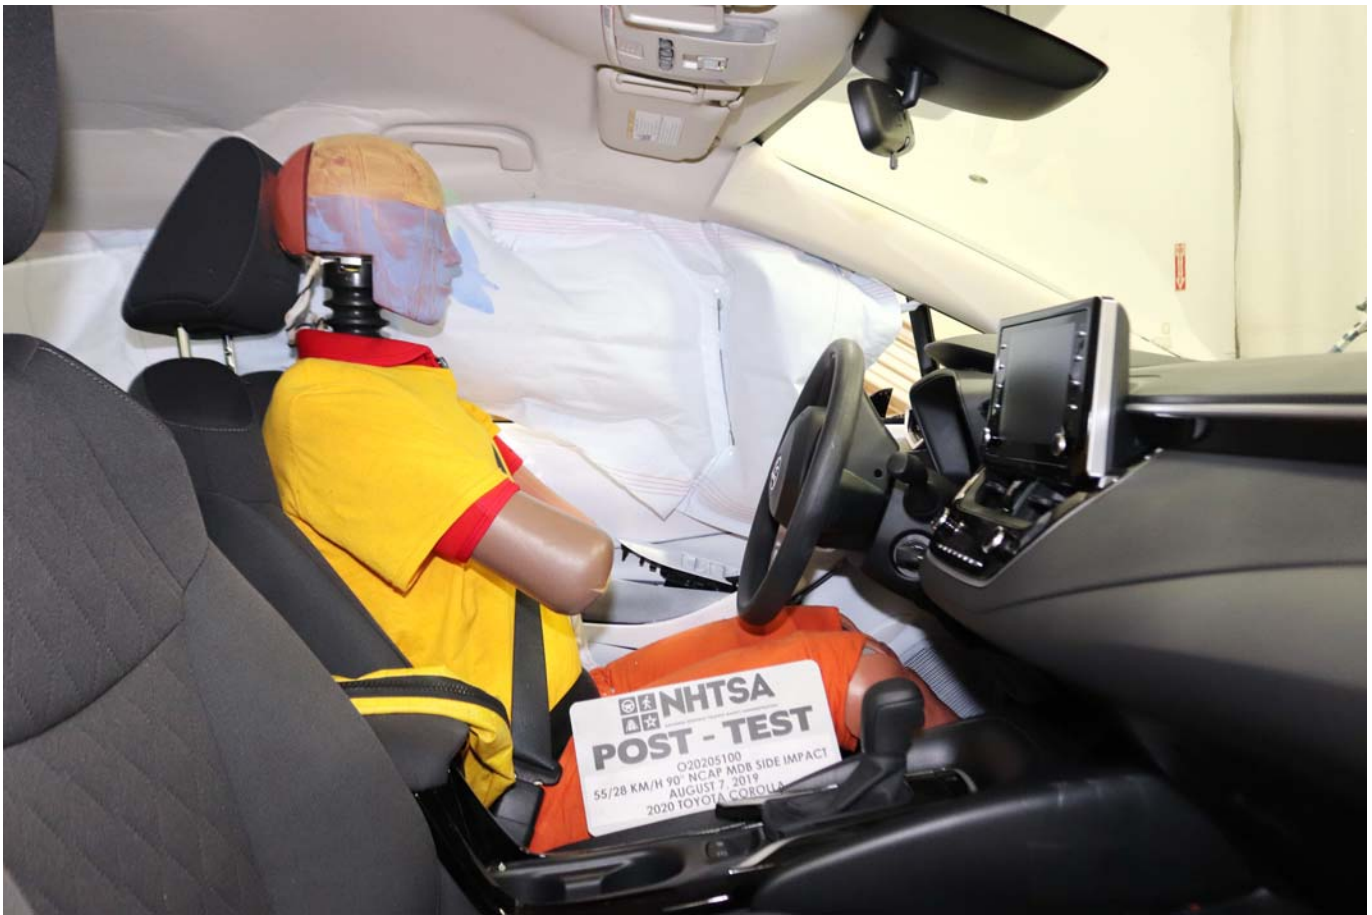
Photo No. 045 - Post-Test Right Side View of Driver Dummy and Front Seat of Occupant Compartment

| | | <u>Page No.</u> |
|---|---|---|
| Photo No. 045 | Post-Test Right Side View of Driver Dummy and Front Seat of Occupant Compartment | A-23 |

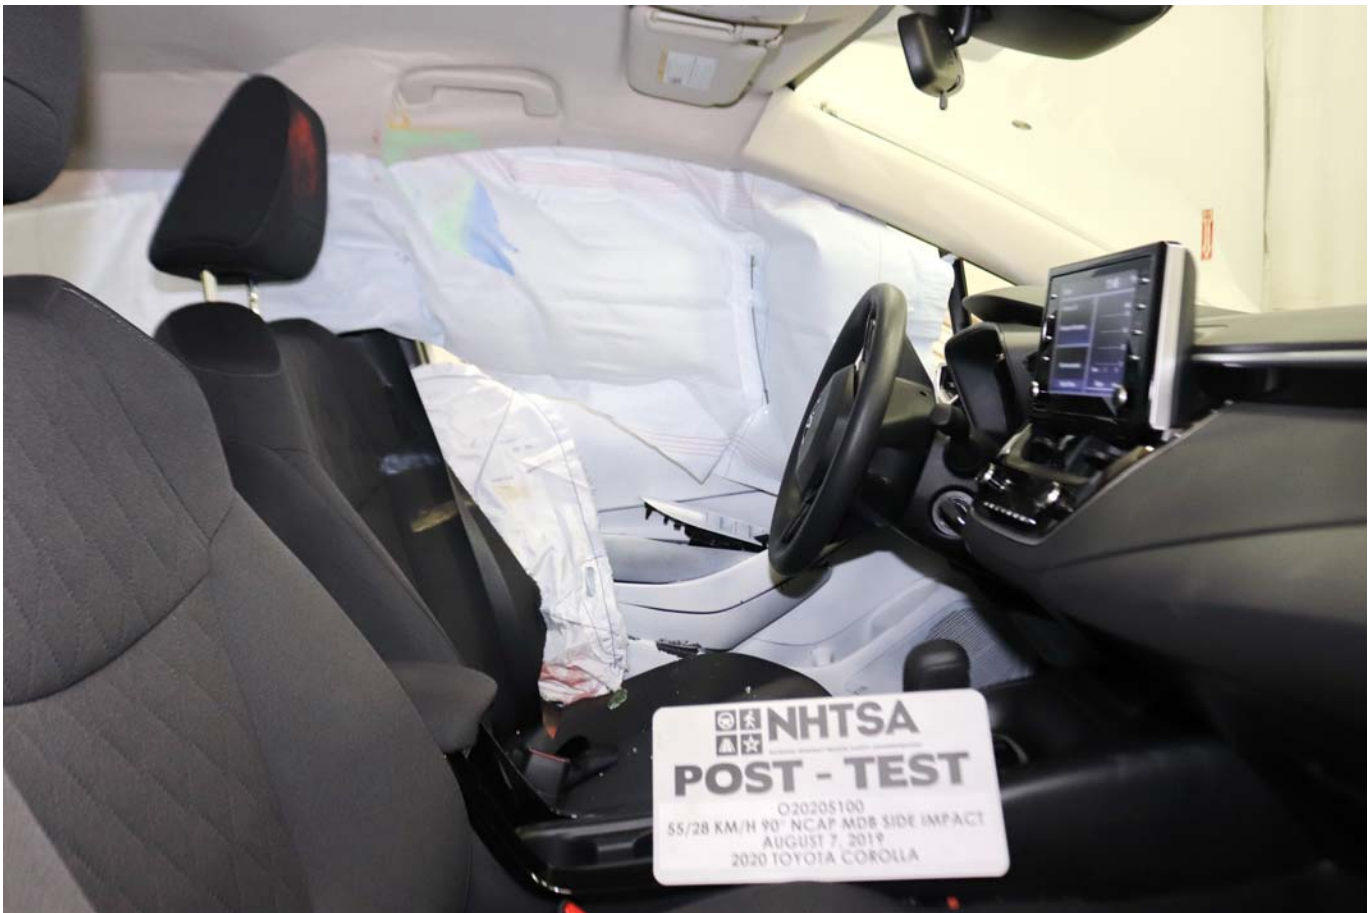
Photo No. 047 - Post-Test Driver Inner Door Panel View

| | | <u>Page No.</u> |
|---|---|---|
| Photo No. 047 | Post-Test Driver Inner Door Panel View | A-24 |

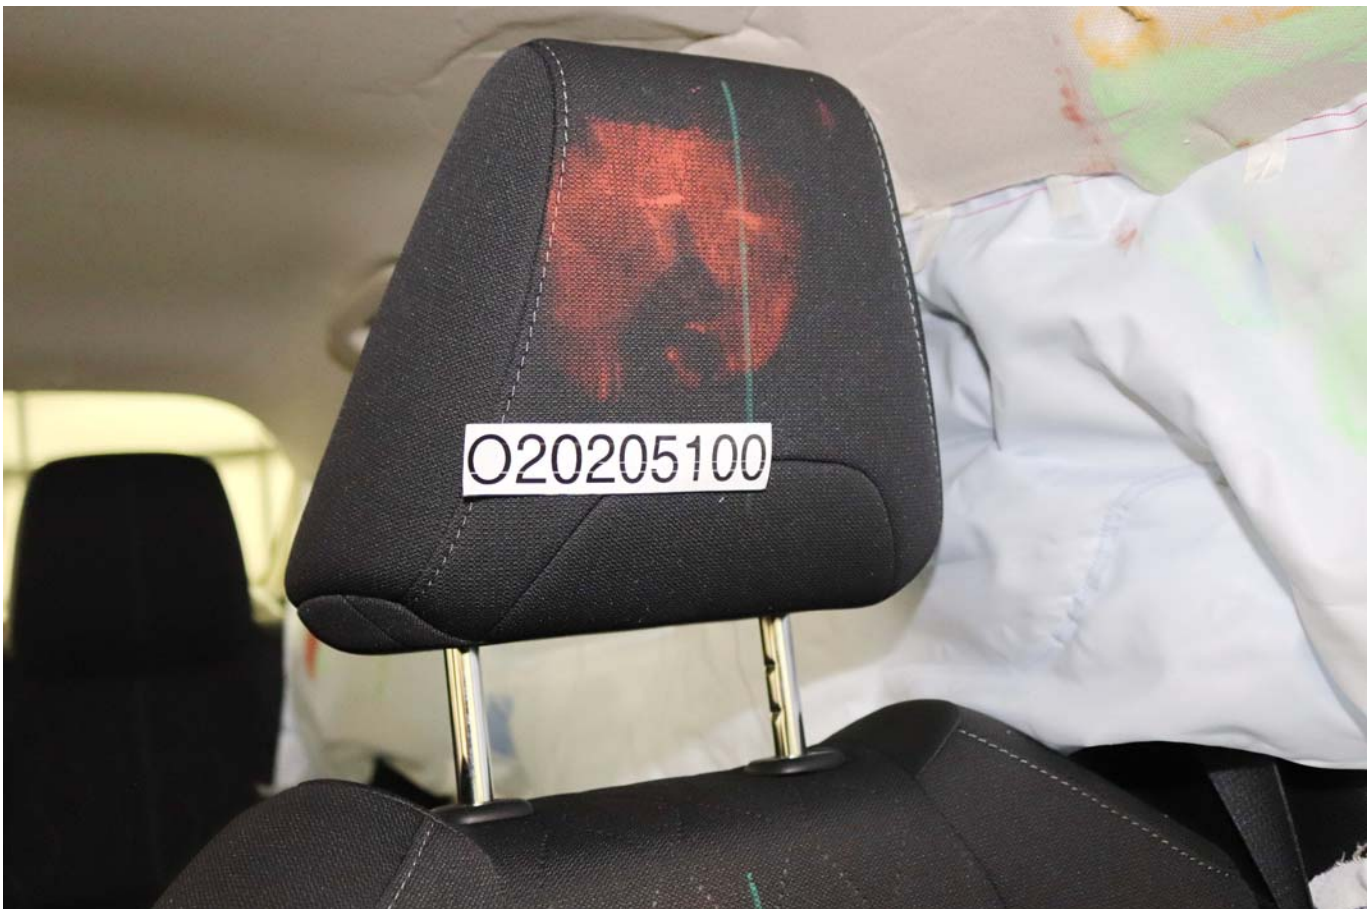
Photo No. 048 - Post-Test Driver Dummy Close-up Head Contact with Vehicle Interior View

| | | <u>Page No.</u> |
|---|---|---|
| Photo No. 048 | Post-Test Driver Dummy Close-up Head Contact with Vehicle Interior View | A-24 |

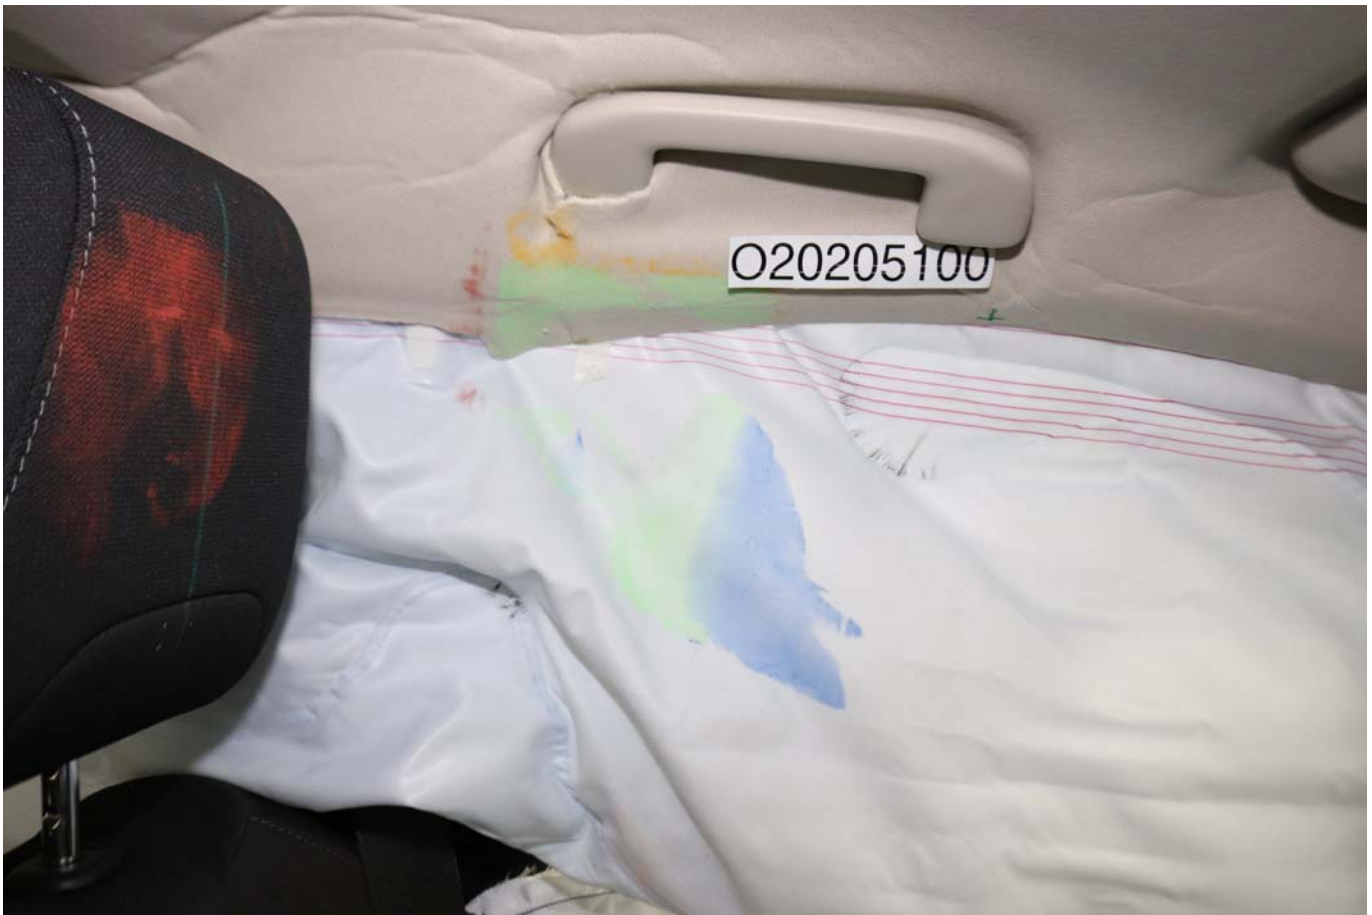
Photo No. 049 - Post-Test Driver Dummy Close-up Head Contact with Side Airbag View

| | | <u>Page No.</u> |
|---|---|---|
| Photo No. 049 | Post-Test Driver Dummy Close-up Head Contact with Side Airbag View | A-25 |
