**REPORT NUMBER: SINCAP-MGA-20-001**

**NEW CAR ASSESSMENT PROGRAM (NCAP)  
Moving Deformable Barrier Side Impact Test**

**TOYOTA MOTOR CORPORATION  
2020 Toyota Corolla LE 4-Door Sedan  
NHTSA No.: O20205100**

**MGA RESEARCH CORPORATION  
5000 Warren Road  
Burlington, WI 53105**

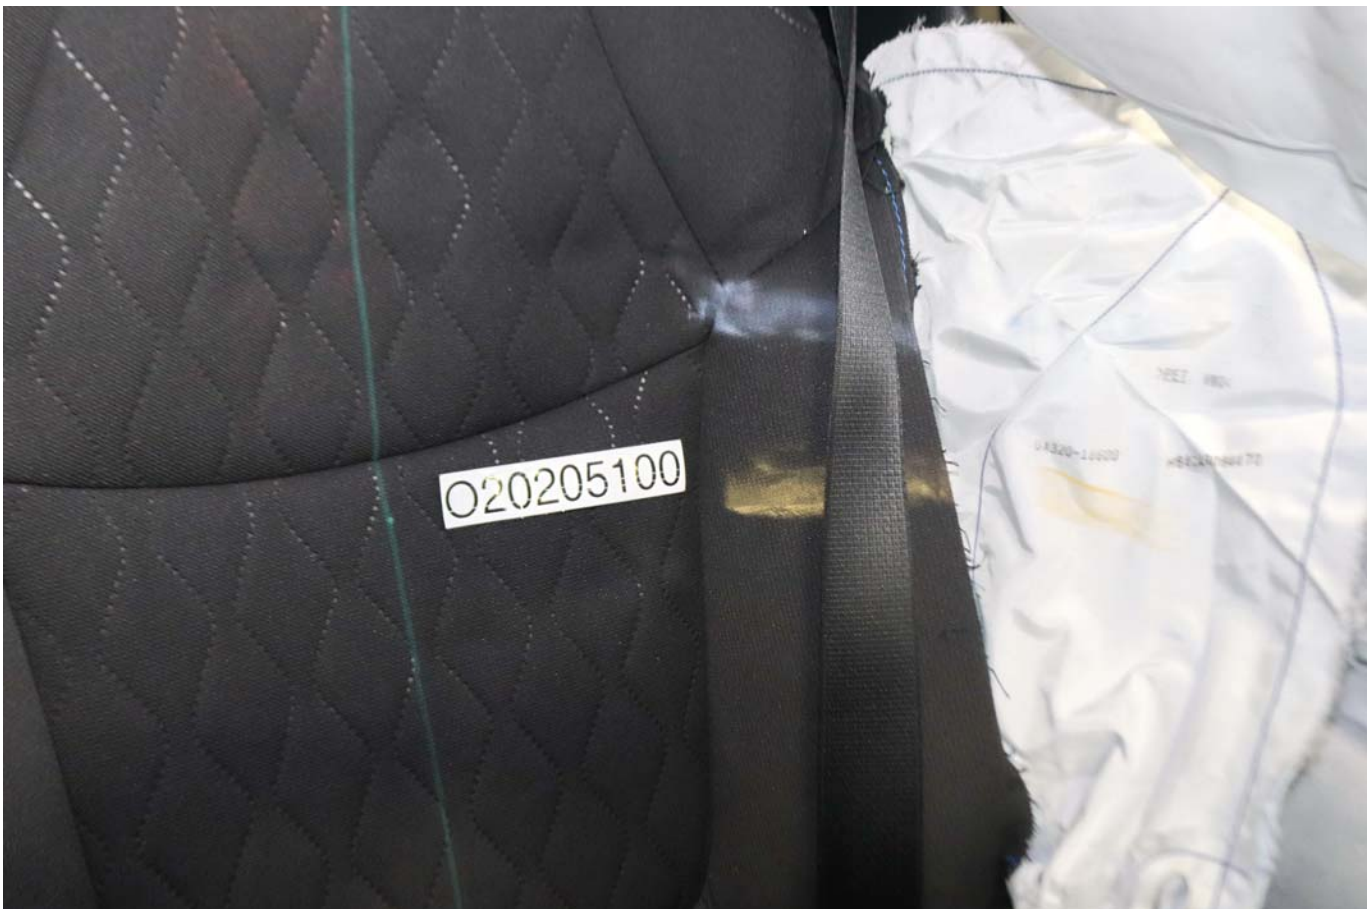
Photo No. 050 - Post-Test Driver Dummy Close-up Torso Contact with Vehicle Interior View

| | | <u>Page No.</u> |
|---|---|---|
| Photo No. 050 | Post-Test Driver Dummy Close-up Torso Contact with Vehicle Interior View | A-25 |

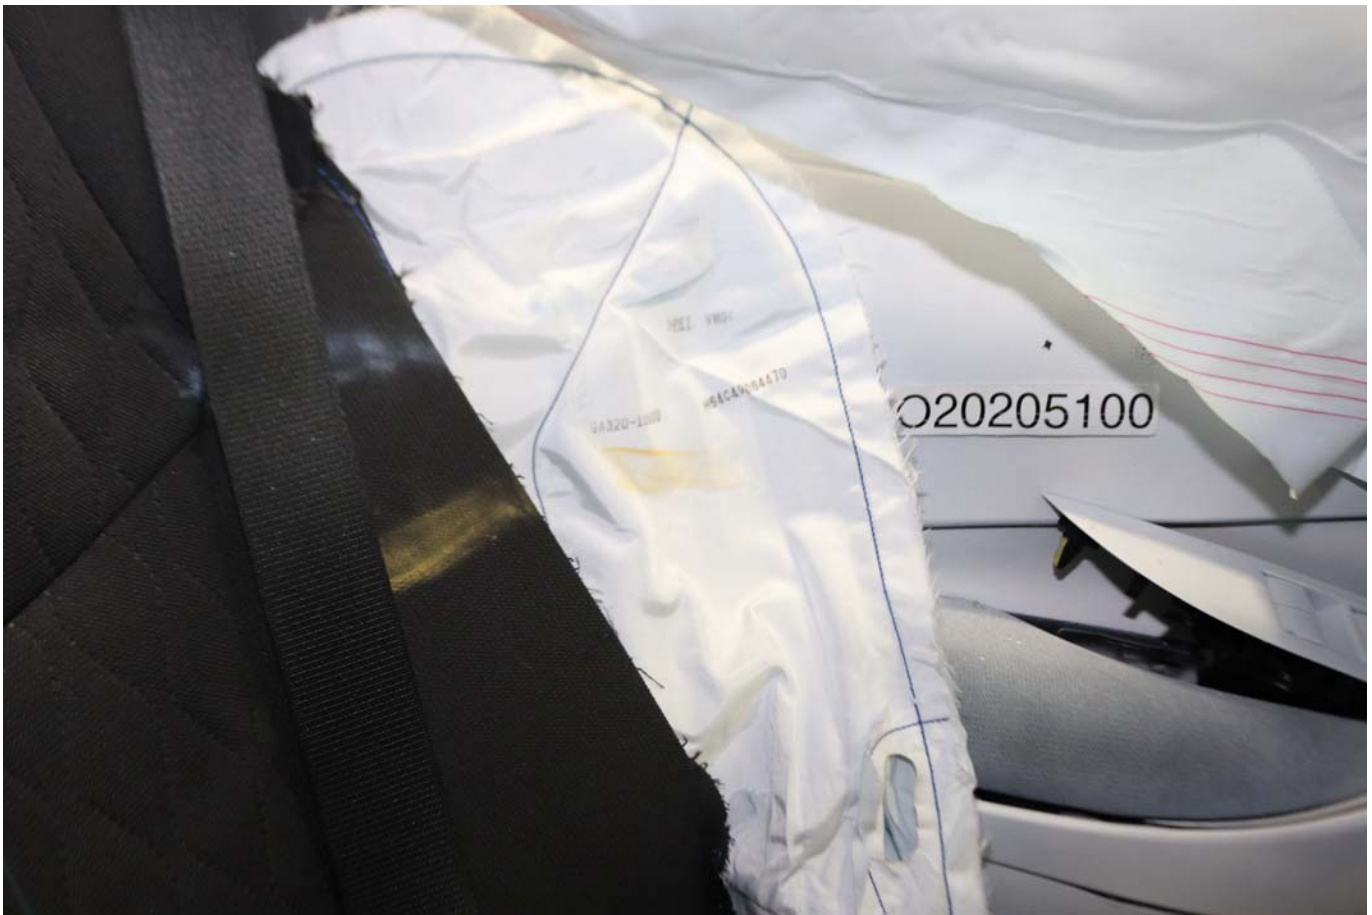
Photo No. 051 - Post-Test Driver Dummy Close-up Torso Contact with Side Airbag View

| | | <u>Page No.</u> |
|---|---|---|
| Photo No. 051 | Post-Test Driver Dummy Close-up Torso Contact with Side Airbag View | A-26 |

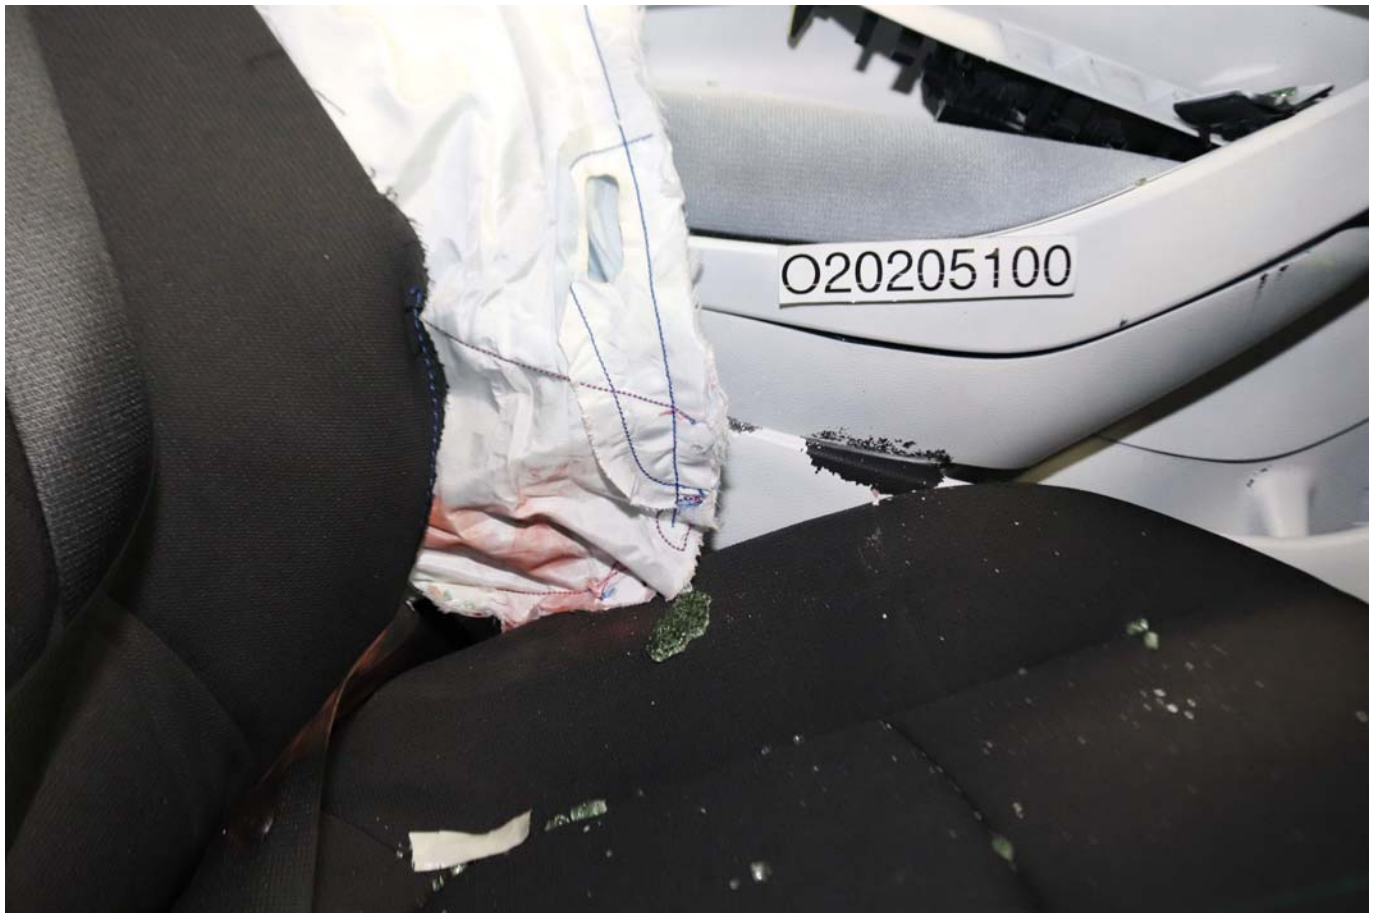
Photo No. 053 - Post-Test Driver Dummy Close-up Pelvis Contact with Side Airbag View

| | | <u>Page No.</u> |
|---|---|---|
| Photo No. 053 | Post-Test Driver Dummy Close-up Pelvis Contact with Side Airbag View | A-27 |

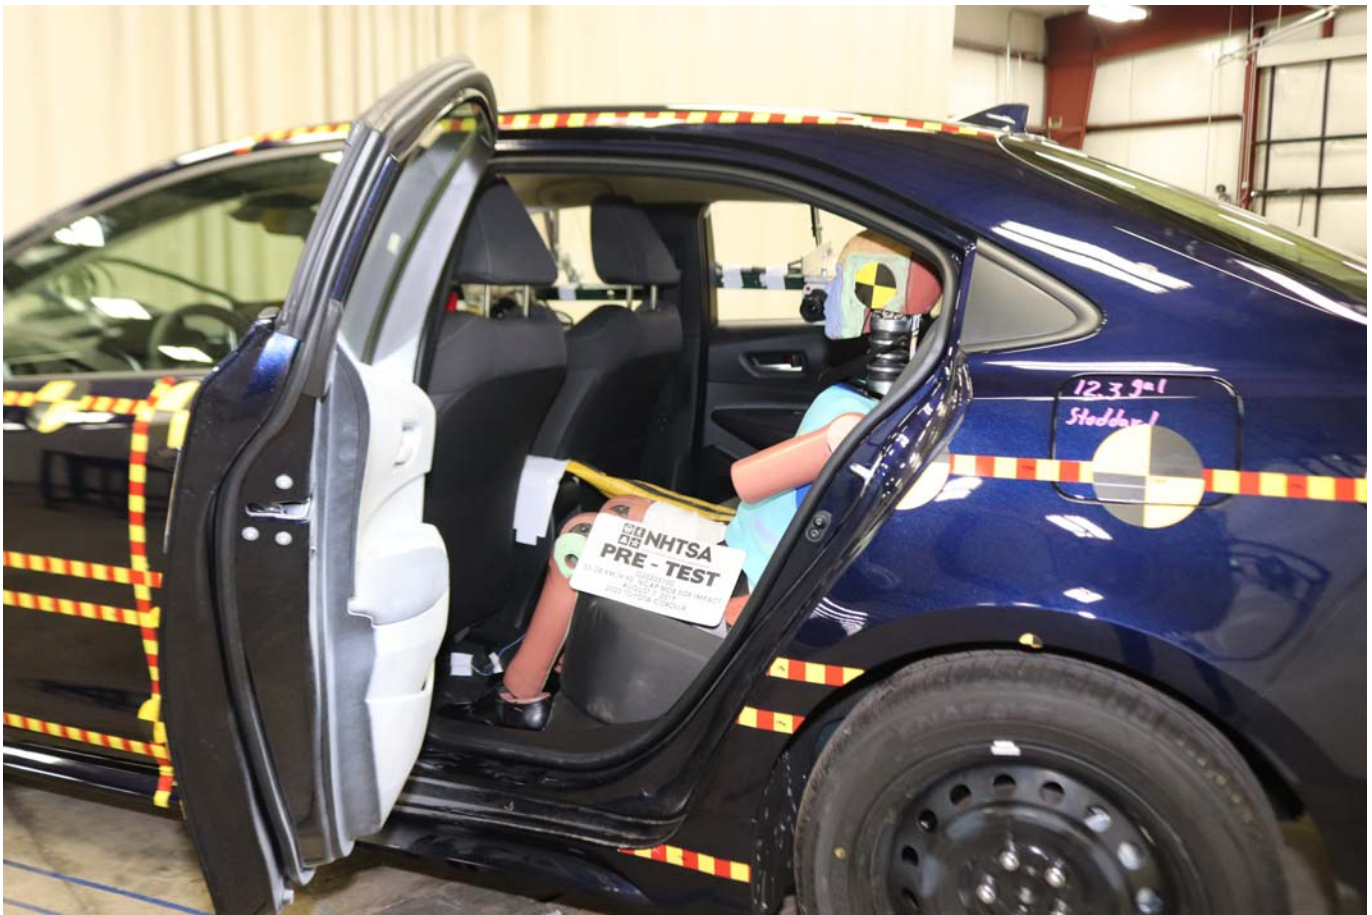
Photo No. 055 - Pre-Test Left Side View of Rear Passenger Dummy Showing Belt and Chalking

| | | <u>Page No.</u> |
|---|---|---|
| Photo No. 055 | Pre-Test Left Side View of Rear Passenger Dummy Showing Belt and Chalking | A-28 |

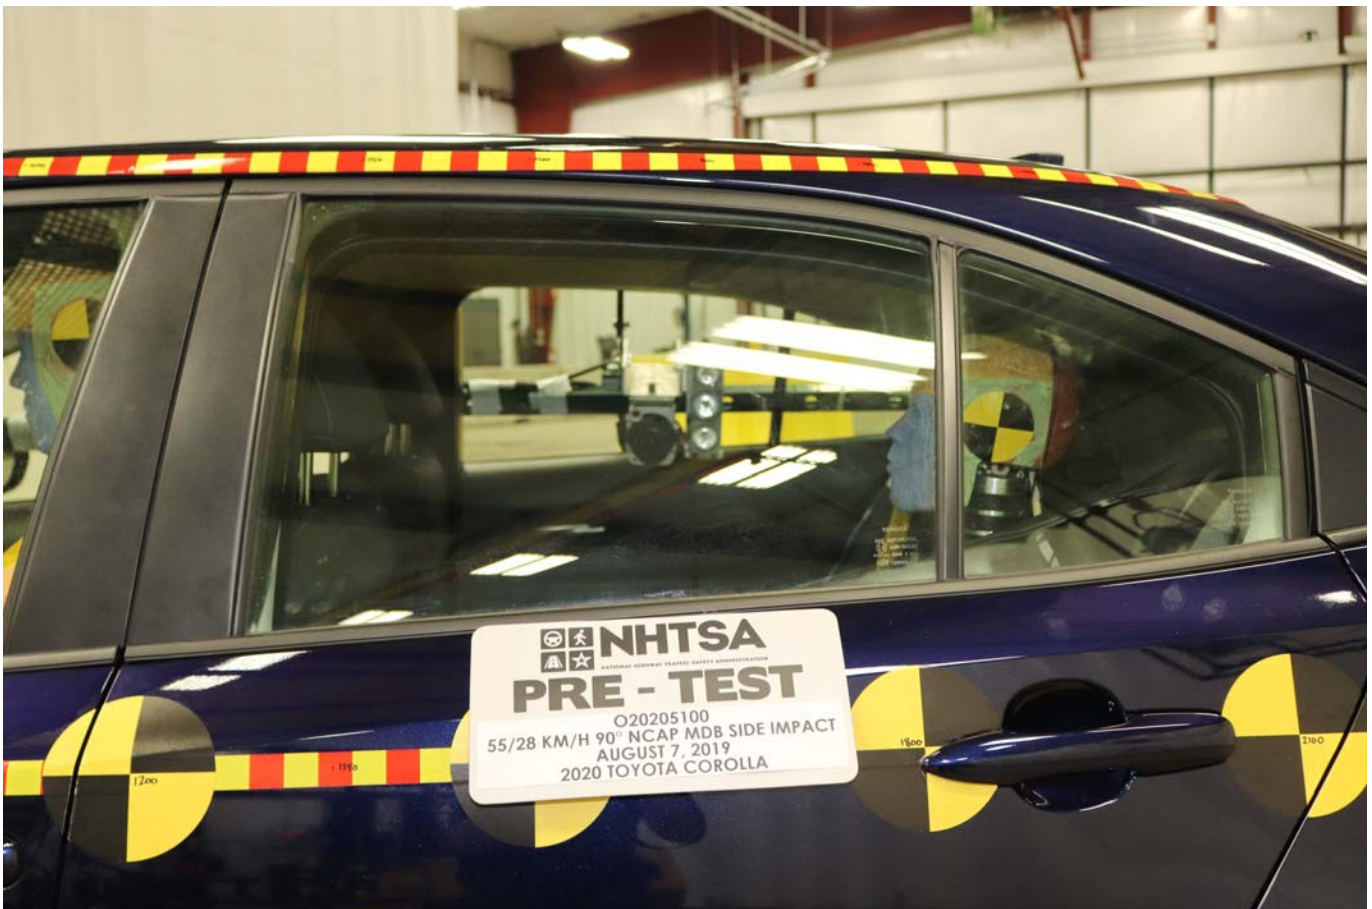
Photo No. 056 - Pre-Test Left Side View of Rear Passenger Dummy Shoulder and Door Top View

| | | <u>Page No.</u> |
|---|---|---|
| Photo No. 056 | Pre-Test Left Side View of Rear Passenger Dummy Shoulder and Door Top View | A-28 |

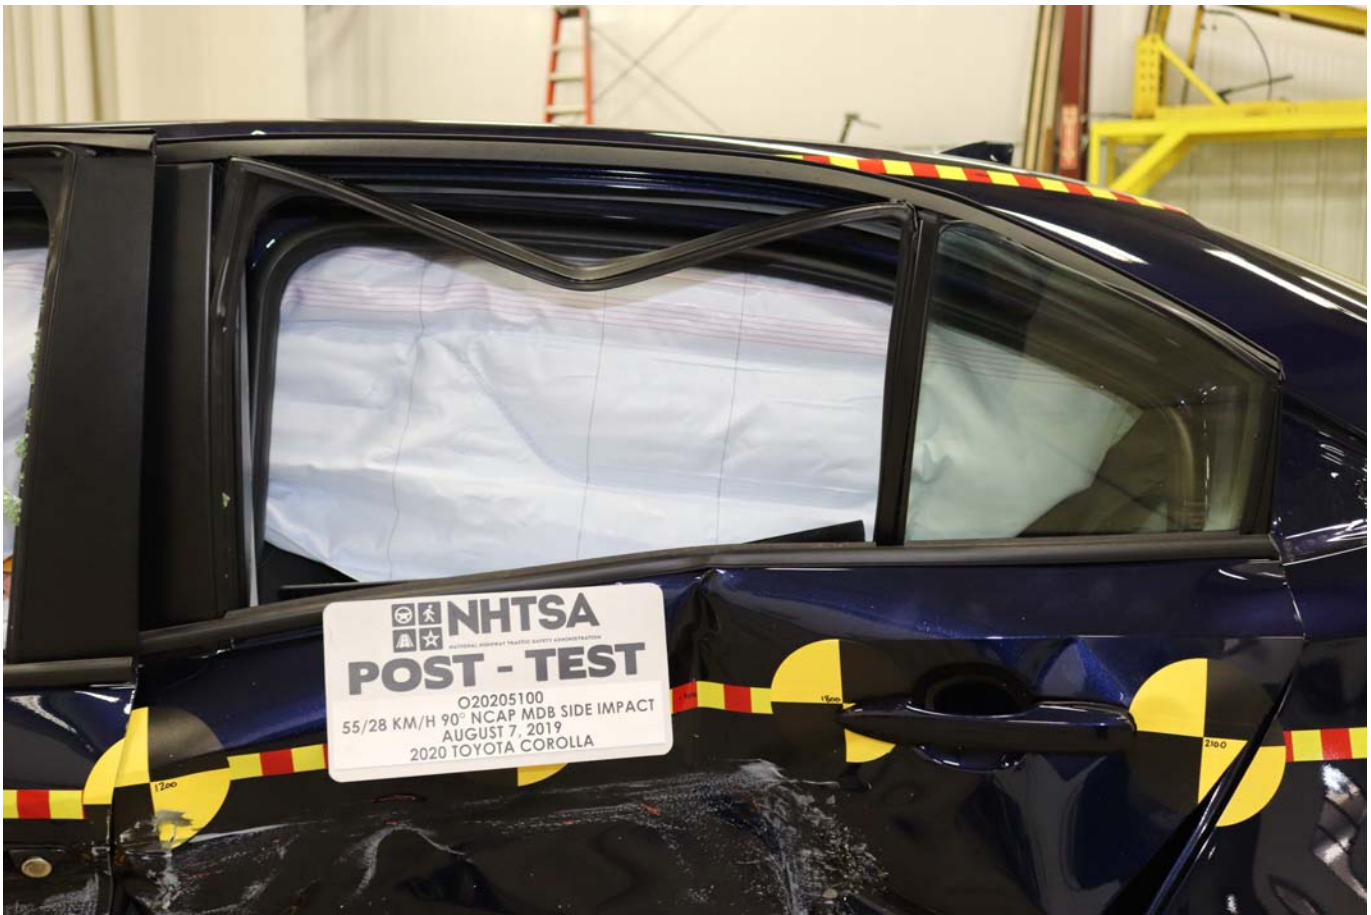
Photo No. 057 - Post-Test Left Side View of Rear Passenger Dummy Shoulder and Door Top View

| | | <u>Page No.</u> |
|---|---|---|
| Photo No. 057 | Post-Test Left Side View of Rear Passenger Dummy Shoulder and Door Top View | A-29 |

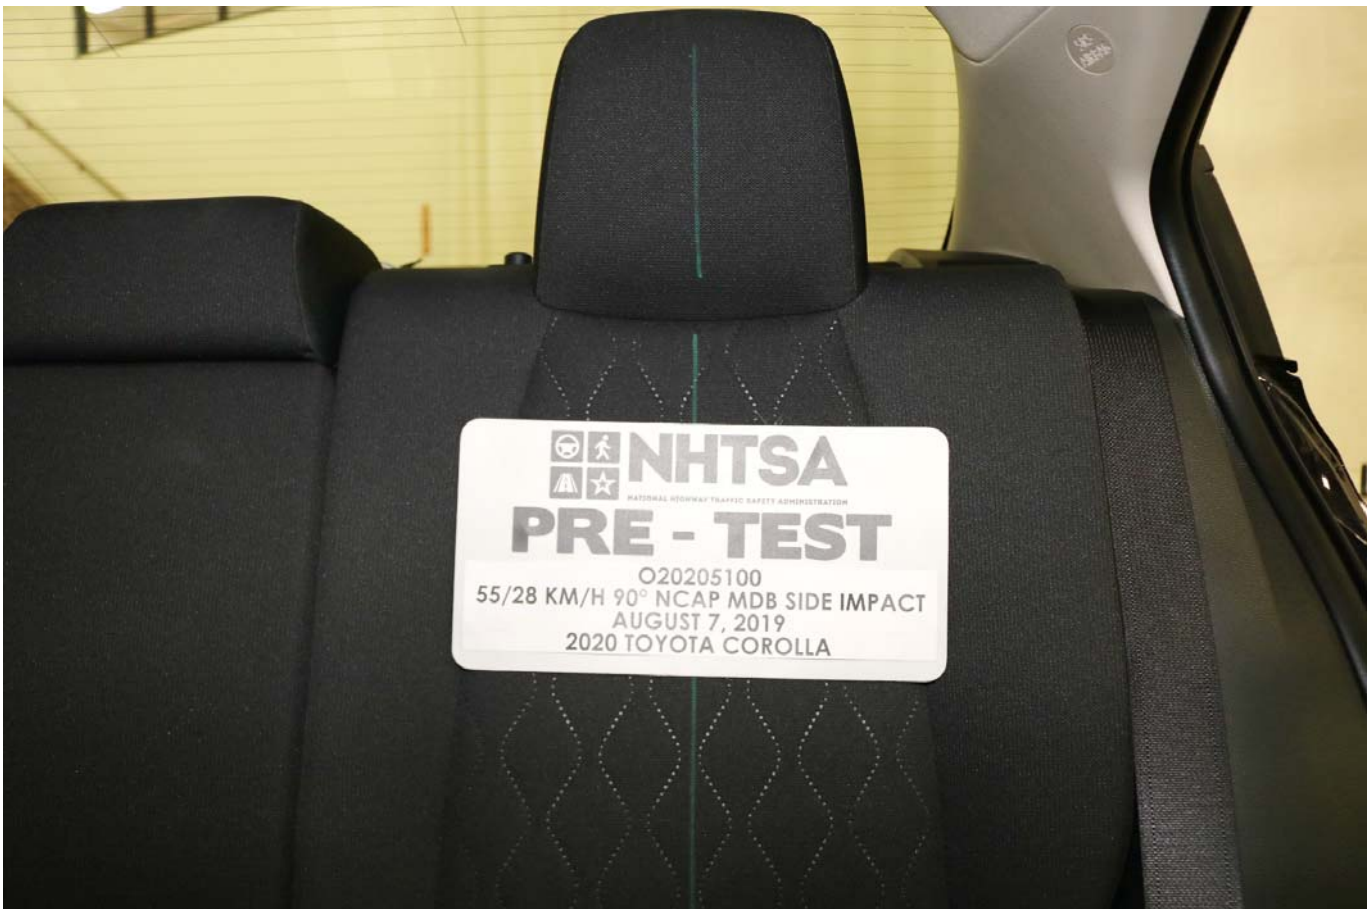
Photo No. 058 - Pre-Test Frontal View of Rear Passenger Seat Back Prior to Dummy Positioning

| | | <u>Page No.</u> |
|---|---|---|
| Photo No. 058 | Pre-Test Frontal View of Rear Passenger Seat Back Prior to Dummy Positioning | A-29 |

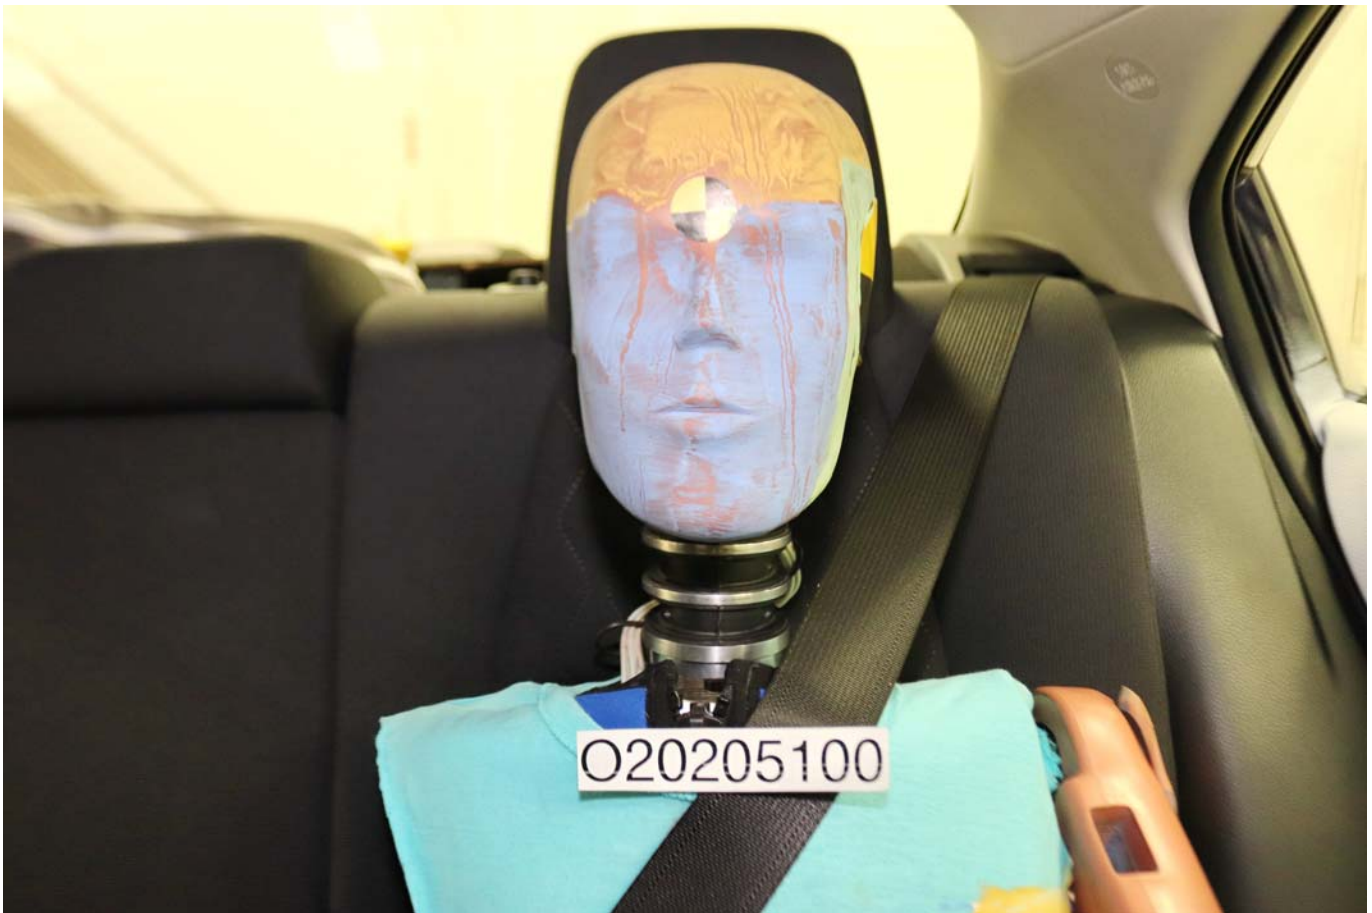
Photo No. 059 - Pre-Test Frontal View of Rear Passenger Dummy Head and Shoulders in Relation to Head Restraint

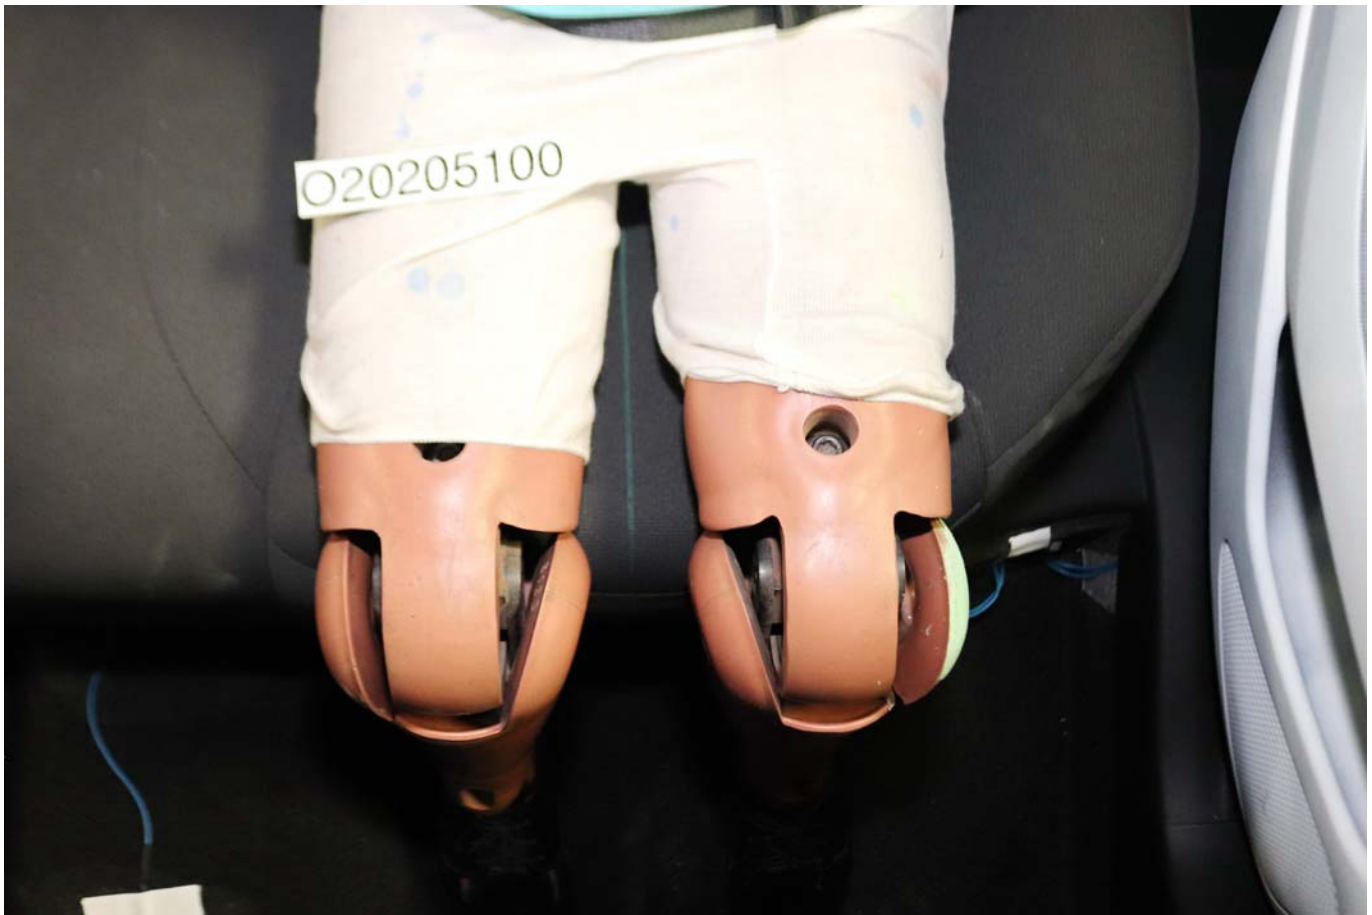
Photo No. 061 - Pre-Test Overhead View of Rear Passenger Dummy Thighs on Seat Pan

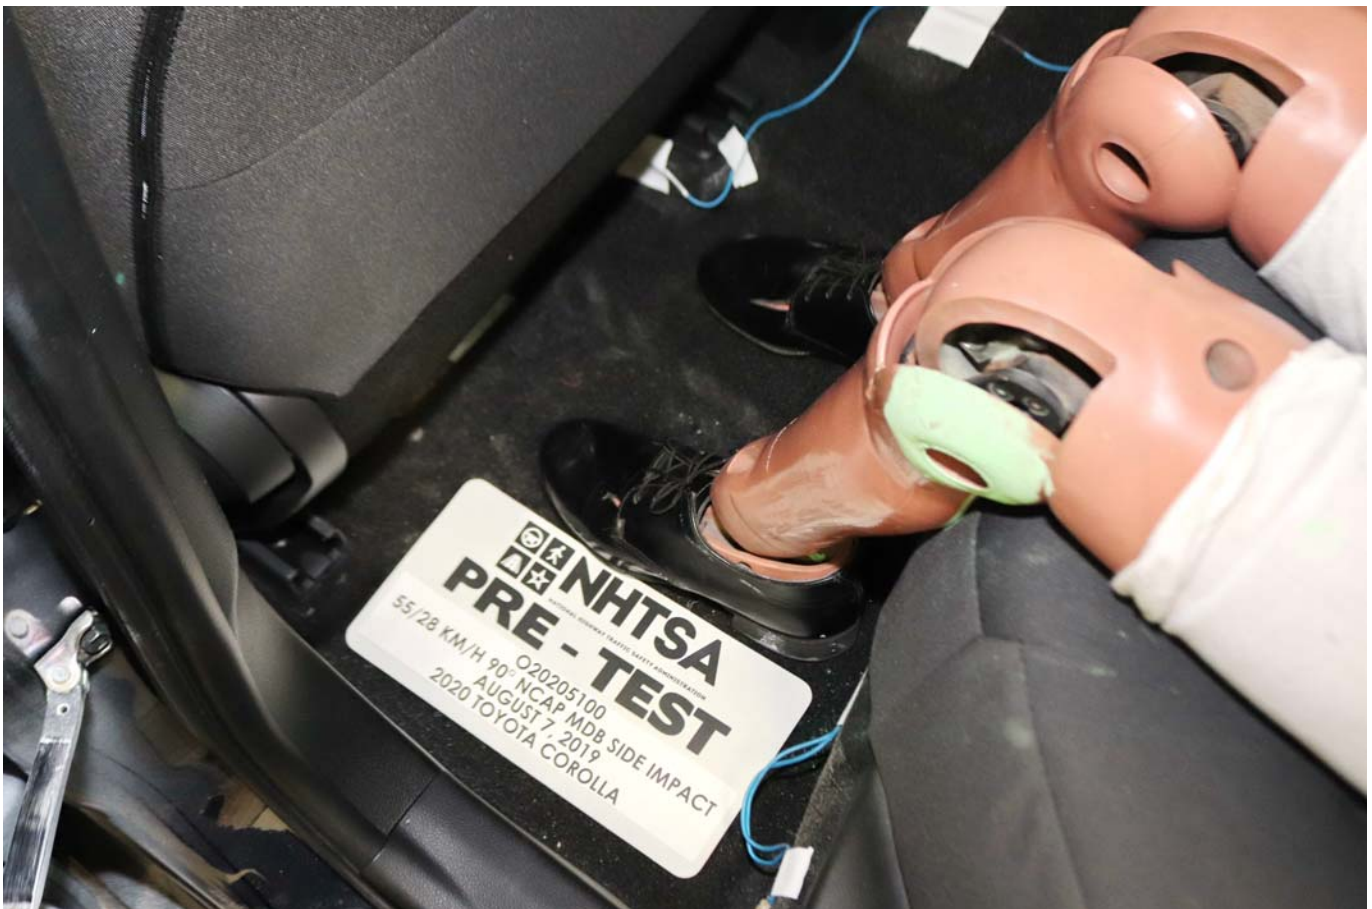
Photo No. 064 - Pre-Test Placement of Rear Passenger Dummy Feet

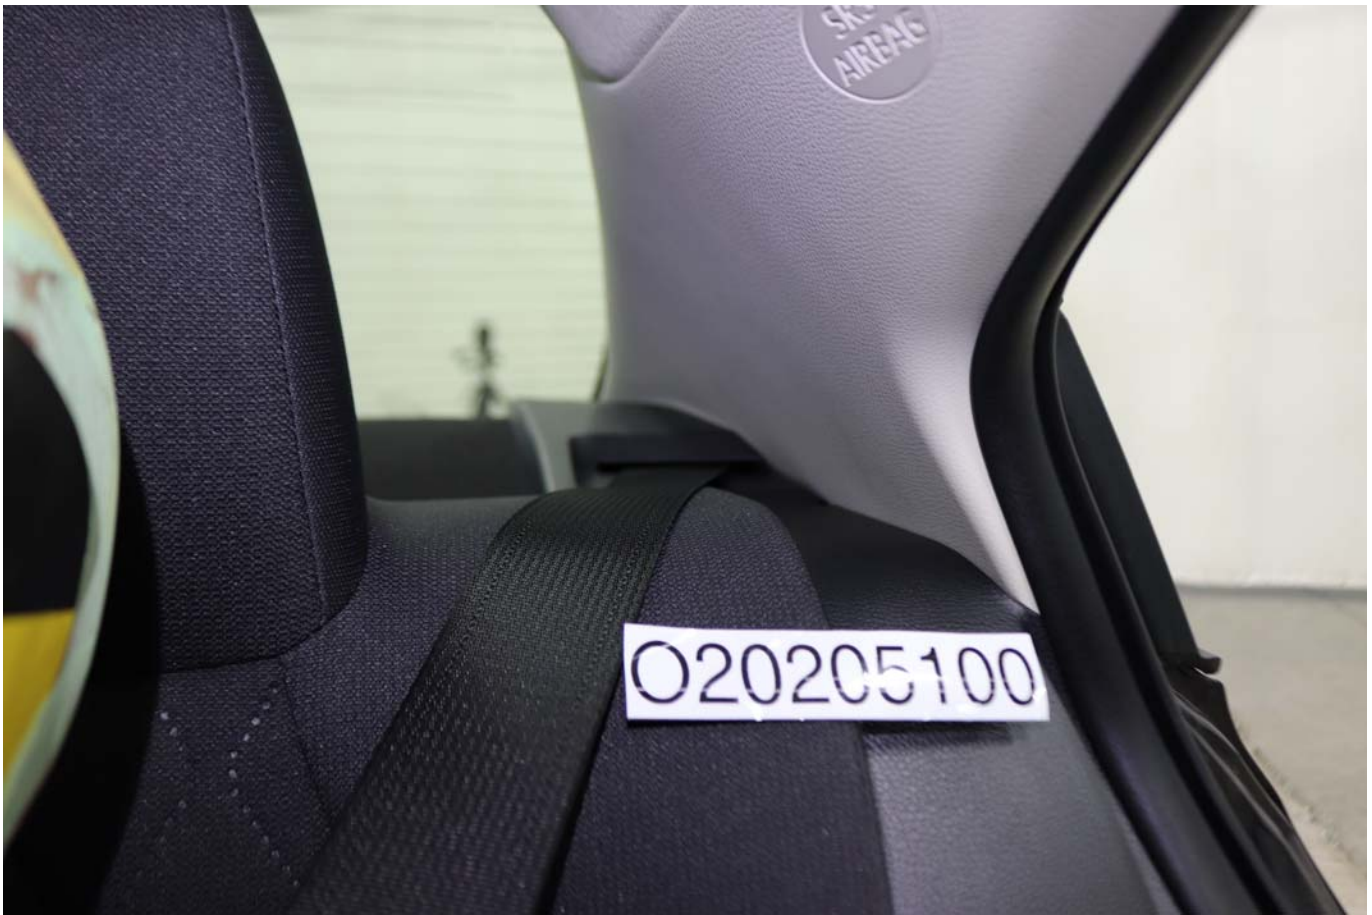
Photo No. 065 - Pre-Test View of Belt Anchorage for Rear Passenger Dummy

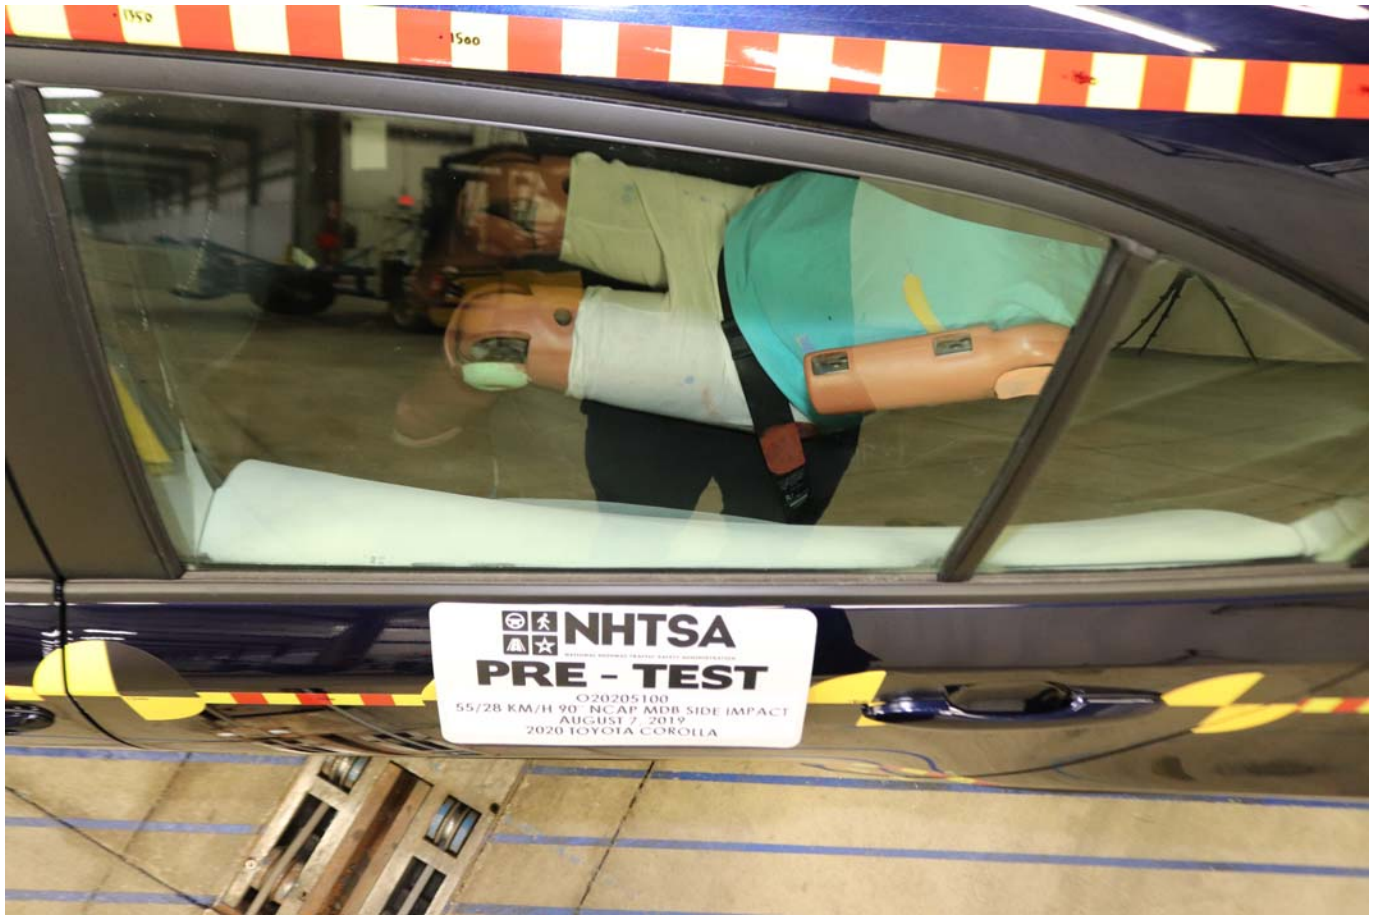
Photo No. 069 - Pre-Test Rear Passenger Dummy and Door Clearance View

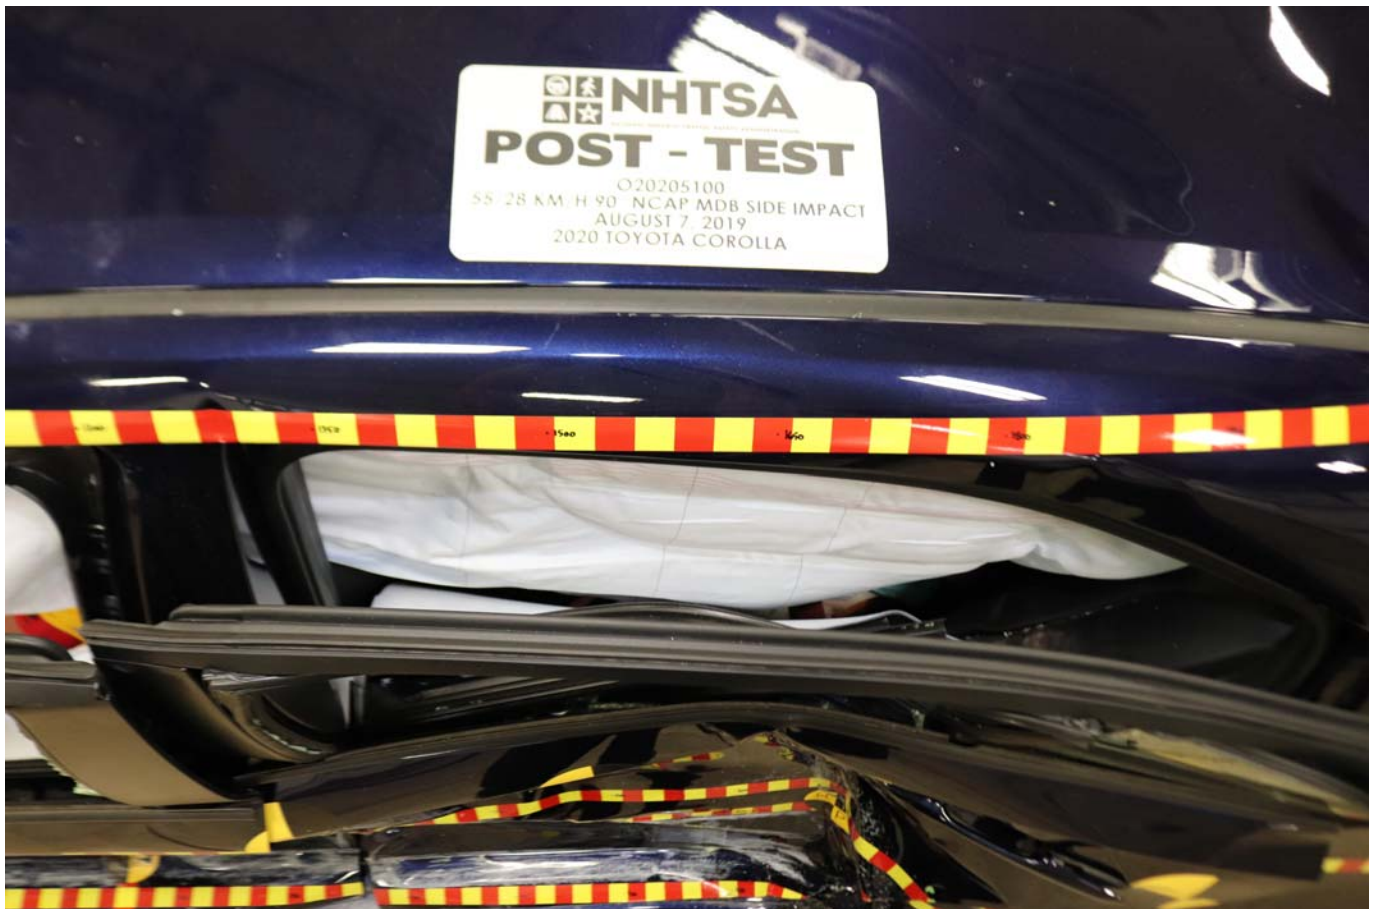
Photo No. 070 - Post-Test Rear Passenger Dummy and Door Clearance View

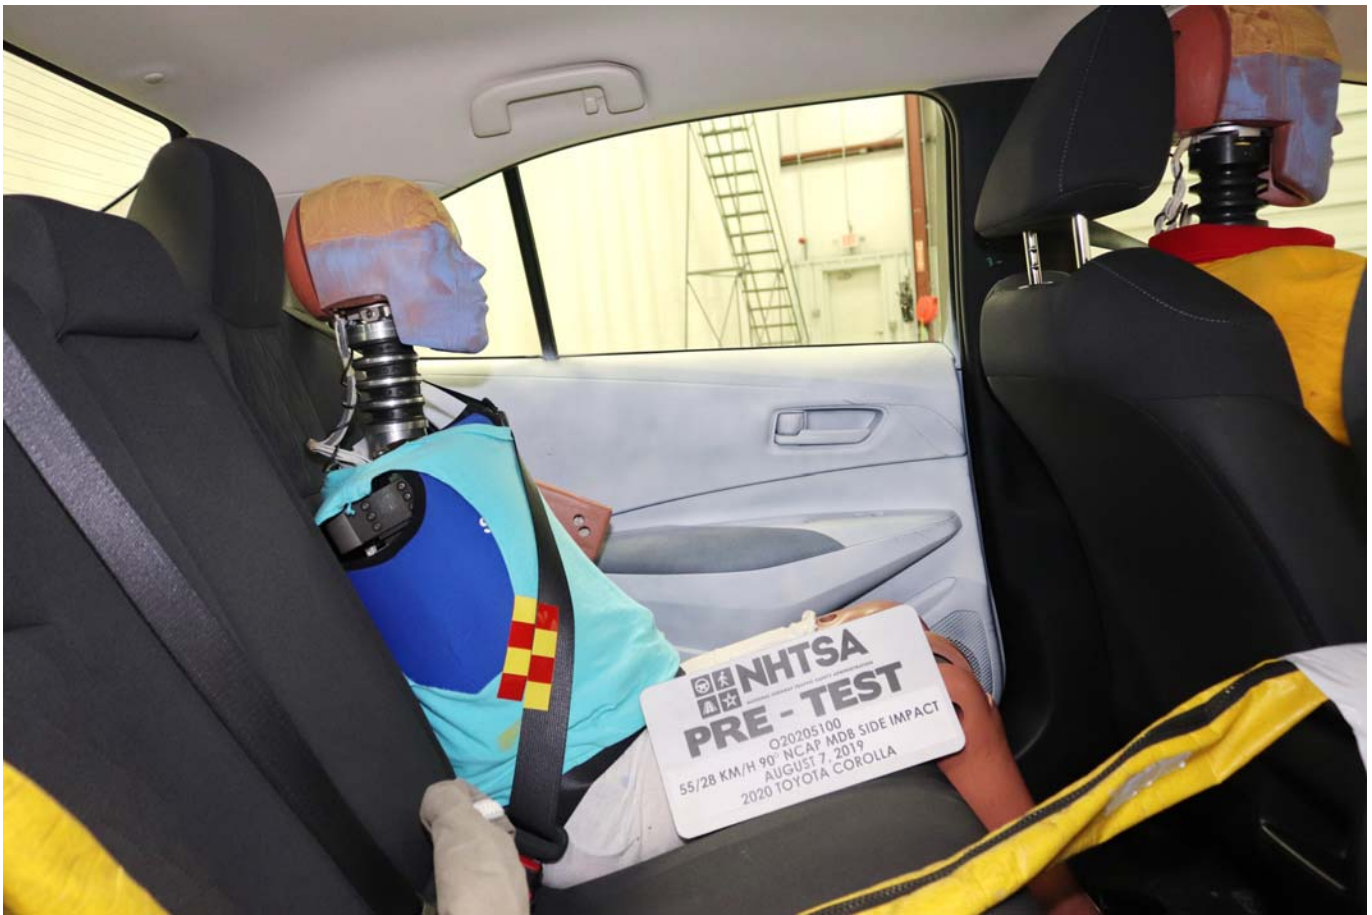
Photo No. 071 - Pre-Test Right Side View of Rear Passenger Dummy and Rear Seat Occupant Compartment

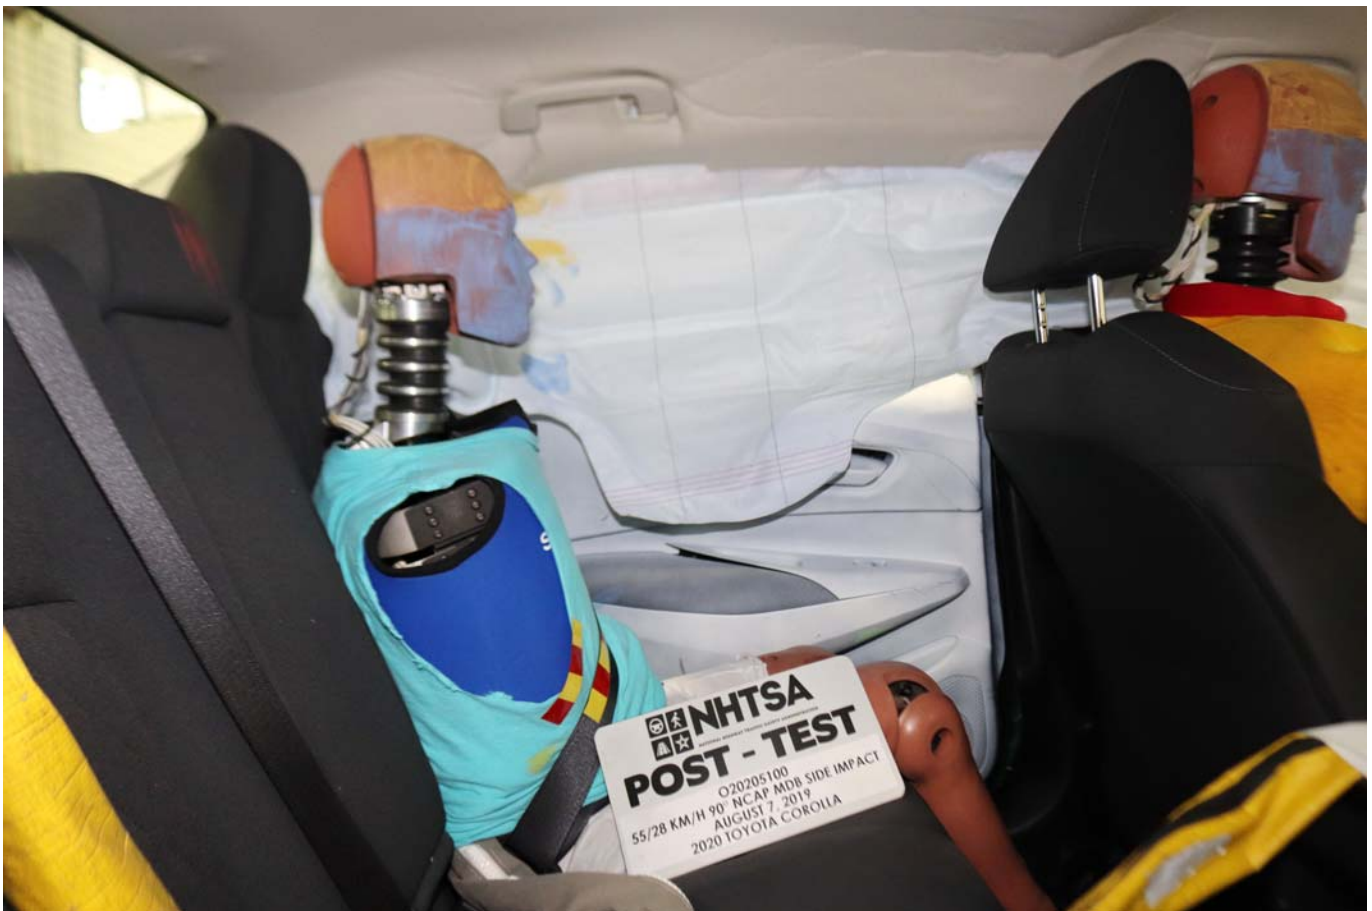
Photo No. 072 - Post-Test Right Side View of Rear Passenger Dummy and Rear Seat Occupant Compartment

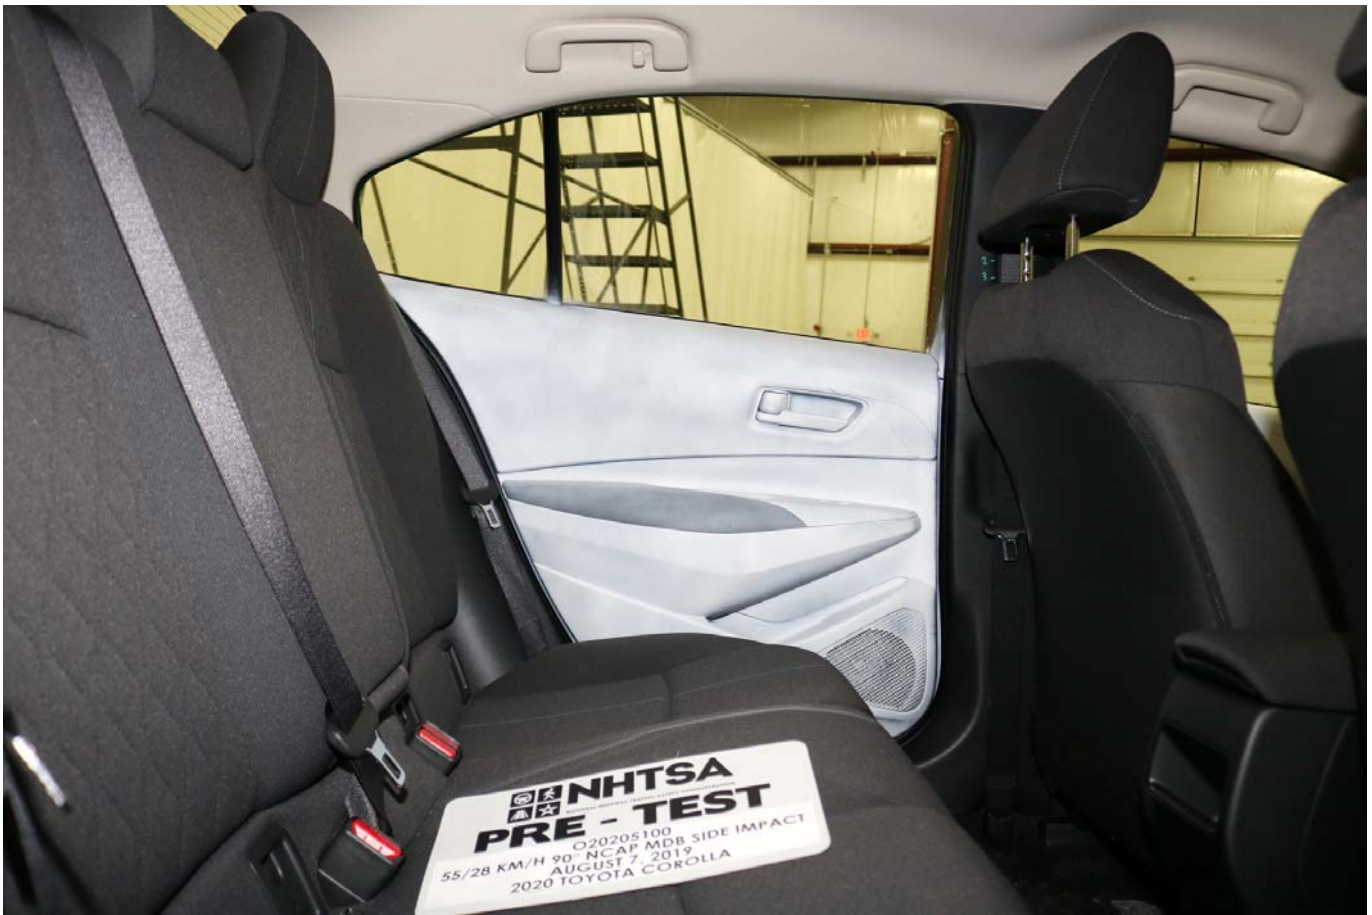
Photo No. 073 - Pre-Test Rear Passenger Inner Door Panel View

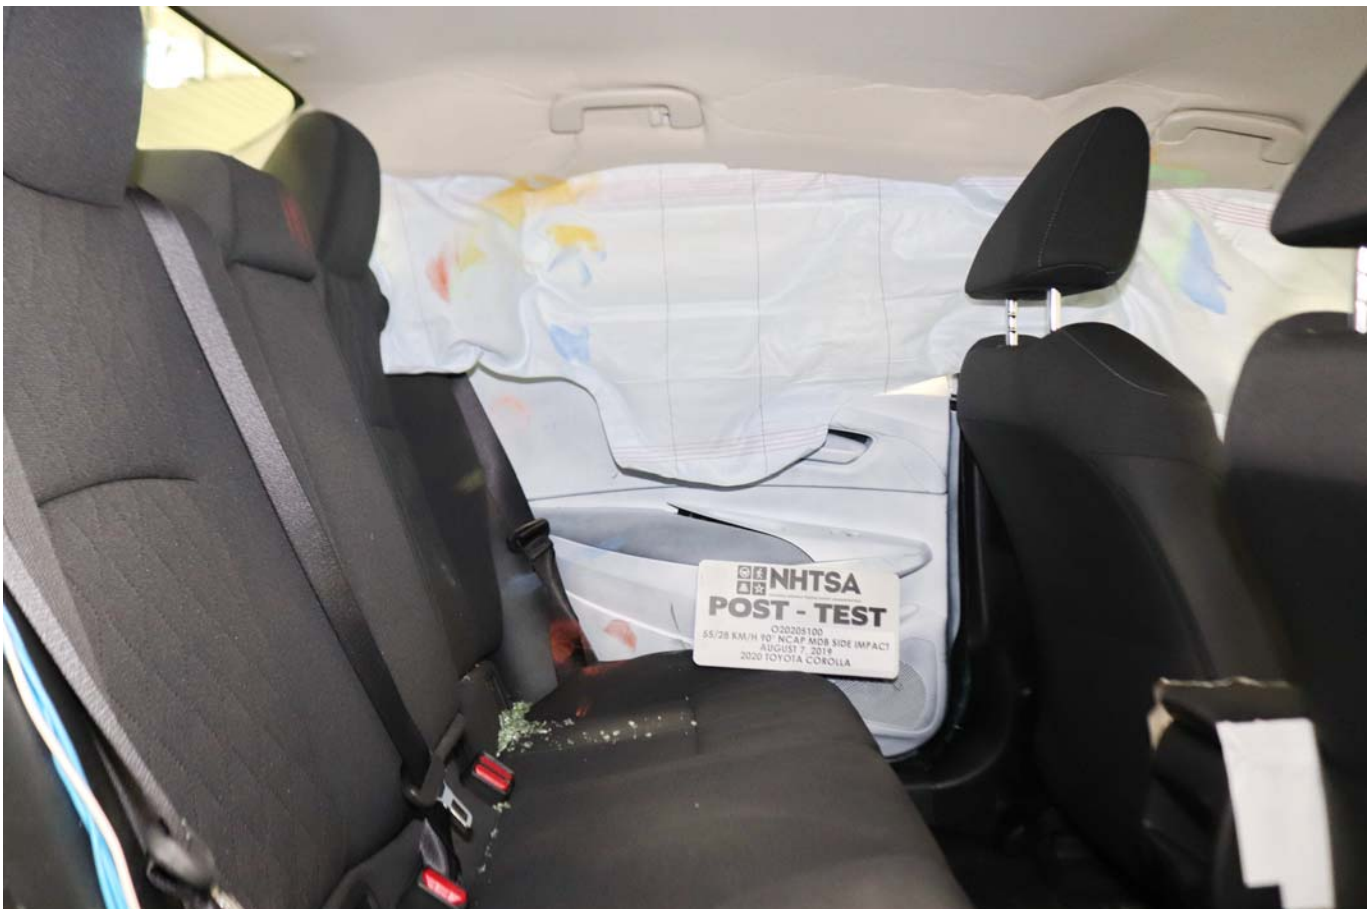
Photo No. 074 - Post-Test Rear Passenger Inner Door Panel View

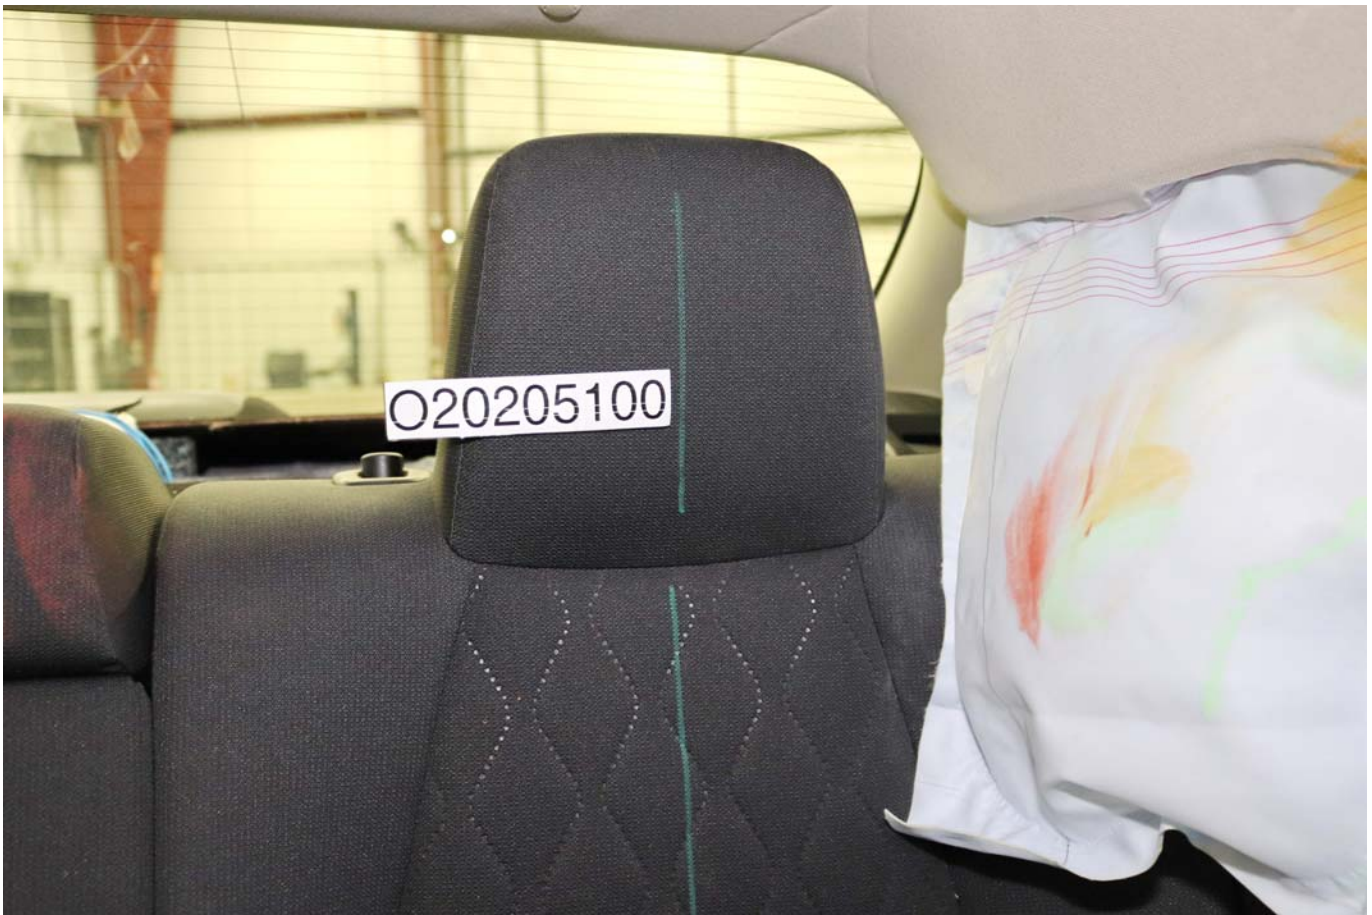
Photo No. 075 - Post-Test Rear Passenger Dummy Close-up Head Contact with Vehicle Interior View
