**REPORT NUMBER: SINCAP-MGA-20-001**

**NEW CAR ASSESSMENT PROGRAM (NCAP)  
Moving Deformable Barrier Side Impact Test**

**TOYOTA MOTOR CORPORATION  
2020 Toyota Corolla LE 4-Door Sedan  
NHTSA No.: O20205100**

**MGA RESEARCH CORPORATION  
5000 Warren Road  
Burlington, WI 53105**

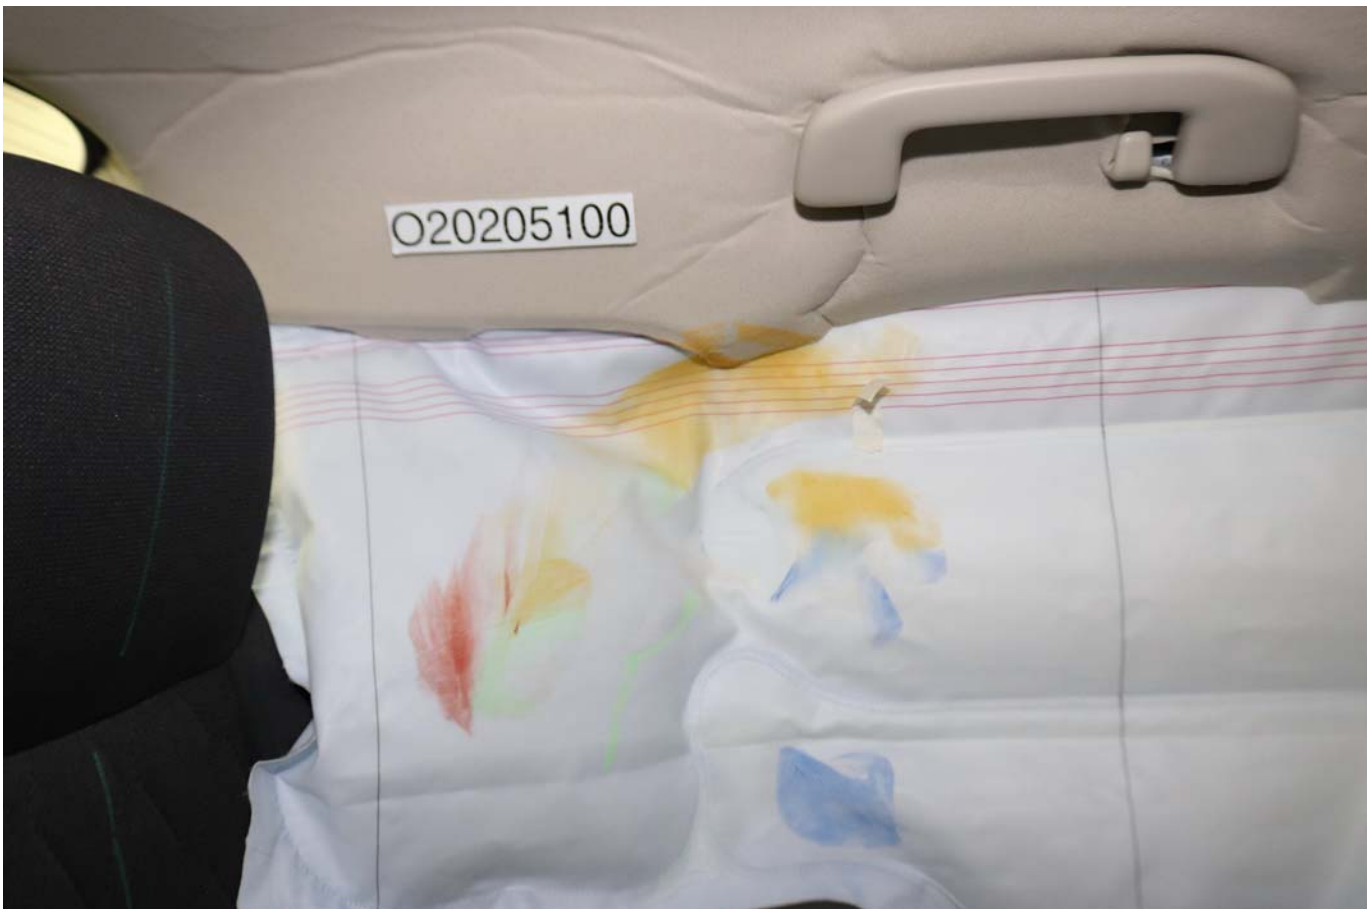
Photo No. 076 - Post-Test Rear Passenger Dummy Close-up Head Contact with Side Airbag View

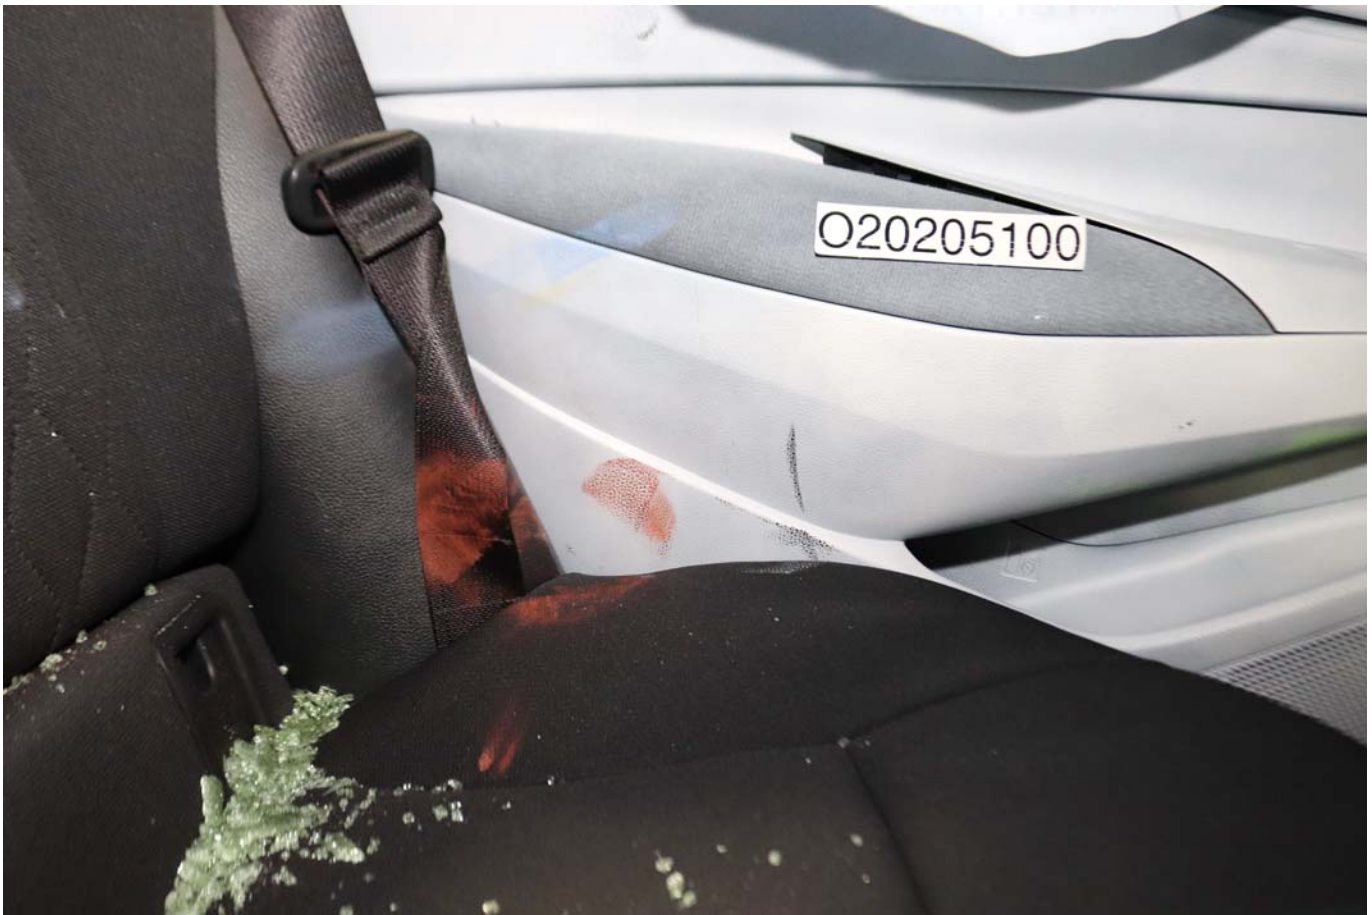
Photo No. 080 - Post-Test Rear Passenger Dummy Close-up Pelvis Contact with Side Airbag View

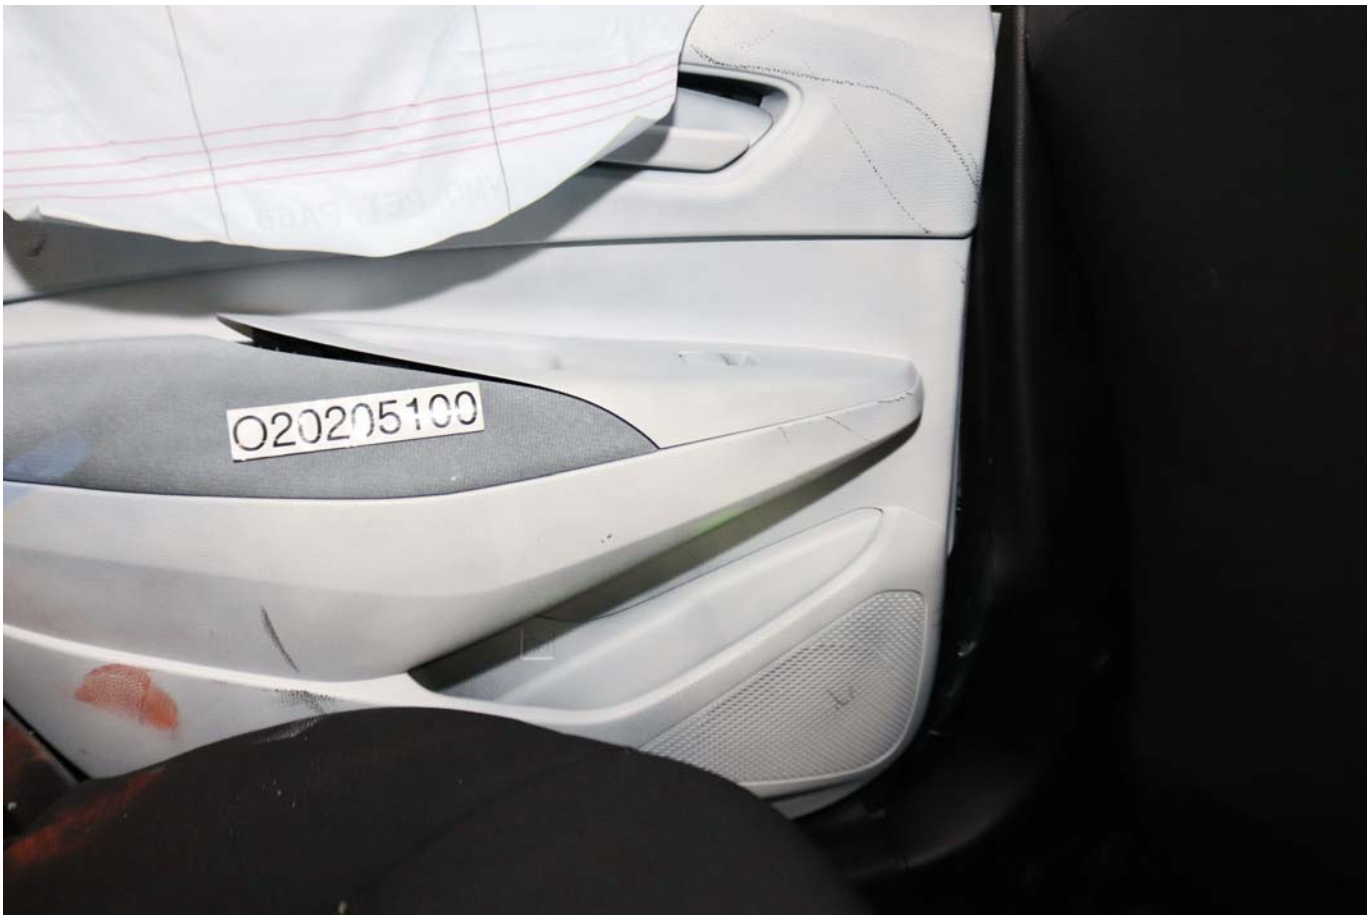
Photo No. 081 - Post-Test Rear Passenger Dummy Close-up Knee Contact View

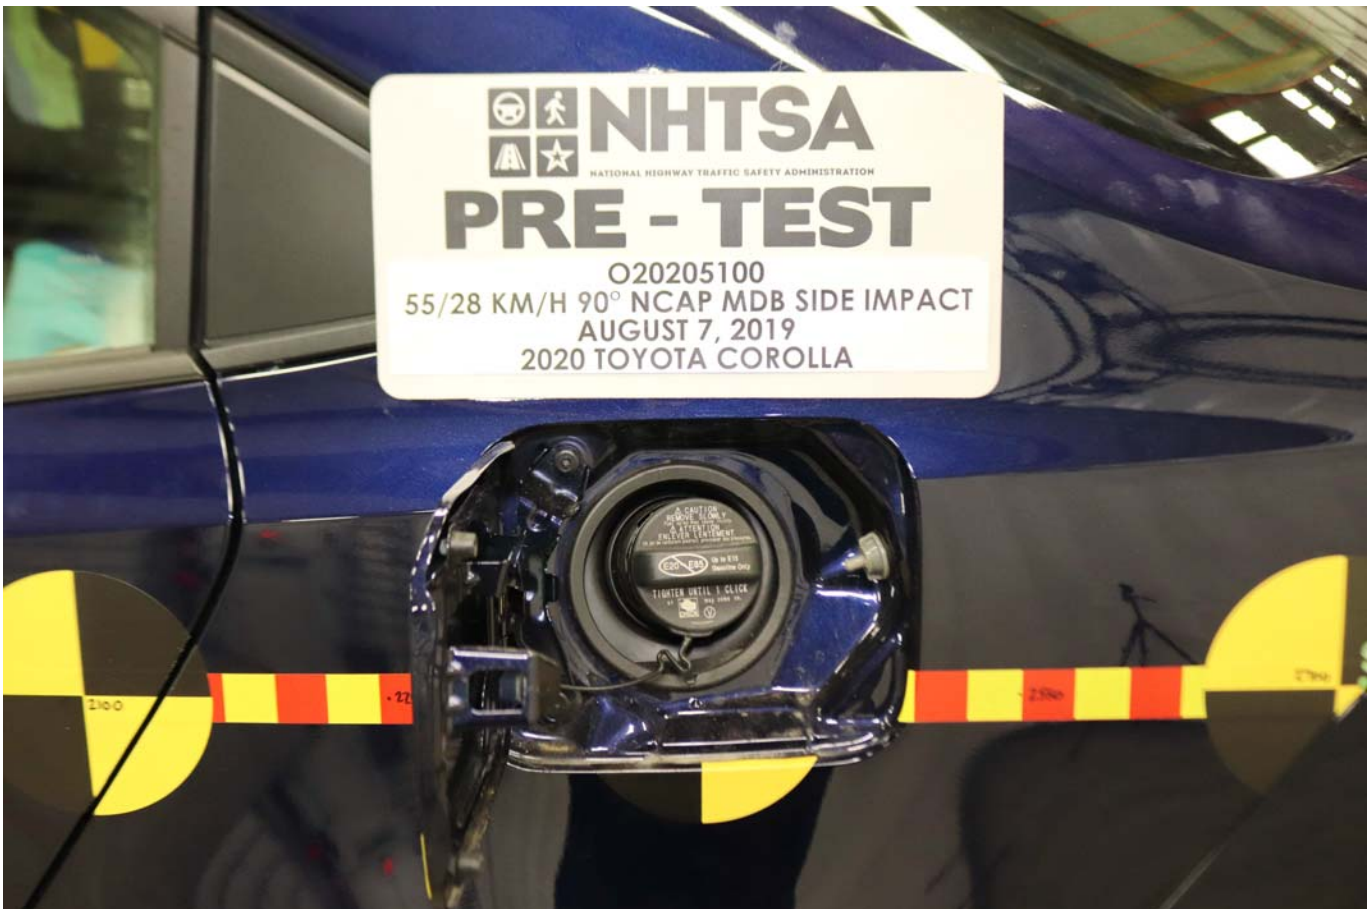
Photo No. 082 - Pre-Test View of Fuel Filler Cap or Fuel Filler Neck

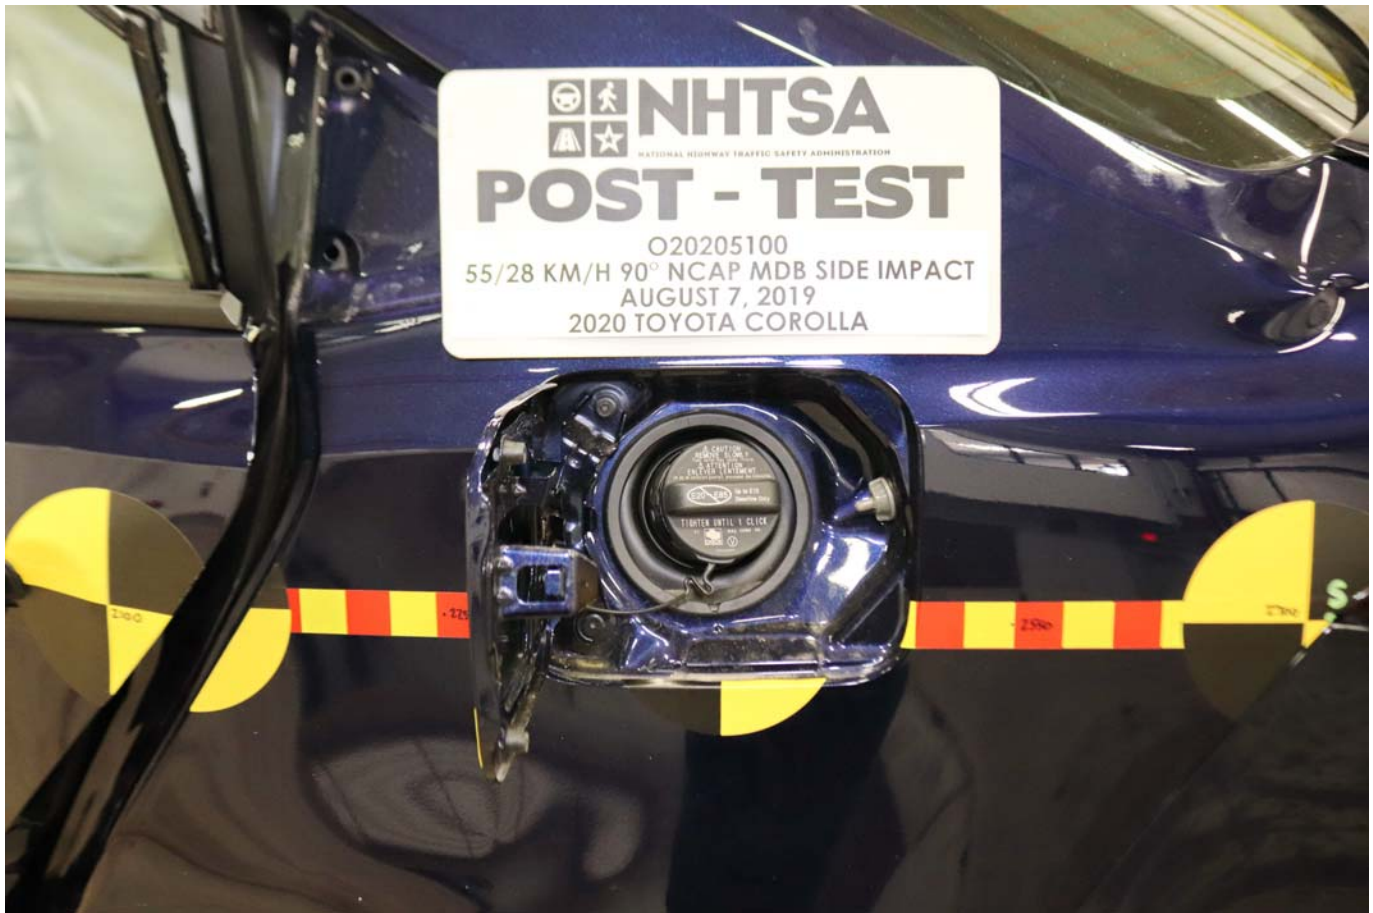
Photo No. 083 - Post-Test View of Fuel Filler Cap or Fuel Filler Neck

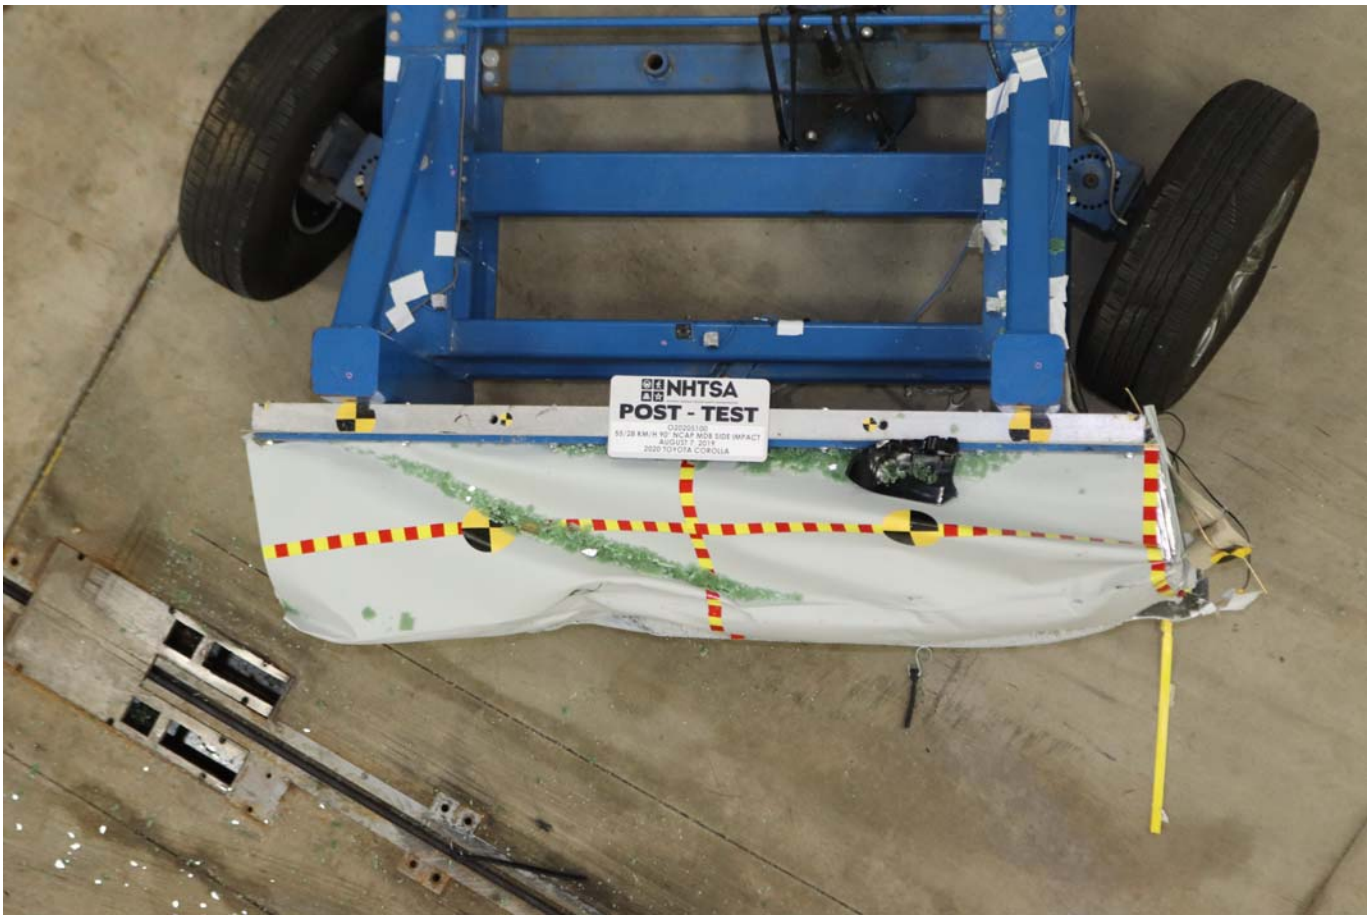
Photo No. 087 - Post-Test Top View of MDB Impactor Face

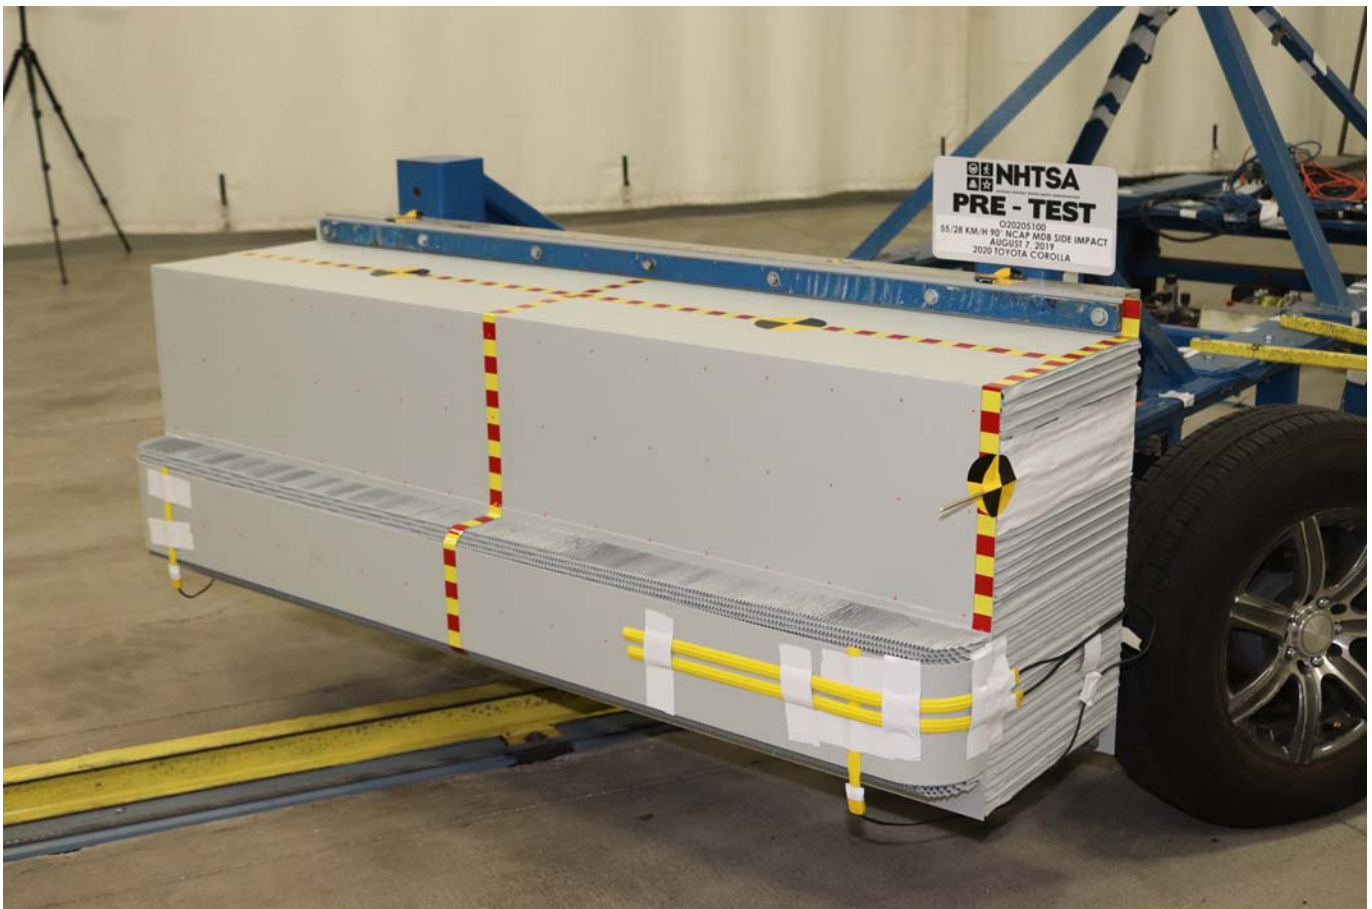
Photo No. 088 - Pre-Test Left Side View of MDB Impactor Face

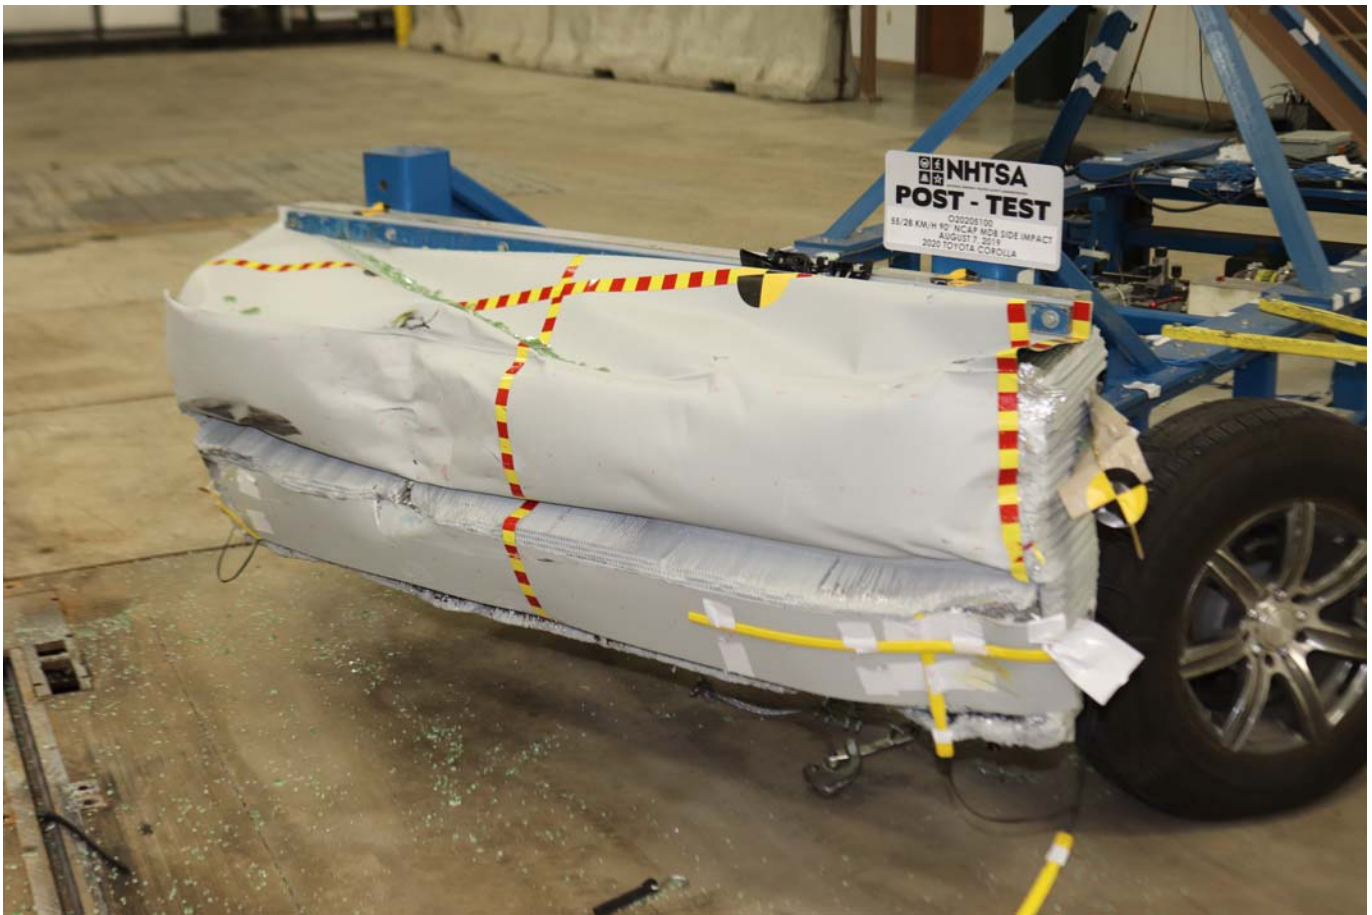
Photo No. 089 - Post-Test Left Side View of MDB Impactor Face

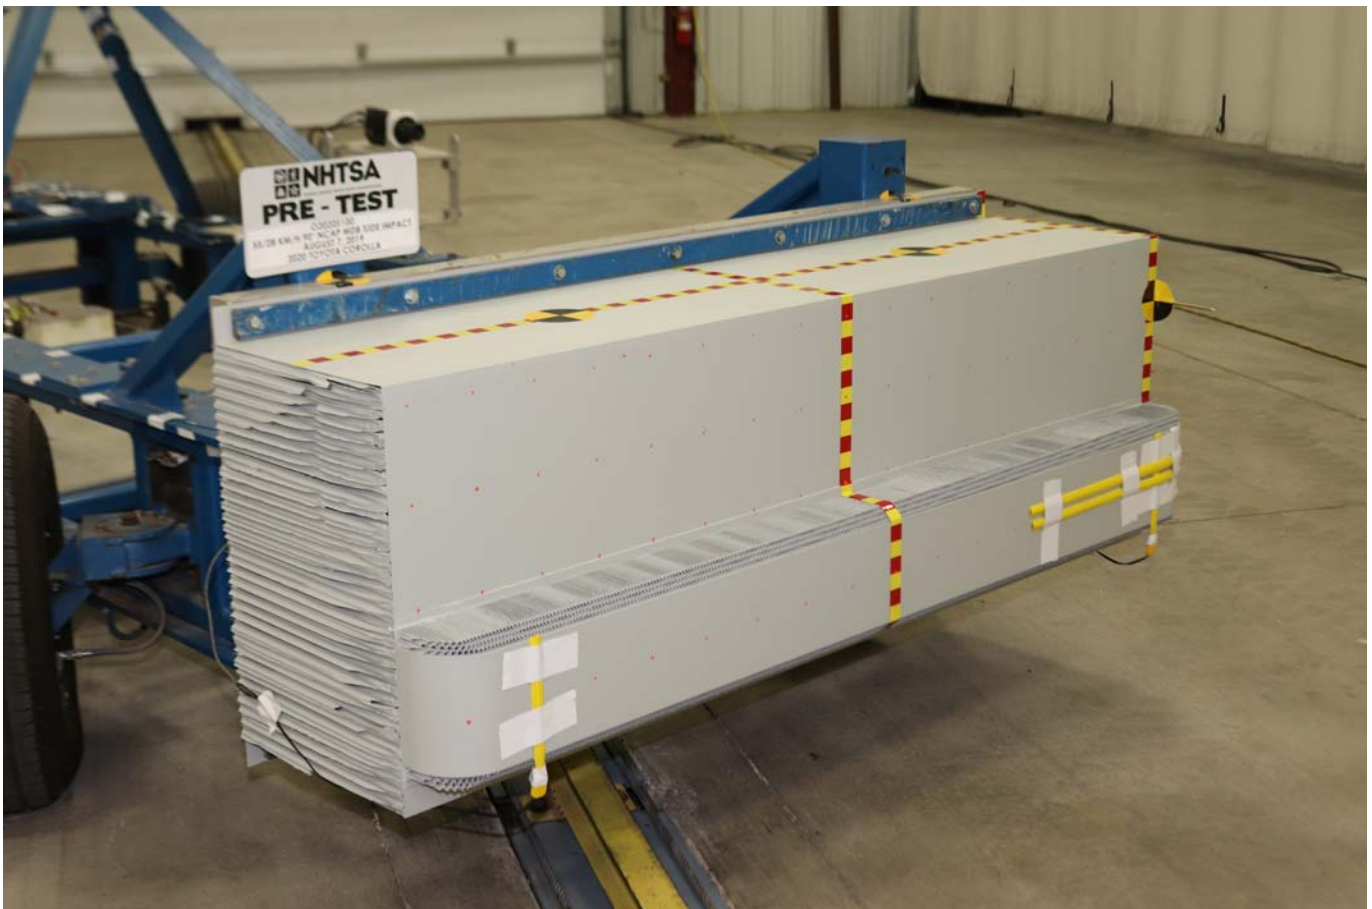
Photo No. 090 - Pre-Test Right Side View of MDB Impactor Face

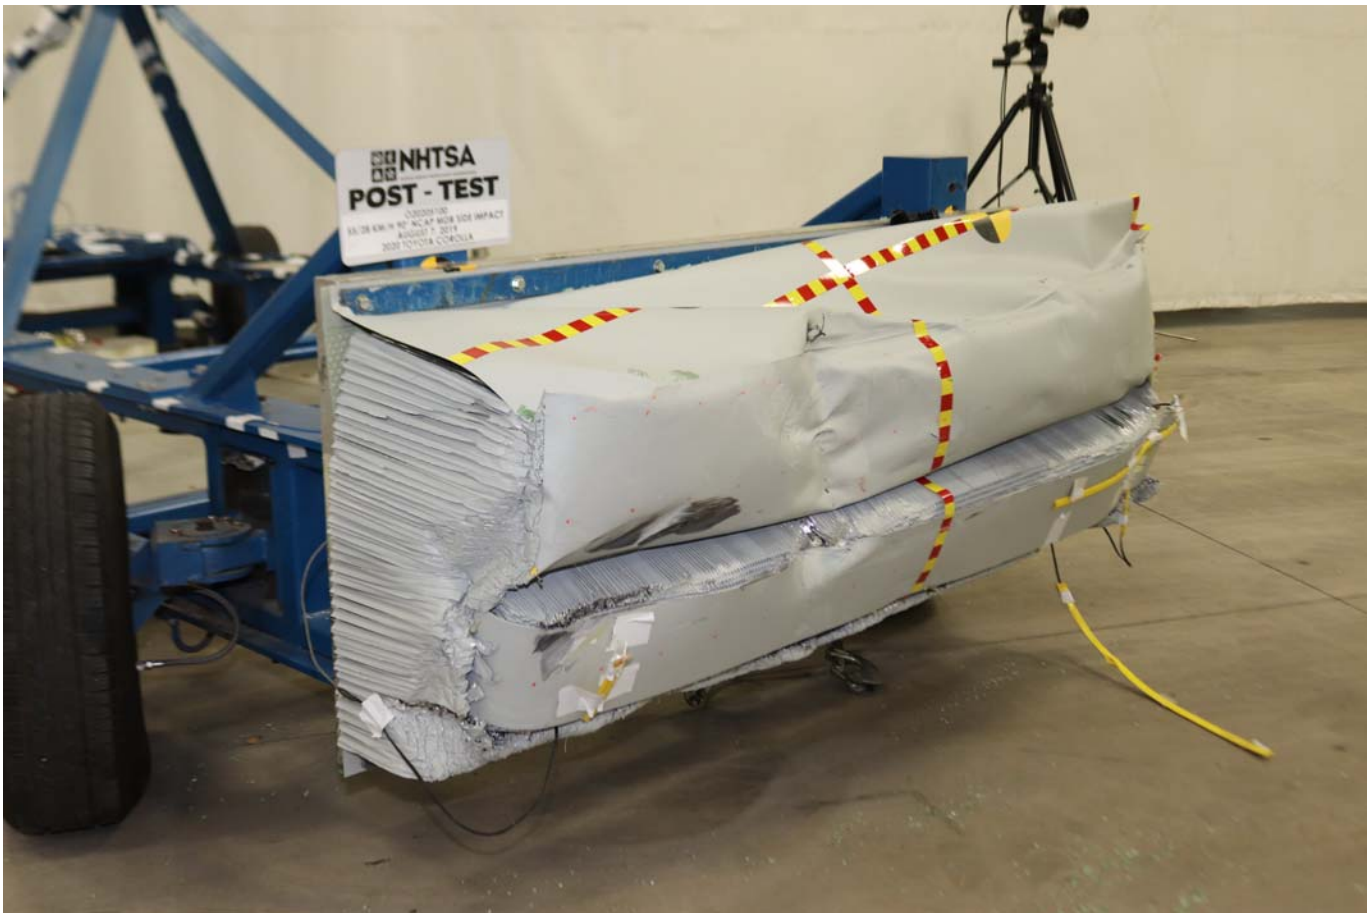
Photo No. 091 - Post-Test Right Side View of MDB Impactor Face

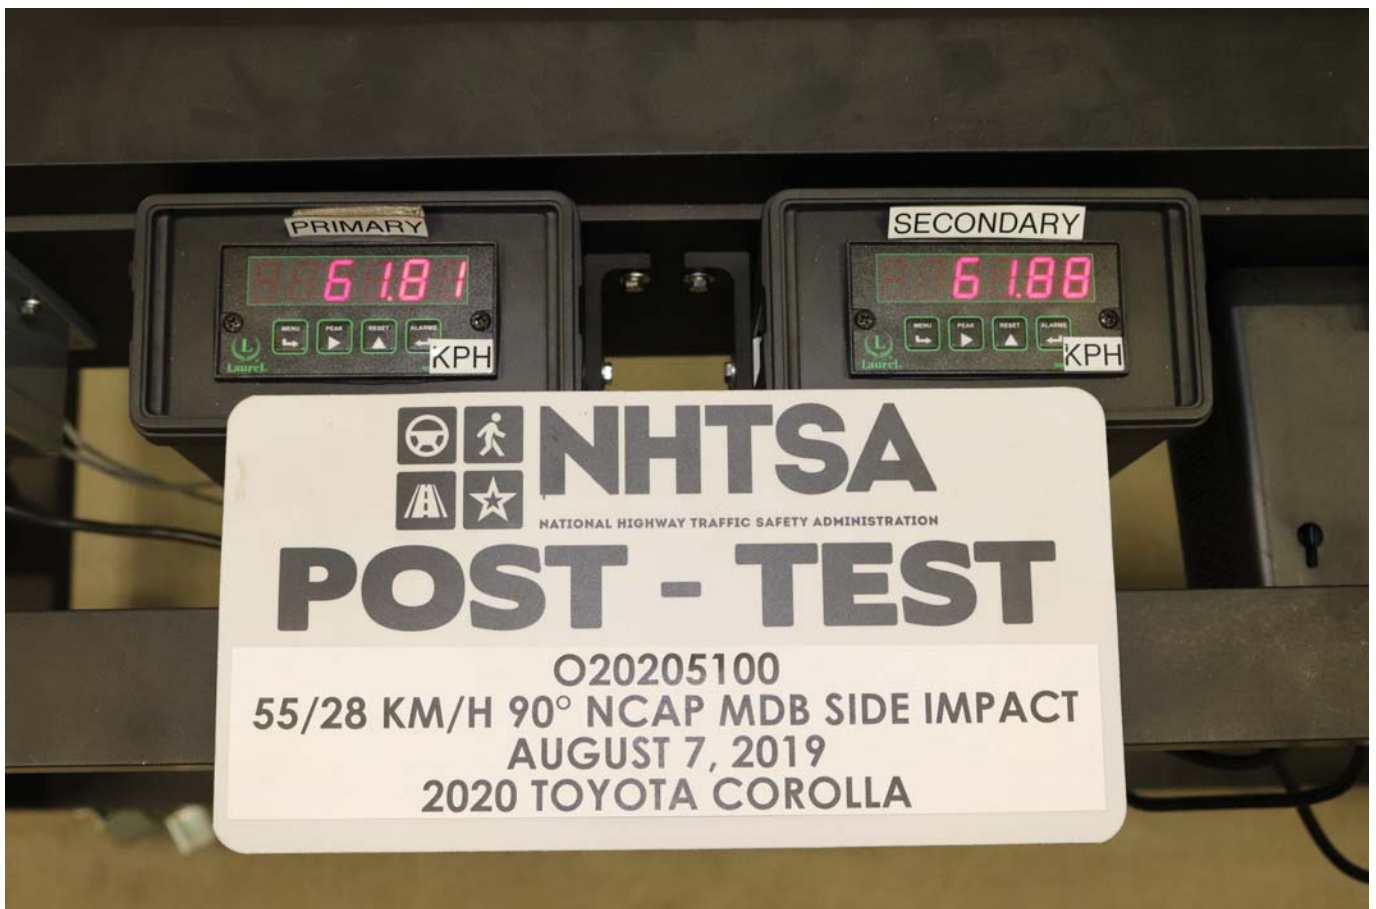
Photo No. 095 - Post-Test Primary and Redundant Speed Trap Read-Out

The impact velocity of the Moving Deformable Barrier (MDB) was 61.81 km/h, and the ambient temperature at the struck (driver's) side of the target vehicle at the time of impact was 21.4°C. The target vehicle post-test maximum crush was 181 mm at level 3. The test vehicle's performance was as follows:

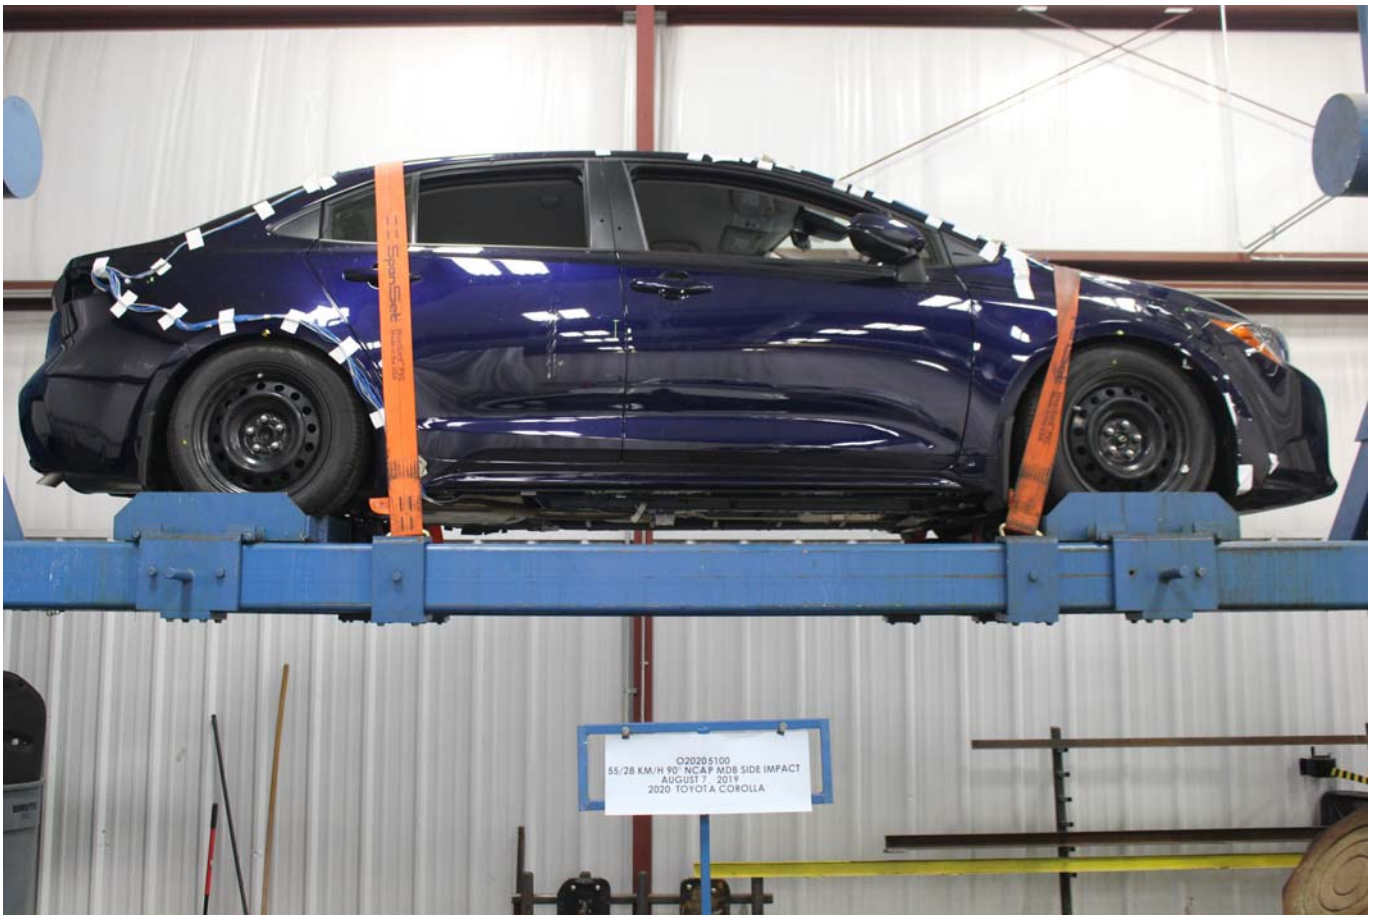
Photo No. 096 - FMVSS Photo No. 301 Static Rollover 0 Degrees

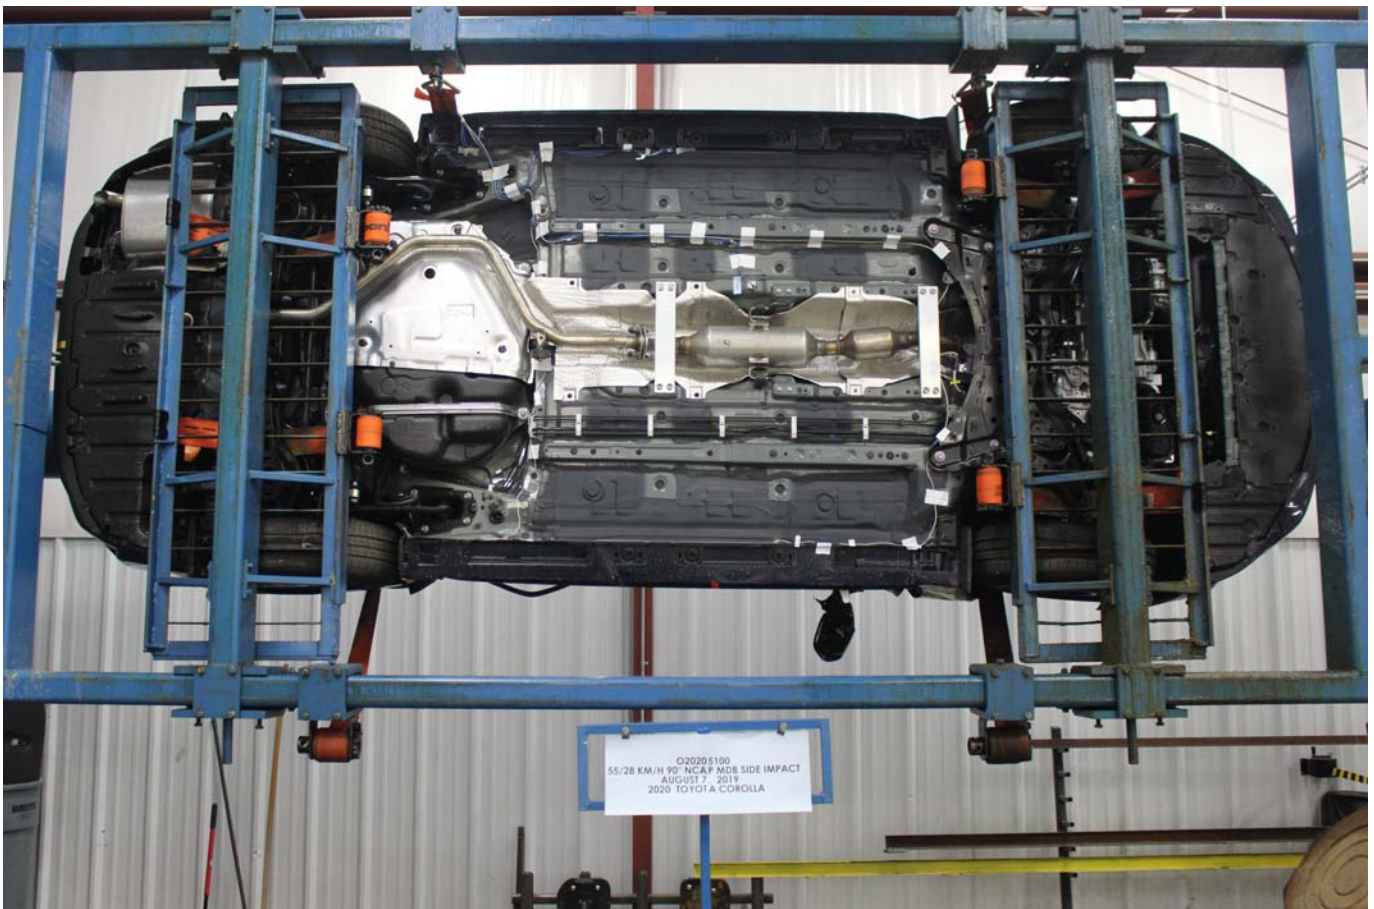
Photo No. 097 - FMVSS Photo No. 301 Static Rollover 90 Degrees

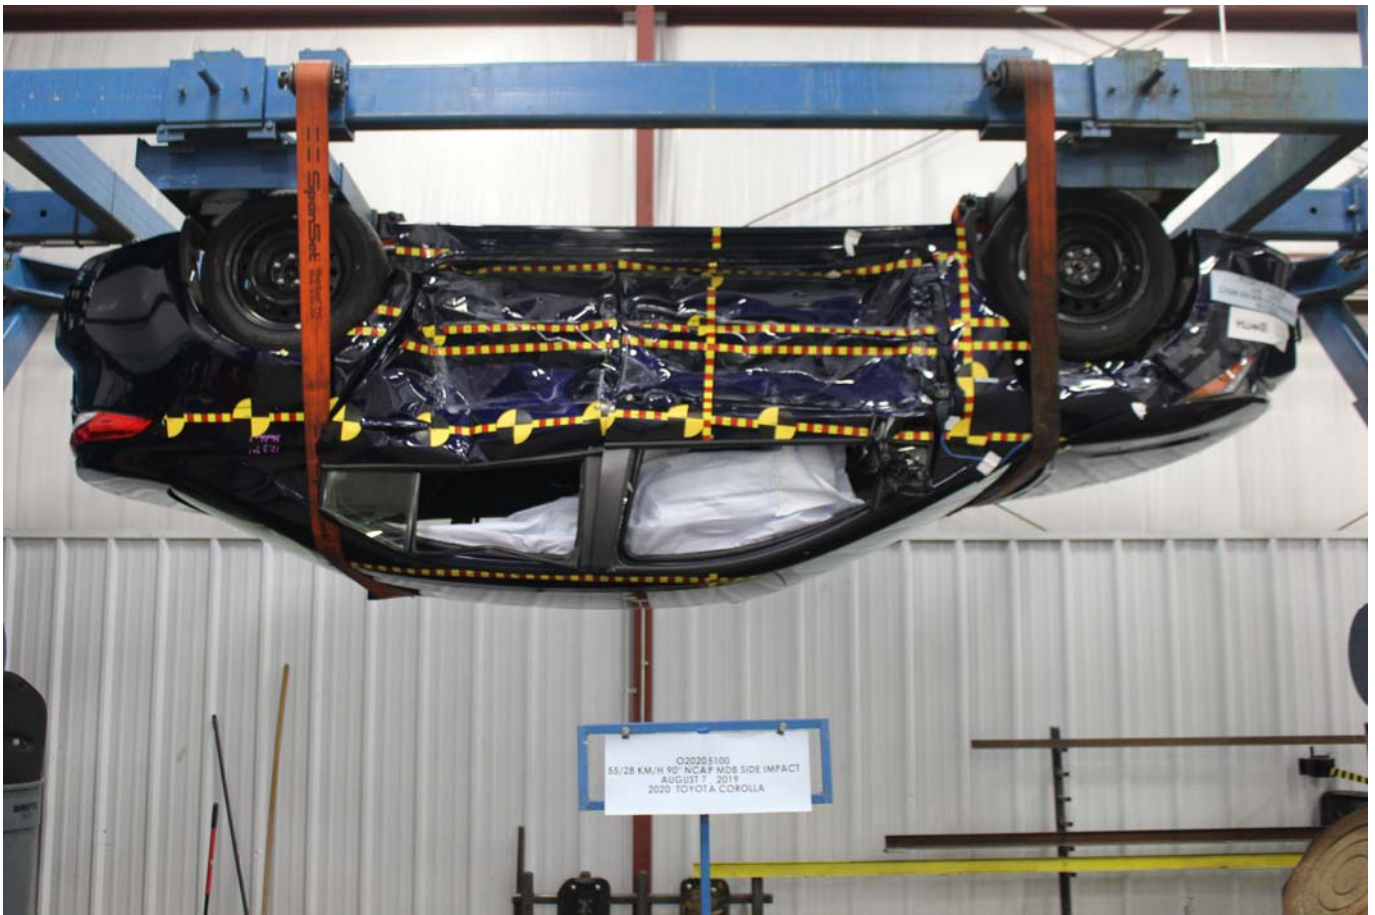
Photo No. 098 - FMVSS Photo No. 301 Static Rollover 180 Degrees

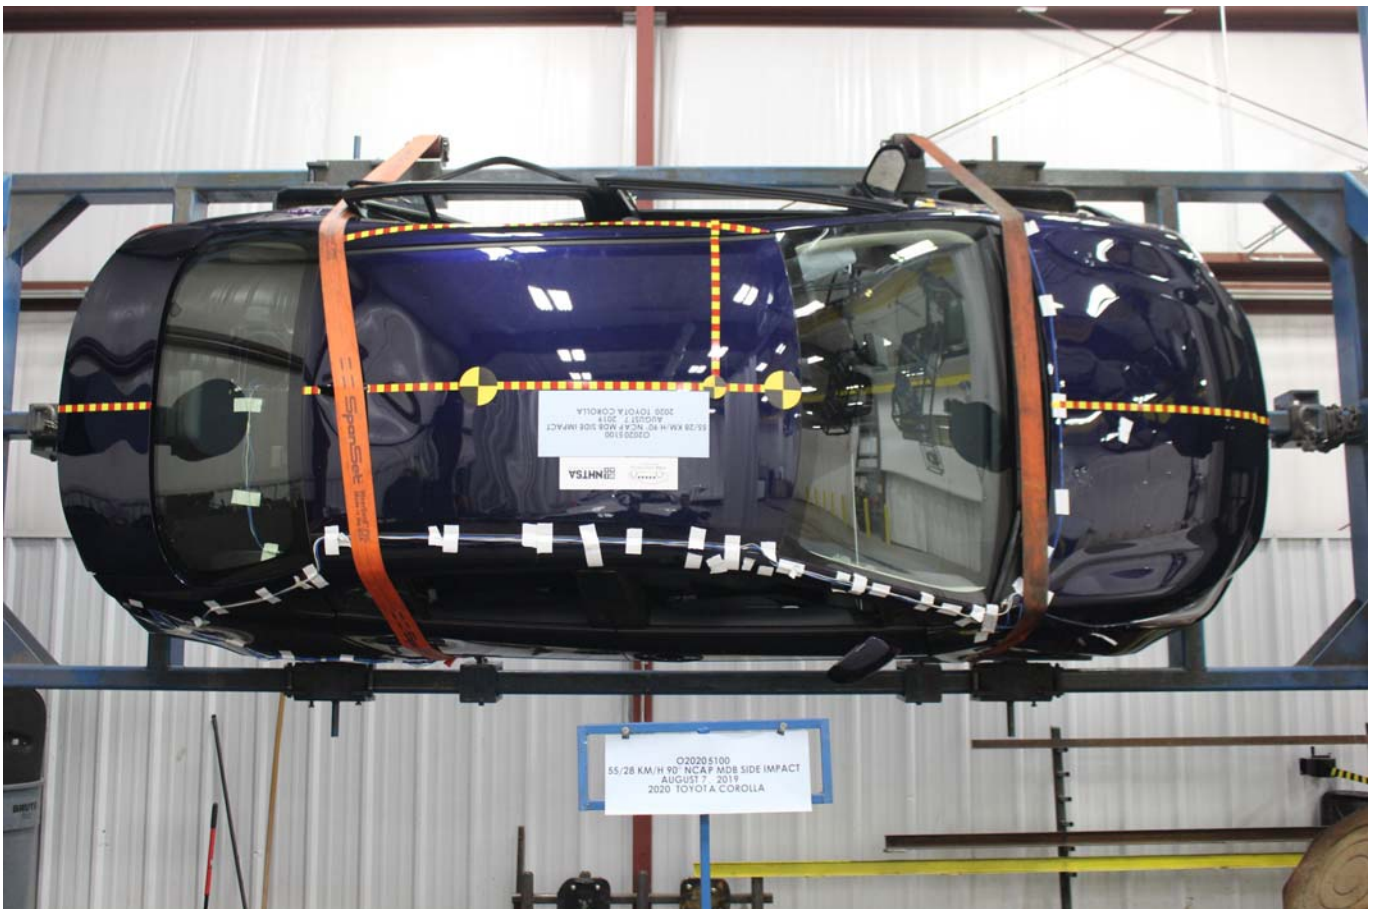
Photo No. 099 - FMVSS Photo No. 301 Static Rollover 270 Degrees

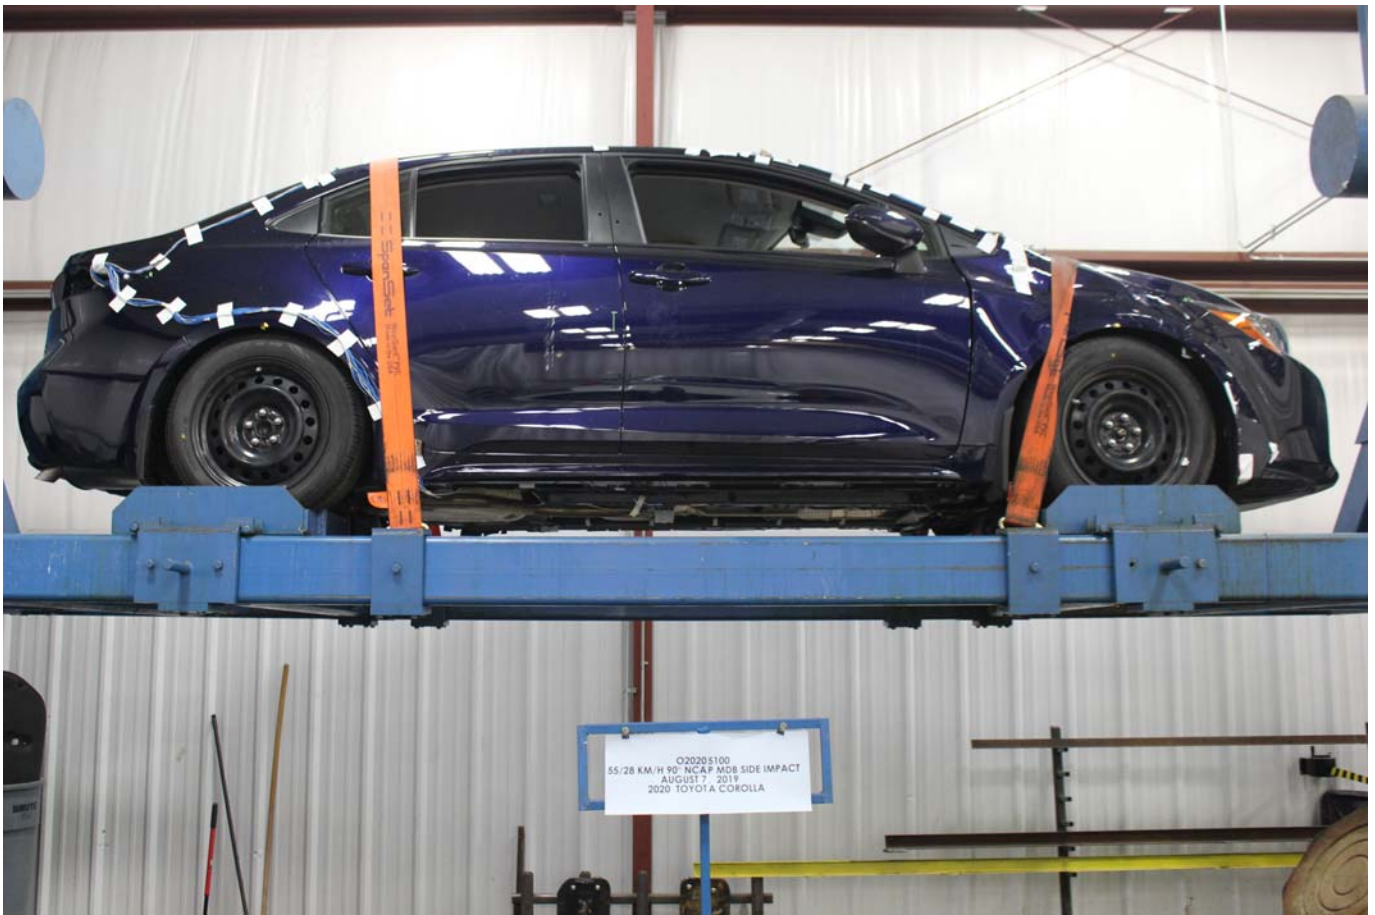
Photo No. 100 - FMVSS Photo No. 301 Static Rollover 360 Degrees

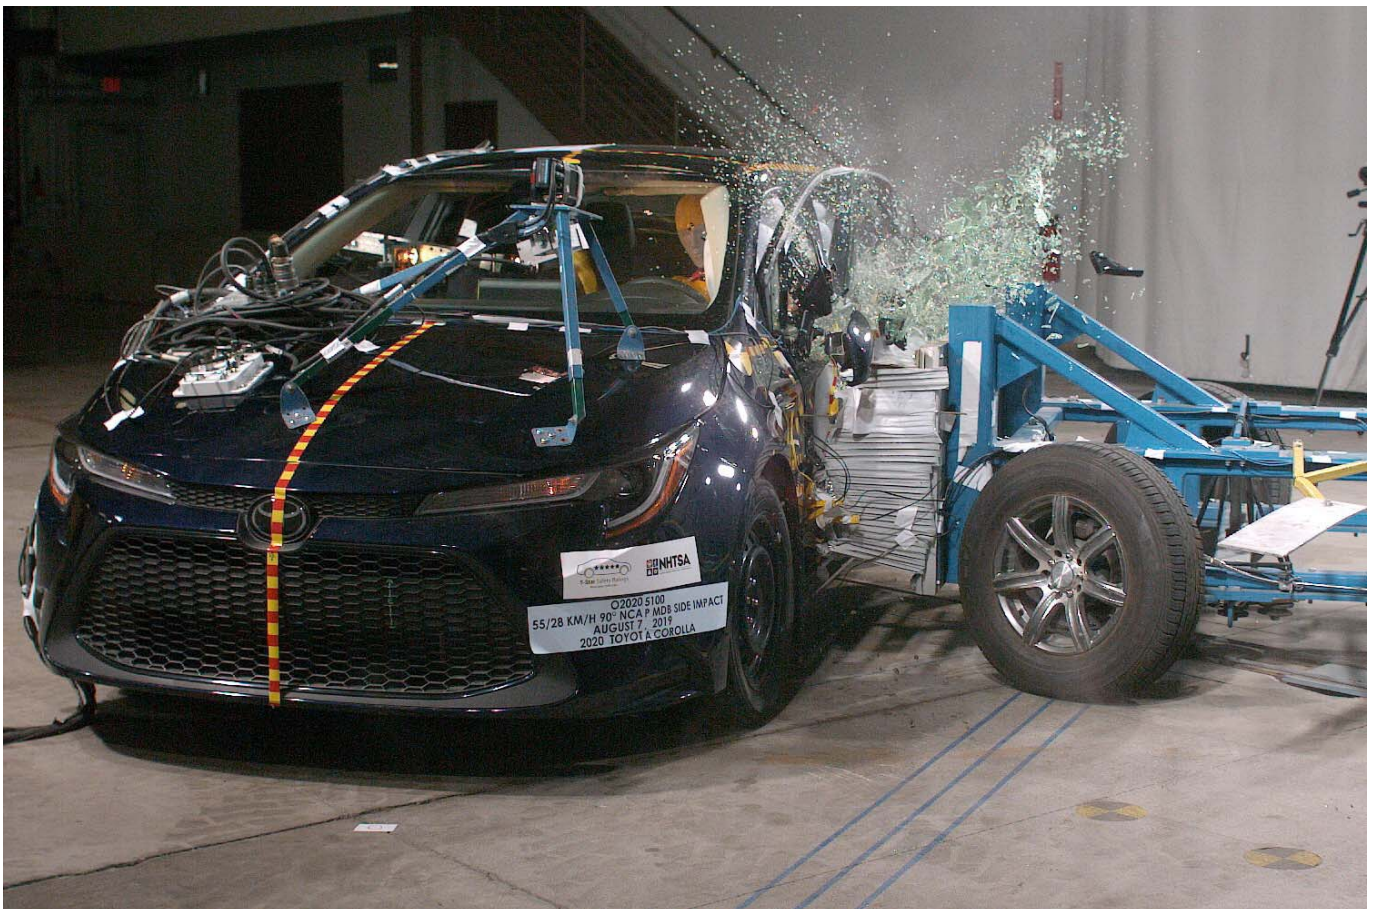
Photo No. 101 - Impact Event

A 55/28 km/h 90° Moving Deformable Barrier NCAP Side Impact Test was conducted on the 2020 Toyota Corolla LE 4-Door Sedan in accordance with the specifications of the Office of Crashworthiness Standards NCAP Side Laboratory Test Procedure for the generation of consumer information on vehicle side crash protection. The test was conducted at MGA Research Corporation in Burlington, Wisconsin on August 7, 2019.
