**REPORT NUMBER: SPNCAP-CAL-20-001**

**NEW CAR ASSESSMENT PROGRAM (NCAP)  
SIDE IMPACT POLE TEST**

**Mitsubishi Motors Corporation  
2020 Mitsubishi Eclipse Cross  
SUV**

**FINAL REPORT**

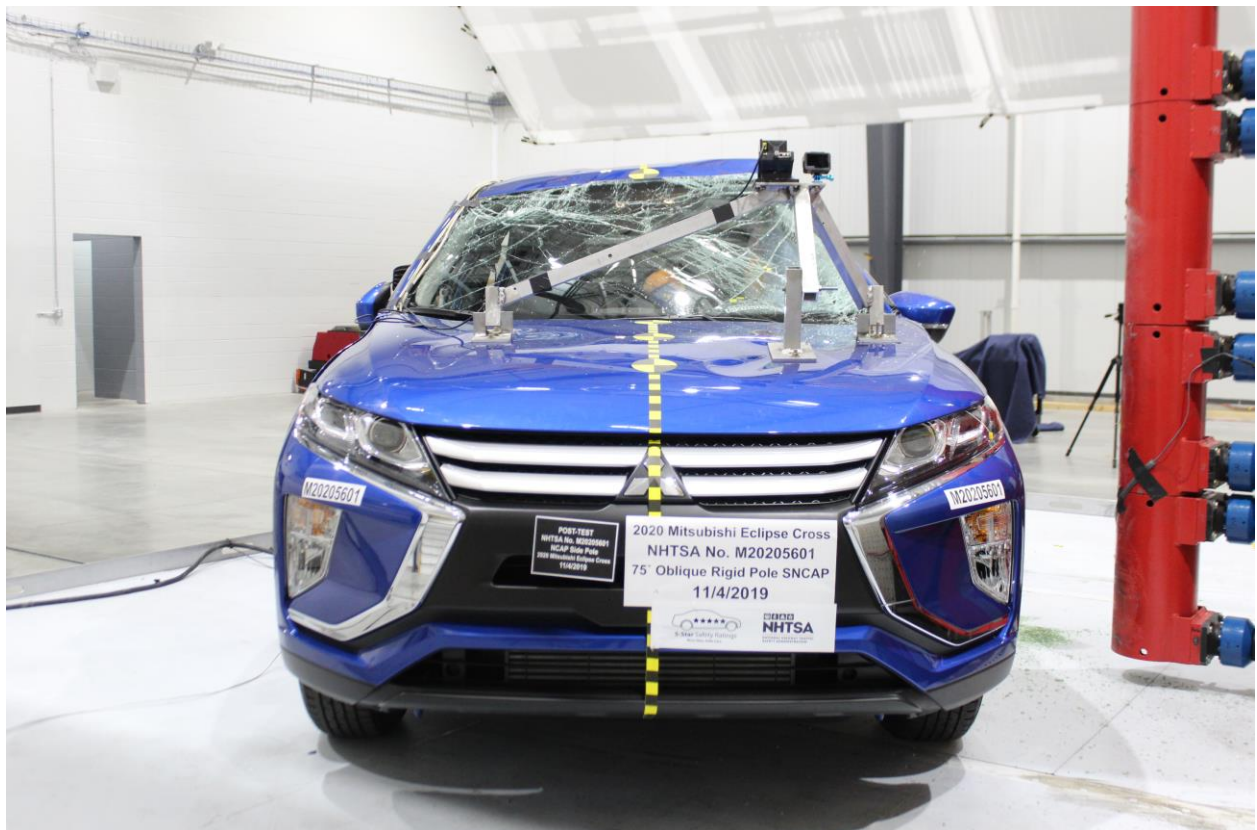
**Figure A-4: Post-Test Frontal View of Test Vehicle**

| Critical Areas of Performance | Observations and Conclusions |
|---|---|
| Windshield Damage | Cracks throughout |

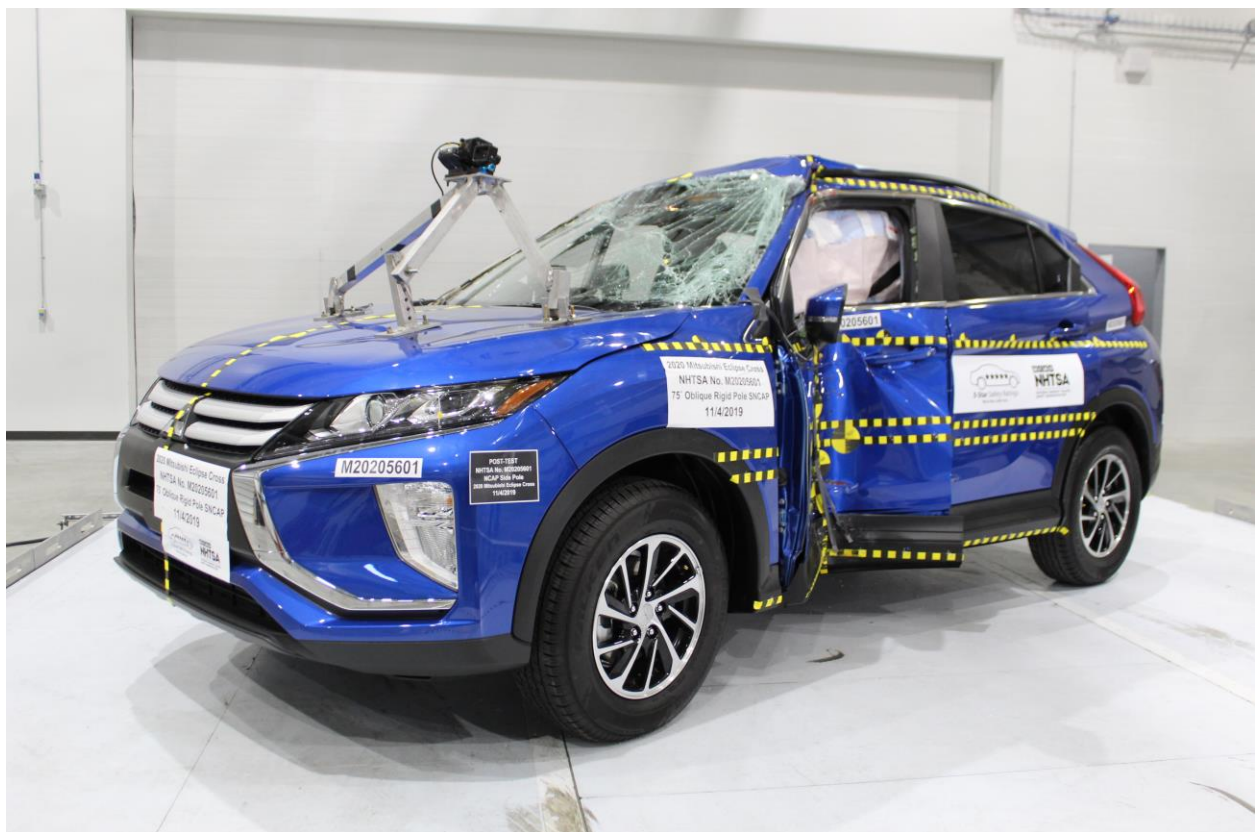
**Figure A-6: Post-Test Left Front  $\frac{3}{4}$  View of Test Vehicle**

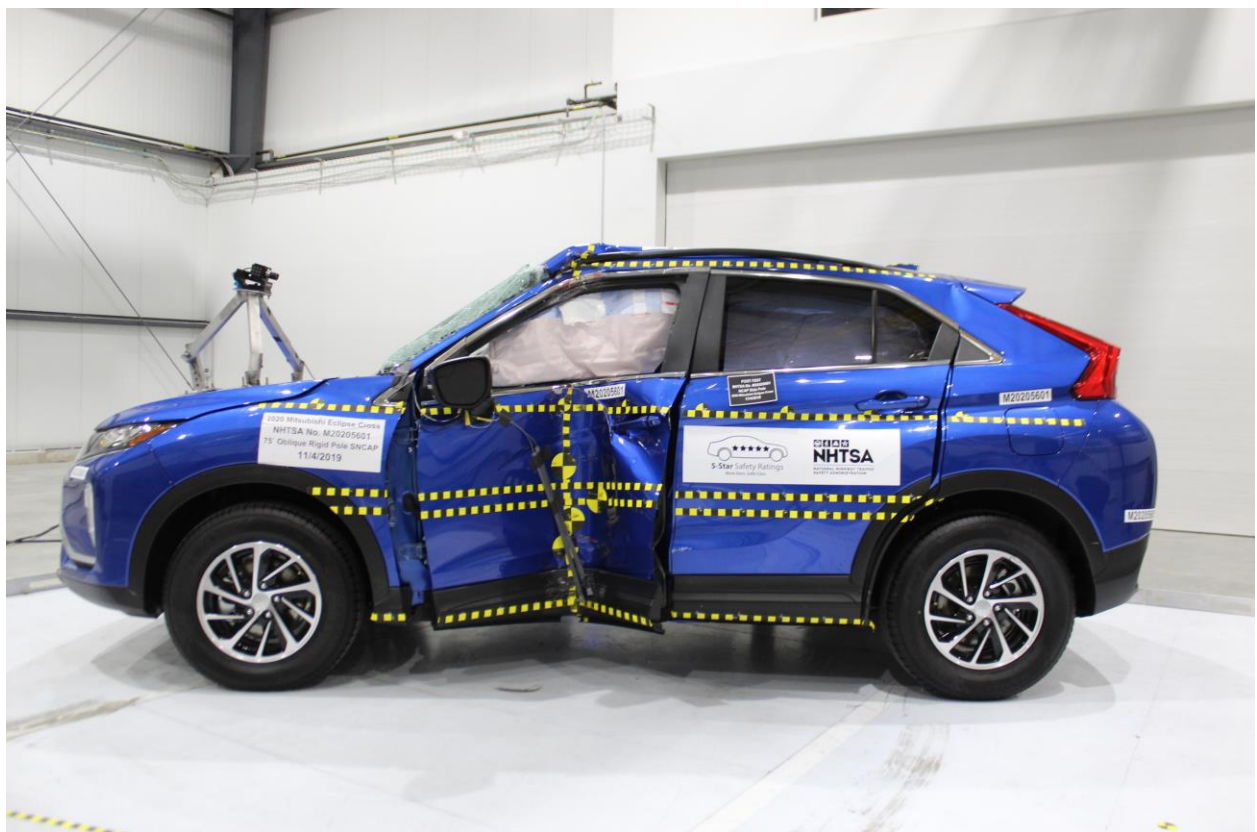
**Figure A-8: Post-Test Left Side View of Test Vehicle**

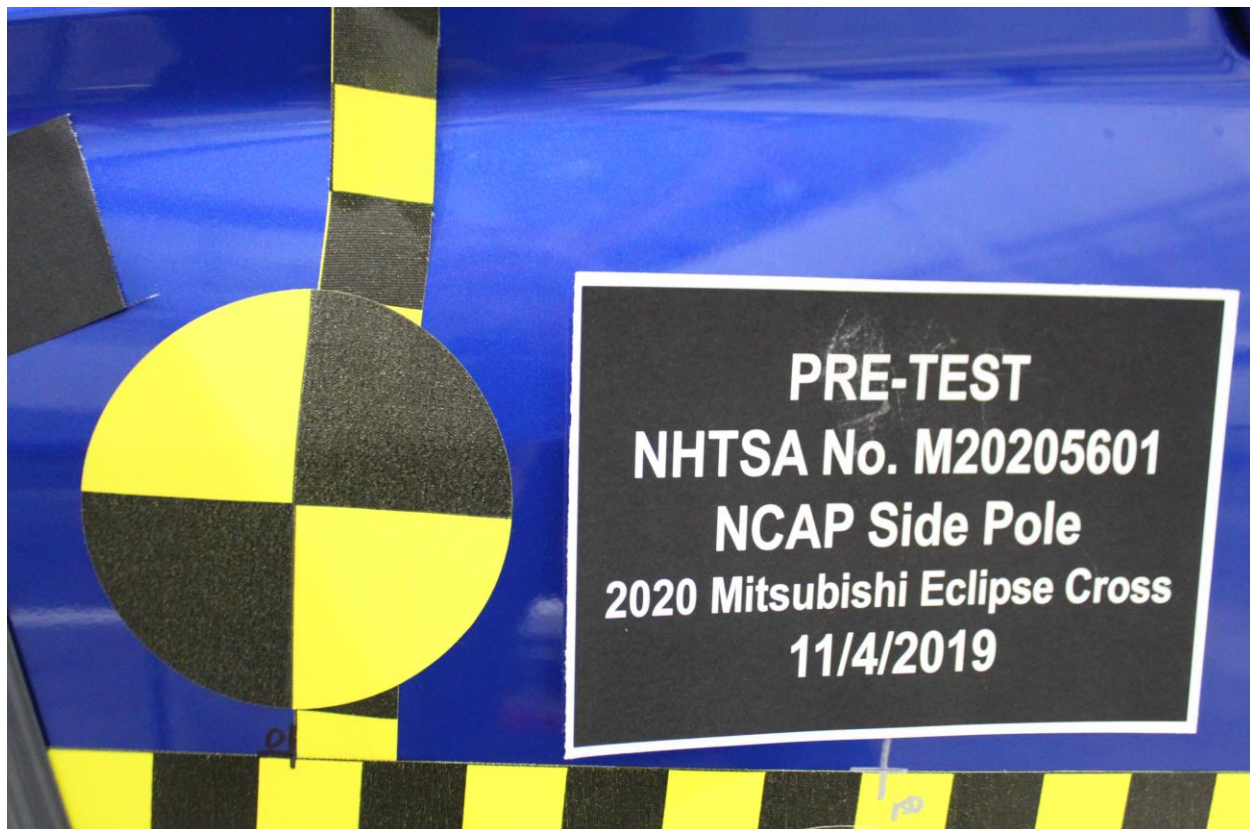
Figure A-19: Pre-Test Close-Up View of Impact Point Target

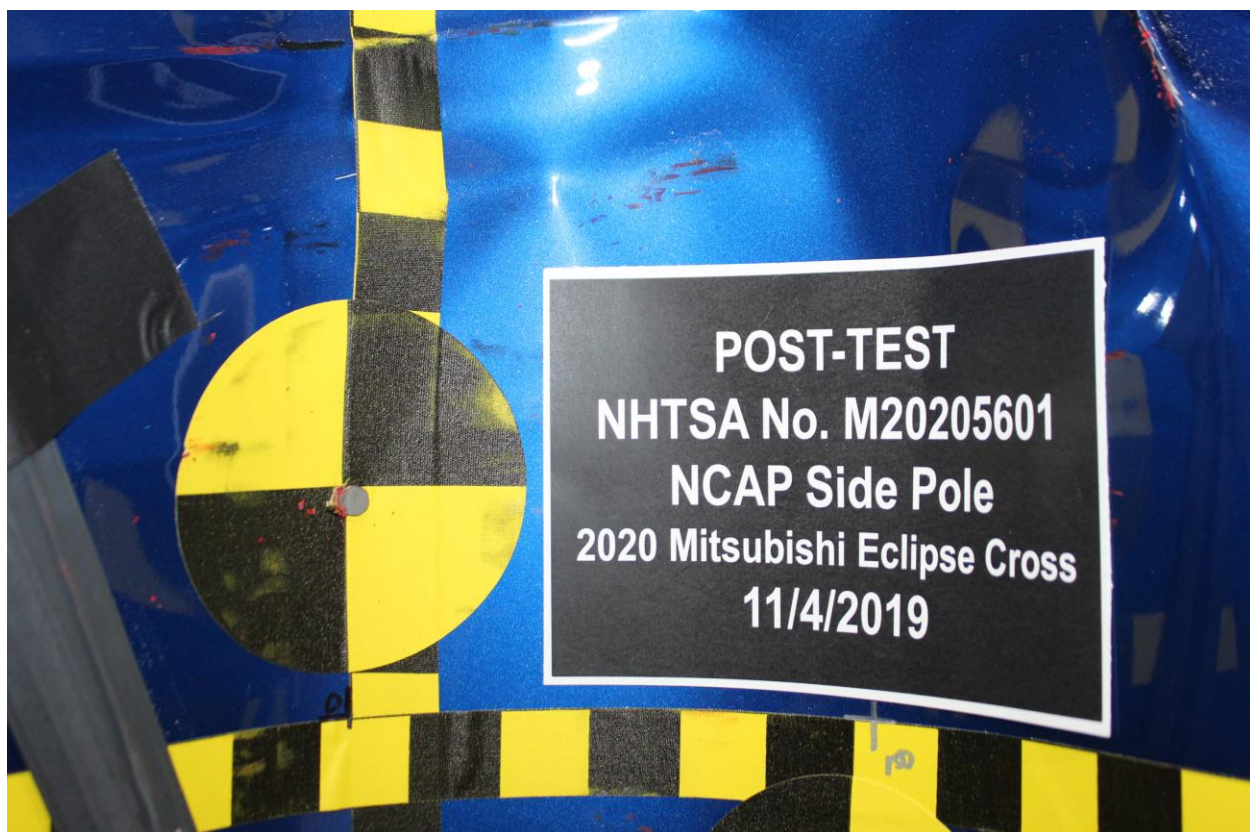
Figure A-20: Post-Test Close-Up View of Impact Point Target Showing Impact Location

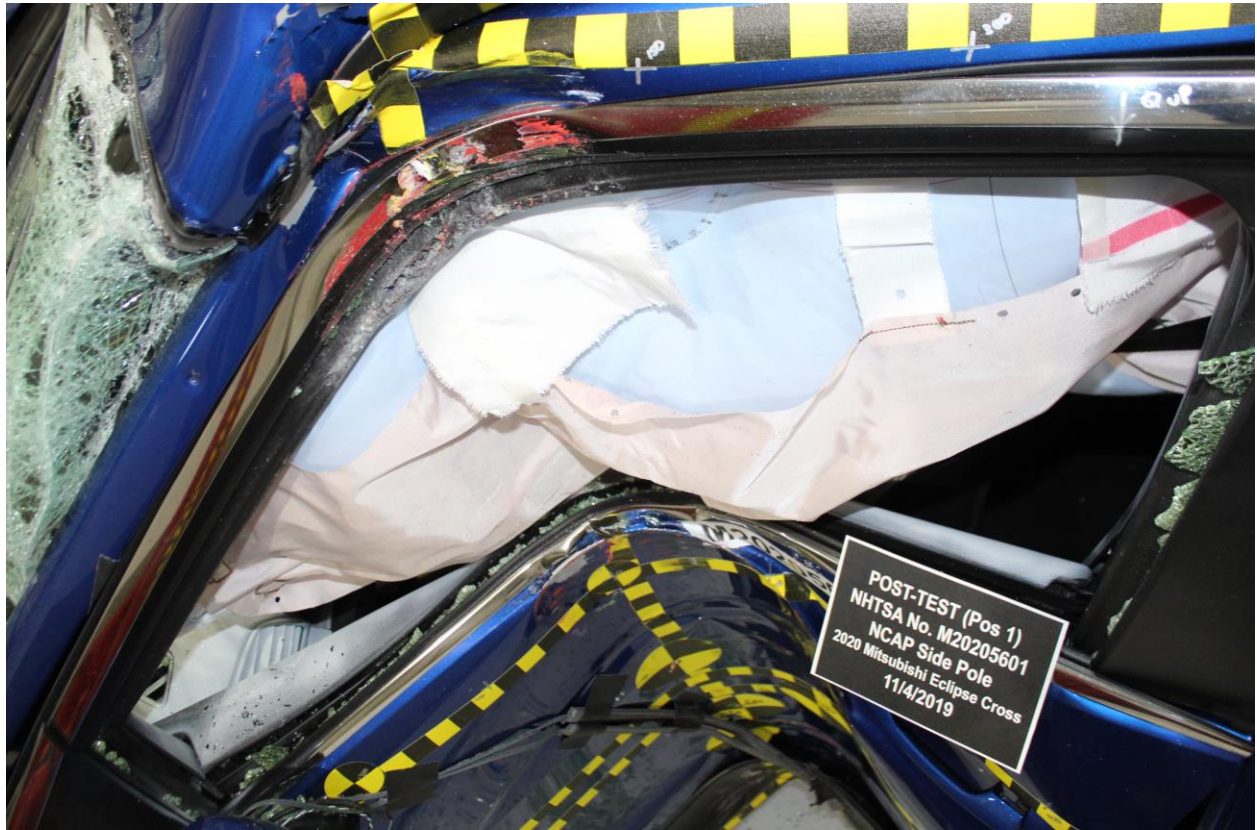
**Figure A-41: Post-Test Dummy and Door Clearance View**

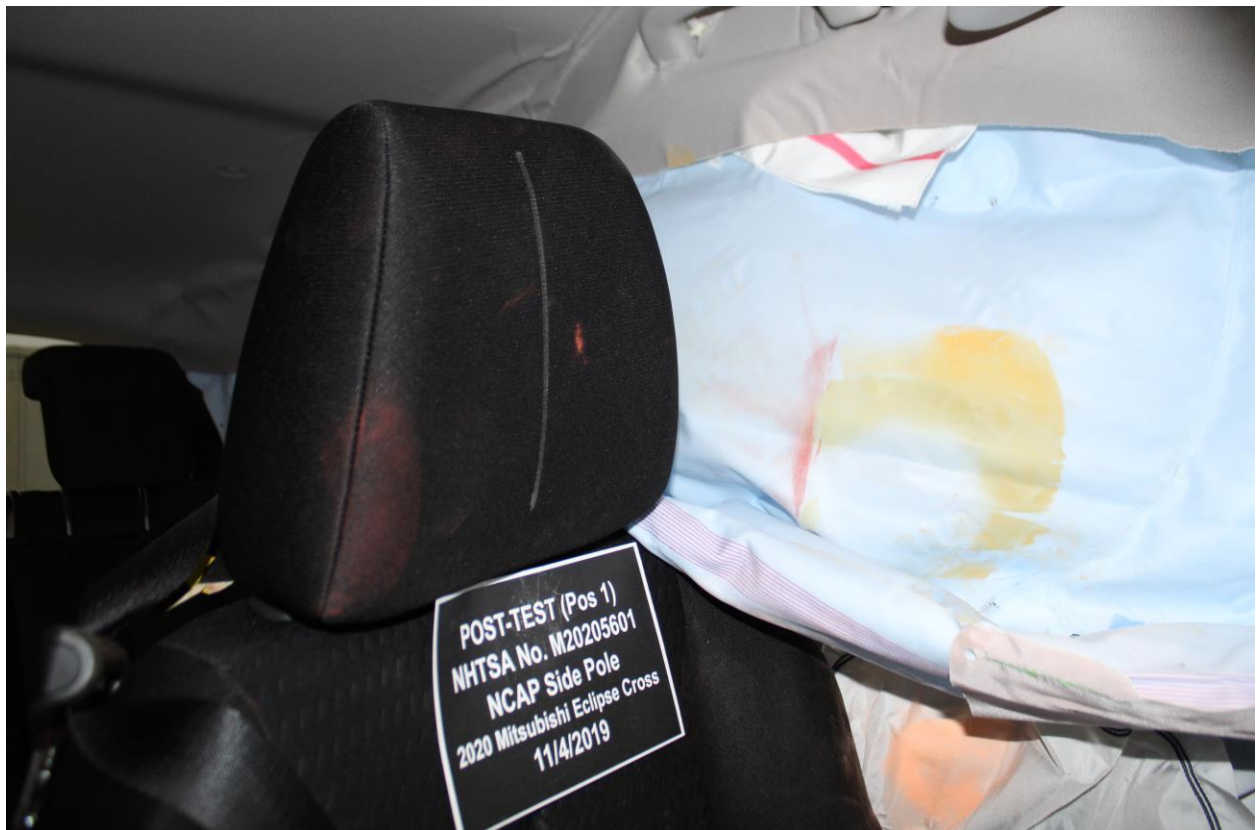
**Figure A-46: Post-Test Dummy Close-Up Head Contact with Vehicle Interior View**

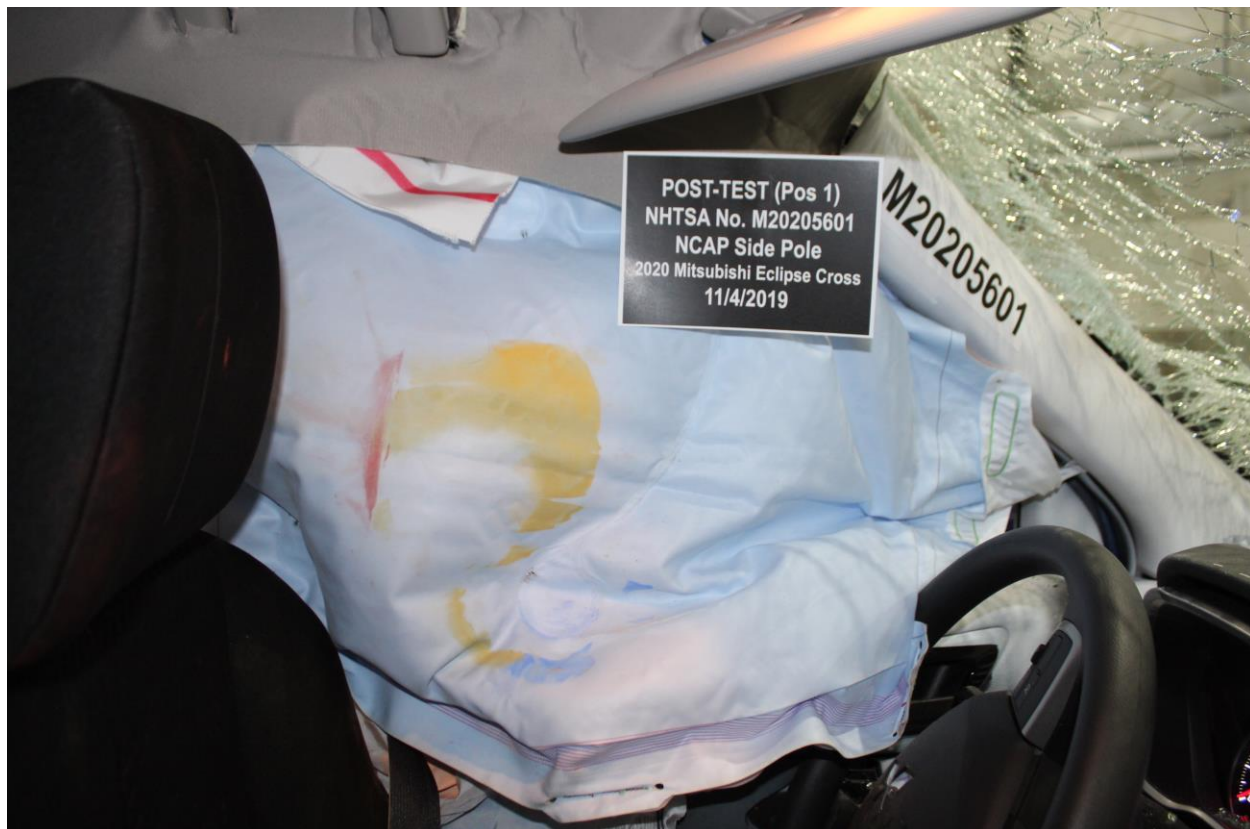
**Figure A-47: Post-Test Dummy Close-Up Head Contact with Side Airbag View**

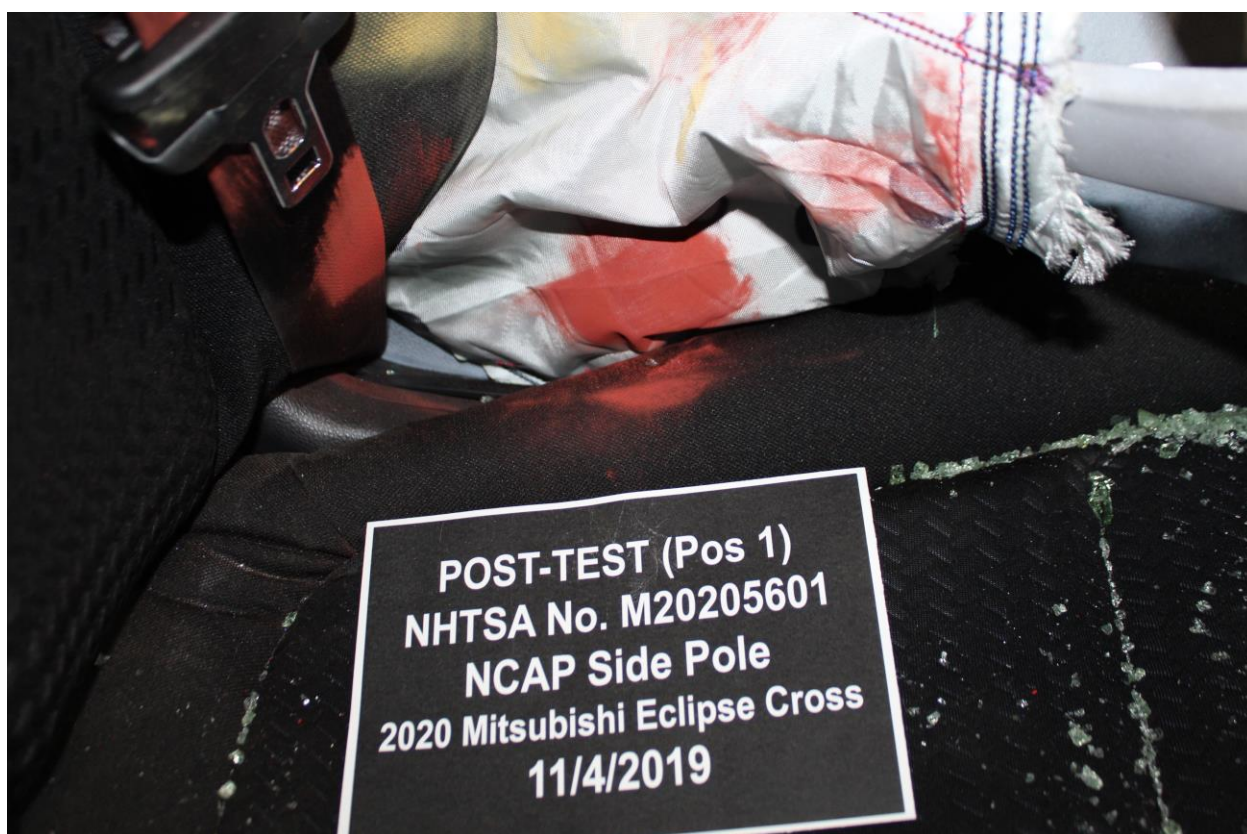
**Figure A-50: Post-Test Dummy Close-Up Pelvis Contact with Vehicle Interior View**

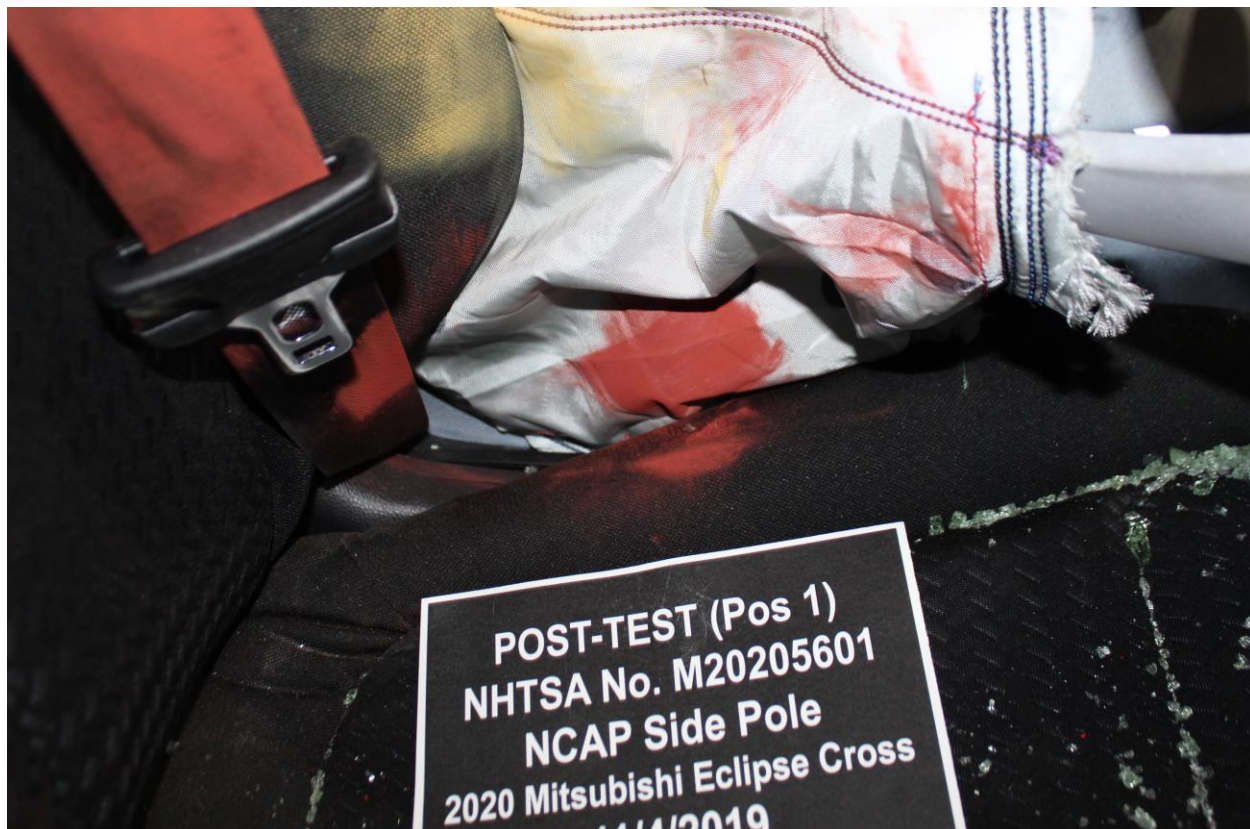
**Figure A-51: Post-Test Dummy Close-Up Pelvis Contact with Side Airbag View**

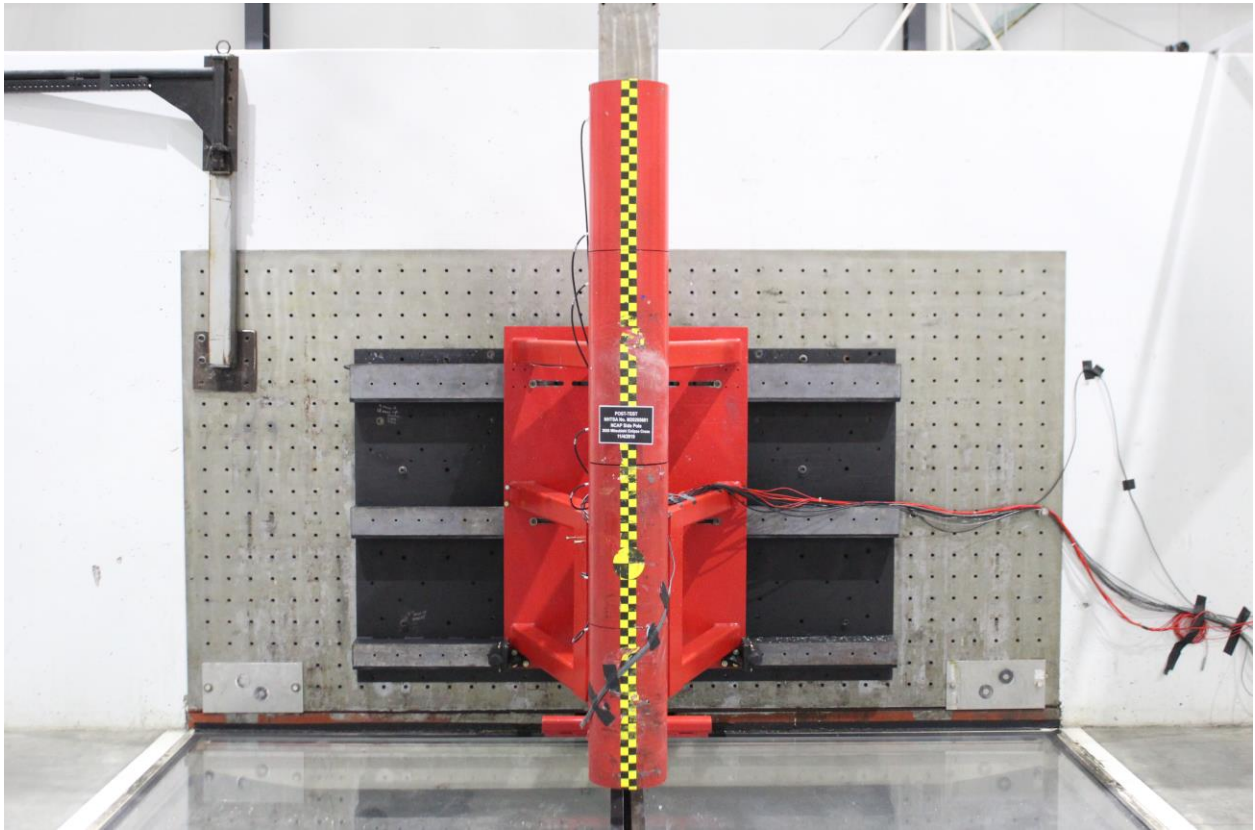
**Figure A-58: Post-Test Pole Barrier Front View**

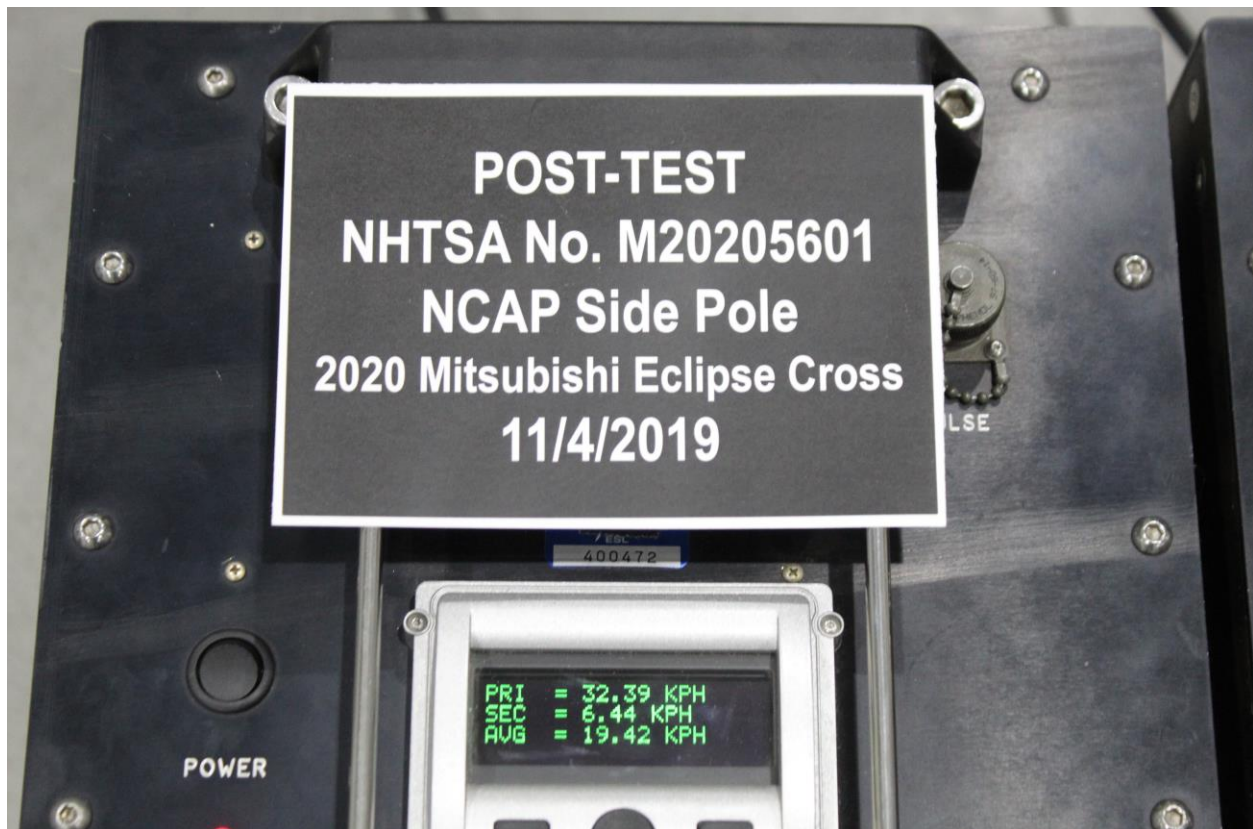
**Figure A-62: Post-Test Primary and Redundant Speed Trap Read-Out**

A rigid pole side impact test was conducted on a 2020 Mitsubishi Eclipse Cross SUV. The subject vehicle was towed into the rigid pole at an angle of 75° and a velocity of 32.39 km/h. The test was conducted by Calspan Corporation's Transportation Test Operations facility in Buffalo, New York on November 4, 2019. Pre-test and post-test photographs of the test vehicle and side impact dummy (SID-IIs) are included in Appendix A of this report.

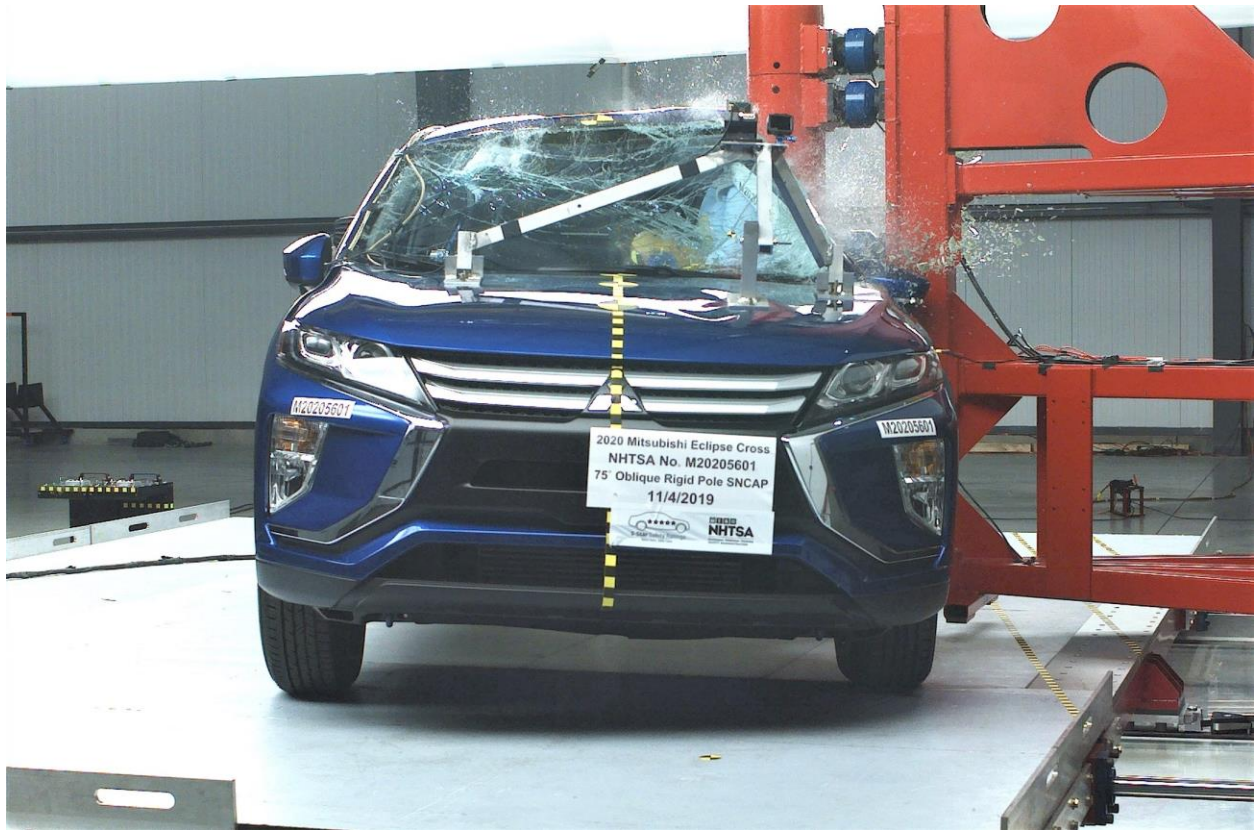
Figure A-68: Impact Event

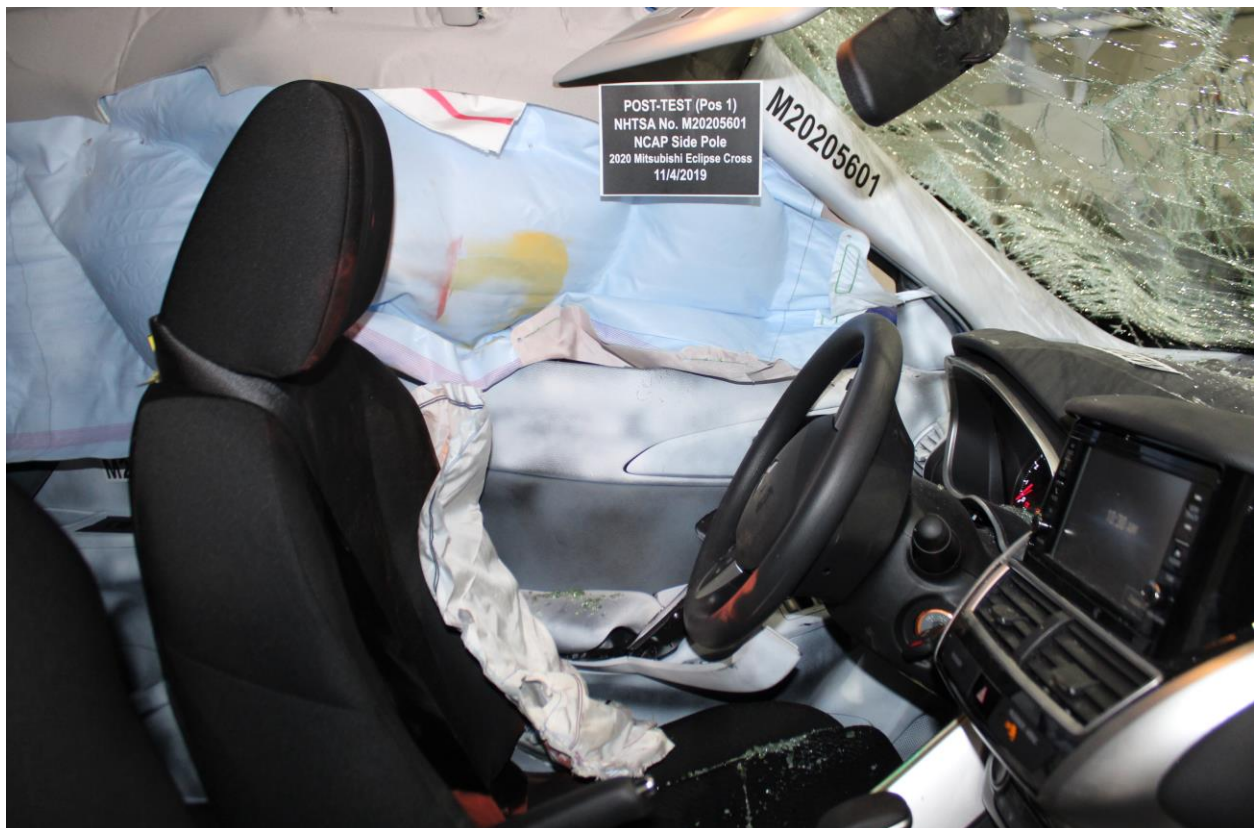
**Figure A-71: Post-Test View of Shattered Vehicle Inner Door Panel (if applicable)**

| Critical Areas of Performance | Observations and Conclusions |
|---|---|
| Side Window Damage | Driver Window Shattered |
