REPORT NUMBER: SINCAP-MGA-20-004

**NEW CAR ASSESSMENT PROGRAM (NCAP)
Moving Deformable Barrier Side Impact Test**

**KIA MOTORS MANUFACTURING GEORGIA, INC.
2020 Kia Telluride S 5-Door SUV
NHTSA No.: M20204220**

**MGA RESEARCH CORPORATION
5000 Warren Road
Burlington, WI 53105**

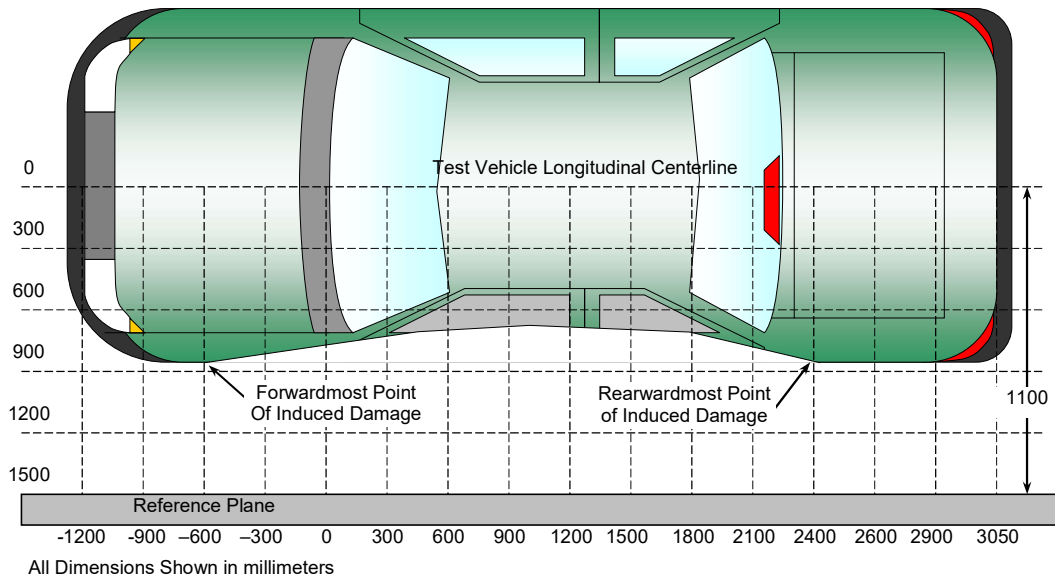
TOP VIEW

VEHICLE DAMAGE PROFILE DISTANCES

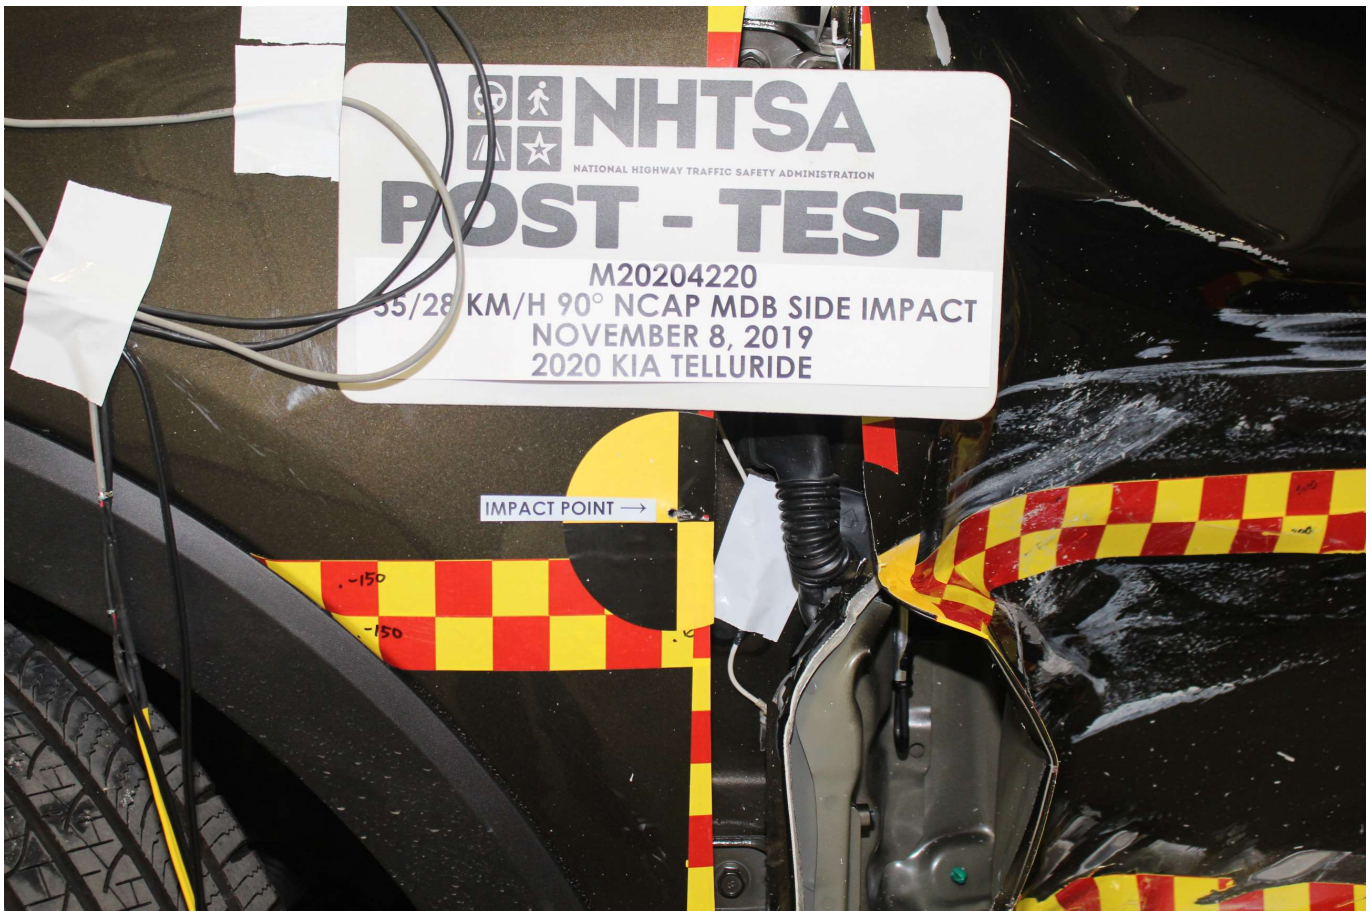
Photo No. 020 - Post-Test Close-Up View of Impact Point Target

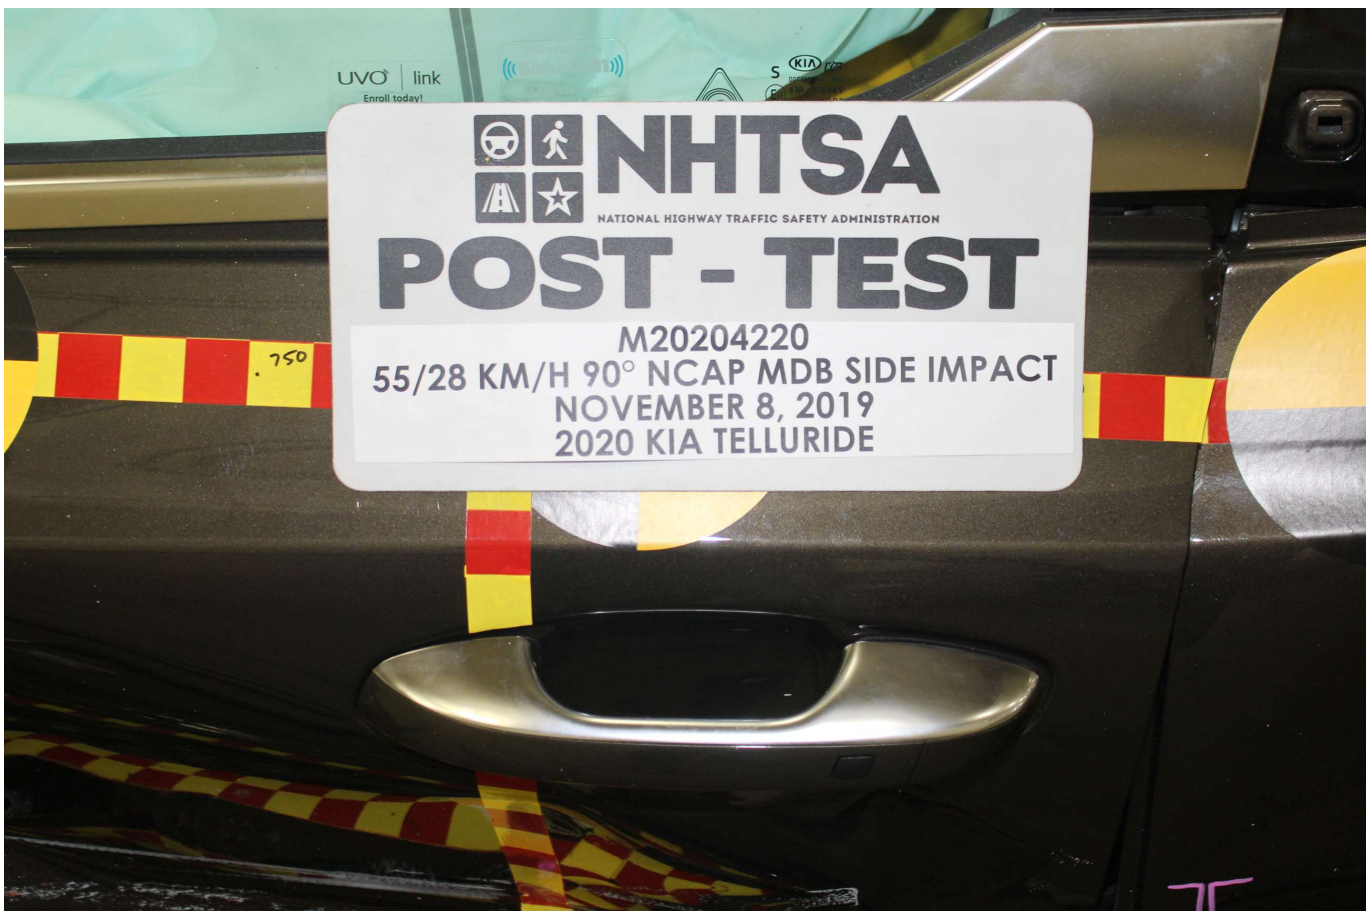
Photo No. 022 - Post-Test Left Front Door Latch Close-Up

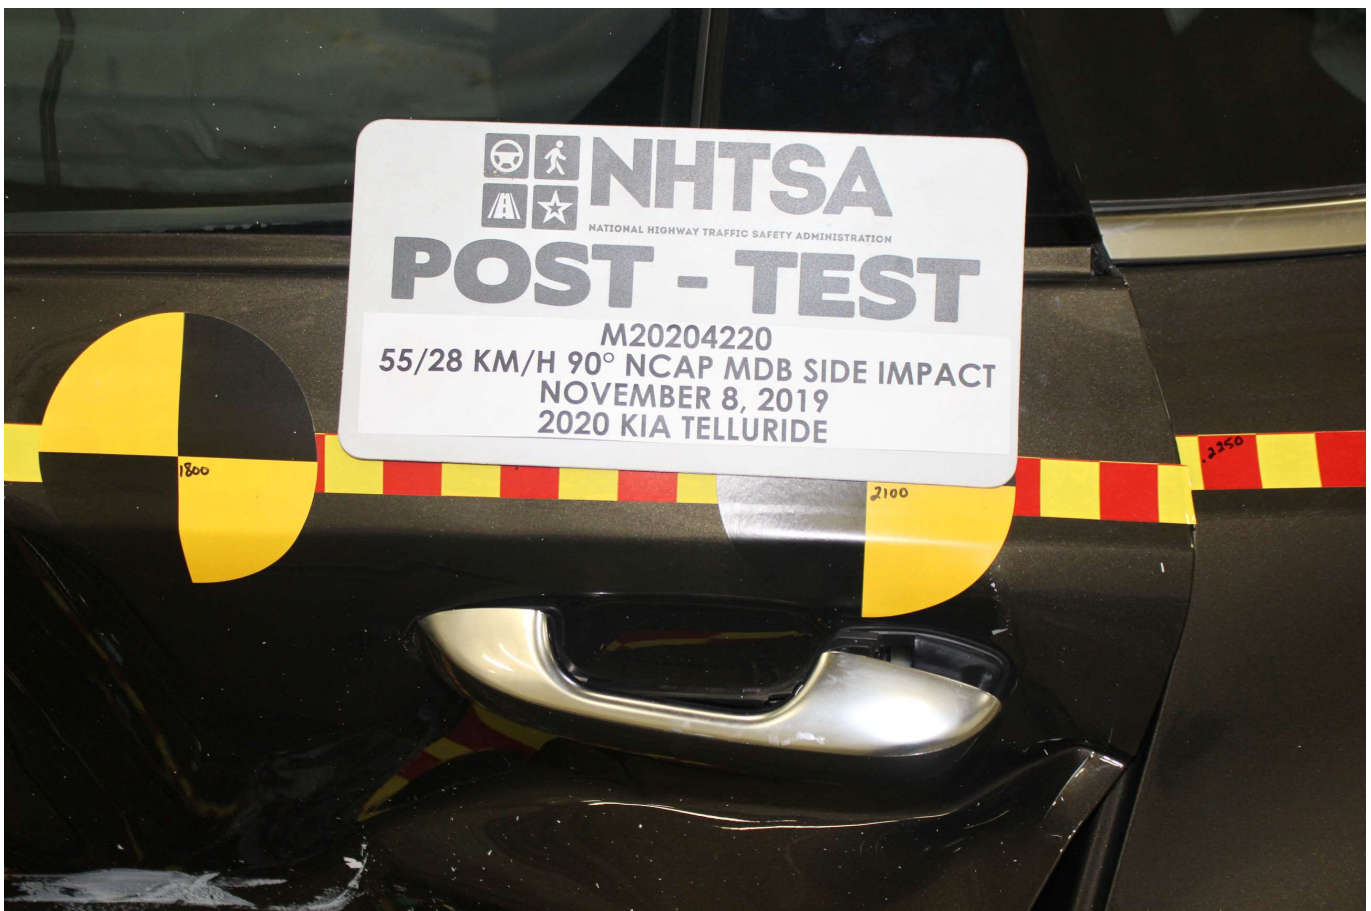
Photo No. 024 - Post-Test Left Rear Door Latch Close-Up

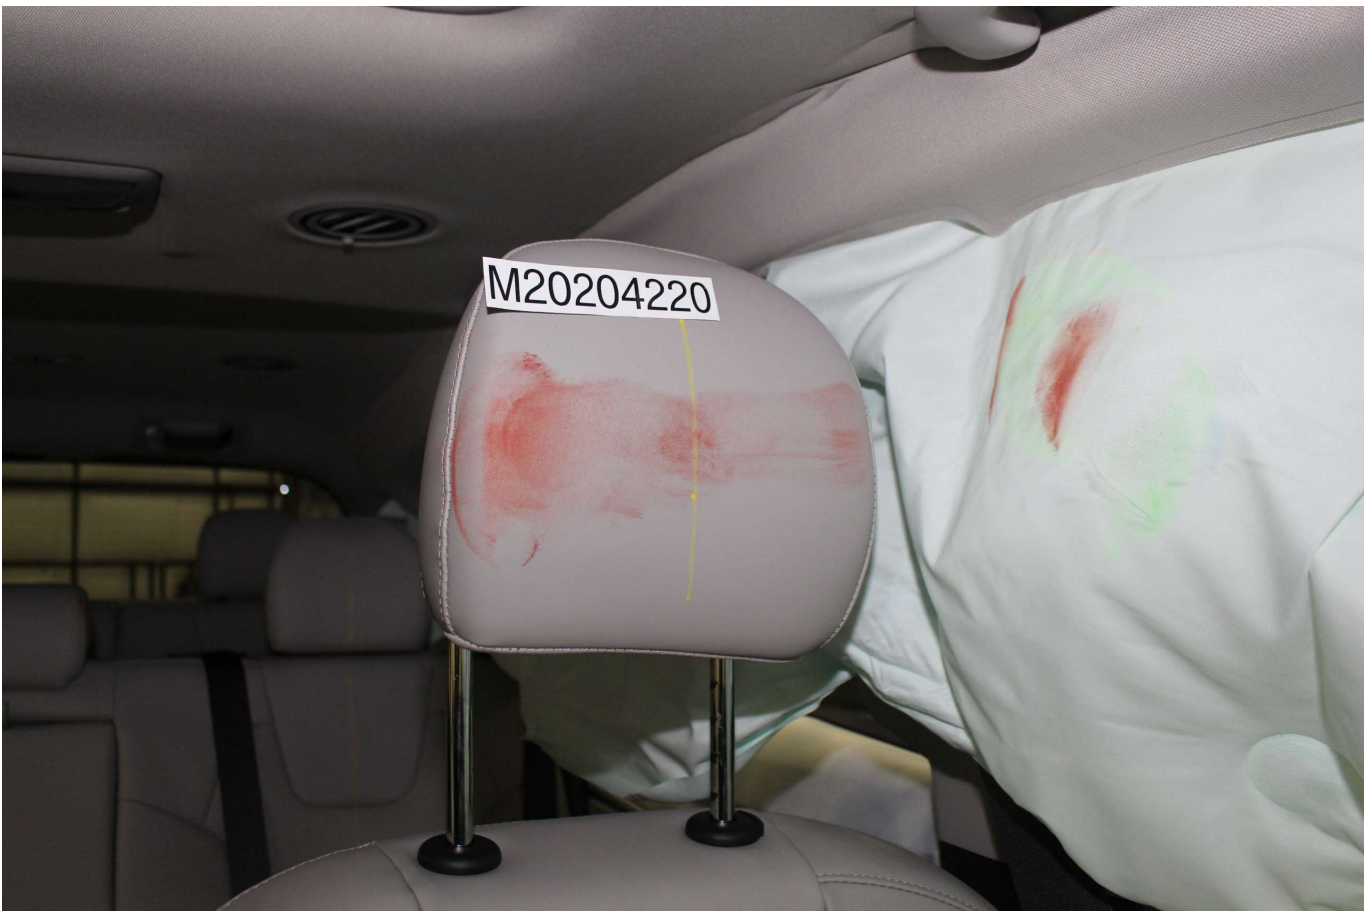
Photo No. 048 - Post-Test Driver Dummy Close-up Head Contact with Vehicle Interior View

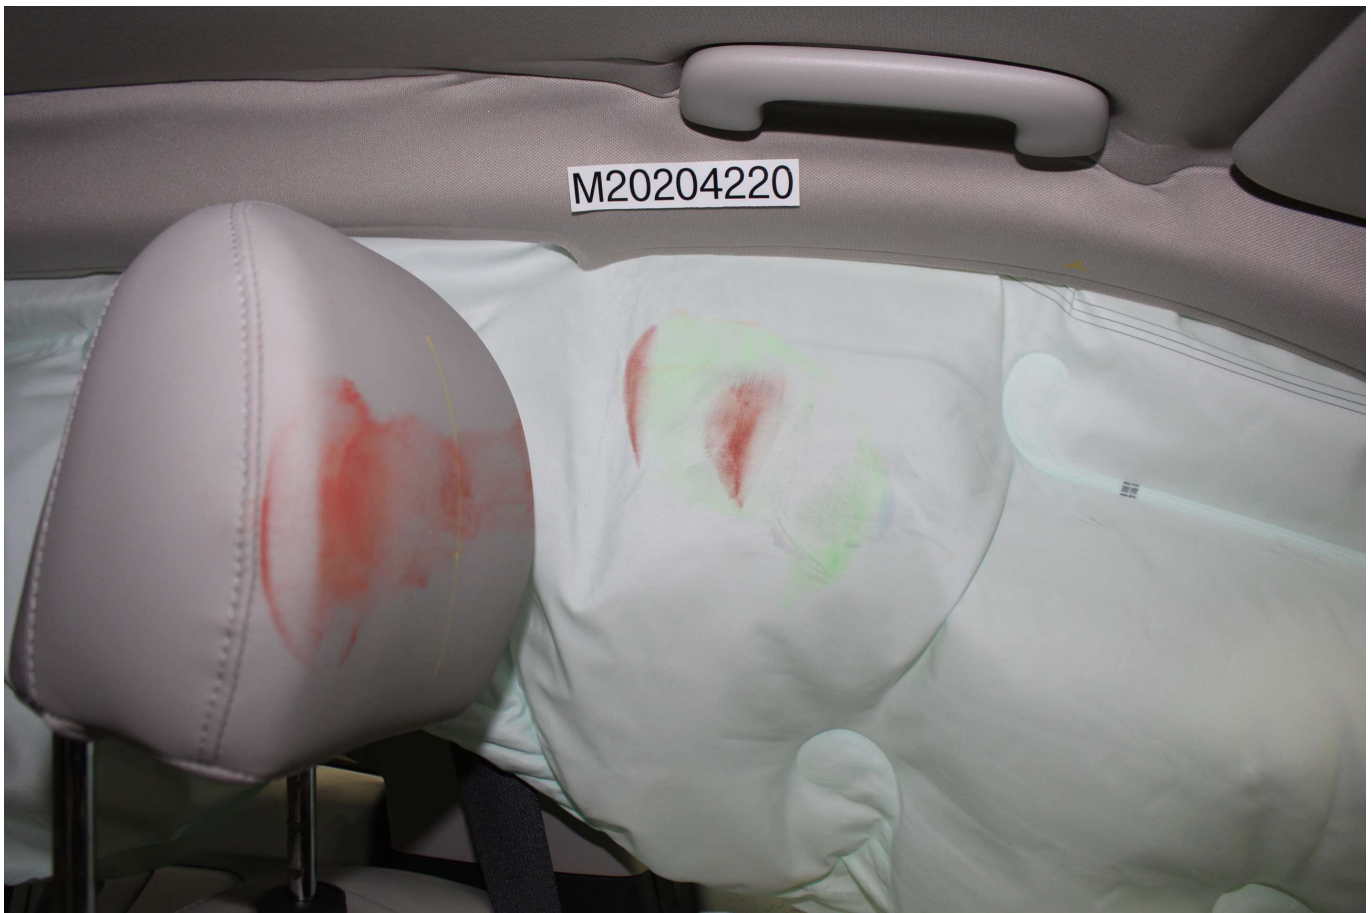
Photo No. 049 - Post-Test Driver Dummy Close-up Head Contact with Side Airbag View

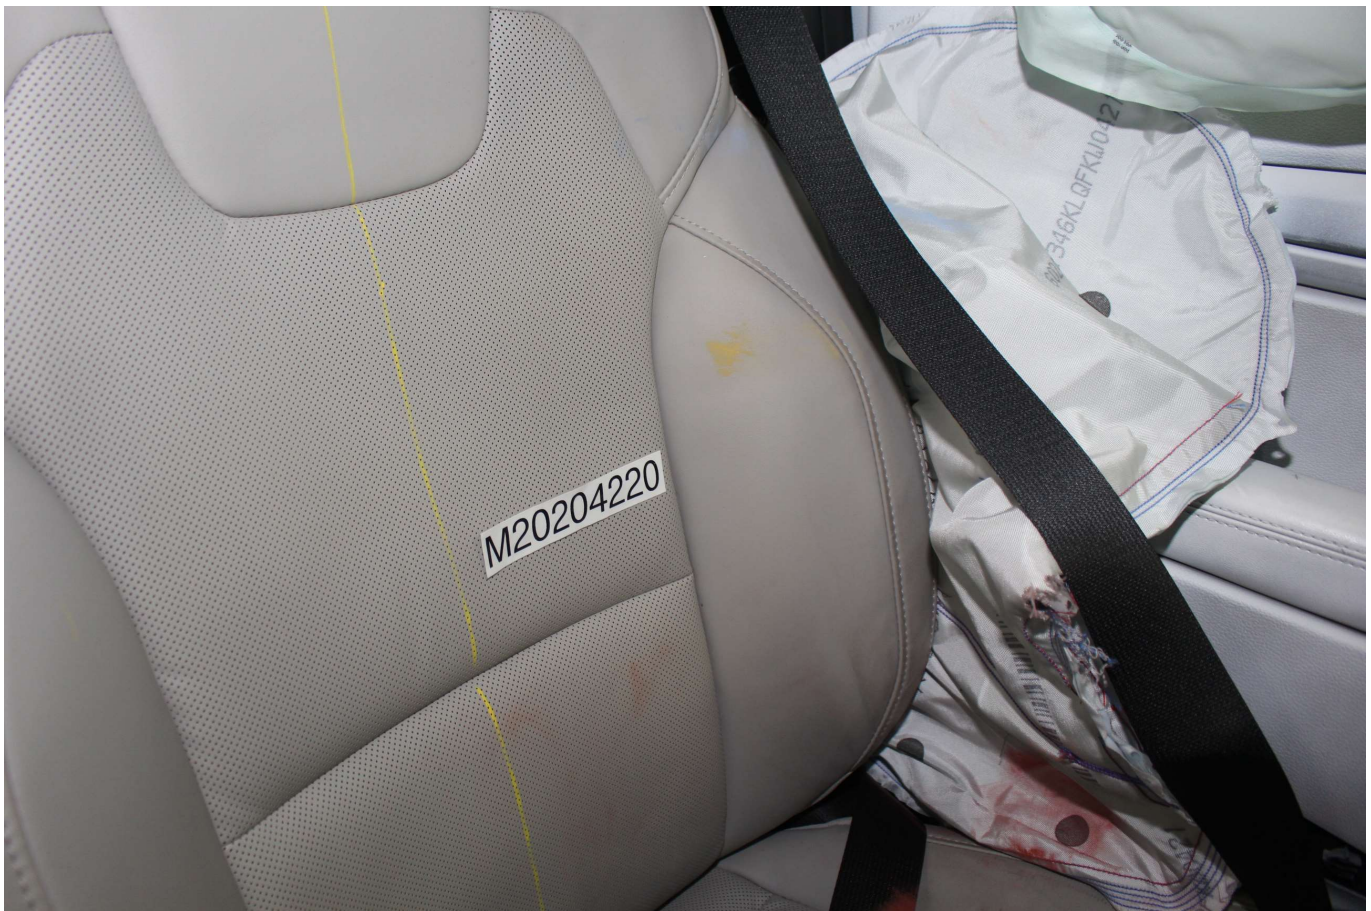
Photo No. 050 - Post-Test Driver Dummy Close-up Torso Contact with Vehicle Interior View

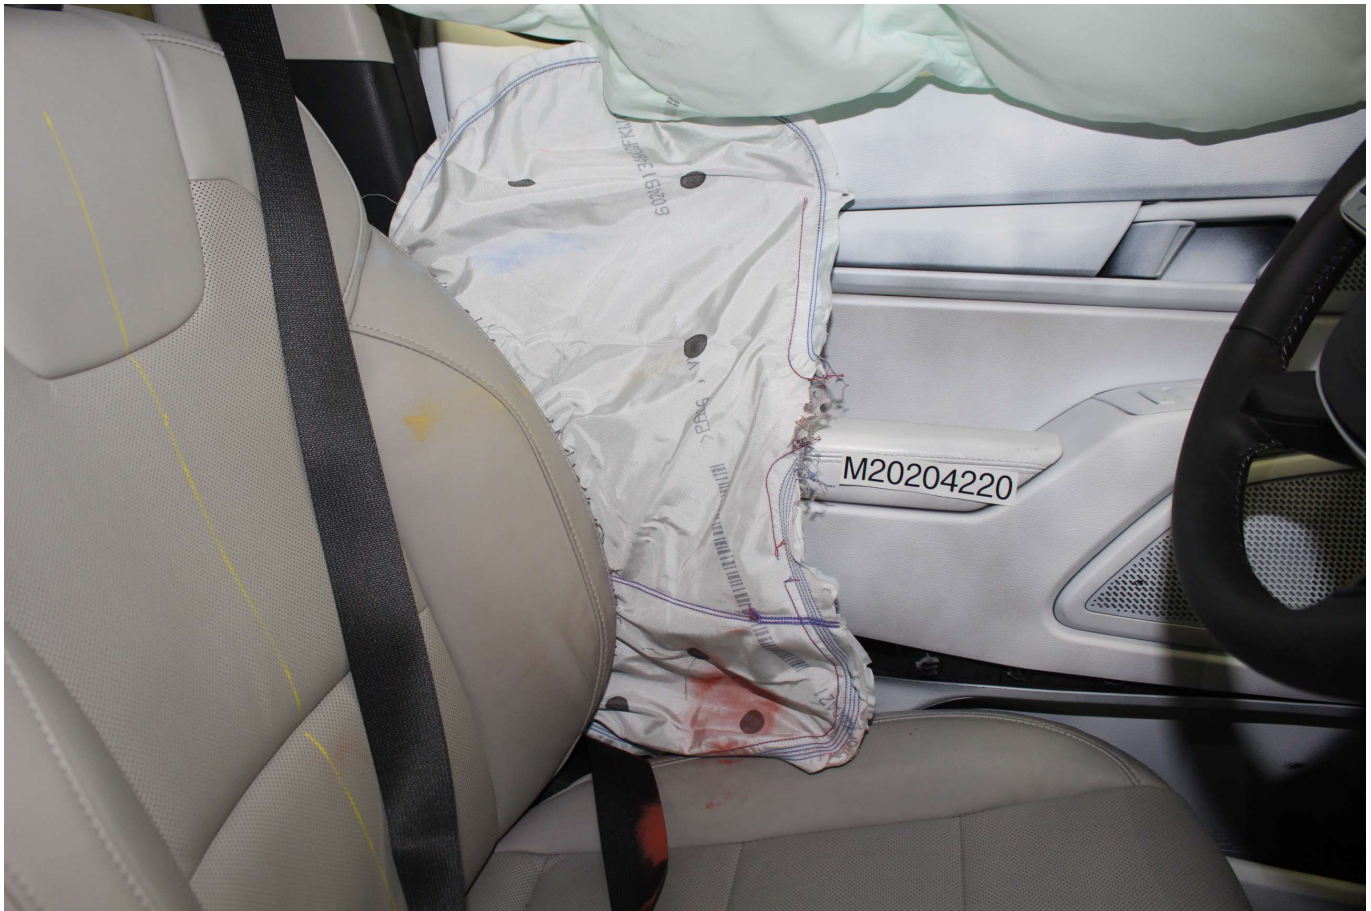
Photo No. 051 - Post-Test Driver Dummy Close-up Torso Contact with Side Airbag View

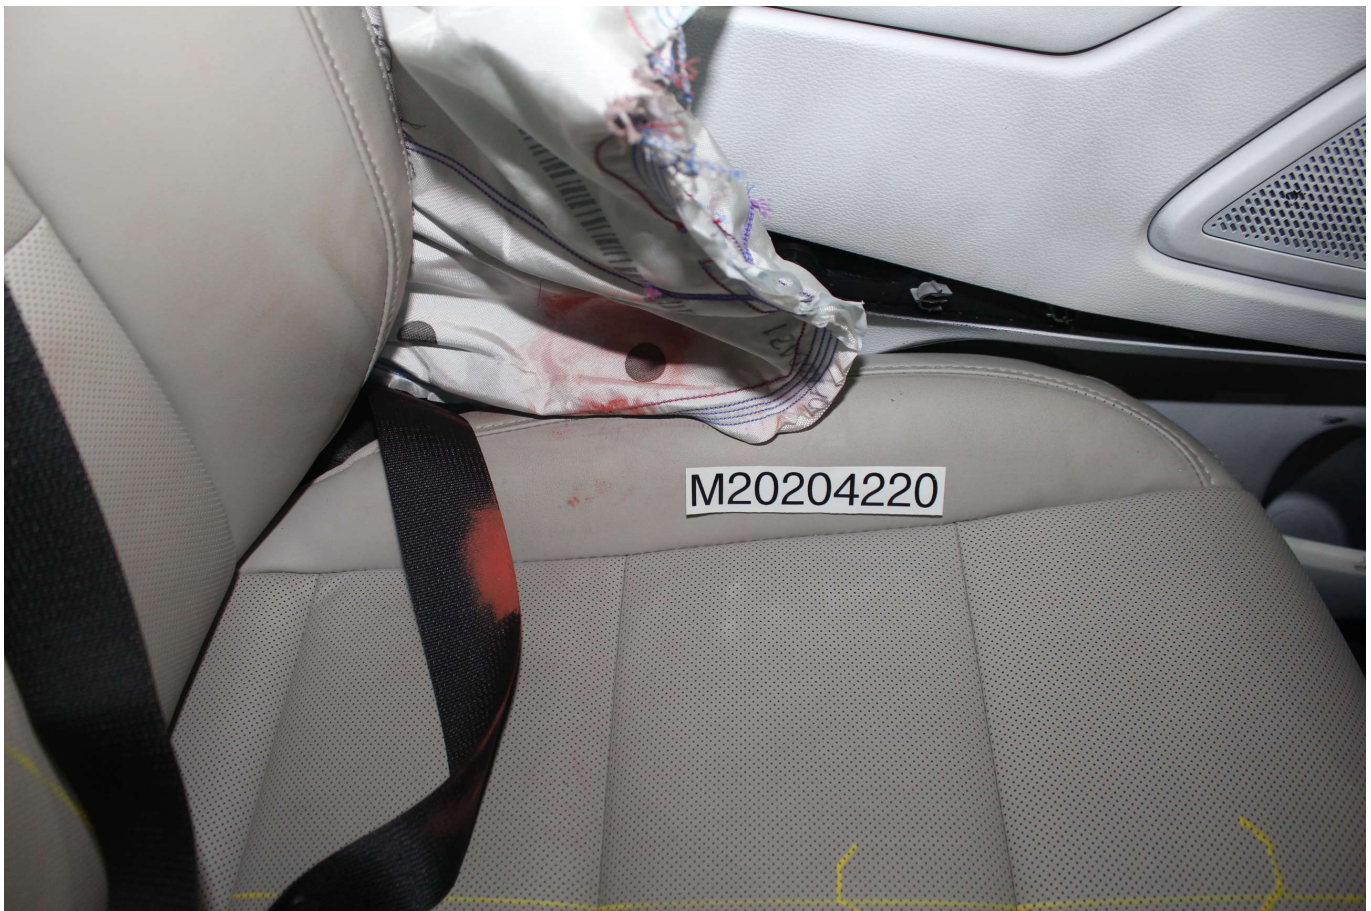
Photo No. 052 - Post-Test Driver Dummy Close-up Pelvis Contact with Vehicle Interior View

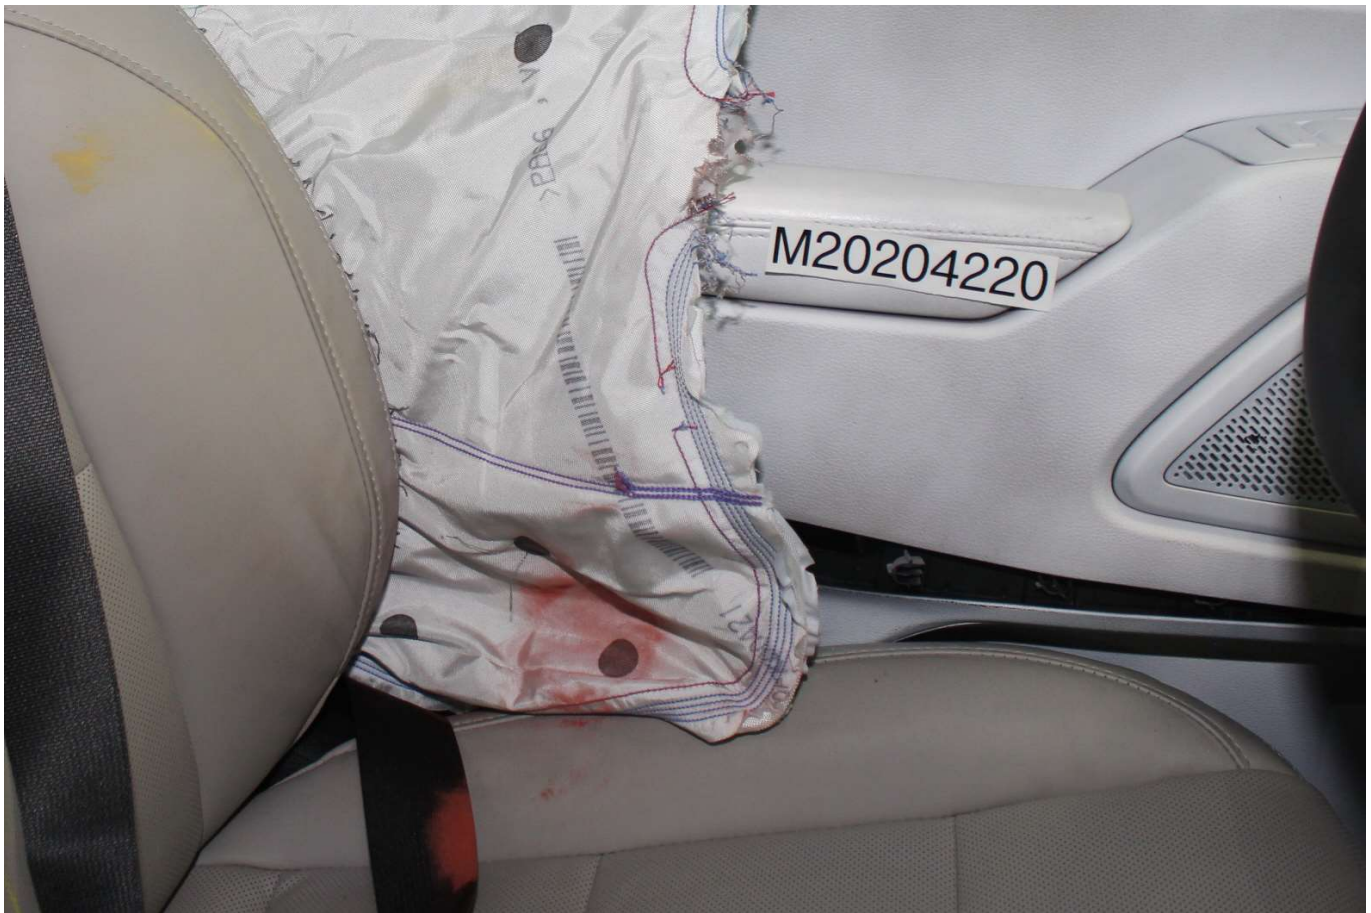
Photo No. 053 - Post-Test Driver Dummy Close-up Pelvis Contact with Side Airbag View

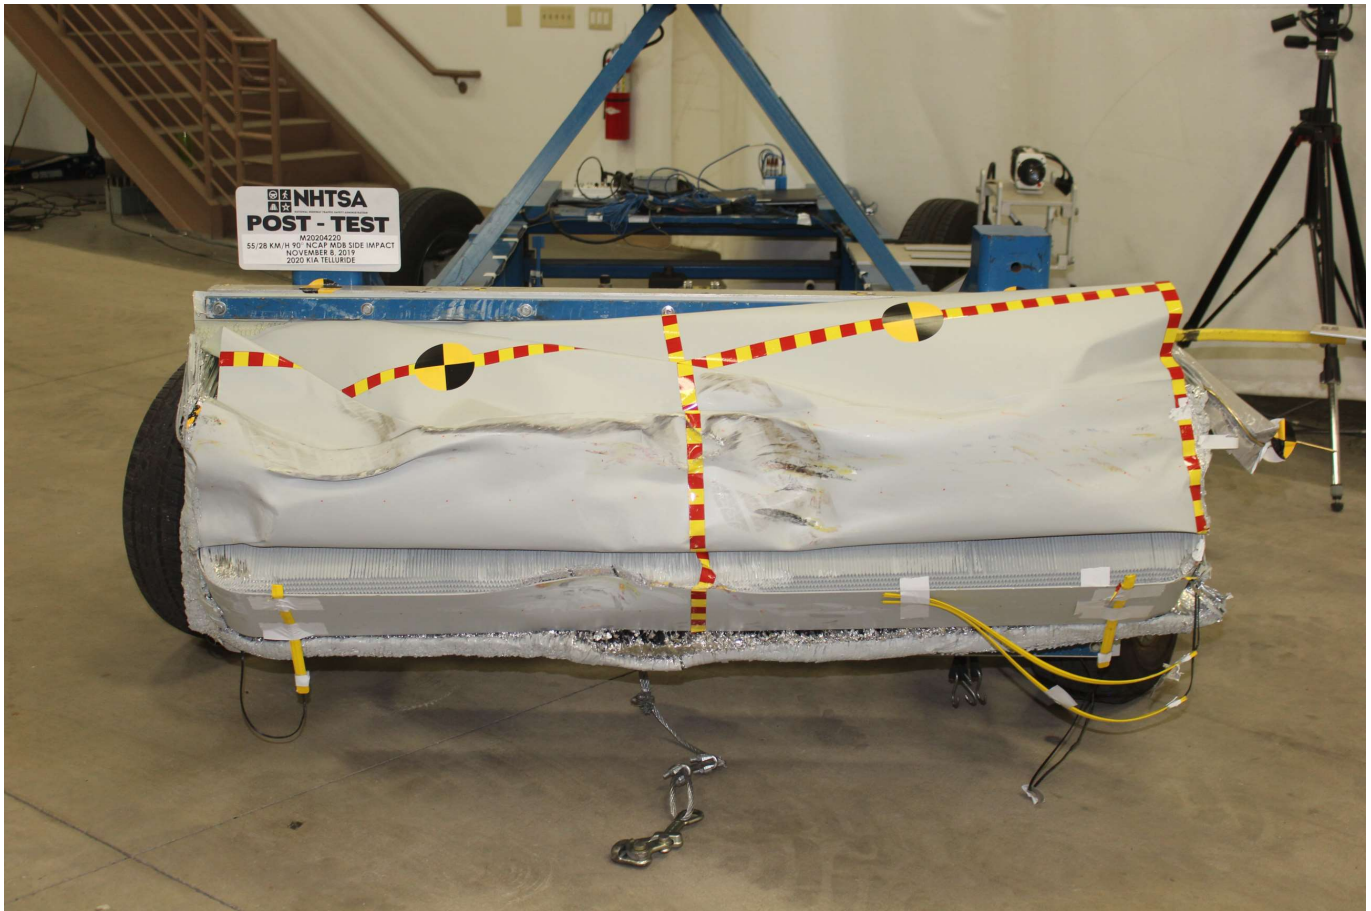
Photo No. 085 - Post-Test Front View of MDB Impactor Face

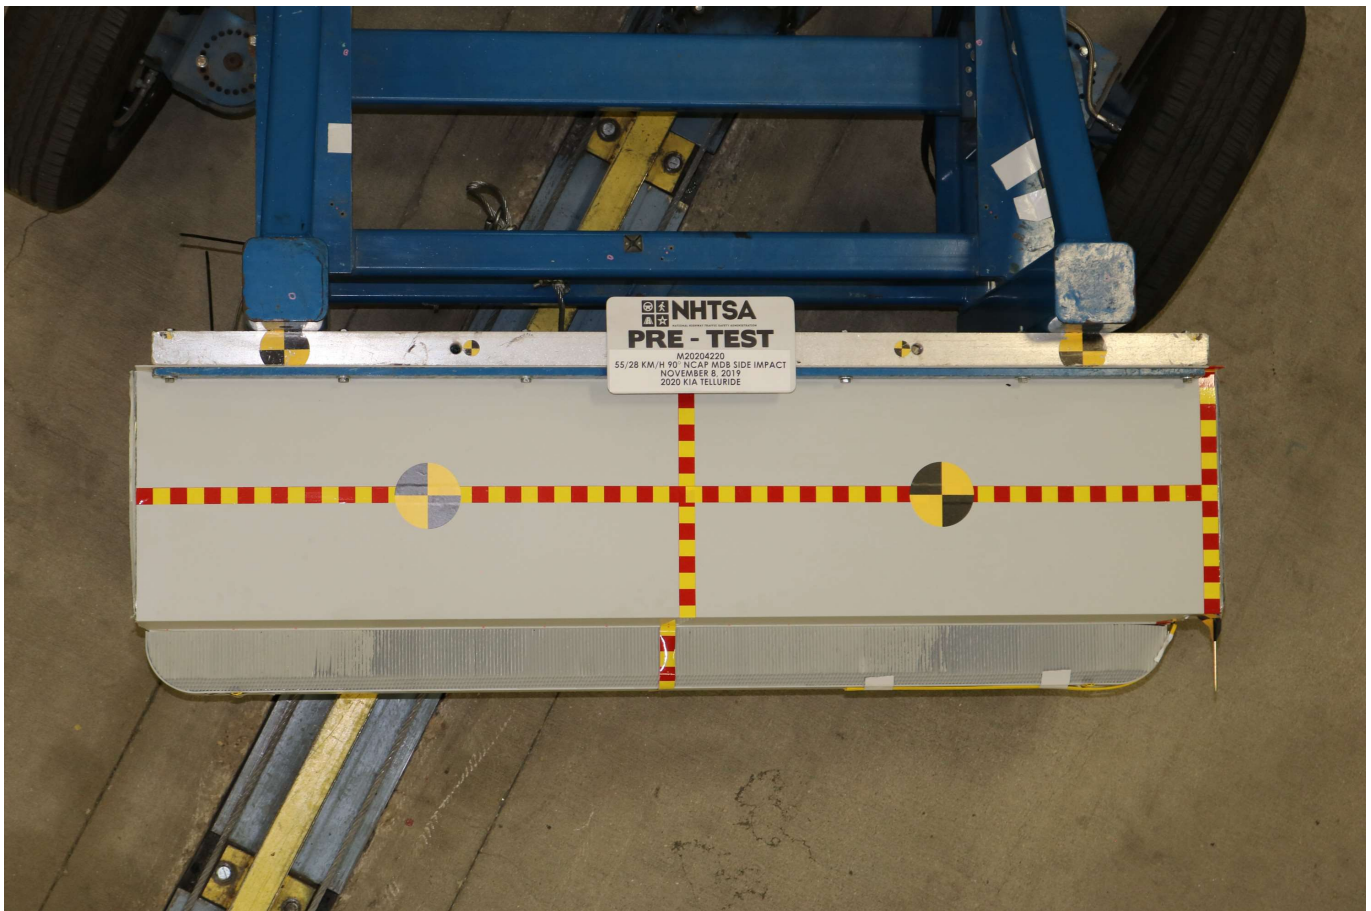
Photo No. 086 - Pre-Test Top View of MDB Impactor Face

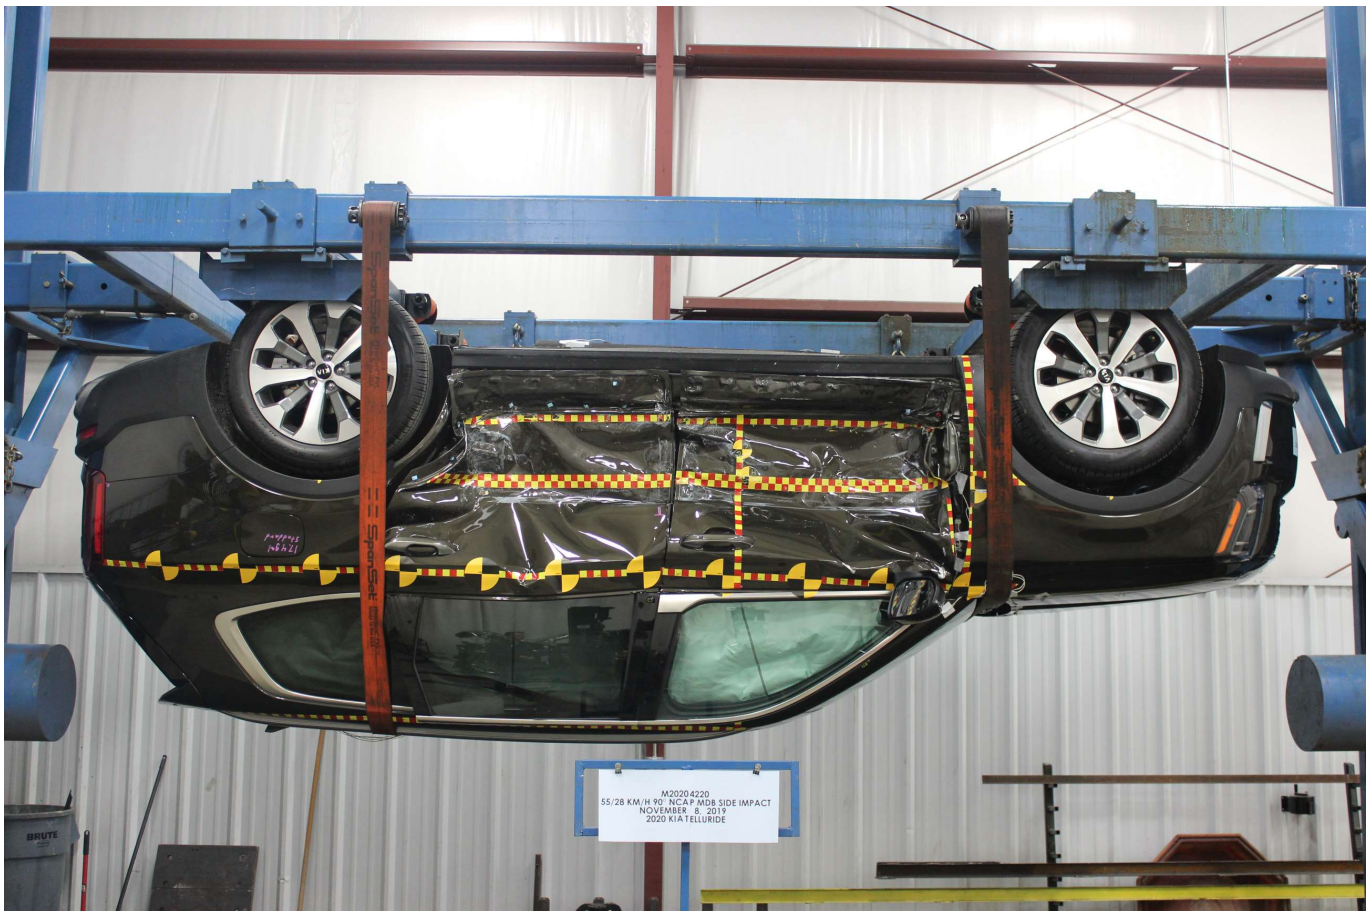
Photo No. 098 - FMVSS Photo No. 301 Static Rollover 180 Degrees

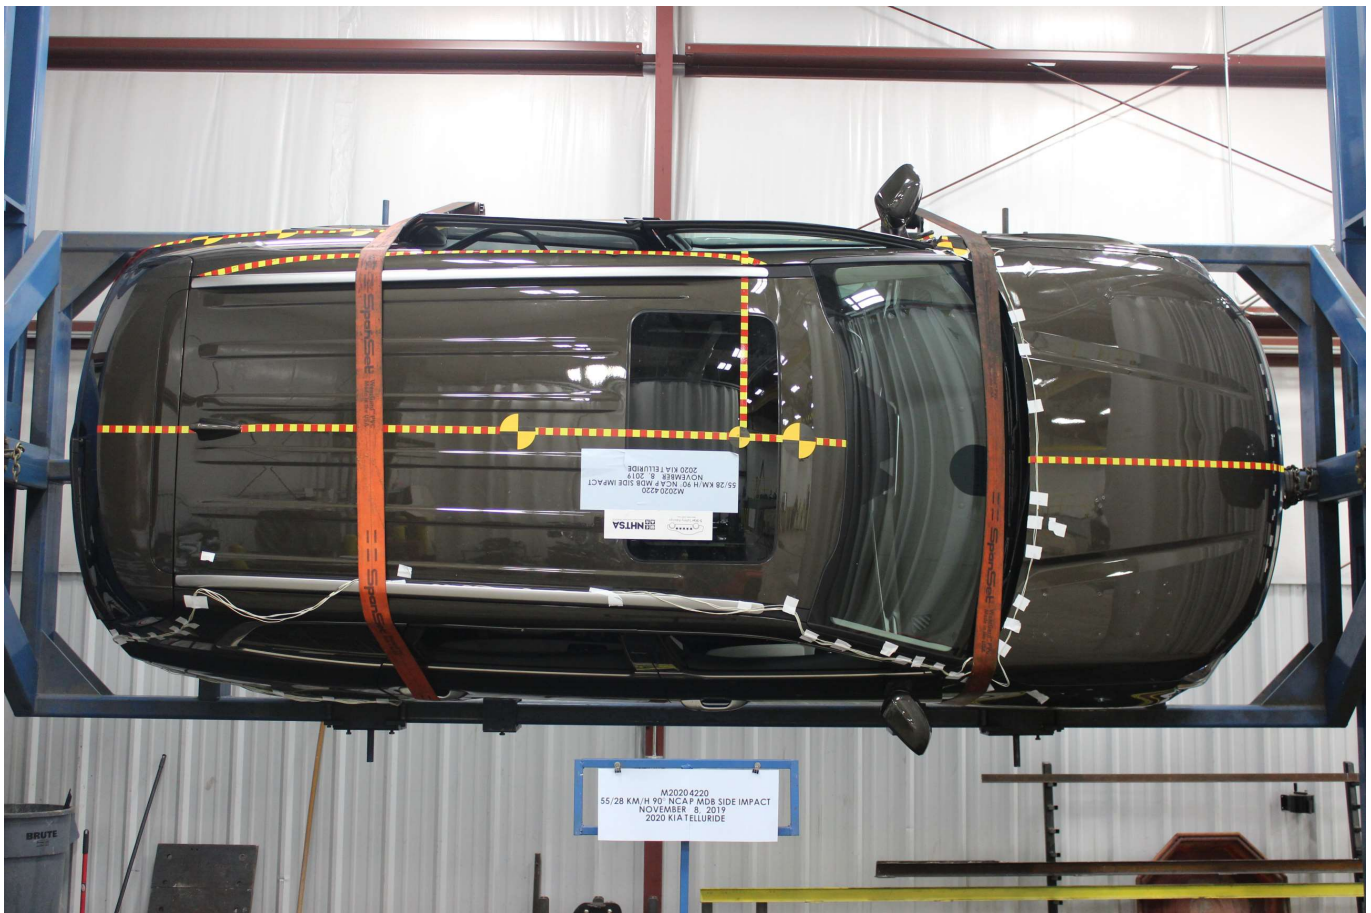
Photo No. 099 - FMVSS Photo No. 301 Static Rollover 270 Degrees

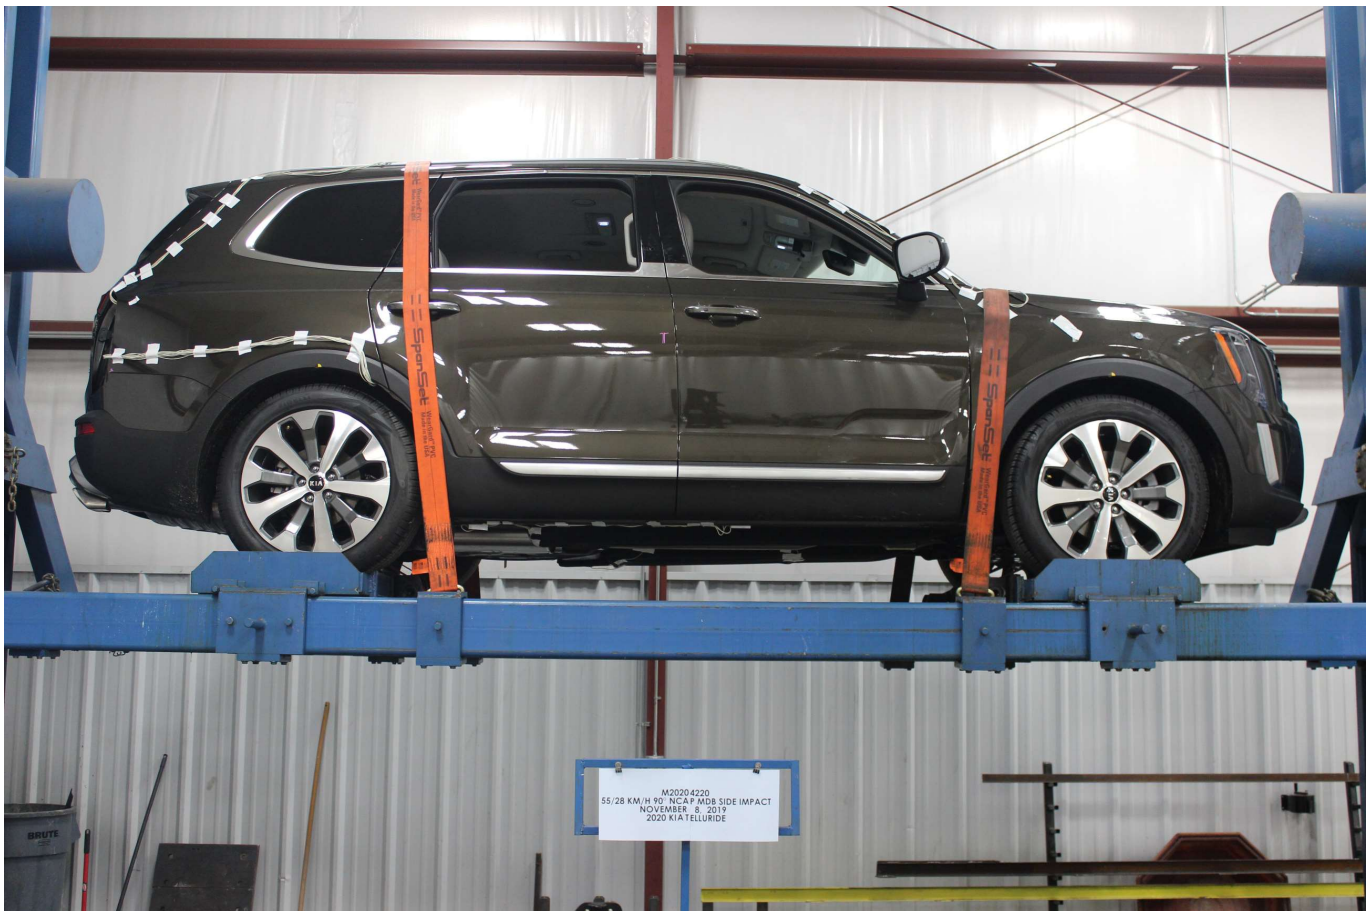
Photo No. 100 - FMVSS Photo No. 301 Static Rollover 360 Degrees

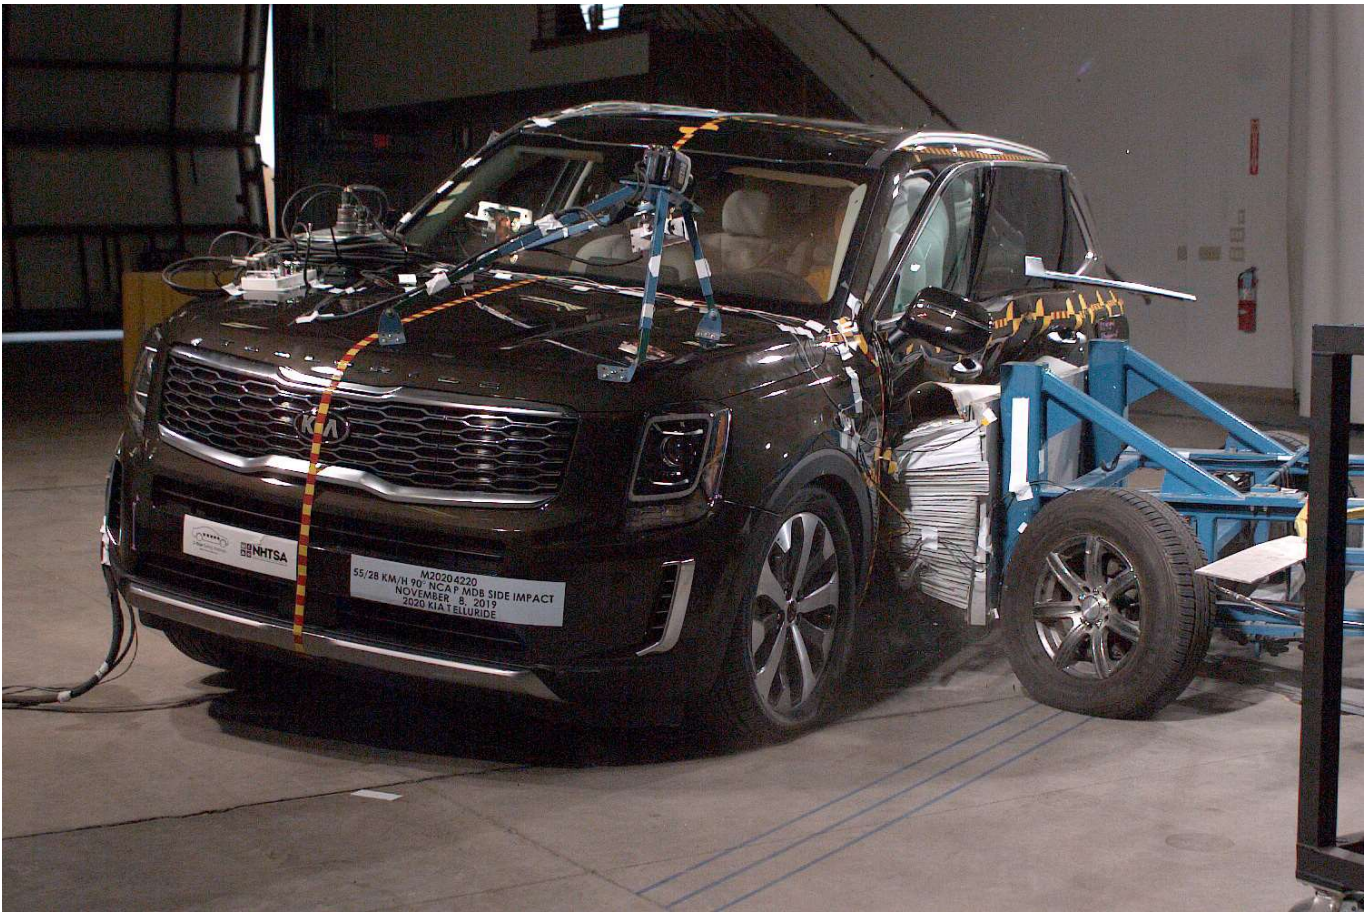
Photo No. 101 - Impact Event
