**SPOLE-KAR-18-002
RESEARCH SIDE IMPACT POLE TEST**

**HONDA OF AMERICA MFG INC
2018 HONDA ACCORD 4-DOOR SEDAN**

NHTSA No: R20185381

FINAL REPORT

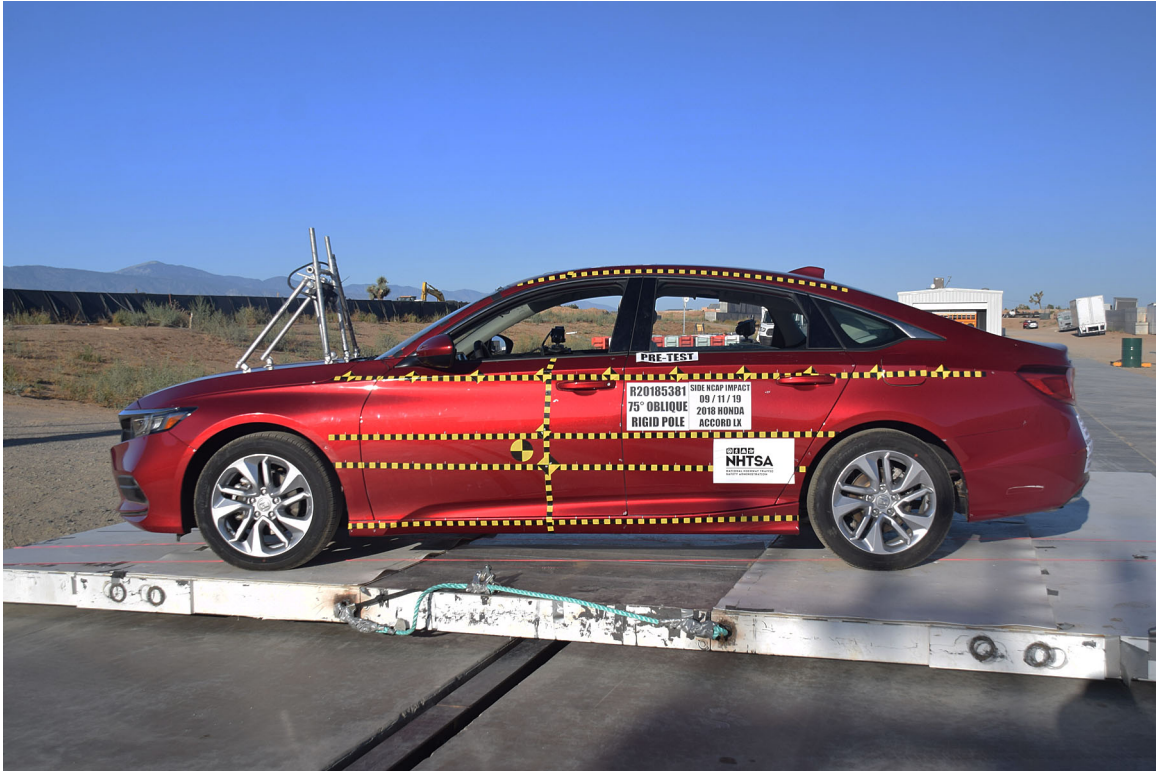
FIGURE 7. Pre-Test Left Side View of Test Vehicle

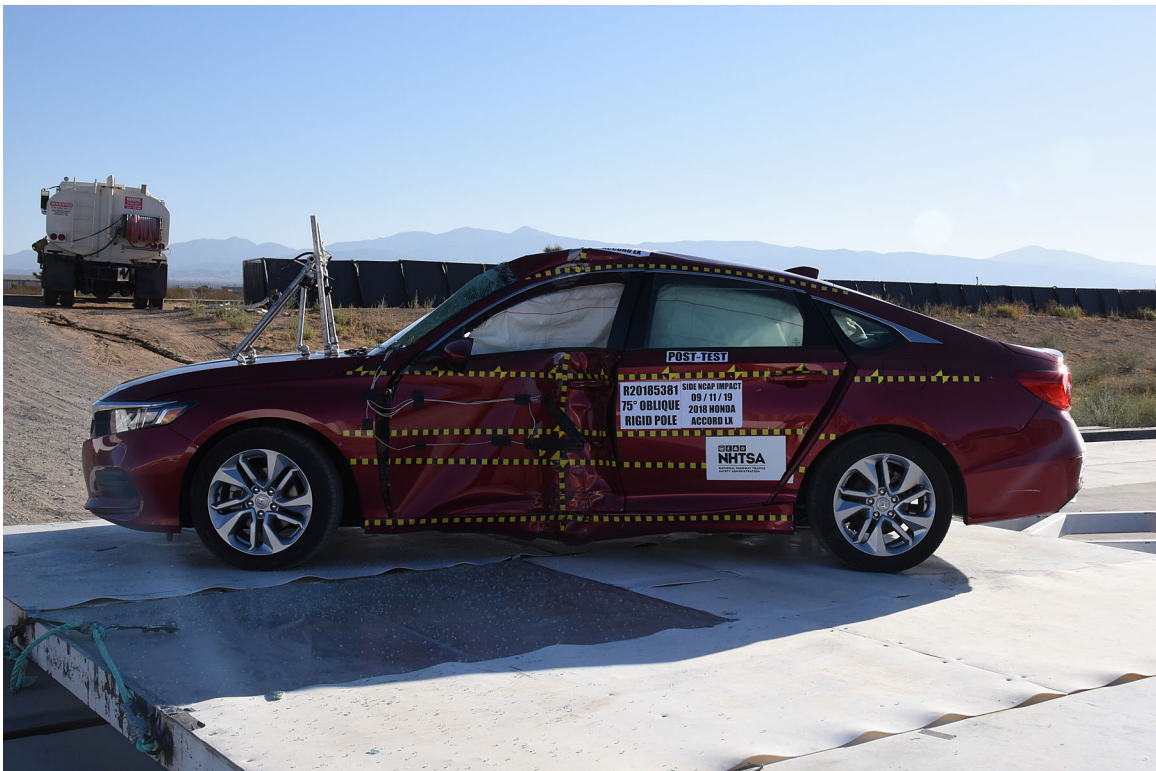
FIGURE 8. Post-Test Left Side View of Test Vehicle

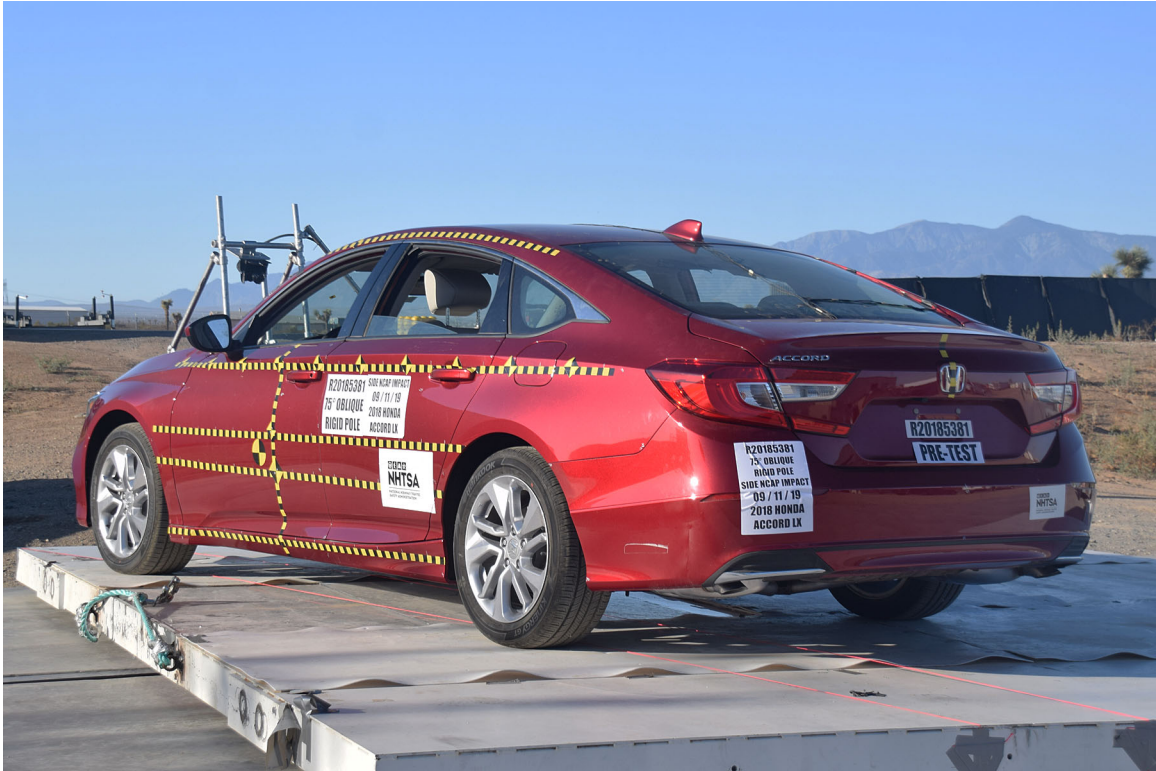
FIGURE 9. Pre-Test Left Rear $\frac{3}{4}$ View of Test Vehicle

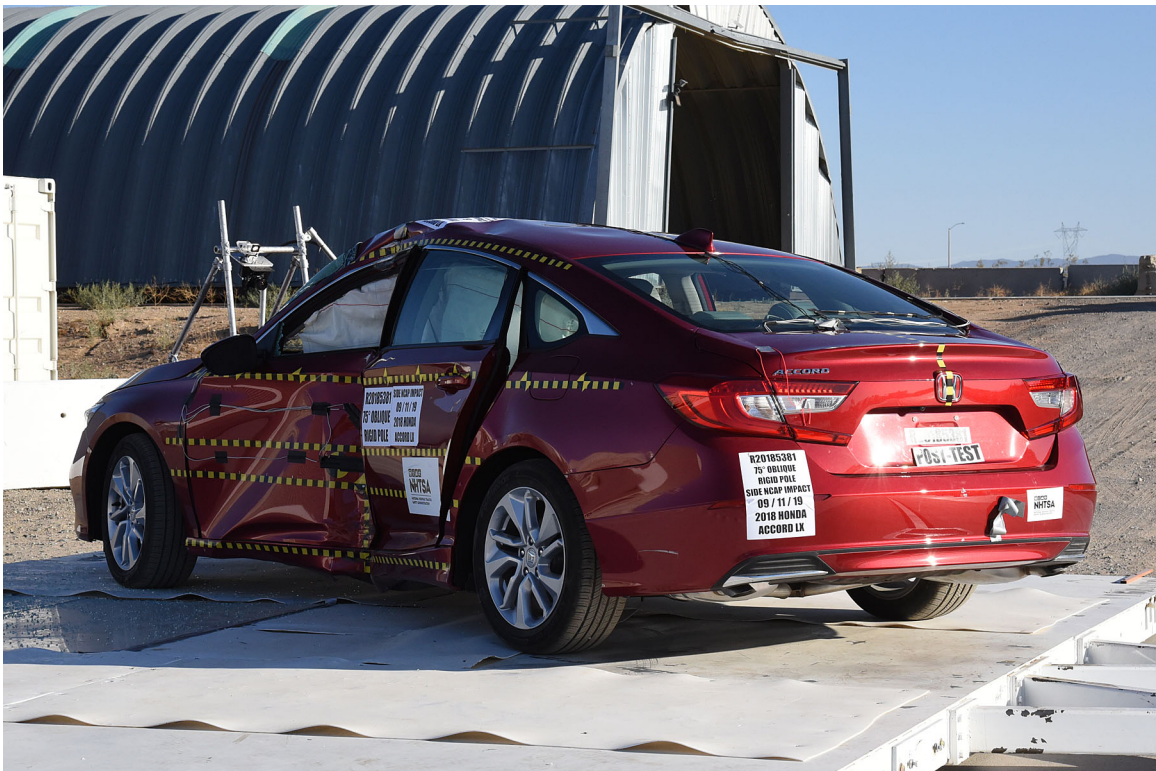
FIGURE 10. Post-Test Left Rear $\frac{3}{4}$ View of Test Vehicle

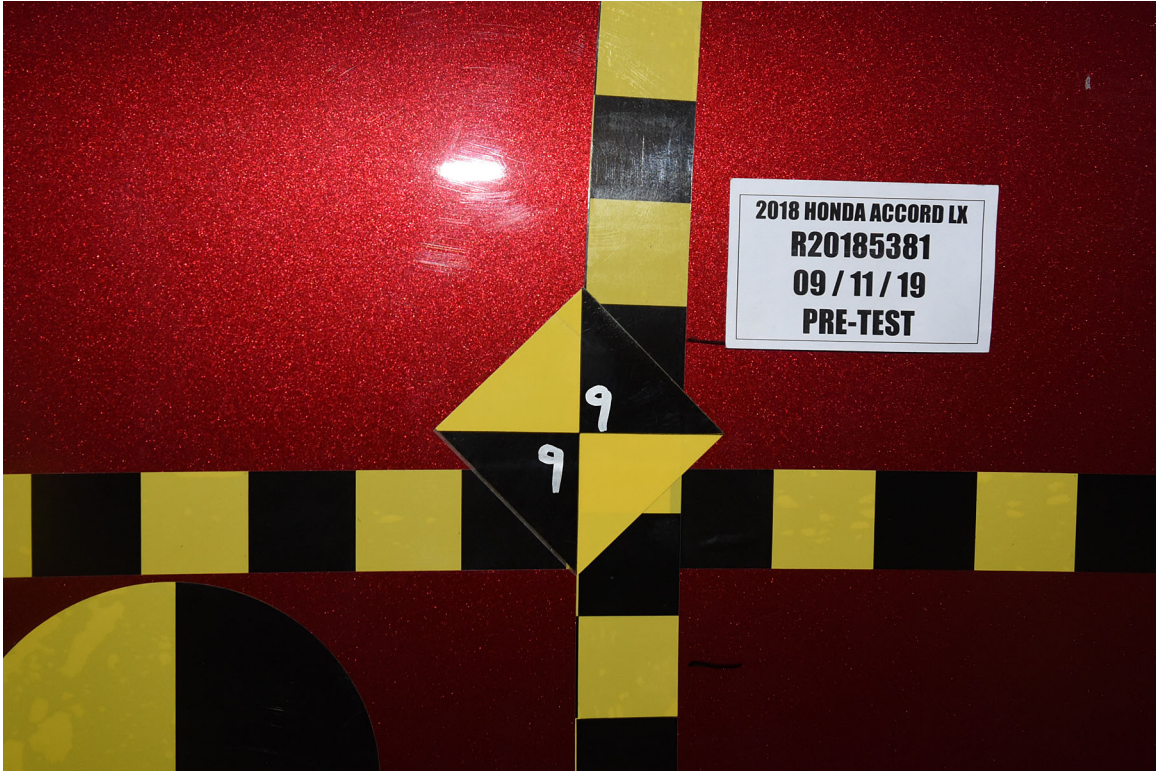
FIGURE 19. Pre-Test Close-Up View of Impact Point Target

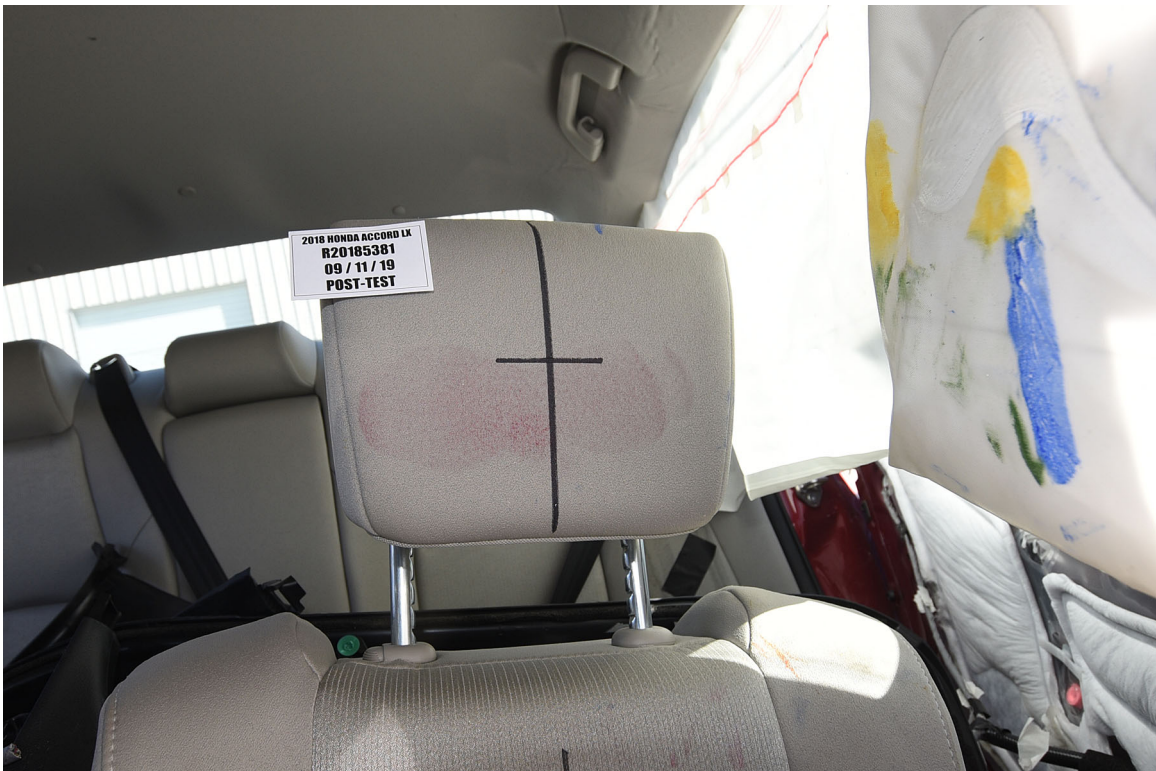
FIGURE 46. Post-Test Dummy Close-Up Head Contact with Vehicle Interior View

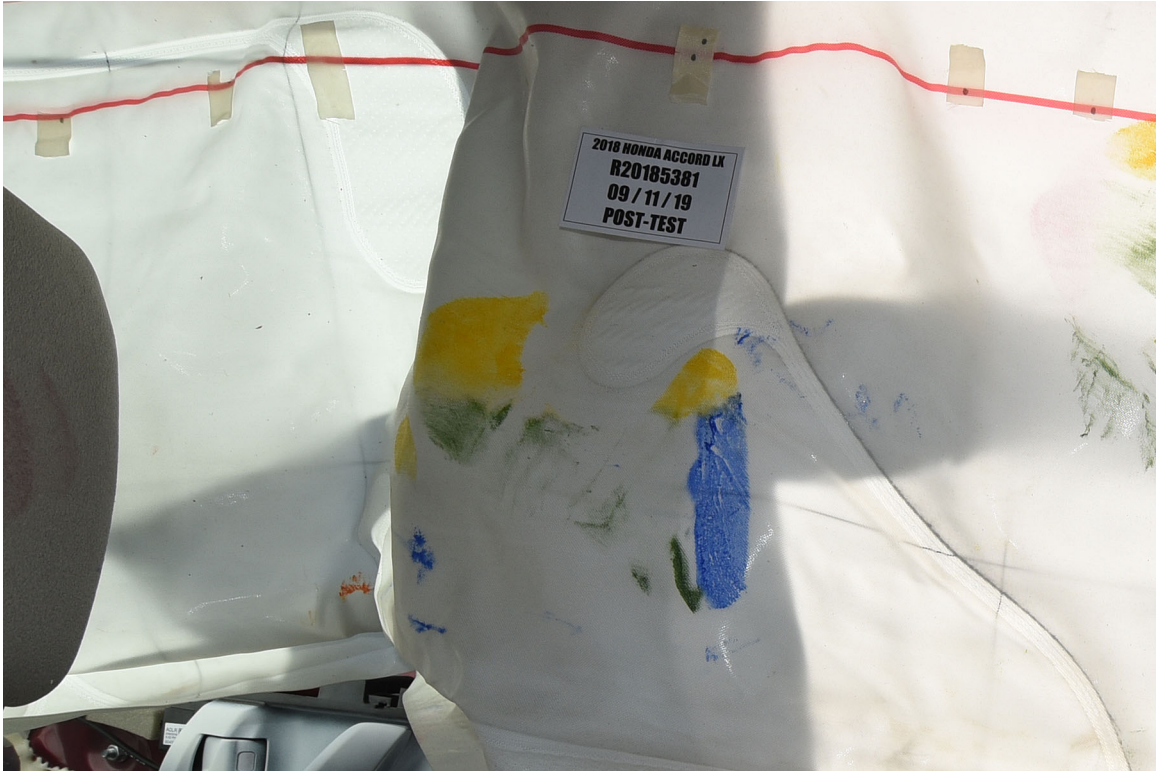
FIGURE 47. Post-Test Dummy Close-Up Head Contact With Side Airbag View

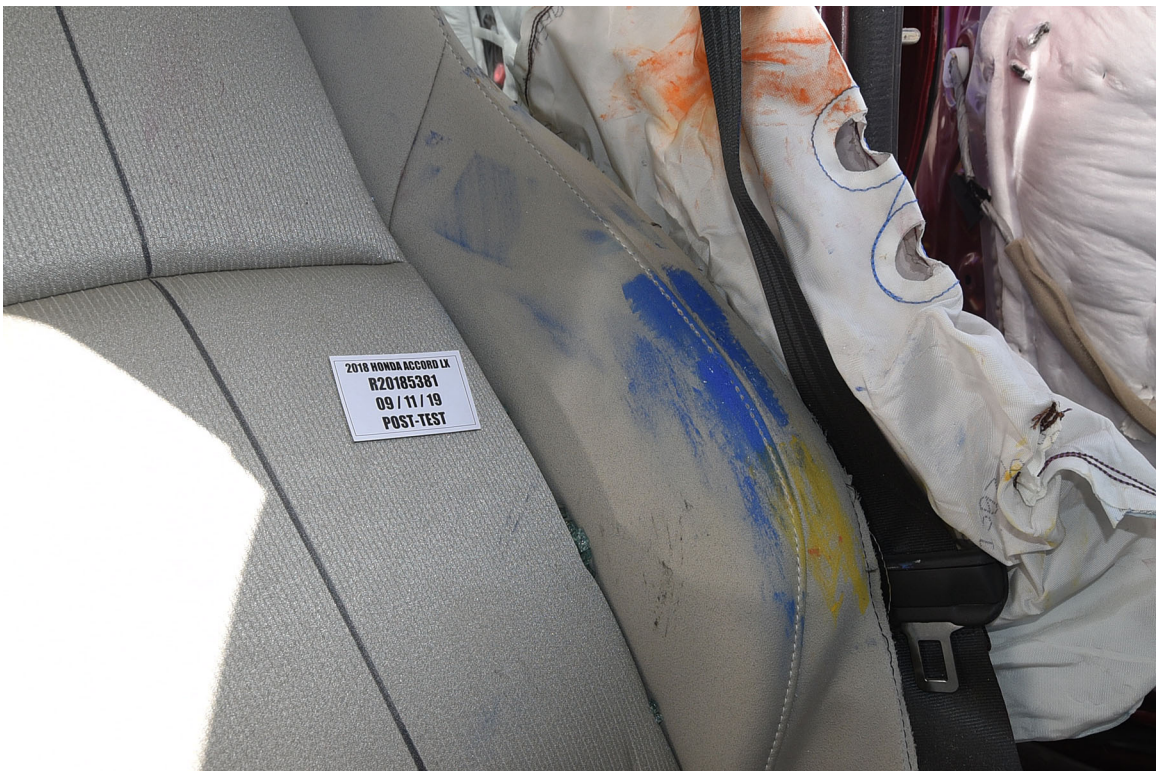
FIGURE 48. Post-Test Dummy Close-Up Torso Contact With Vehicle Interior View

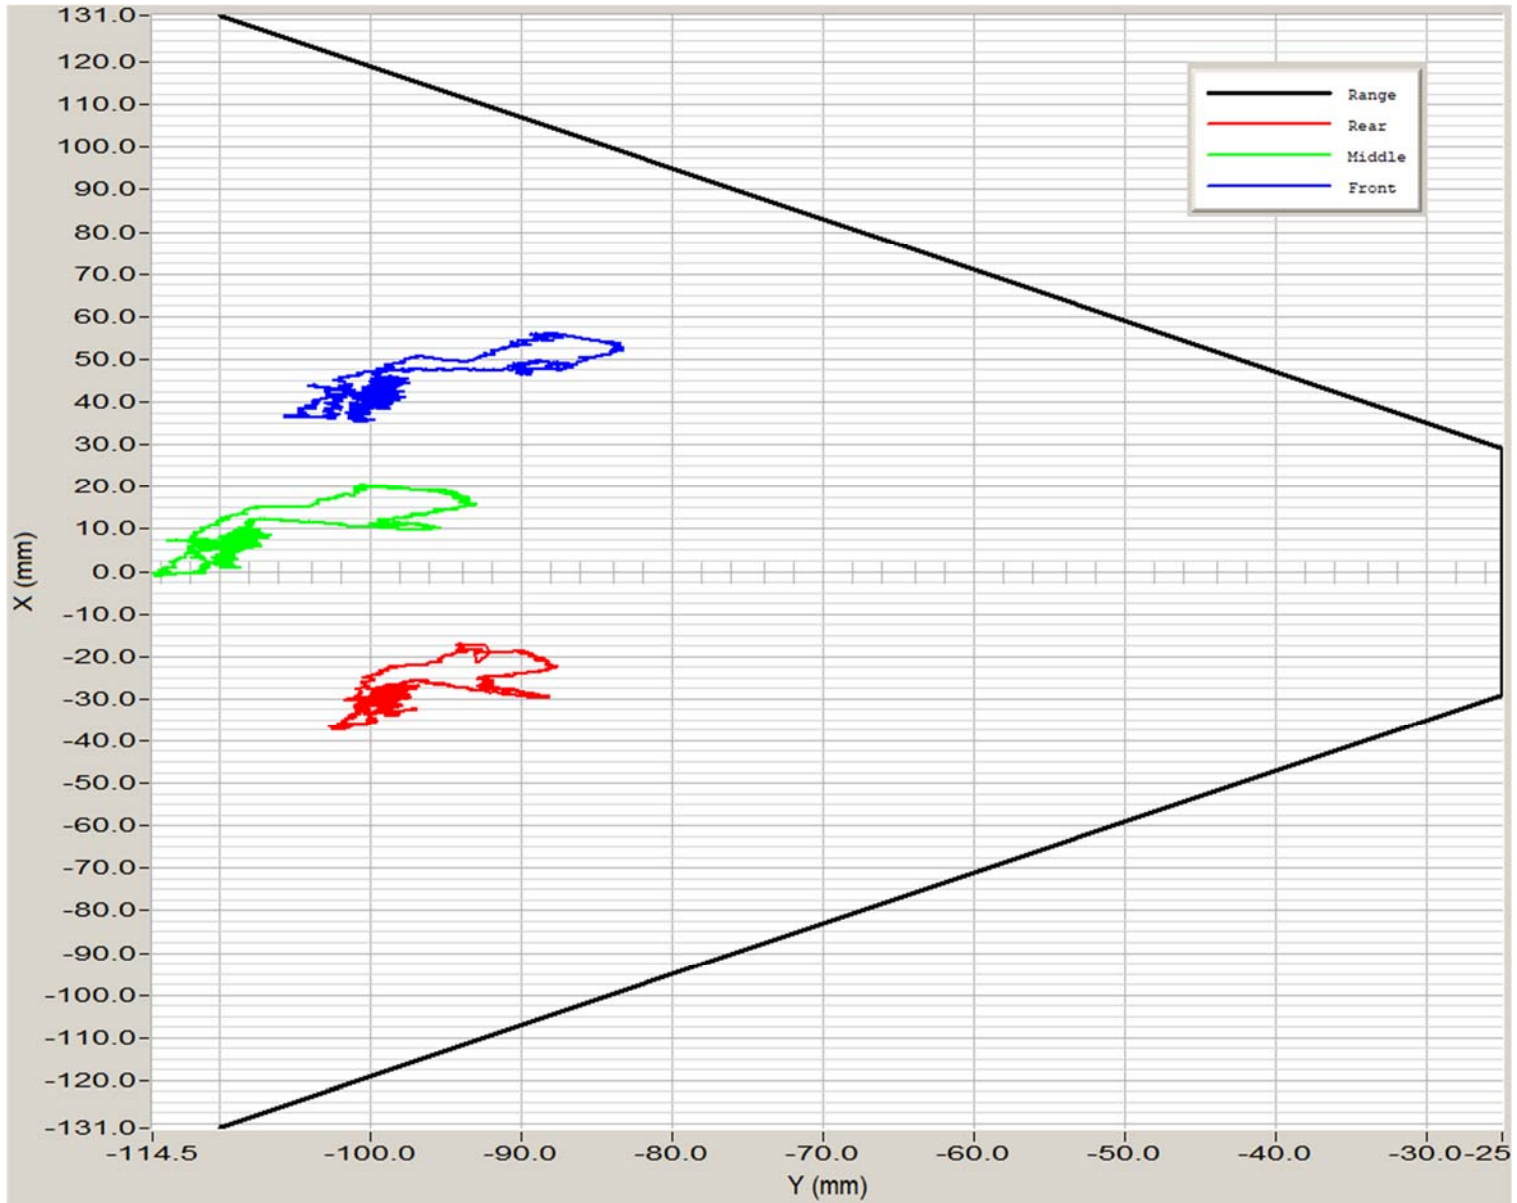
WORLD SID POLE 3 RIBEYE THORAX_2_XY PLOTS
