**REPORT NUMBER: SPNCAP-KAR-20-001
NEW CAR ASSESSMENT PROGRAM (NCAP)
SIDE IMPACT POLE TEST**

**SUBARU CORPORATION
2020 SUBARU LEGACY 4-DOOR SEDAN**

NHTSA No: O20205500

FINAL REPORT

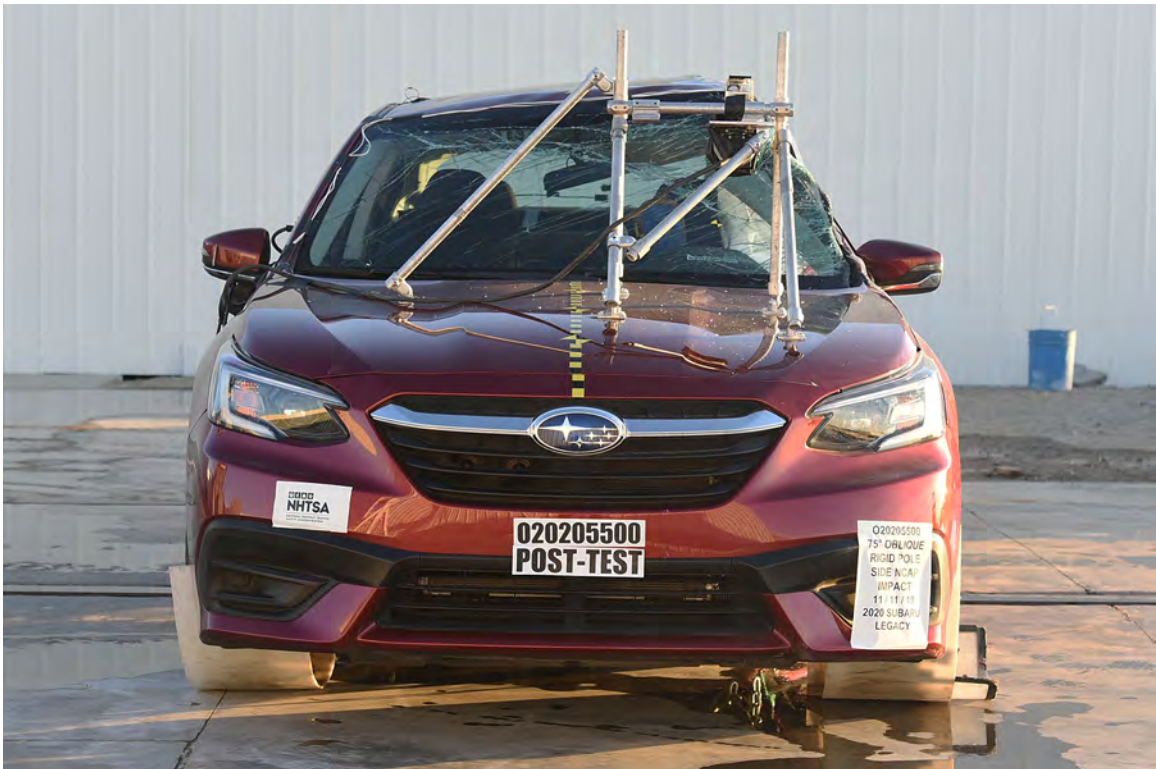
FIGURE 4. Post-Test Frontal View of Test Vehicle

The struck side doors of the vehicle were jammed shut. There was no separation at the hinges or latches. The remaining doors remained closed and latched. There were no ATD values that exceeded limits. Left A-Post at Sill Acceleration Y failed at 12.2 ms.

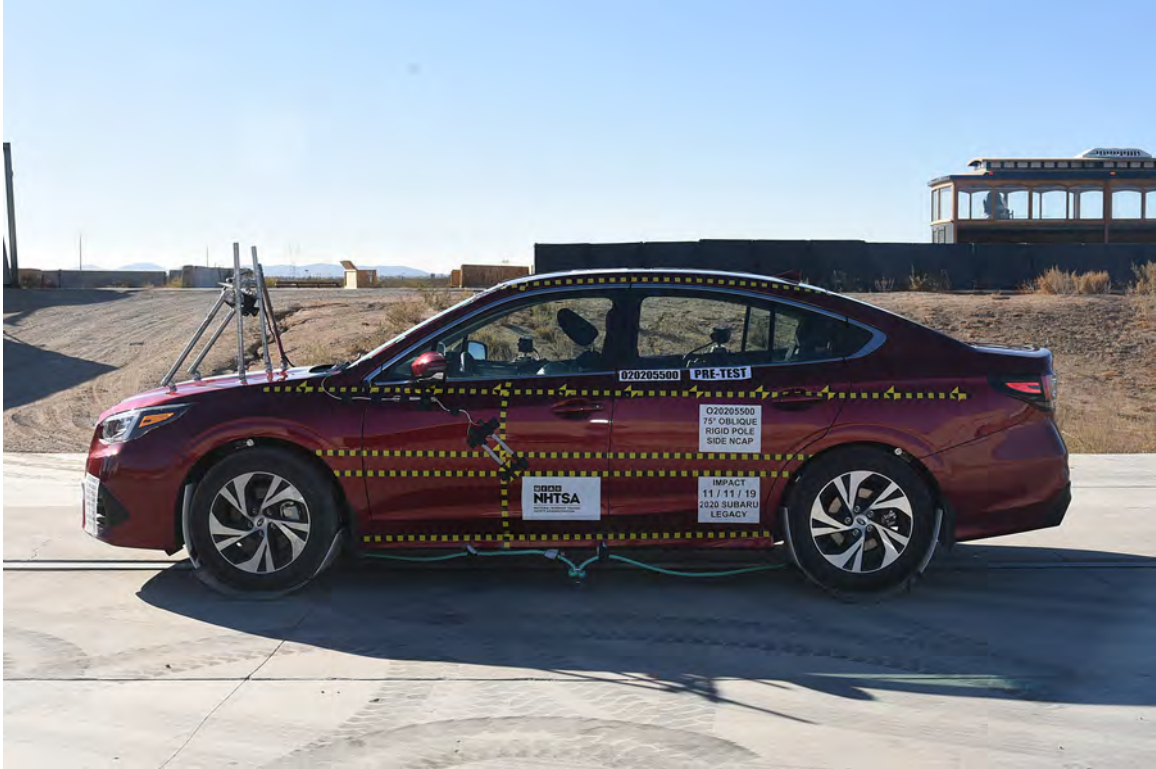
FIGURE 7. Pre-Test Left Side View of Test Vehicle

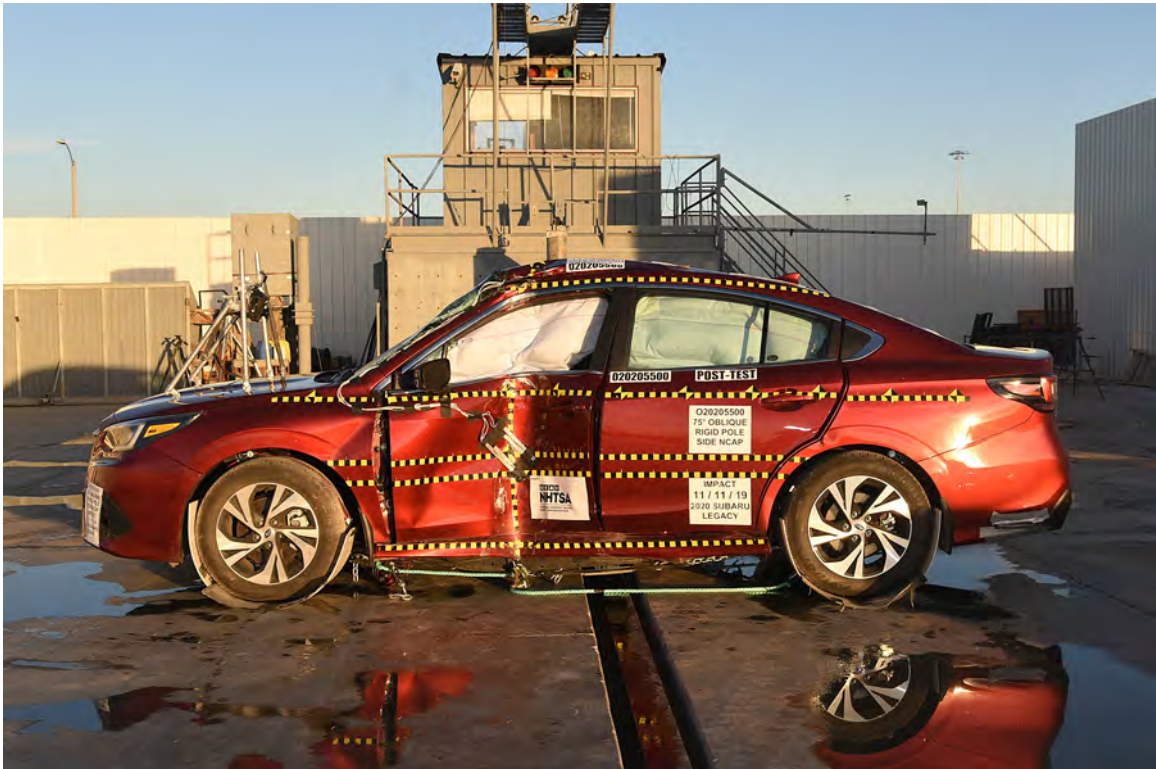
FIGURE 8. Post-Test Left Side View of Test Vehicle

Critical Areas of Performance	Observations and Conclusions
Pillar Performance	No separation occurred
Sill Separation	No separation occurred
Windshield Damage	Broken
Side Window Damage	Left front window broken
Other Notable Effects	None

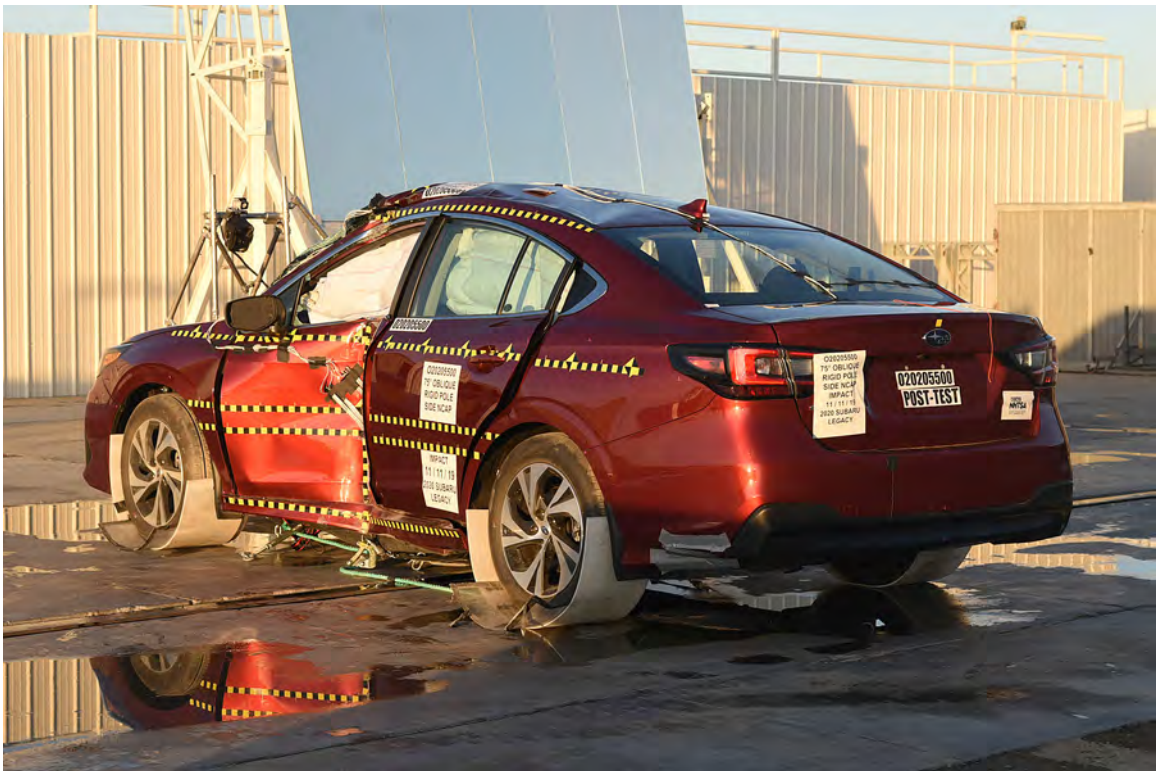
FIGURE 10. Post-Test Left Rear $\frac{3}{4}$ View of Test Vehicle

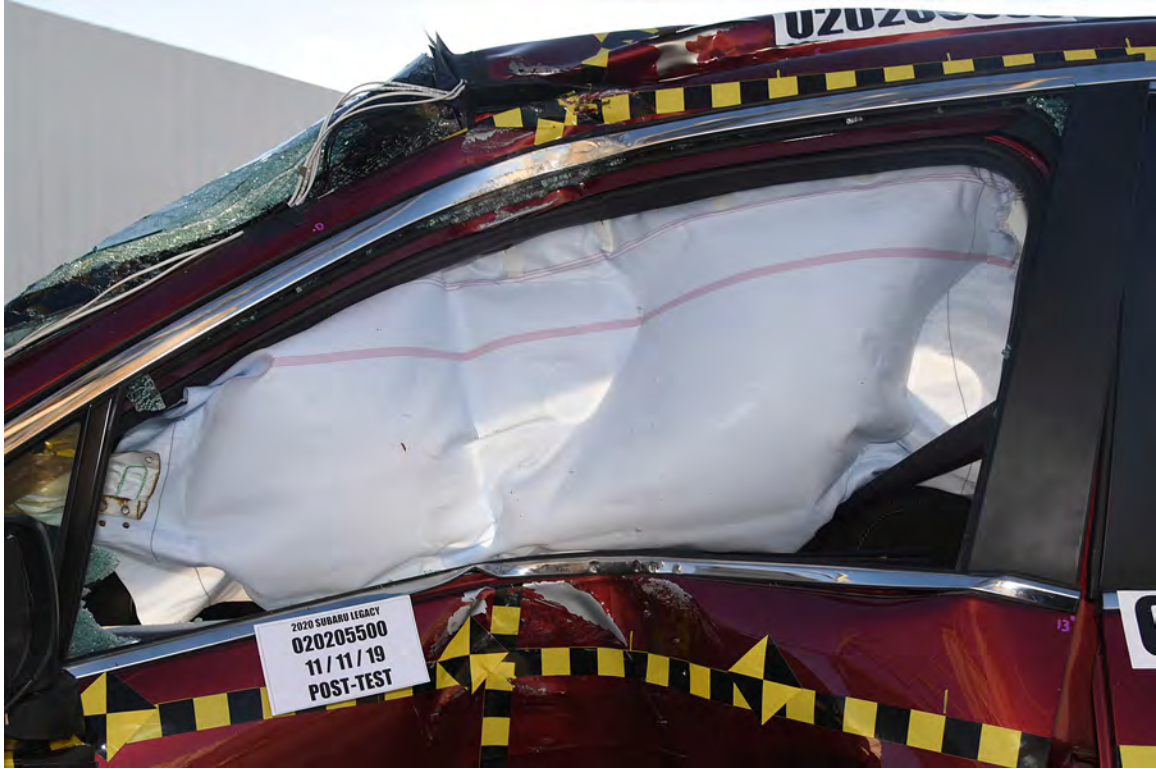
FIGURE 25. Post-Test Left Side View of Dummy Shoulder and Door Top View

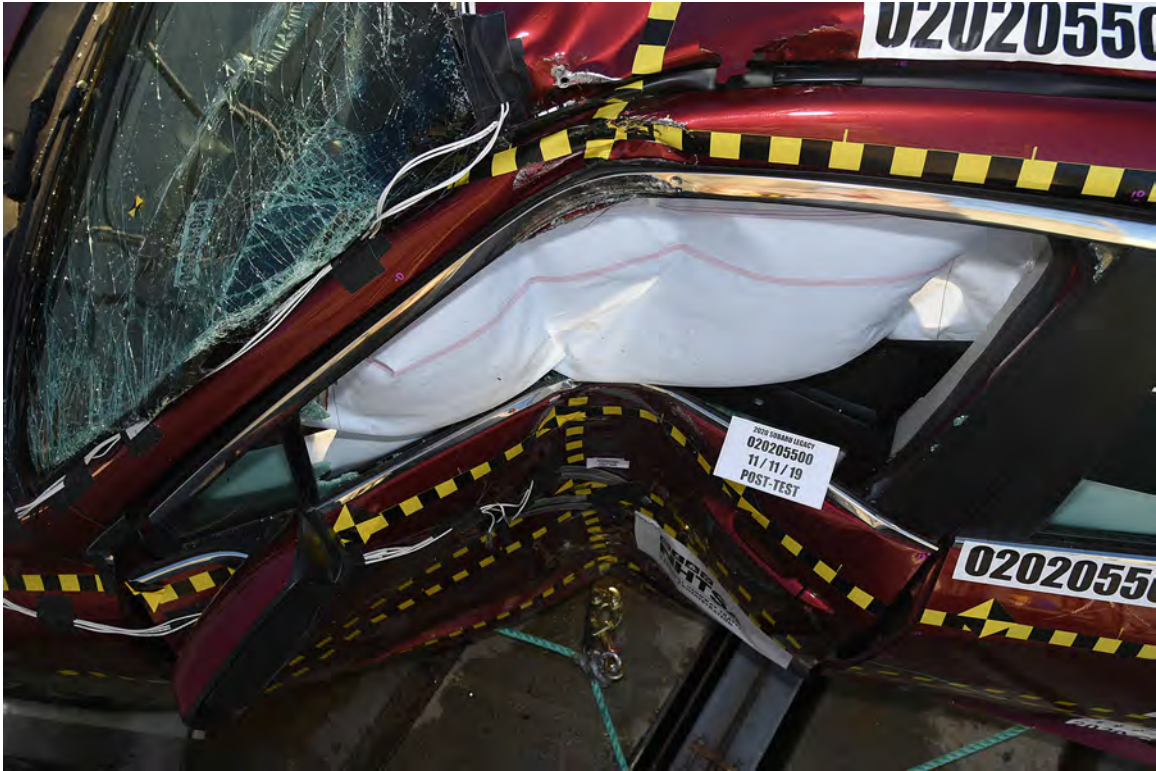
FIGURE 41. Post-Test Dummy and Door Clearance View

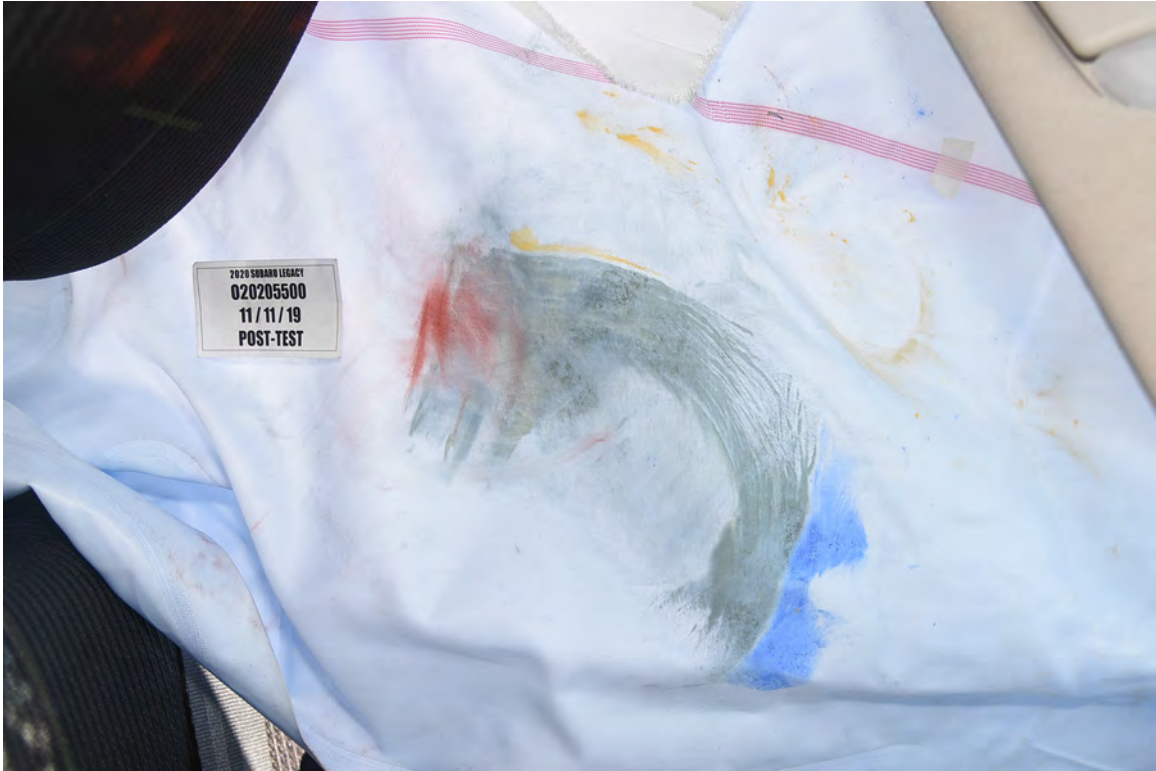
FIGURE 47. Post-Test Dummy Close-Up Head Contact With Side Airbag View

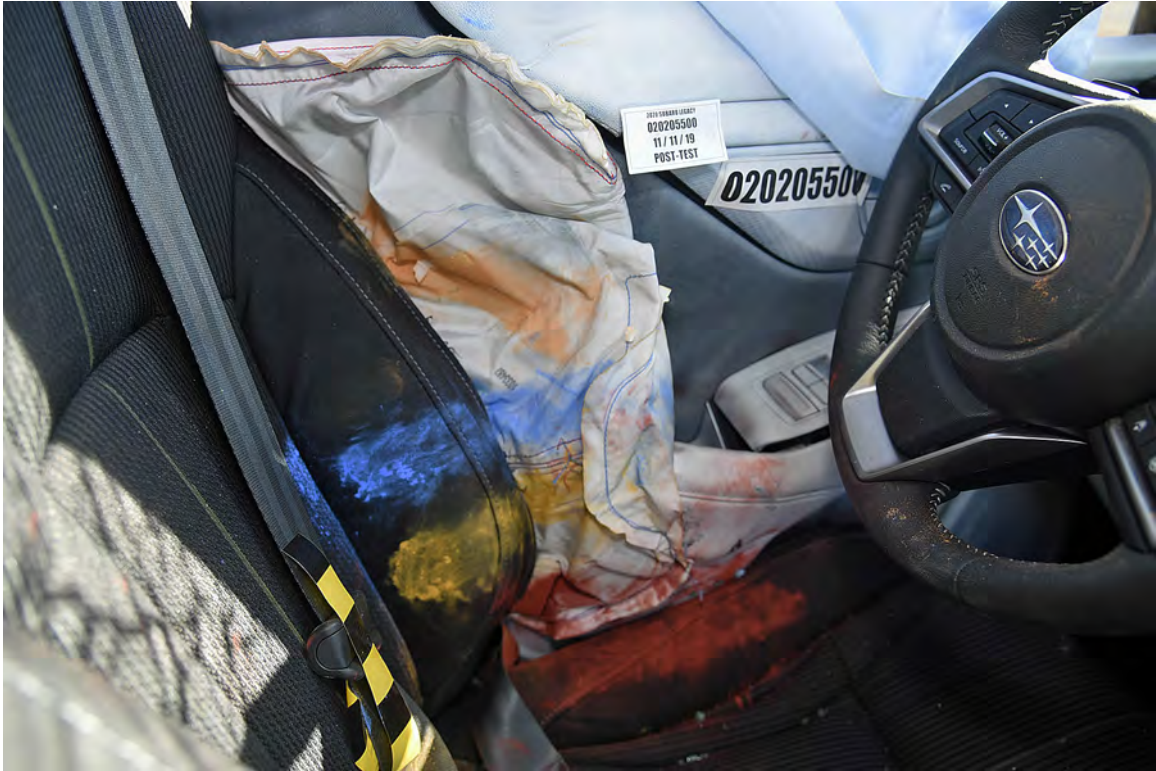
FIGURE 49. Post-Test Dummy Close-Up Torso Contact With Side Airbag View
