**REPORT NUMBER: SPNCAP-KAR-20-020
NEW CAR ASSESSMENT PROGRAM (NCAP)
SIDE IMPACT POLE TEST**

**NISSAN MOTOR CO., LTD.
2020 NISSAN KICKS 5-DOOR SUV**

**PREPARED BY:
APPLUS IDIADA KARCO ENGINEERING, LLC.
9270 HOLLY ROAD
ADELANTO, CA 92301**

FINAL REPORT

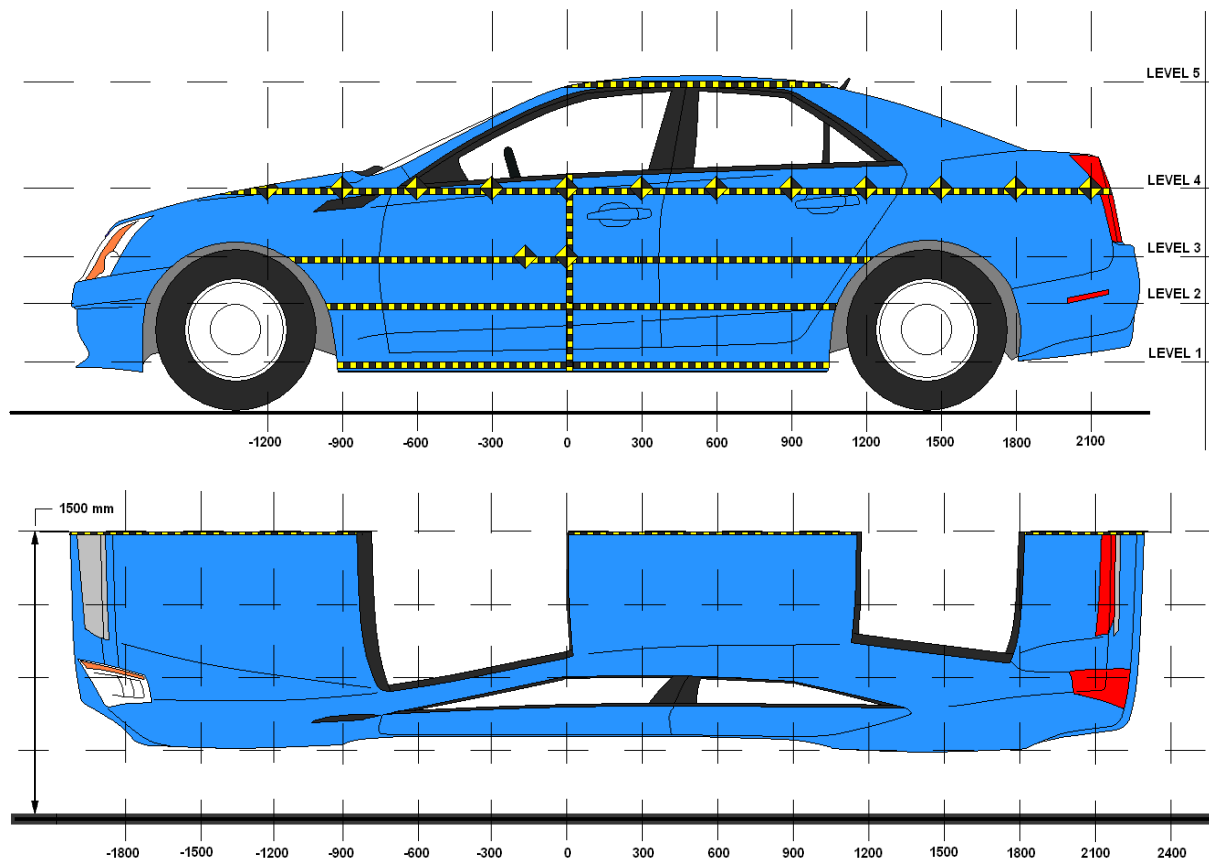
TEST VEHICLE EXTERIOR CRUSH MEASUREMENTS

NOTE: All measurements in mm with tolerance of ± 3 mm

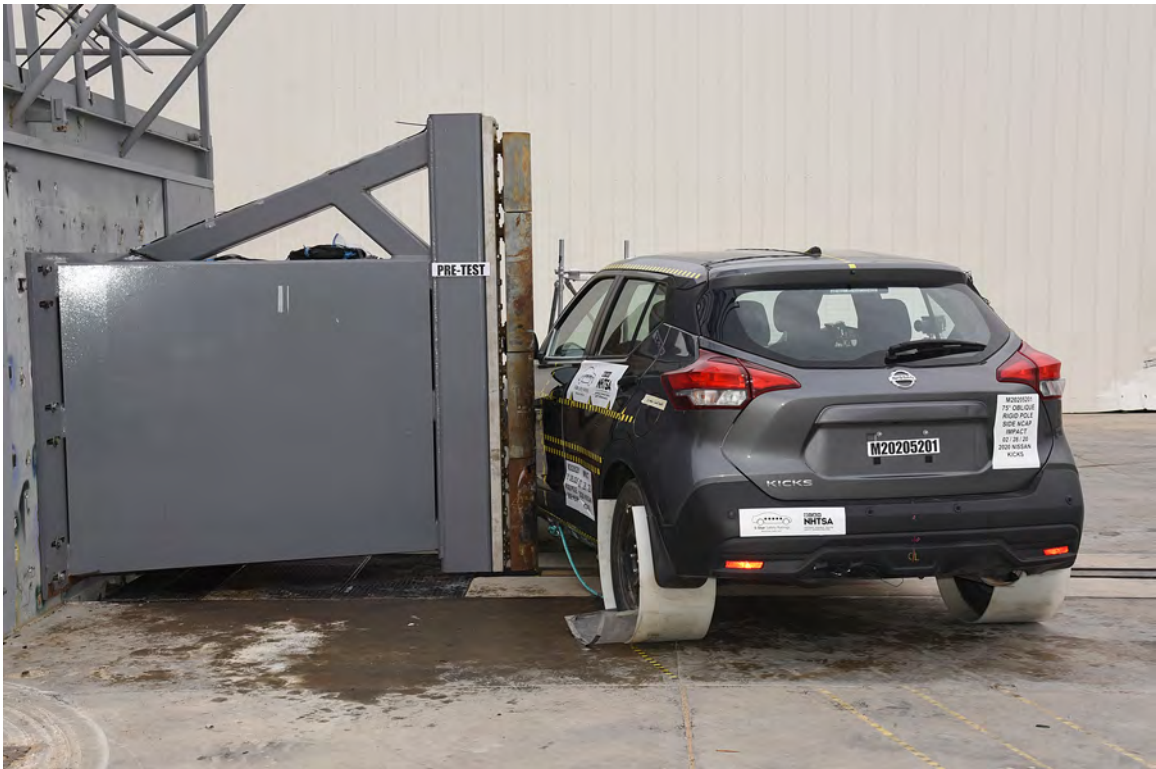
FIGURE 17. Pre-Test Left Side View of Pole Positioned Against Side of Vehicle
