REPORT NUMBER: R&D-KAR-20-001

**VEHICLE TO RIGID BARRIER CRASH TEST IN SUPPORT OF
NHTSA'S FRONTAL RESEARCH CRASH TEST PROGRAM
LEFT SIDE 30° FRONTAL RIGID BARRIER IMPACT**

**HONDA OF AMERICA MFG., INC.
2020 HONDA ACCORD 4-DOOR SEDAN**

NHTSA No: R20205378

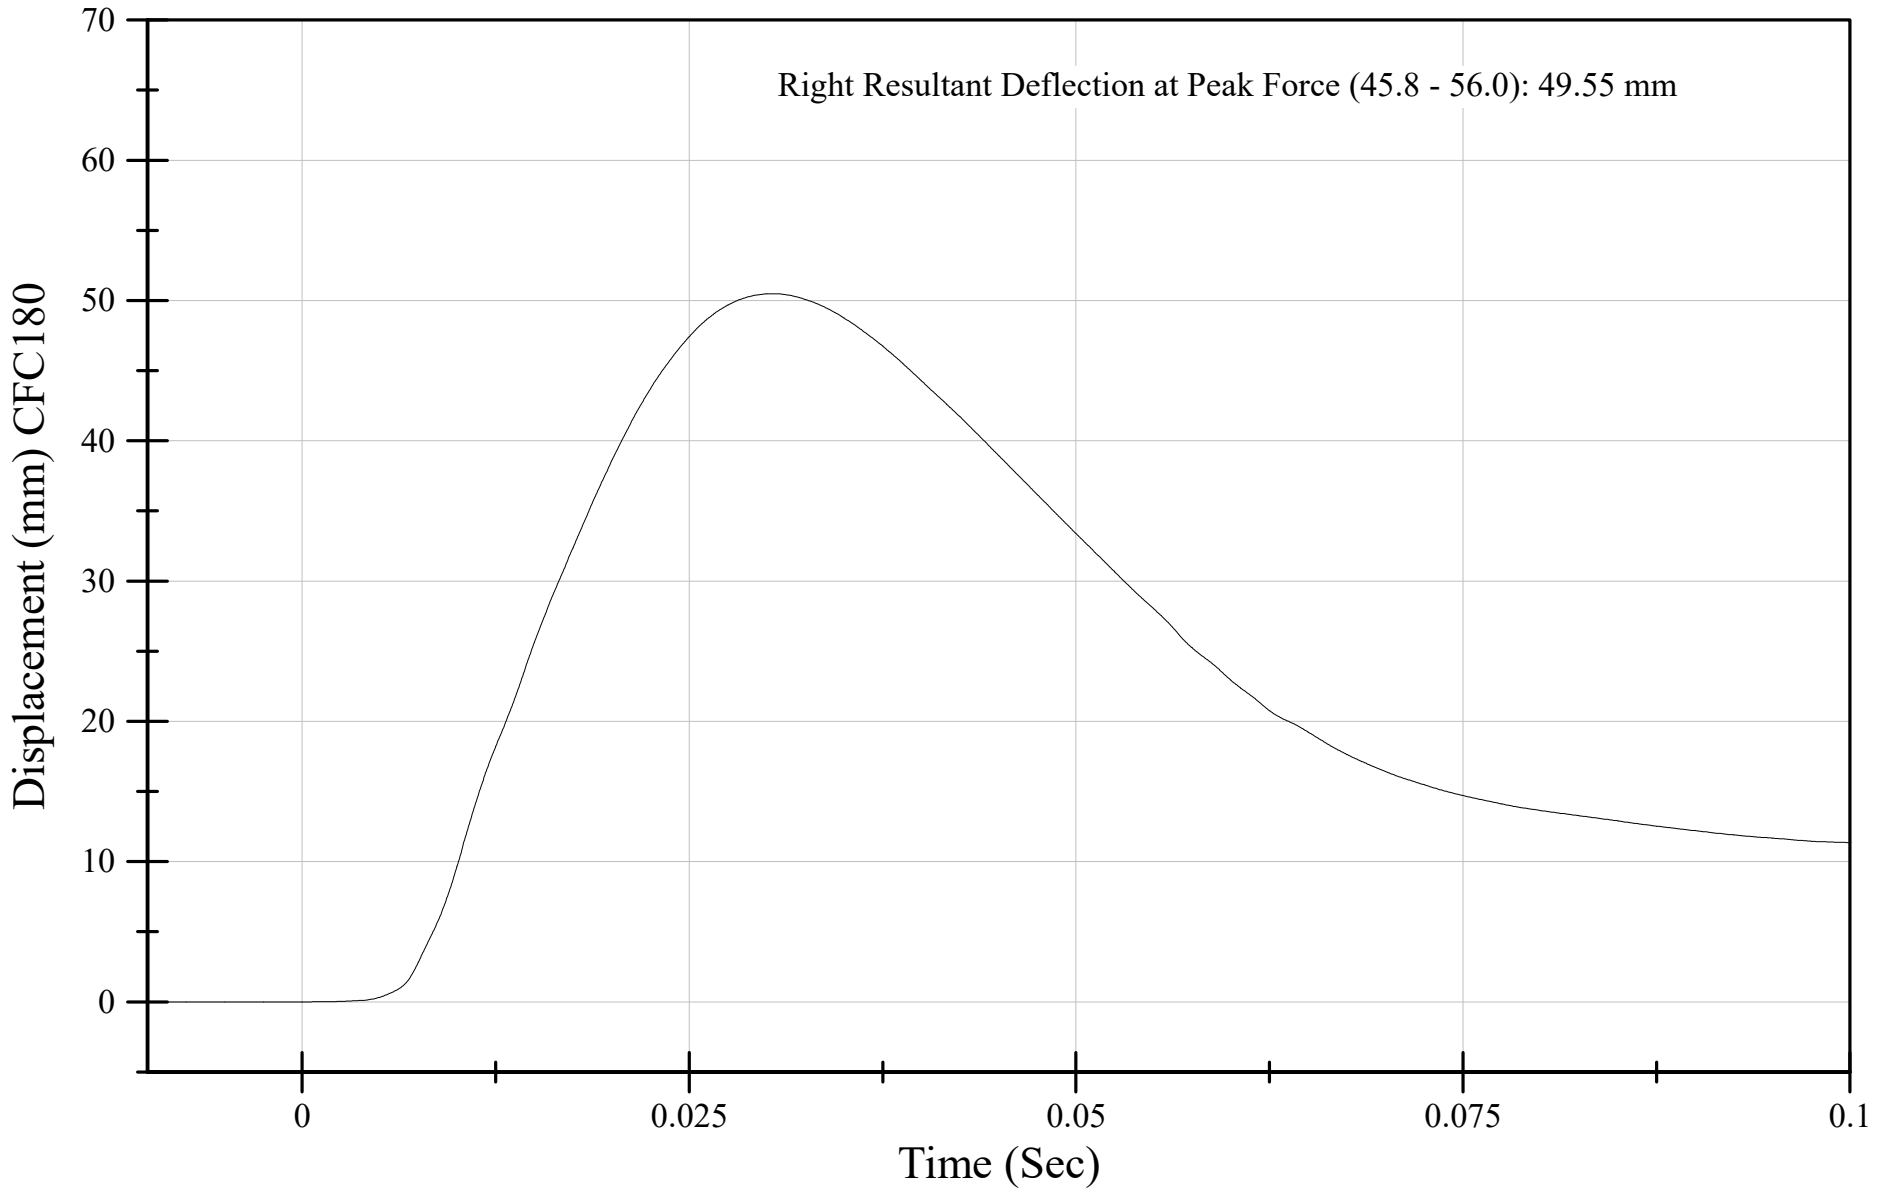
THOR Lower Right Thorax Qualification
Right Resultant Deflection
Serial Number: DO9799
