**REPORT NUMBER: SPNCAP-CAL-20-003**

**NEW CAR ASSESSMENT PROGRAM (NCAP)  
SIDE IMPACT POLE TEST**

**Nissan Motor Co., LTD.  
2021 Nissan Maxima  
Four Door Sedan**

**FINAL REPORT**

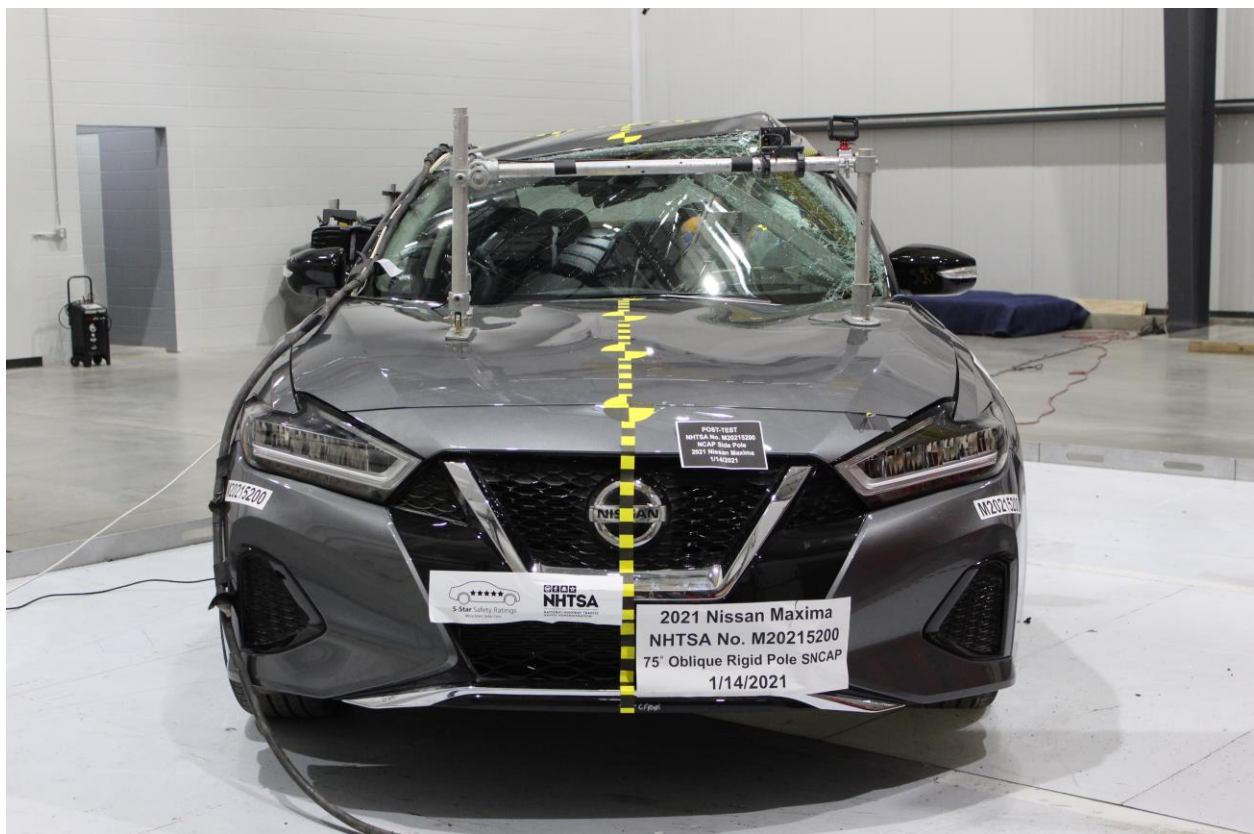
**Figure A-4: Post-Test Frontal View of Test Vehicle**

| Critical Areas of Performance | Observations and Conclusions |
|---|---|
| Windshield Damage | Cracks Throughout with Separation Along Driver A-Pillar |

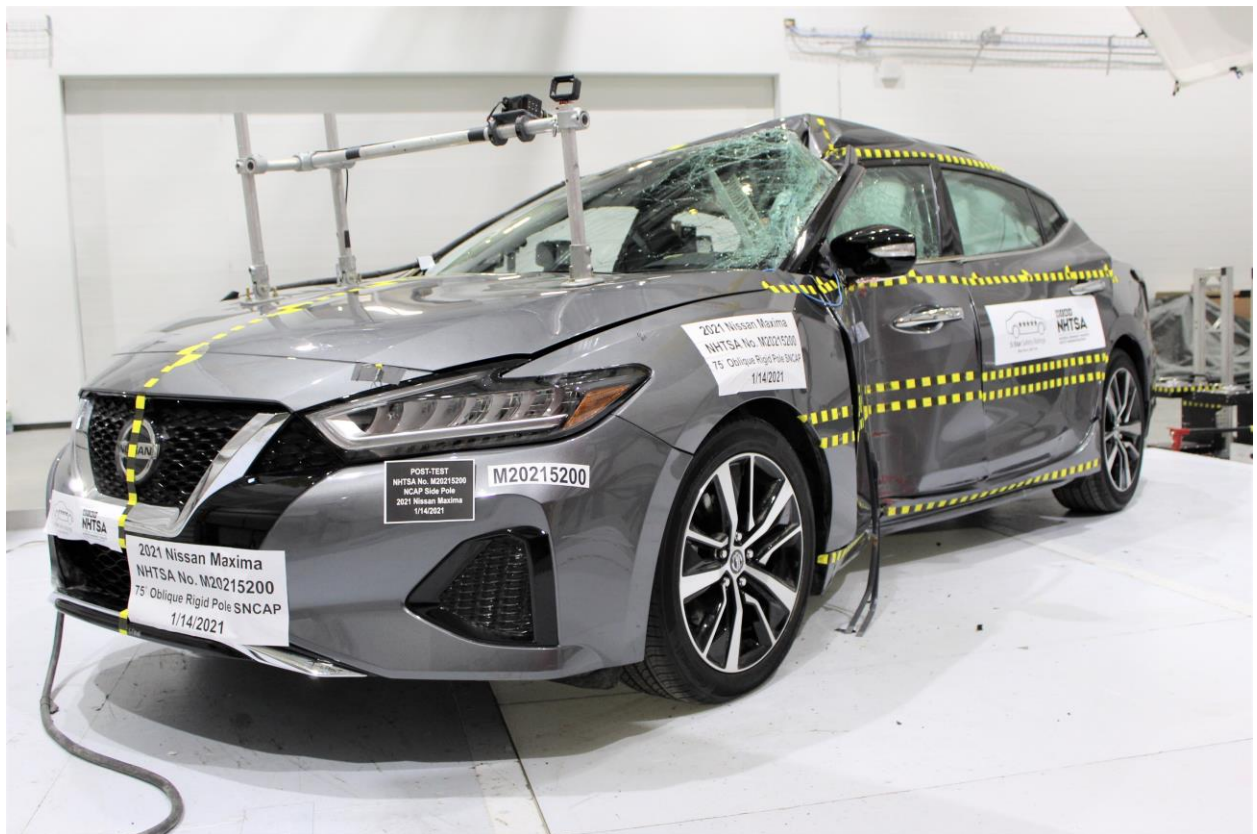
**Figure A-6: Post-Test Left Front  $\frac{3}{4}$  View of Test Vehicle**

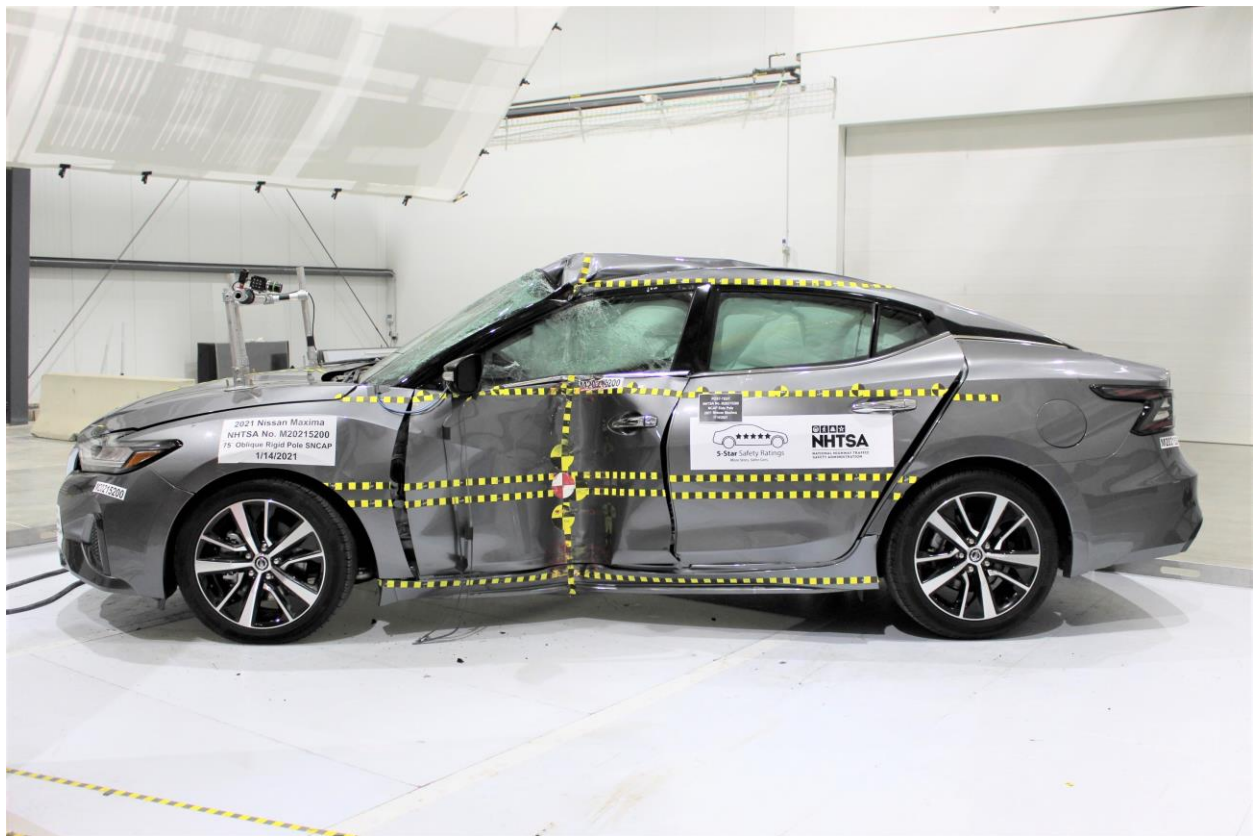
**Figure A-8: Post-Test Left Side View of Test Vehicle**

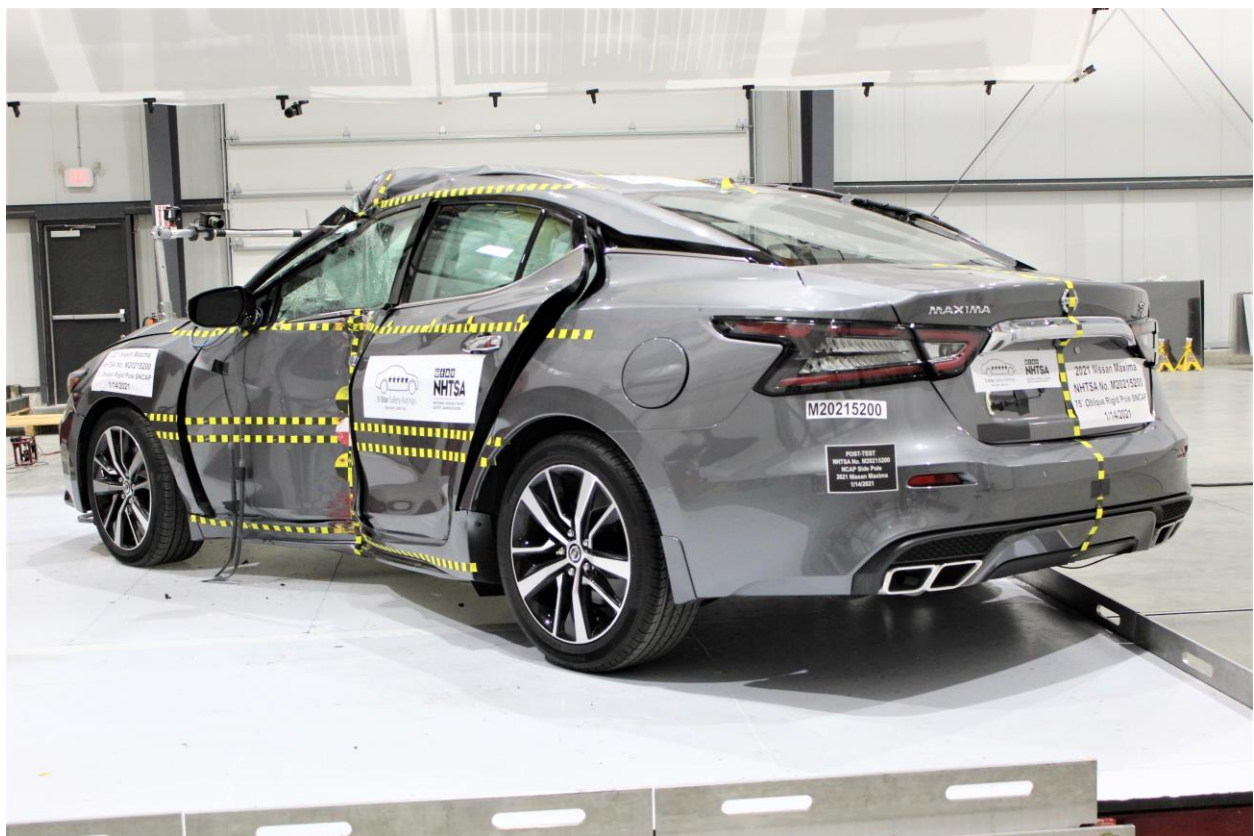
**Figure A-10: Post-Test Left Rear  $\frac{3}{4}$  View of Test Vehicle**

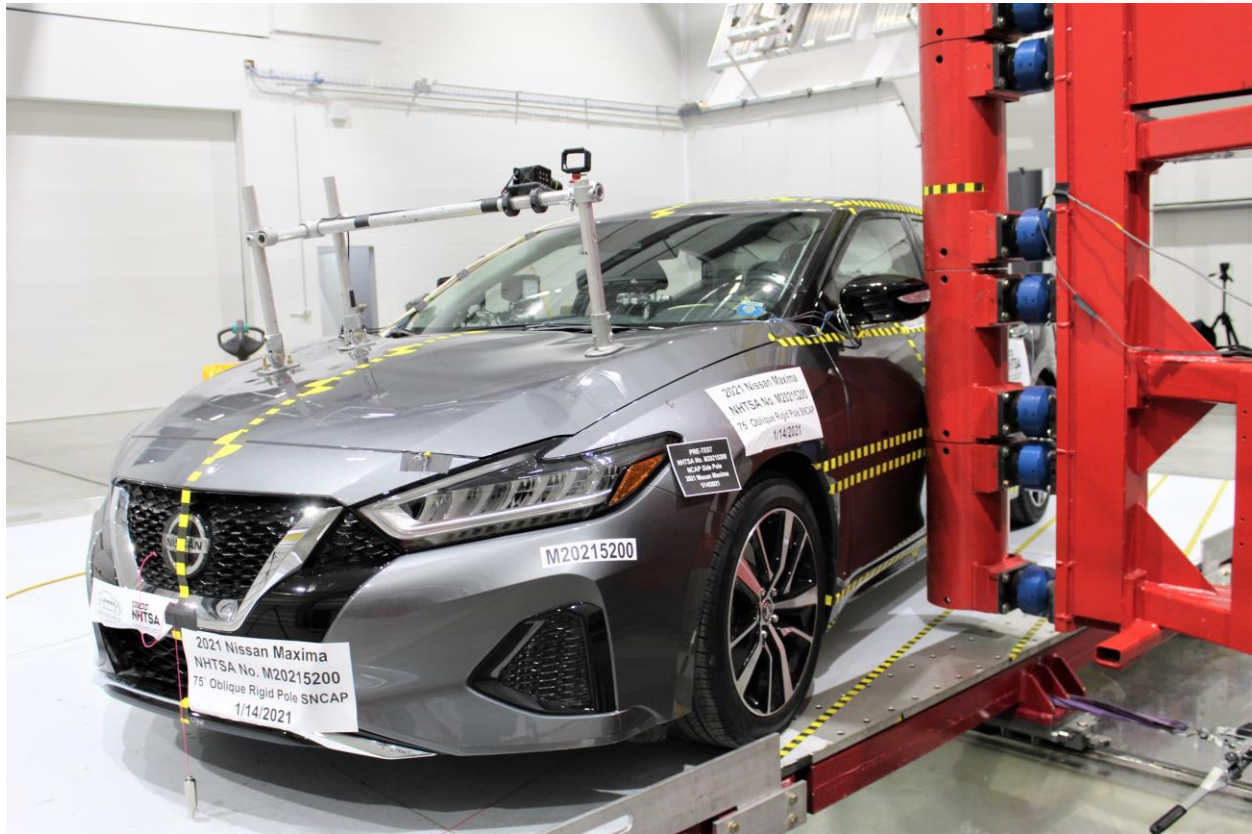
**Figure A-17: Pre-Test Left Side View of Pole Positioned Against Side of Vehicle**

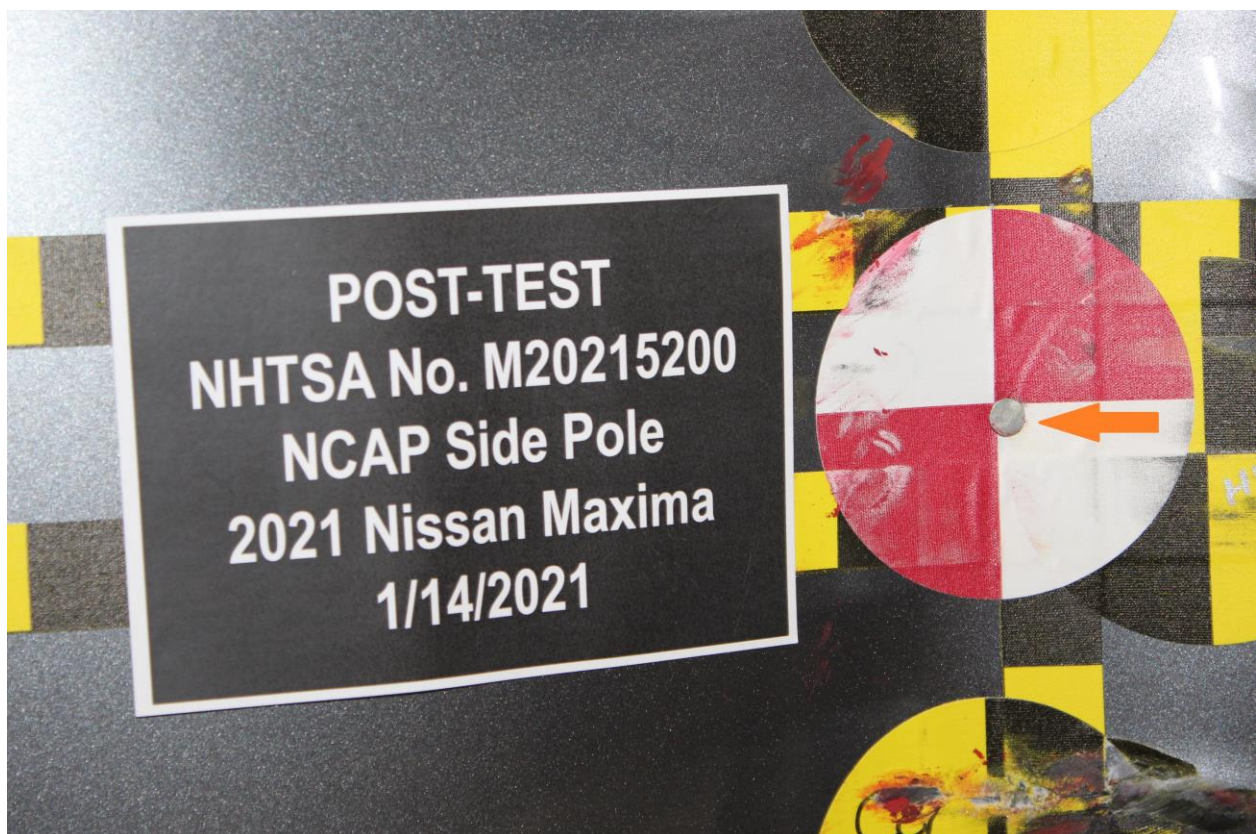
Figure A-20: Post-Test Close-Up View of Impact Point Target Showing Impact Location

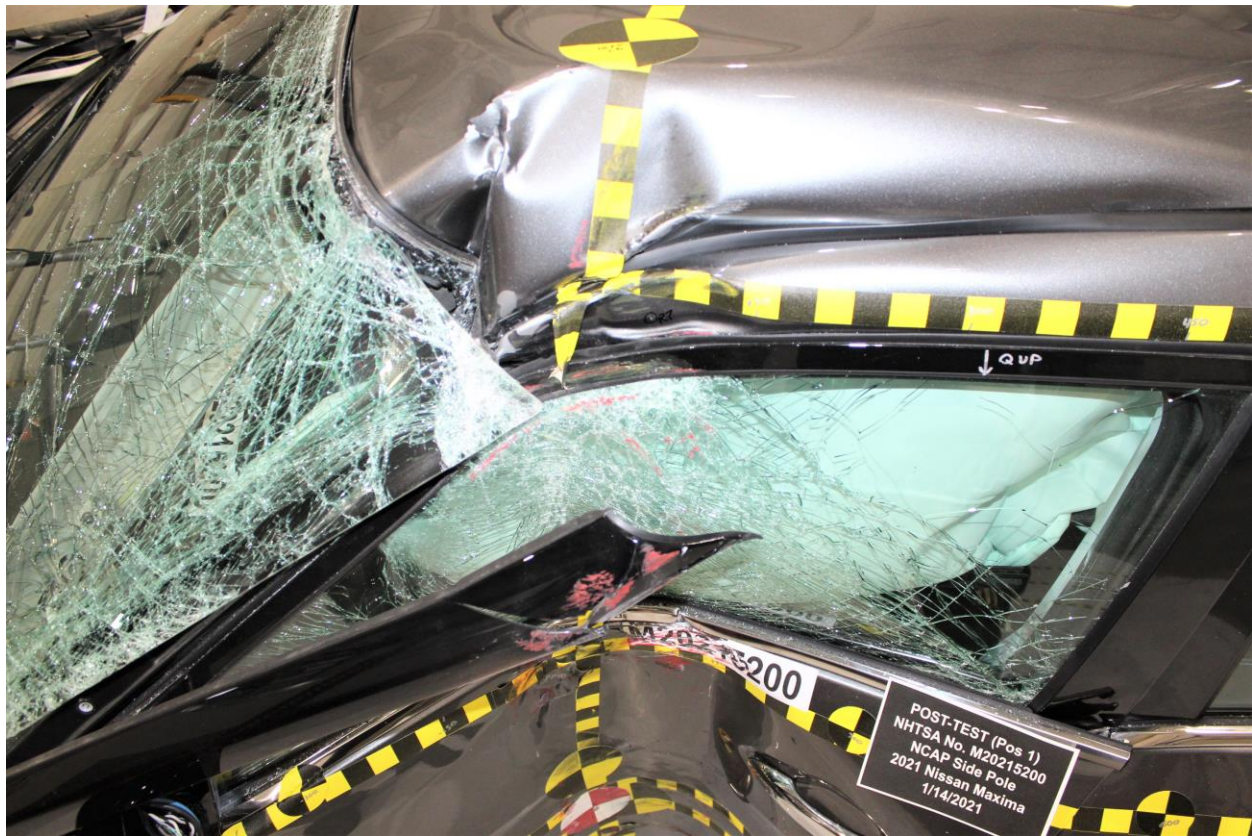
**Figure A-41: Post-Test Dummy and Door Clearance View**

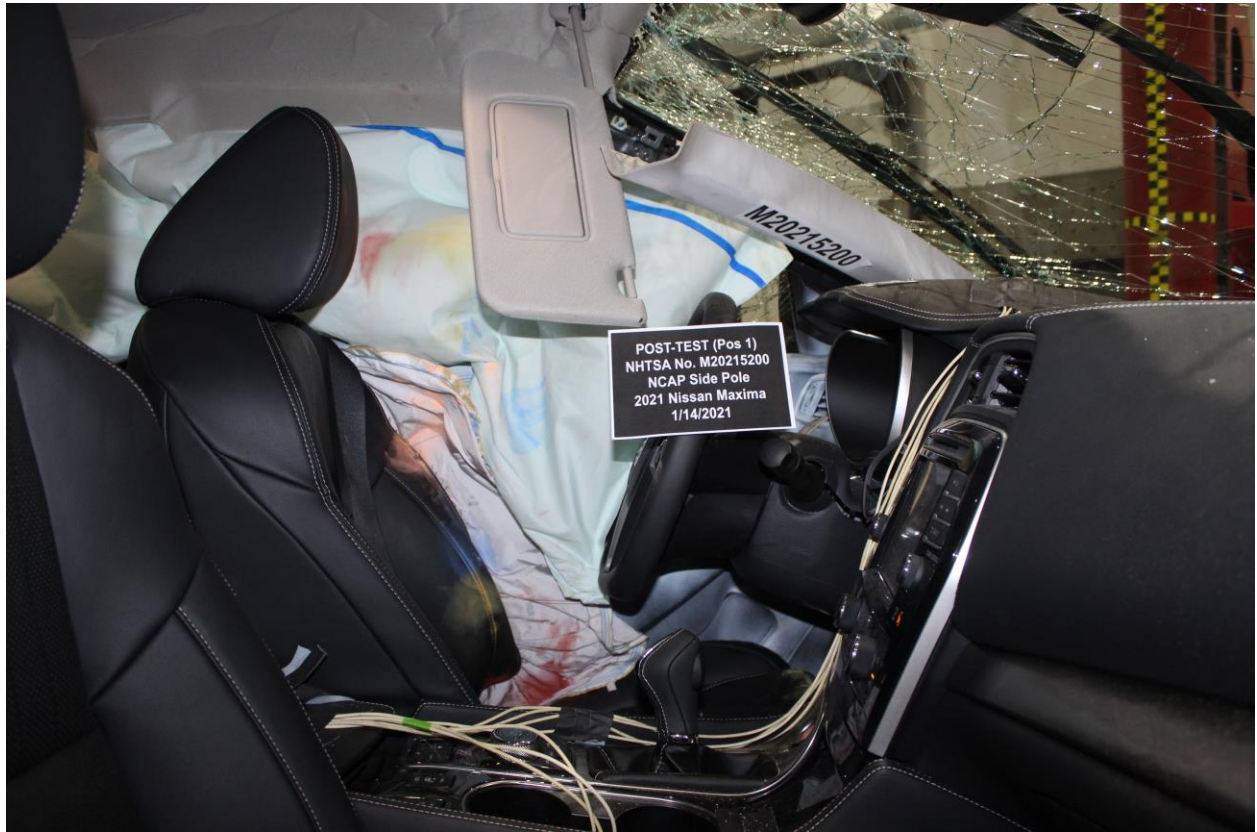
**Figure A-45: Post-Test Inner Door Panel View Showing Dummy Contact Location**

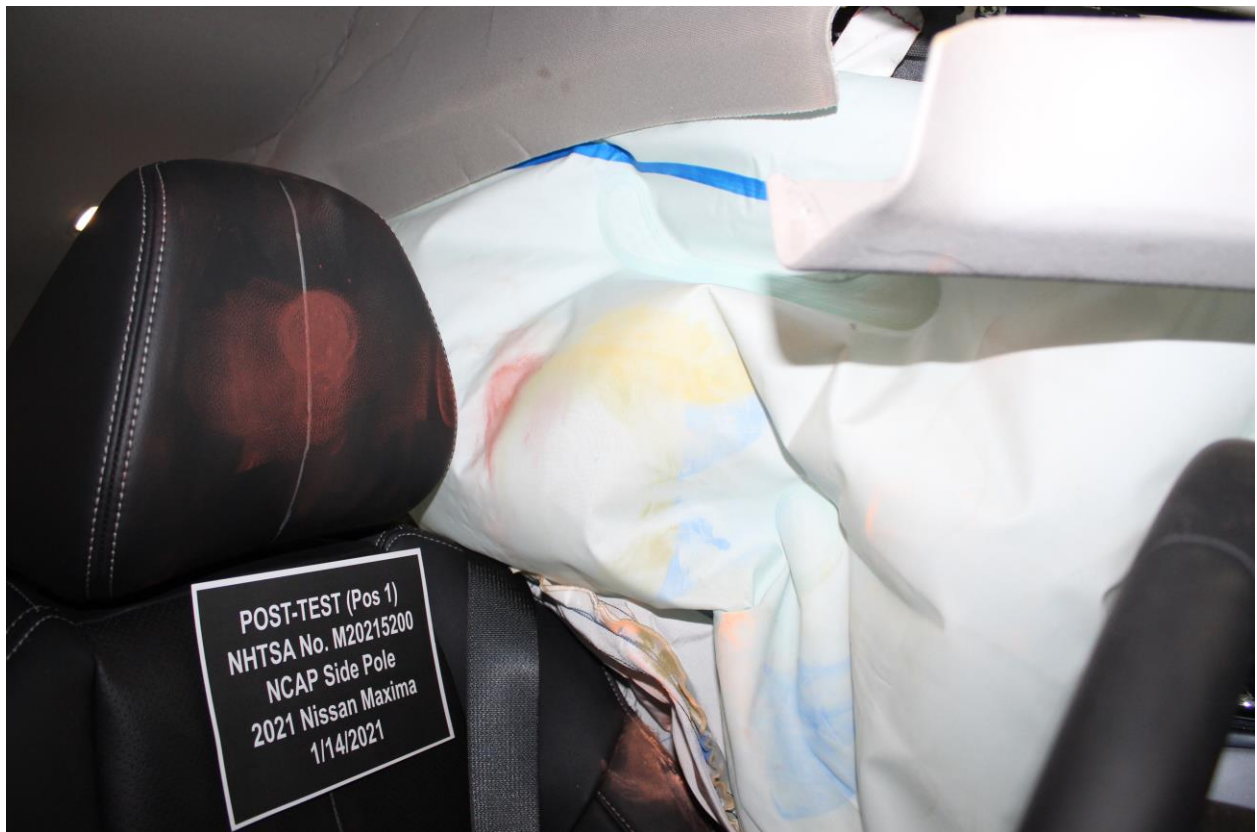
**Figure A-46: Post-Test Dummy Close-Up Head Contact with Vehicle Interior View**

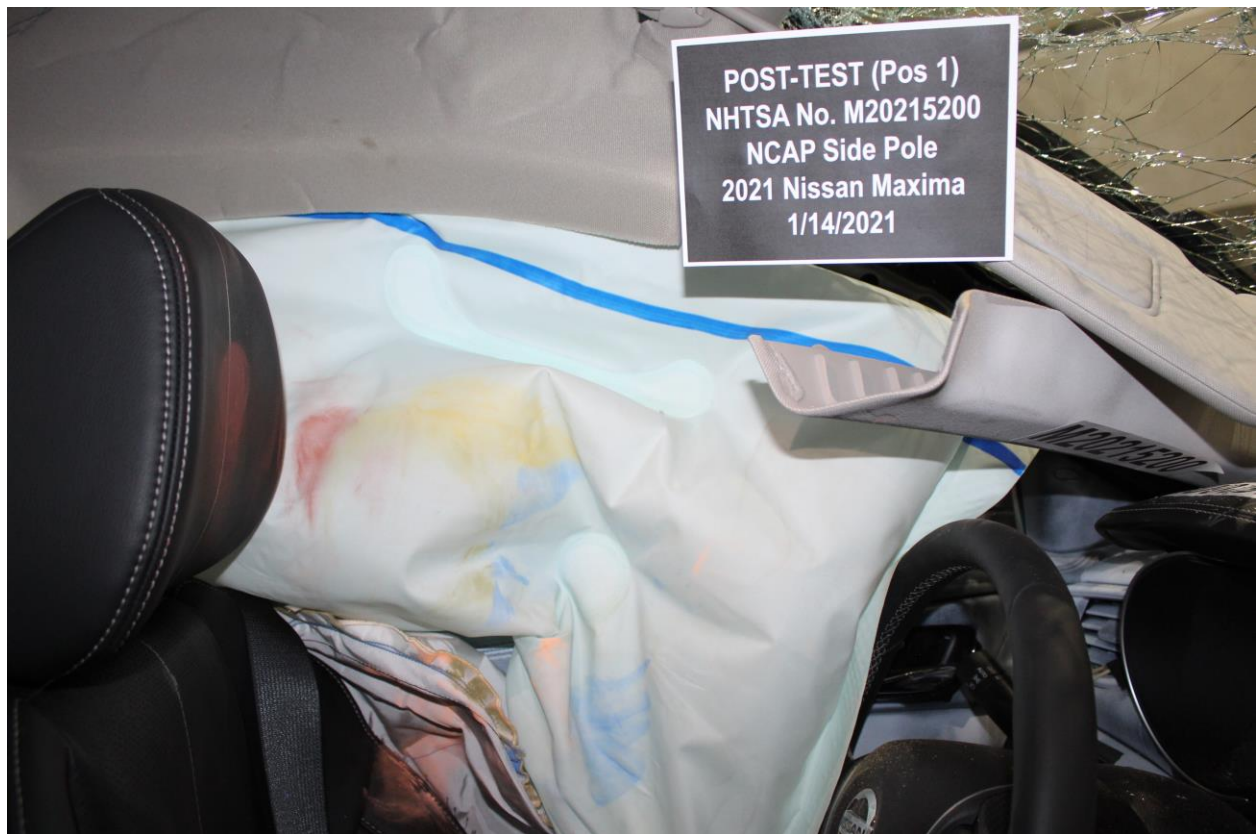
**Figure A-47: Post-Test Dummy Close-Up Head Contact with Side Airbag View**

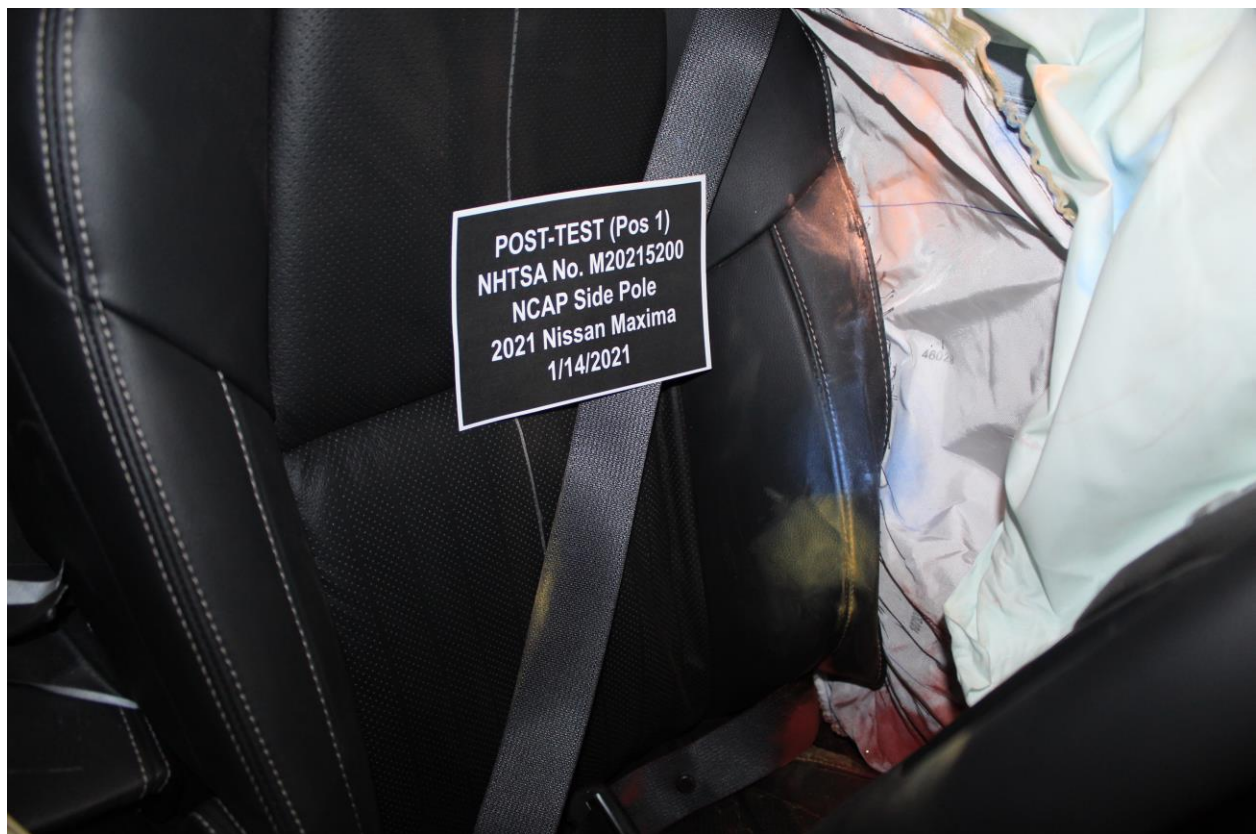
**Figure A-48: Post-Test Dummy Close-Up Torso Contact with Vehicle Interior View**

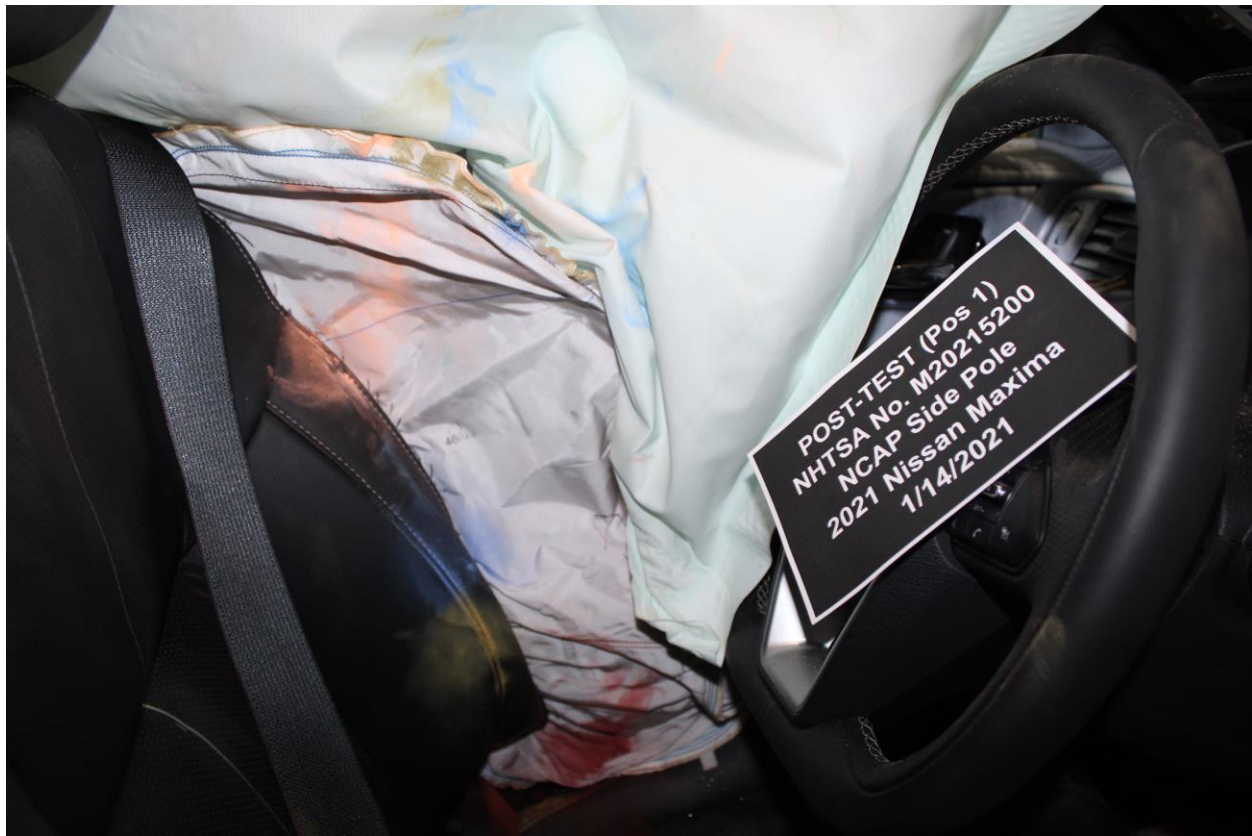
**Figure A-49: Post-Test Dummy Close-Up Torso Contact with Side Airbag View**

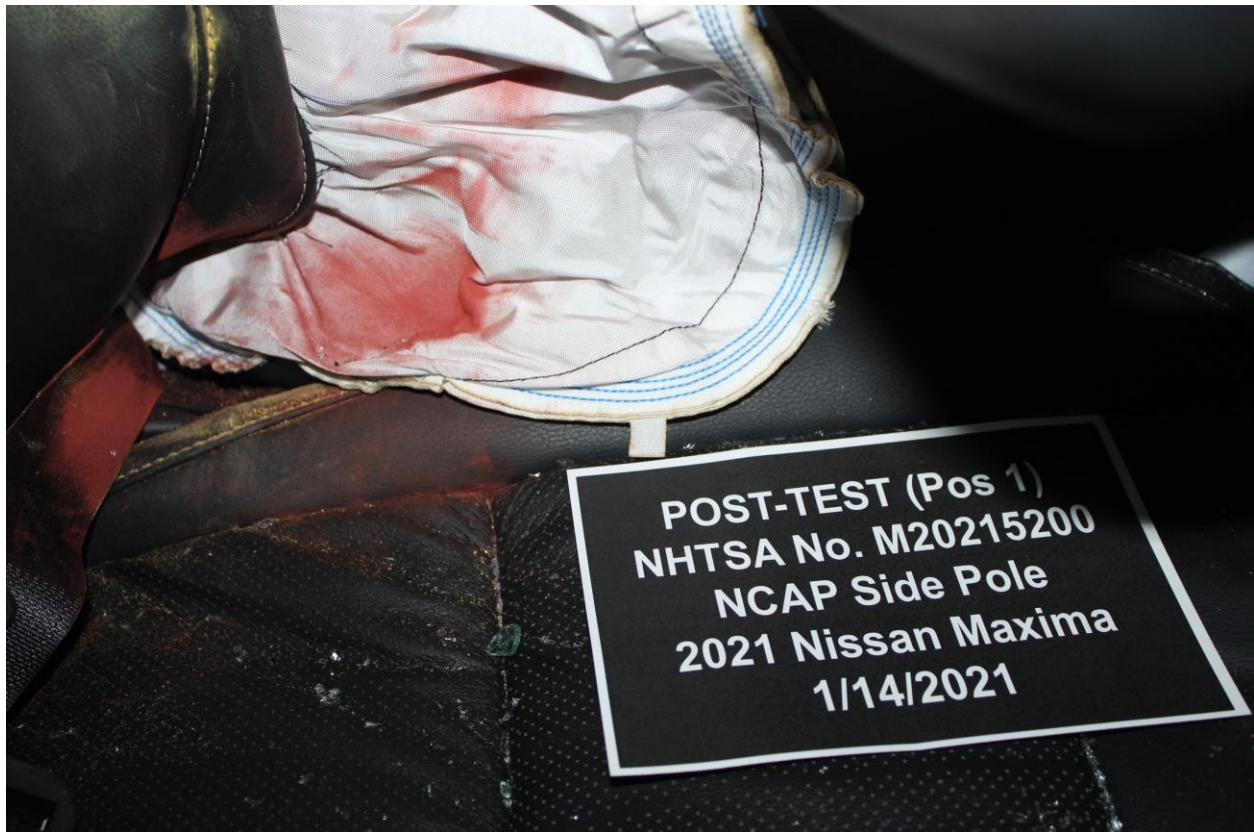
**Figure A-51: Post-Test Dummy Close-Up Pelvis Contact with Side Airbag View**

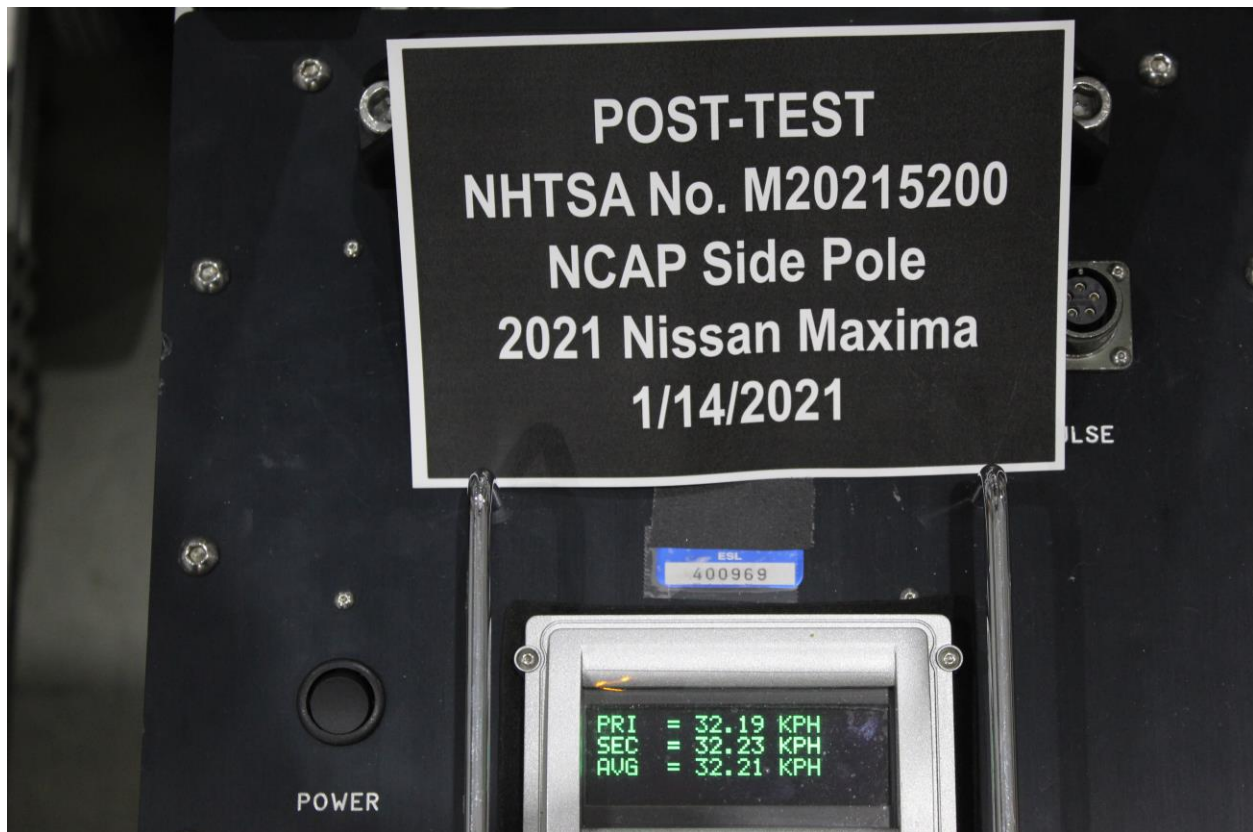
Figure A-62: Post-Test Primary and Redundant Speed Trap Read-Out
