REPORT NUMBER: R&D-KAR-20-008

**VEHICLE TO RIGID BARRIER CRASH TEST IN SUPPORT OF
NHTSA'S FRONTAL RESEARCH CRASH TEST PROGRAM
LEFT SIDE 30° FRONTAL RIGID BARRIER IMPACT**

**MAZDA MOTOR CORPORATION
2020 MAZDA CX-5 5-DOOR MPV**

NHTSA No: R20205413

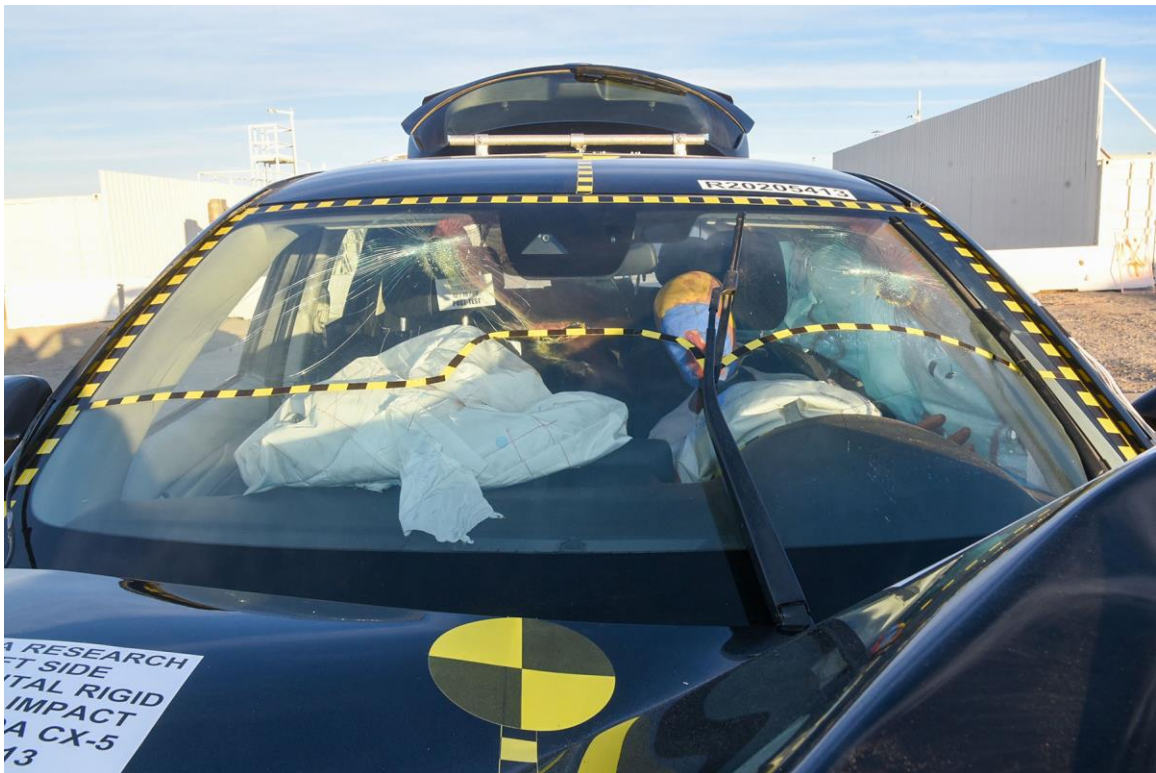
FIGURE 22. Post-Test Windshield View

The windshield was broken during impact but there was no separation recorded. There was no intrusion into the protected zone of the windshield during any portion of the impact event. The maximum static crush of the vehicle was 434.4 mm measured on the left of the vehicle's centerline.

- The front end including the bumper, grille, and hood were crushed, with the damage concentrated on the left side
- The windshield was broken due to an impact with the driver and passenger ATD's head, respectively
