REPORT NUMBER: R&D-KAR-20-010

**VEHICLE TO RIGID BARRIER CRASH TEST IN SUPPORT OF
NHTSA'S FRONTAL RESEARCH CRASH TEST PROGRAM
FULL FRONTAL RIGID BARRIER IMPACT**

**MAZDA MOTOR CORPORATION
2020 MAZDA CX-5 5-DOOR MPV**

NHTSA No: R20205415

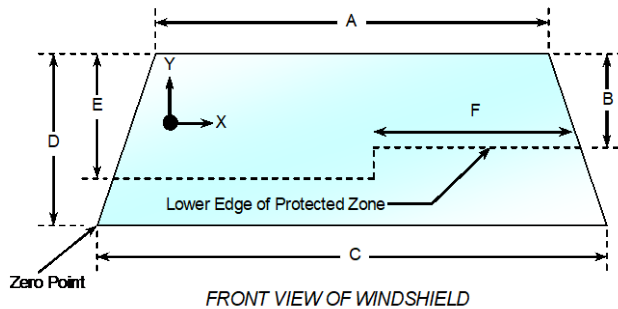
WINDSHIELD PERIPHERY MEASUREMENTS

Item	Units	Value
A	mm	1260
B	mm	375
C	mm	1520
D	mm	925
E	mm	505
F	mm	580

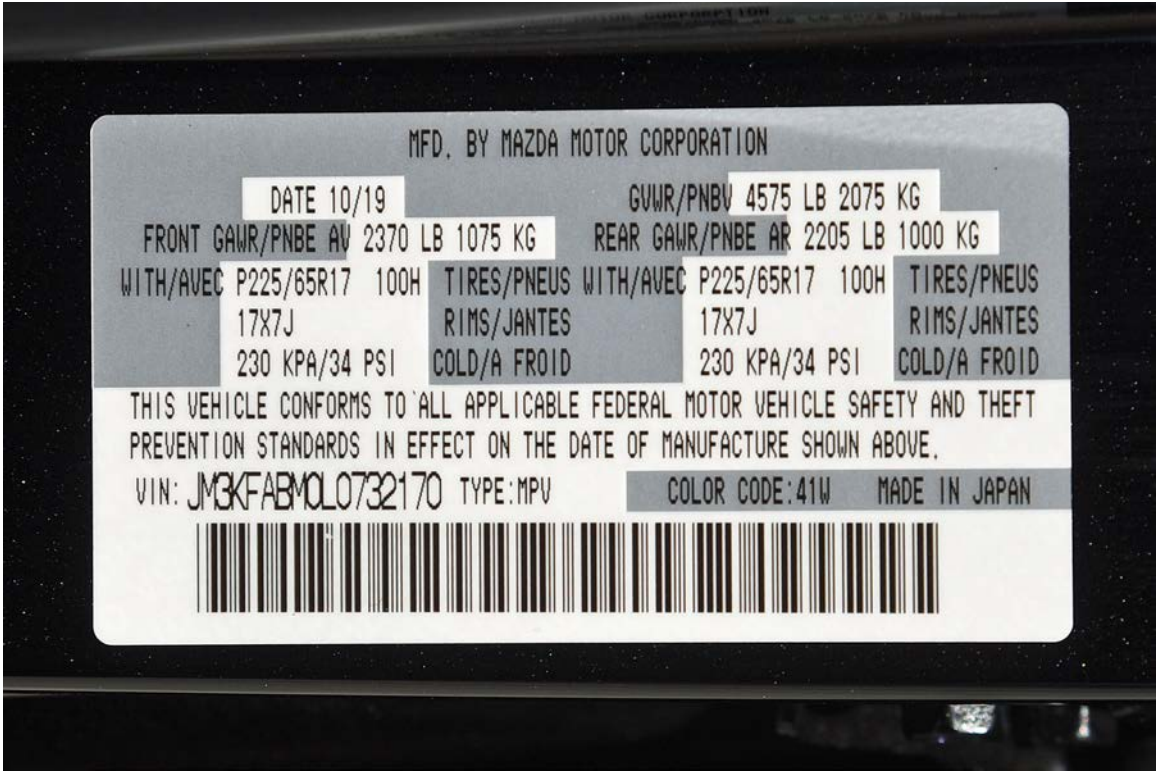
FIGURE 1. Test Vehicle Certification Label

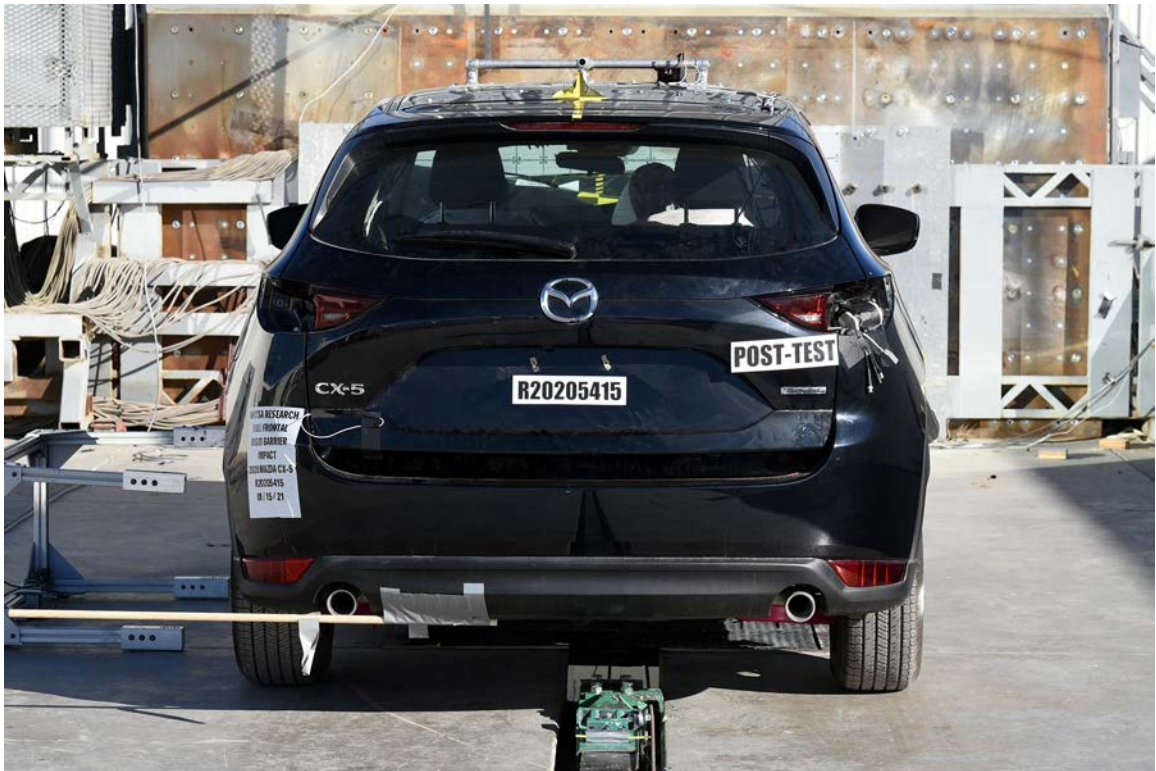
FIGURE 18. Post-Test Rear View of Test Vehicle

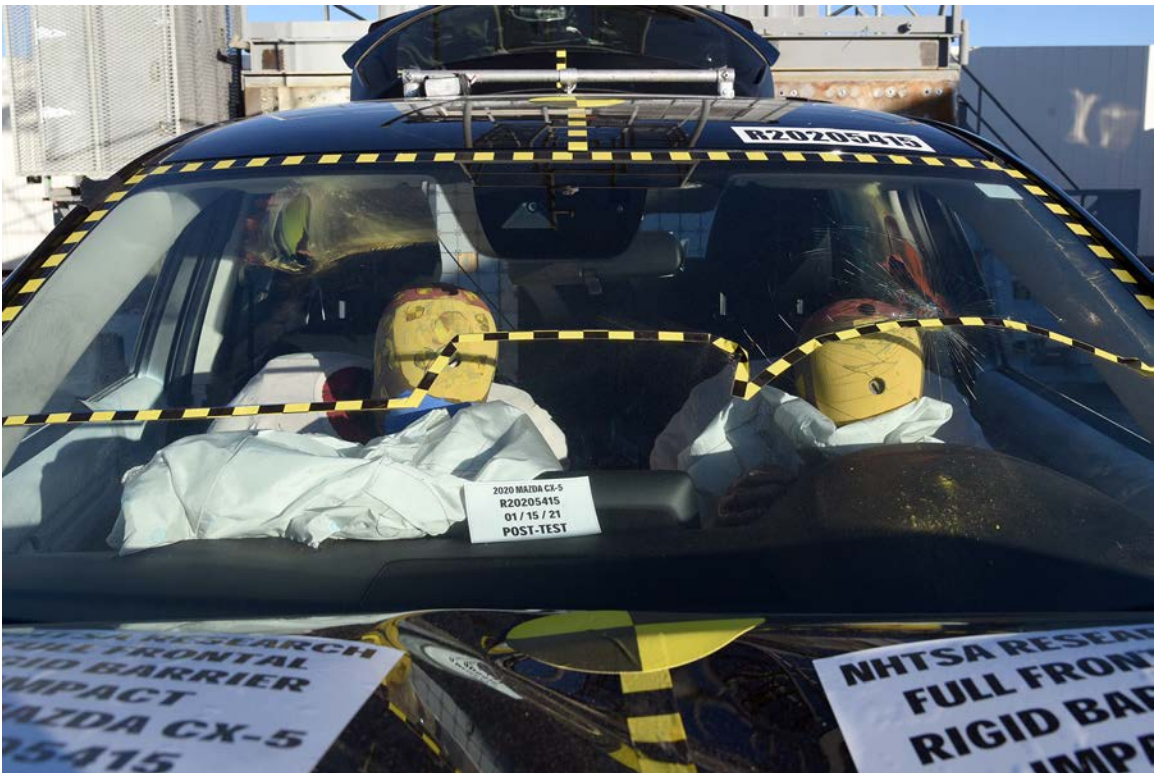
FIGURE 22. Post-Test Windshield View

- The front end including the bumper, grill, and hood were crushed, with the damage concentrated at the vehicle's centerline
- The windshield was broken at the top left and right corner due to an impact with the driver and passenger ATD's head, respectively.

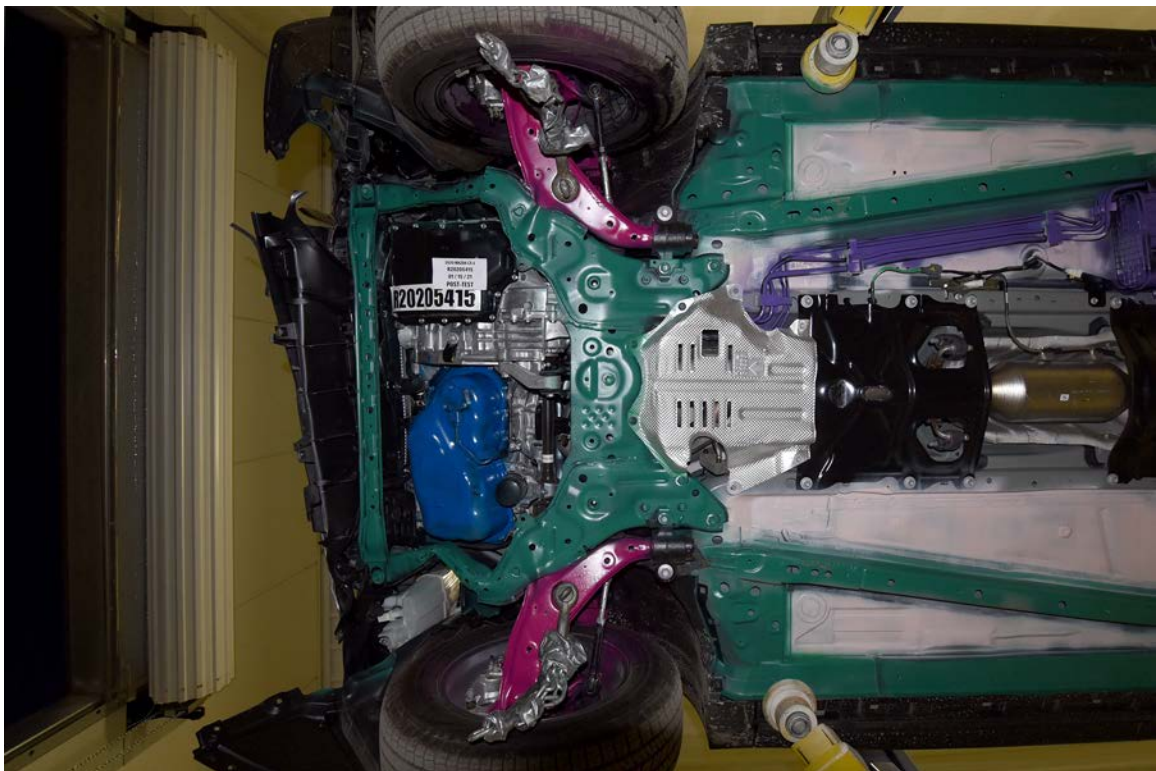
FIGURE 28. Post-Test Front Underbody View

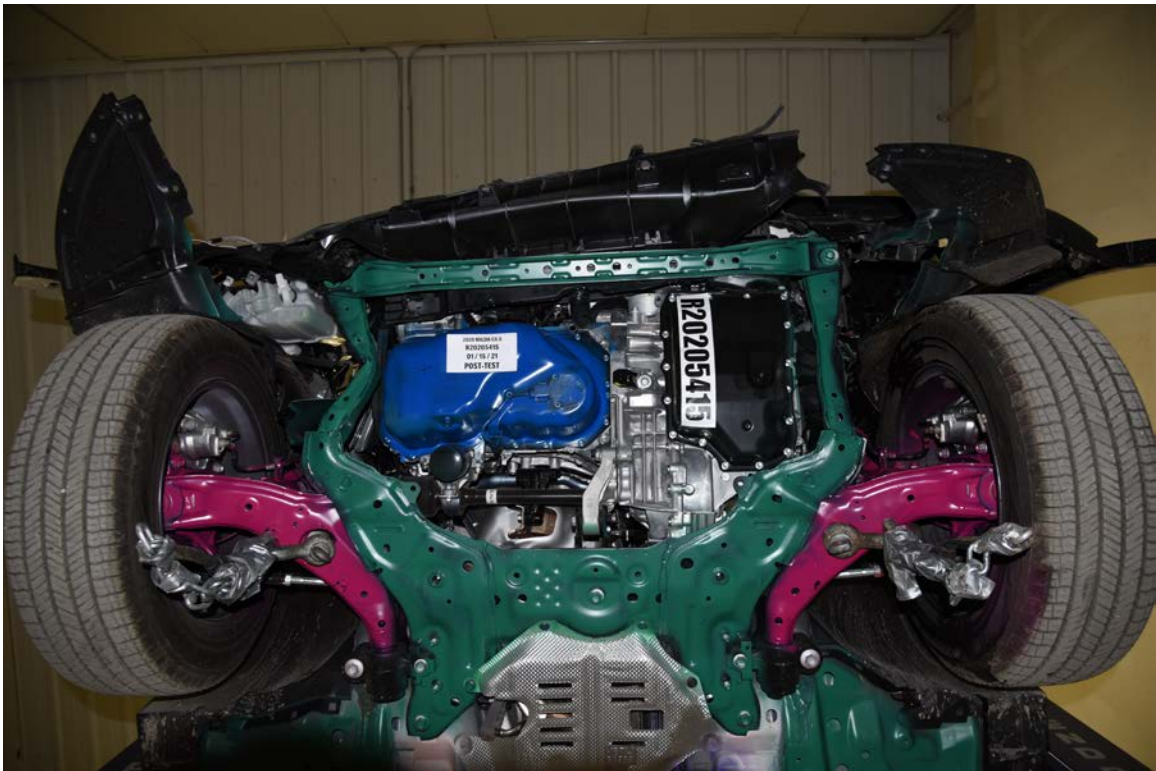
FIGURE 34. Post-Test Bumper to Rail Attachments and Crush Initiators

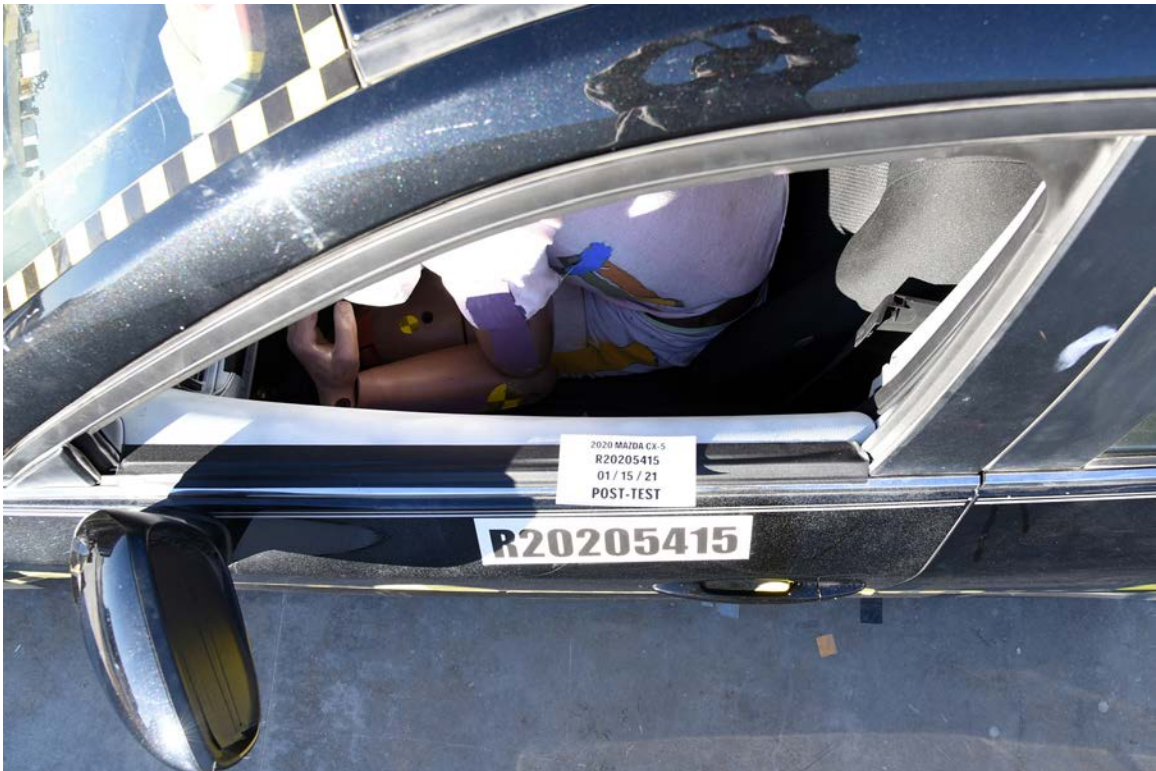
FIGURE 48. Post-Test View of Driver Door Clearance

All four vehicle doors remained closed and latched during the test. All doors remained operational after the impact event.

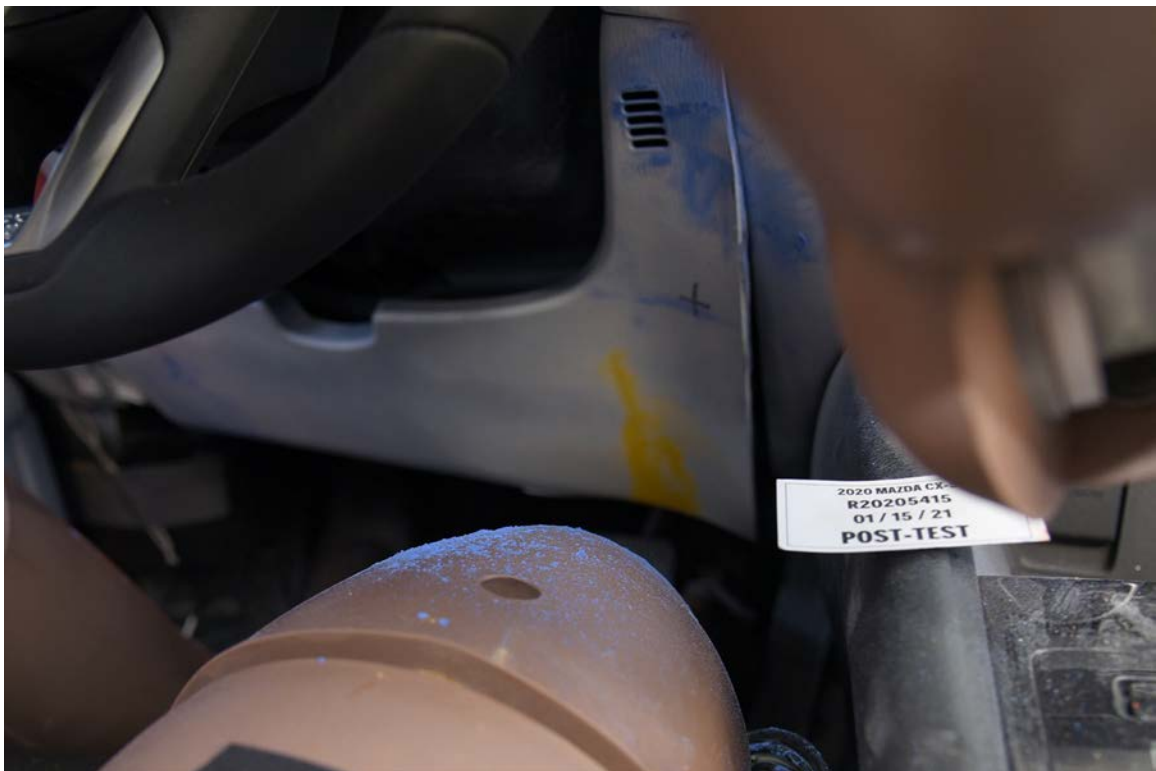
FIGURE 62. Post-Test View of Driver Right Knee and Bolster

- Head contacted the front airbag, headliner, and windshield
- Torso contacted the front airbag
- Left leg contacted the knee bolster
- Right leg contacted the knee bolster

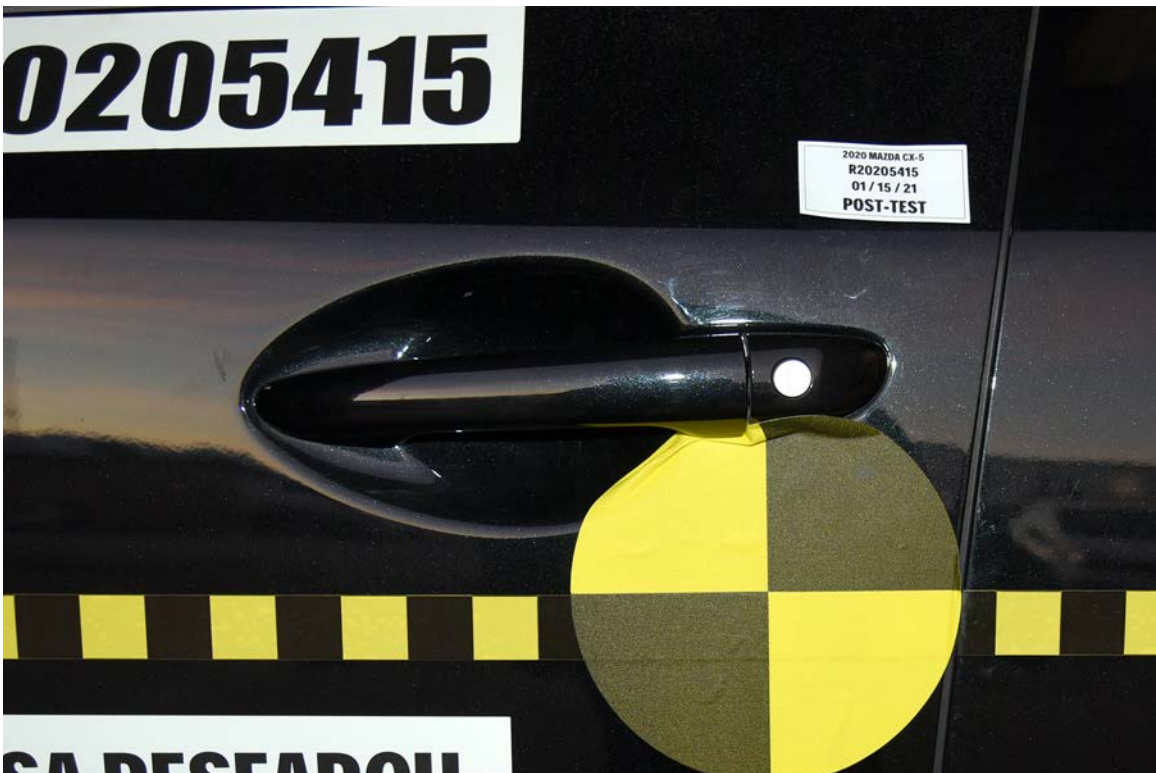
FIGURE 74. Post-Test Close-Up View of Driver Door Latch

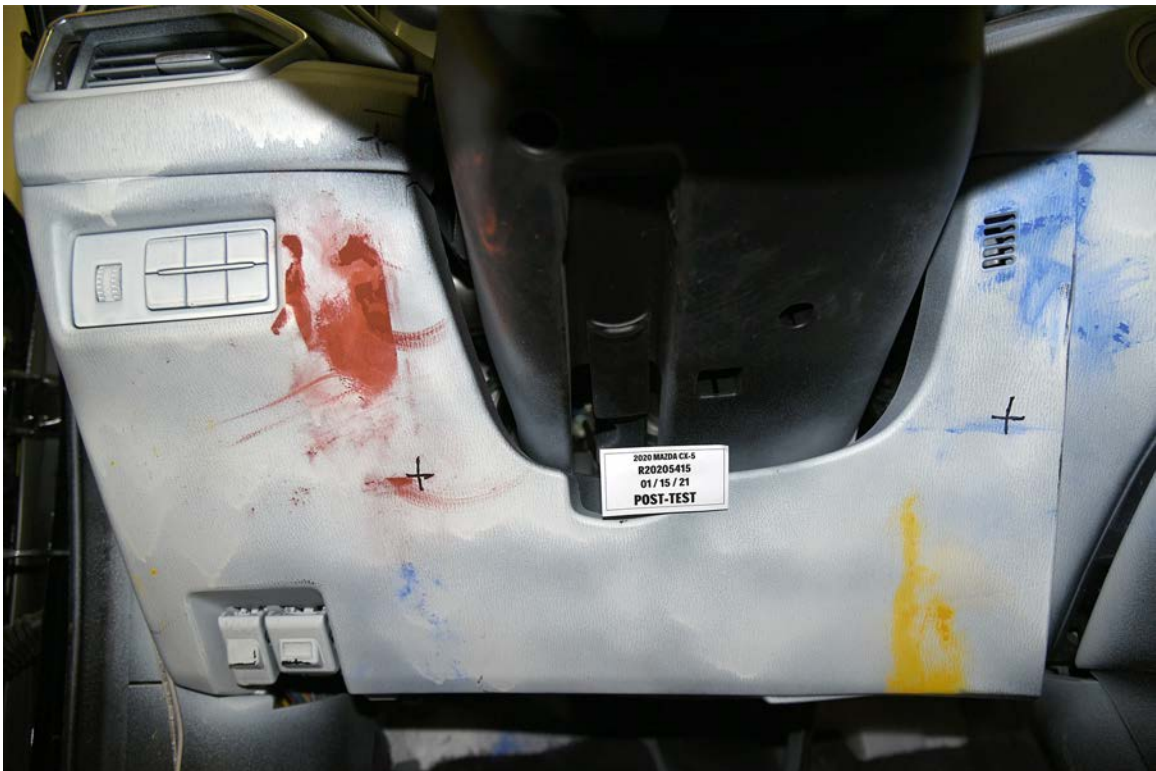
FIGURE 80. Post-Test Overall View of Driver Knee Bolster

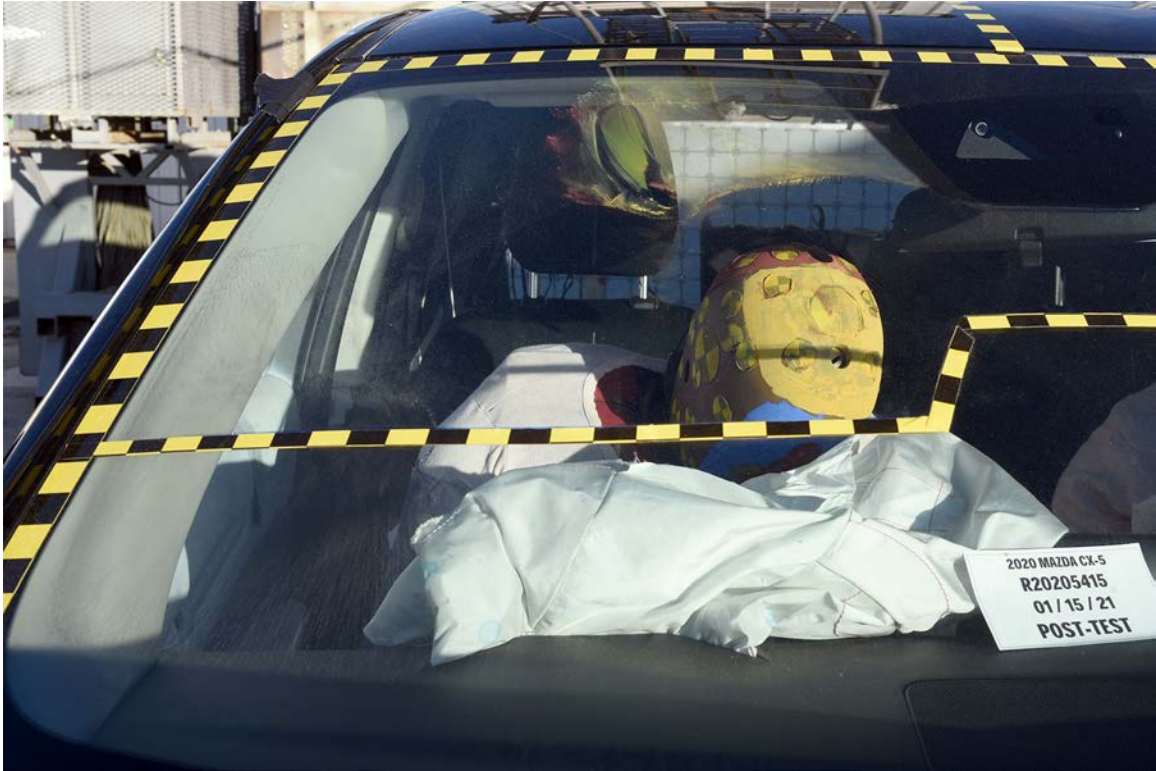
FIGURE 93. Post-Test Passenger Front Windshield View

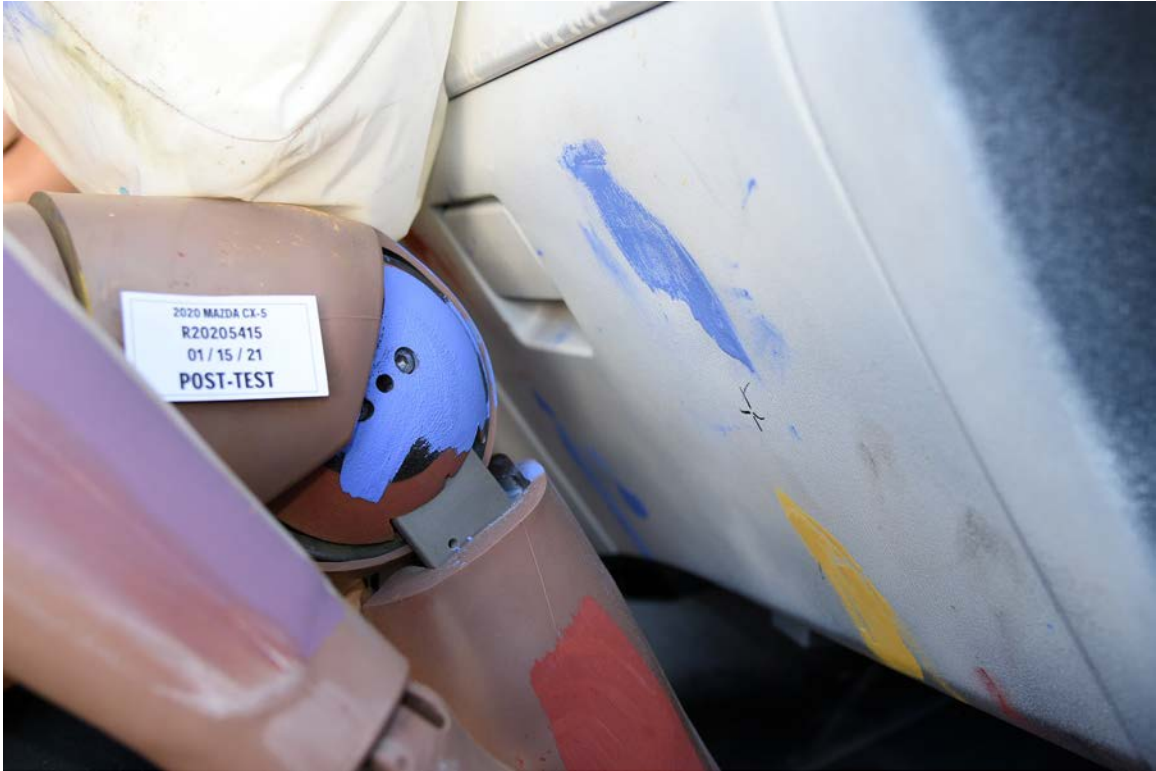
FIGURE 107. Post-Test View of Passenger Right Knee and Bolster

- Head contacted the front airbag, headliner, and windshield
- Torso contacted the front airbag
- Left leg contacted the knee bolster
- Right leg contacted the knee bolster

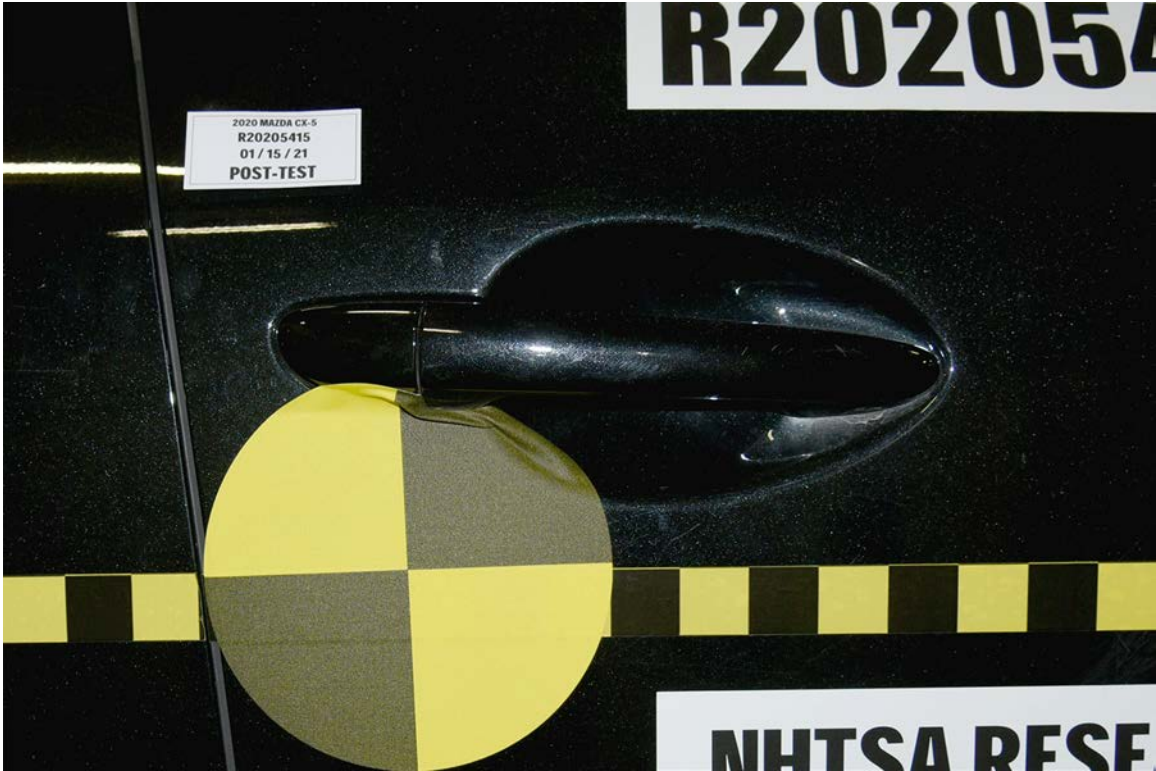
FIGURE 119. Post-Test Close-up View of Passenger Door Latch
