REPORT NUMBER: SideNCAPMDB-MGA-21-034

**NEW CAR ASSESSMENT PROGRAM (NCAP)
Moving Deformable Barrier Side Impact Test**

**HYUNDAI MOTOR COMPANY
2021 Hyundai Elantra SEL 4-Door Sedan
NHTSA No.: O20214208**

**MGA RESEARCH CORPORATION
5000 Warren Road
Burlington, WI 53105**

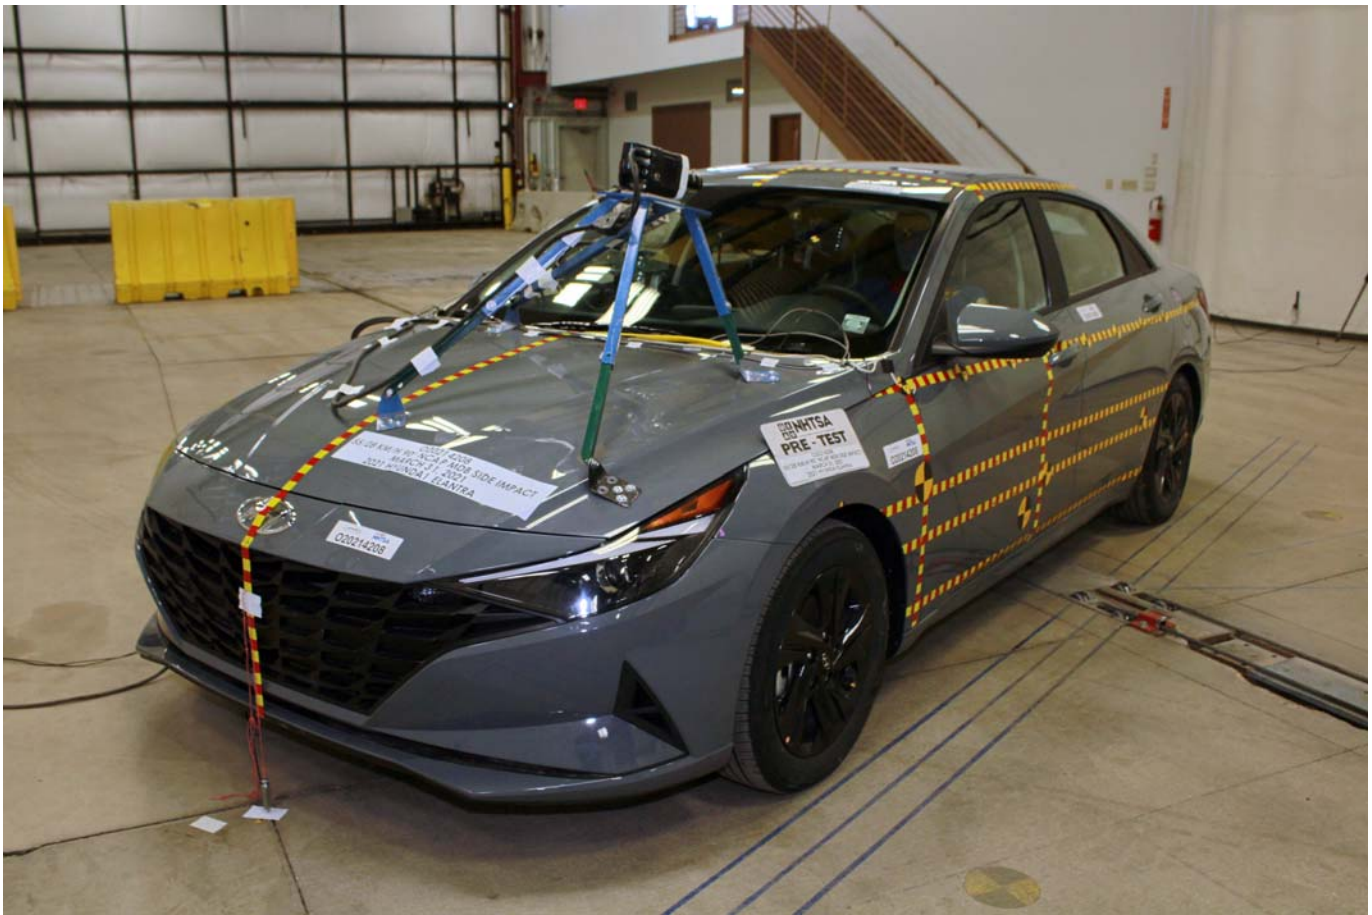
Photo No. 006 - Post-Test Left Front Three-Quarter View of Test Vehicle

Critical Areas of Performance	Observations and Conclusions
Pillar Performance	No Separation
Sill Separation	None
Windshield Damage	None
Side Window Damage	LF, LR window broken
Other Notable Effects	None

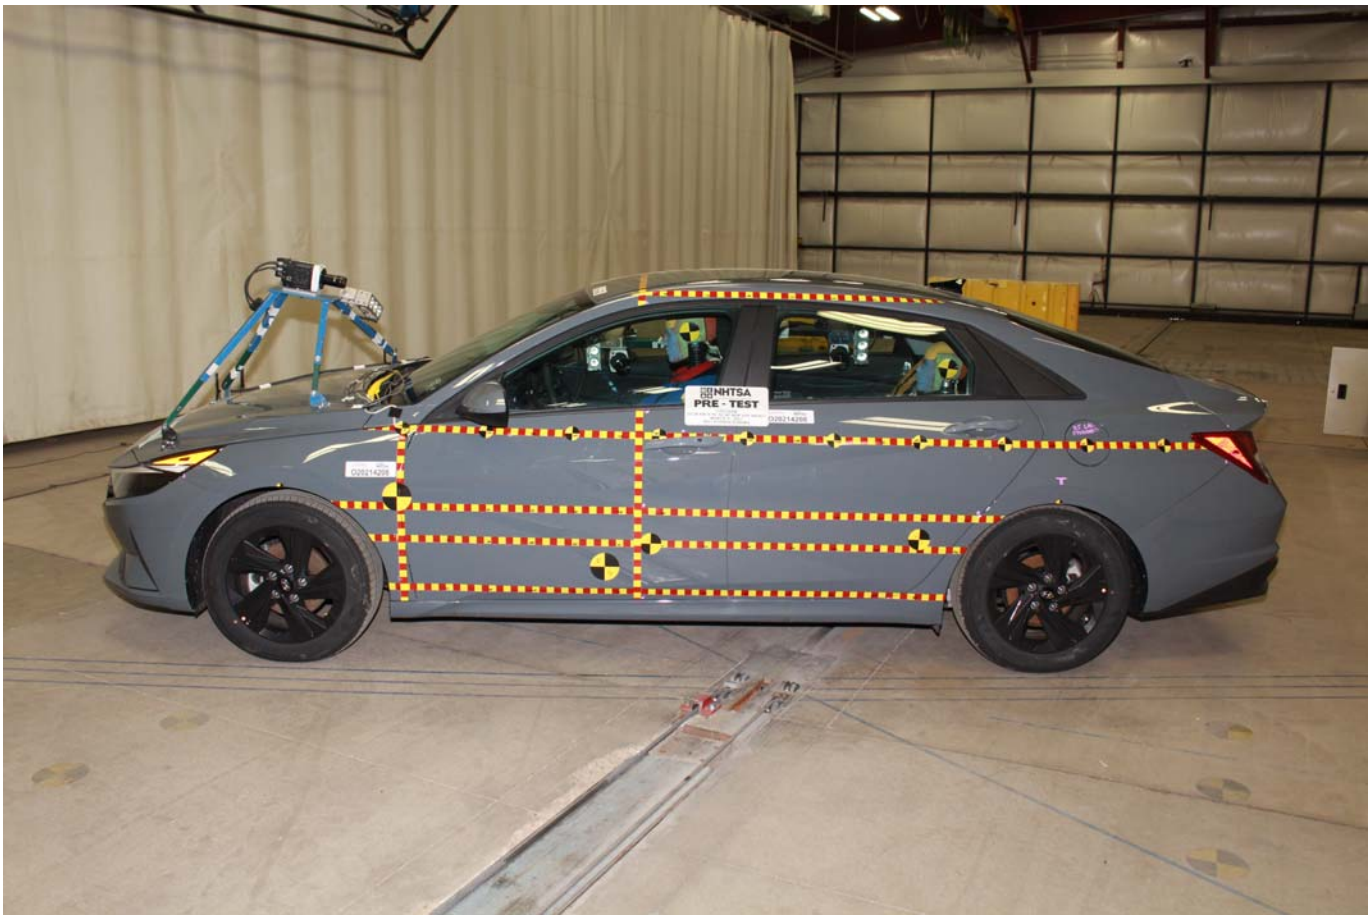
Photo No. 008 - Post-Test Left Side View of Test Vehicle

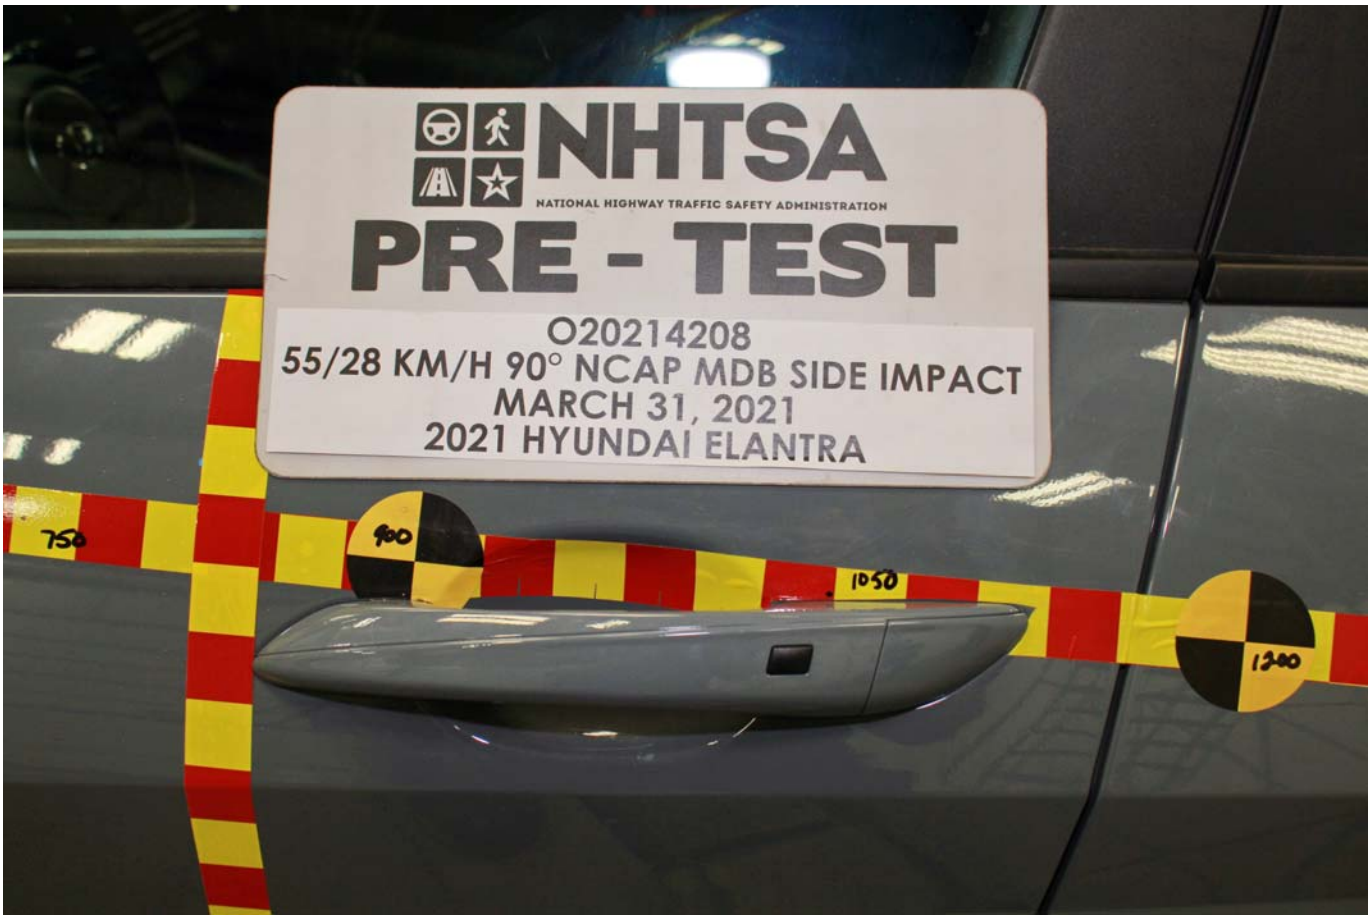
Photo No. 022 - Post-Test Left Front Door Latch Close-Up

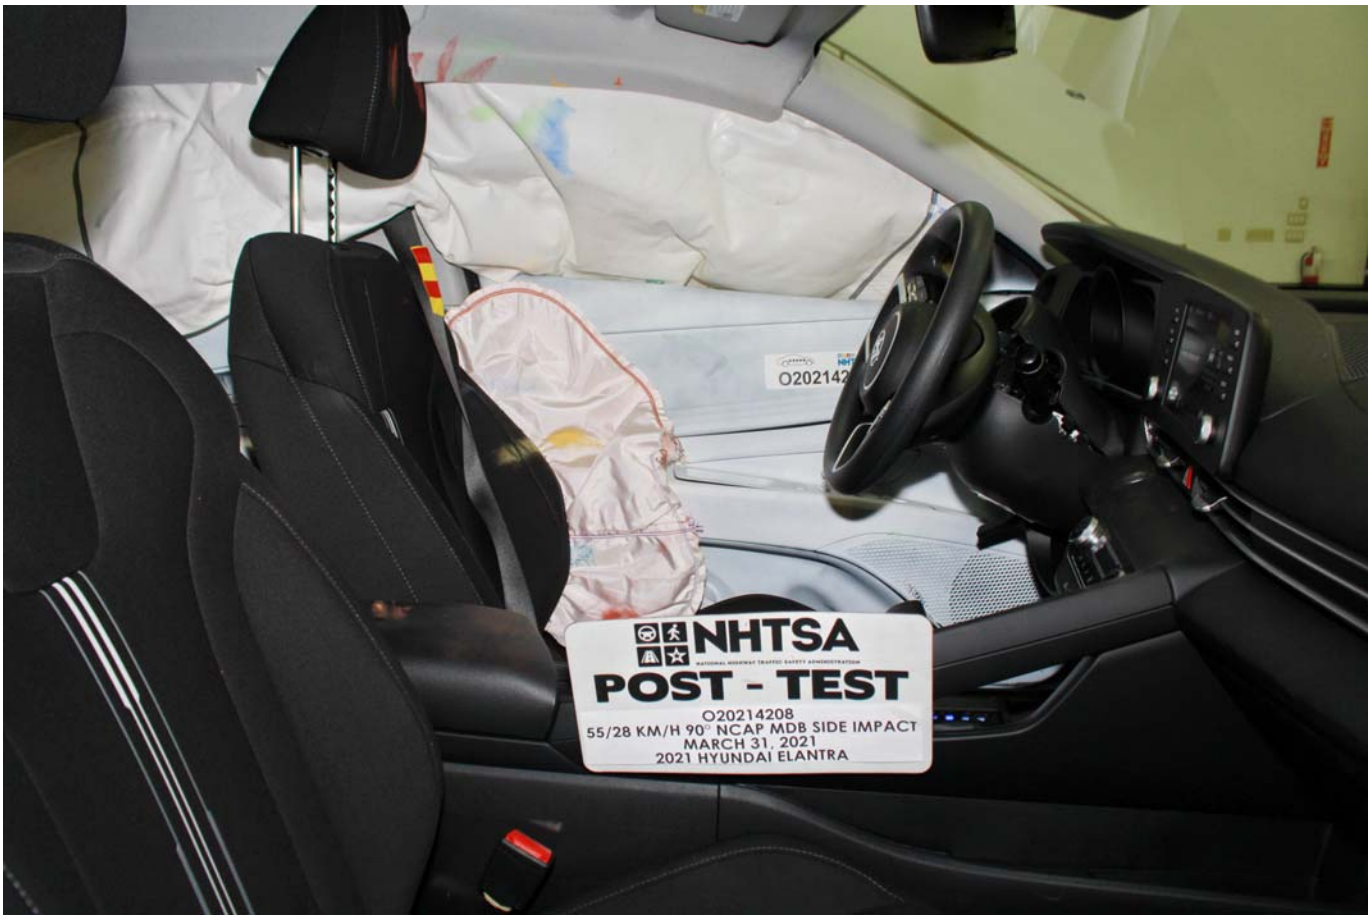
Photo No. 047 - Post-Test Driver Inner Door Panel View

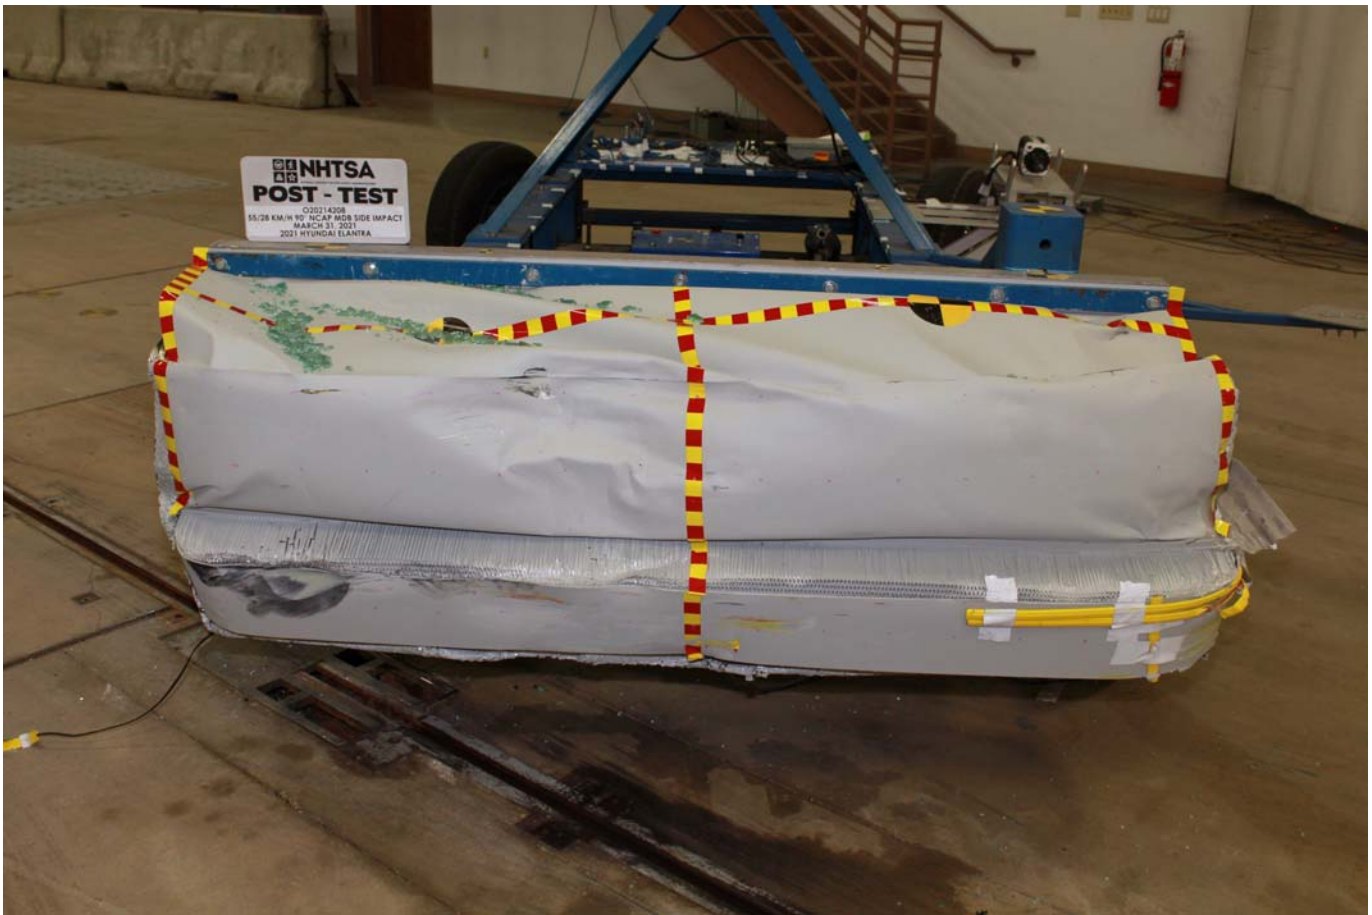
Photo No. 085 - Post-Test Front View of MDB Impactor Face

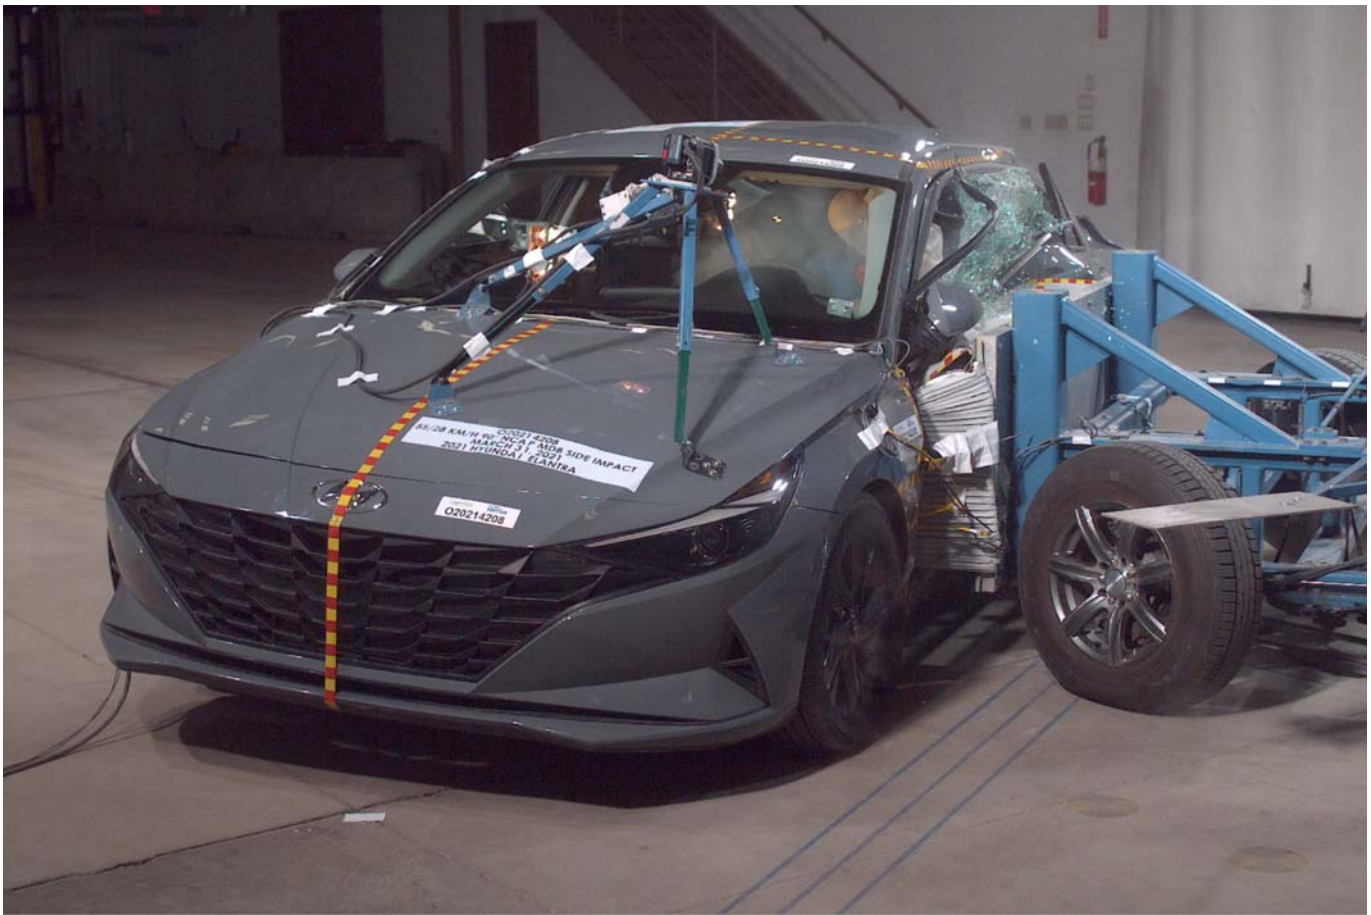
Photo No. 101 - Impact Event
