REPORT NUMBER: SPNCAP-CAL-21-007

**NEW CAR ASSESSMENT PROGRAM (NCAP)
SIDE IMPACT POLE TEST**

**Ford Motor Co.
2021 Ford F-250 Super Duty Crew Cab
Truck**

NHTSA No: M20210213

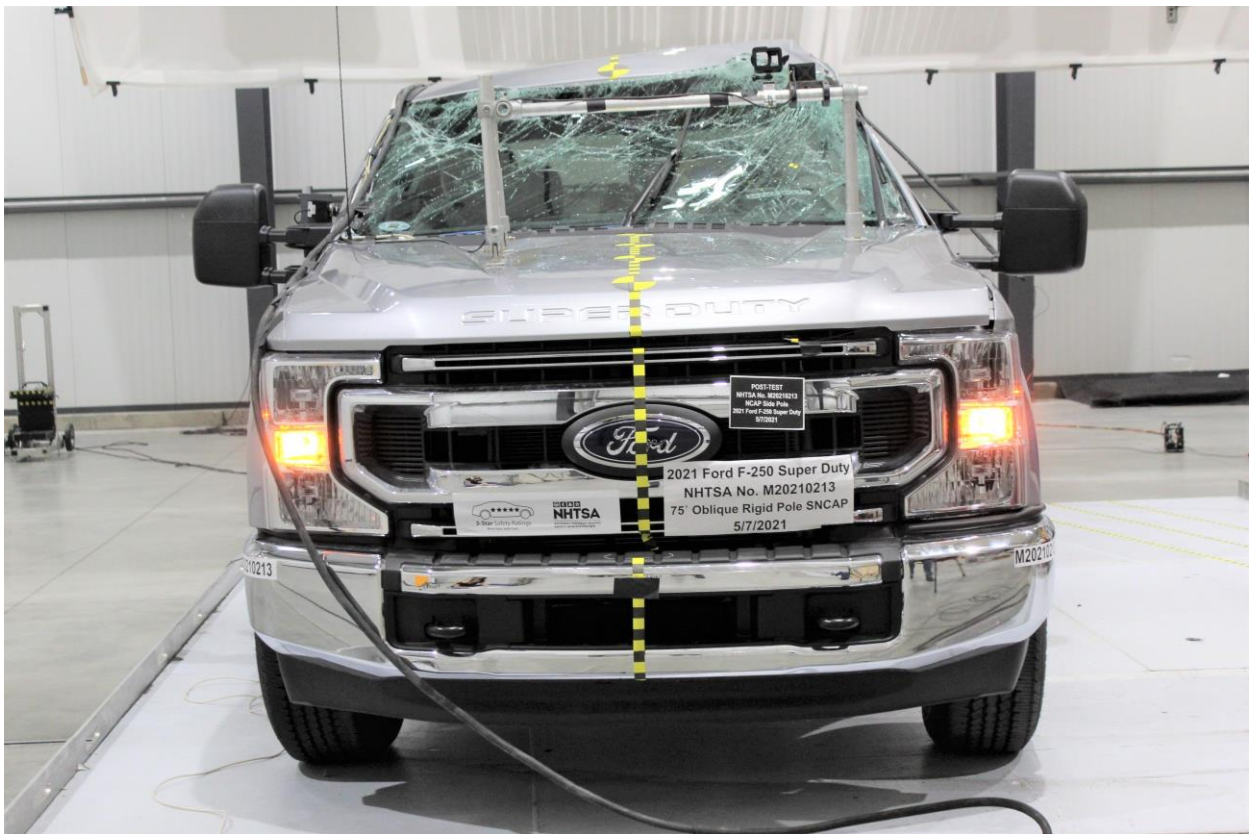
Figure A-4: Post-Test Frontal View of Test Vehicle

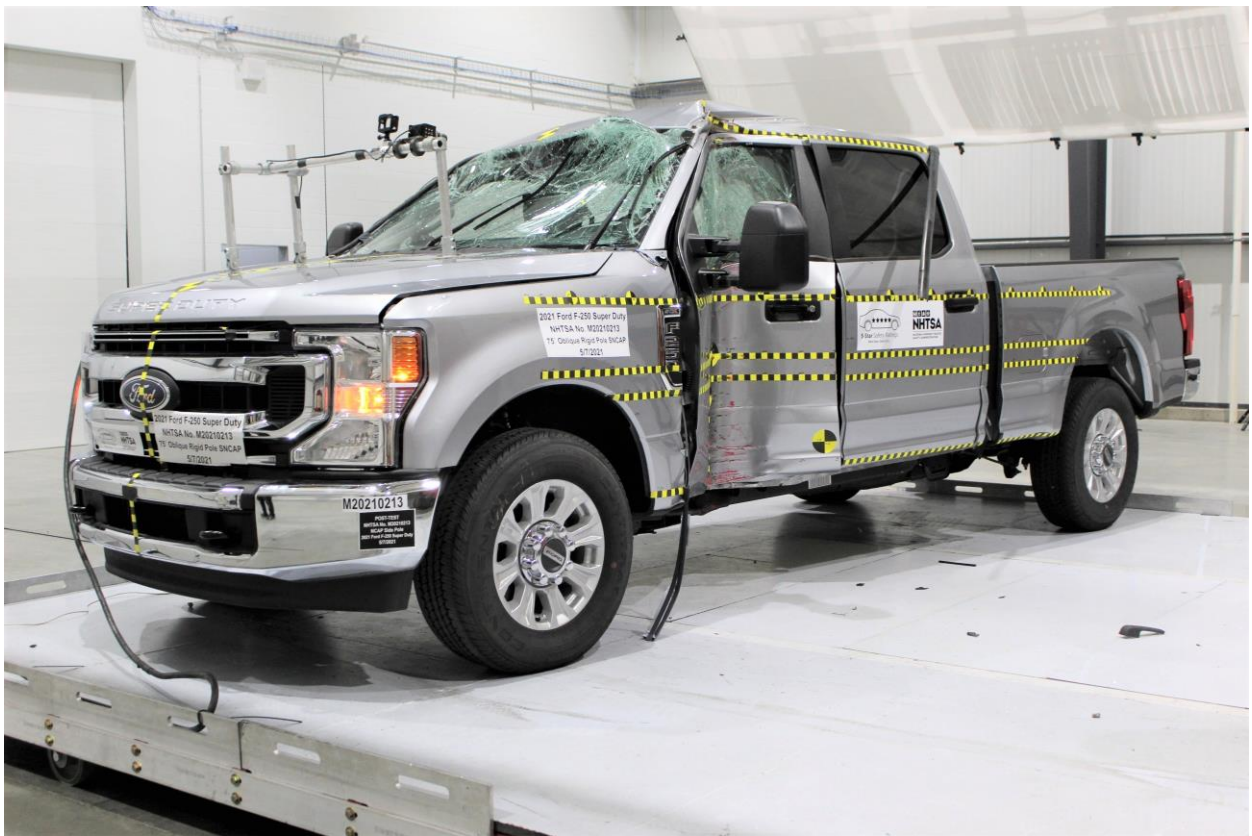
Figure A-6: Post-Test Left Front ¾ View of Test Vehicle

Critical Areas of Performance	Observations and Conclusions
Pillar Performance	A-Pillar Buckled
Sill Separation	Minor sill separation of approximately 310mm
Windshield Damage	Cracks throughout
Side Window Damage	Driver window cracked throughout
Other Notable Effects	None

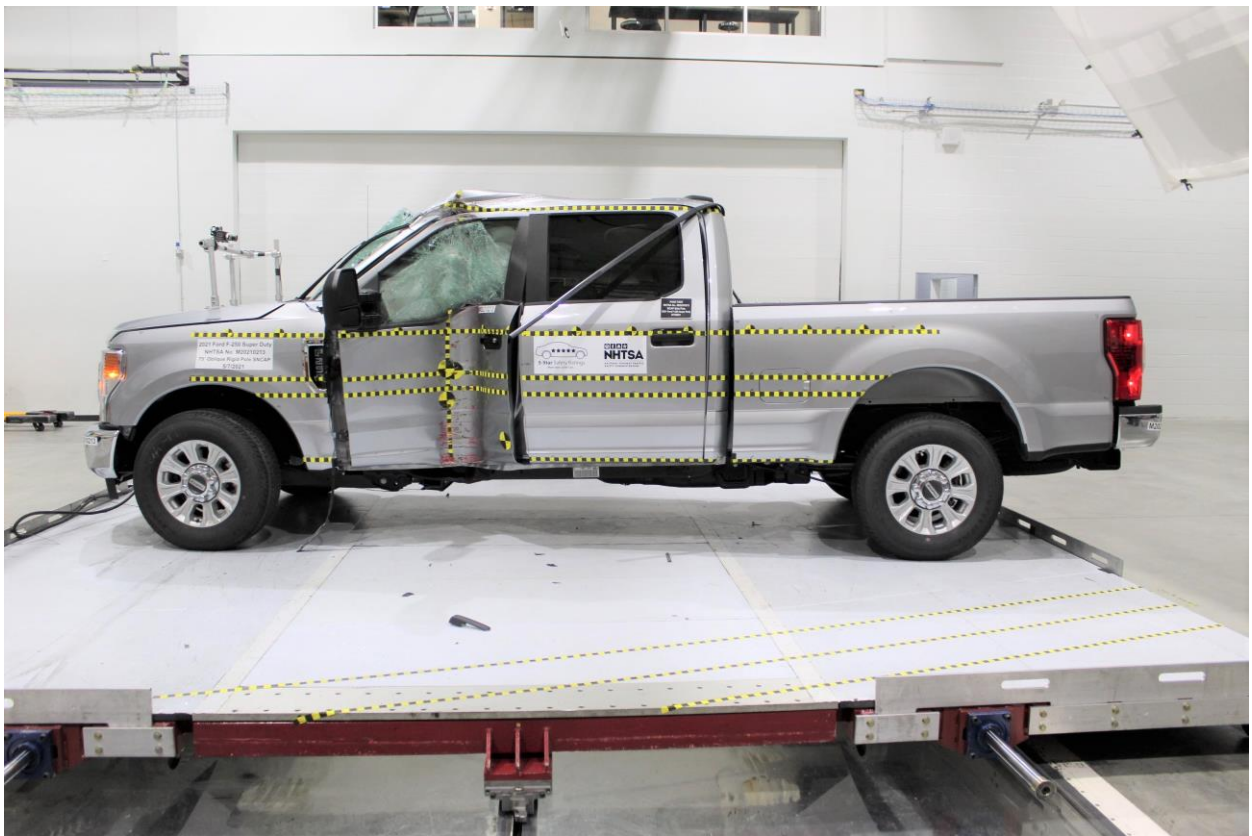
Figure A-8: Post-Test Left Side View of Test Vehicle

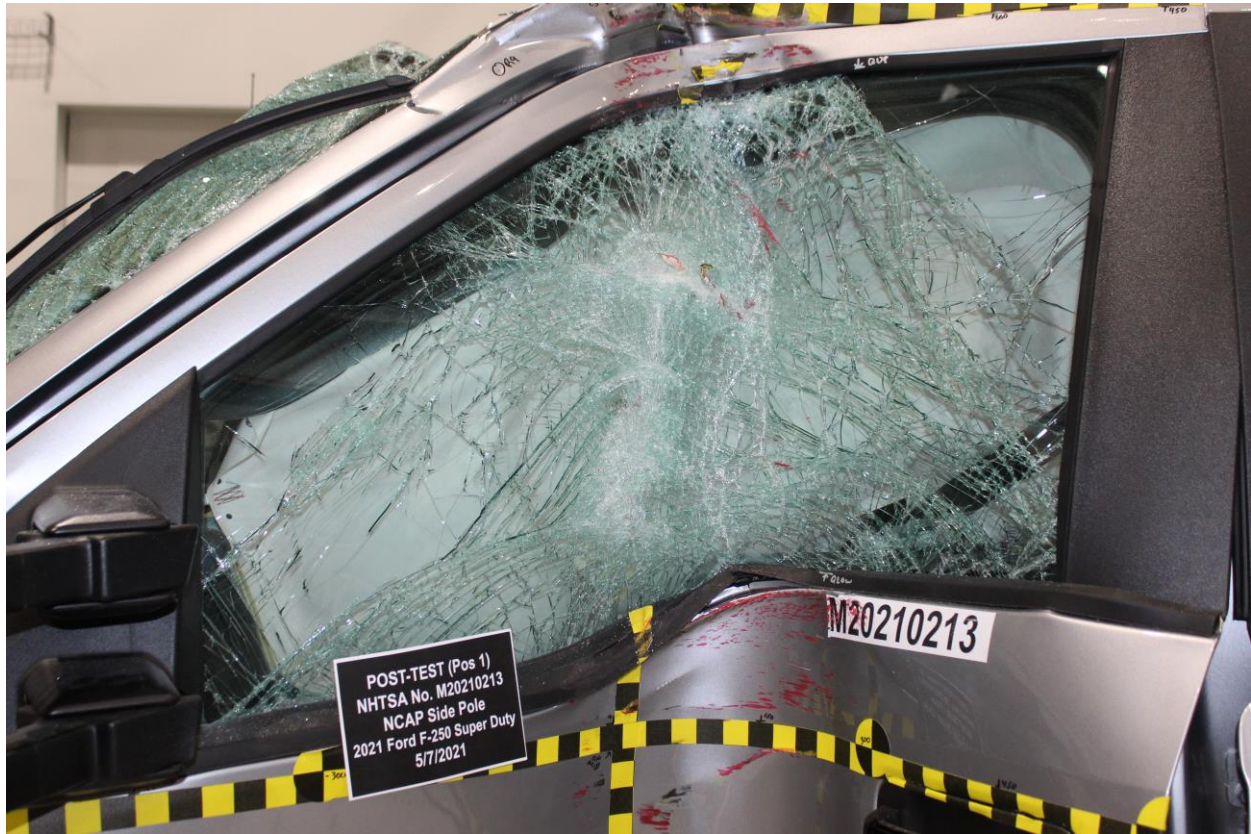
Figure A-25: Post-Test Left Side View of Dummy Shoulder and Door Top View

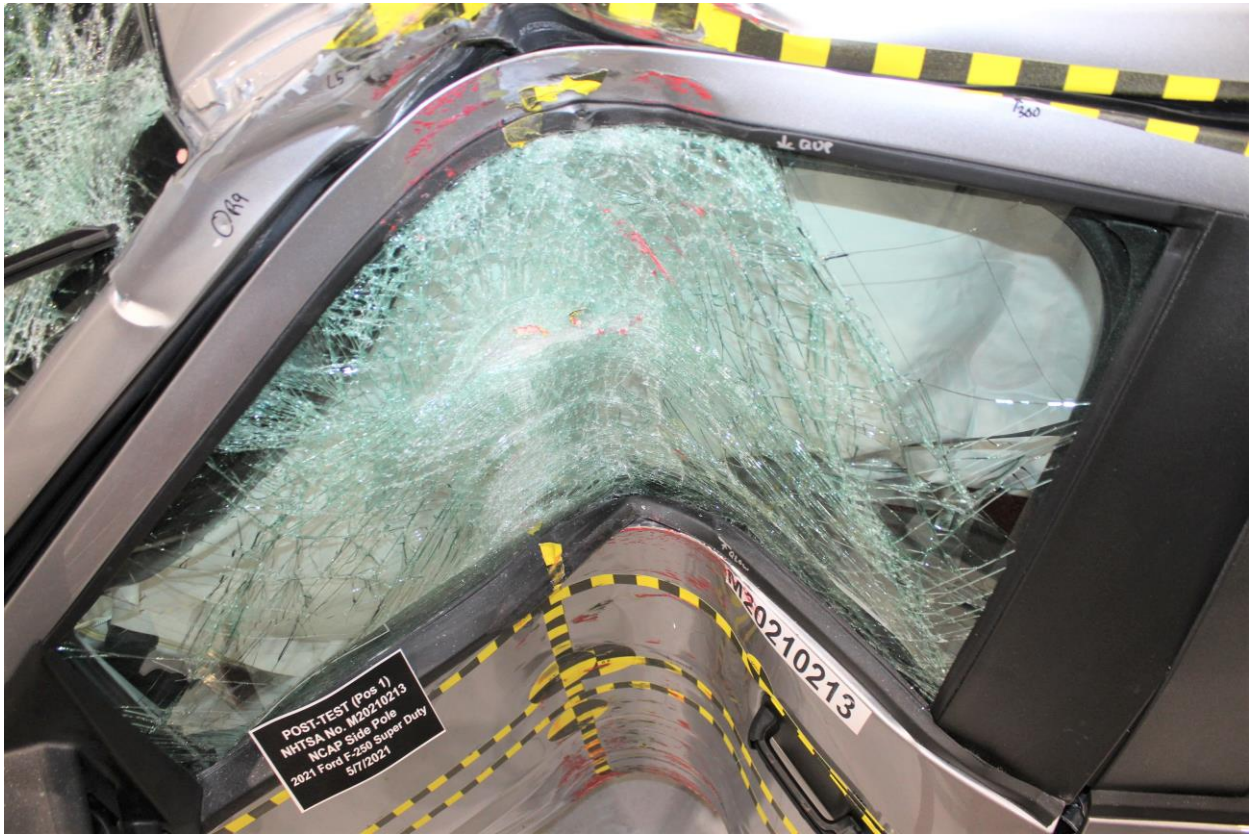
Figure A-41: Post-Test Dummy and Door Clearance View

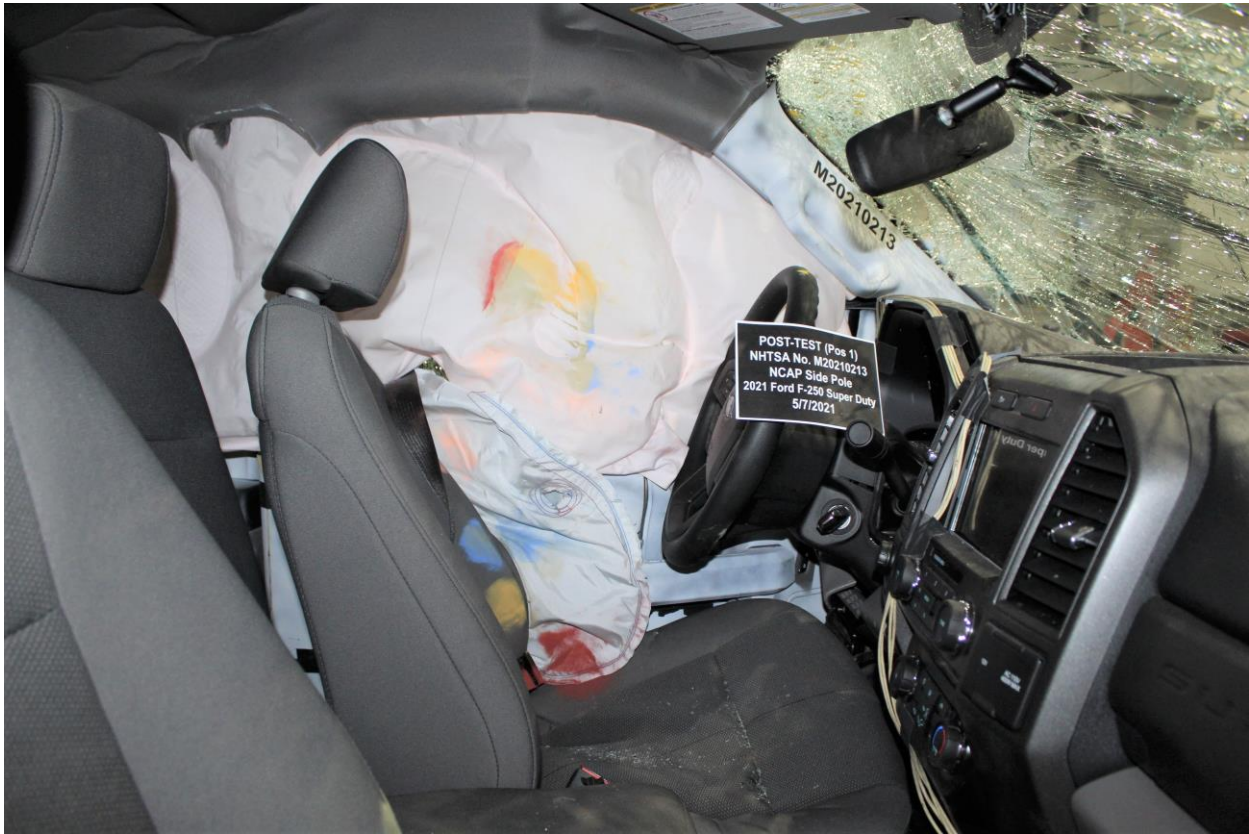
Figure A-45: Post-Test Inner Door Panel View Showing Dummy Contact Location

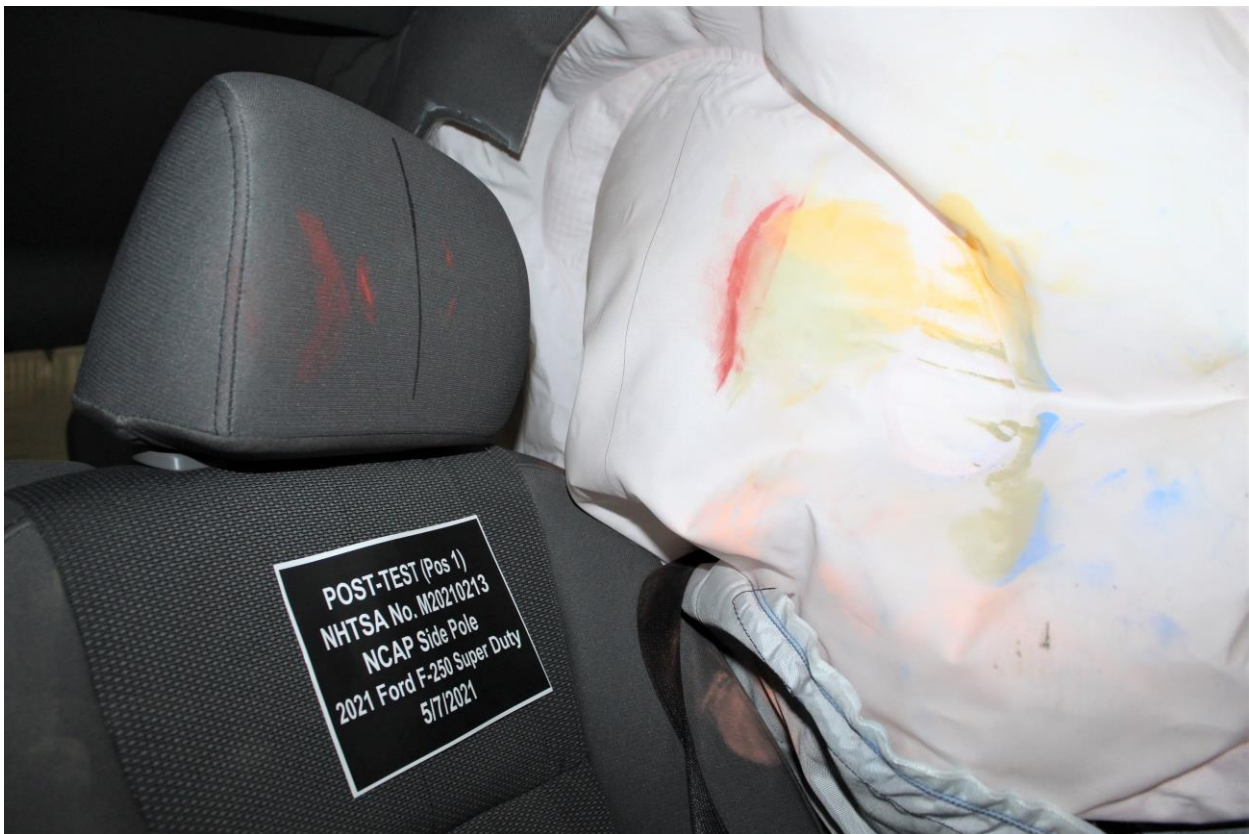
Figure A-46: Post-Test Dummy Close-Up Head Contact with Vehicle Interior View

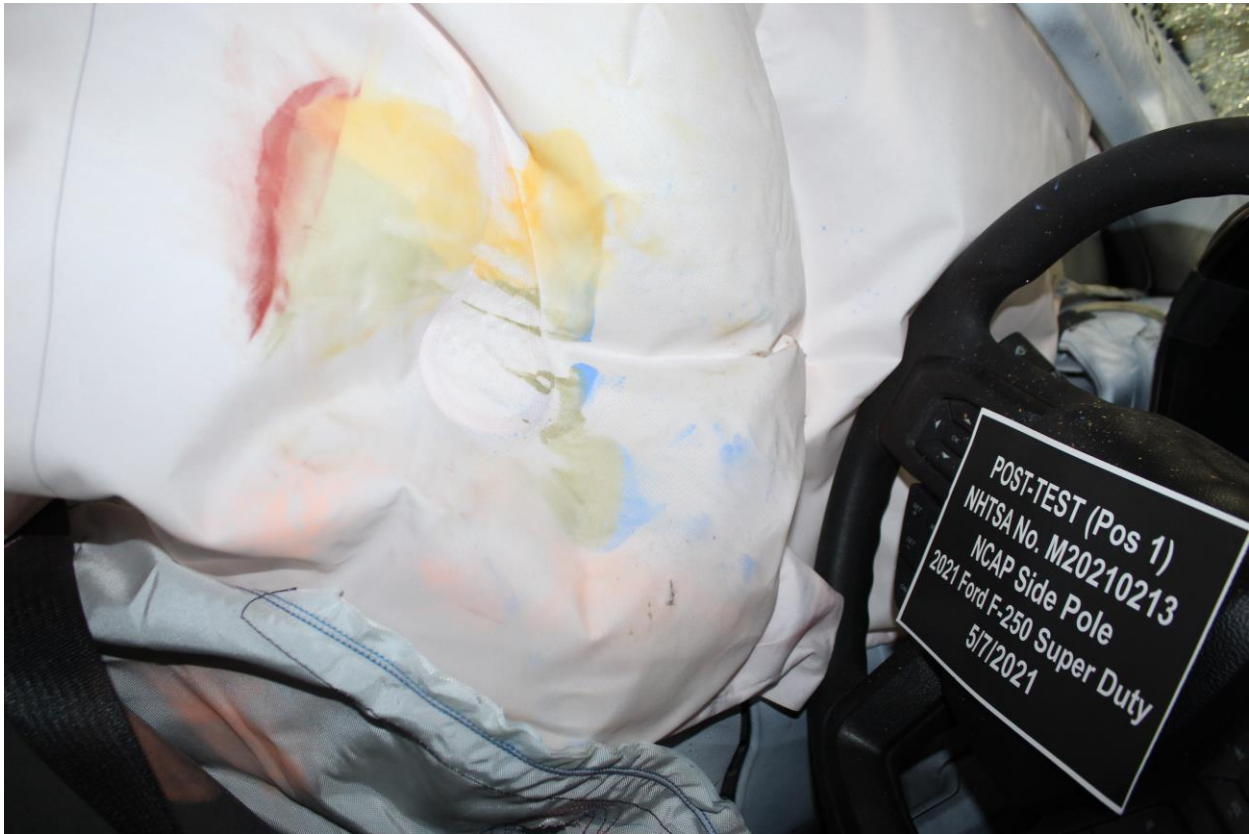
Figure A-47: Post-Test Dummy Close-Up Head Contact with Side Airbag View

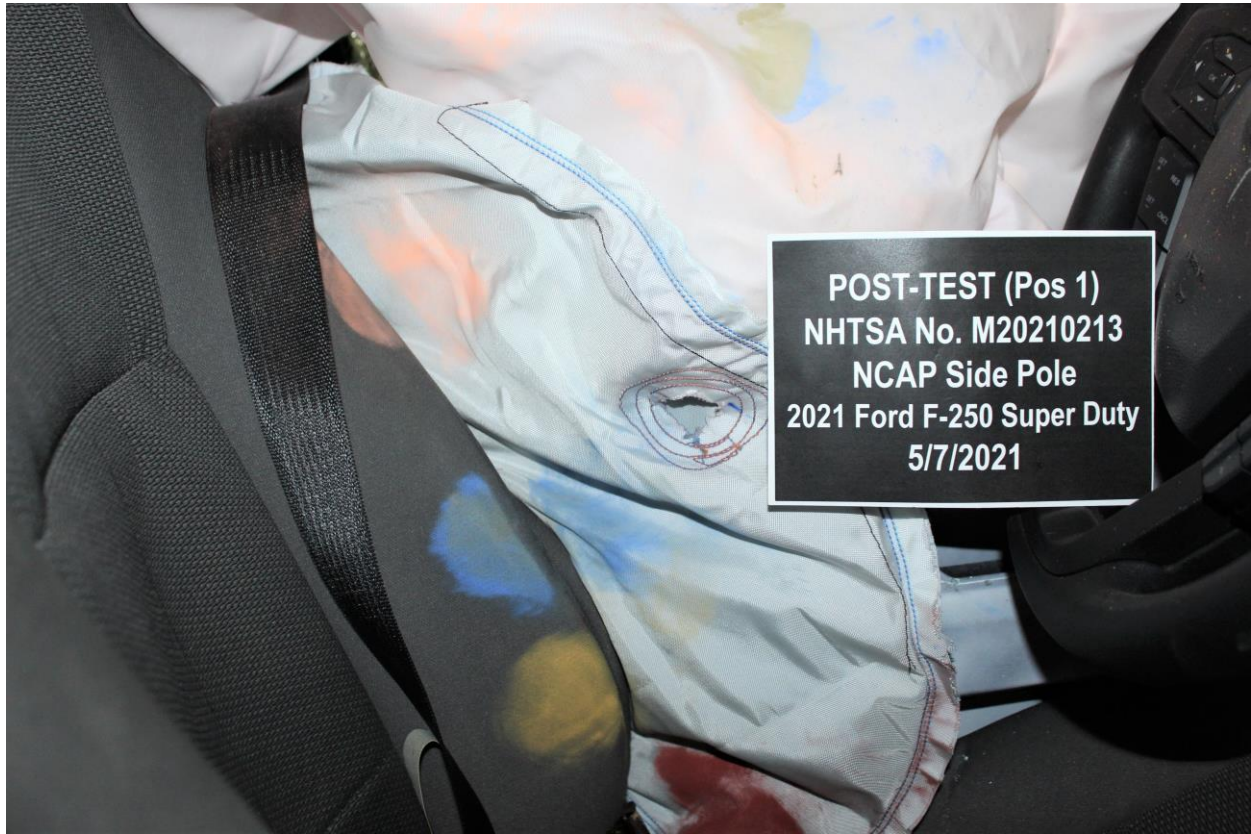
Figure A-49: Post-Test Dummy Close-Up Torso Contact with Side Airbag View

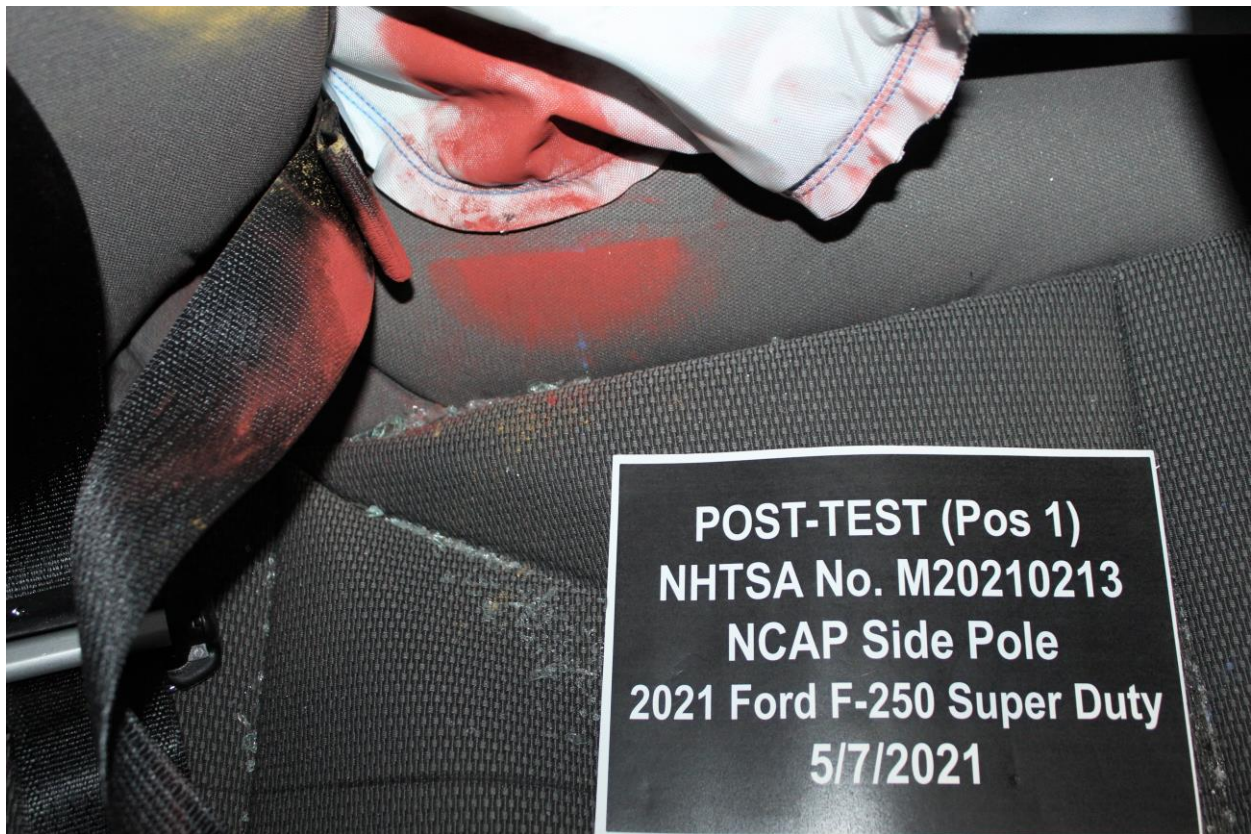
Figure A-50: Post-Test Dummy Close-Up Pelvis Contact with Vehicle Interior View

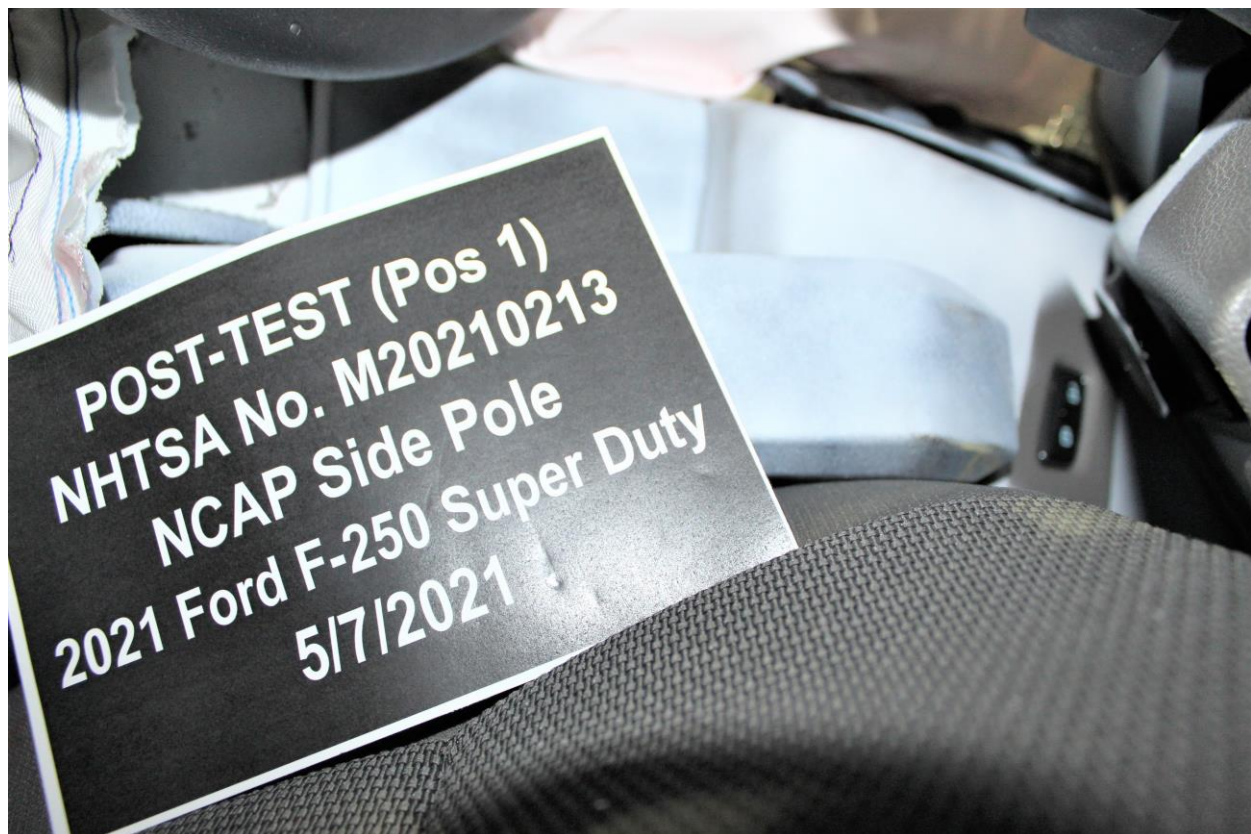
Figure A-52: Post-Test Dummy Close-Up Knee Contact with Vehicle Interior View

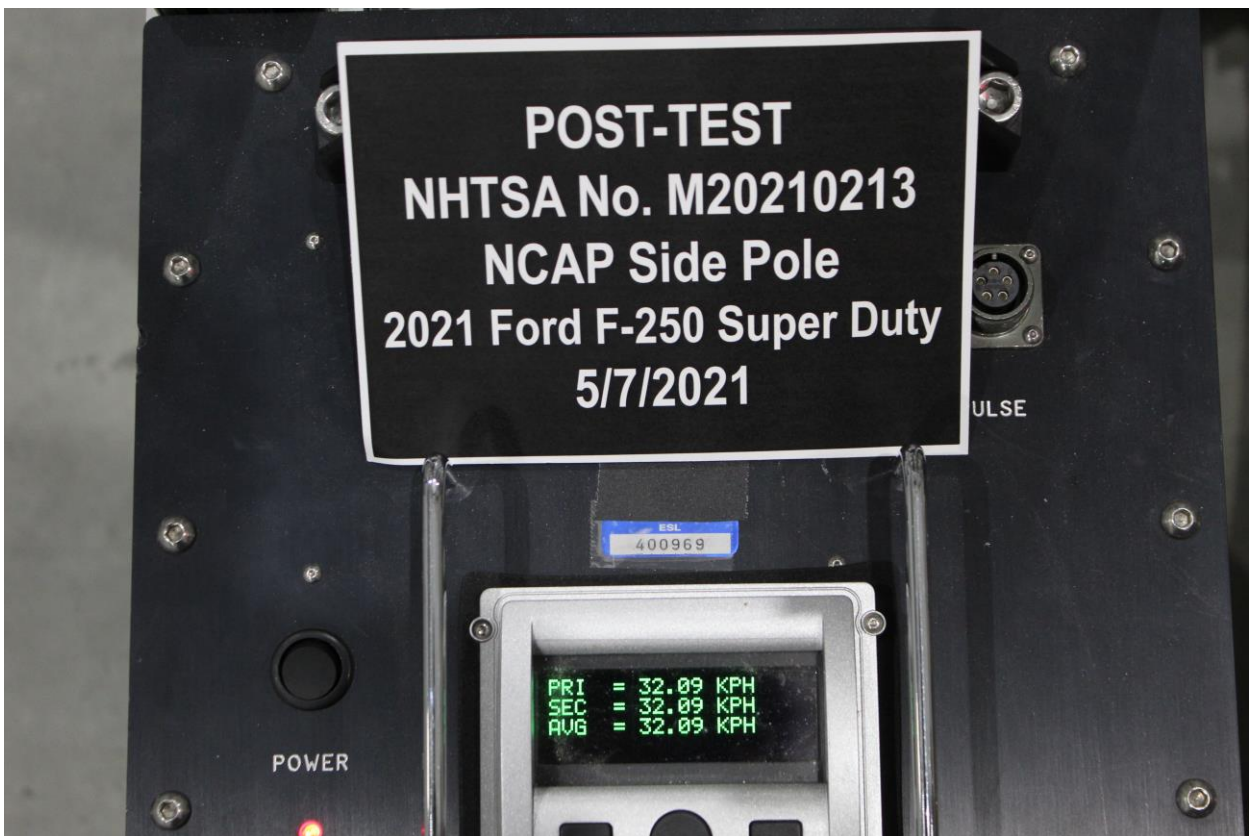
Figure A-64: Post-Test Primary and Redundant Speed Trap Read-Out

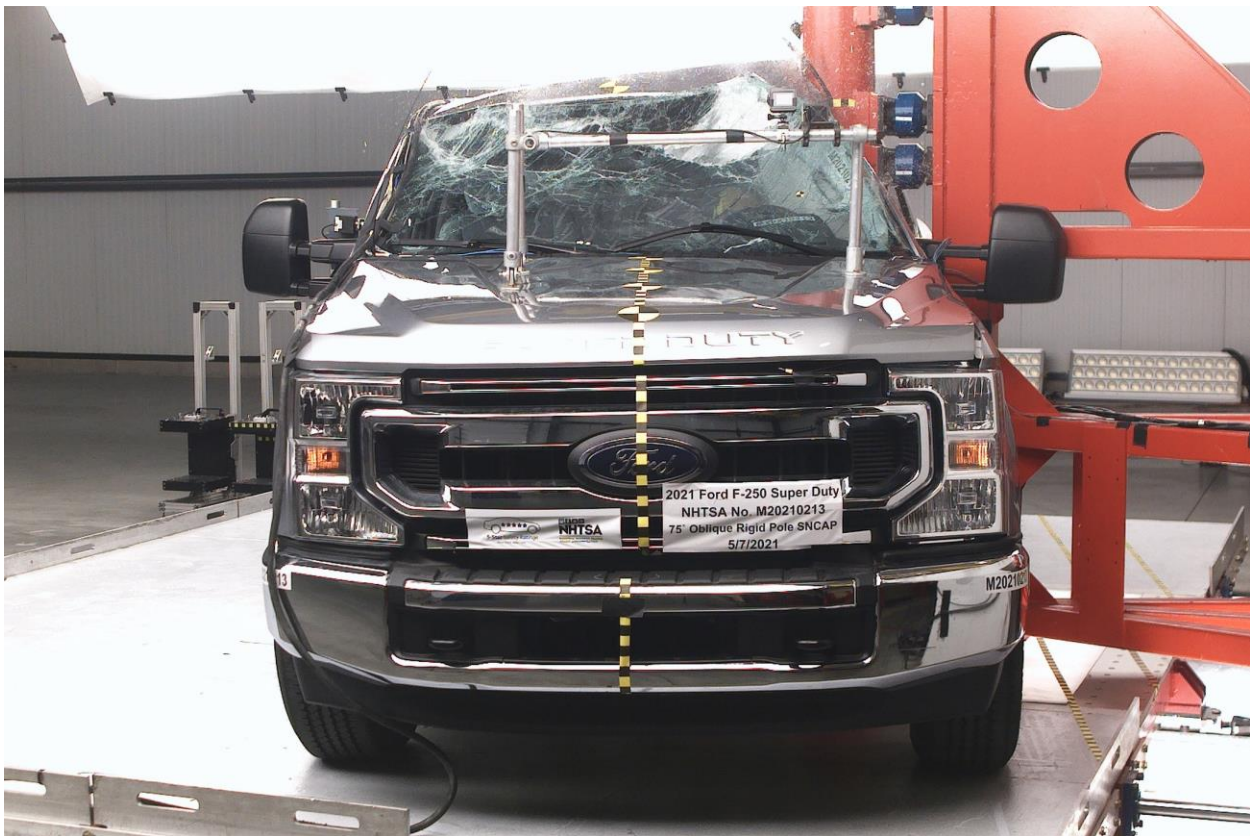
Figure A-70: Impact Event

A rigid pole side impact test was conducted on a 2021 Ford F-250 Super Duty Crew Cab Truck. The subject vehicle was towed into the rigid pole at an angle of 75° and a velocity of 32.09 km/h. The test was conducted by Calspan Corporation's Transportation Test Operations facility in Buffalo, New York on May 7, 2021. Pre-test and post-test photographs of the test vehicle and side impact dummy (SID-IIs) are included in Appendix A of this report.
