**REPORT NUMBER: SideNCAPMDB-MGA-21-047**

**NEW CAR ASSESSMENT PROGRAM (NCAP)  
Moving Deformable Barrier Side Impact Test**

**NISSAN MOTOR CO., LTD.  
2021 Infiniti QX50 LUXE 5-Door SUV  
NHTSA No.: O20215203**

**MGA RESEARCH CORPORATION  
5000 Warren Road  
Burlington, WI 53105**

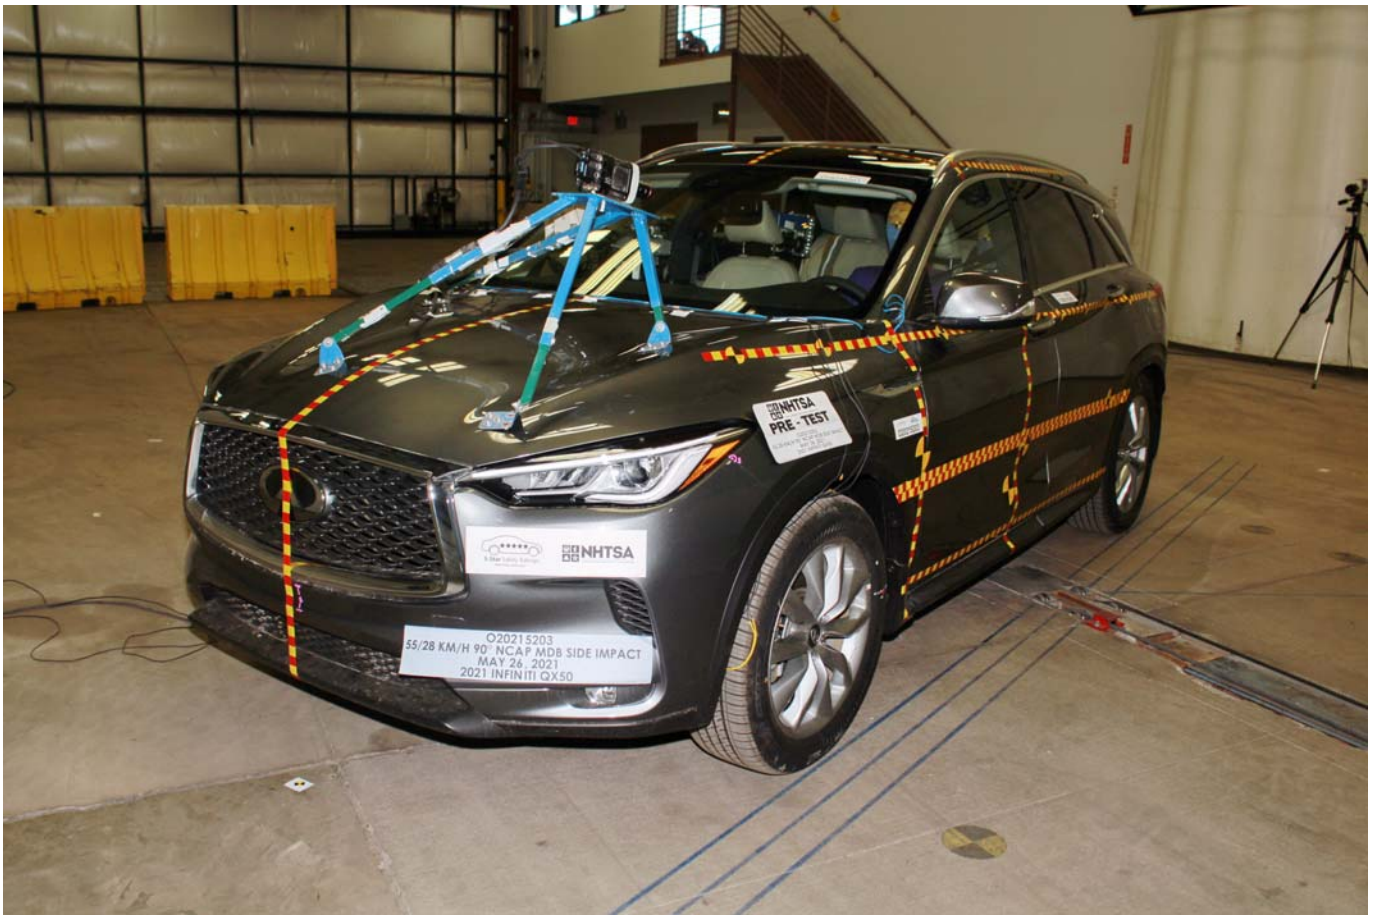
Photo No. 006 - Post-Test Left Front Three-Quarter View of Test Vehicle

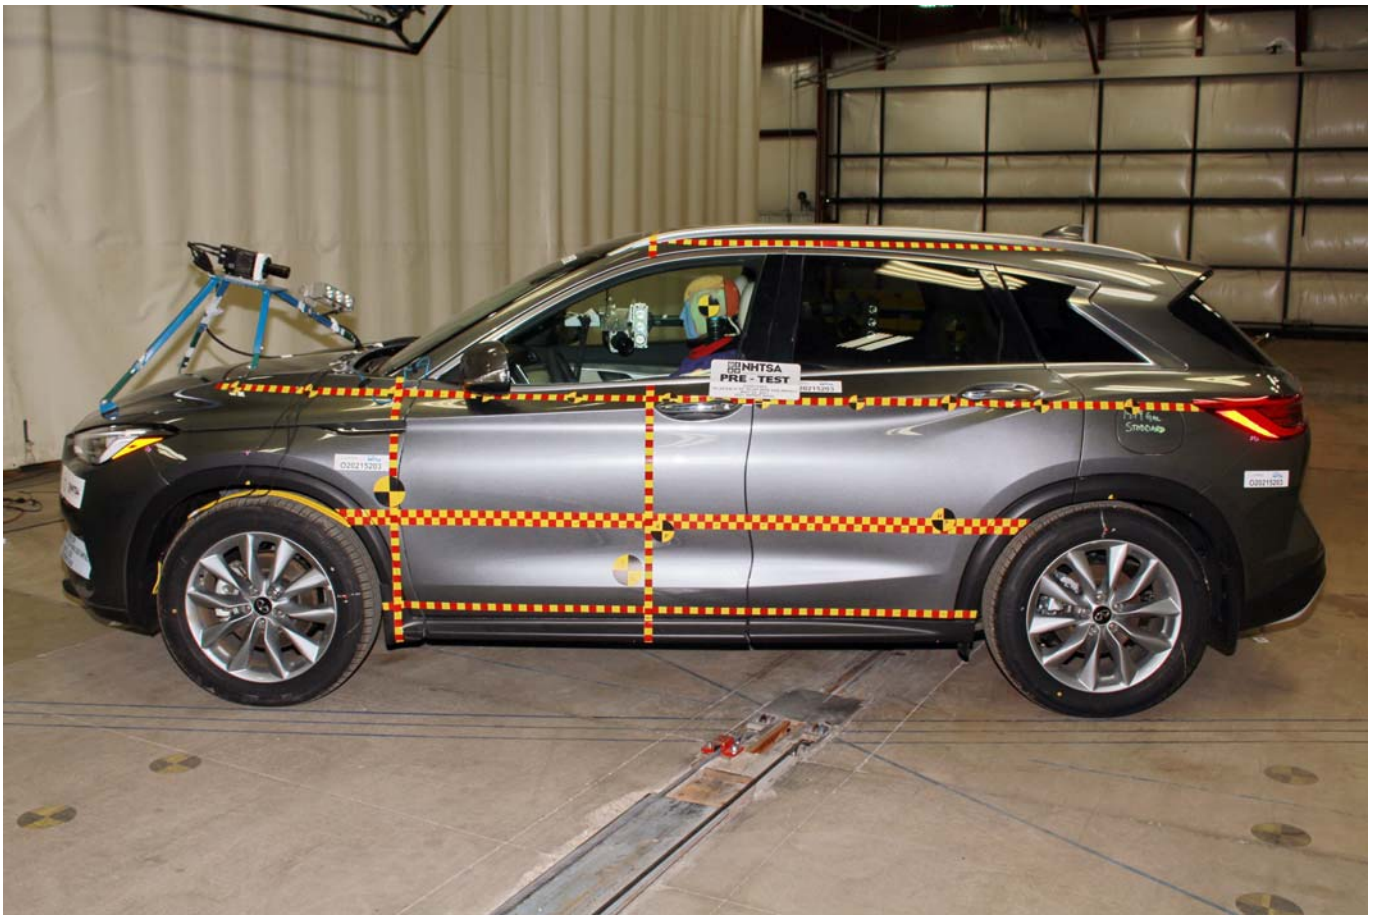
Photo No. 008 - Post-Test Left Side View of Test Vehicle

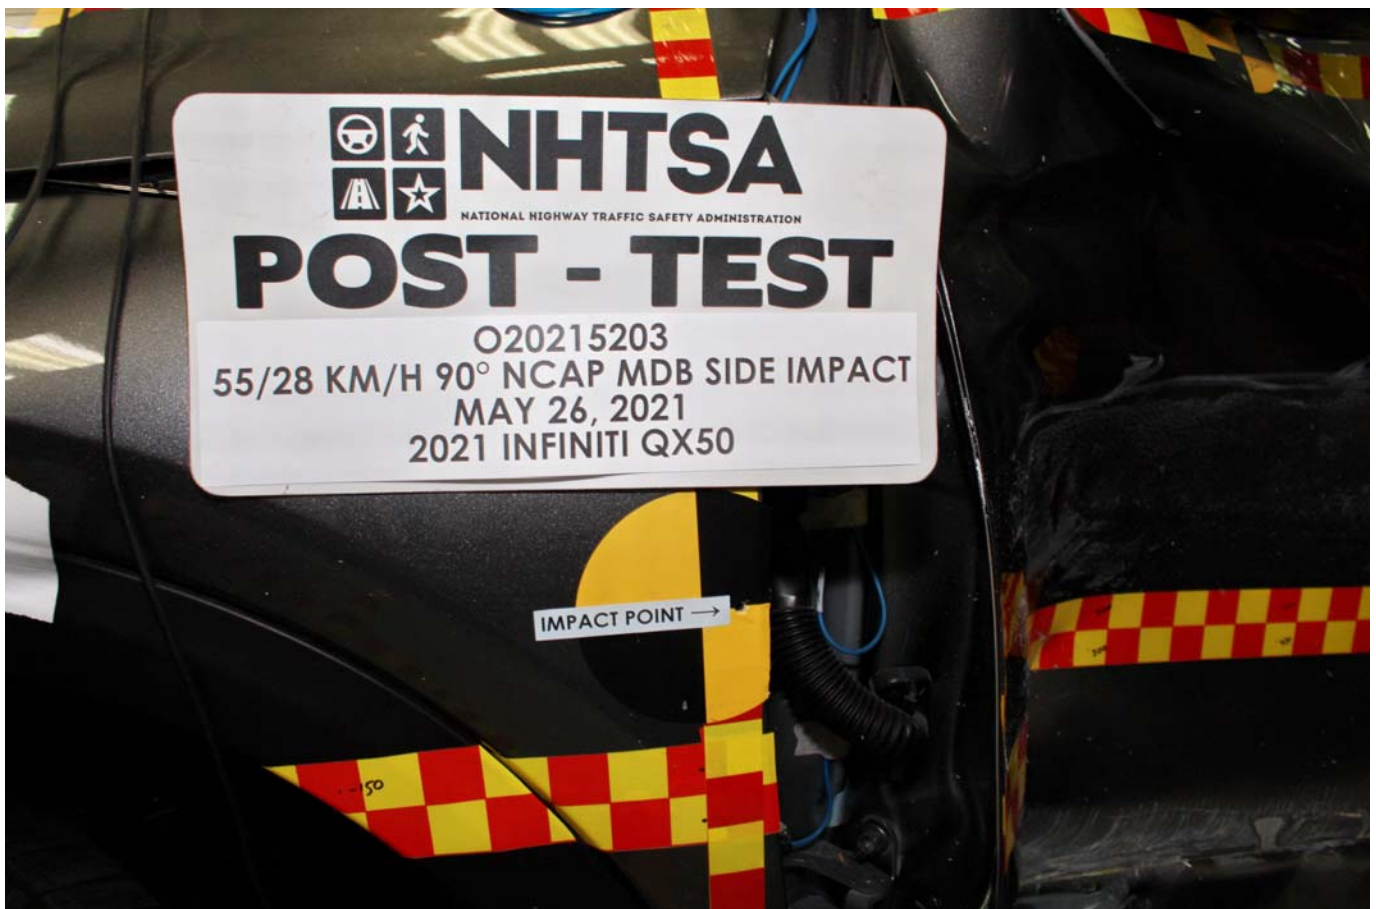
Photo No. 020 - Post-Test Close-Up View of Impact Point Target

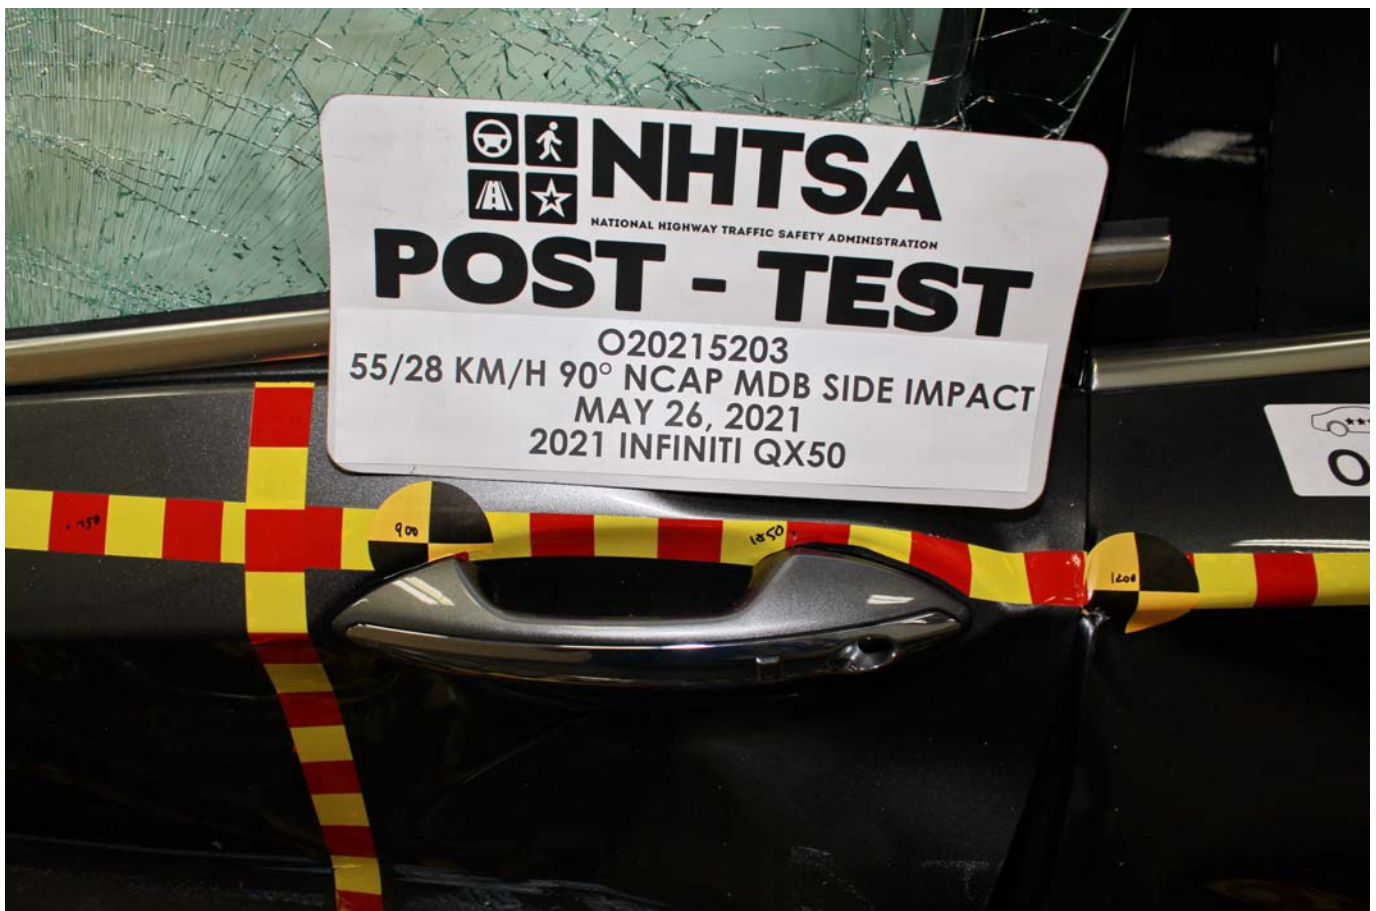
Photo No. 022 - Post-Test Left Front Door Latch Close-Up

The two doors on the struck side of the vehicle did not separate from the body at the hinges or latches and the opposite door(s) did not open during the side impact event.

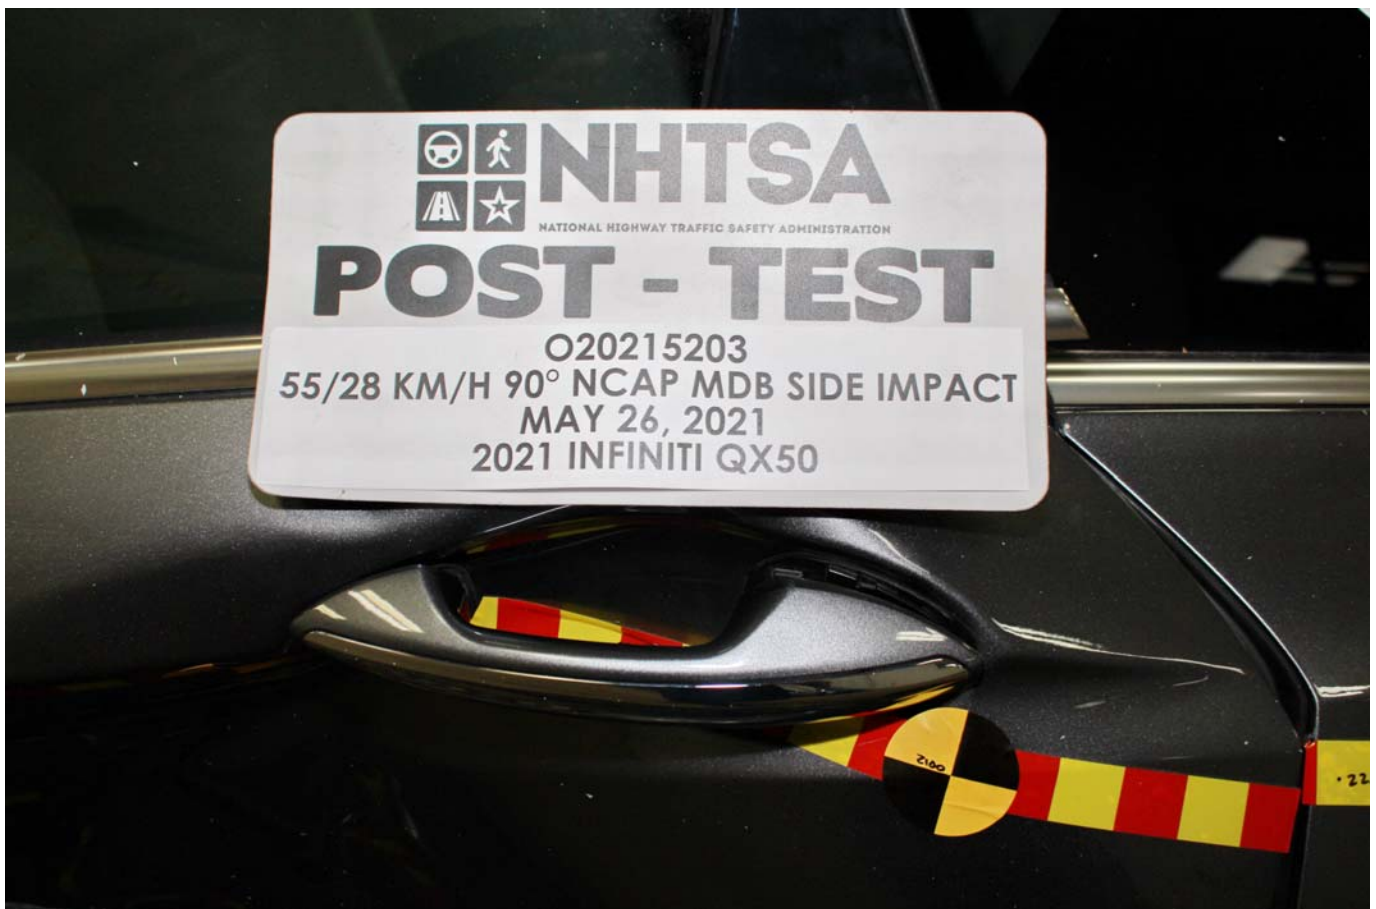
Photo No. 024 - Post-Test Left Rear Door Latch Close-Up

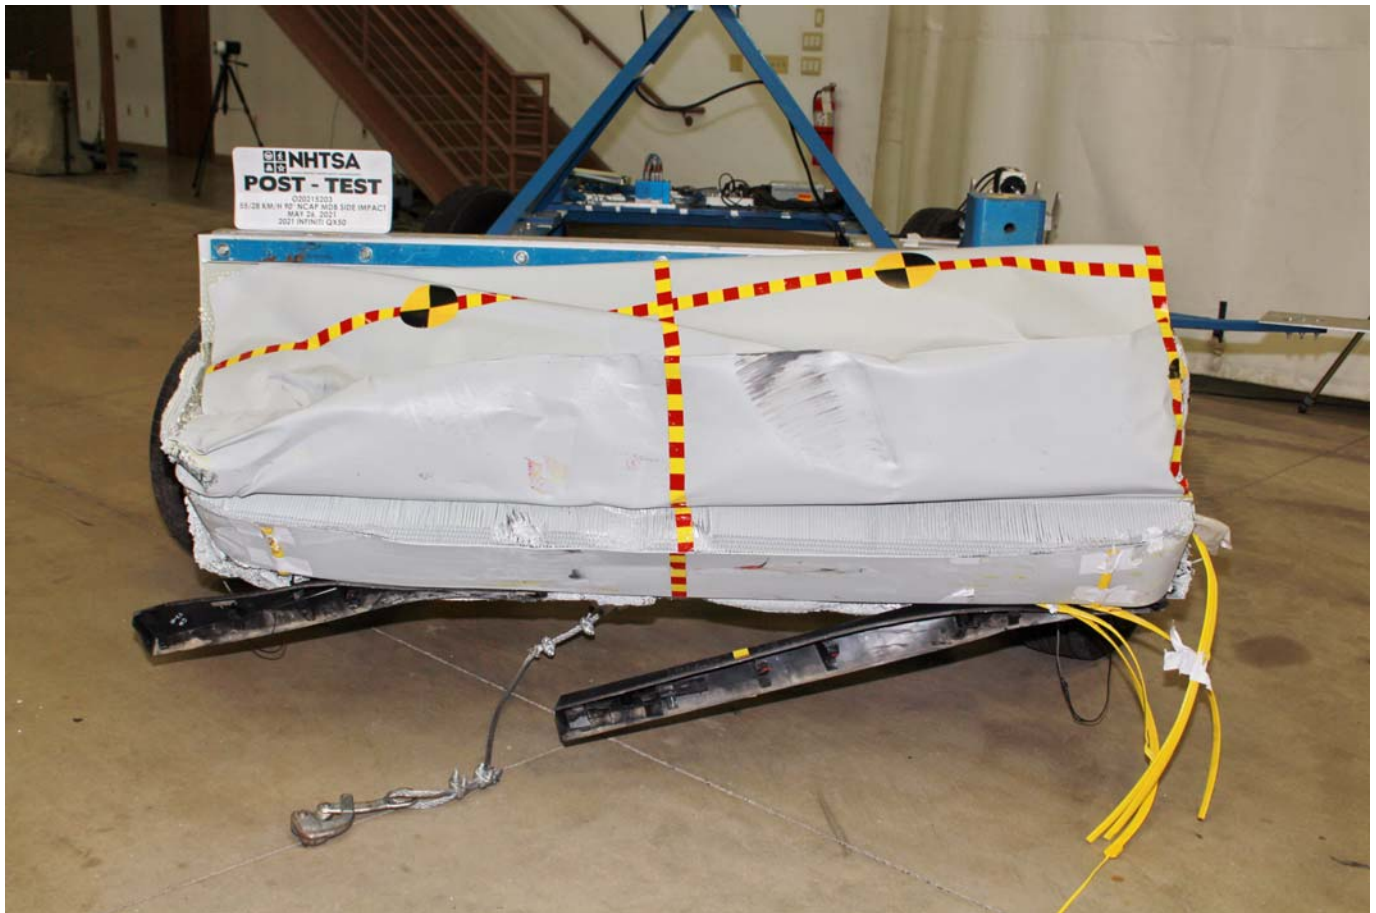
Photo No. 085 - Post-Test Front View of MDB Impactor Face

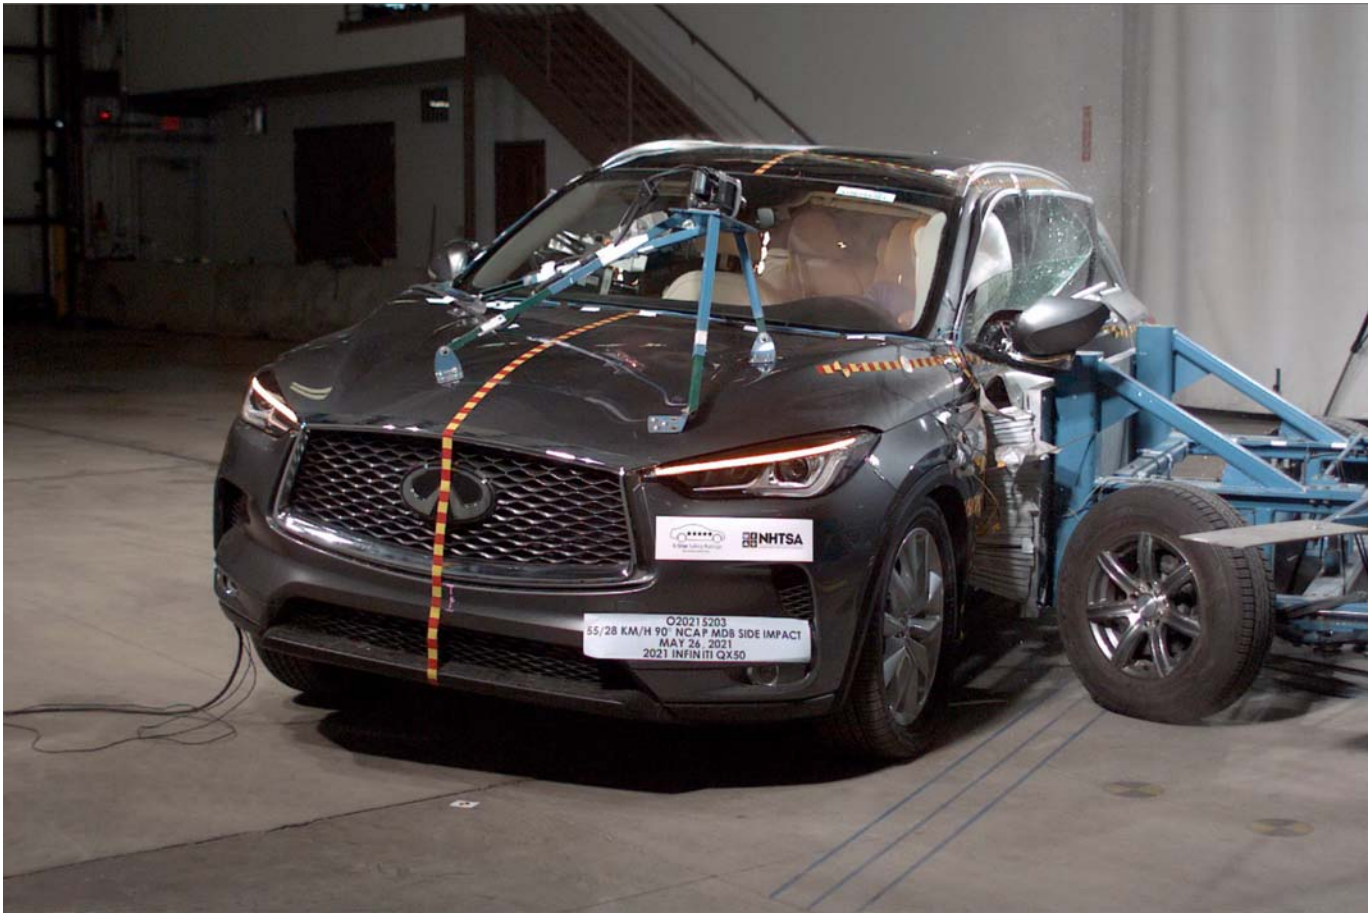
Photo No. 101 - Impact Event

The impact velocity of the Moving Deformable Barrier (MDB) was 62.09 km/h, and the ambient temperature at the struck (driver's) side of the target vehicle at the time of impact was 21.4°C. The target vehicle post-test maximum crush was 246 mm at level 3. The test vehicle's performance was as follows:
