REPORT NUMBER: R&D-KAR-20-012

**VEHICLE TO RIGID BARRIER CRASH TEST IN SUPPORT OF
NHTSA'S FRONTAL RESEARCH CRASH TEST PROGRAM
LEFT SIDE 30° FRONTAL RIGID BARRIER IMPACT**

**MAZDA MOTOR CORPORATION
2020 MAZDA CX-5 5-DOOR MPV**

NHTSA No: R20205417

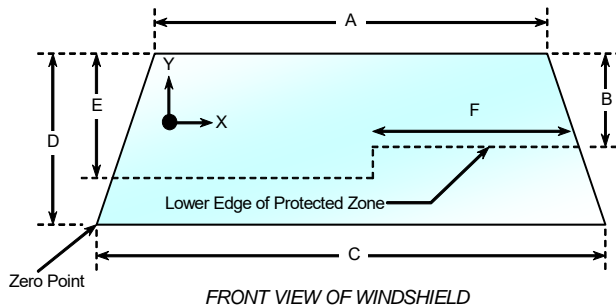
WINDSHIELD PERIPHERY MEASUREMENTS

Measurement	Pre-Test (mm)	Post-Test (mm)	% Retention
Left Side	2153	2153	100.0%
Right Side	2153	2153	100.0%
Total	4306	4306	100.0%

Item	Units	Value
A	mm	620
B	mm	765
C	mm	768
D	mm	620
E	mm	765
F	mm	768

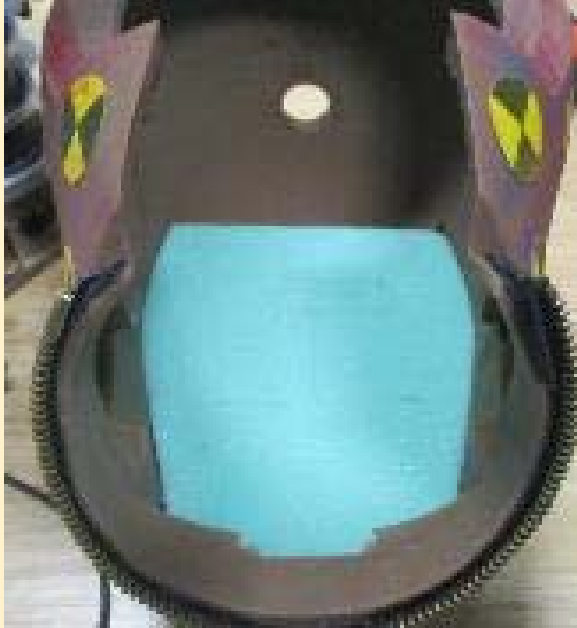
Damage and Discrepancy Details

HEAD – Pass(✓)/Fail(✗). If Fail, explain reason and/or attach picture		Note
✓	Rear head cap mounts securely to head:	
✓	Head skin fits securely over skull	
✓	Head skin shows no sign of tears or damage	
✓	Interior components of skull (ballast, sensor mounts, sensors) securely attached:	
✓	Head securely mounted to OC joint:	
✗	Other:	See Details Page

Cuts in Face Foam

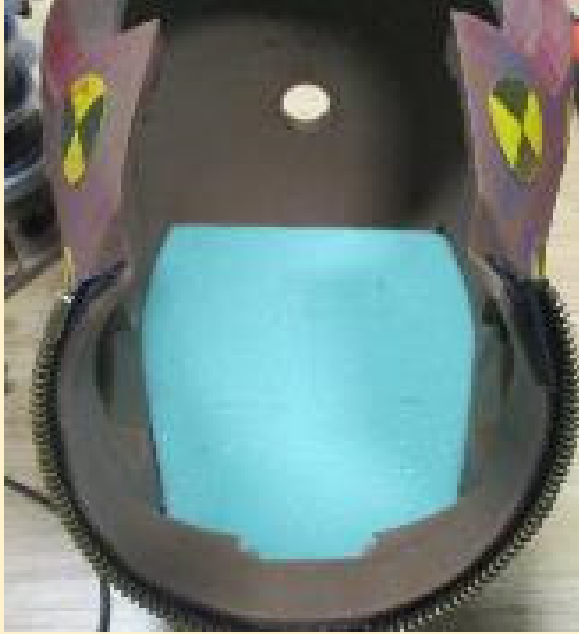
Damage and Discrepancy Details

HEAD – Pass(✓)/Fail(✗). If Fail, explain reason and/or attach picture		Note
✓	Rear head cap mounts securely to head:	
✓	Head skin fits securely over skull	
✓	Head skin shows no sign of tears or damage	
✓	Interior components of skull (ballast, sensor mounts, sensors) securely attached:	
✓	Head securely mounted to OC joint:	
✗	Other:	See Details Page

Cuts in Face Foam
