**REPORT NUMBER: R&D-KAR-20-019**

**VEHICLE TO RIGID BARRIER CRASH TEST IN SUPPORT OF  
NHTSA'S FRONTAL RESEARCH CRASH TEST PROGRAM  
LEFT SIDE 30° FRONTAL RIGID BARRIER IMPACT**

**MAZDA MOTOR CORPORATION  
2021 MAZDA CX-5 5-DOOR MPV**

**NHTSA No: Q20215417**

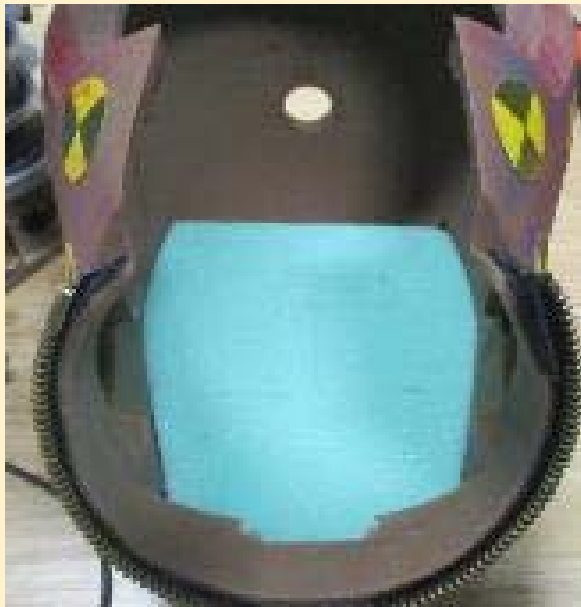
Damage and Discrepancy Details

Cuts in Face Foam

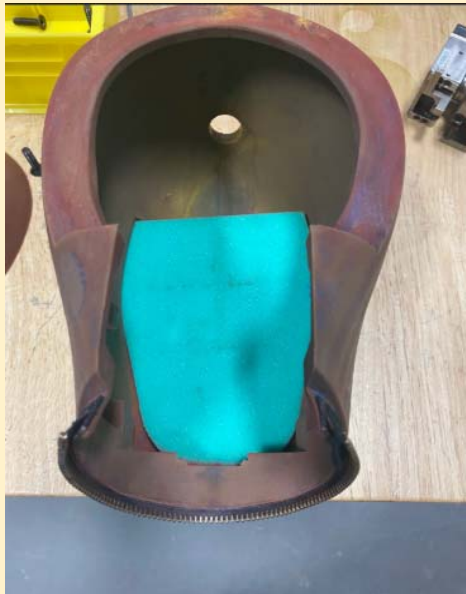
Damage and Discrepancy Details

Cuts in Face Foam
