**REPORT NUMBER: NCAP-MGA-22-006**

**NEW CAR ASSESSMENT PROGRAM (NCAP)  
Frontal Barrier Impact Test**

**HYUNDAI MOTOR MANUFACTURING ALABAMA, LLC  
2022 Hyundai Tucson SEL 5-Door SUV  
NHTSA No.: M20224206**

**FINAL REPORT**

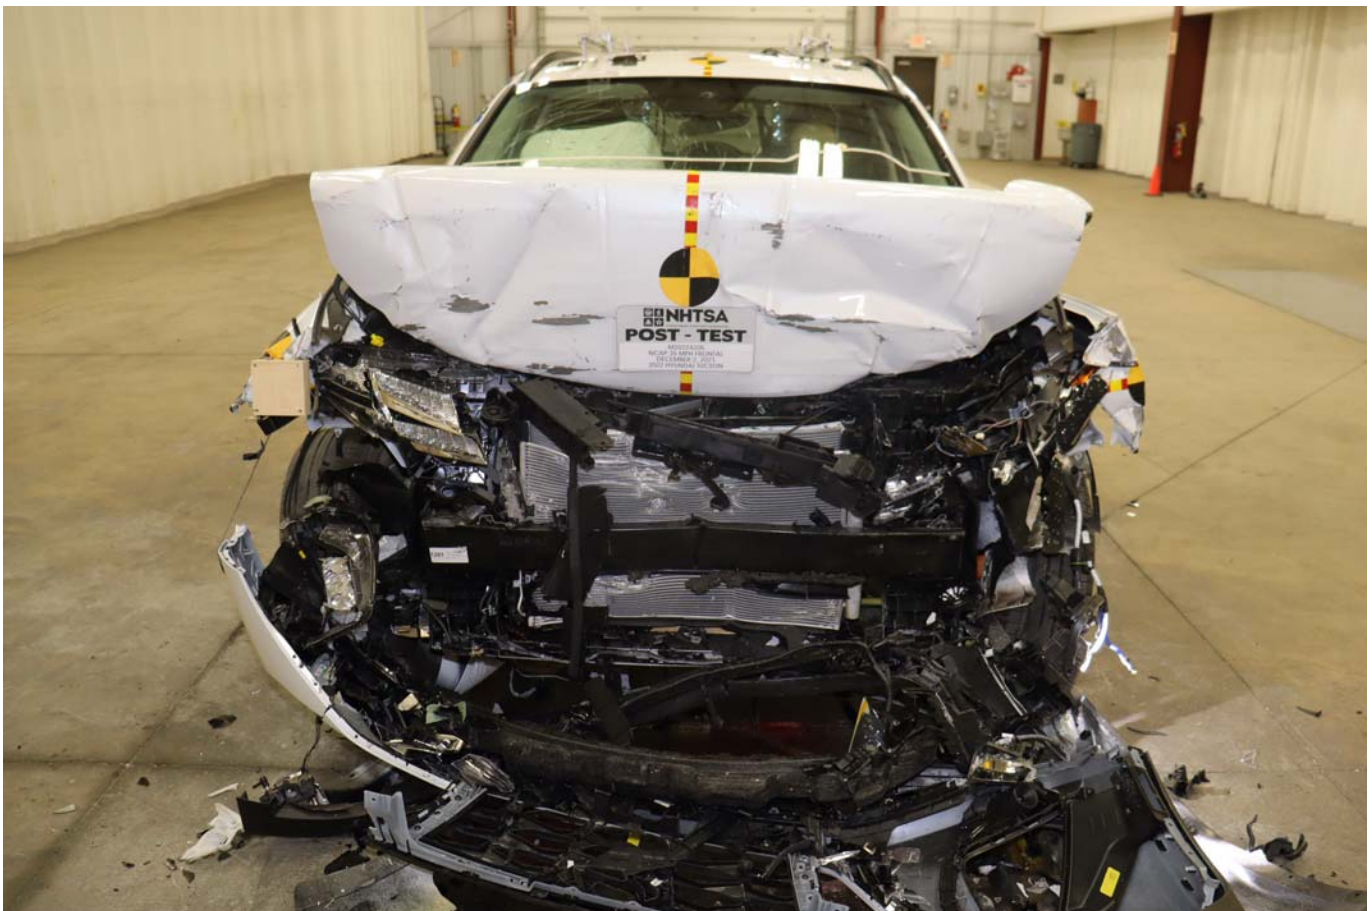
Photo No. 009 - Post-Test Front View of Test Vehicle

The maximum static crush of the vehicle was 442 mm located at the vehicle centerline and both the driver and passenger side doors remained closed during the impact event and were operable after the impact.

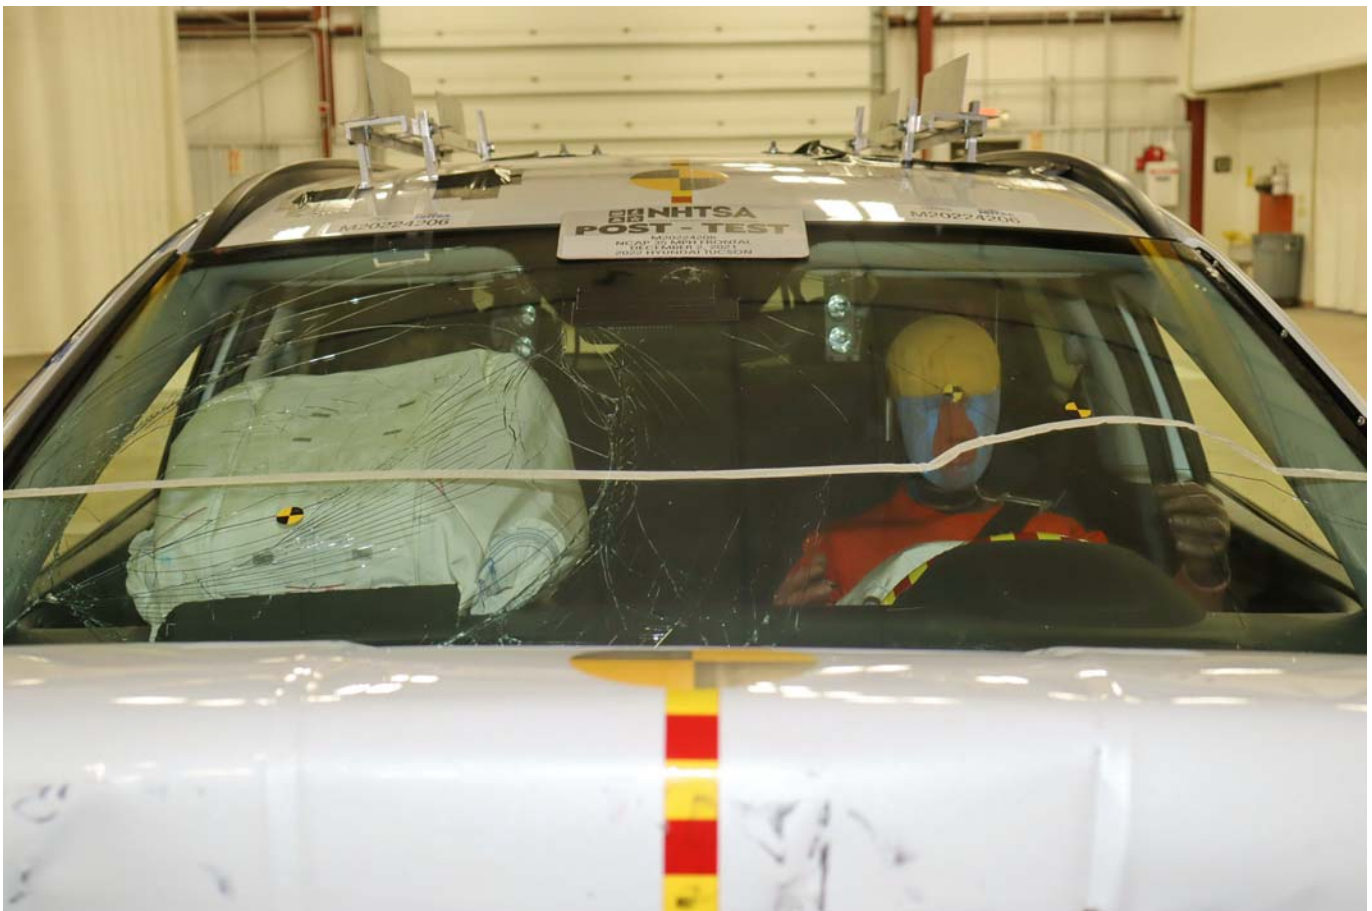
Photo No. 019 - Post-Test Windshield View

There was 100 percent windshield retention and no intrusion into the protected zone of the windshield during the event. There was no Stoddard Solvent leakage after the event or during any phase of the static rollover.

Critical Areas of Performance	Observations and Conclusions
Windshield Damage	Cracked
Window Damage	None
Other Notable Effects	None

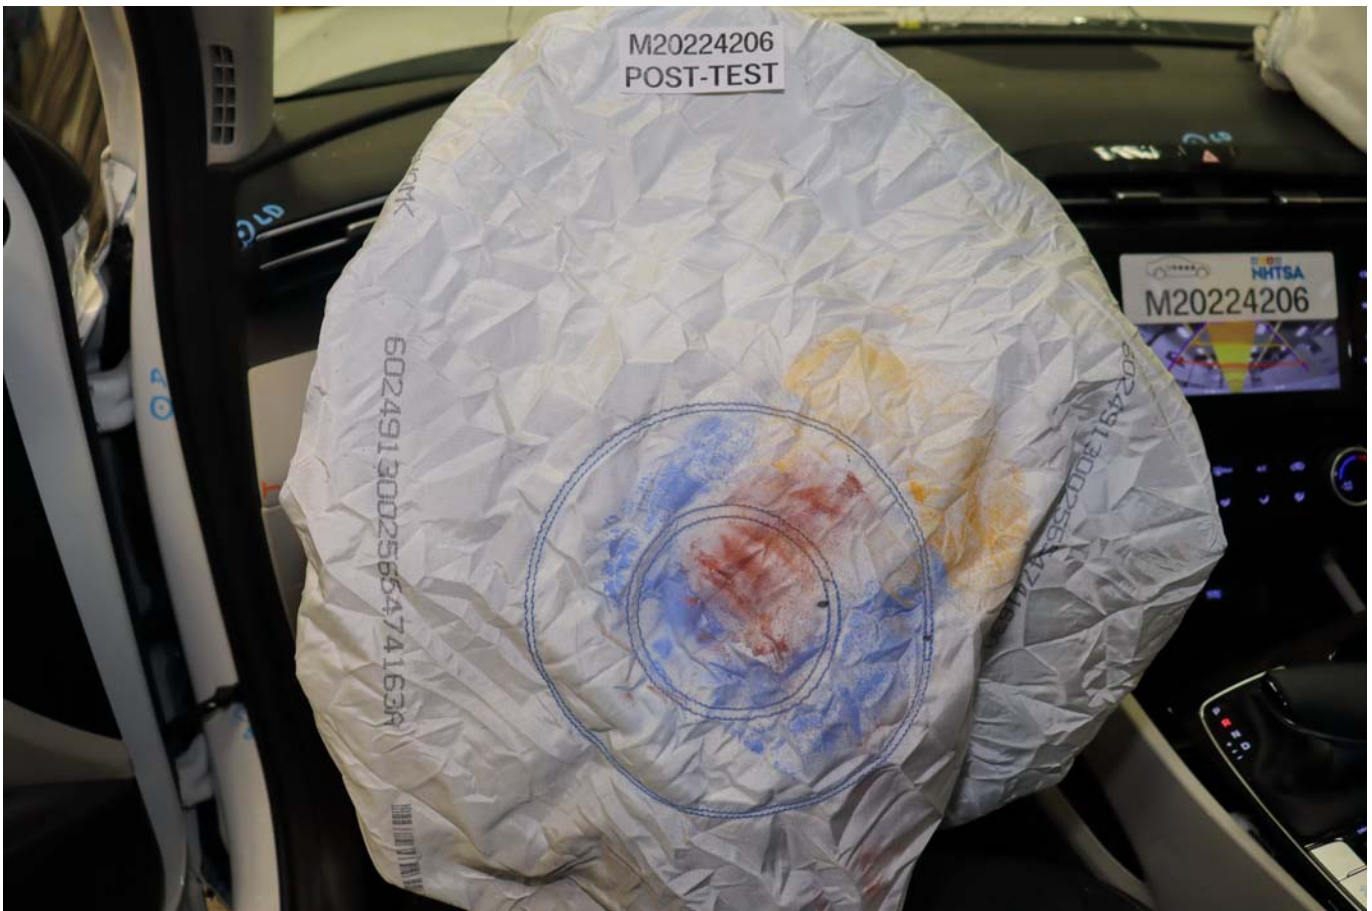
Photo No. 049 - Post-Test Driver Dummy Contact with Airbag

The driver's visible contact points were as follows: The driver's head contacted the airbag. The driver's head also contacted the headrest.
