REPORT NUMBER: SINCAP-MGA-2018-015

**NEW CAR ASSESSMENT PROGRAM (NCAP)
Moving Deformable Barrier Side Impact Test**

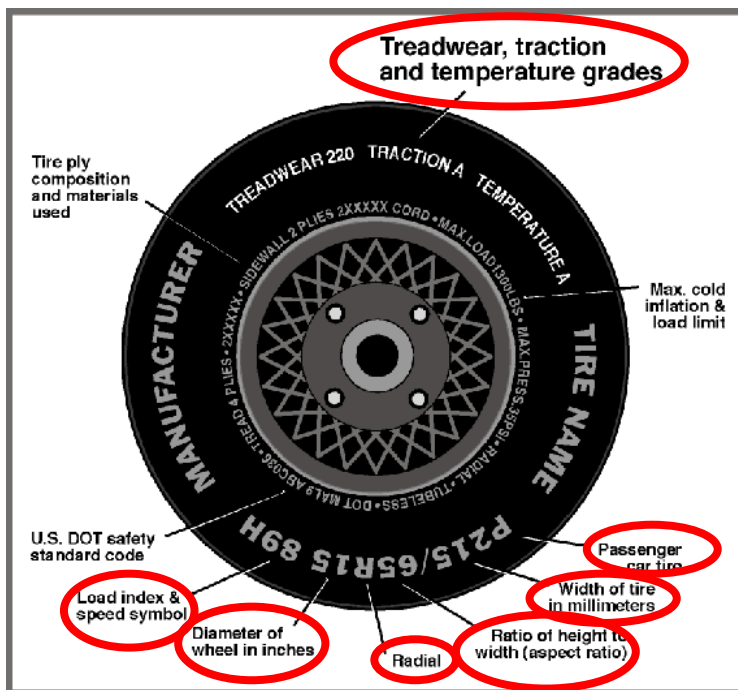
Measured Parameter	Front	Rear
Max. Tire Pressure (kPa)	350	350
Cold Pressure (kPa)	220	240
Recommended Tire Size	255/60R18	255/60R18
Tire Size on Vehicle	255/60R18	255/60R18
Tire Manufacturer	Goodyear	Goodyear
Tire Model	Eagle Sport	Eagle Sport
Treadwear	560	560
Traction	A	A
Temperature Grade	A	A
Tire Plies Sidewall	2 Rayon	2 Rayon
Tire Plies Body	2 Steel, 2 Rayon, 1 Polyamide	2 Steel, 2 Rayon, 1 Polyamide
Load Index/Speed Symbol	108H	108H
Tire Material	Rubber	Rubber
DOT Safety Code Left	NEYP JJ1R 5016	NEYP JJ1R 5116
DOT Safety Code Right	NEYP JJ1R 5116	NEYP JJ1R 5116

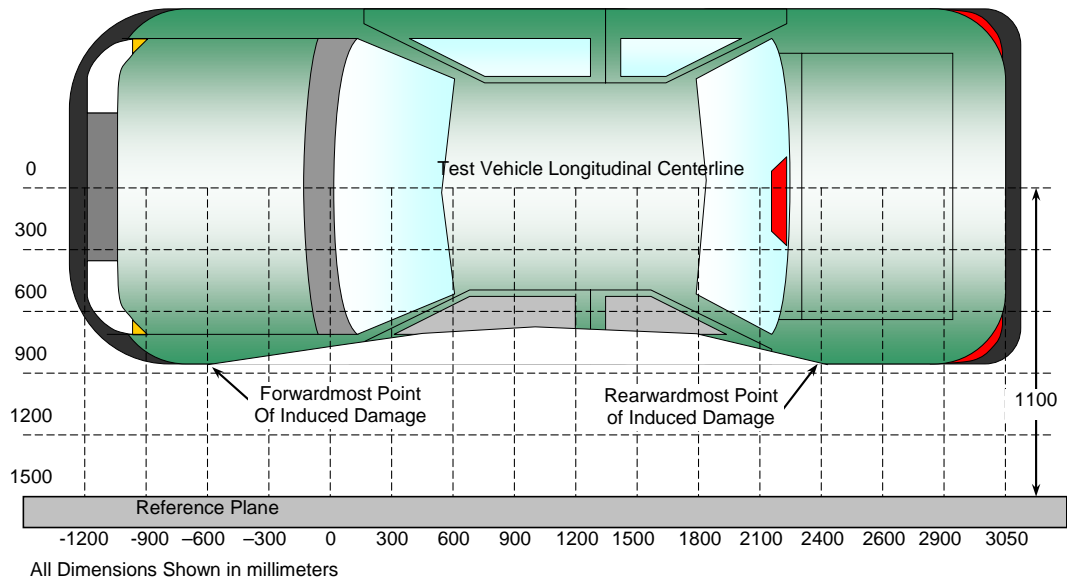
NHTSA No. O20185811
Test Date: 11/3/2017

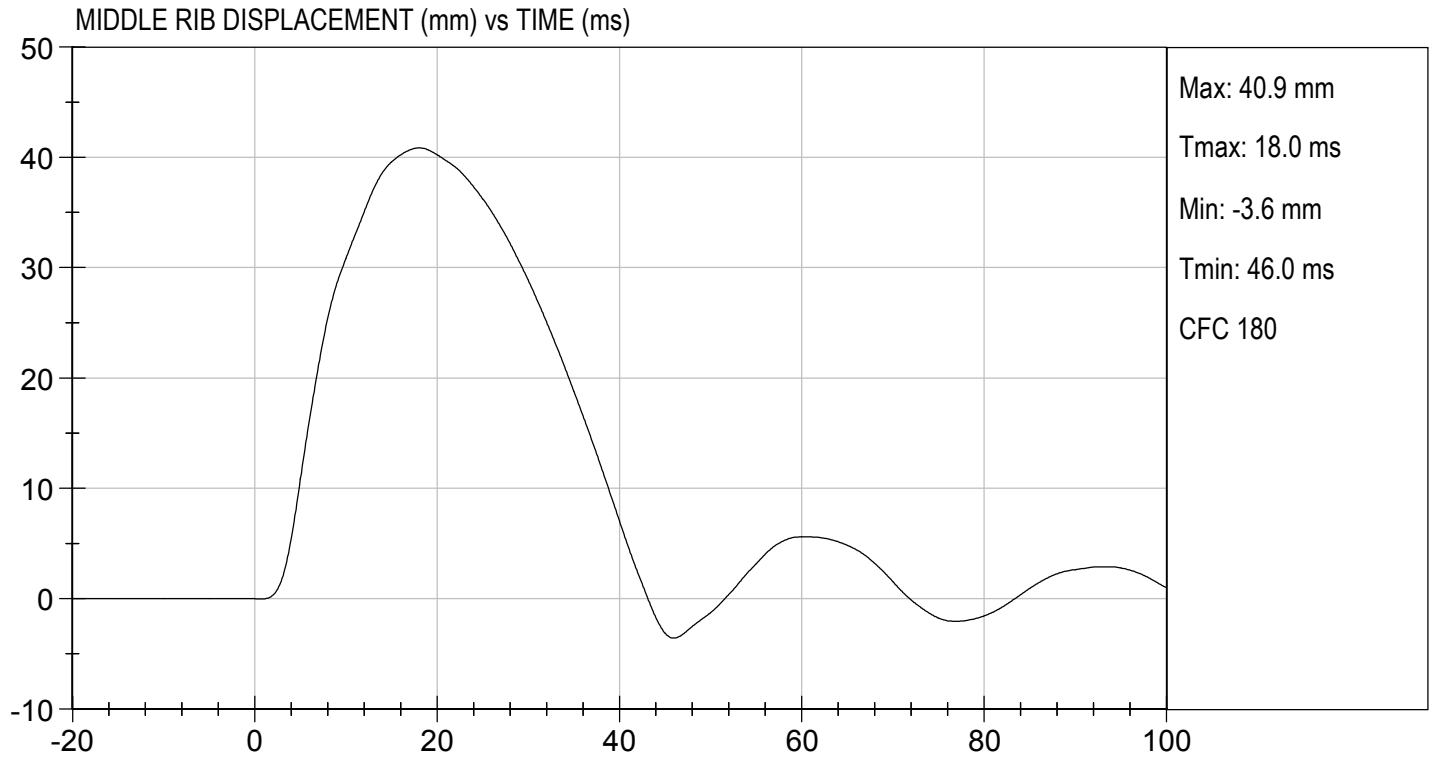
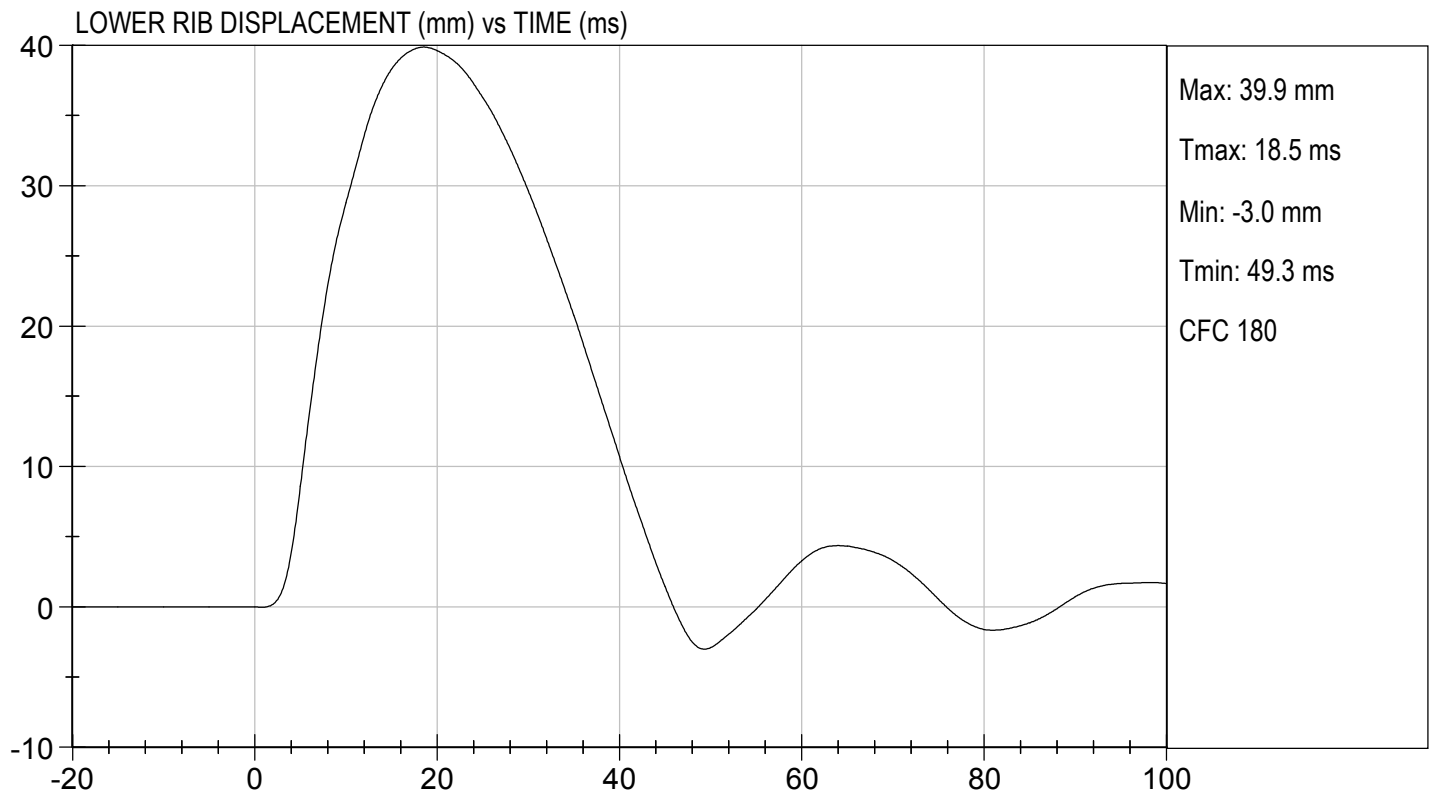
ES-2re External Measurements
SN: 032

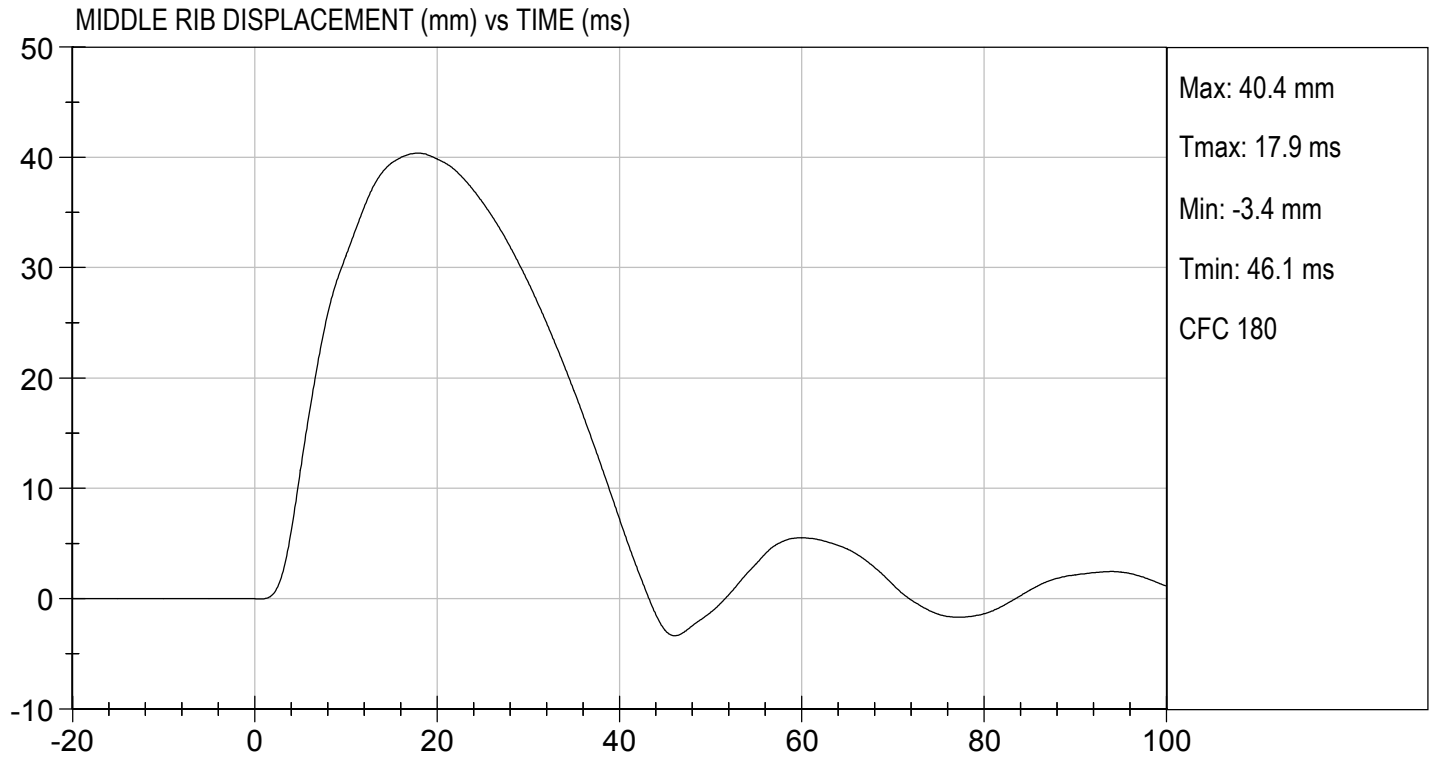
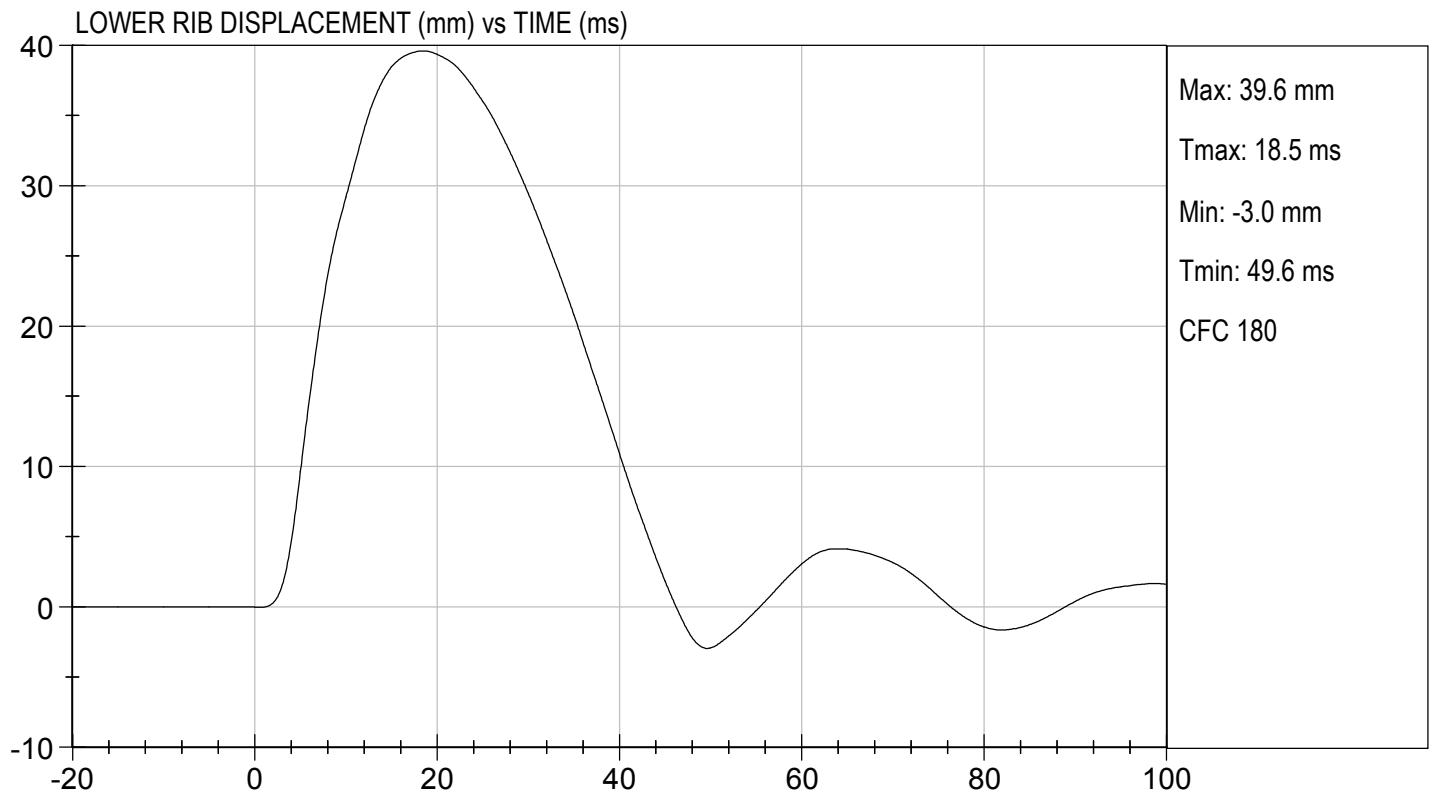
SID-IIsD External Measurements
SN: 296

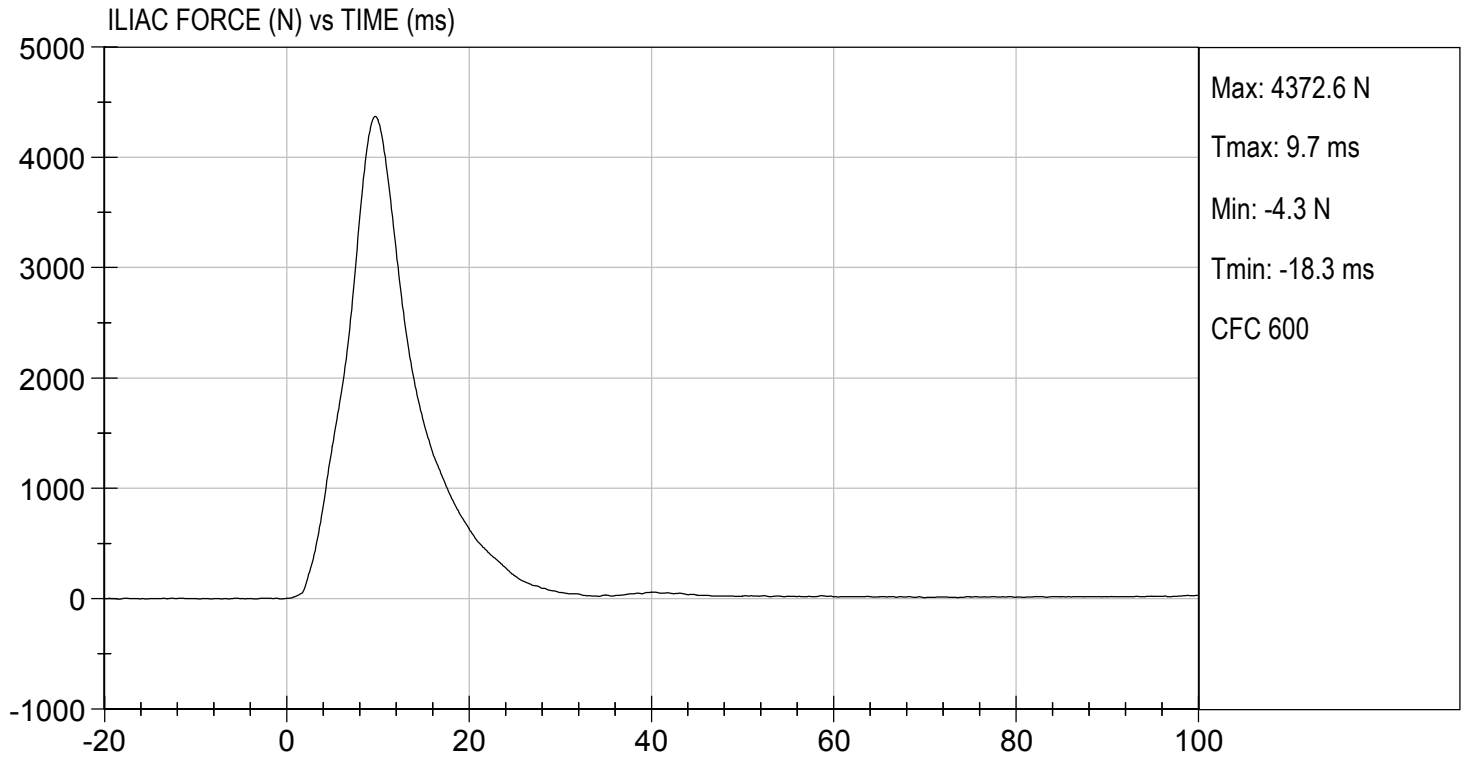
SID-IIsD External Measurements
SN: 296
