REPORT NUMBER: TWG-CAL-18-05

**NEW CAR ASSESSMENT PROGRAM (NCAP)**  
SIDE AIRBAG OUT-OF-POSITION INJURY TESTING

**Ford Motor Co.**  
**2018 Ford EcoSport**

NHTSA NUMBER: M20180202TWG2  
CALSPAN TEST NUMBER: CT2018-05

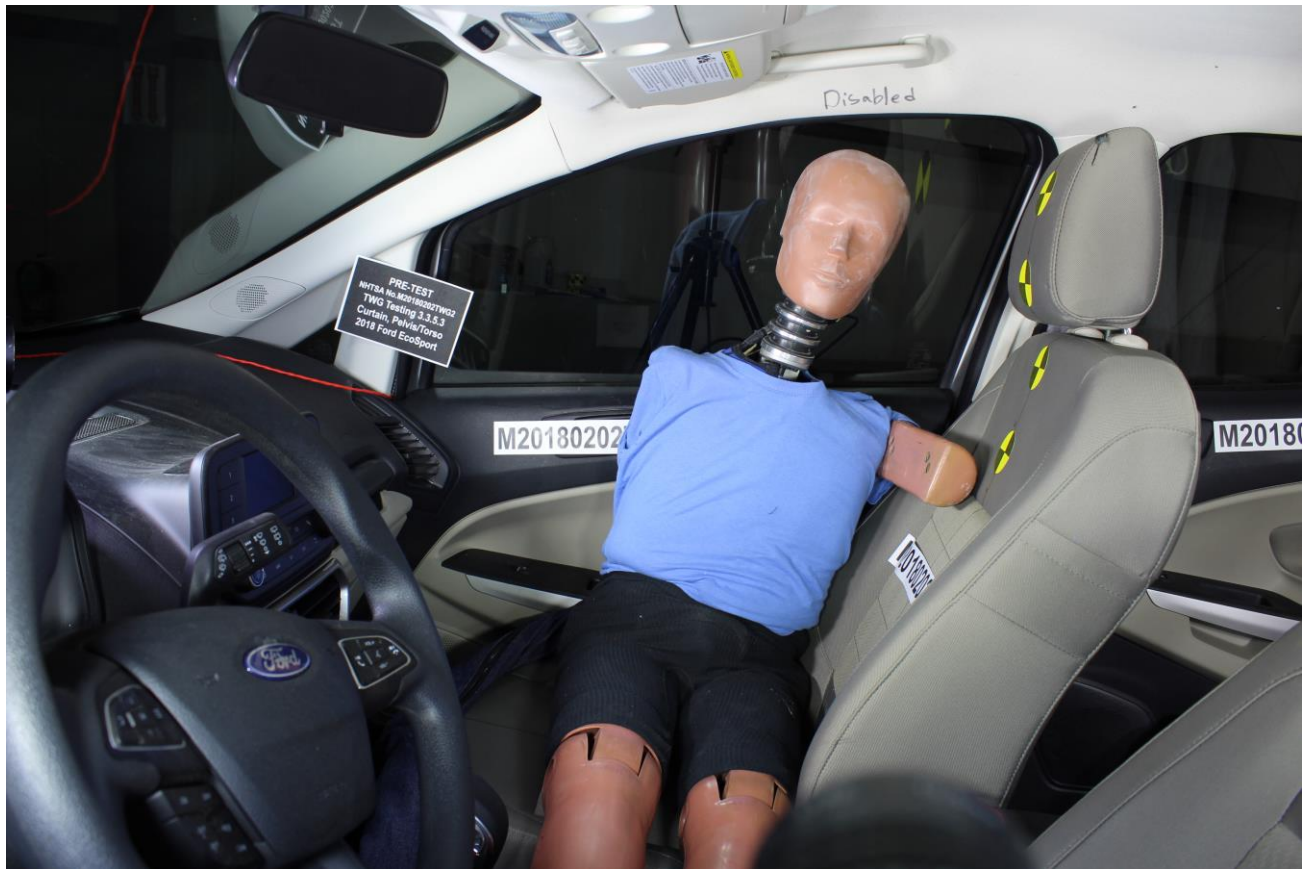
**Figure A-3: Pre-Test SID-IIs Left Side View**

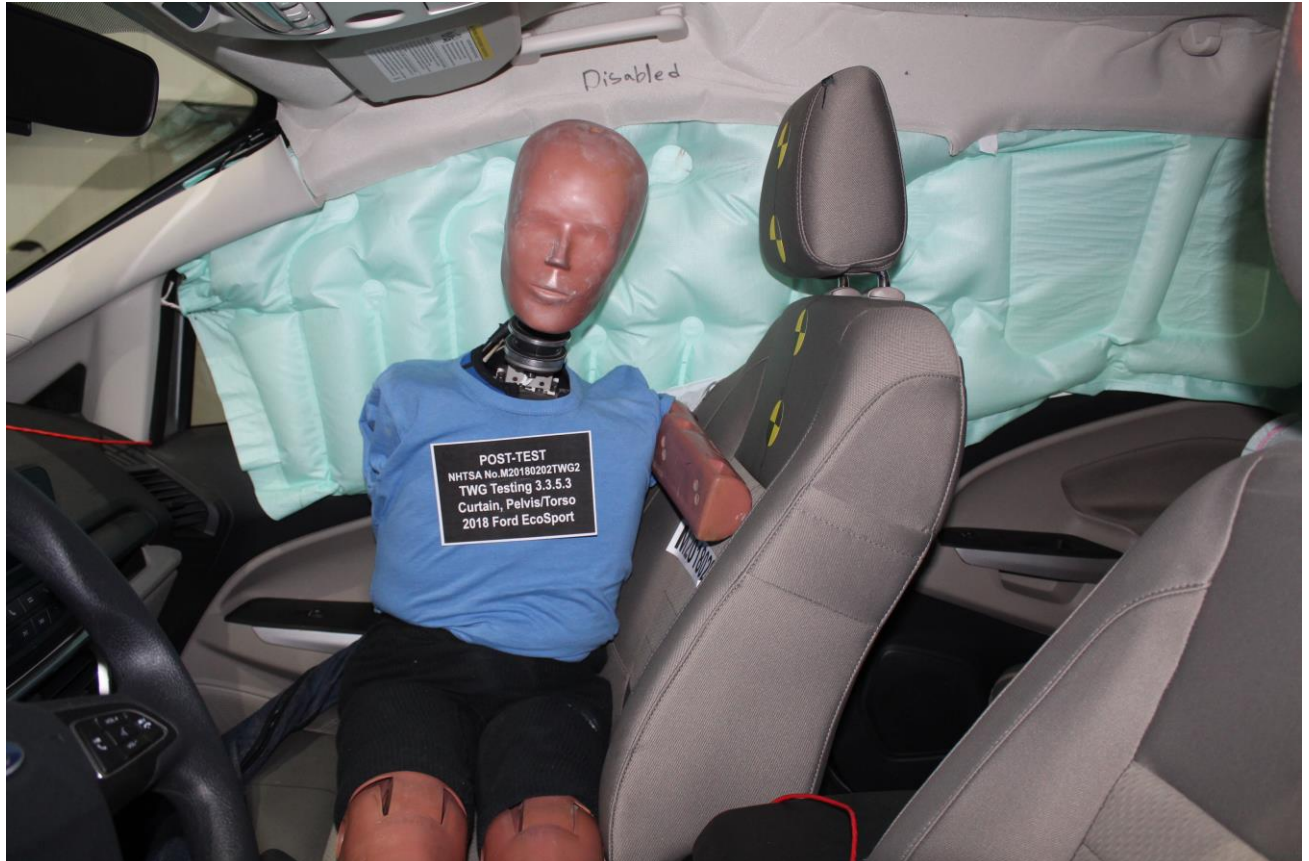
**Figure A-4: Post-Test SID-IIs Left Side View**

| <b>Head Contact:</b> | Curtain Airbag |
| <b>Upper Torso Contact:</b> | Torso Airbag & Seatback |
| <b>Lower Torso Contact:</b> | Torso Airbag & Seatback |

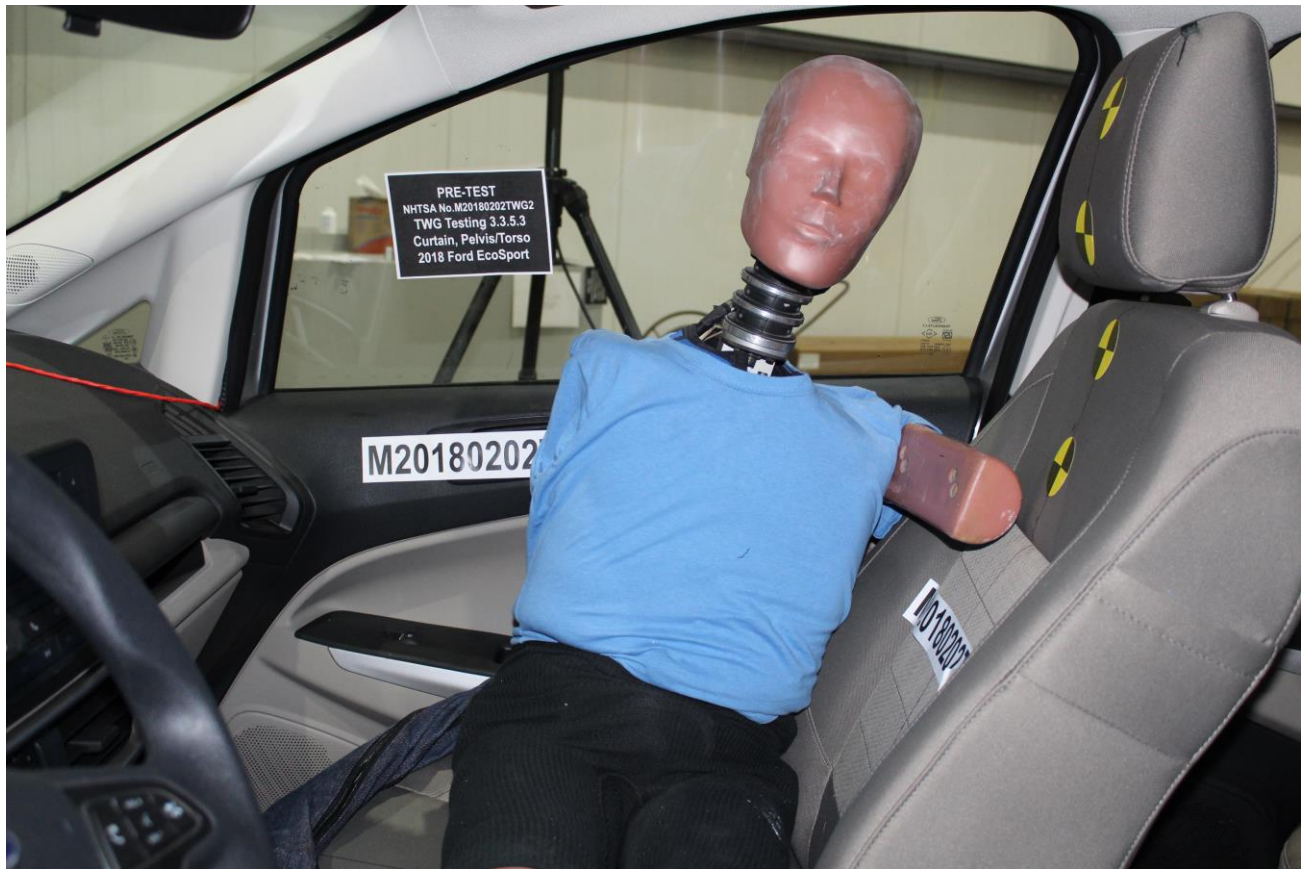
**Figure A-5: Pre-Test SID-IIs Left Side Close-up View**

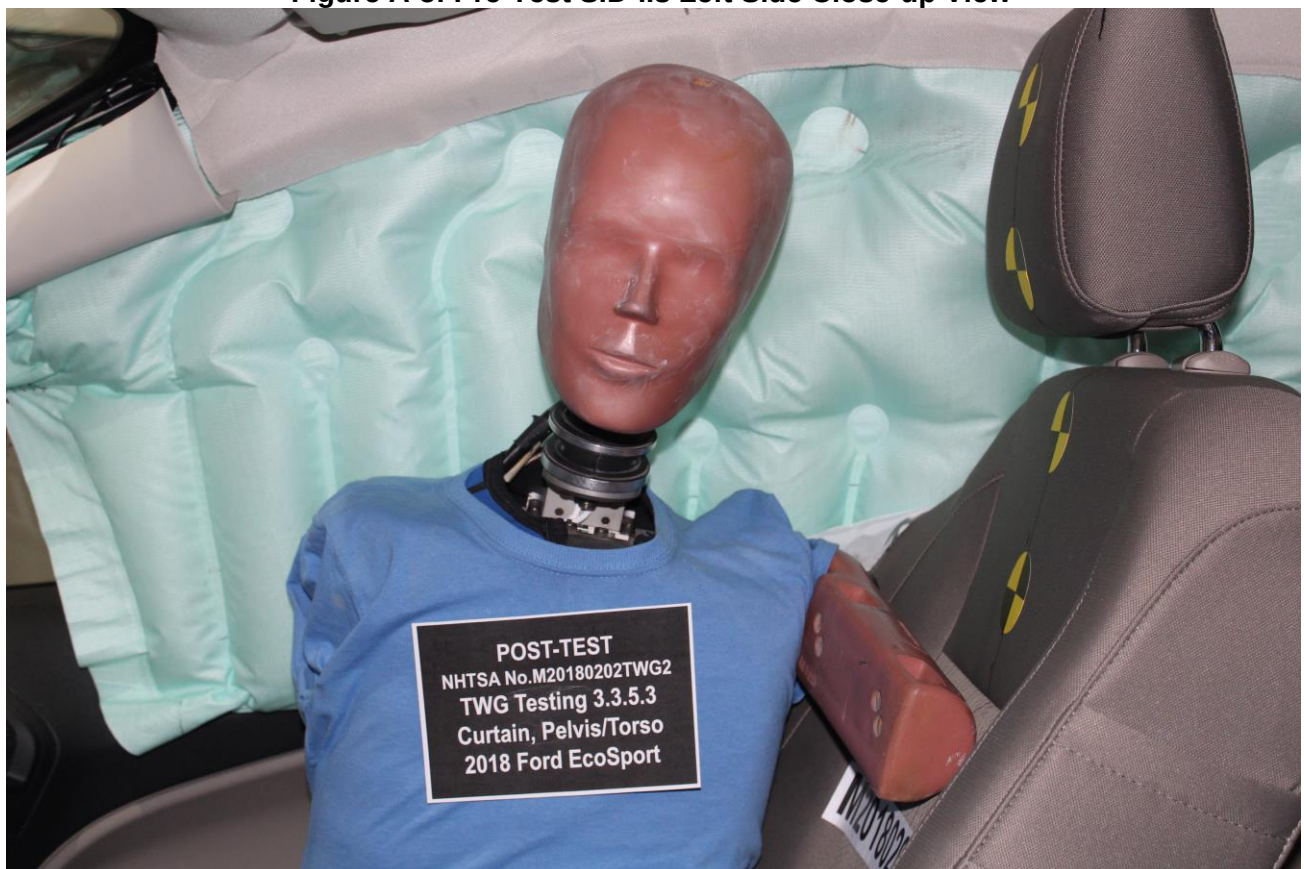
**Figure A-6: Post-Test SID-IIs Left Side Close-up View**

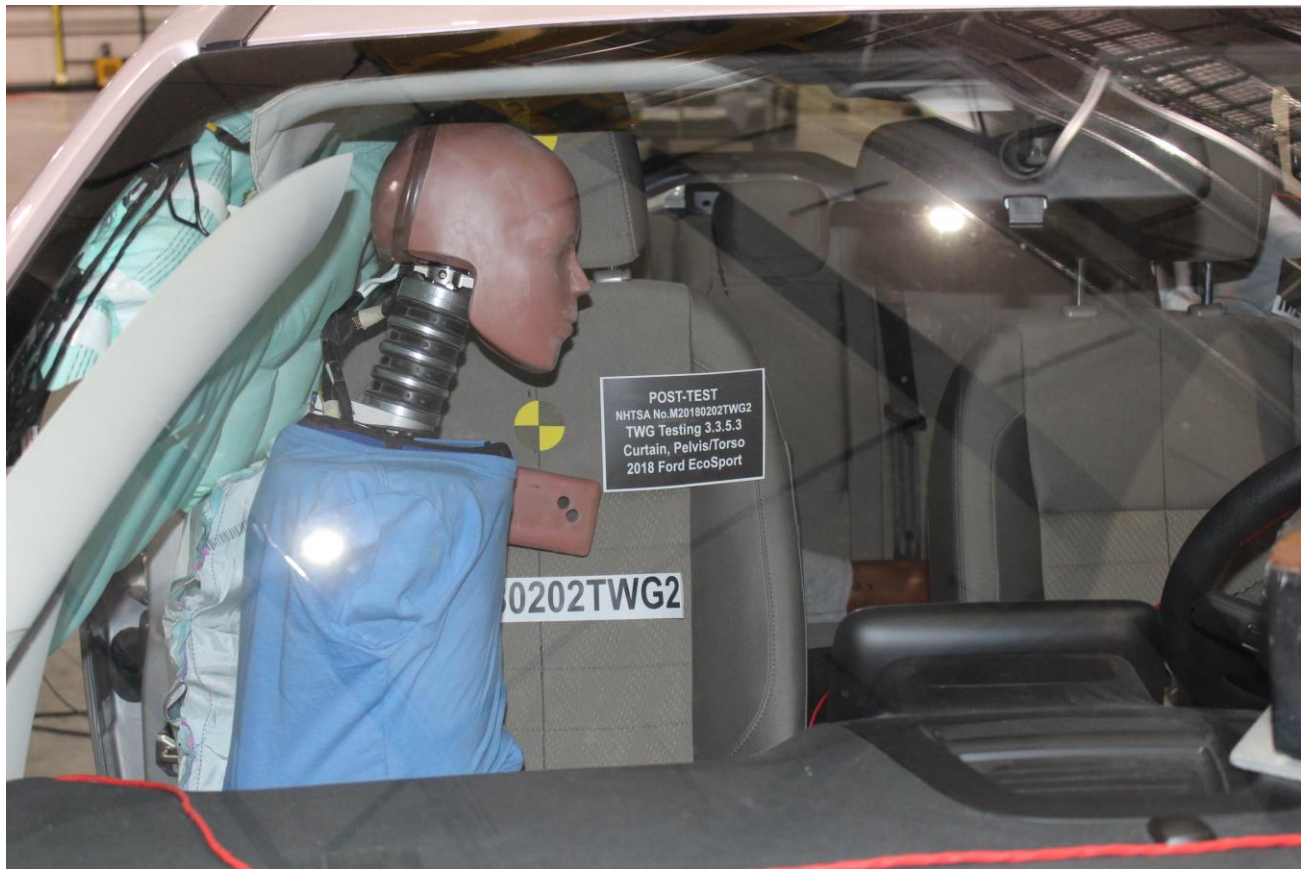
**Figure A-7: Pre-Test SID-IIs Front View**

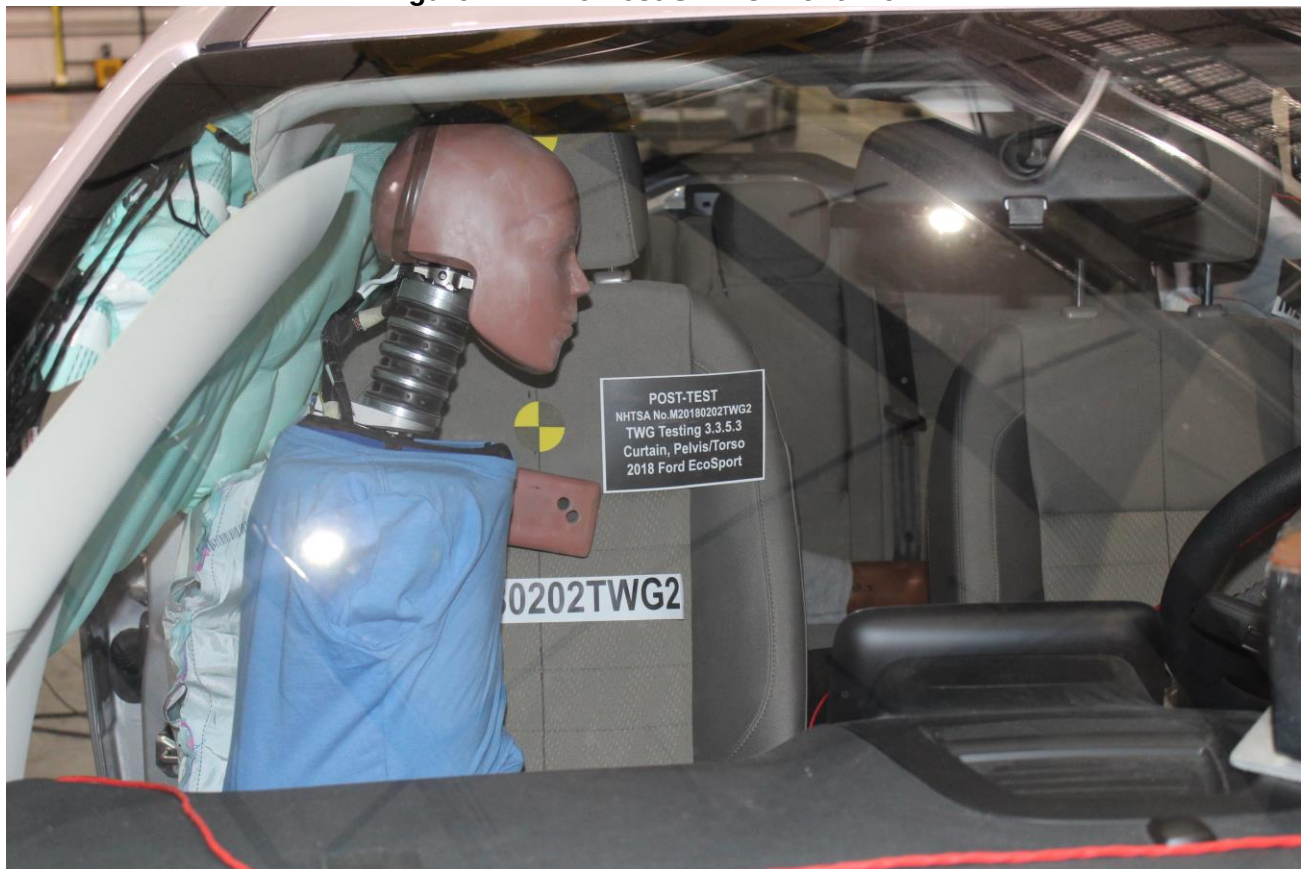
**Figure A-8: Post-Test SID-IIs Front View**

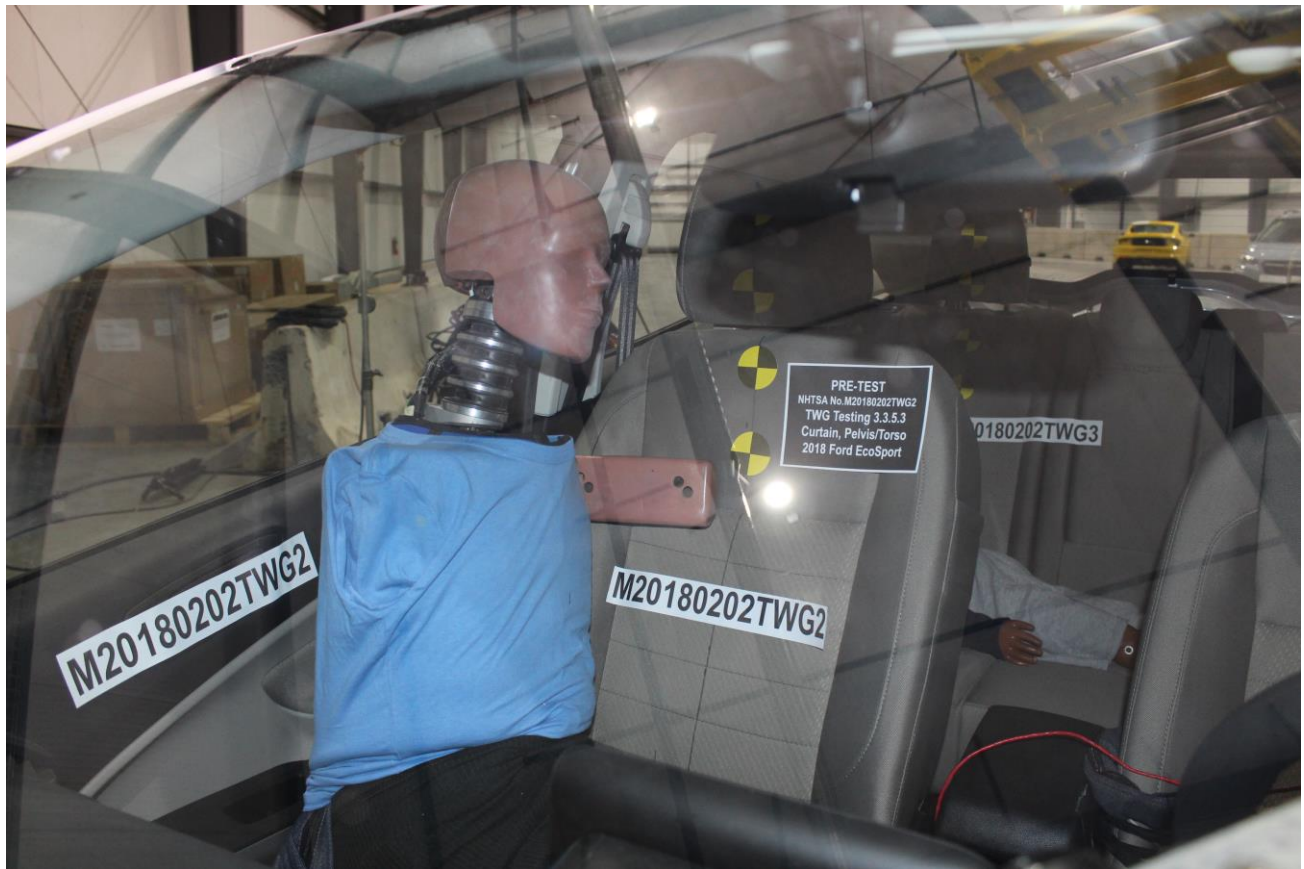
**Figure A-9: Pre-Test SID-IIs Left  $\frac{3}{4}$  Front View**

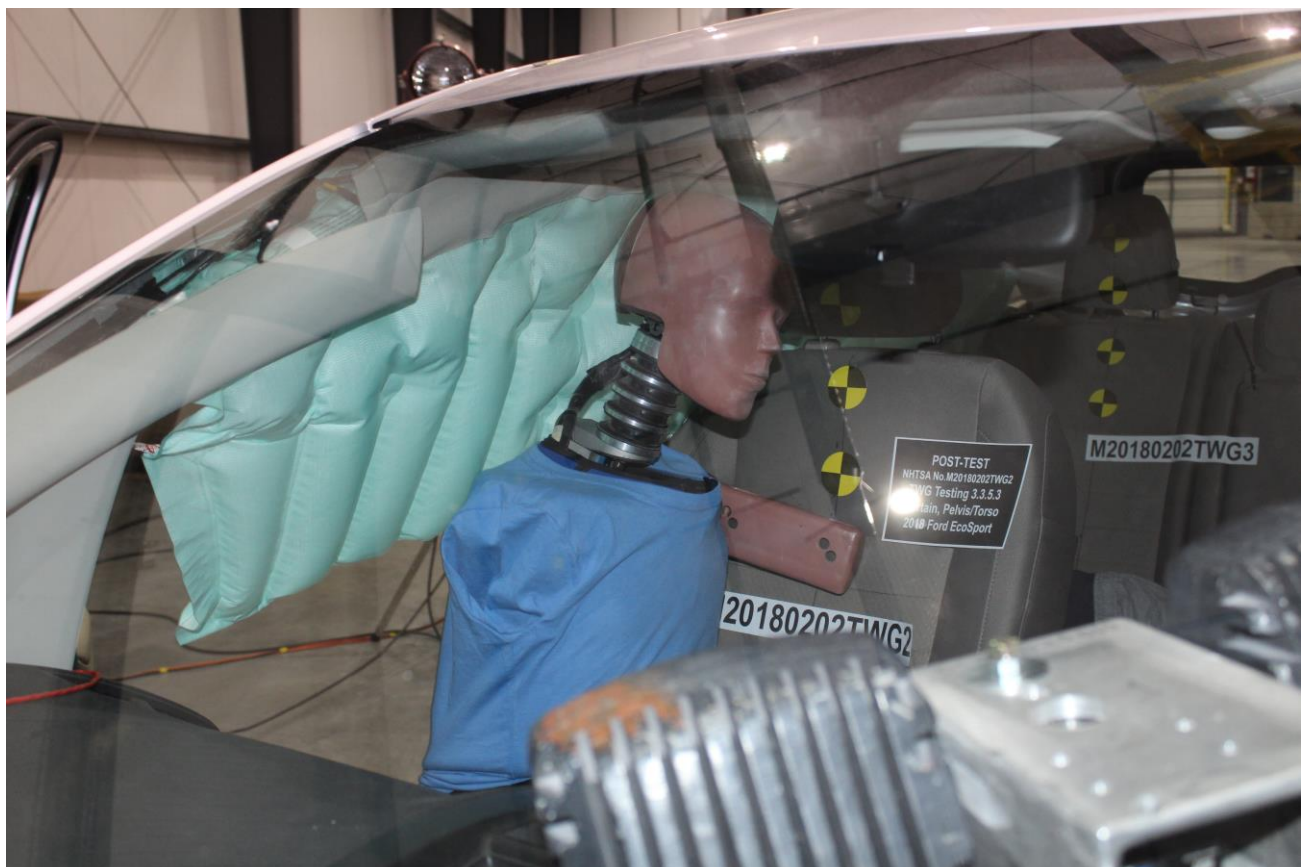
**Figure A-10: Post-Test SID-IIs Left  $\frac{3}{4}$  Front View**

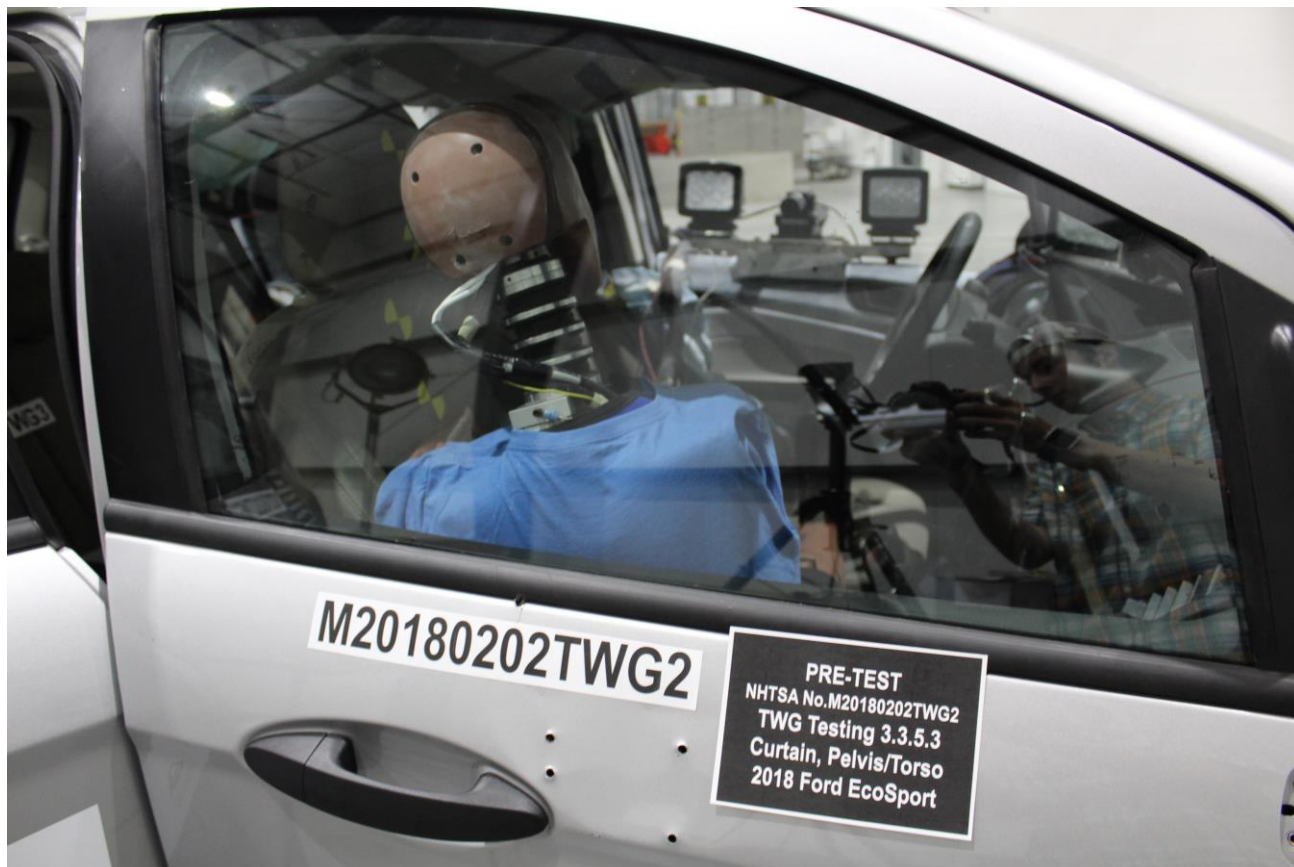
Figure A-11: Pre-Test SID-III Right Side View

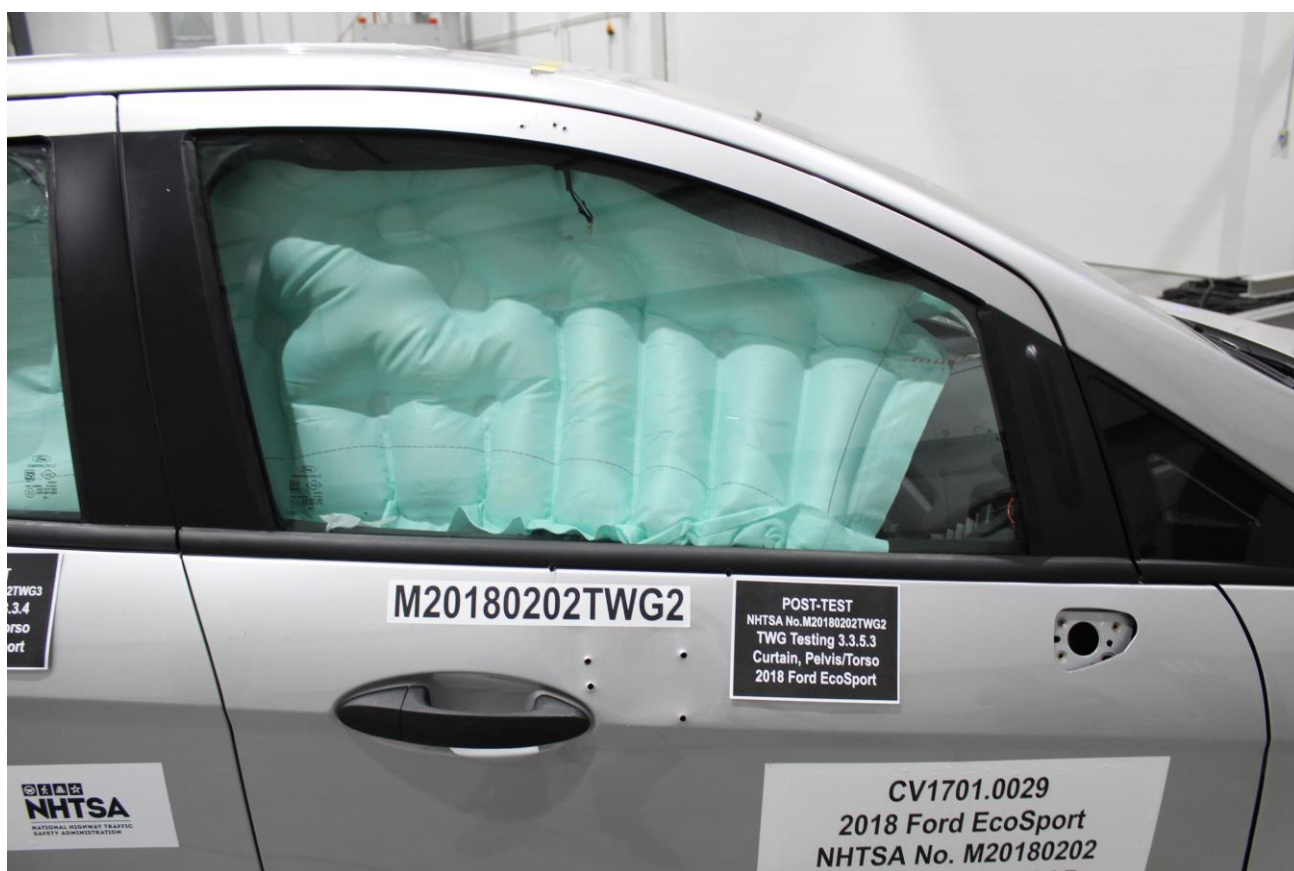
Figure A-12: Post-Test SID-III Right Side View

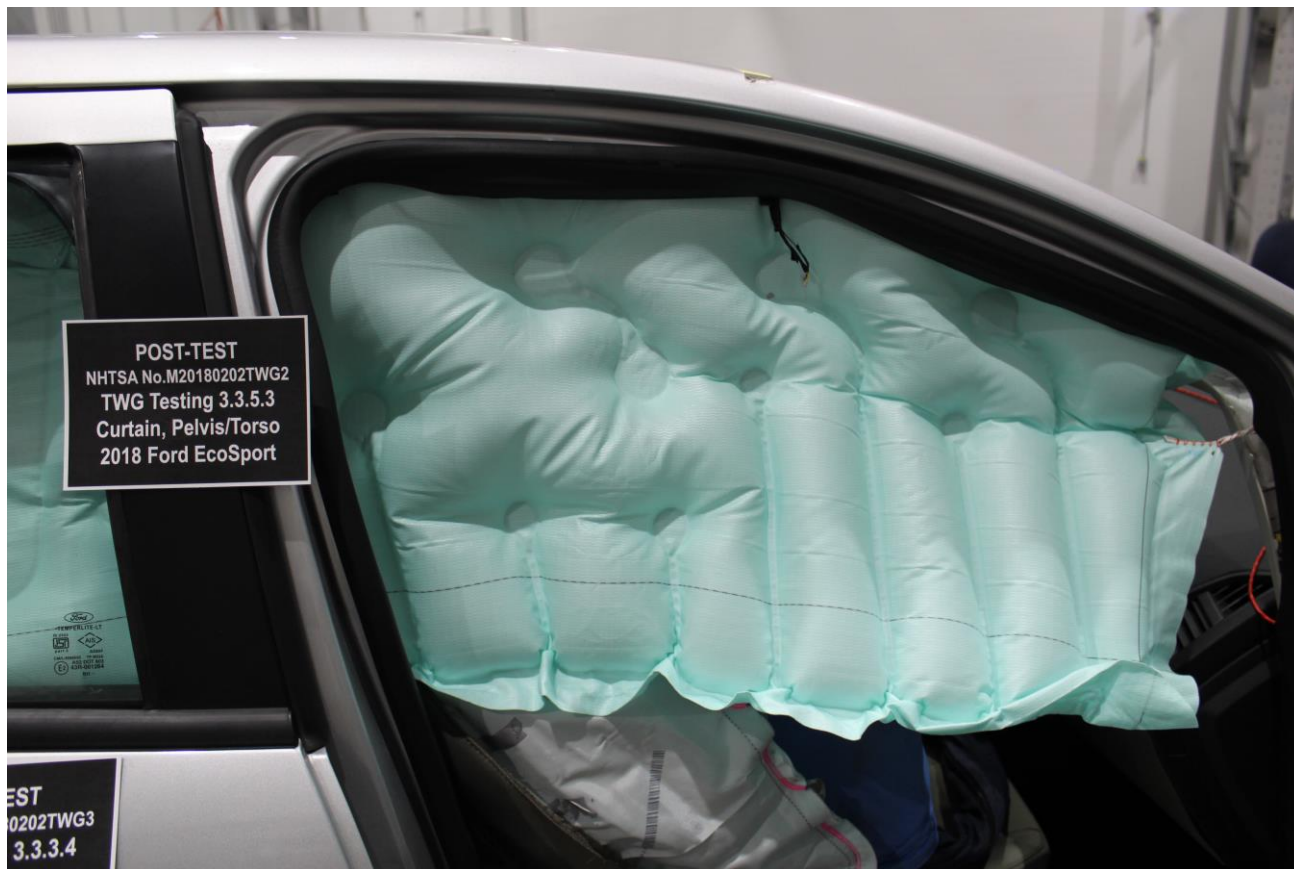
**Figure A-13: Post-Test Curtain Airbag View**

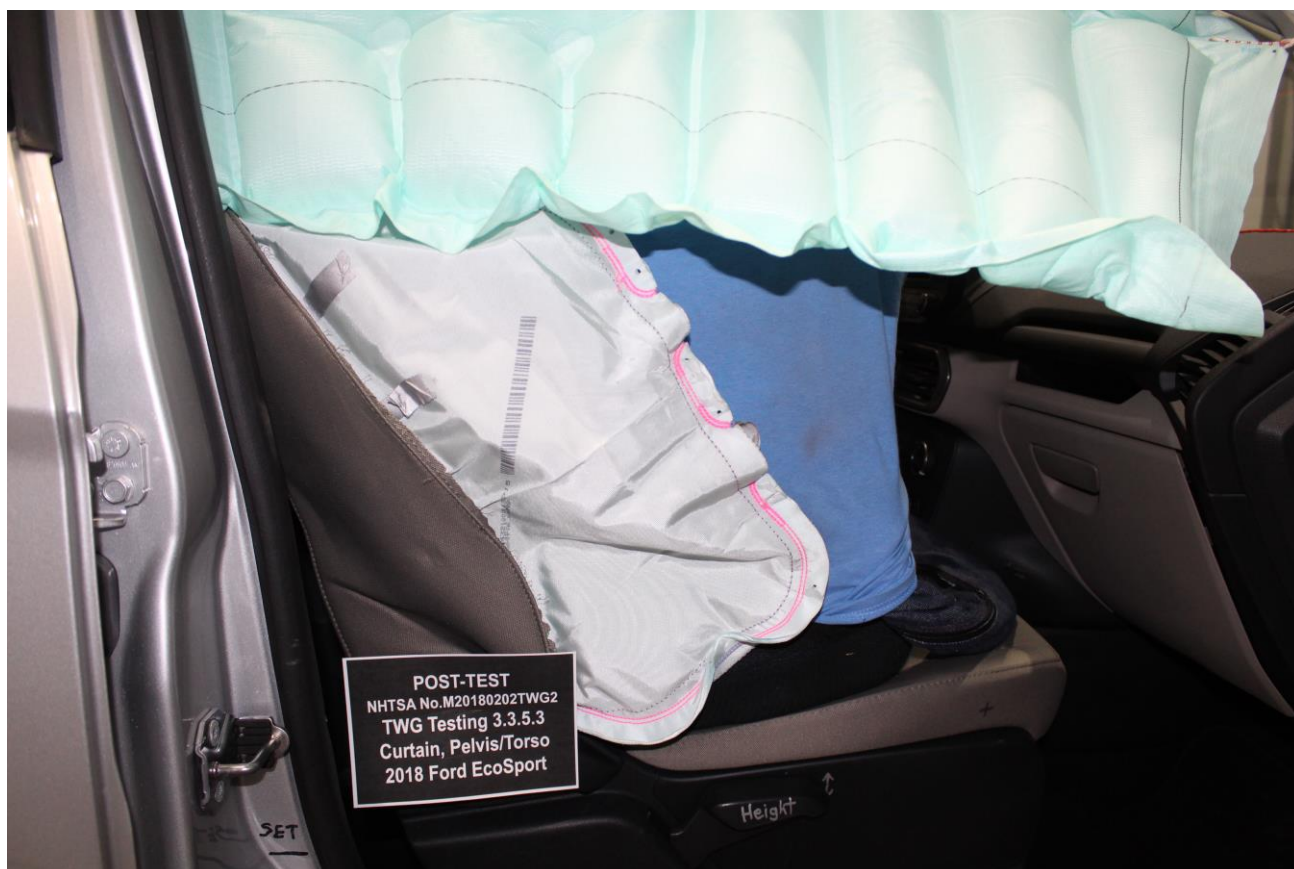
**Figure A-14: Post-Test Seat Airbag View**

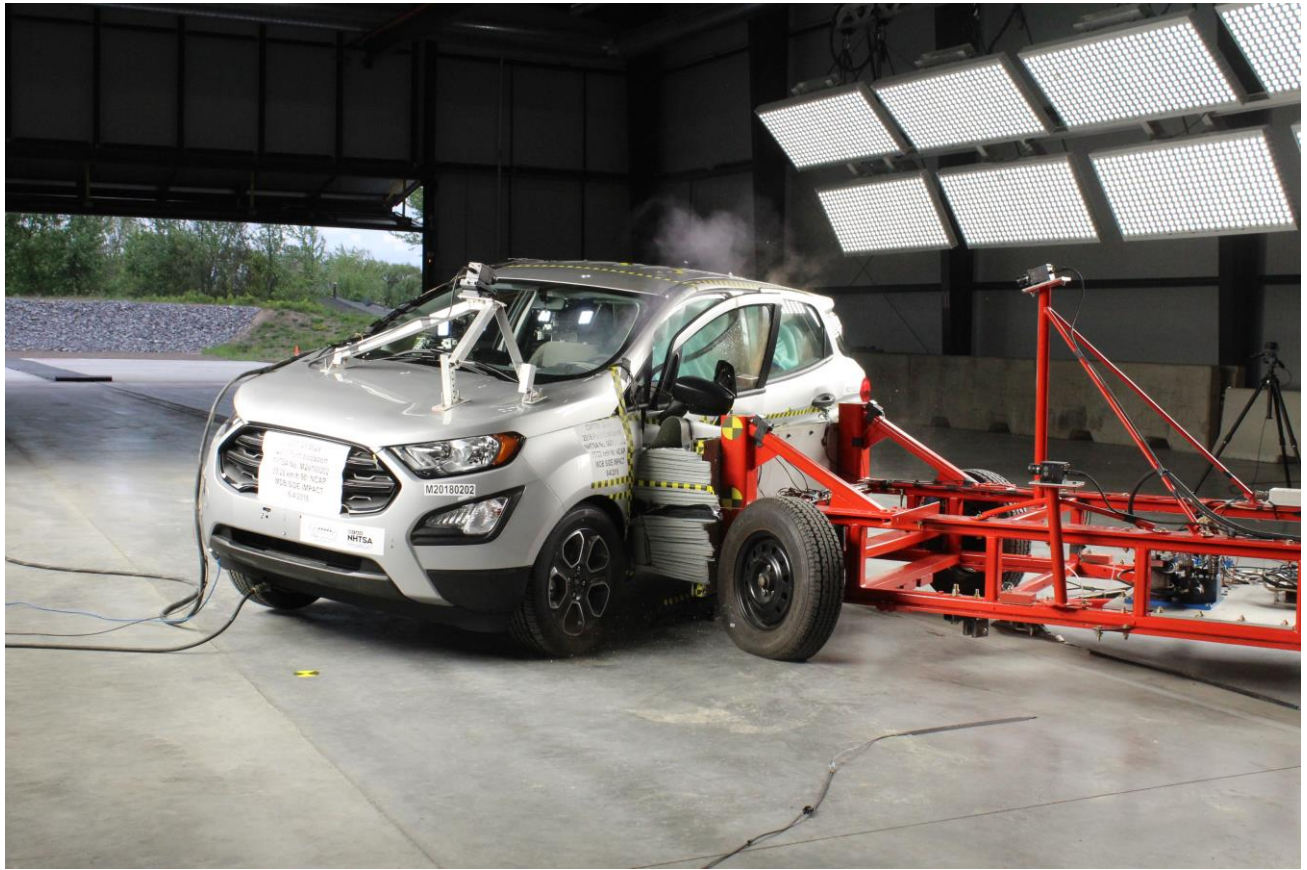
**Figure A-15: Impact Event**

Three high-speed digital cameras were used to document the side airbag deployment event. Images were recorded at rates of 1000 frames per second. The cameras were placed perpendicular to the right-front passenger seat centerline, Oblique, and through the passenger window to capture the deployment event from various positions.
