**REPORT NUMBER: 301R-CAL-18-002**

**SAFETY COMPLIANCE TESTING FOR FMVSS 301R  
FUEL SYSTEM INTEGRITY – REAR IMPACT**

**Honda MFG. of Alabama, LLC  
2018 Honda Odyssey**

**NHTSA NUMBER: C20185303**

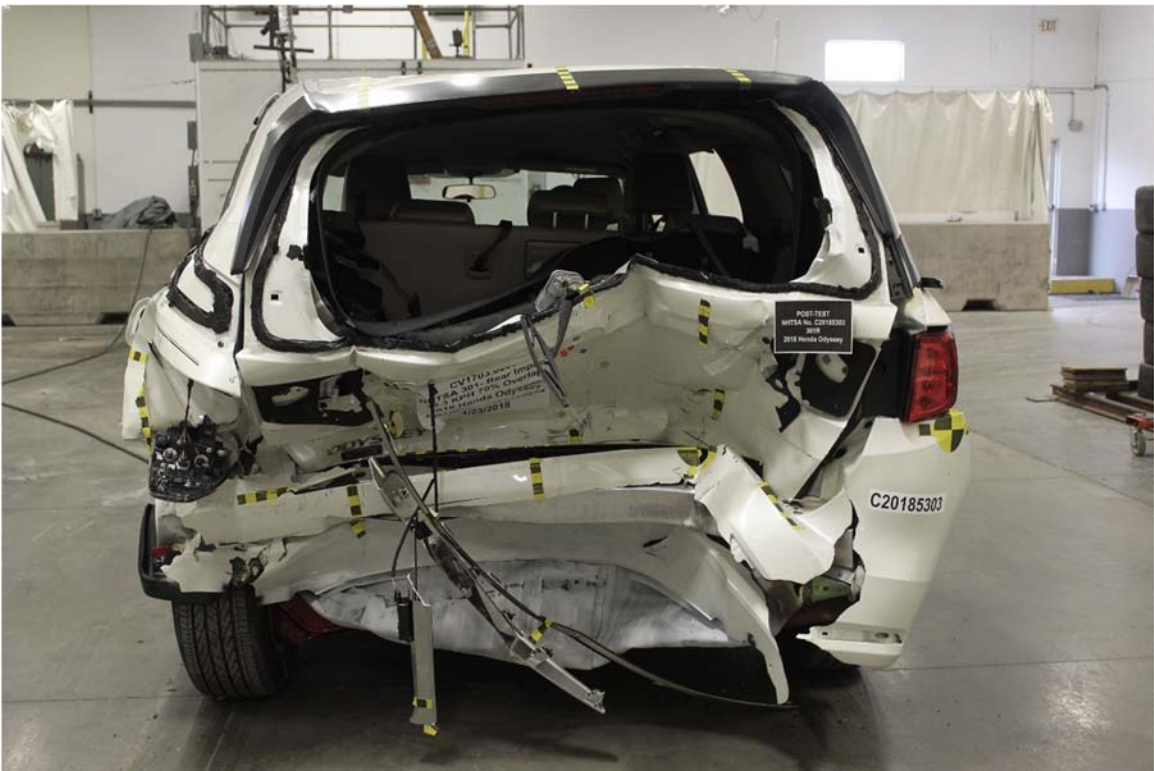
**Figure A-18: Post-Test Rear View**

Critical Areas of Performance	Observations and Conclusions
Windshield Damage	None
Window Damage	None
Other Notable Effects	Rear Windshield Shattered
