**REPORT NUMBER: NCAP-MGA-22-008**

**NEW CAR ASSESSMENT PROGRAM (NCAP)  
Frontal Barrier Impact Test**

**HONDA OF CANADA MFG.  
2022 Honda Civic LX 4-Door Sedan  
NHTSA No.: O20225303**

**MGA RESEARCH CORPORATION  
5000 Warren Road  
Burlington, WI 53105**

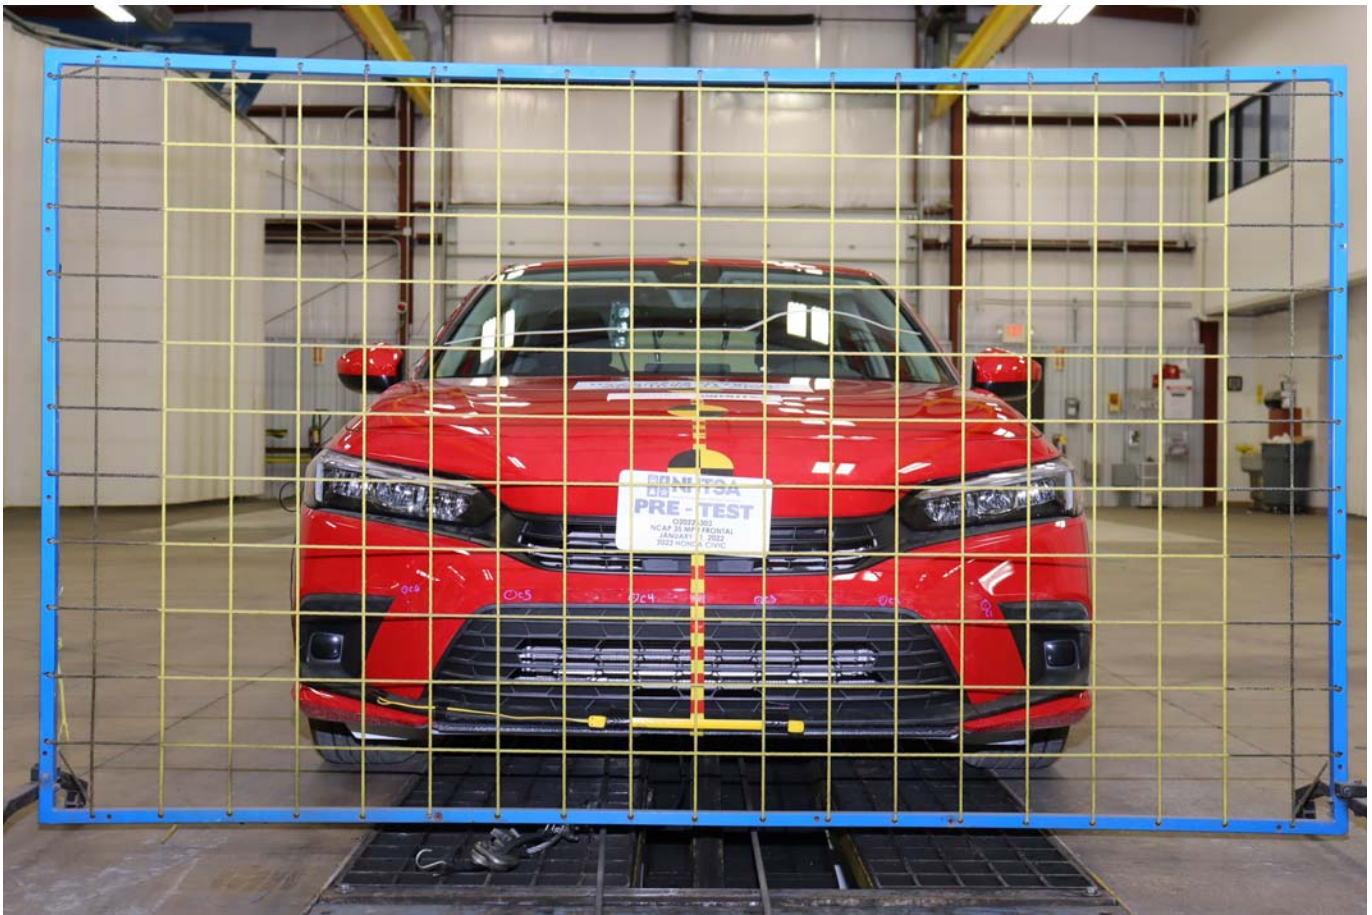
Photo No. 001 - Load Cell Location

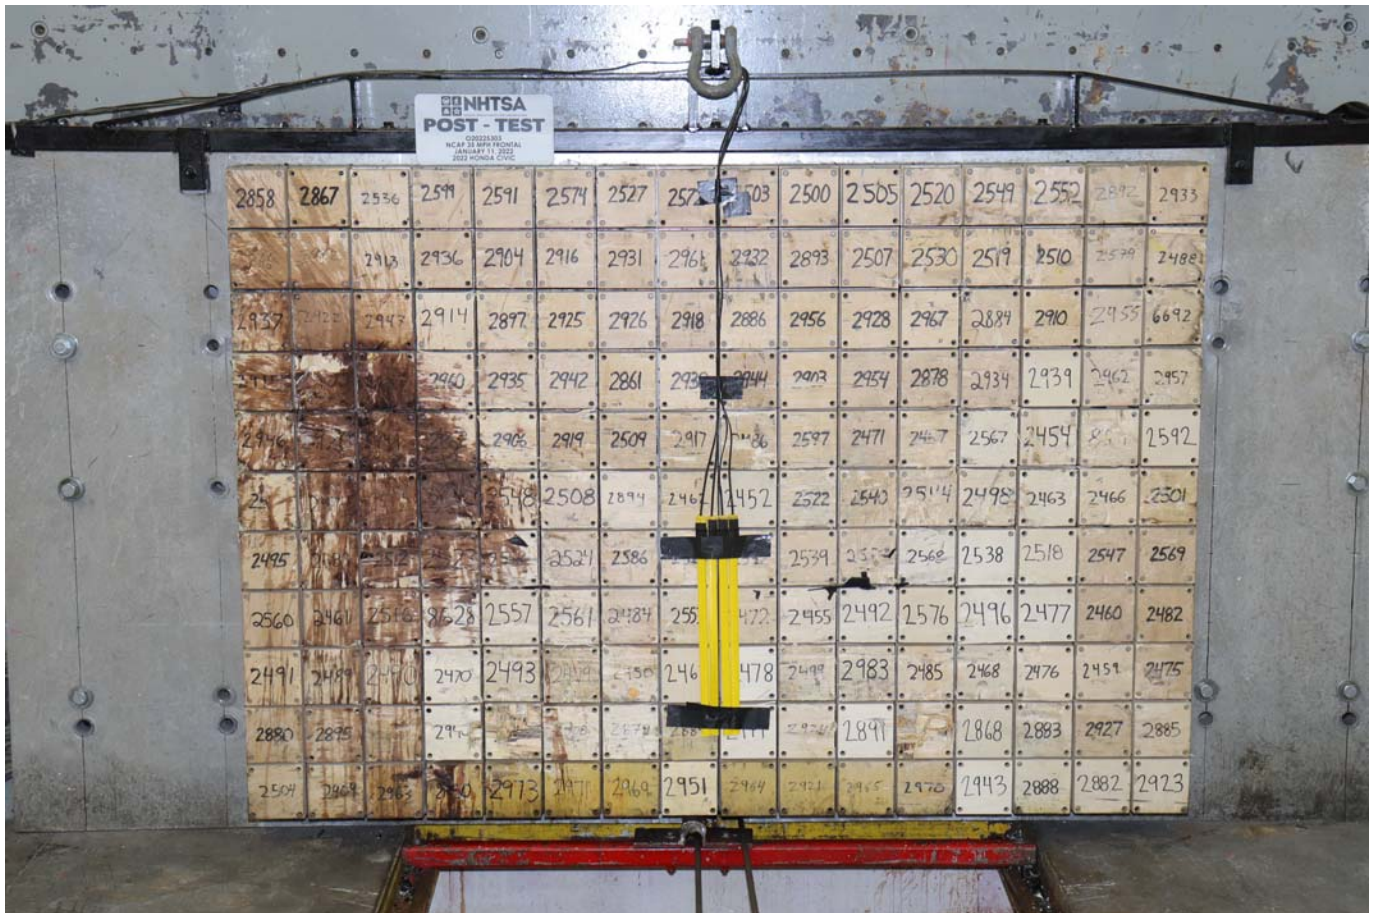
Photo No. 003 - Post-Test Load Cell Wall

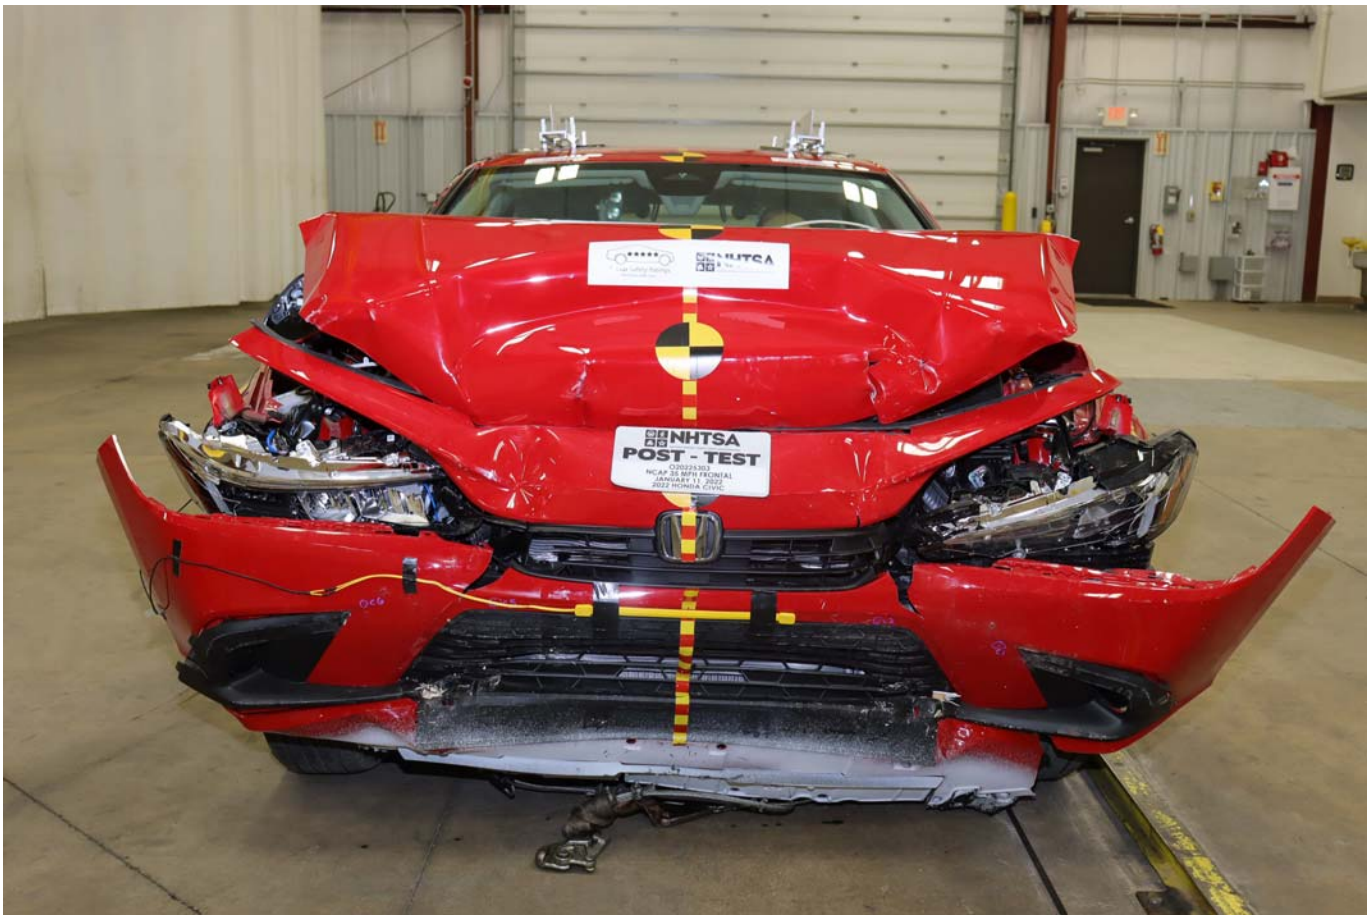
Photo No. 009 - Post-Test Front View of Test Vehicle

The maximum static crush of the vehicle was 602 mm located to the left of the vehicle centerline and both the driver and passenger side doors remained closed during the impact event and were operable after the impact.

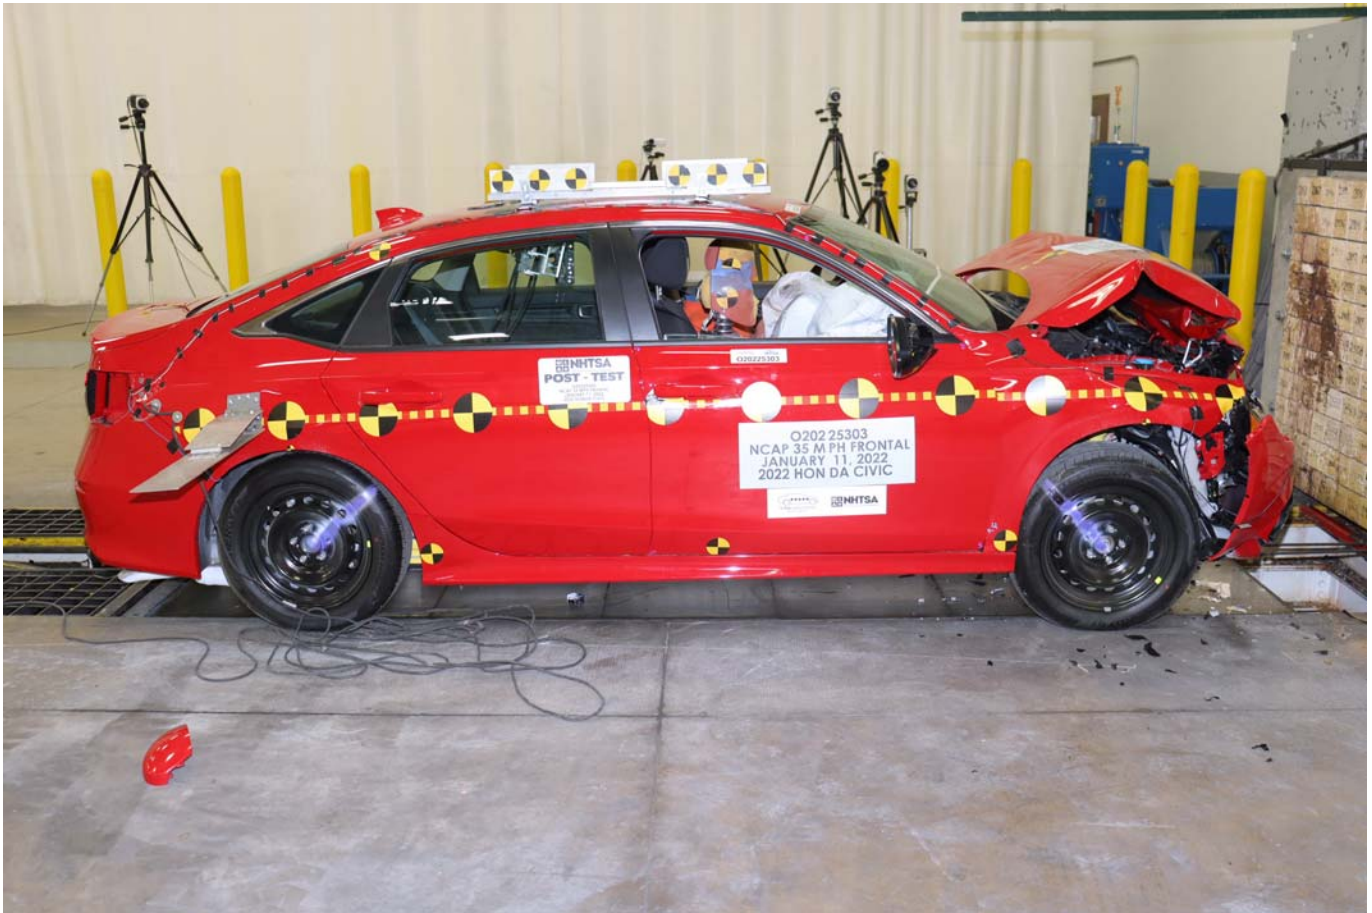
Photo No. 013 - Post-Test Right View of Test Vehicle

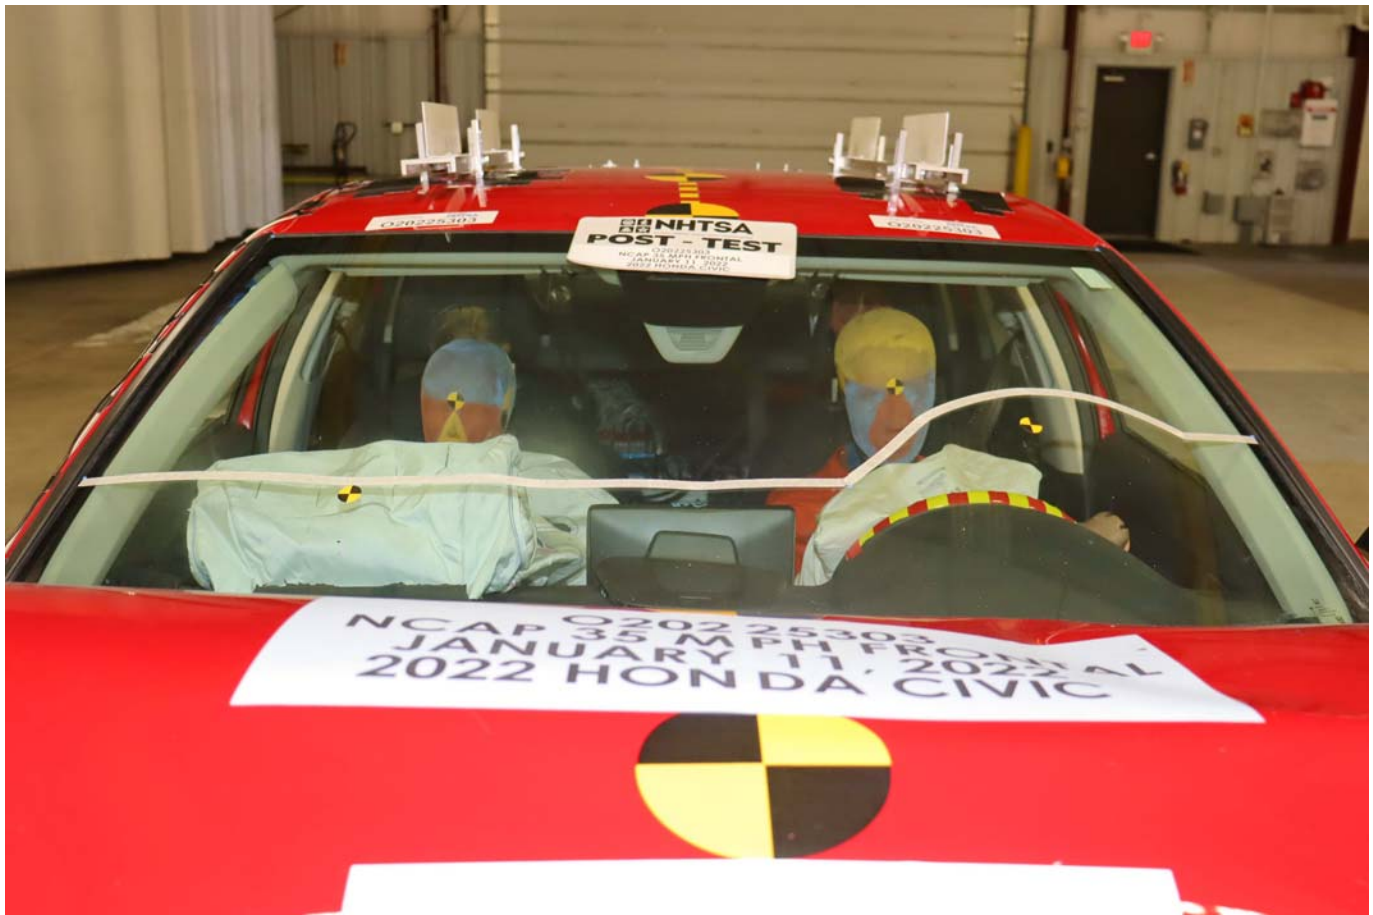
Photo No. 019 - Post-Test Windshield View

There was 100 percent windshield retention and no intrusion into the protected zone of the windshield during the event. There was no Stoddard Solvent leakage after the event or during any phase of the static rollover.

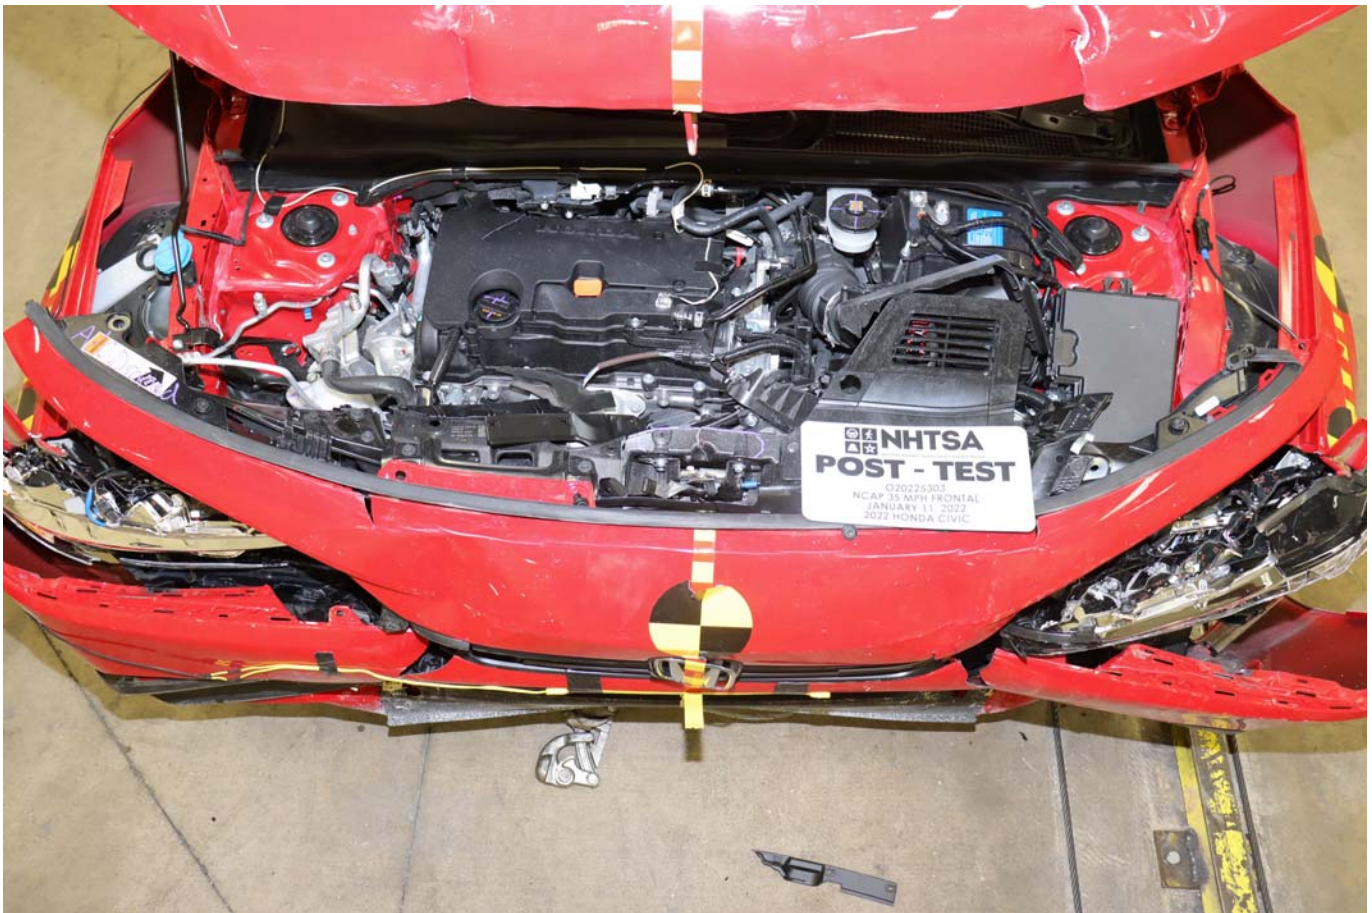
Photo No. 021 - Post-Test Engine Compartment View

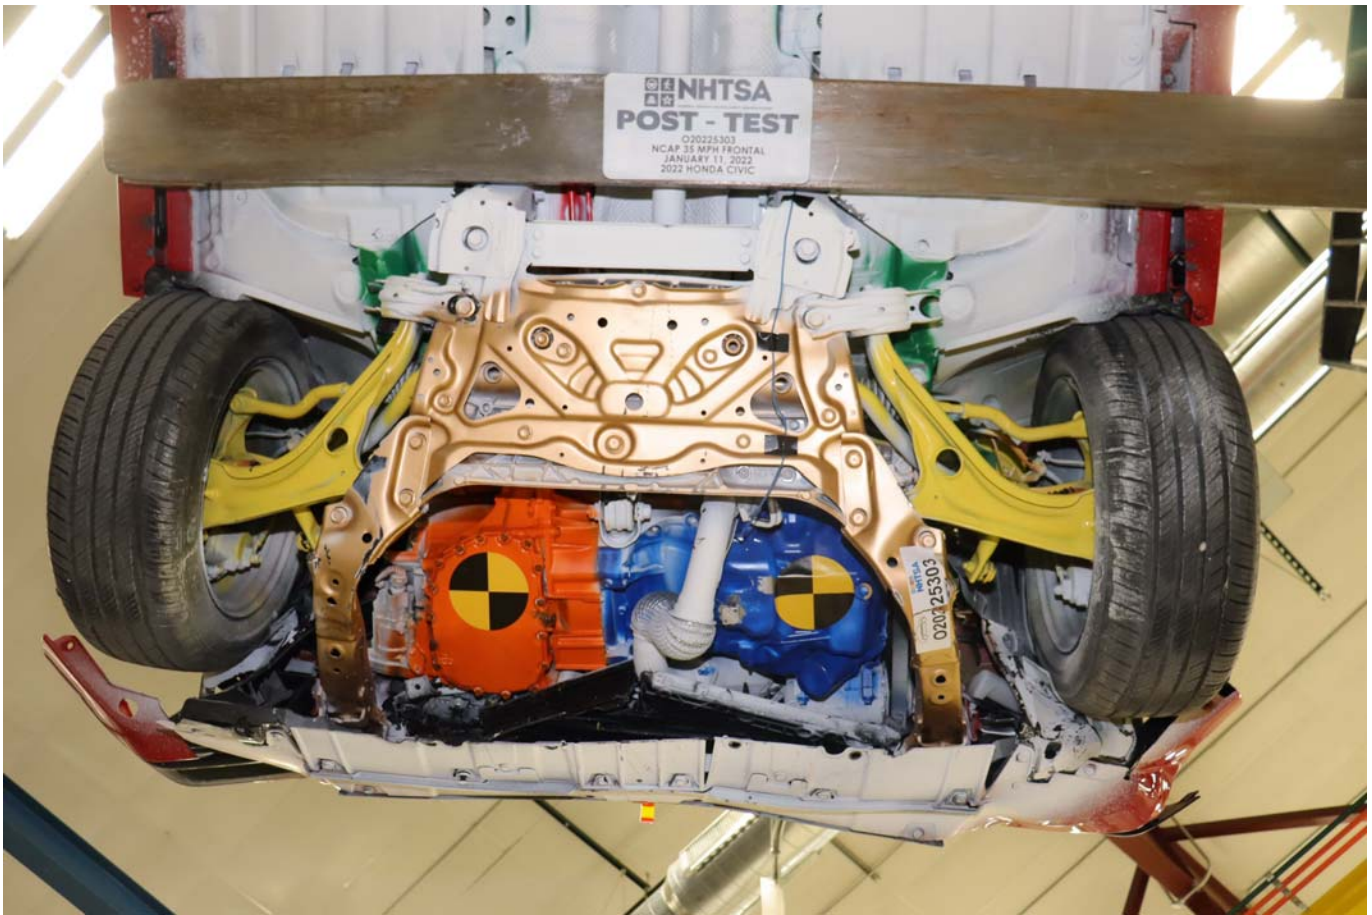
Photo No. 025 - Post-Test Front Underbody View

| Critical Areas of Performance | Observations and Conclusions |
|---|---|
| Other Notable Effects | Underbody pit cover broken by subframe deformation |

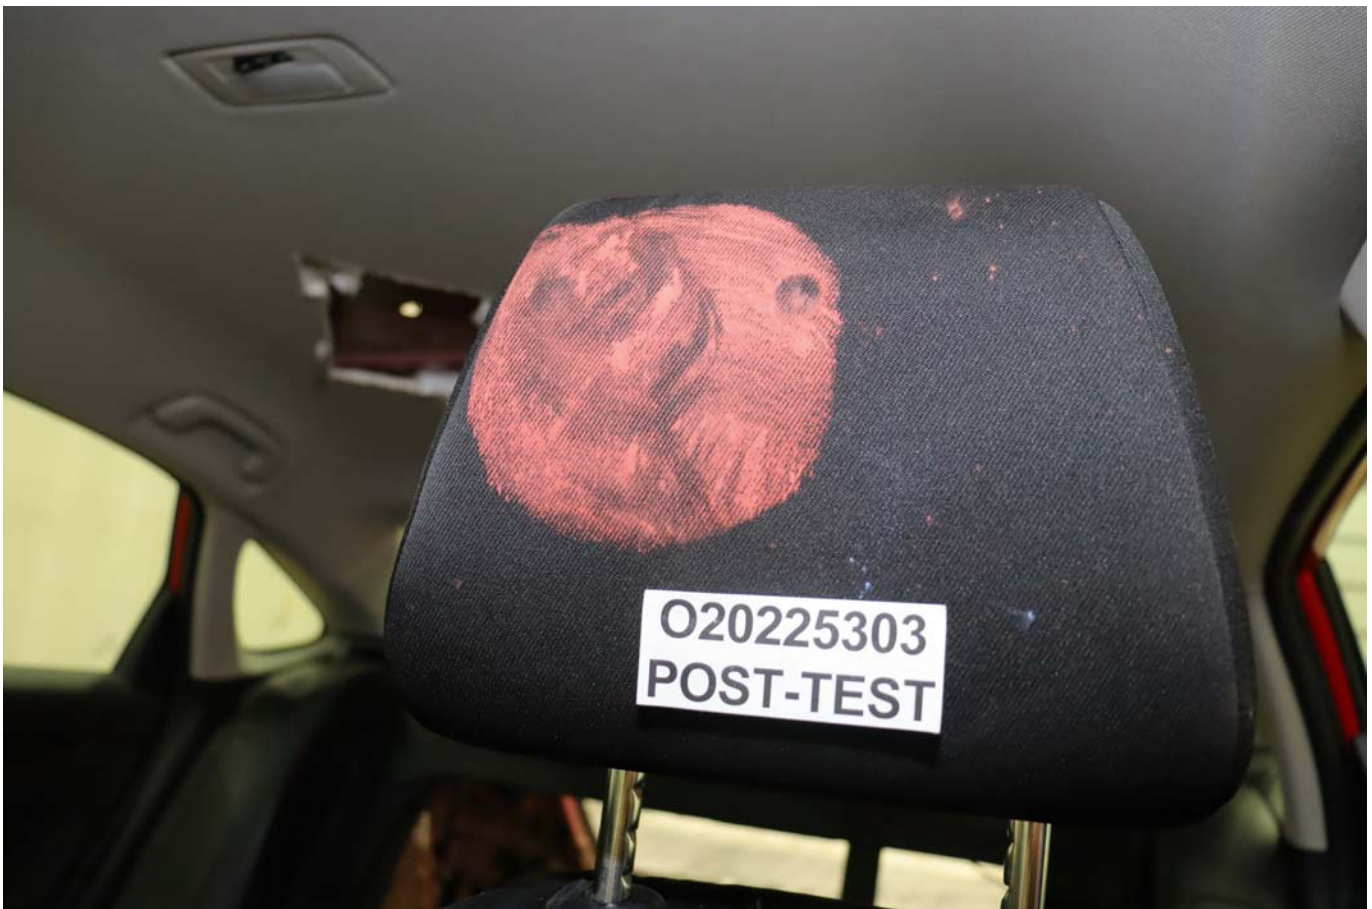
Photo No. 050 - Post-Test Driver Dummy Contact with Headrest

The driver's visible contact points were as follows: The driver's head contacted the airbag. The driver's head also contacted the headrest. The driver's knees contacted the knee airbag.

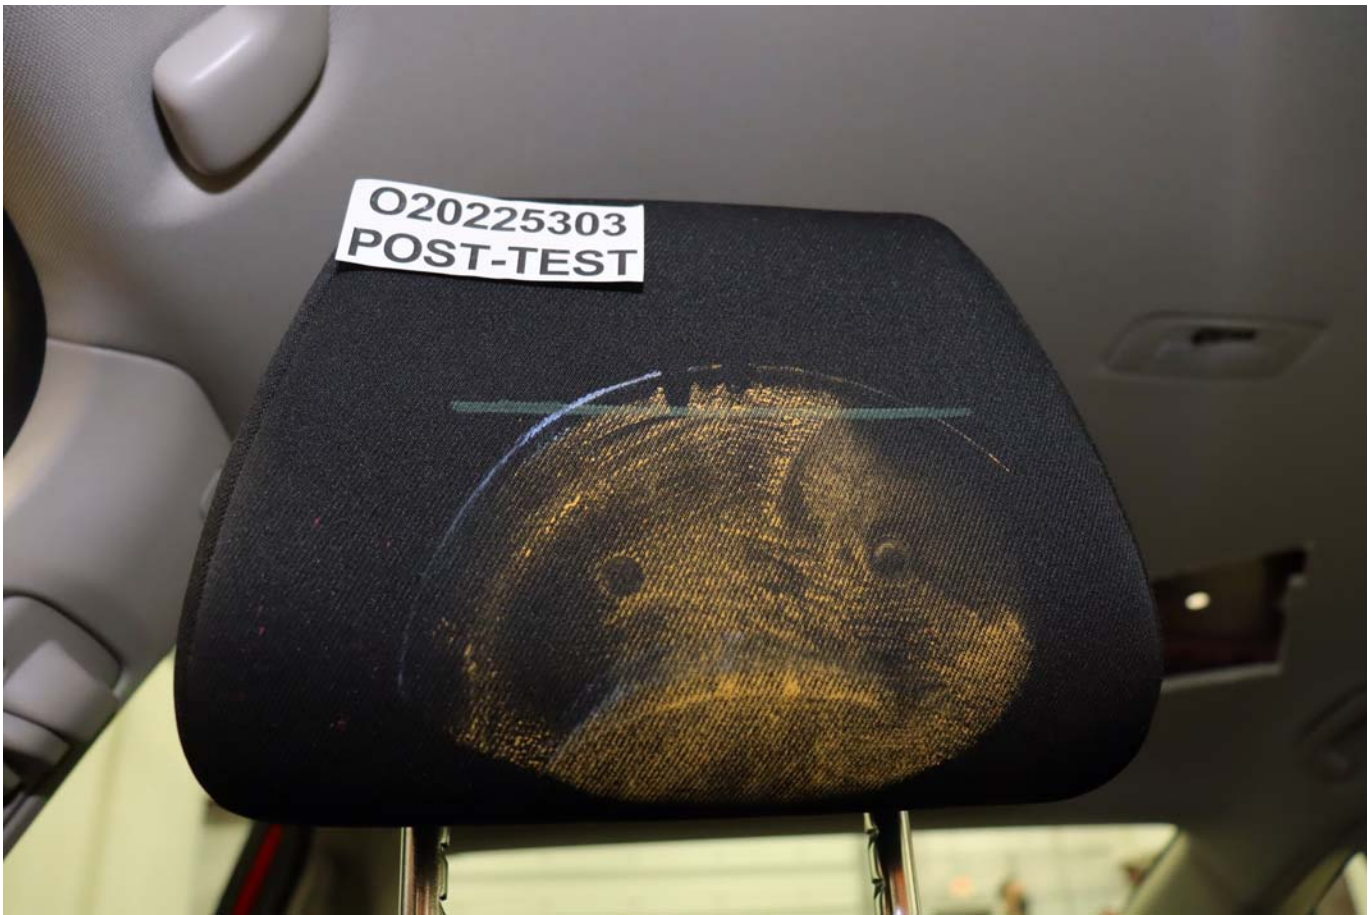
Photo No. 073 - Post-Test Passenger Dummy Contact with Headrest

The passenger's visible contact points were as follows: The passenger's head contacted the airbag. The passenger's head also contacted the headrest. The passenger's knees contacted the knee airbag.

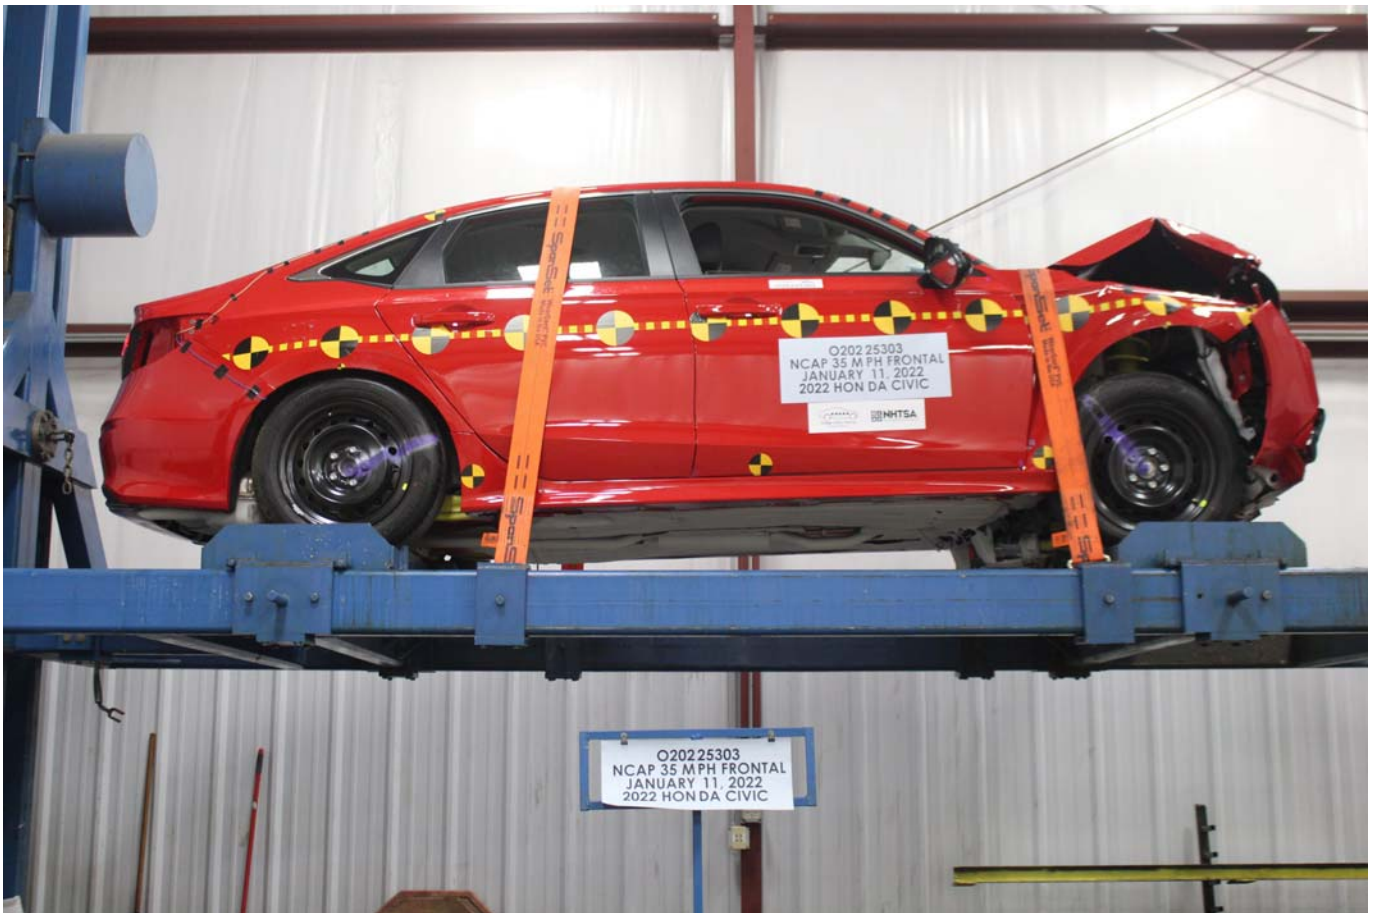
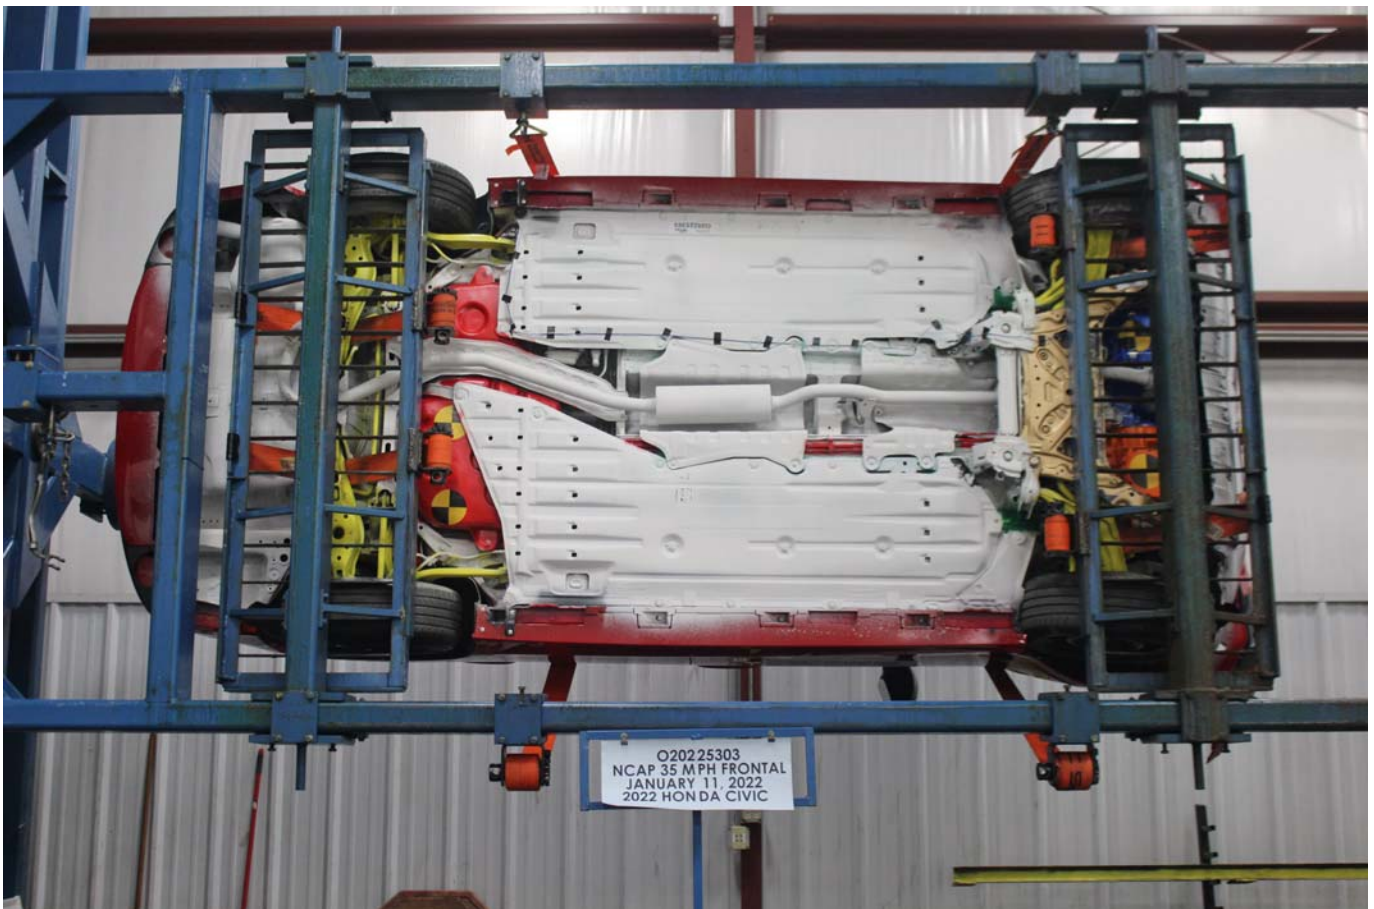
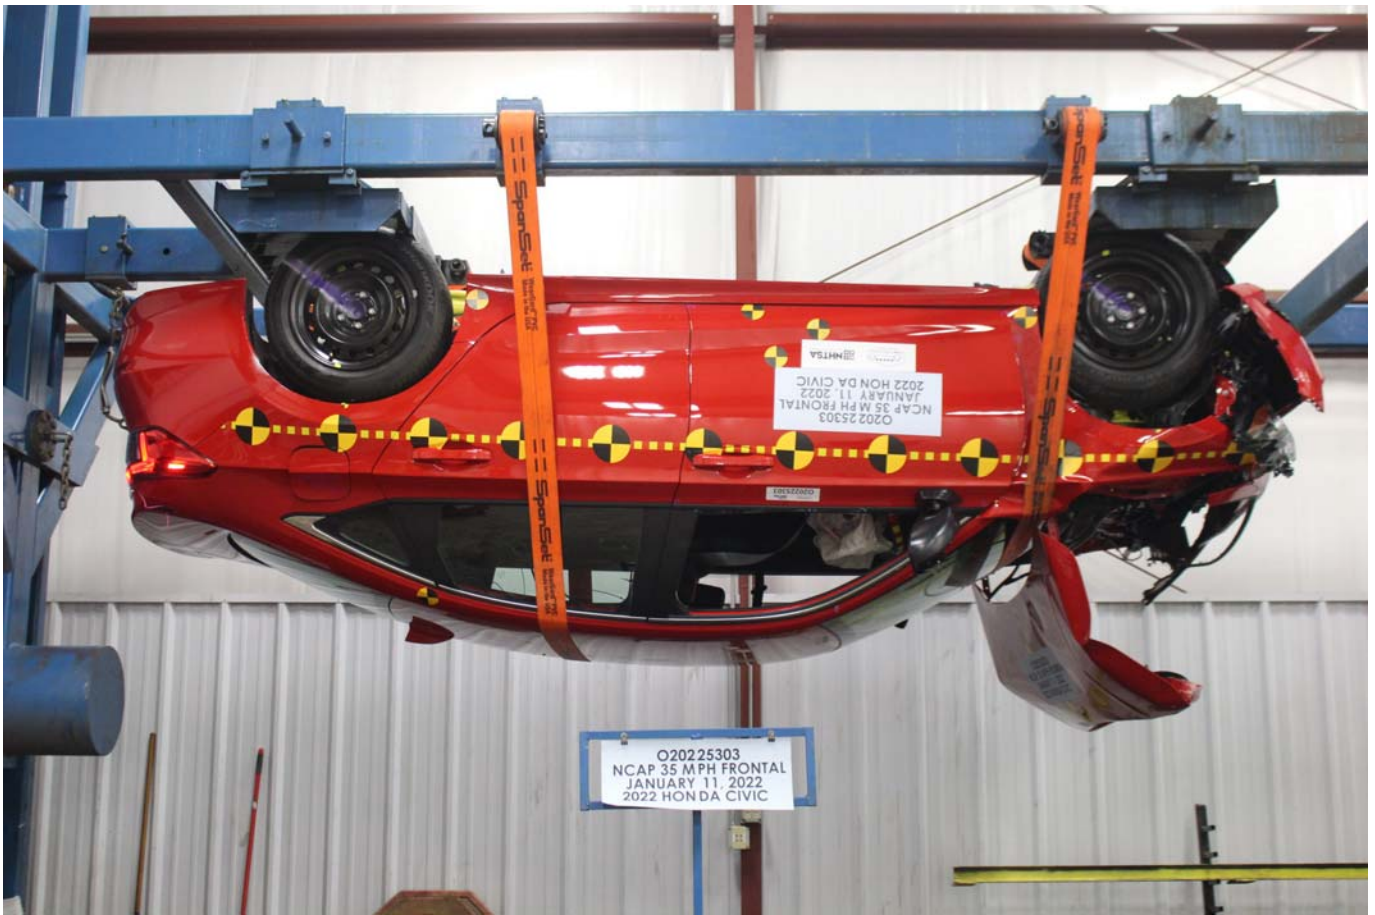
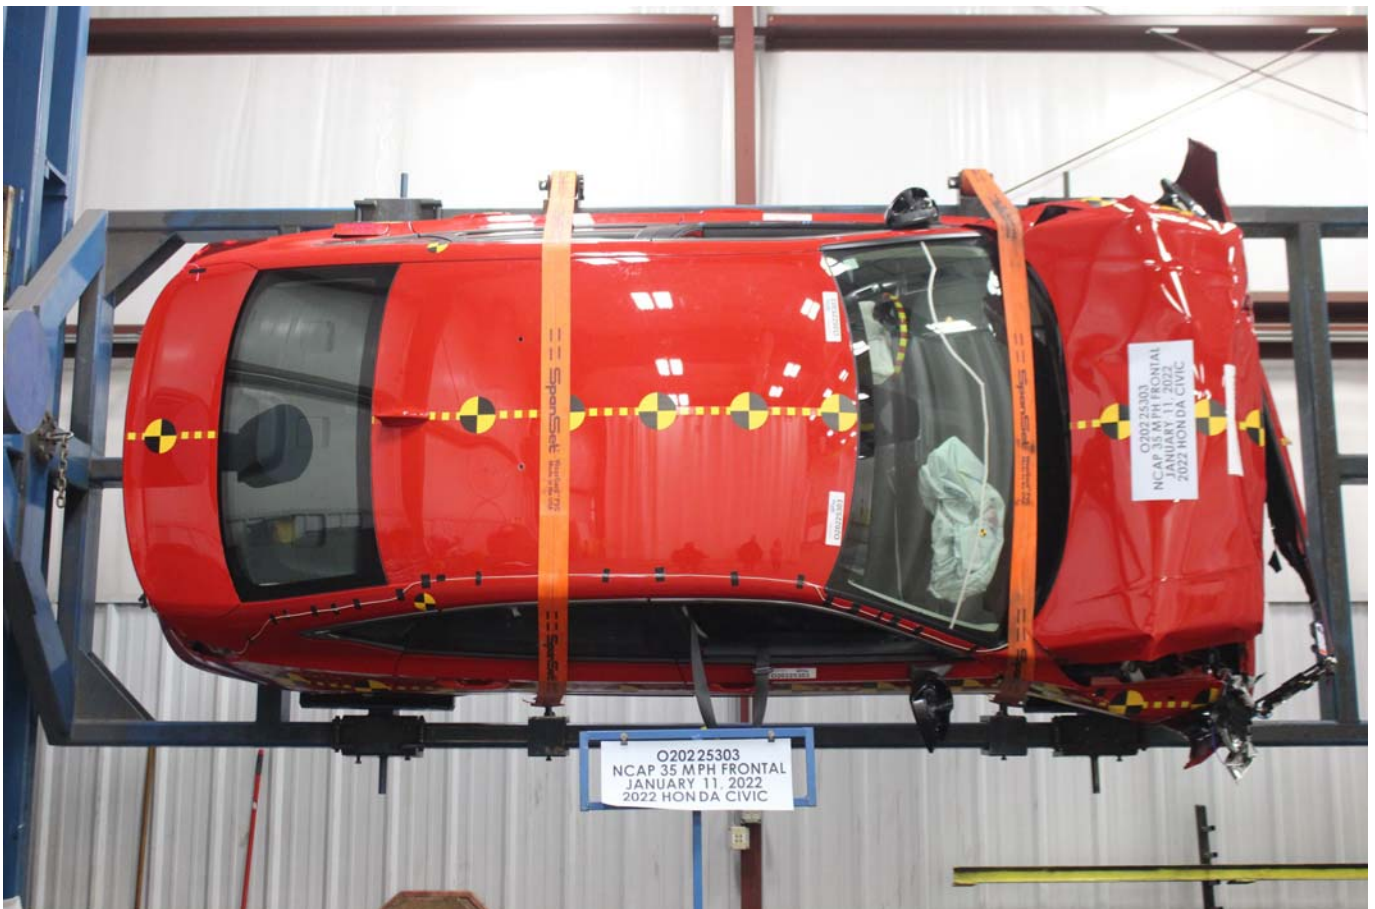
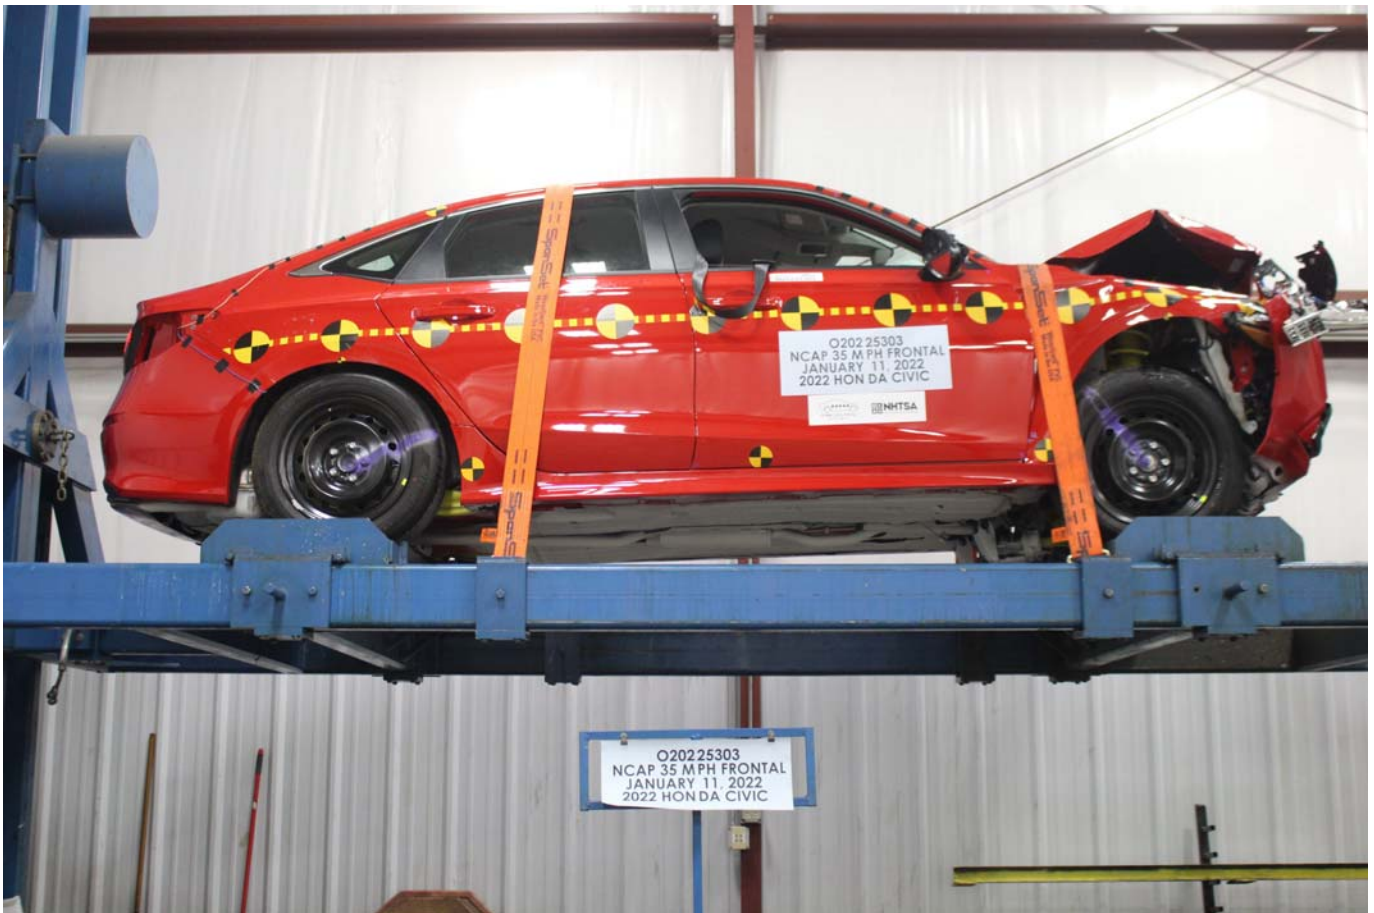
Photo No. 077 - Vehicle at 0 Degrees on Static Rollover Device

Photo No. 078 - Vehicle at 90 Degrees on Static Rollover Device

Photo No. 079 - Vehicle at 180 Degrees on Static Rollover Device

Photo No. 080 - Vehicle at 270 Degrees on Static Rollover Device

Photo No. 081 - Vehicle at 360 Degrees on Static Rollover Device
