**REPORT NUMBER: NCAP-MGA-22-010**

**NEW CAR ASSESSMENT PROGRAM (NCAP)  
Frontal Barrier Impact Test**

**MAZDA MOTOR CORPORATION  
2022 Mazda MX-30 5-Door Hatchback  
NHTSA No.: O20225400**

**MGA RESEARCH CORPORATION  
5000 Warren Road  
Burlington, WI 53105**

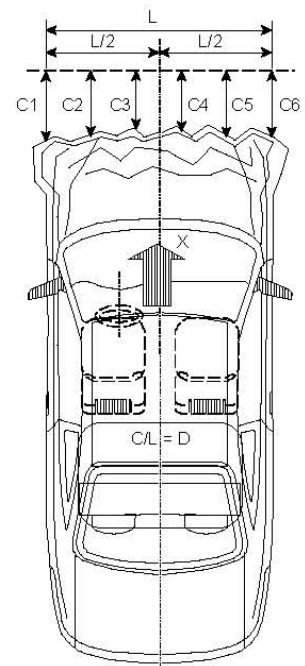
**CRUSH PROFILE**

Collision Deformation Classification: 12FDEW4  
Midpoint of Damage: Centerline  
Damage Region Length (mm): 1152  
Impact Mode: Frontal

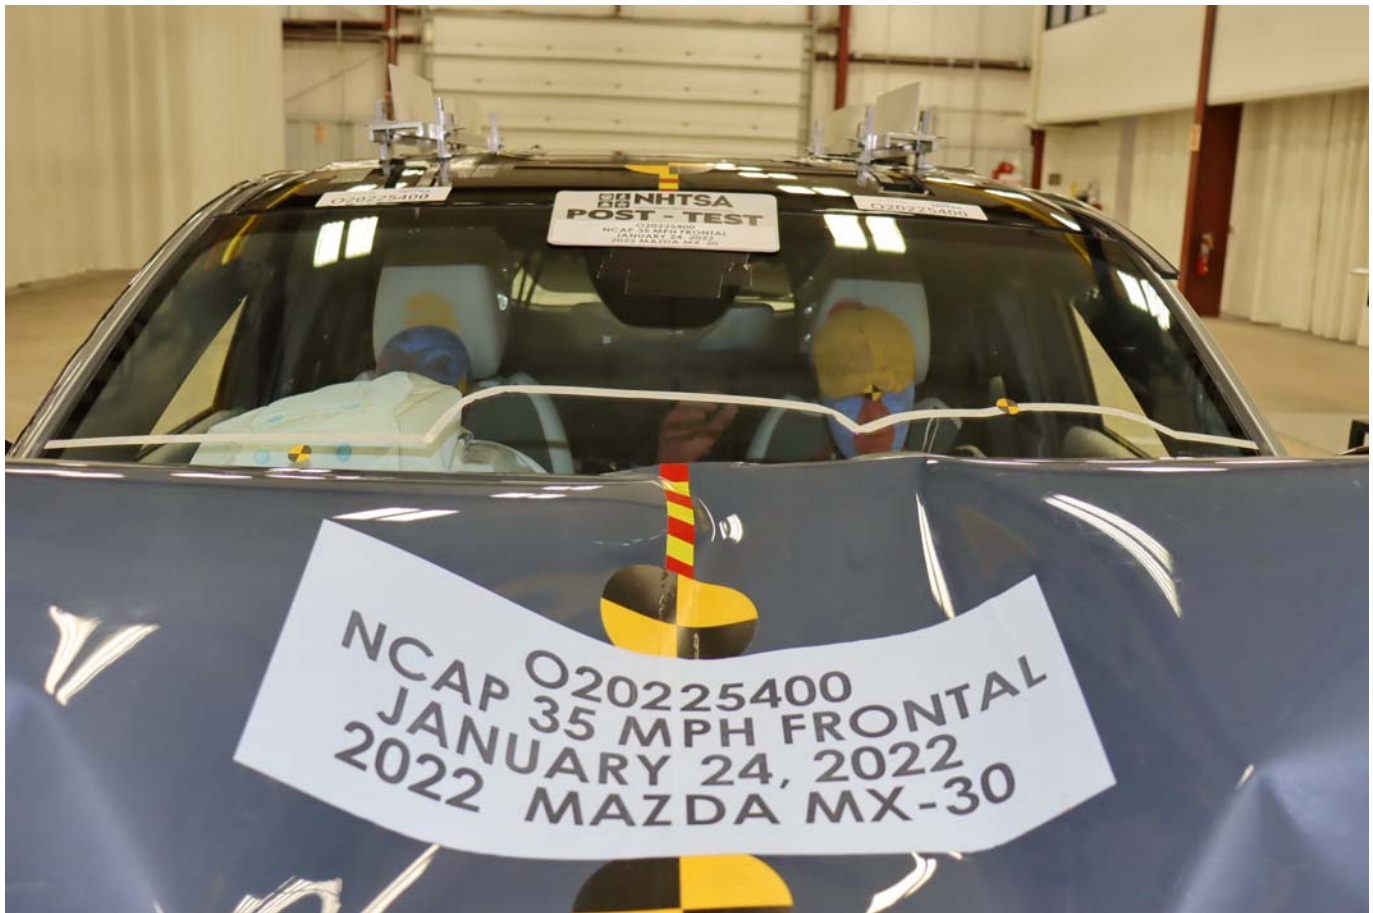
Photo No. 019 - Post-Test Windshield View

There was 100 percent windshield retention and no intrusion into the protected zone of the windshield during the event. There was no battery electrolyte leakage and no loss of protection against direct or indirect contact with high-voltage sources after the event or during any phase of the static rollover.
