REPORT NUMBER: SideNCAPPole-MGA-22-017

**NEW CAR ASSESSMENT PROGRAM (NCAP)
Side Impact Pole Test**

**HYUNDAI MOTOR MANUFACTURING ALABAMA, LLC
2022 Hyundai Tucson SEL 5-Door SUV
NHTSA No.: O20224201**

FINAL REPORT

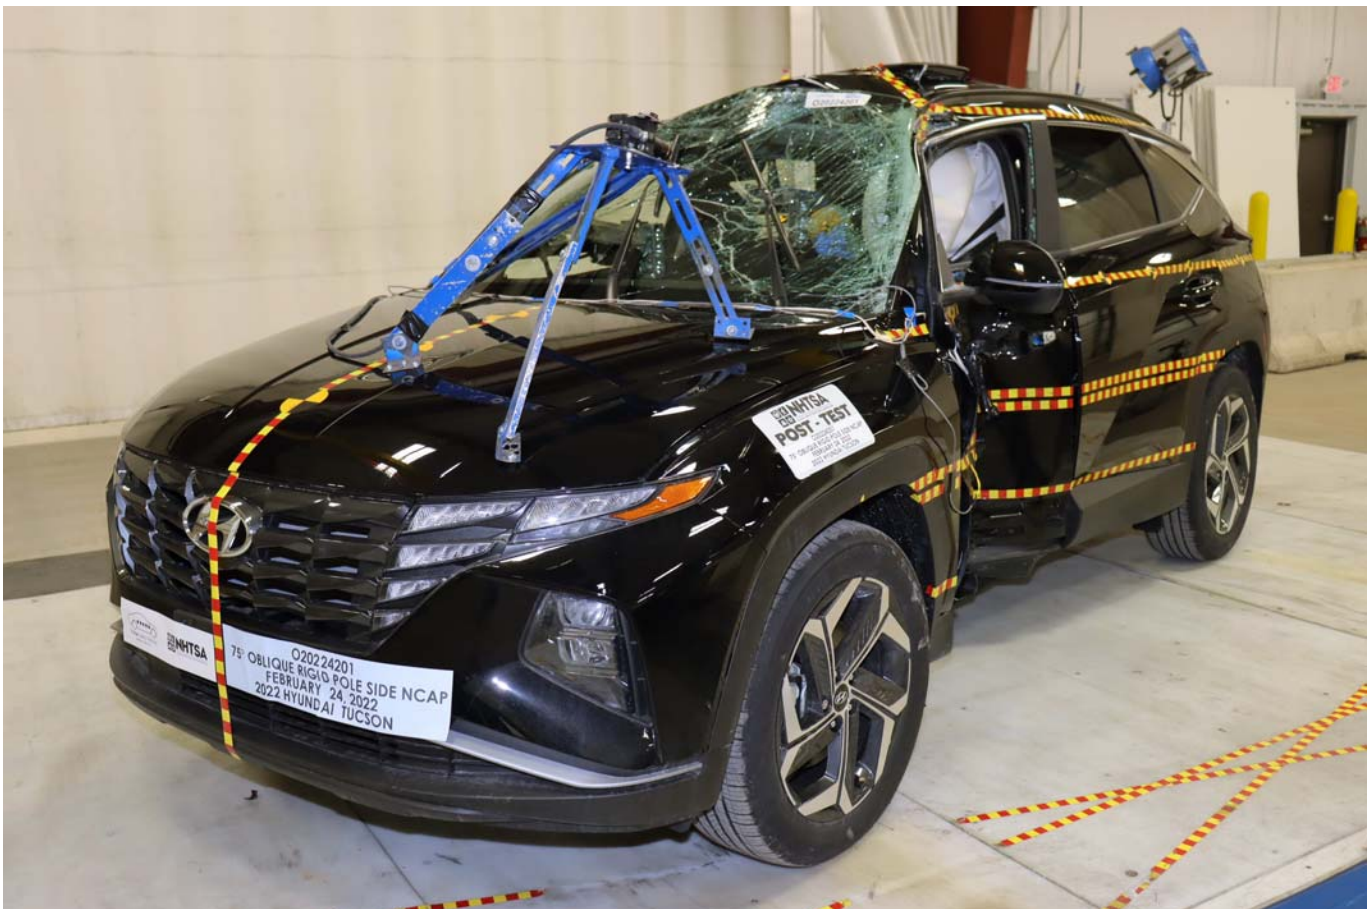
Photo No. 006 - Post-Test Left Front Three-Quarter View of Test Vehicle

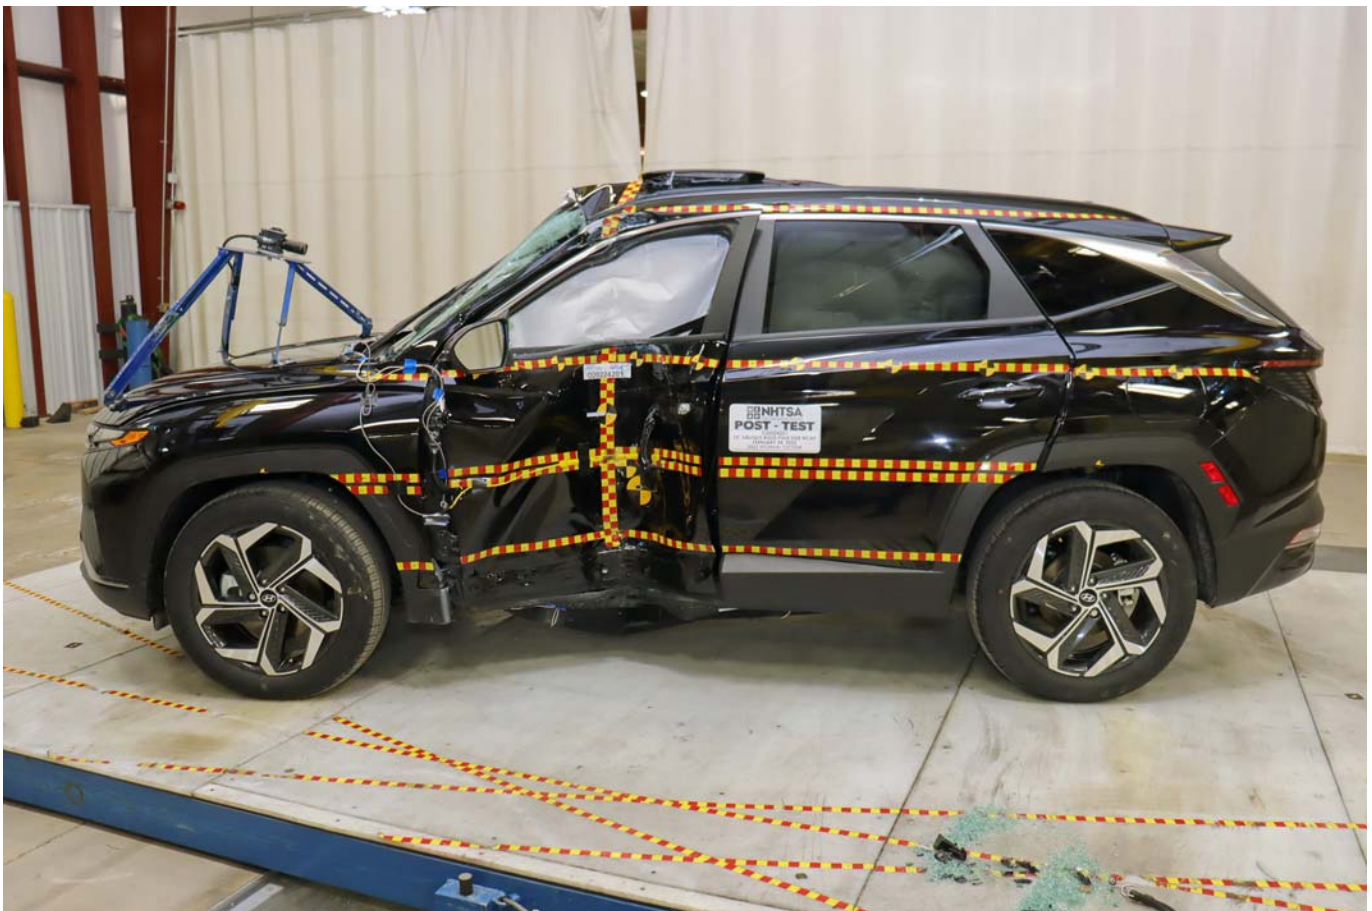
Photo No. 008 - Post-Test Left Side View of Test Vehicle

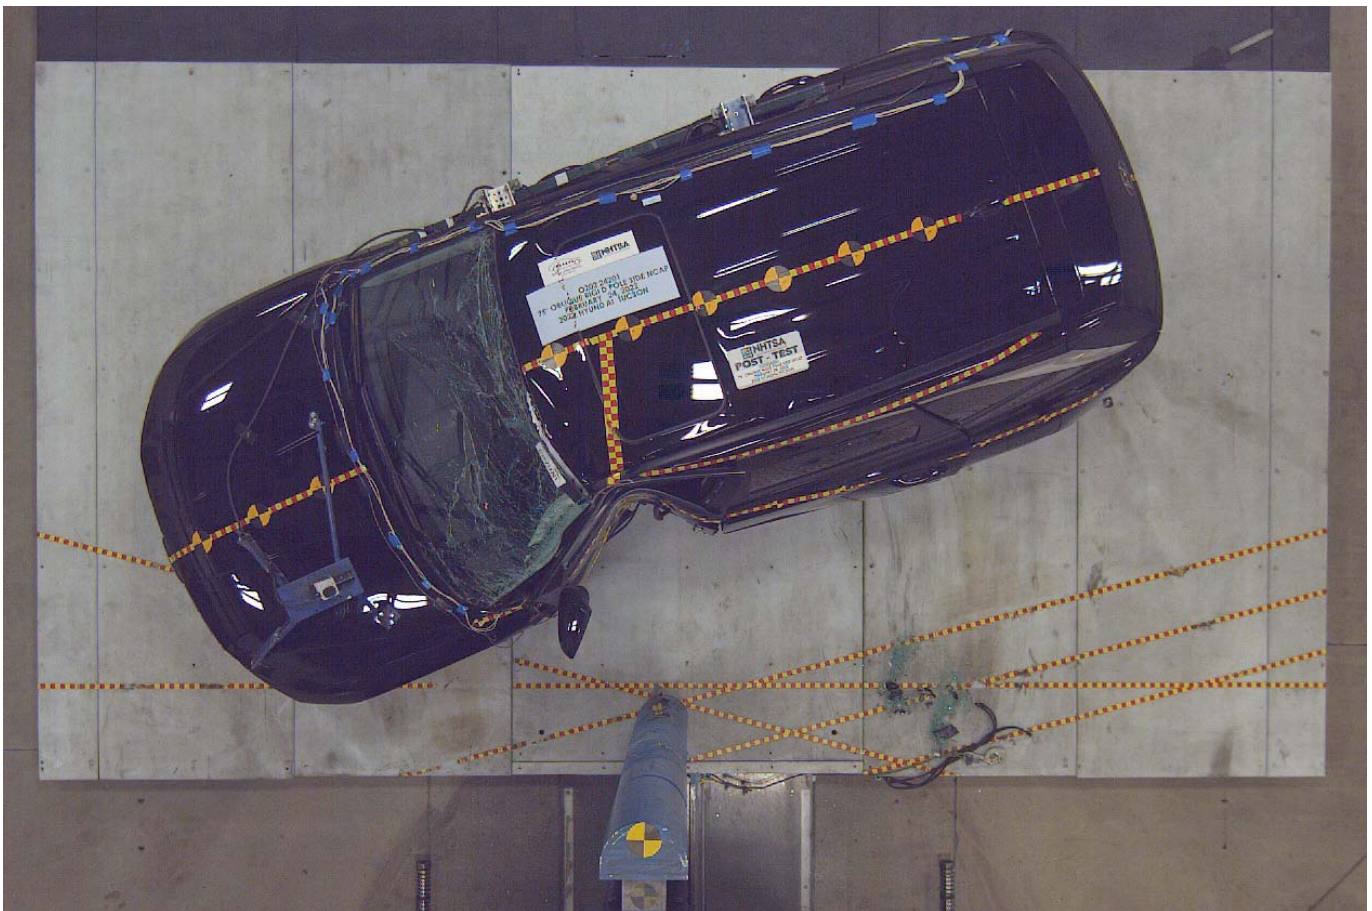
Photo No. 016 - Post-Test Overhead View of Test Area

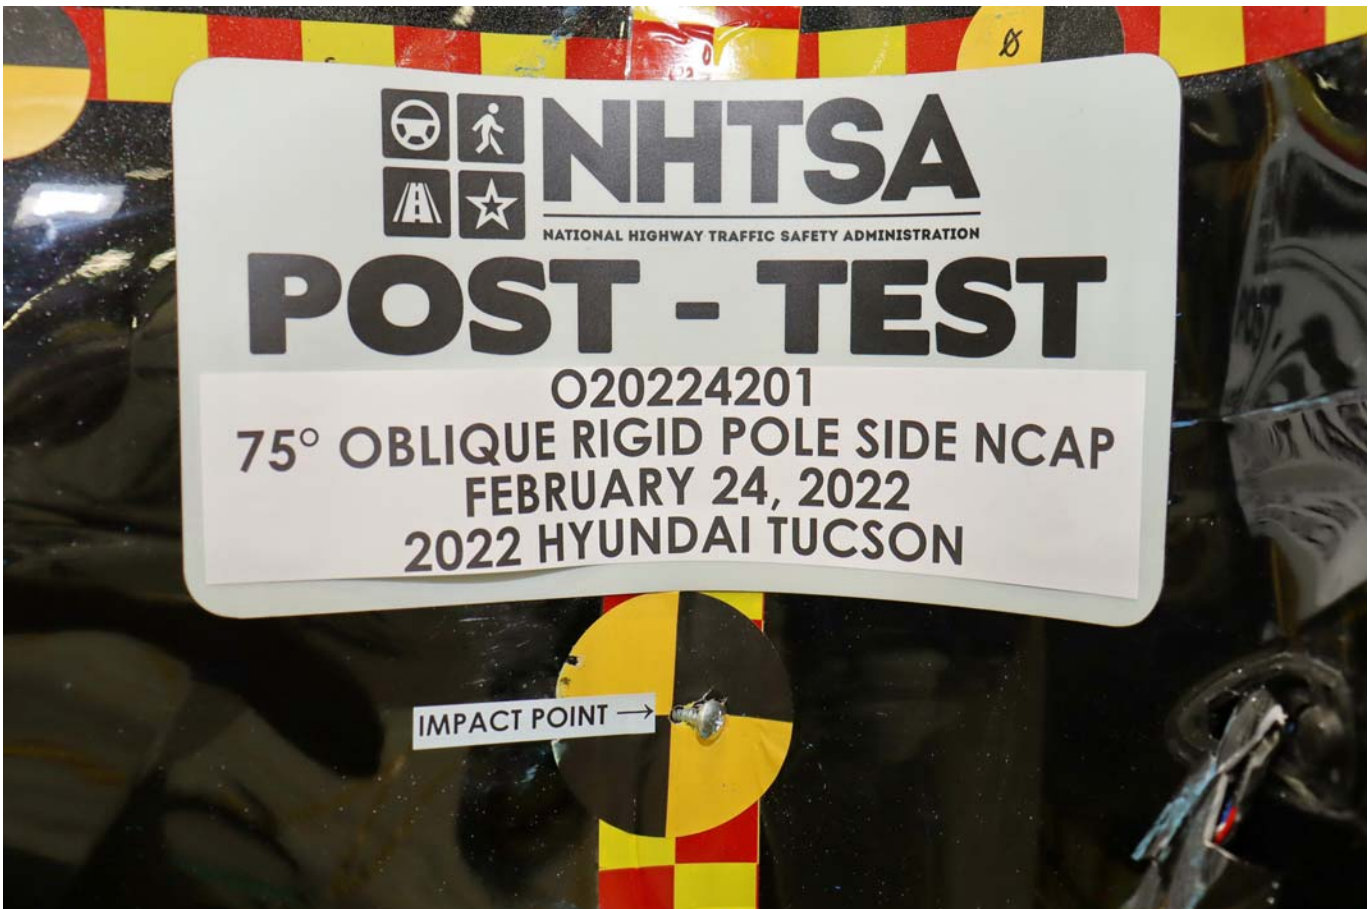
Photo No. 020 - Post-Test Close-Up View of Impact Point Target Showing Impact Location

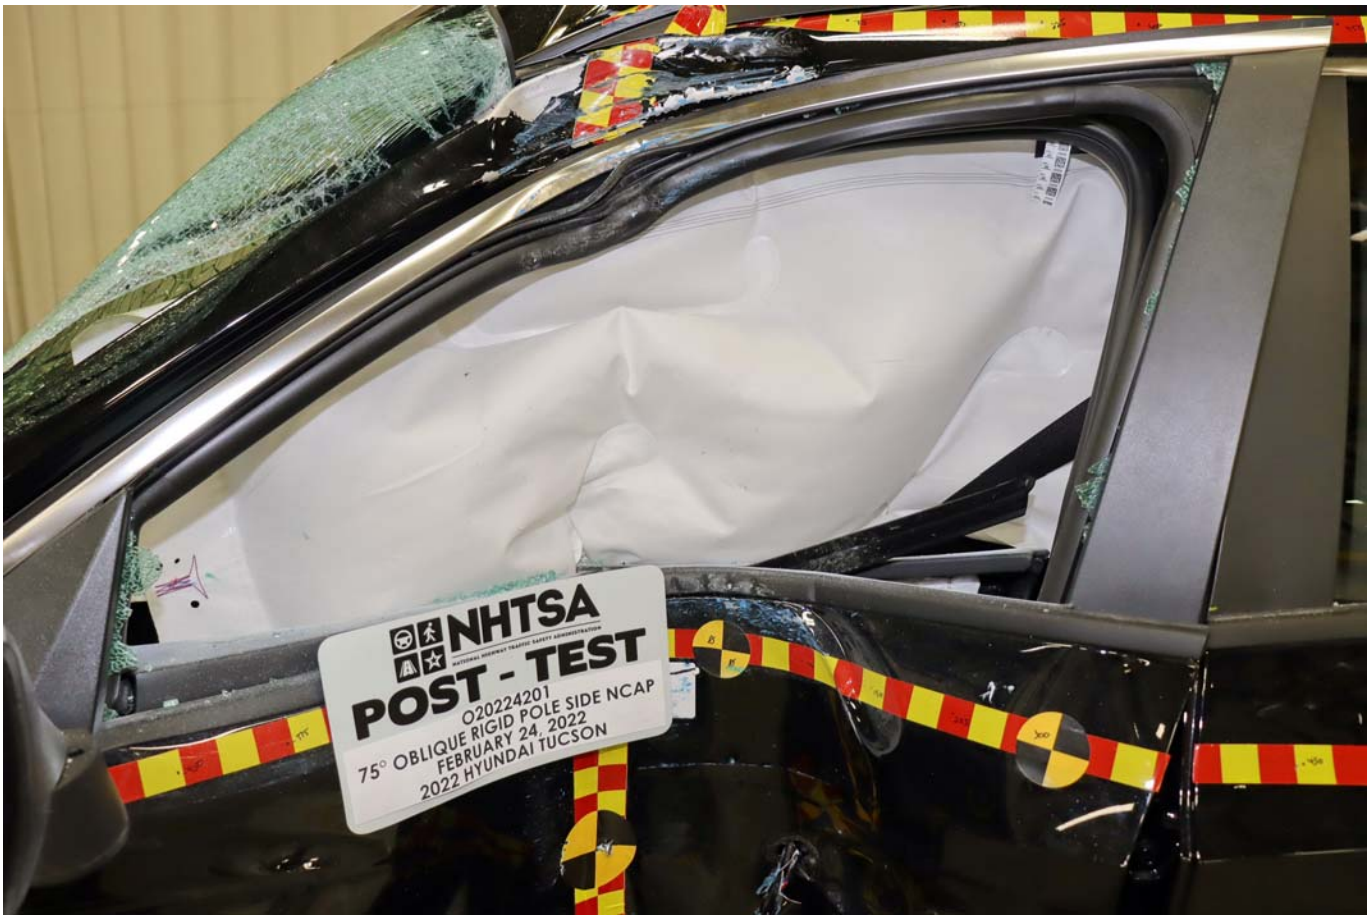
Photo No. 025 - Post-Test Left Side View of Dummy Shoulder and Door Top View

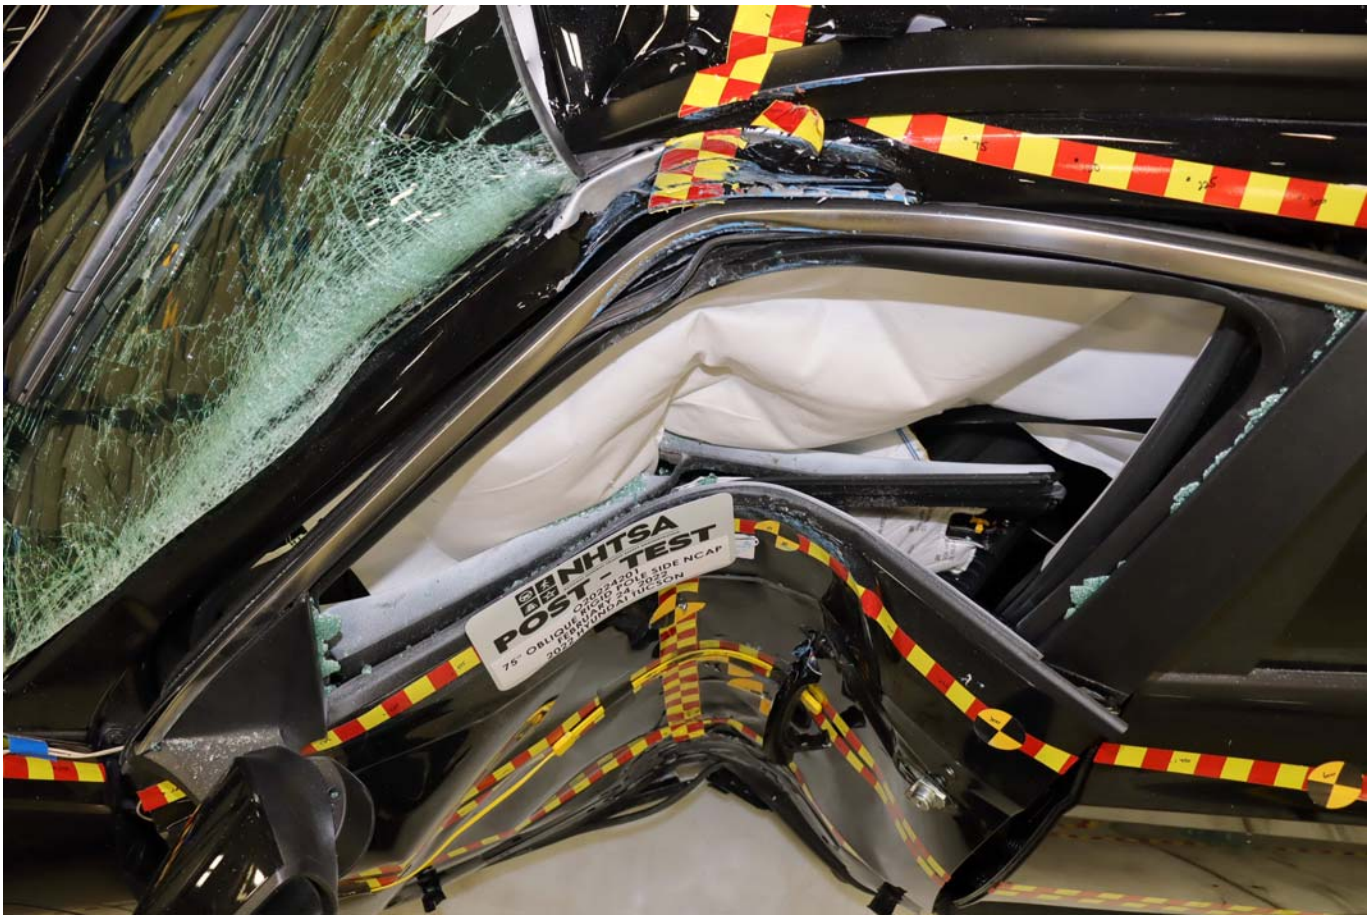
Photo No. 041 - Post-Test Dummy and Door Clearance View

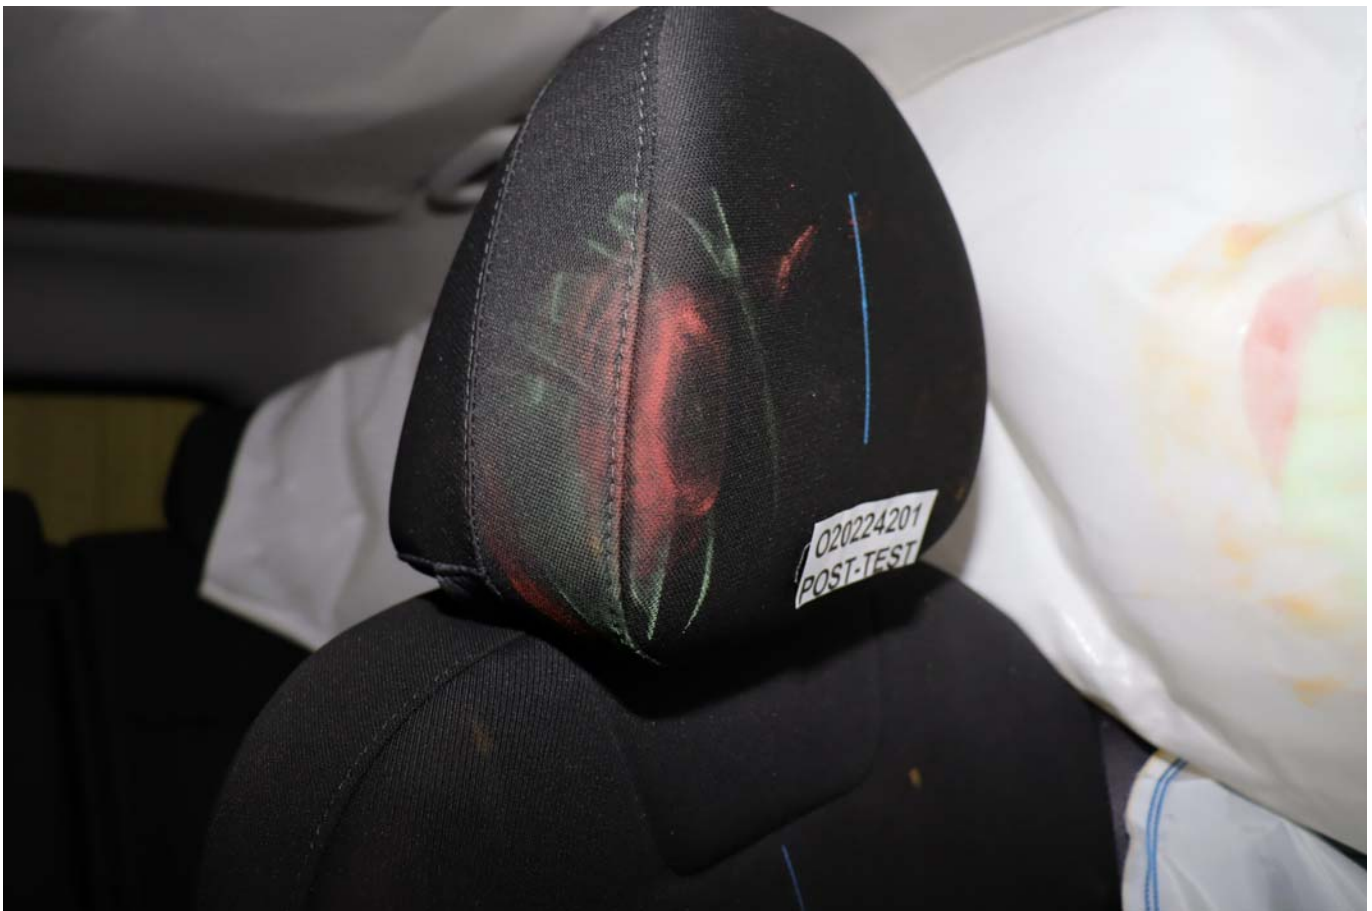
Photo No. 046 - Post-Test Dummy Close-Up Head Contact with Vehicle Interior View

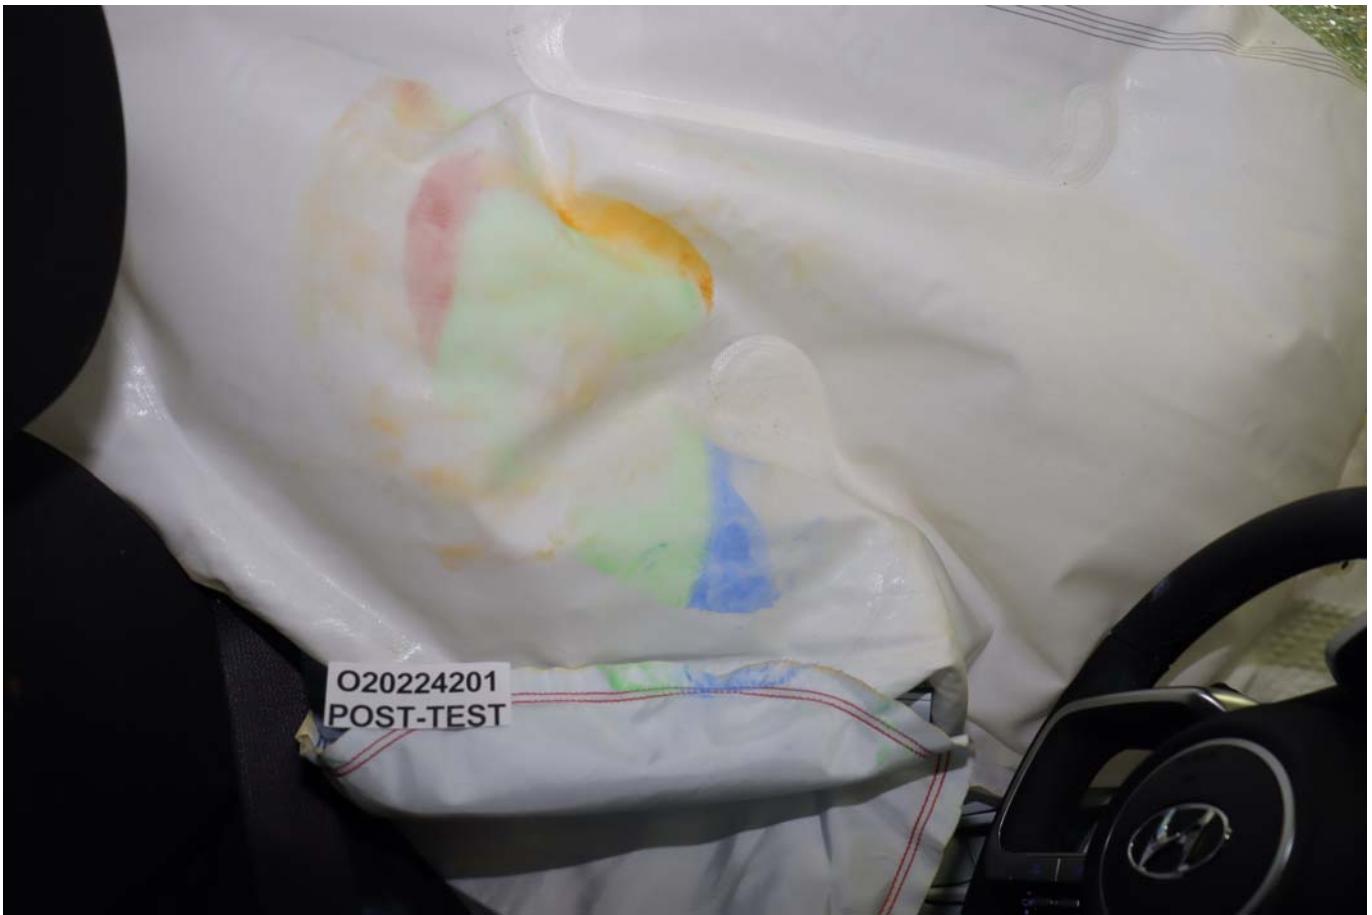
Photo No. 047 - Post-Test Dummy Close-Up Head Contact with Side Air Bag View

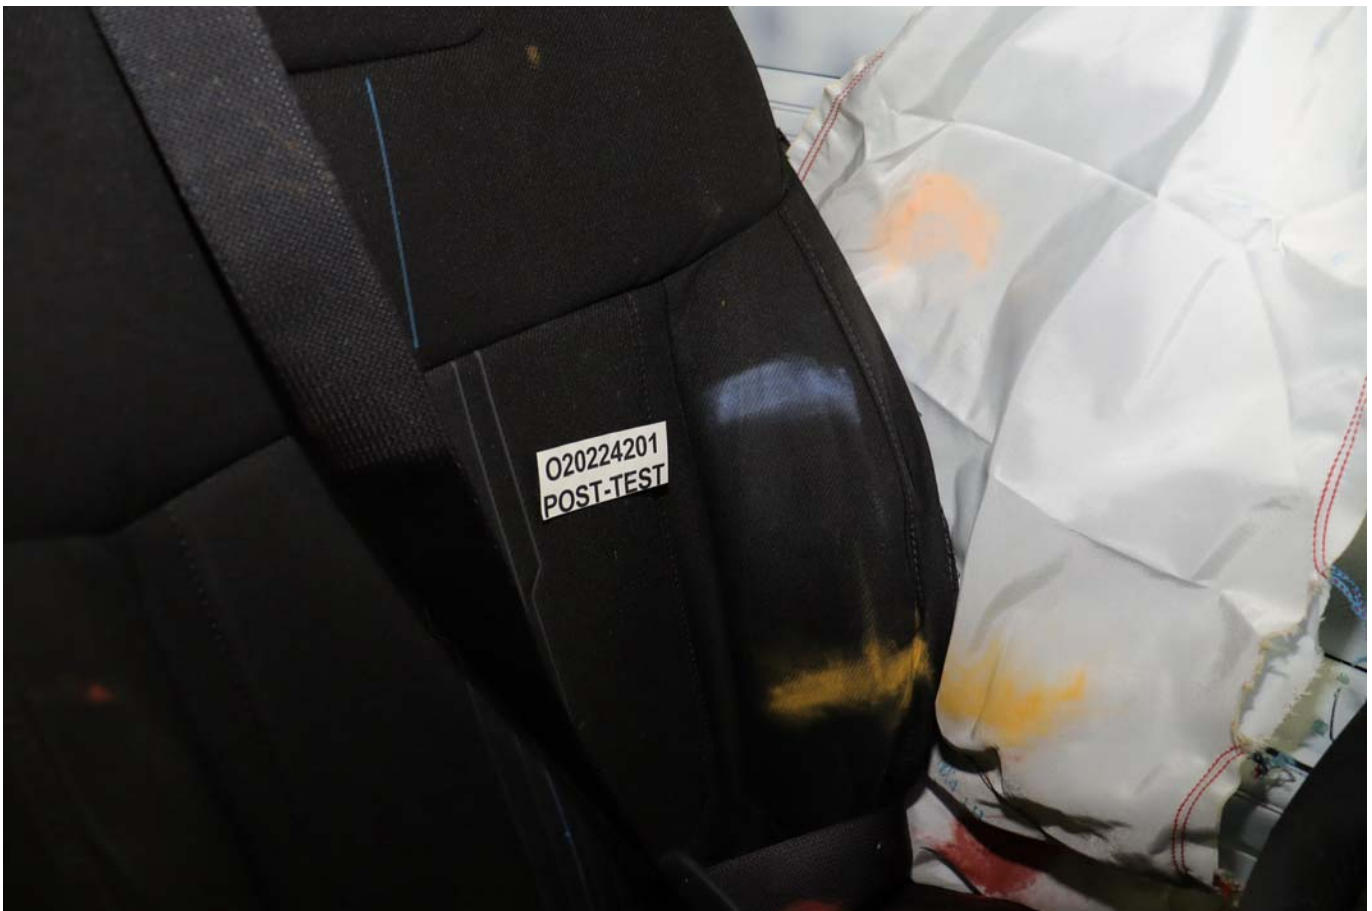
Photo No. 048 - Post-Test Dummy Close-Up Torso Contact with Vehicle Interior View

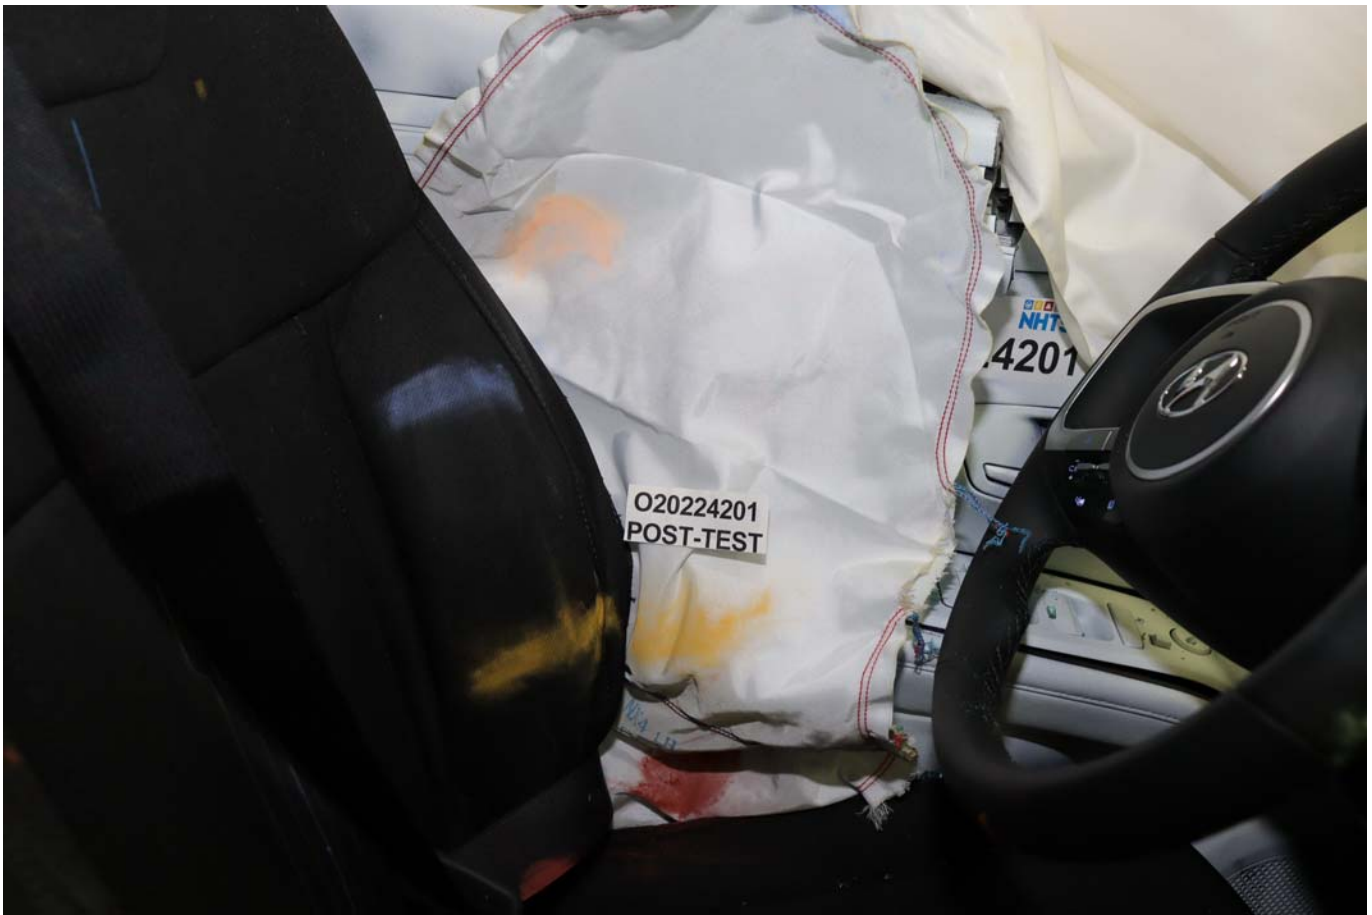
Photo No. 049 - Post-Test Dummy Close-Up Torso Contact with Side Air Bag View

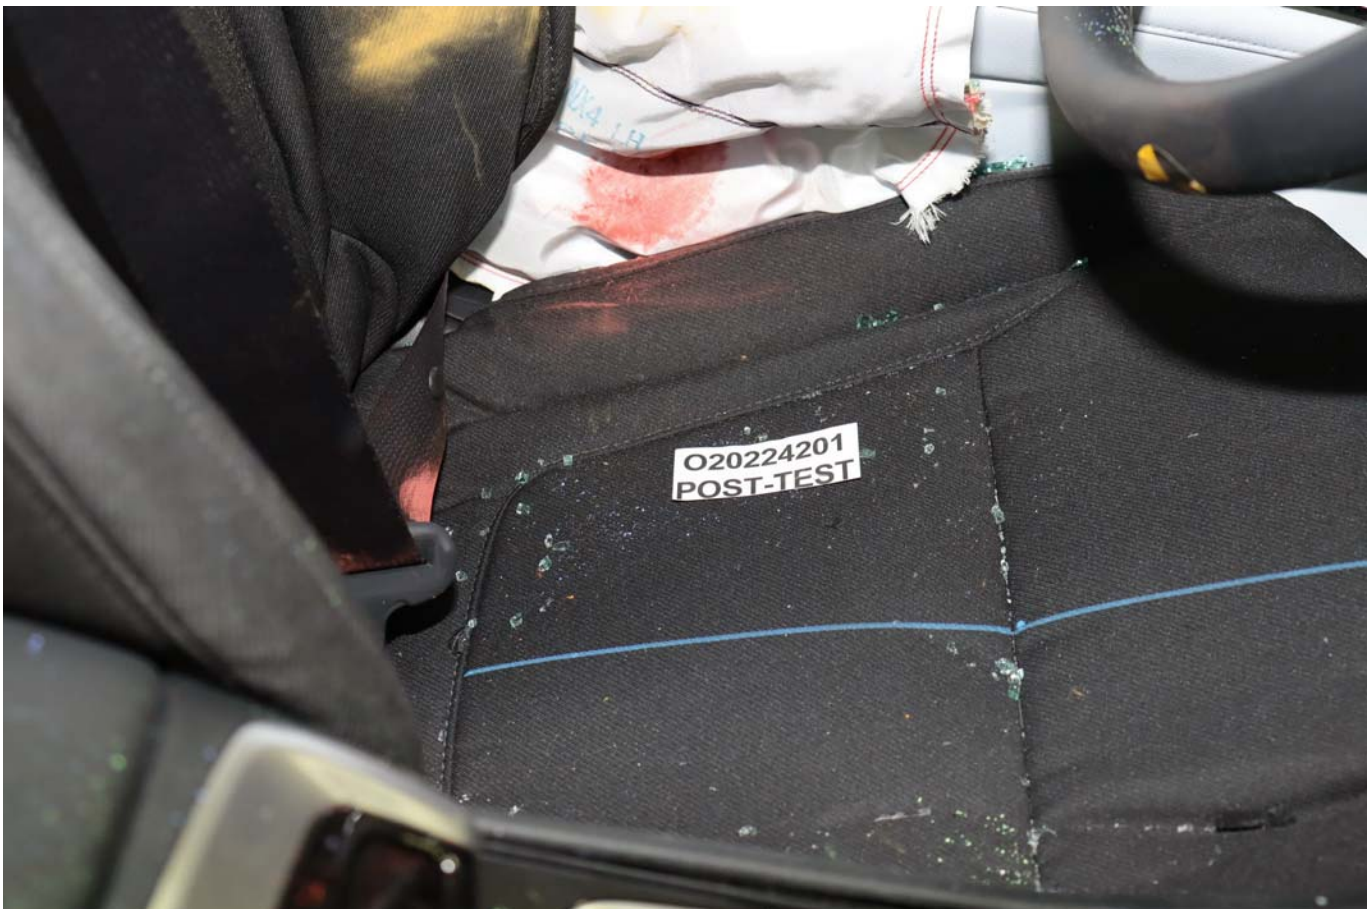
Photo No. 050 - Post-Test Dummy Close-Up Pelvis Contact with Vehicle Interior View

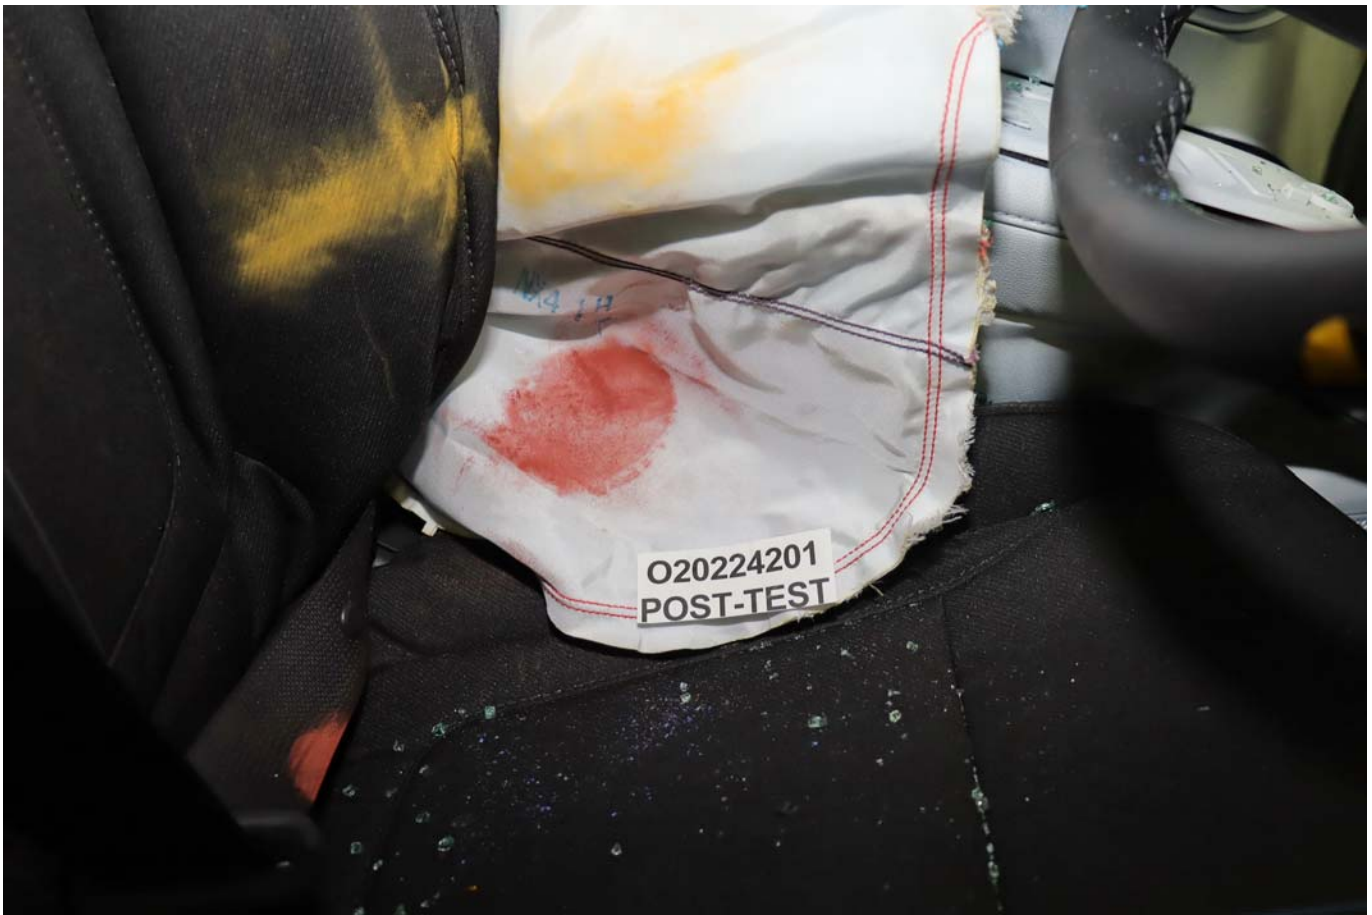
Photo No. 051 - Post-Test Dummy Close-Up Pelvis Contact with Side Air Bag View

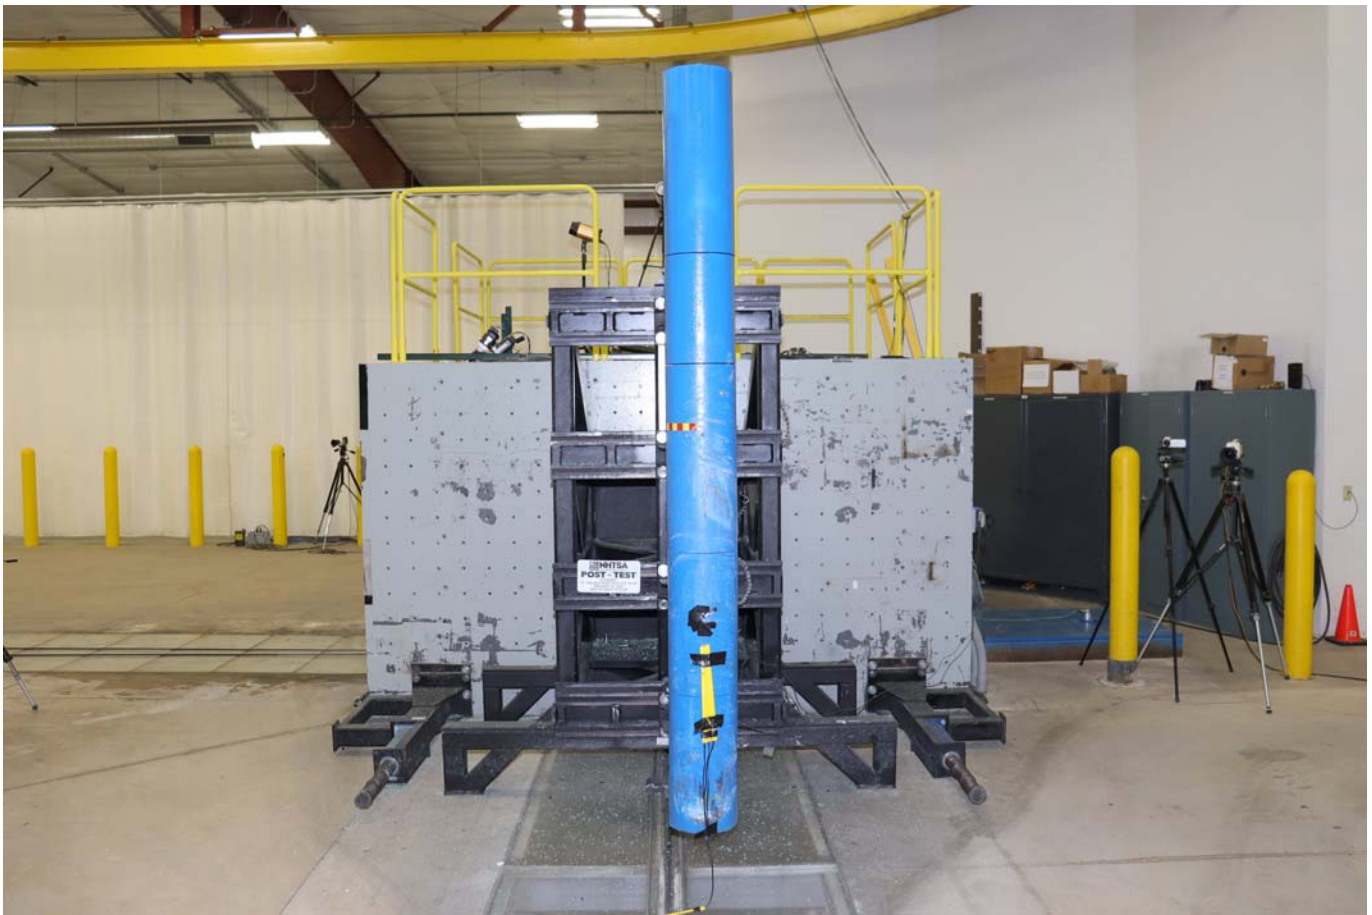
Photo No. 060 - Post-Test Pole Barrier Front View

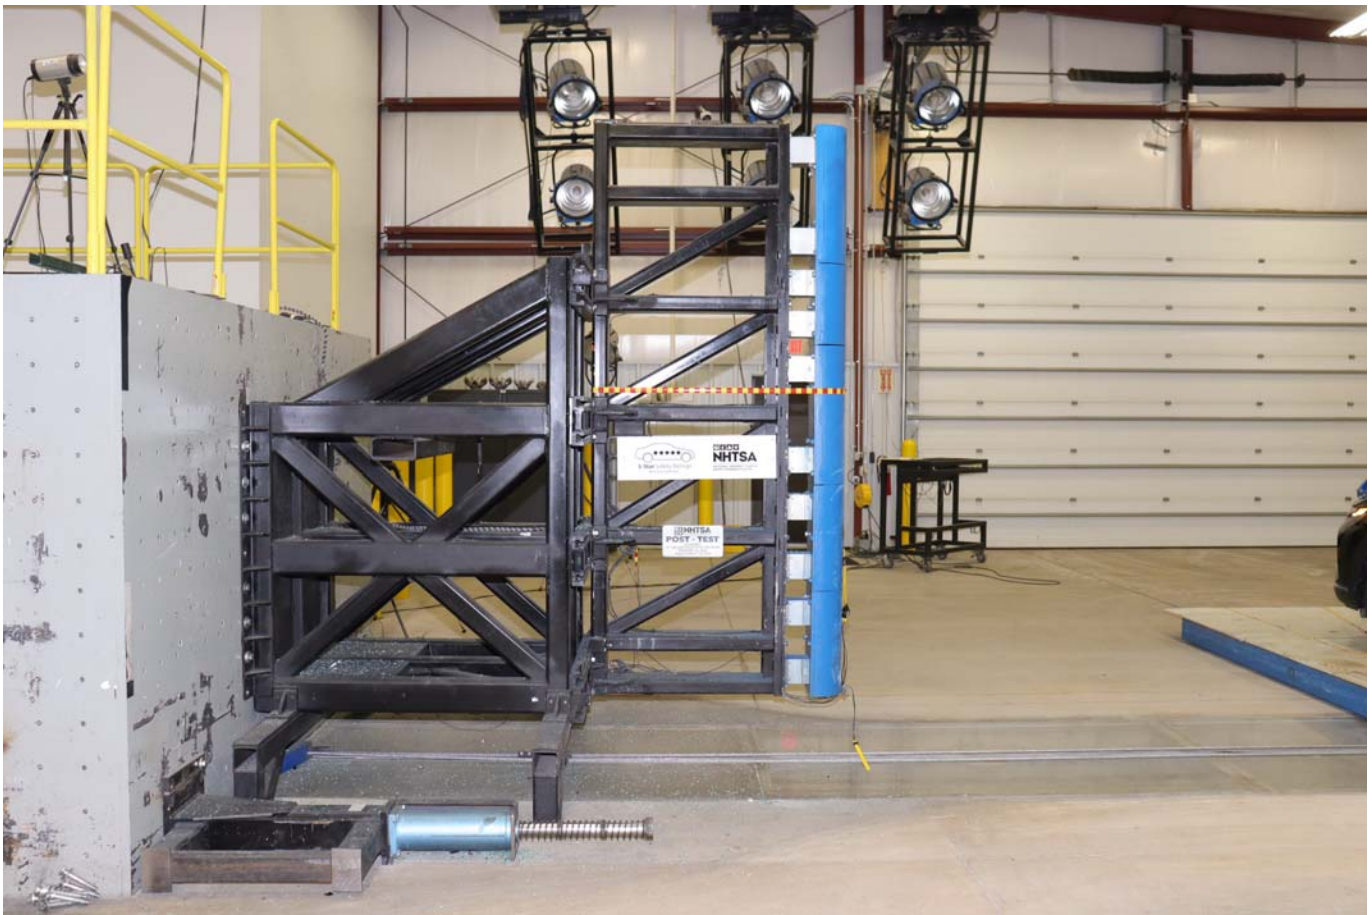
Photo No. 062 - Post-Test Pole Barrier Side View

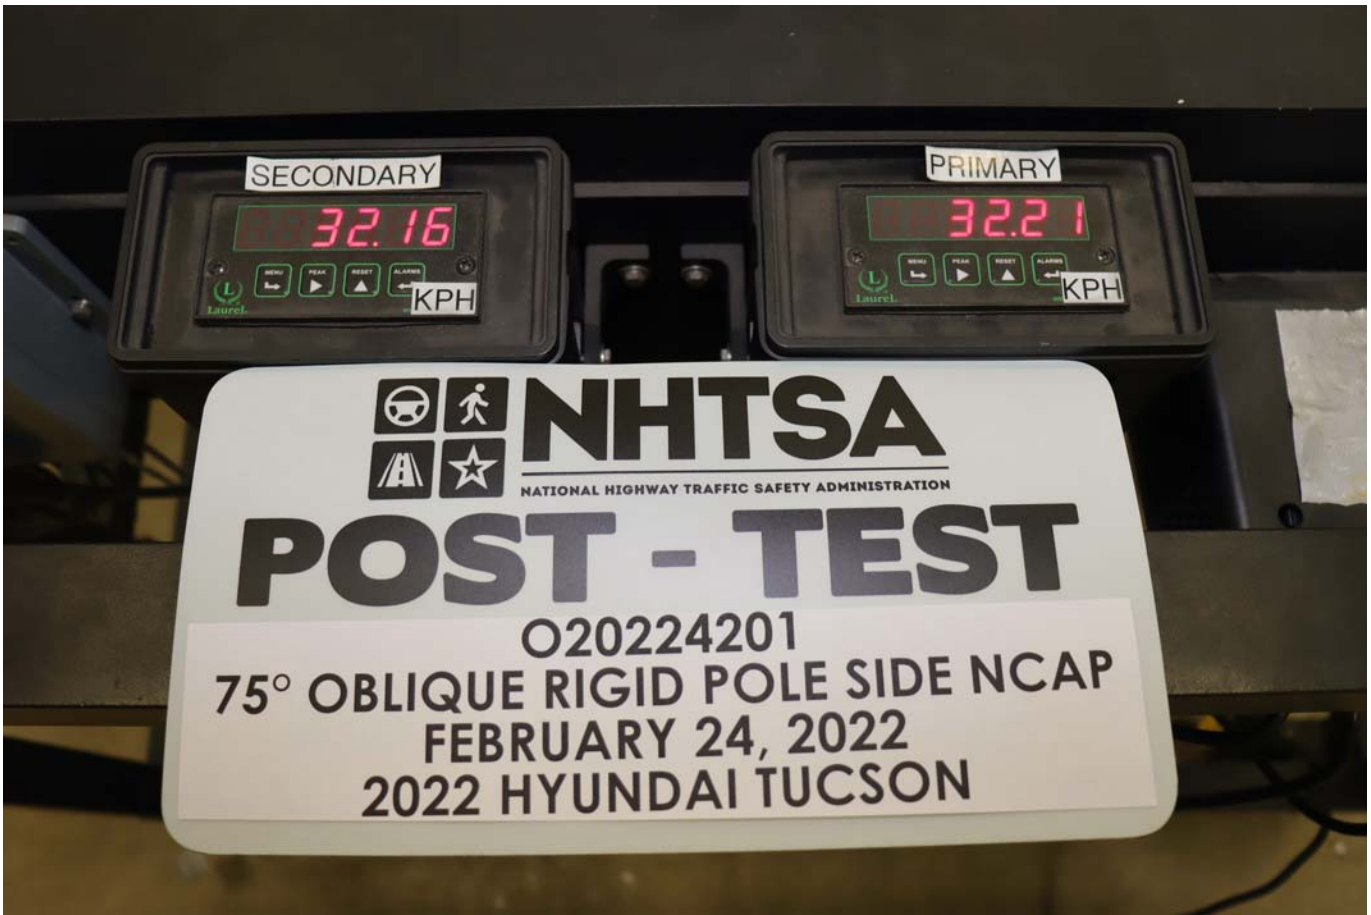
Photo No. 064 - Post-Test Primary and Redundant Speed Trap Read-Out
