FINAL REPORT NUMBER: SINCAP-TRC-22-001

**NEW CAR ASSESSMENT PROGRAM (NCAP)
MOVING DEFORMABLE BARRIER SIDE IMPACT TEST**

**FCA US LLC
2022 Jeep Compass
NHTSA NUMBER: M20220302**

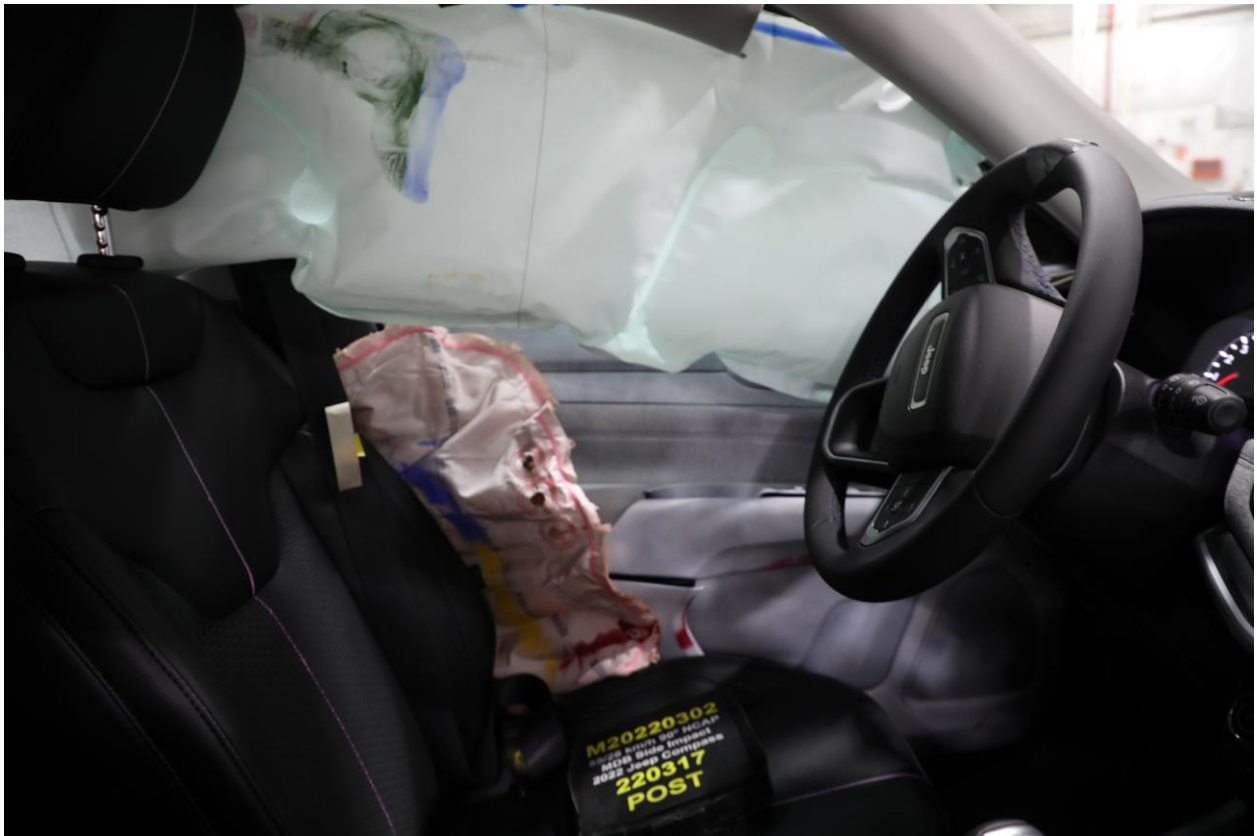
047 Post-Test Driver Inner Door Panel View Showing Driver Dummy Contact Locations
