FINAL REPORT NUMBER: SPNCAP-TRC-22-001

**NEW CAR ASSESSMENT PROGRAM (NCAP)
SIDE IMPACT POLE TEST**

**FCA US LLC
2022 Jeep Compass
NHTSA NUMBER: M20220301**

**PREPARED BY:
Transportation Research Center Inc.
10820 State Route 347
P. O. Box B-67
East Liberty, OH 43319**

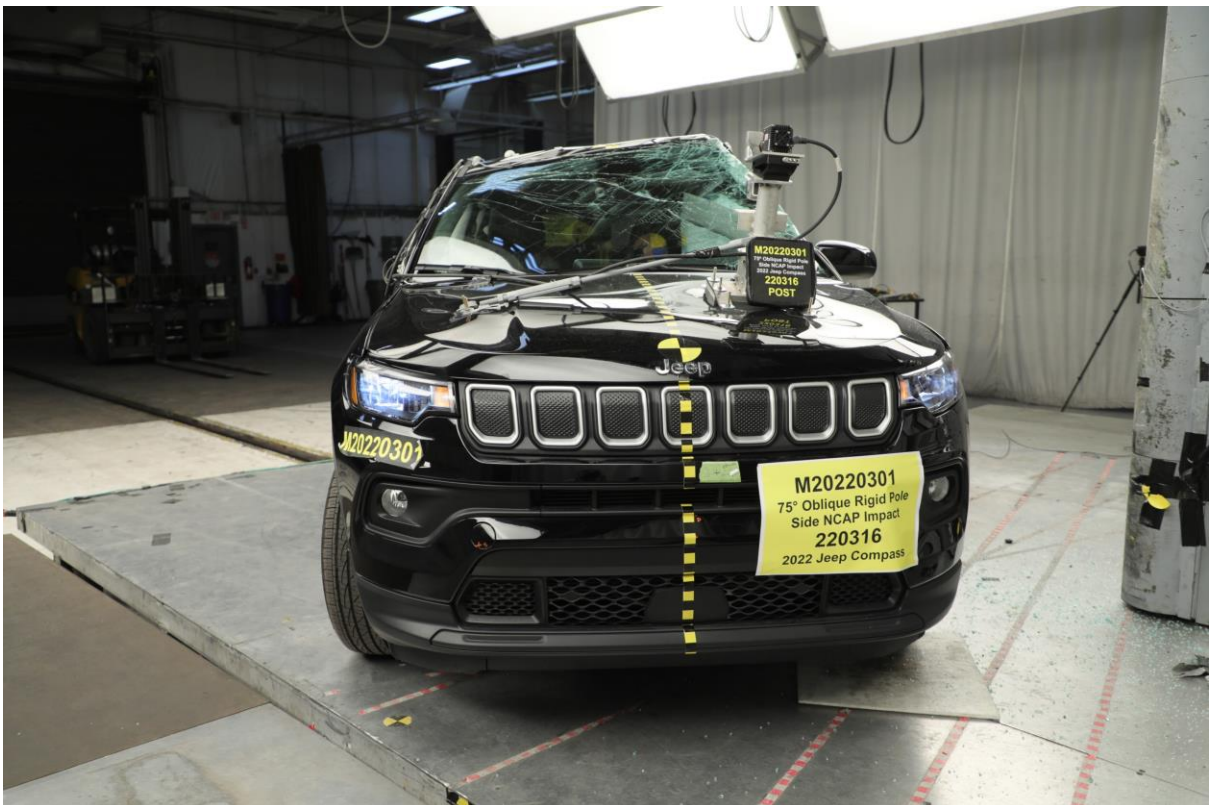
No. 004 Post-Test Frontal View of Test Vehicle

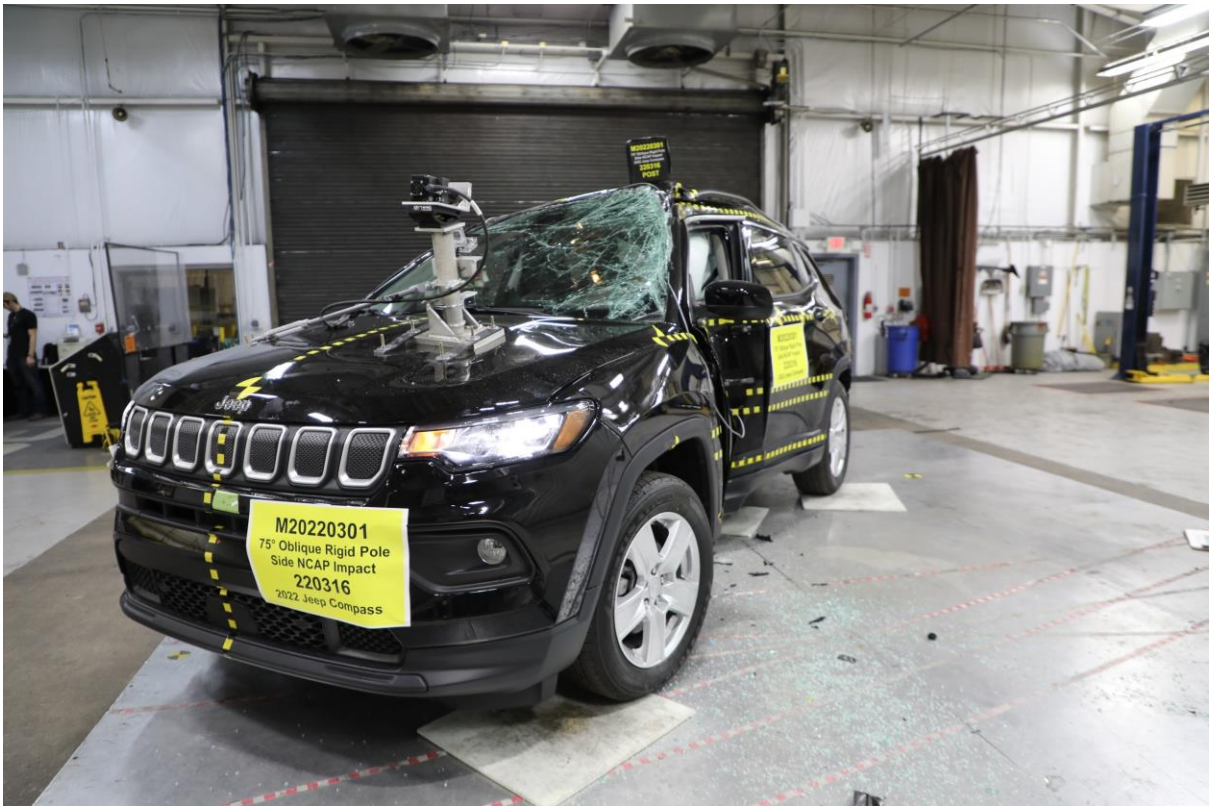
No. 006 Post-Test Left Front $\frac{3}{4}$ View of Test Vehicle

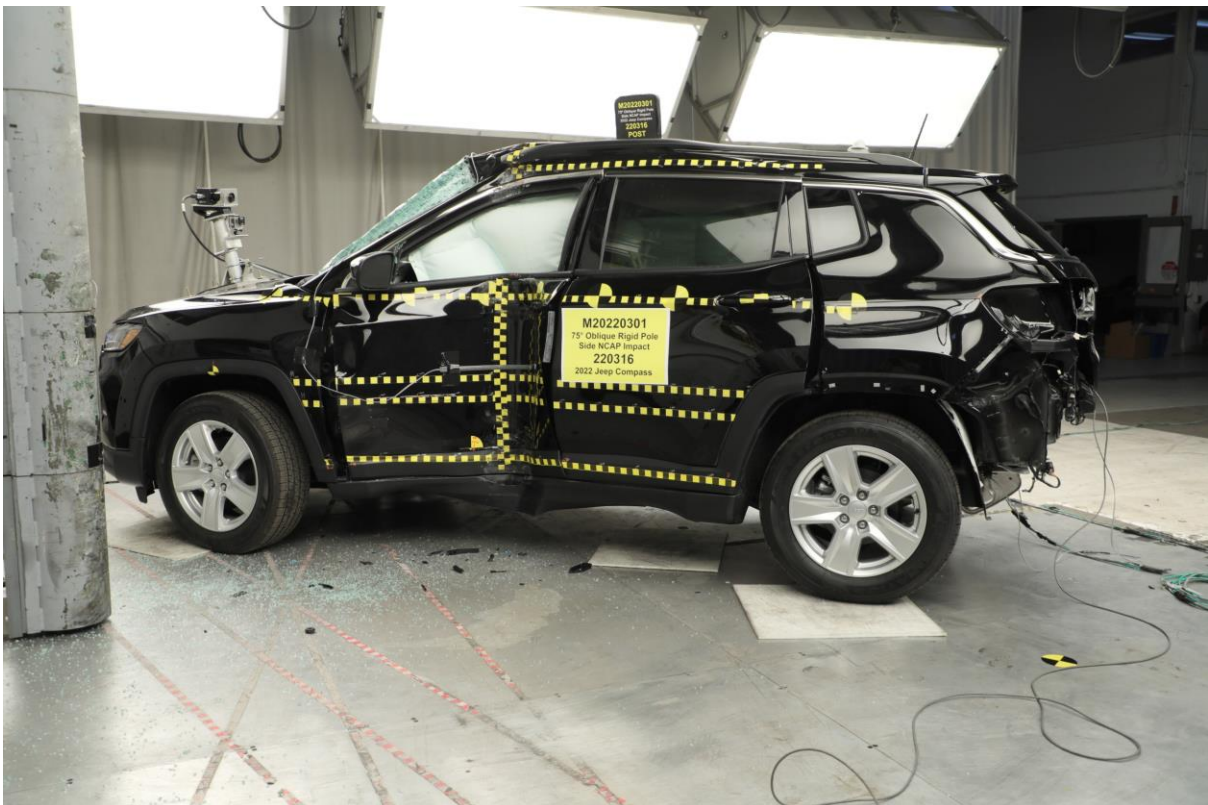
No. 008 Post-Test Left Side View of Test Vehicle

Critical Areas of Performance	Observations and Conclusions
Pillar Performance	Good
Sill Separation	None
Windshield Damage	Heavy cracking
Side Window Damage	Front driver window completely shattered
Other Notable Effects	None

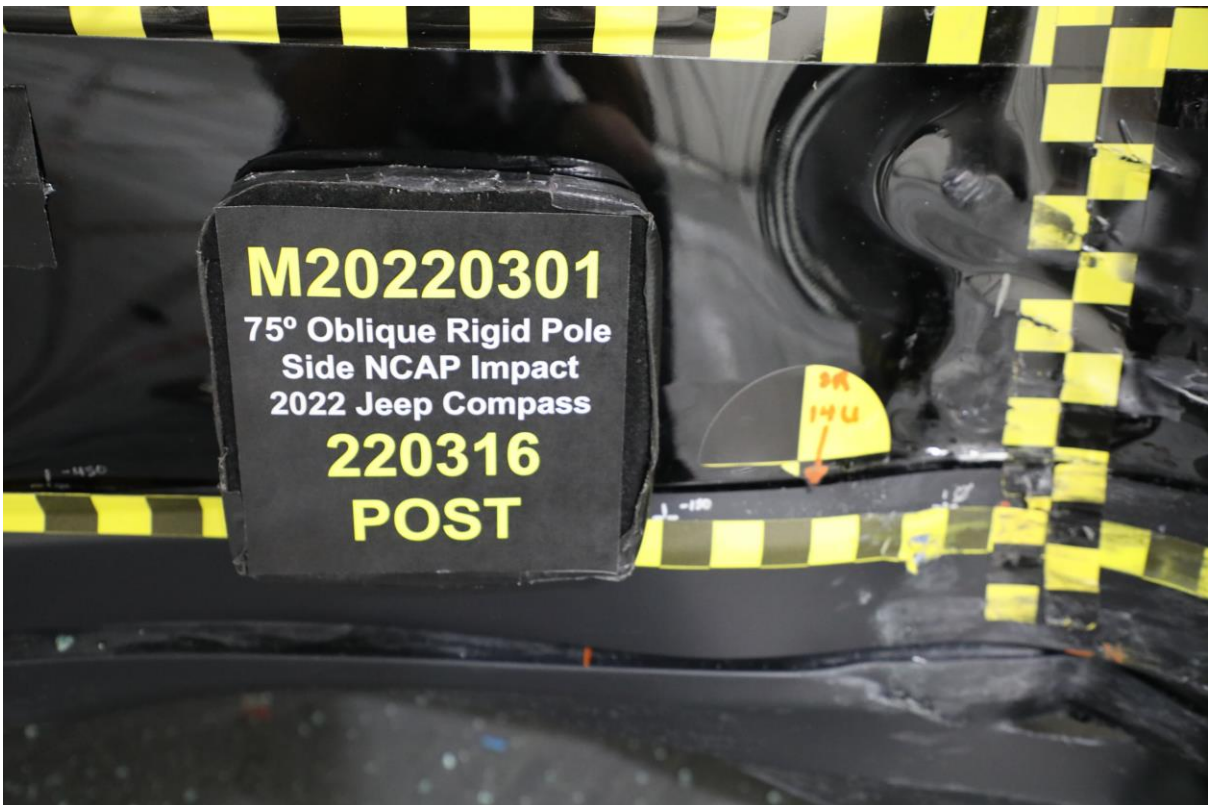
No. 020 Post-Test Close-Up View of Impact Point Target Showing Impact Location

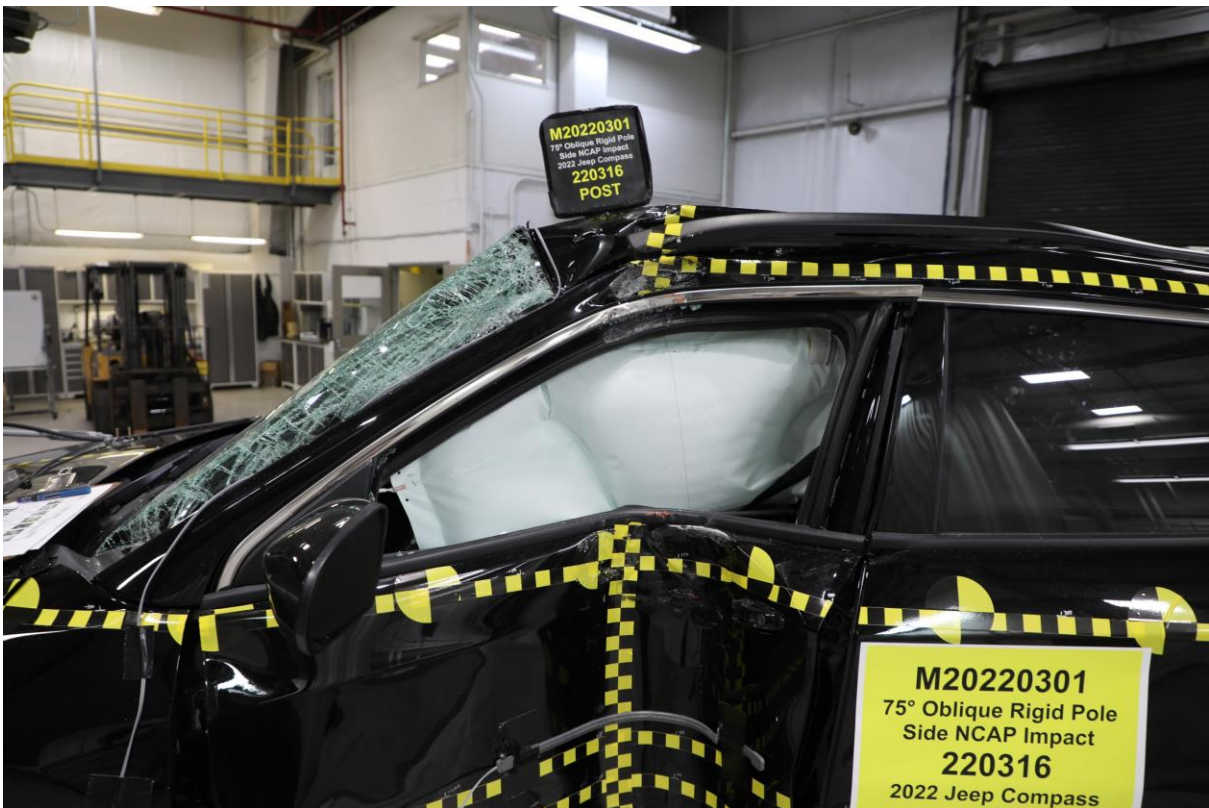
No. 025 Post-Test Left Side View of Dummy Shoulder and Door Top View

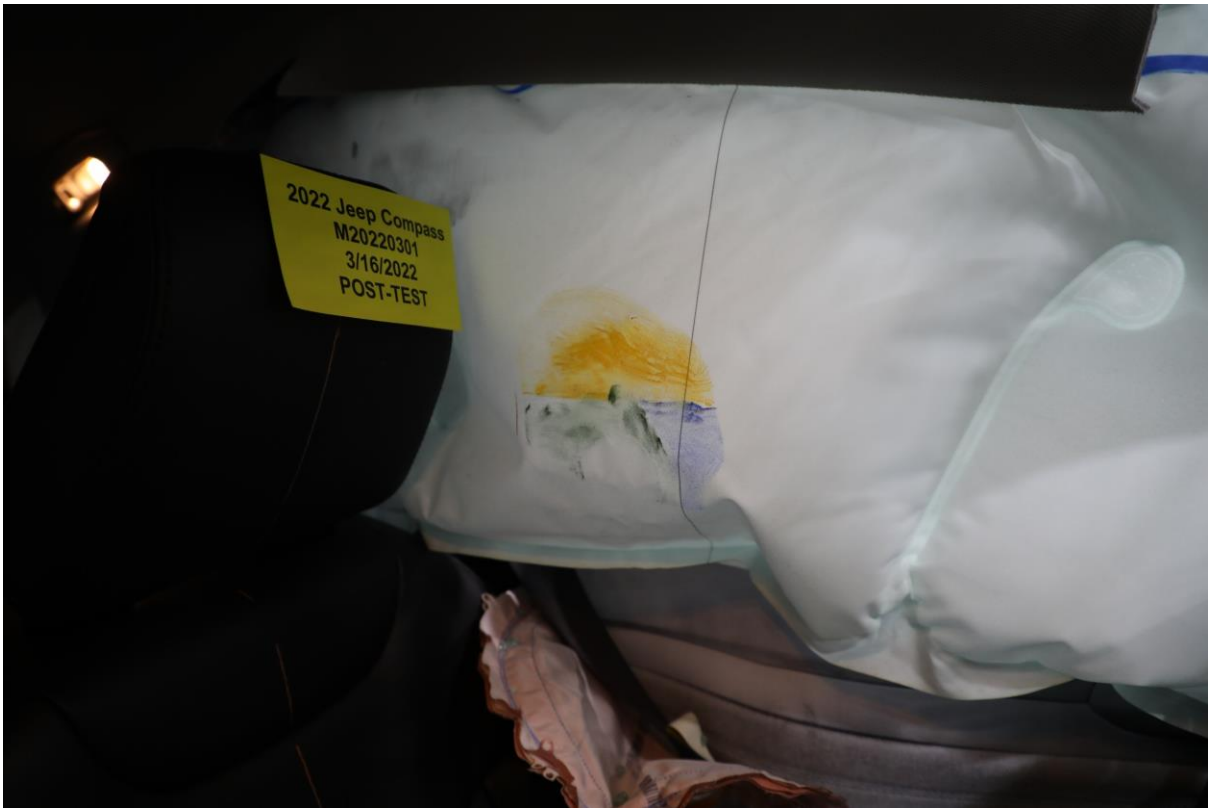
No. 047 Post-Test Dummy Close-Up Head Contact with Side Airbag View

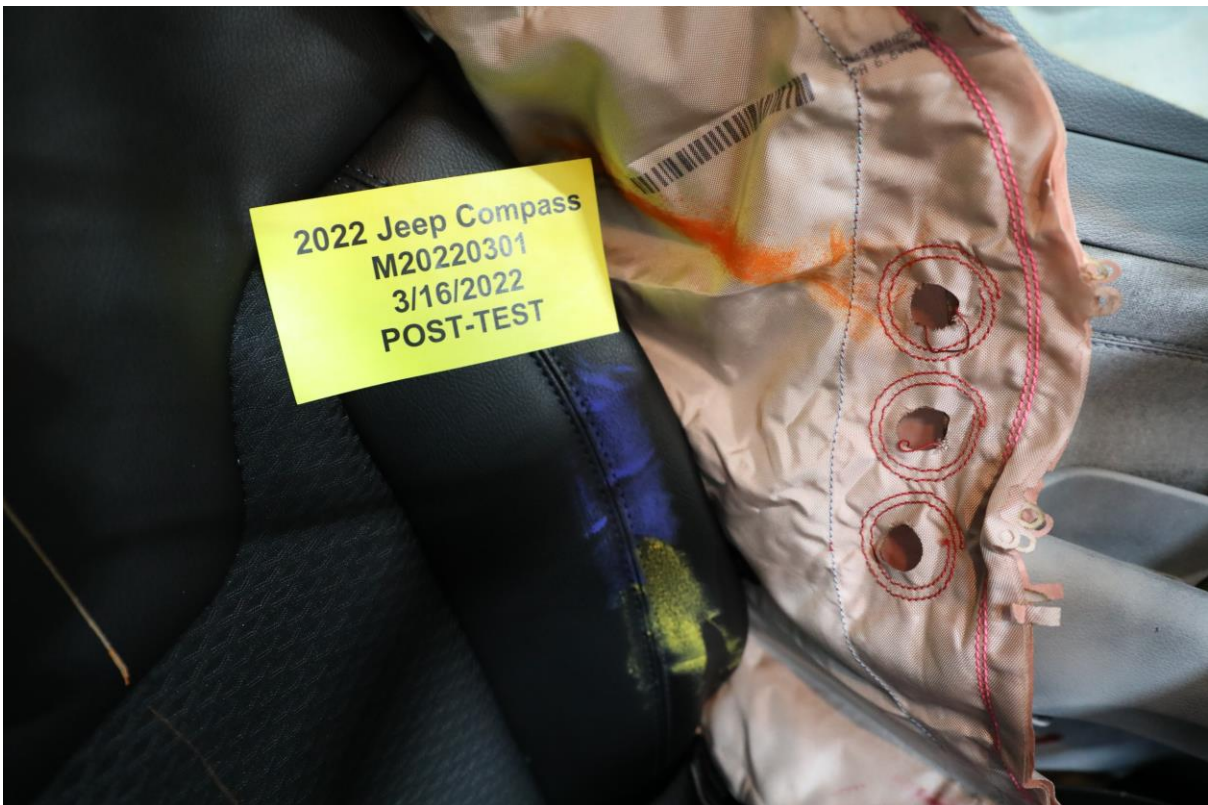
No. 048 Post-Test Dummy Close-Up Torso Contact with Vehicle Interior View

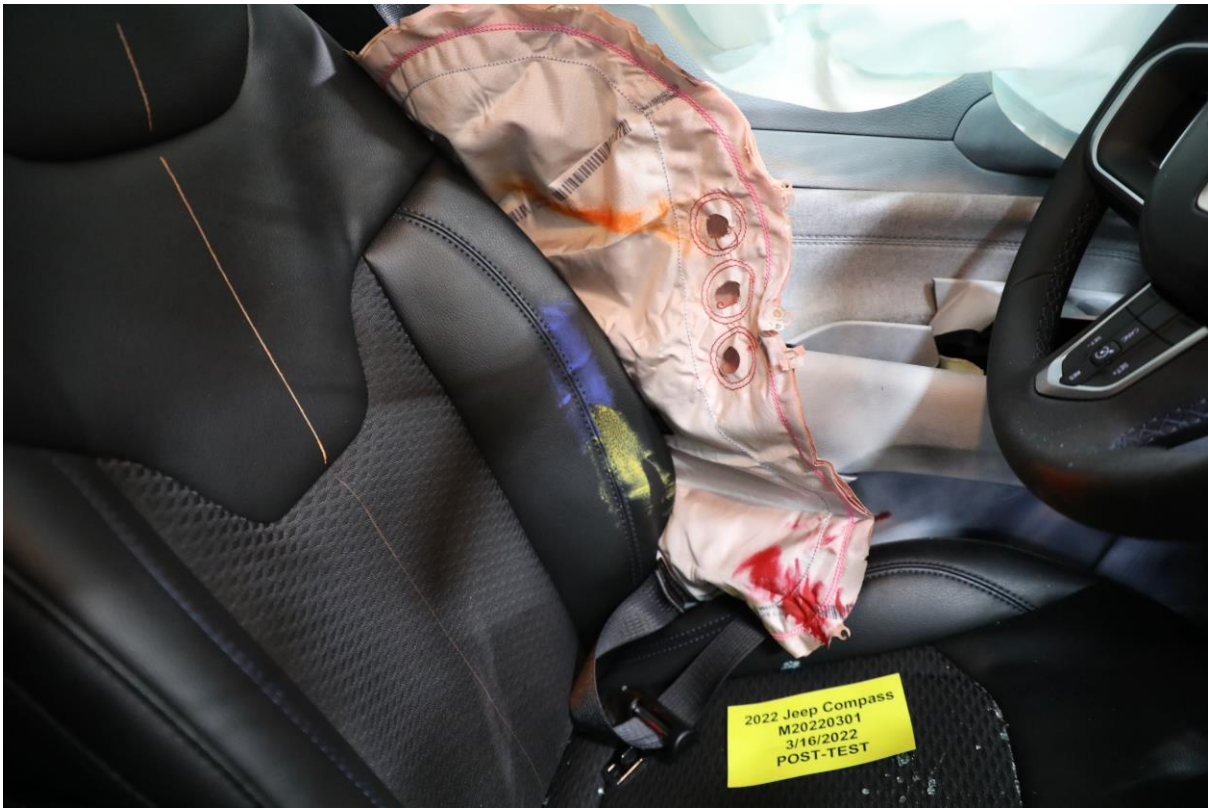
No. 049 Post-Test Dummy Close-Up Torso Contact with Side Airbag View

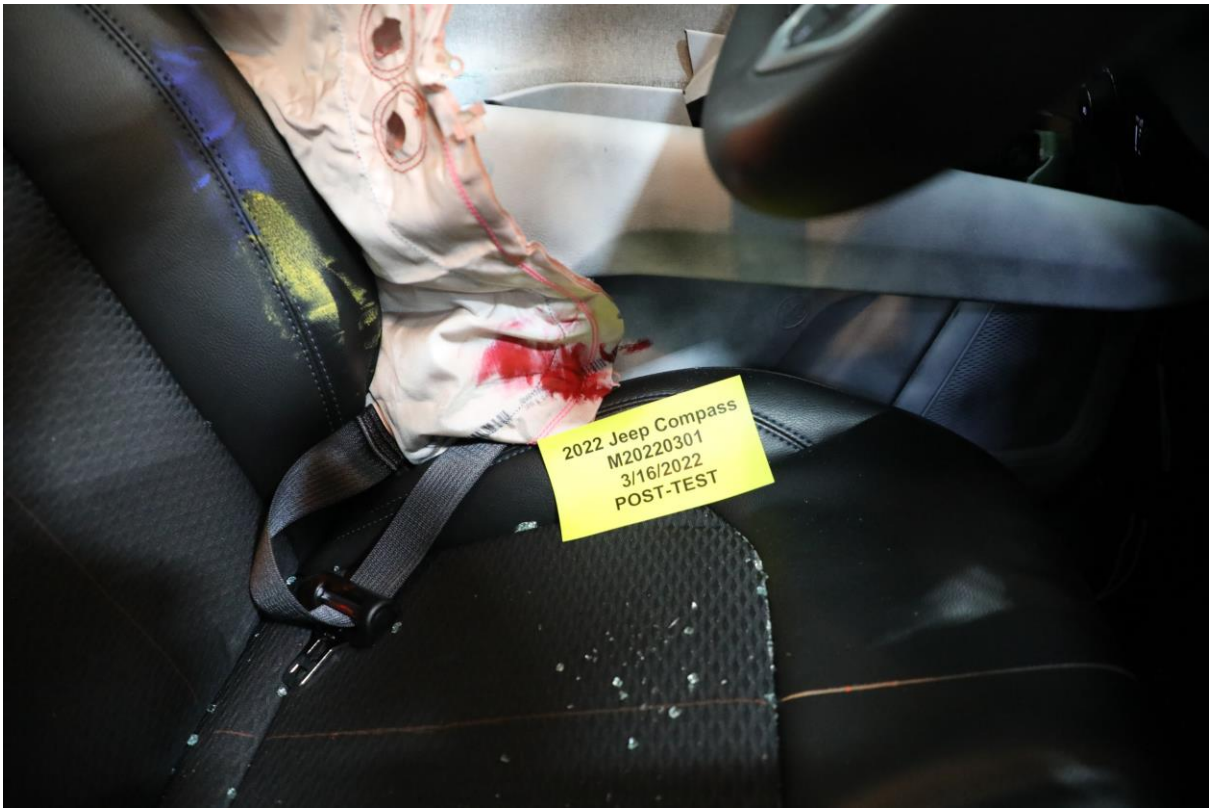
No. 051 Post-Test Dummy Close-Up Pelvis Contact with Side Airbag View

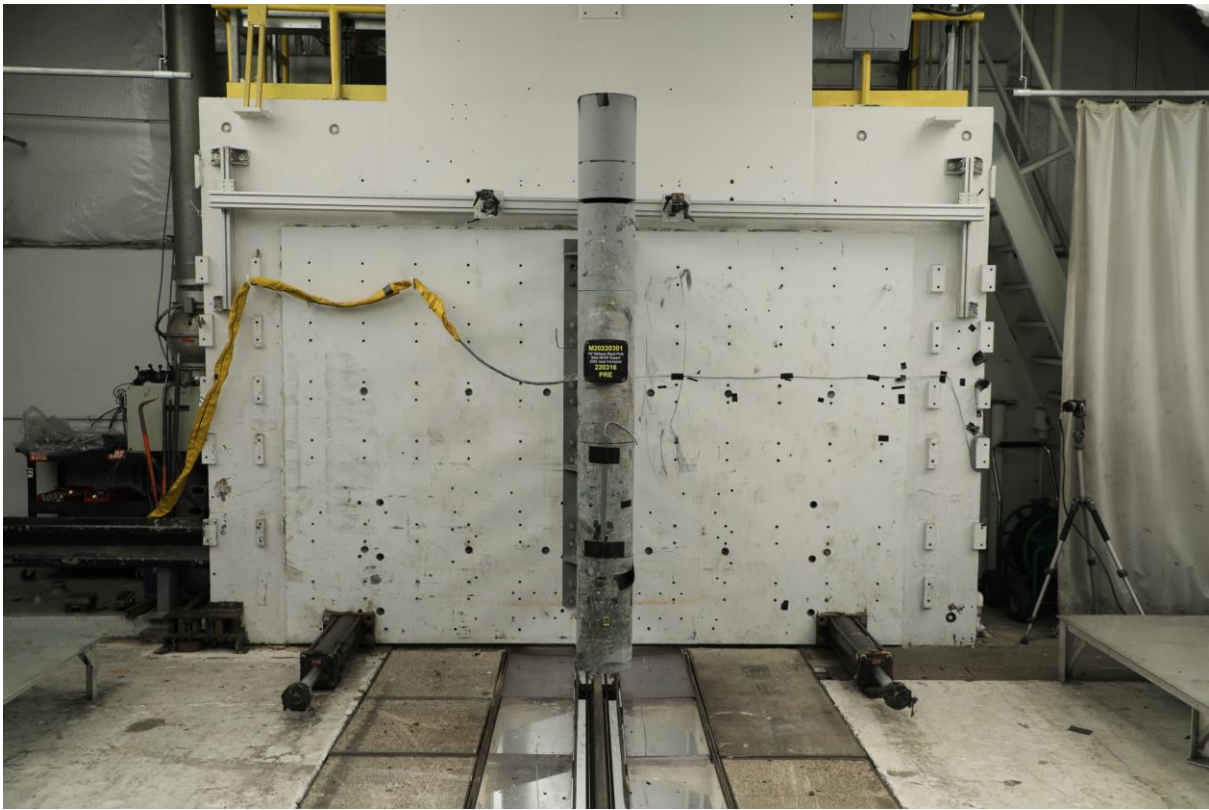
No. 059 Pre-Test Pole Barrier Front View

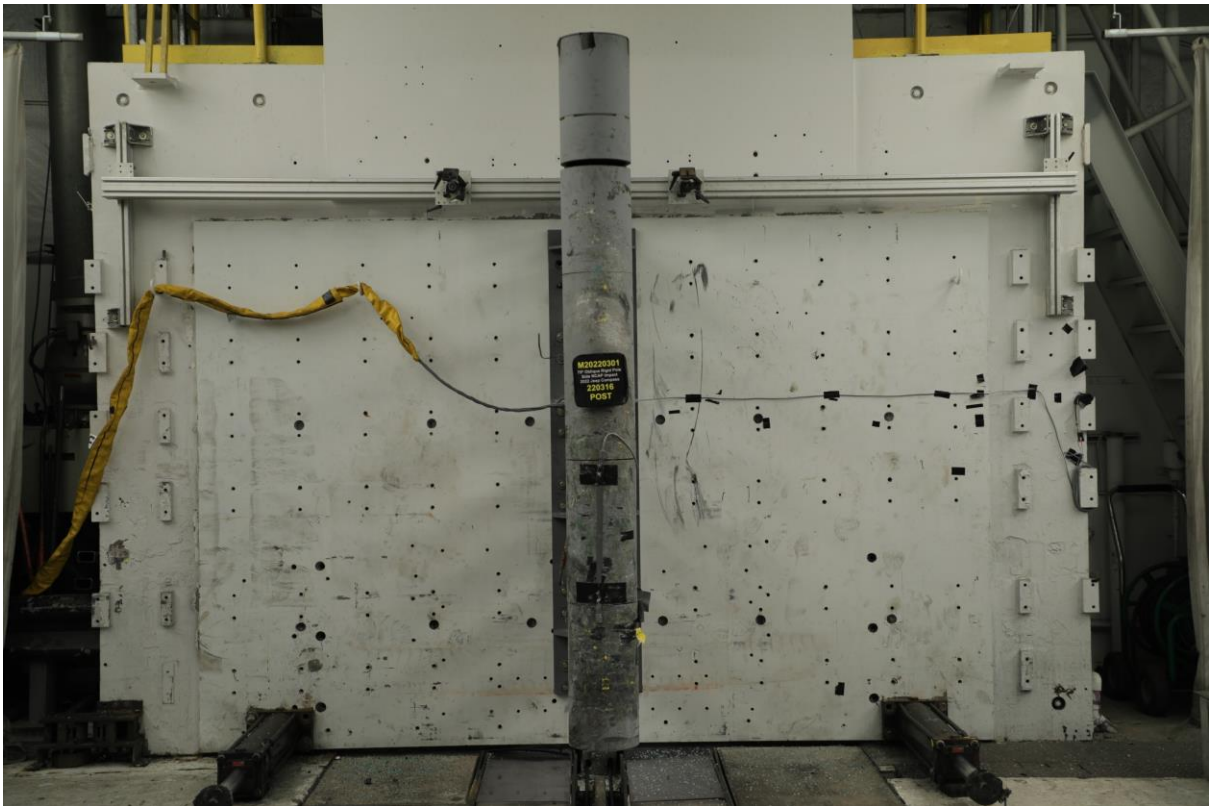
No. 060 Post-Test Pole Barrier Front View

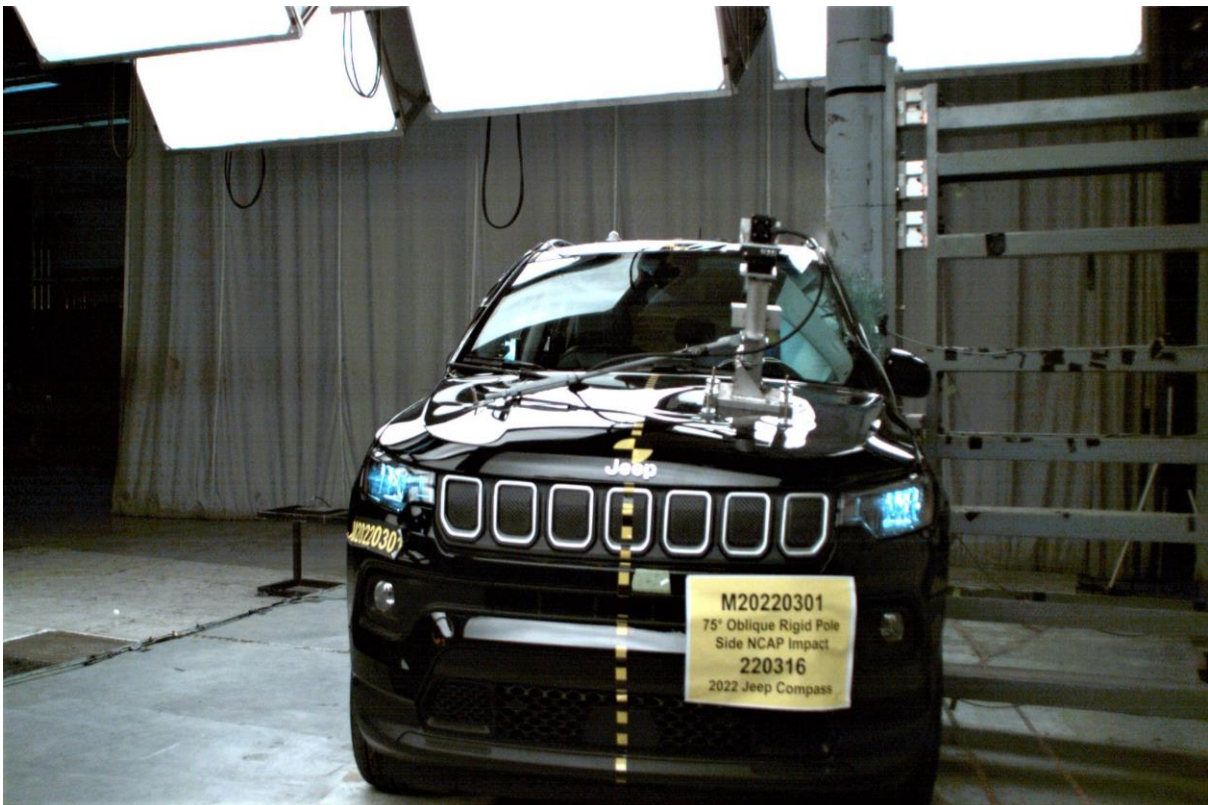
No. 070 Impact Event

A rigid pole side impact test was conducted on a model year 2022 Jeep Compass. The subject vehicle was towed into the rigid pole at an angle of 75° and a velocity of 32.19 km/h. The side impact test was conducted by Transportation Research Center Inc. in East Liberty, OH, on March 16, 2022. Pre-test and post-test photographs of the test vehicle and the side impact dummy (SID-IIs) are included in Appendix A of this report.
