**REPORT NUMBER: NCAP-MGA-22-015**

**NEW CAR ASSESSMENT PROGRAM (NCAP)  
Frontal Barrier Impact Test**

**NISSAN MOTOR CO., LTD.  
2022 Nissan Frontier S 4x4 Crew Cab  
NHTSA No.: M20225202**

**MGA RESEARCH CORPORATION  
5000 Warren Road  
Burlington, WI 53105**

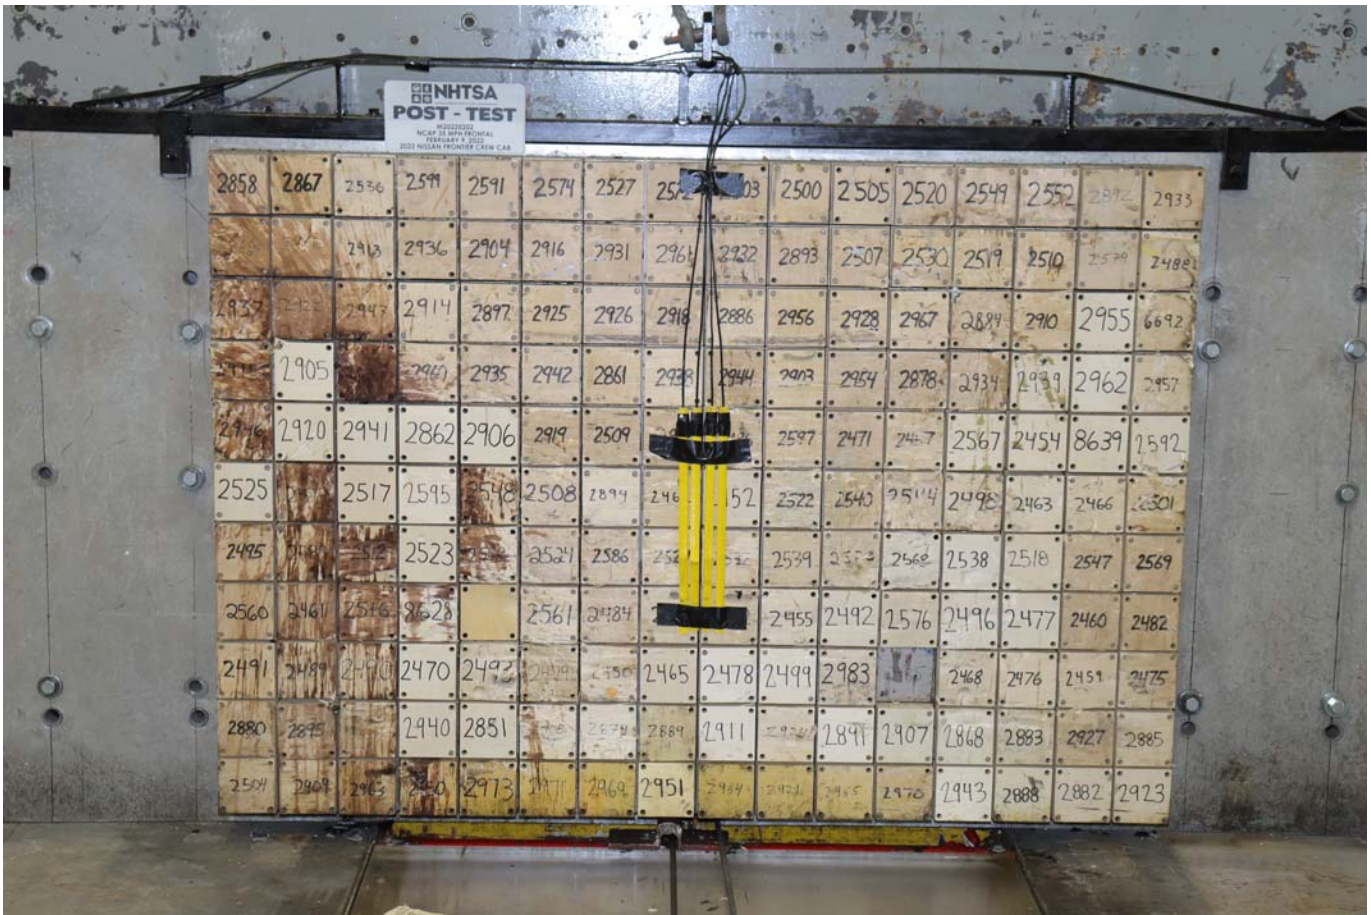
Photo No. 003 - Post-Test Load Cell Wall

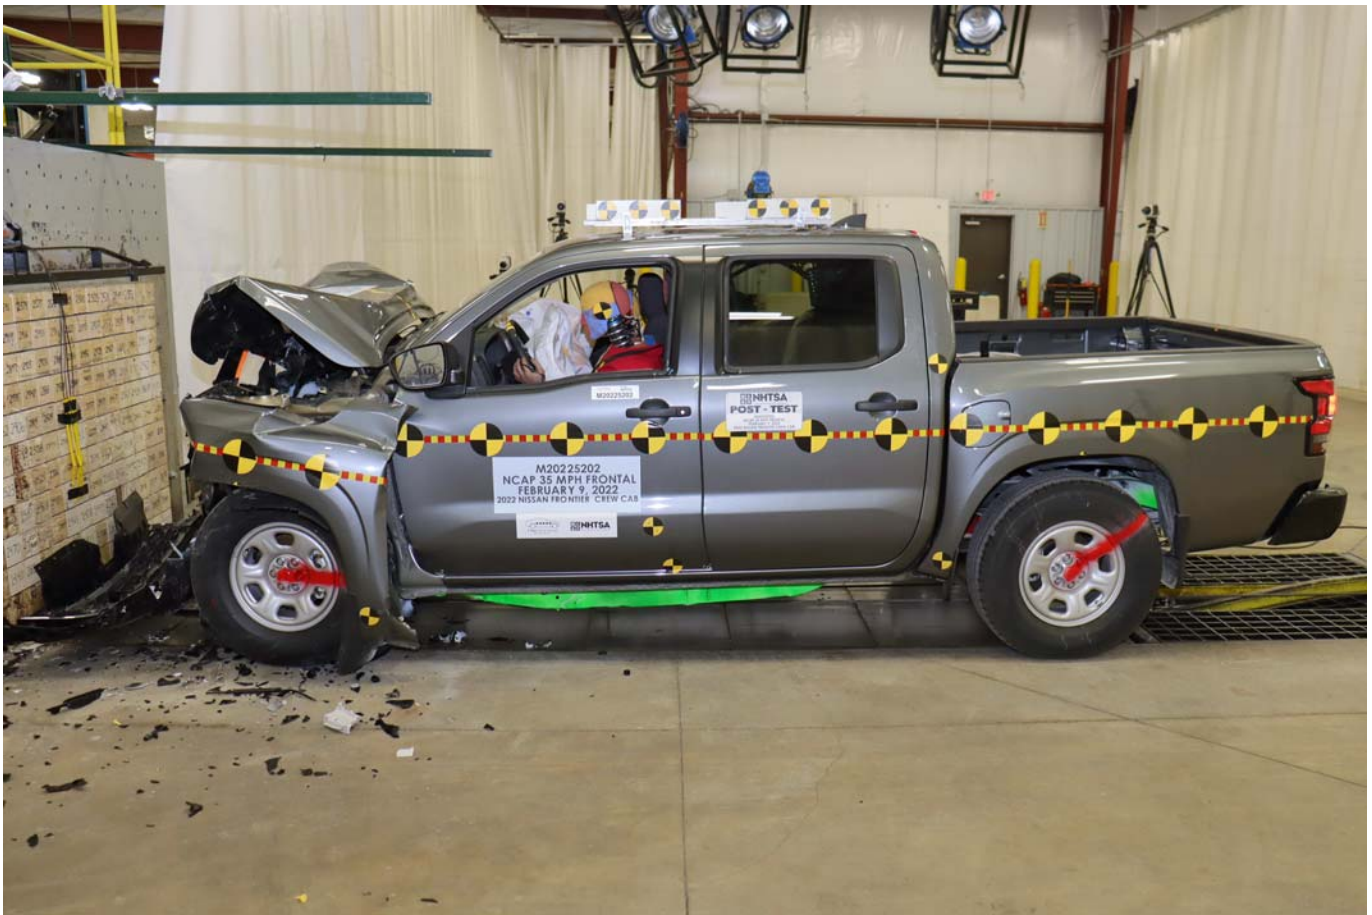
Photo No. 011 - Post-Test Left View of Test Vehicle

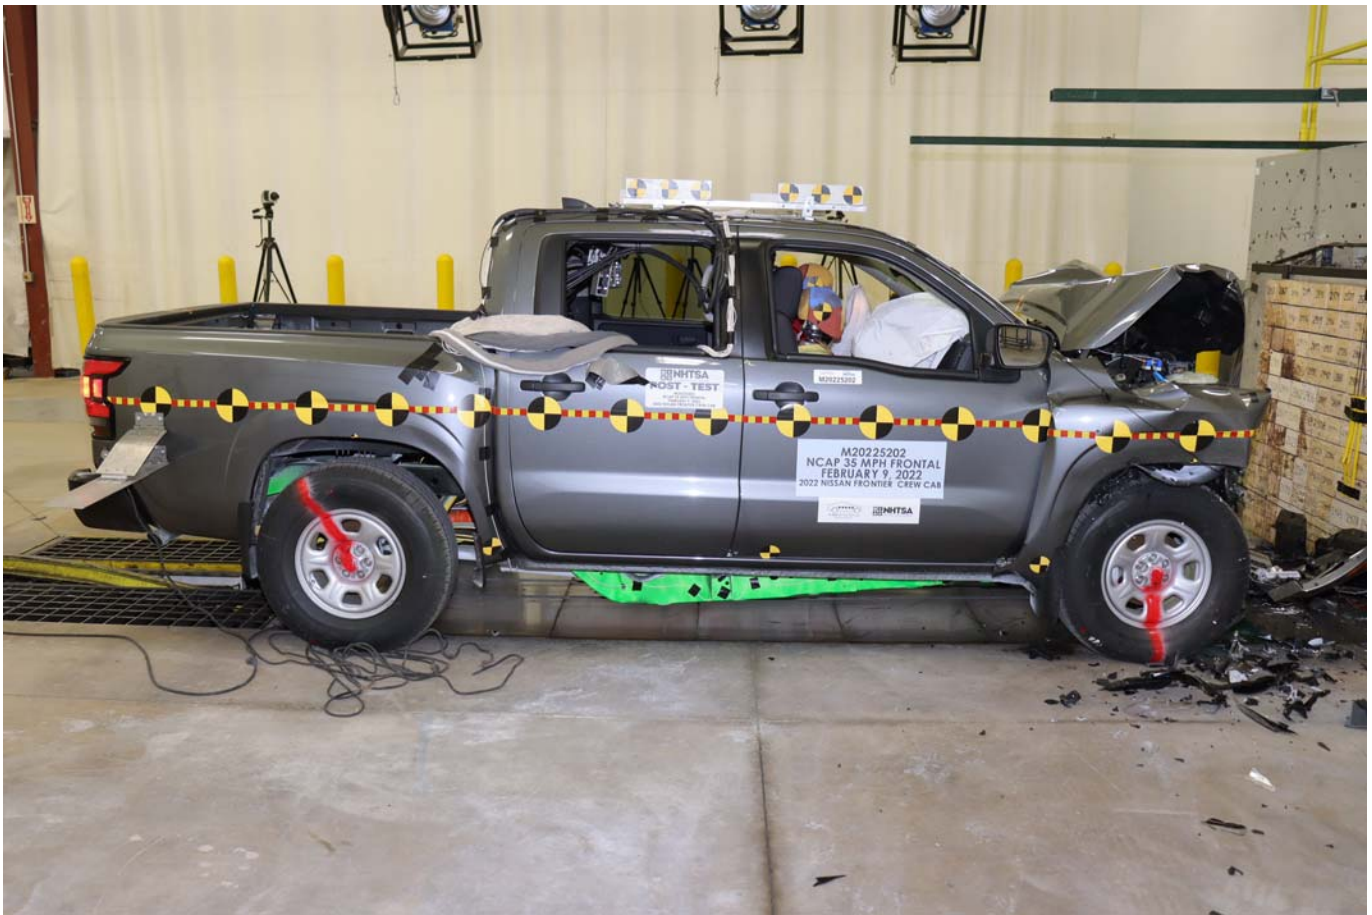
Photo No. 013 - Post-Test Right View of Test Vehicle

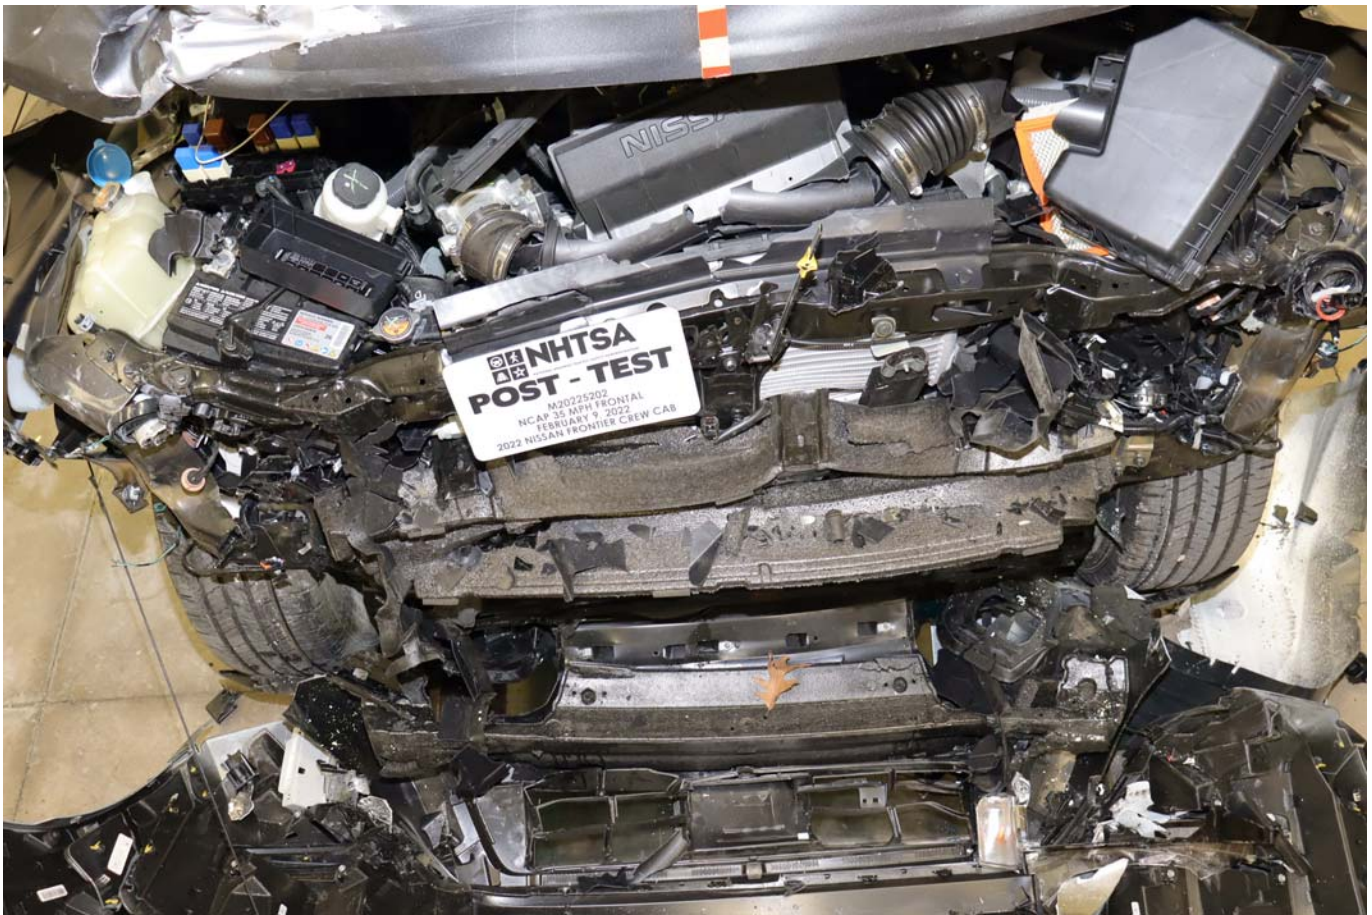
Photo No. 021 - Post-Test Engine Compartment View

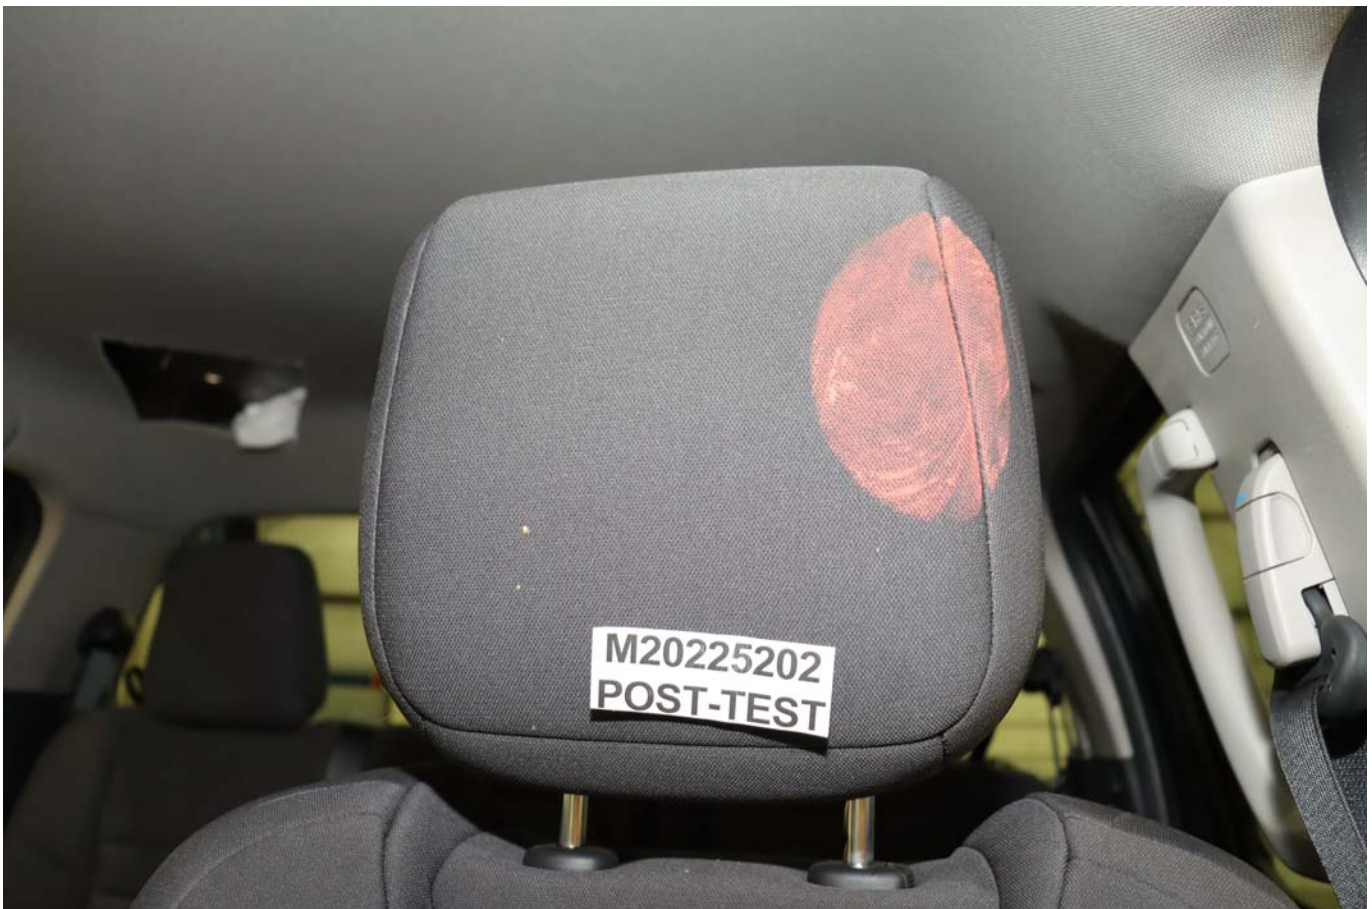
Photo No. 050 - Post-Test Driver Dummy Contact with Headrest

The driver's visible contact points were as follows: The driver's head contacted the airbag. The driver's head also contacted the headrest. The driver's knees contacted the knee airbag. The passenger's visible contact points were as follows: The passenger's head contacted the airbag. The passenger's head also contacted the headrest. The passenger's knees contacted the glove box.

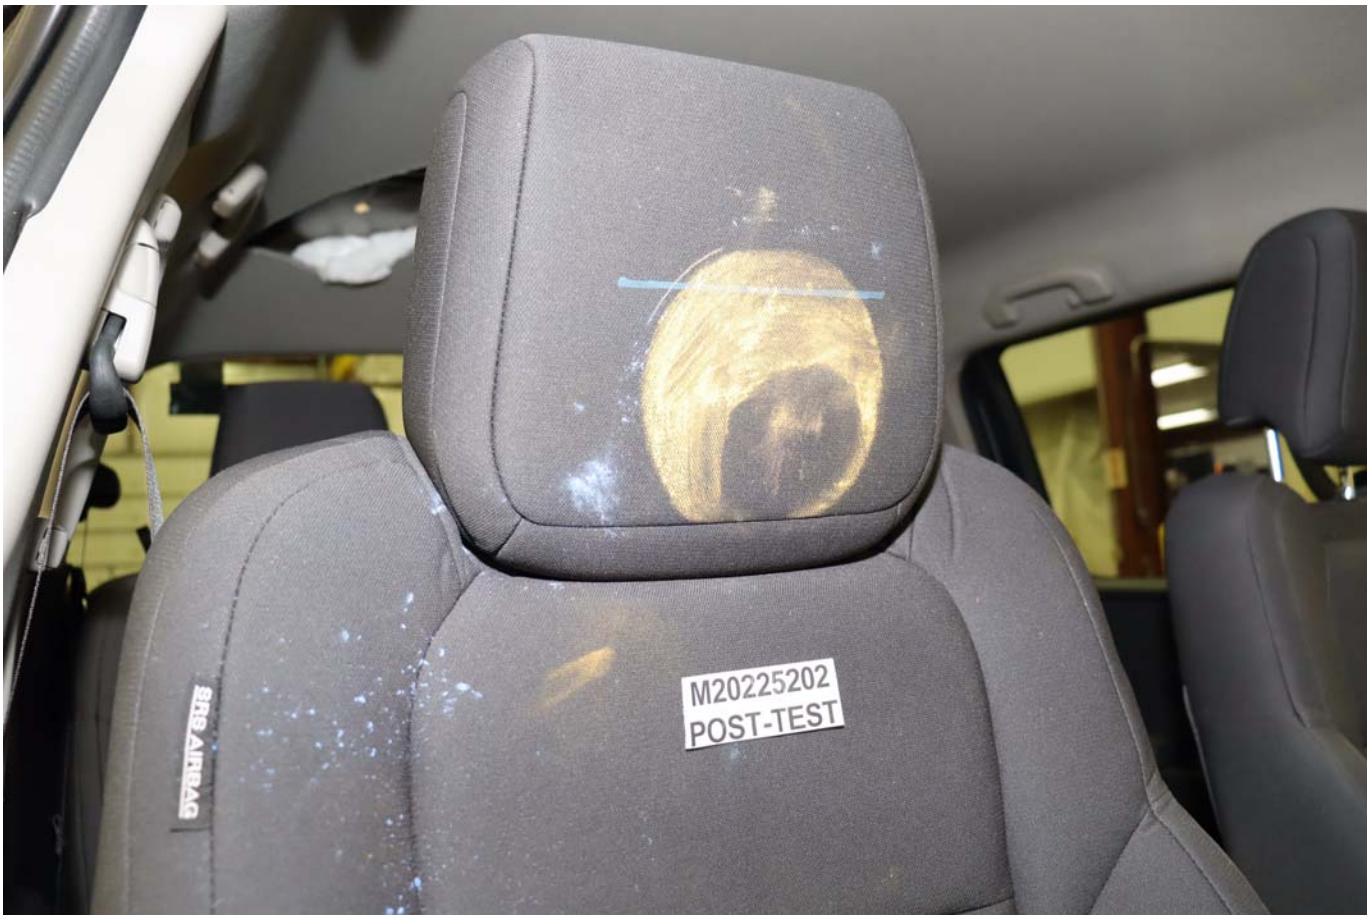
Photo No. 073 - Post-Test Passenger Dummy Contact with Headrest

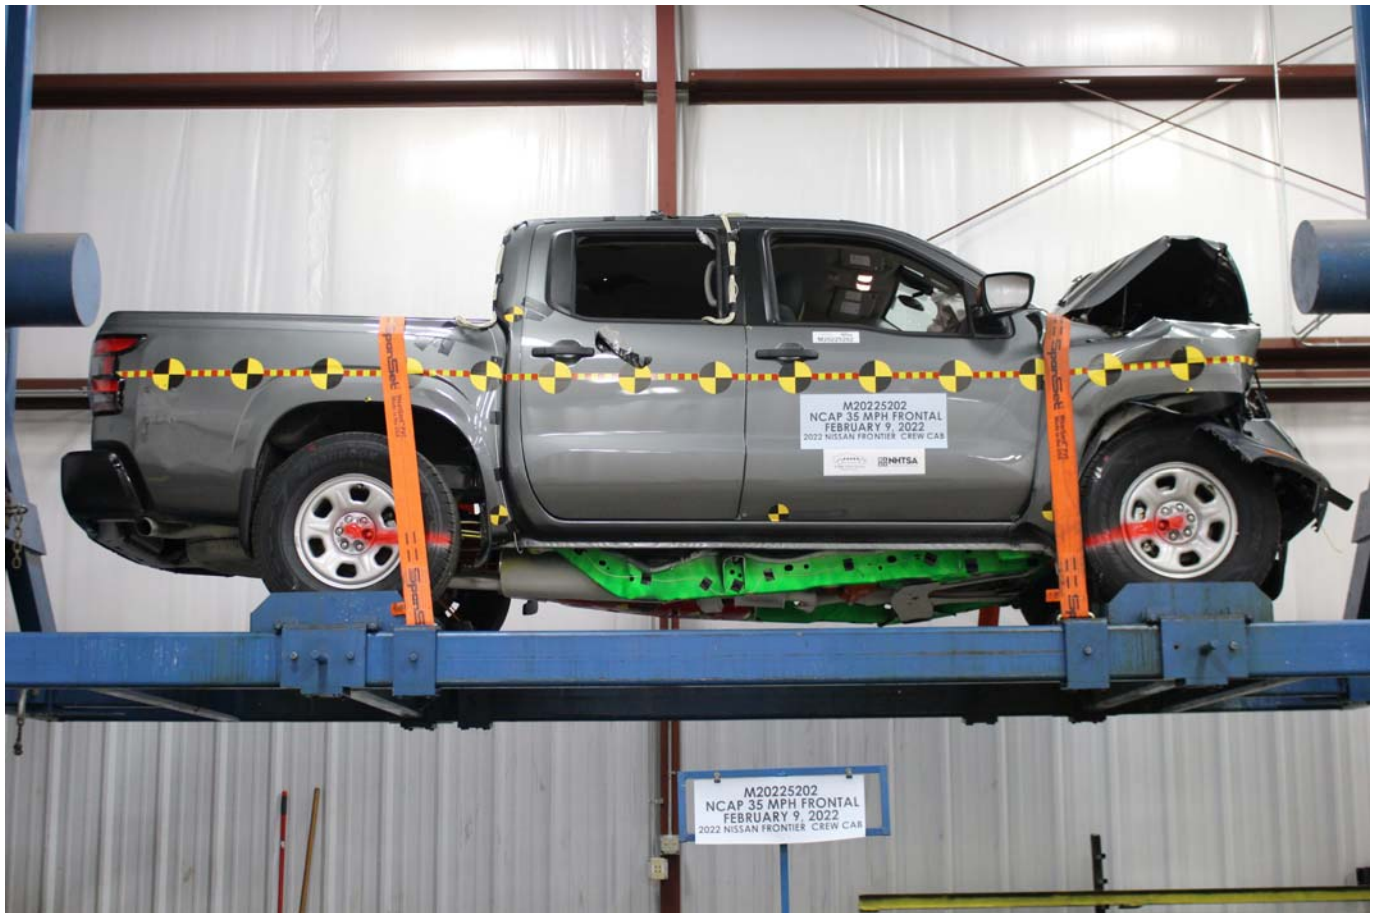
Photo No. 077 - Vehicle at 0 Degrees on Static Rollover Device

There was 100 percent windshield retention and no intrusion into the protected zone of the windshield during the event. There was no Stoddard Solvent leakage after the event or during any phase of the static rollover.

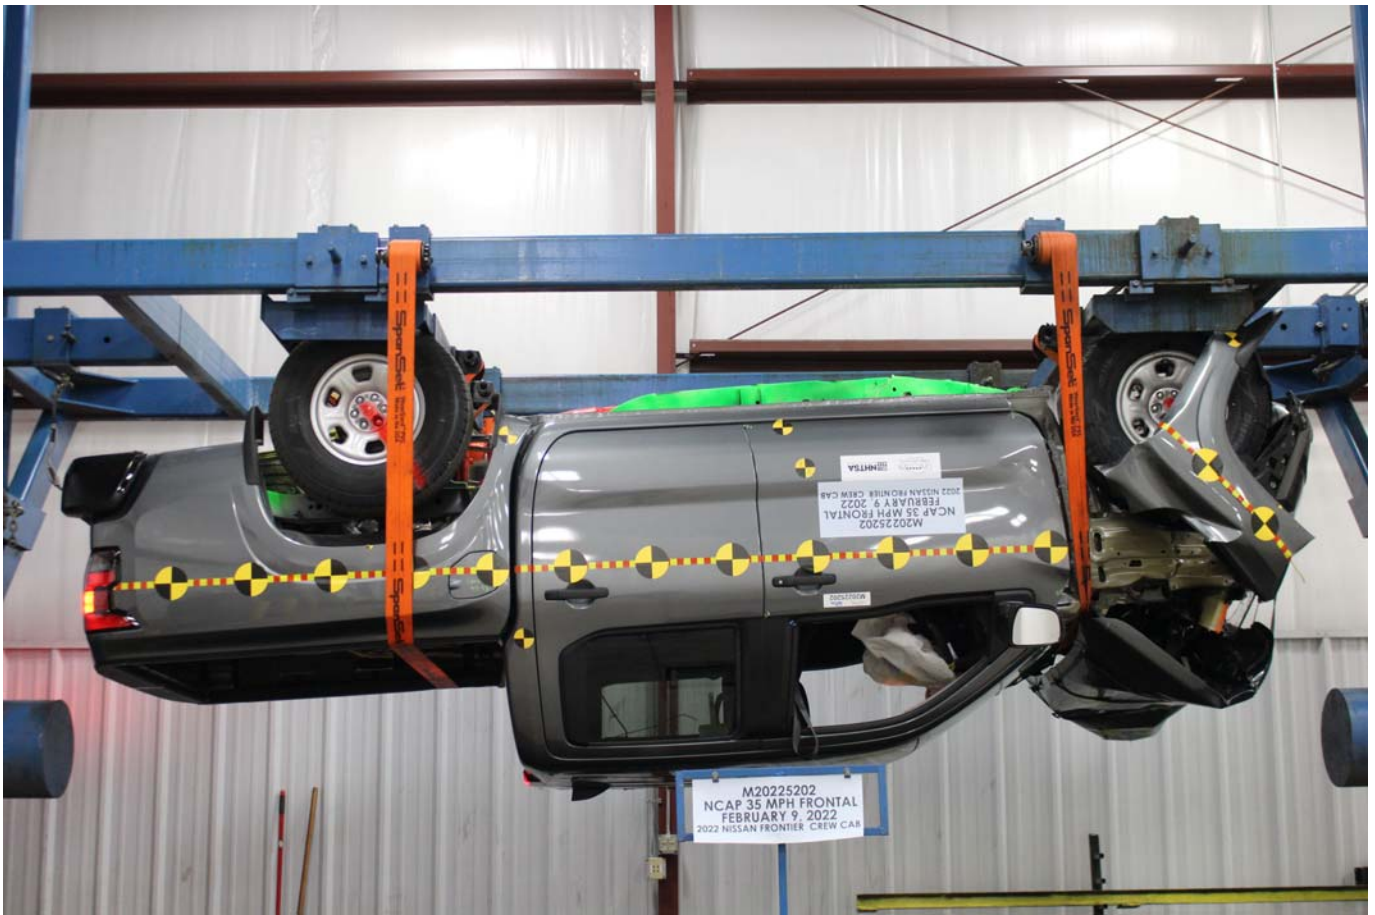
Photo No. 079 - Vehicle at 180 Degrees on Static Rollover Device

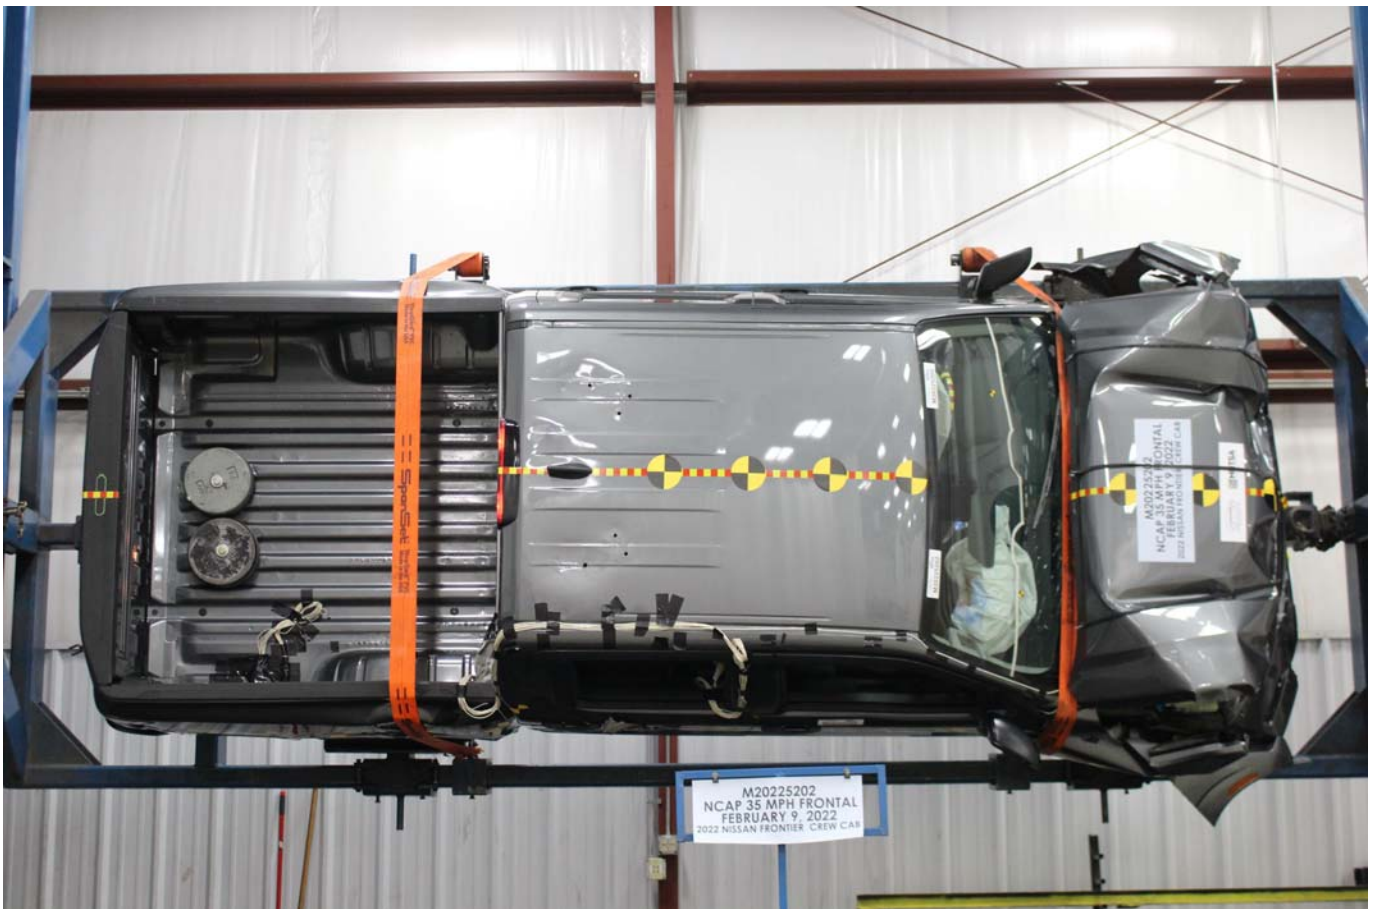
Photo No. 080 - Vehicle at 270 Degrees on Static Rollover Device

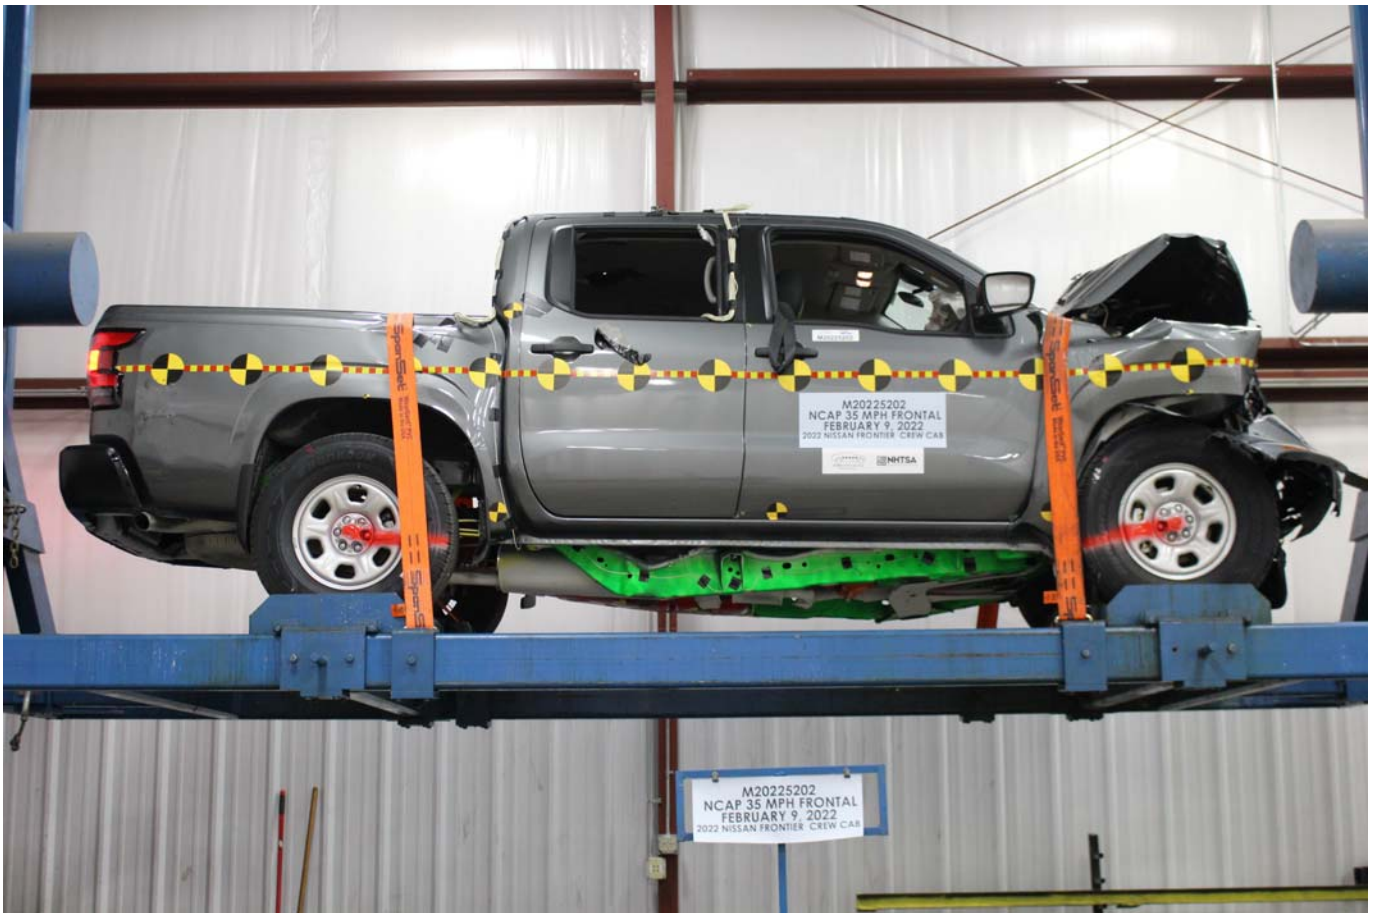
Photo No. 081 - Vehicle at 360 Degrees on Static Rollover Device

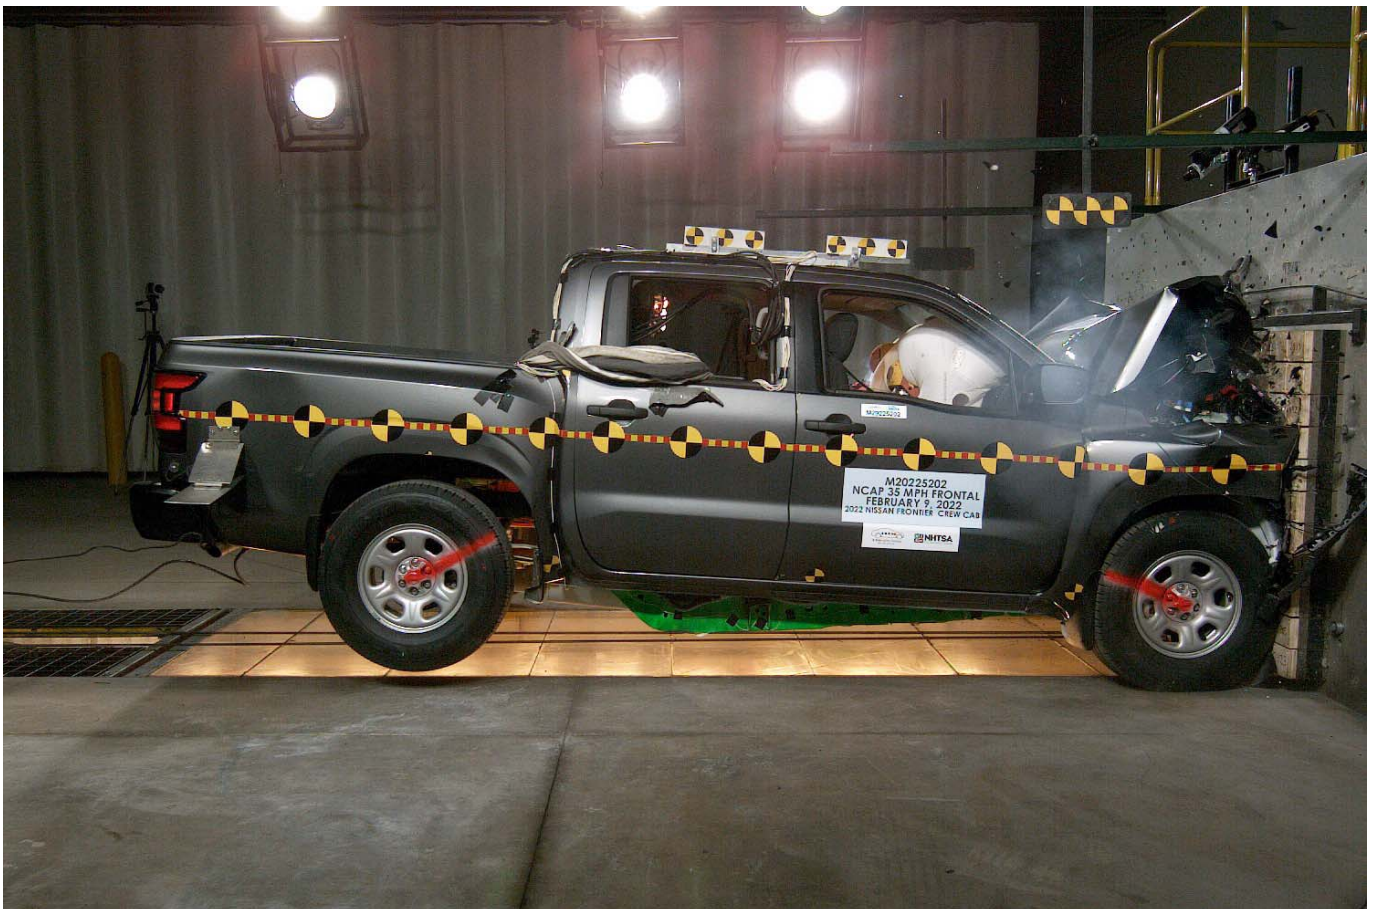
Photo No. 082 - 2022 Nissan Frontier S 4x4 Crew Cab Frontal Impact Event

A load cell barrier consisting of 176 load cells was impacted by a 2022 Nissan Frontier S 4x4 Crew Cab at a velocity of 56.10 km/h. The test was performed at MGA Research Corporation on February 9, 2022. Pre-test and post-test photographs of the vehicle and dummies can be found in Appendix A.
