REPORT NUMBER: NCAP-MGA-22-023

**NEW CAR ASSESSMENT PROGRAM (NCAP)
Frontal Barrier Impact Test**

**FORD MOTOR CO.
2022 Ford Escape SEL PHEV 5-Door SUV
NHTSA No.: M20220200**

**MGA RESEARCH CORPORATION
5000 Warren Road
Burlington, WI 53105**

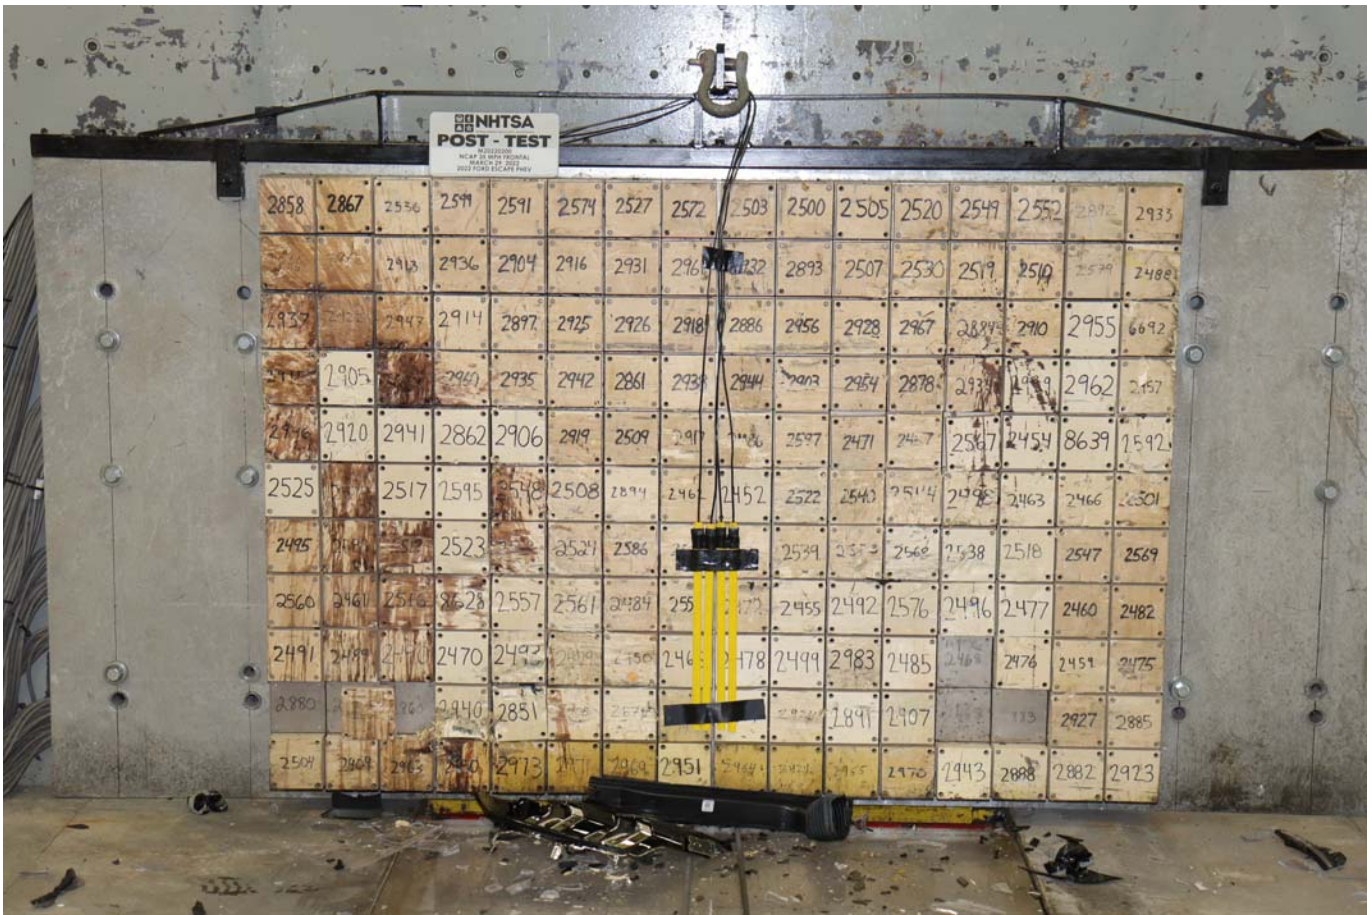
Photo No. 003 - Post-Test Load Cell Wall

A load cell barrier consisting of 176 load cells was impacted by a 2022 Ford Escape SEL PHEV 5-Door SUV at a velocity of 56.15 km/h. The test was performed at MGA Research Corporation on March 29, 2022. Pre-test and post-test photographs of the vehicle and dummies can be found in Appendix A.

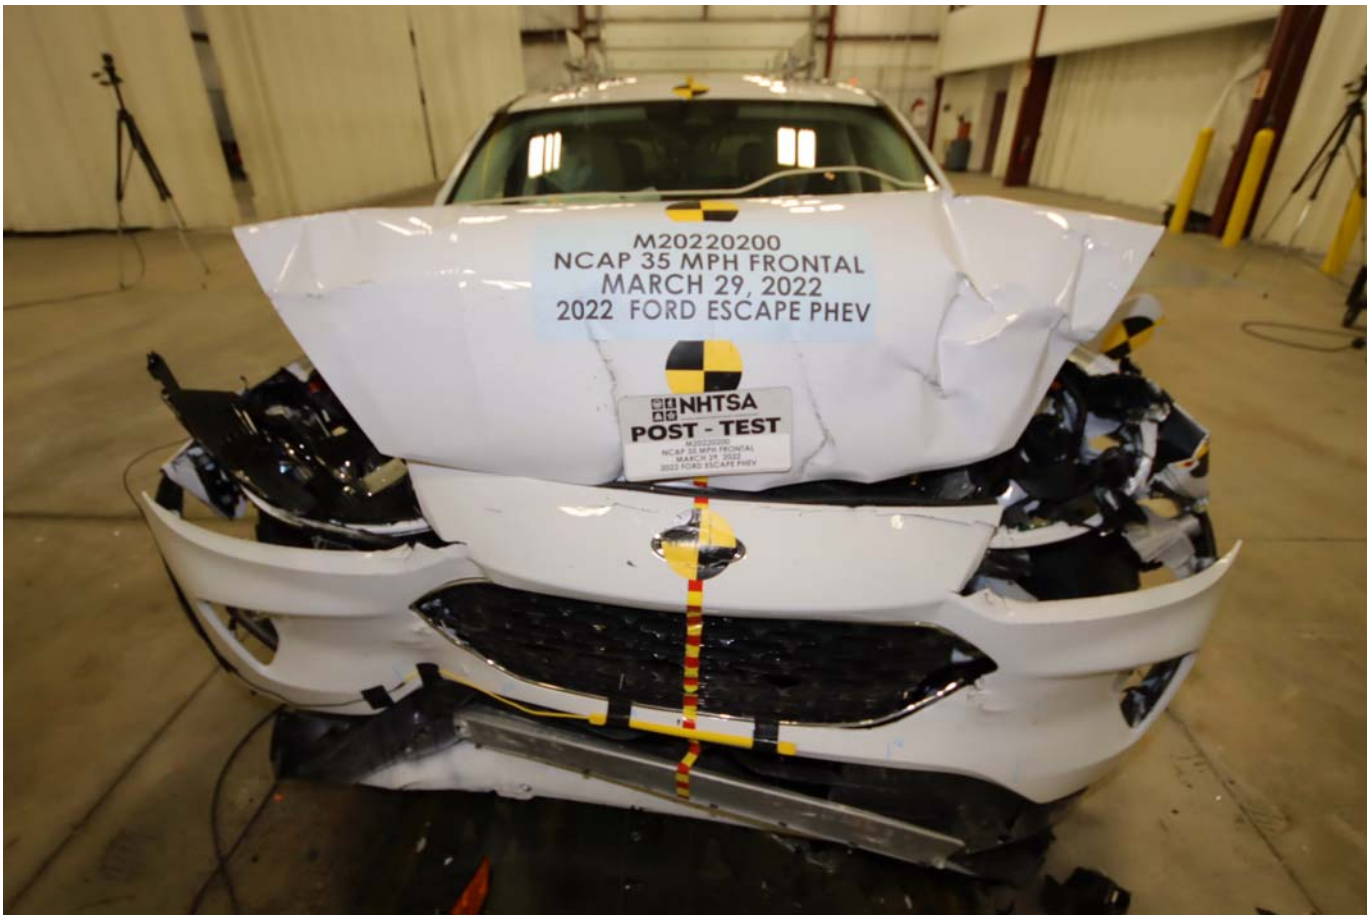
Photo No. 009 - Post-Test Front View of Test Vehicle

The maximum static crush of the vehicle was 627 mm located to the left of the vehicle centerline and both the driver and passenger side doors remained closed during the impact event and were operable after the impact.

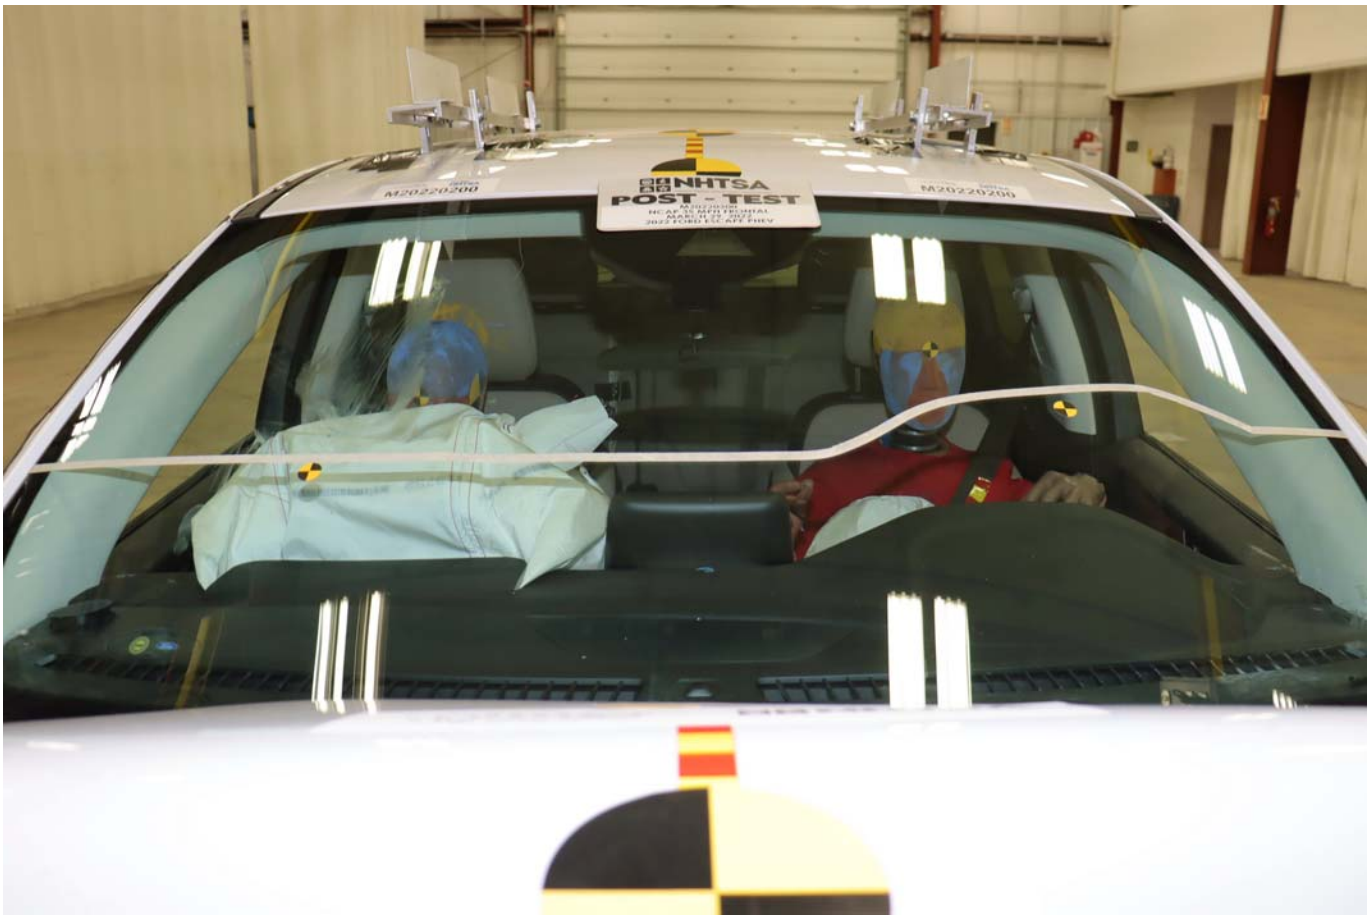
Photo No. 019 - Post-Test Windshield View

There was 100 percent windshield retention and no intrusion into the protected zone of the windshield during the event. There was no Stoddard Solvent or battery electrolyte leakage and no loss of high-voltage battery isolation after the event or during any phase of the static rollover.

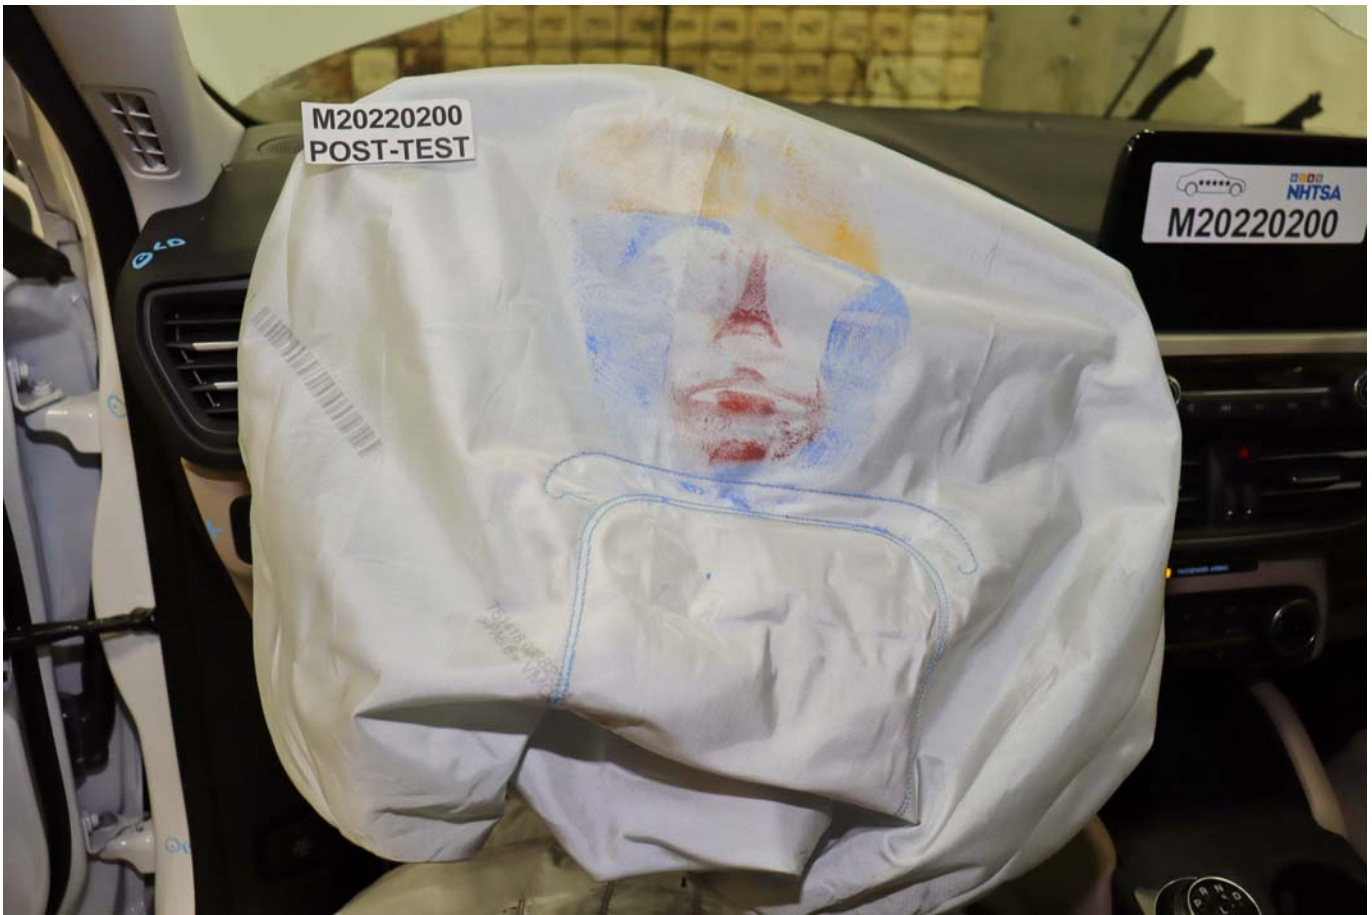
Photo No. 049 - Post-Test Driver Dummy Contact with Airbag

The driver's visible contact points were as follows: The driver's head contacted the airbag. The driver's head also contacted the headrest. The driver's knees contacted the knee airbag.

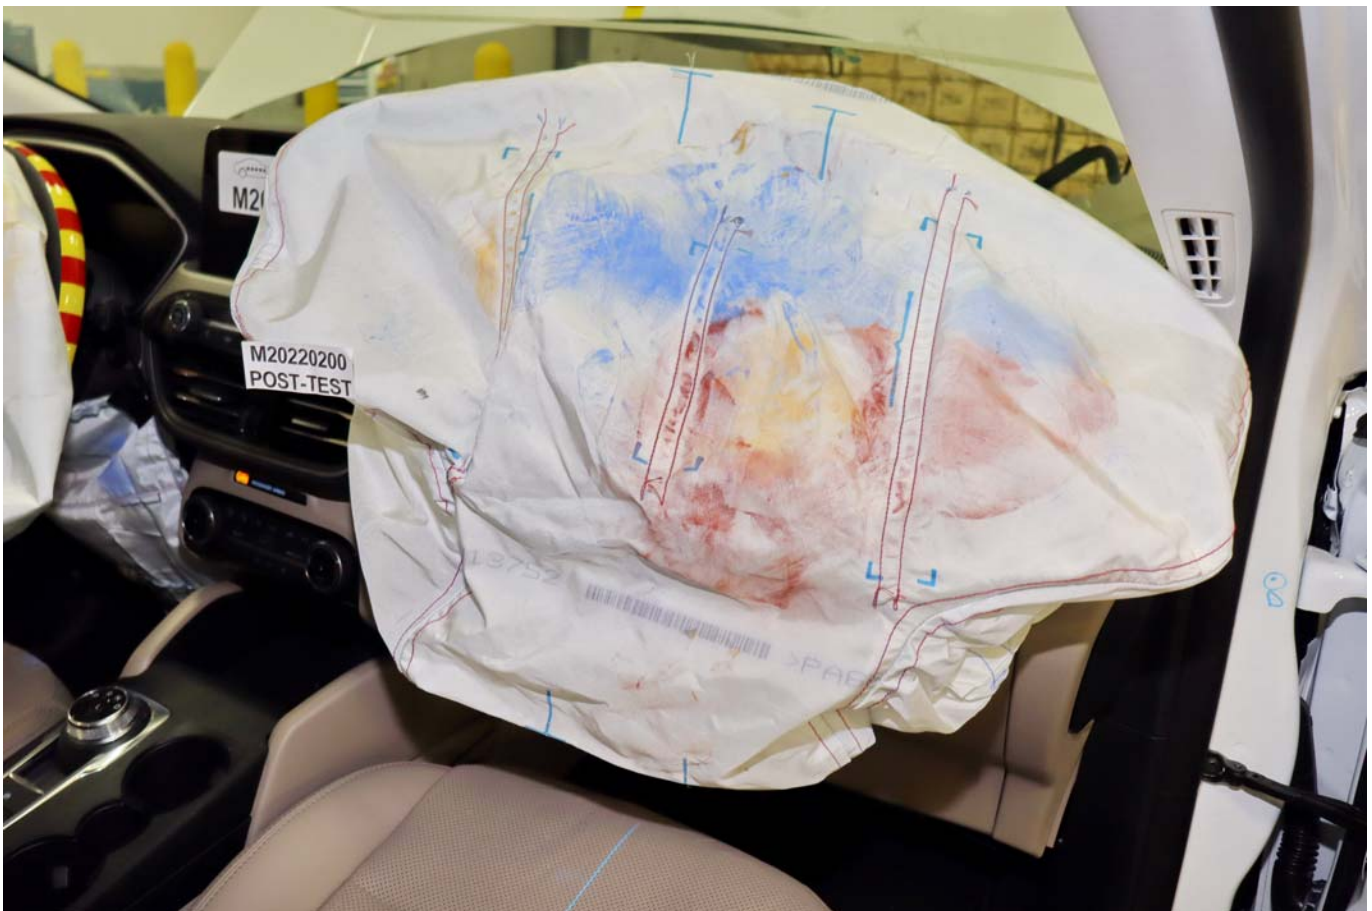
Photo No. 072 - Post-Test Passenger Dummy Contact with Airbag

The passenger's visible contact points were as follows: The passenger's head contacted the airbag. The passenger's head also contacted the headrest. The passenger's knees contacted the glove box.
