**REPORT NUMBER: SINCAP-CAL-21-007**

**NEW CAR ASSESSMENT PROGRAM (NCAP)  
MOVING DEFORMABLE BARRIER SIDE IMPACT TEST**

**Ford Motor Co.  
2021 Ford Mustang Mach-E  
5 Door SUV**

**NHTSA No: M20210217**

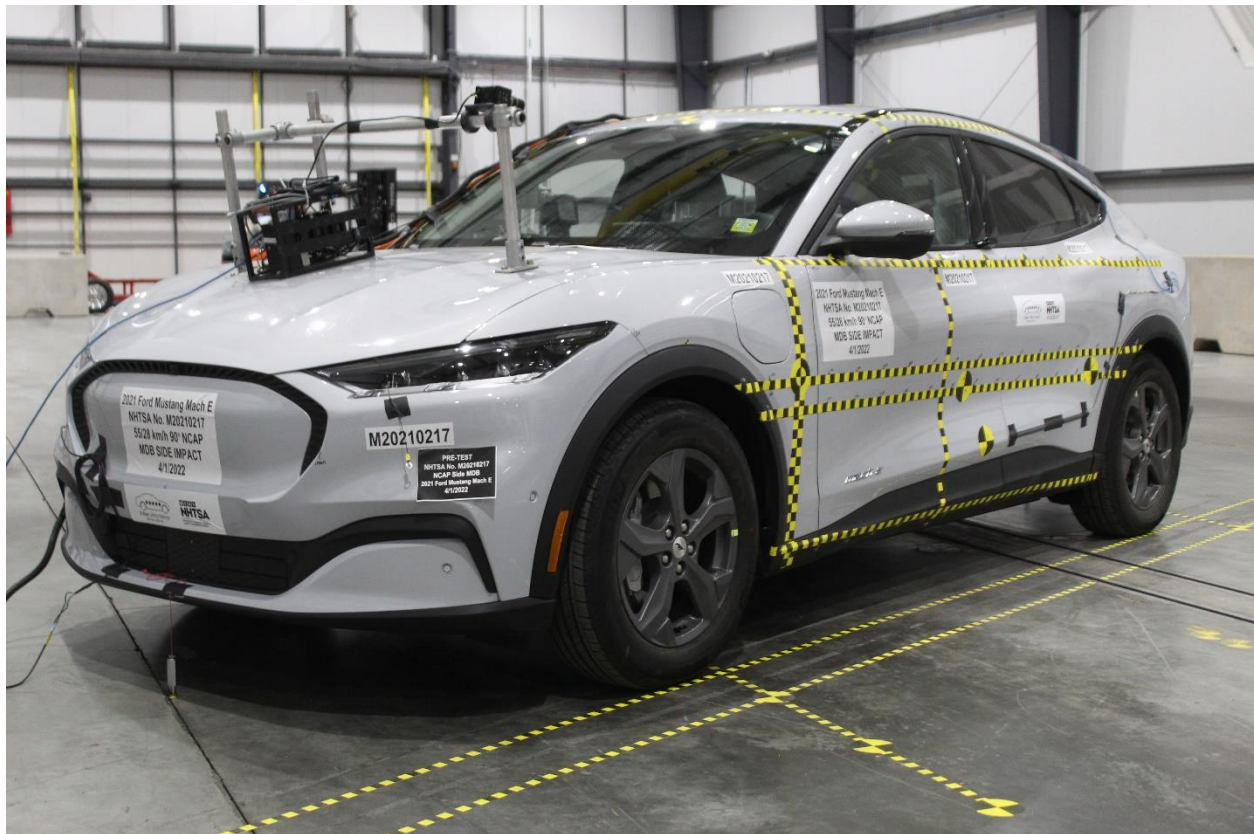
**Figure A-5: Pre-Test Left Front  $\frac{3}{4}$  View of Test Vehicle**

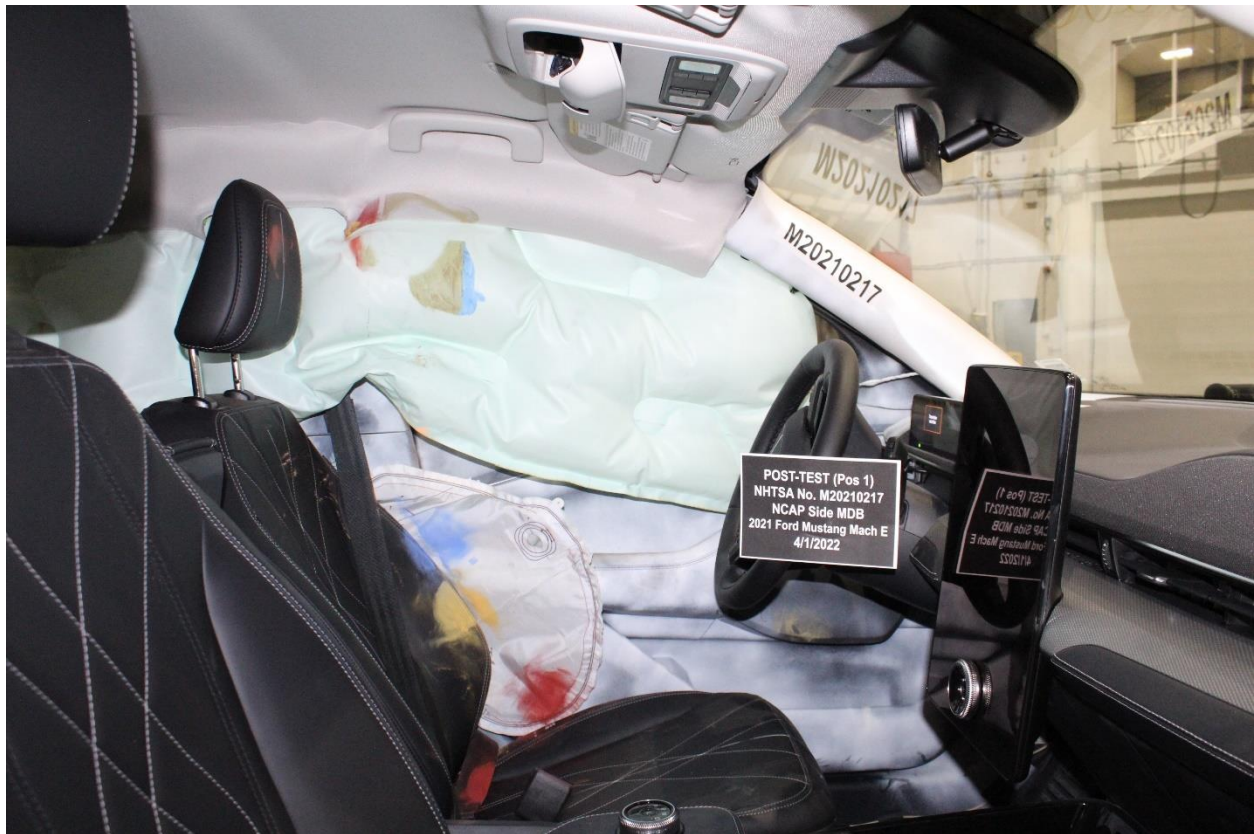
**Figure A-47: Post-Test Driver Inner Door Panel View Showing Driver Dummy Contact Locations**

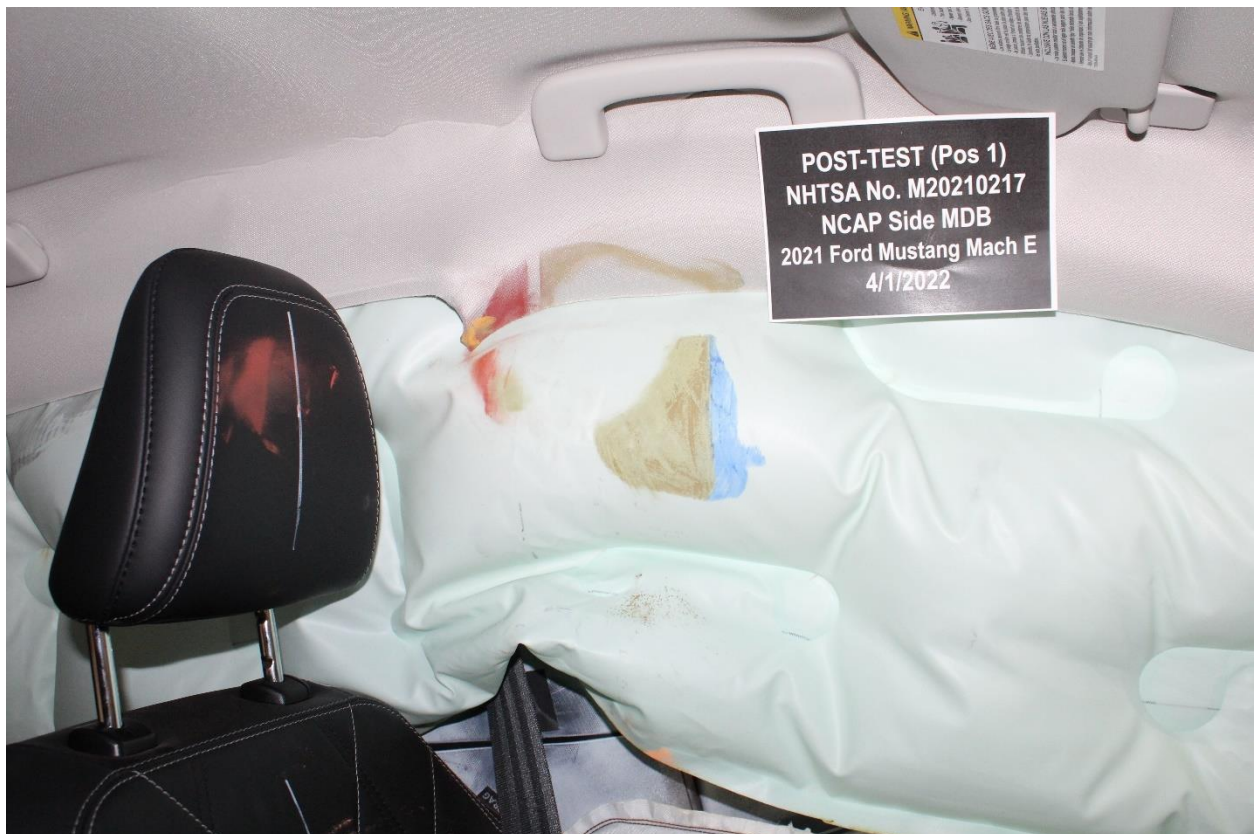
**Figure A-48: Post-Test Driver Dummy Close-Up Head Contact with Vehicle View**

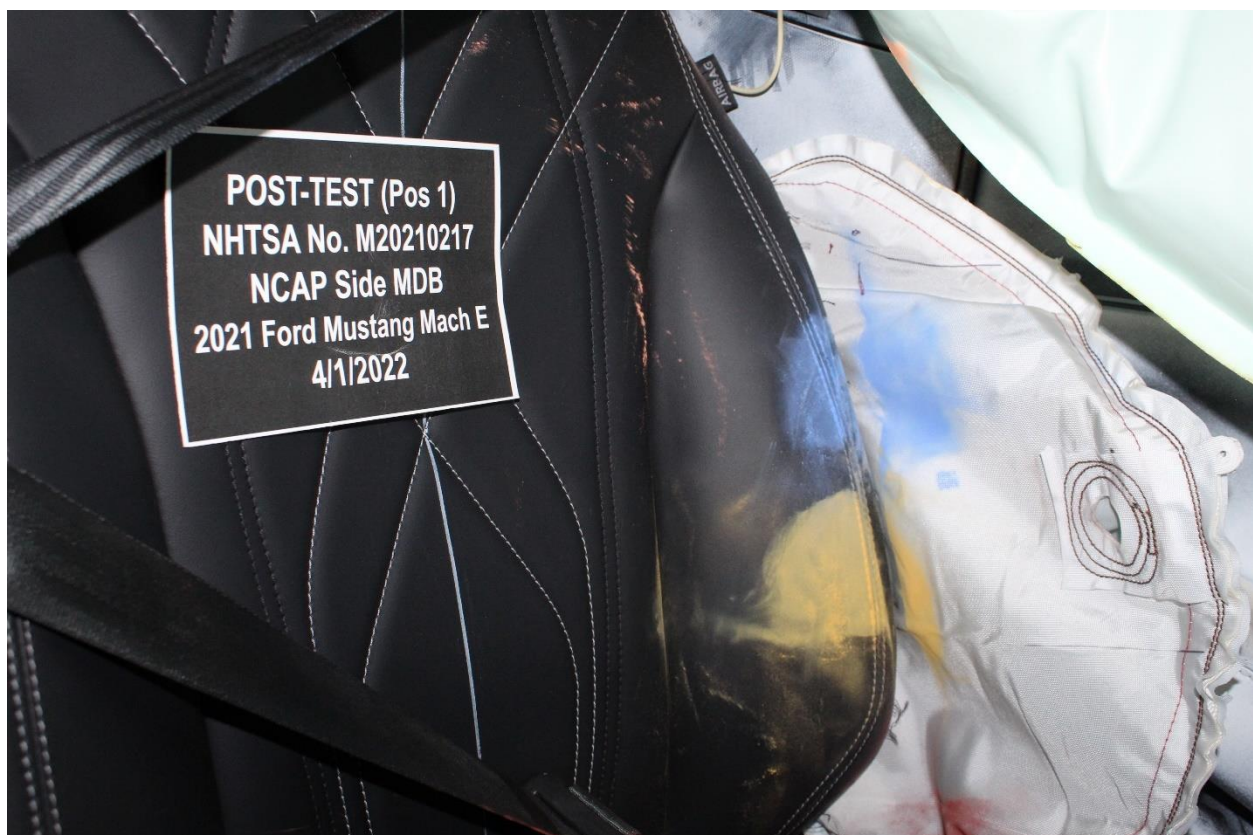
**Figure A-50: Post-Test Driver Dummy Close-Up Torso Contact with Vehicle Interior View**

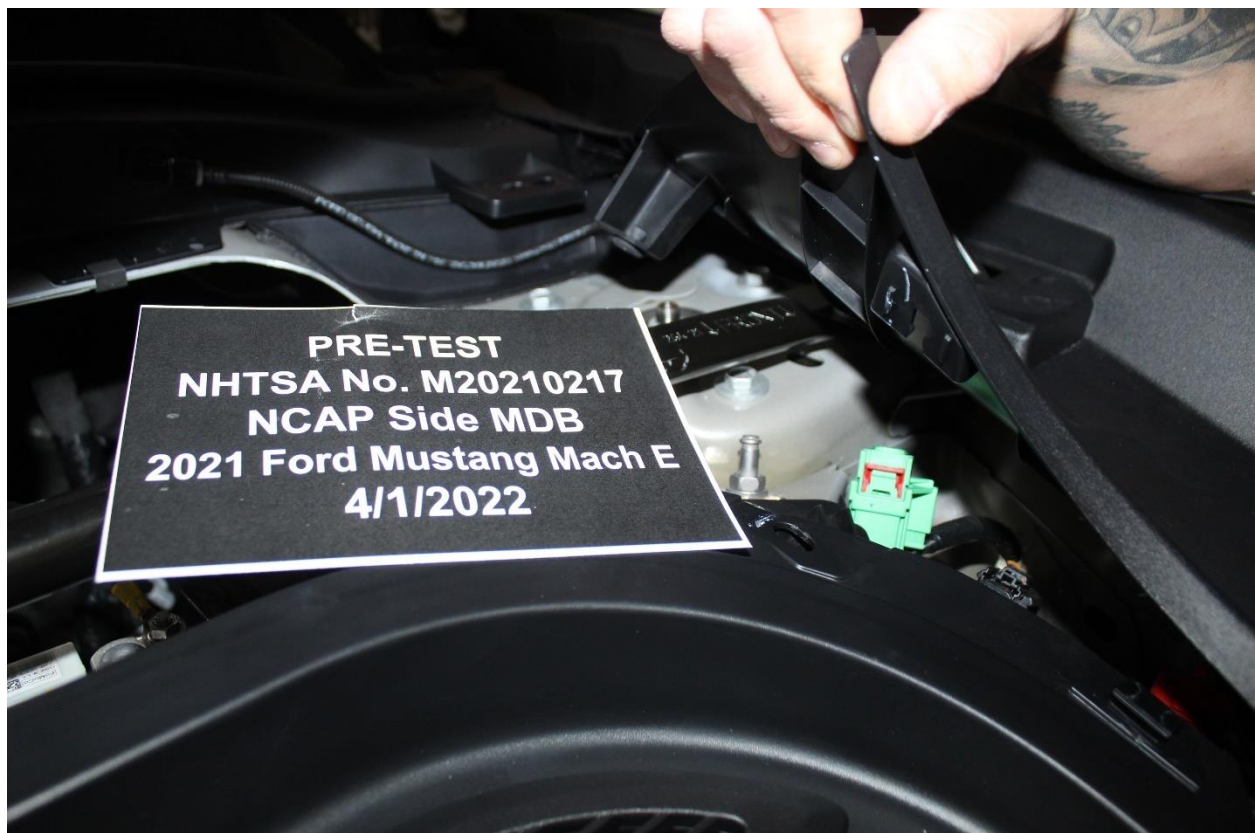
Figure 305-6: Manual High Voltage Service Disconnect in Place

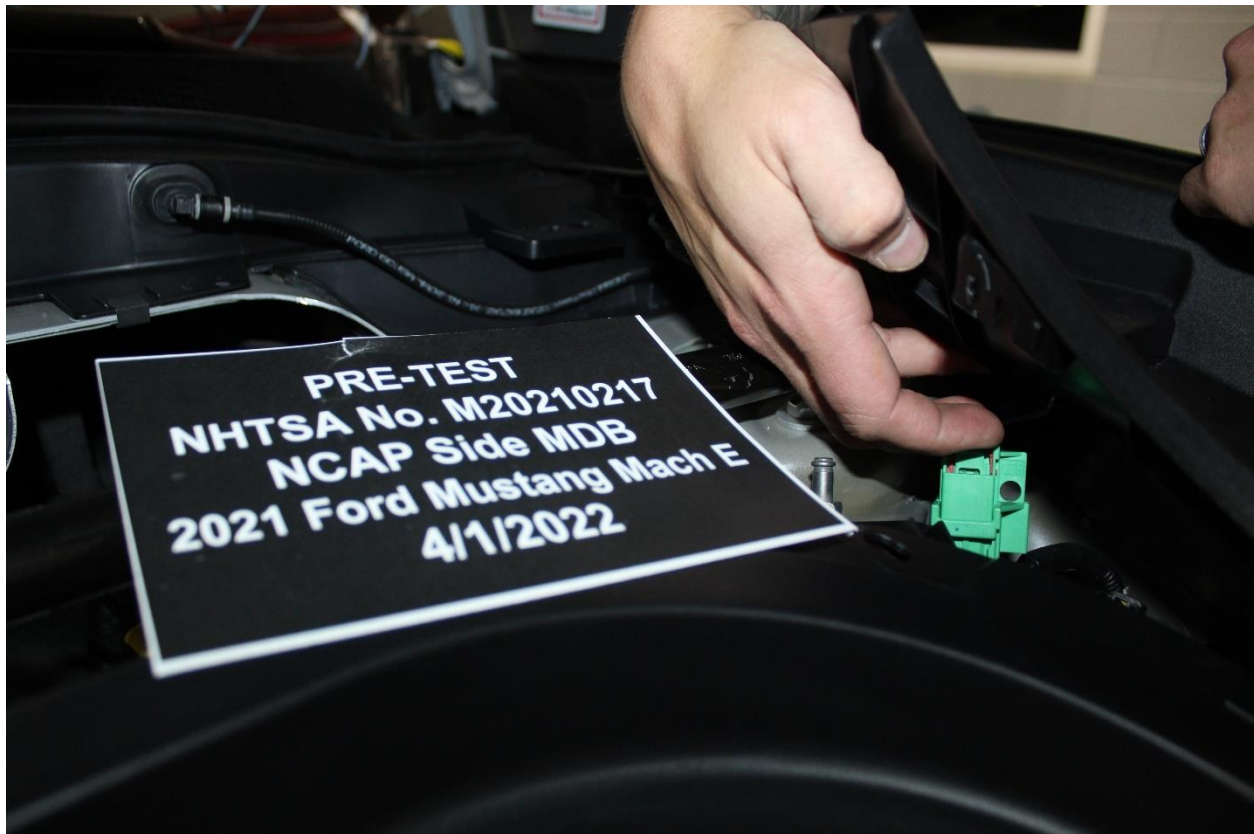
**Figure 305-7: Manual High Voltage Service Disconnect Removed (Show Plug)**

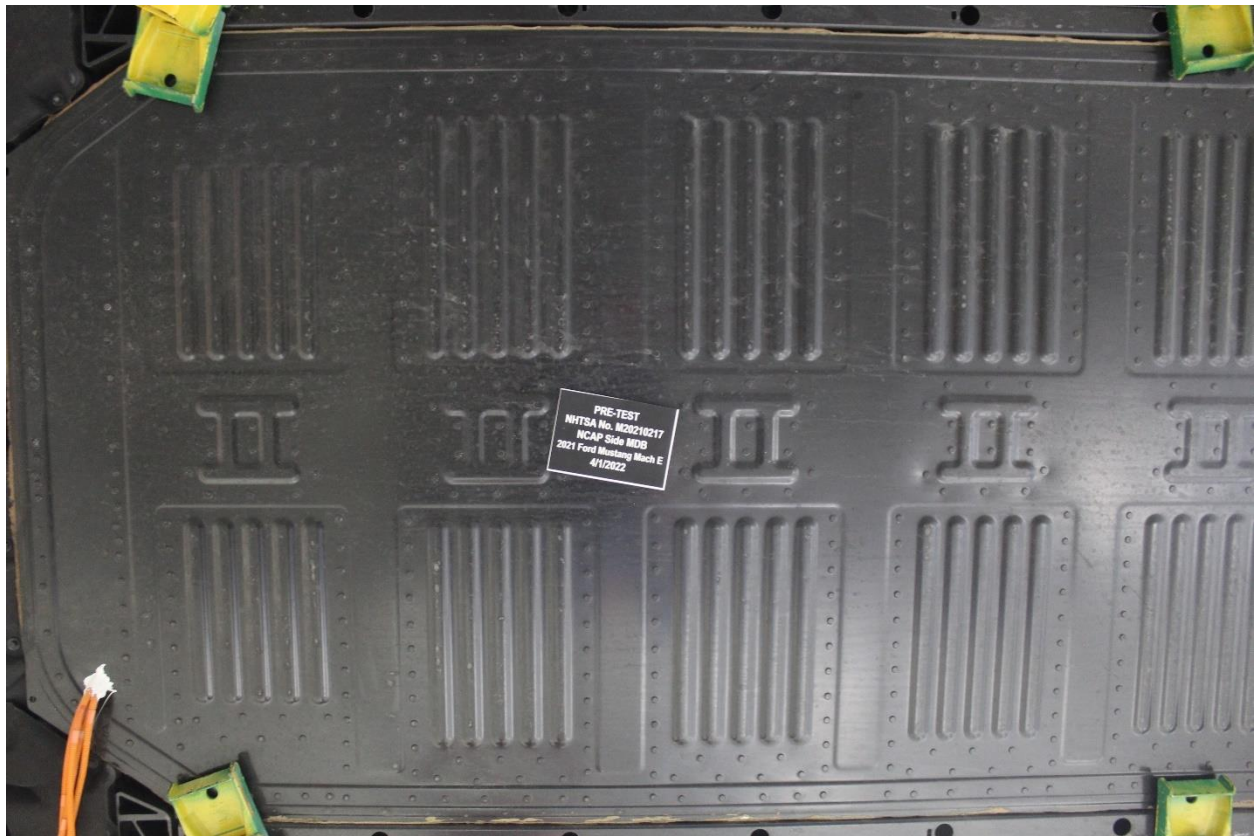
**Figure 305-9: Pre-Impact View of Propulsion Battery**

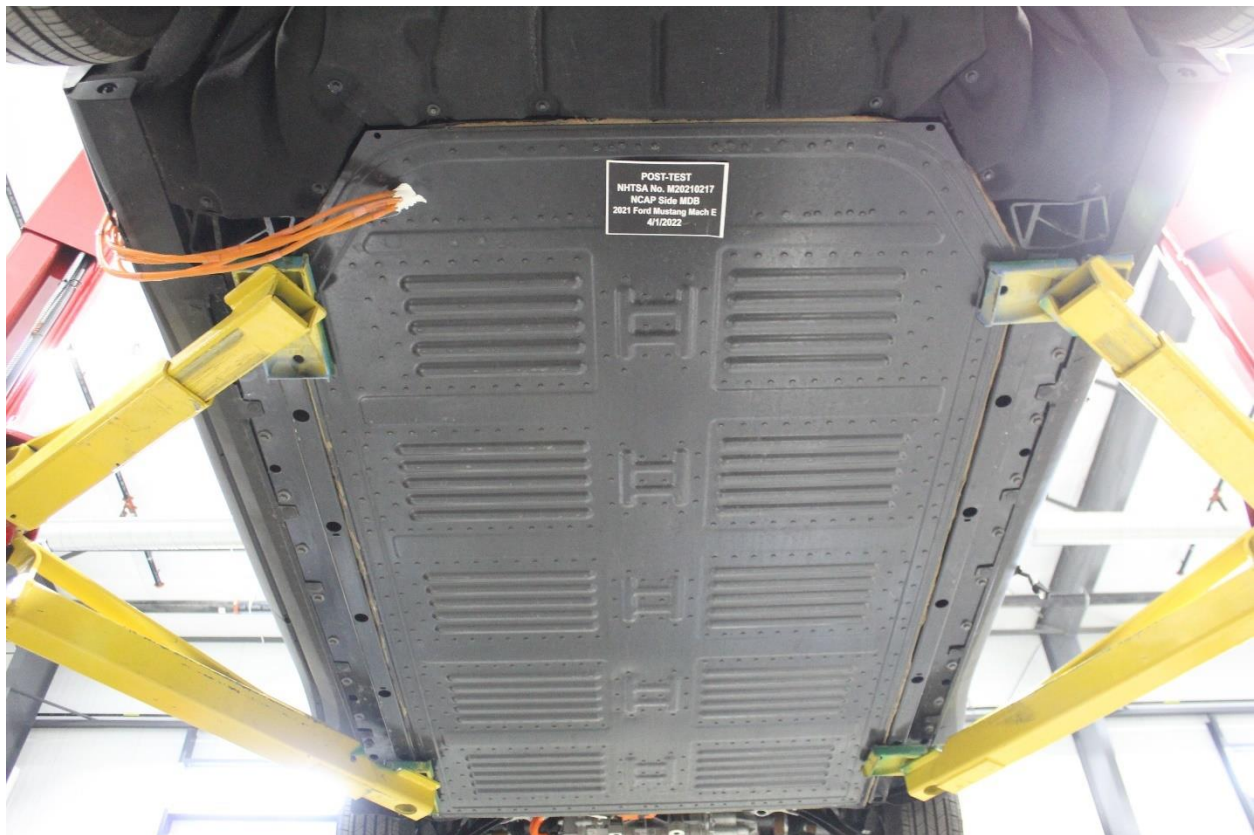
**Figure 305-10: Post-Impact Front View of Propulsion Battery**

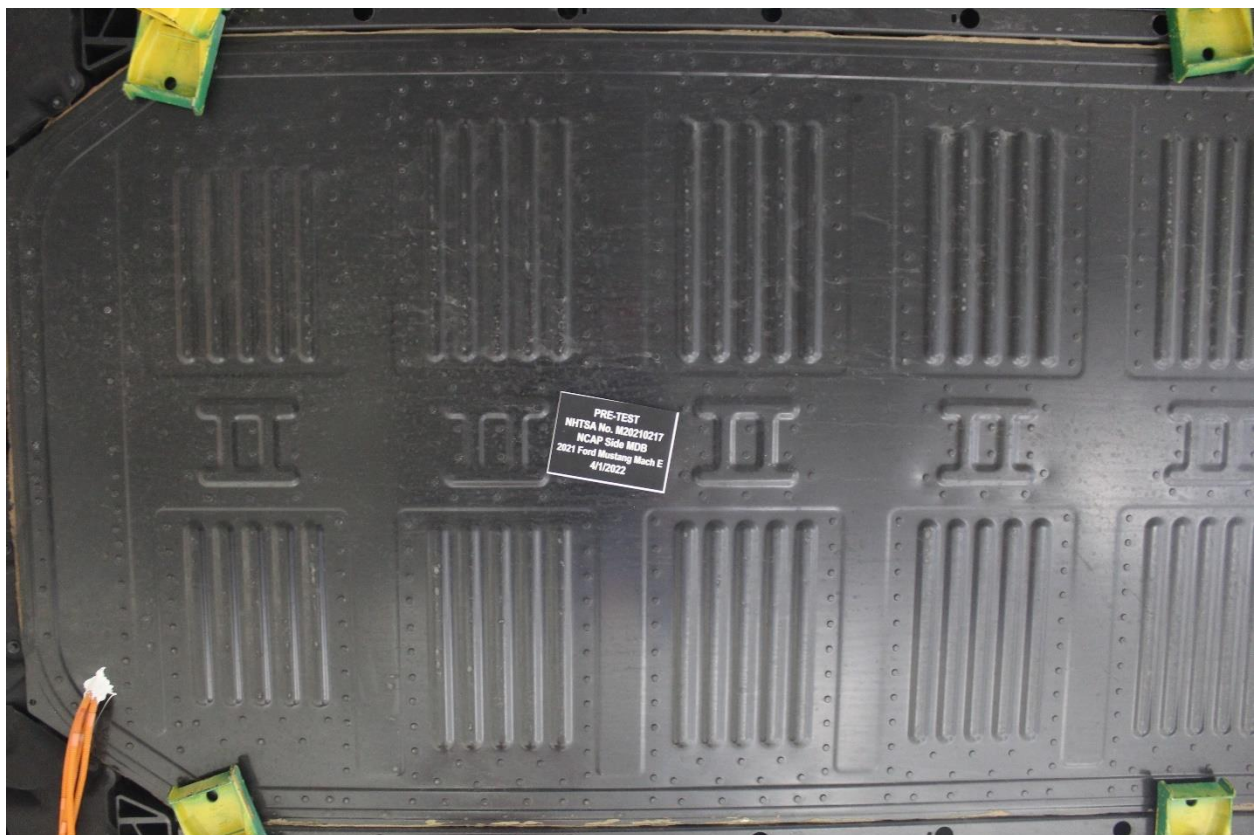
**Figure 305-12: Pre-Impact View of Battery Box(s) or Container(s) Which Holds Individual Battery Modules**

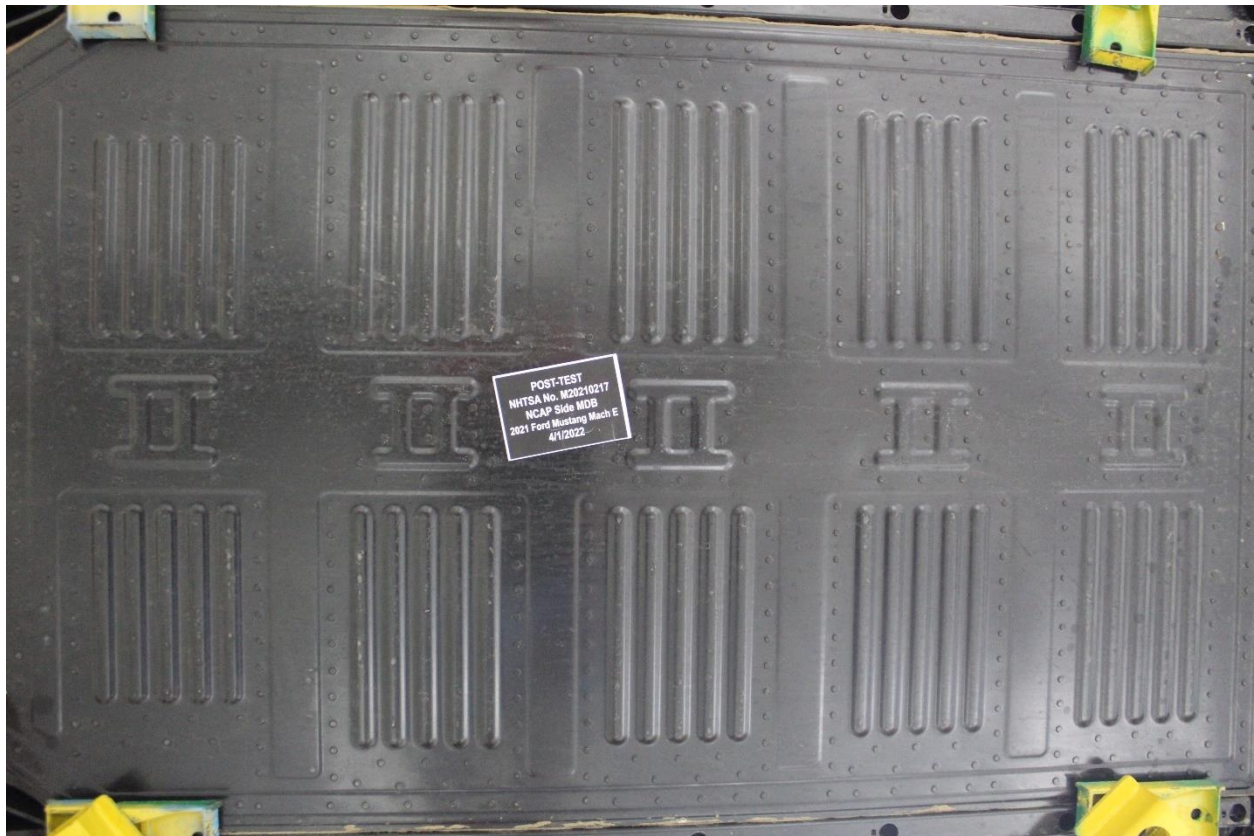
**Figure 305-13: Post-Impact View of Battery Box(s) or Container(s) Which Holds Individual Battery Modules**
