**REPORT NUMBER: SideNCAPMDB-KAR-22-001**

**NEW CAR ASSESSMENT PROGRAM (NCAP)  
MOVING DEFORMABLE BARRIER SIDE IMPACT TEST**

**VOLKSWAGEN DE MEXICO  
2022 VOLKSWAGEN TAOS 5-DOOR MPV**

**NHTSA No: M20225805**

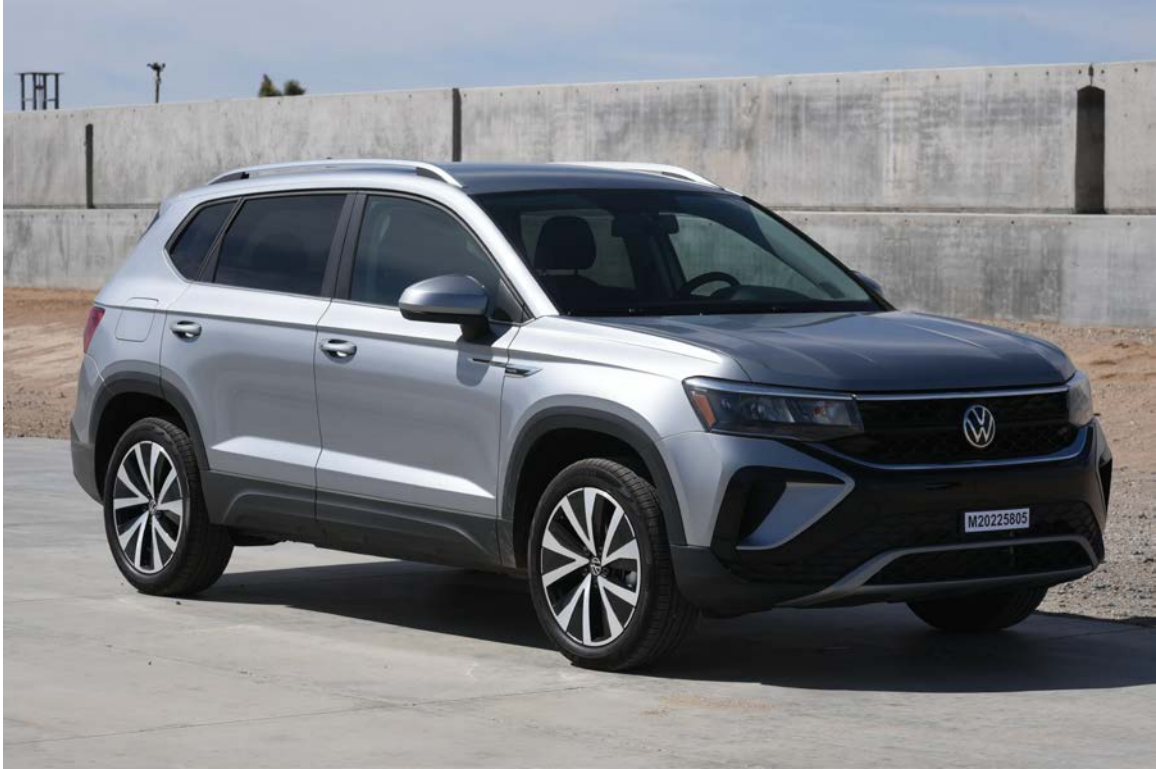
FIGURE 1. As-Delivered Right Front  $\frac{3}{4}$  View of Test Vehicle

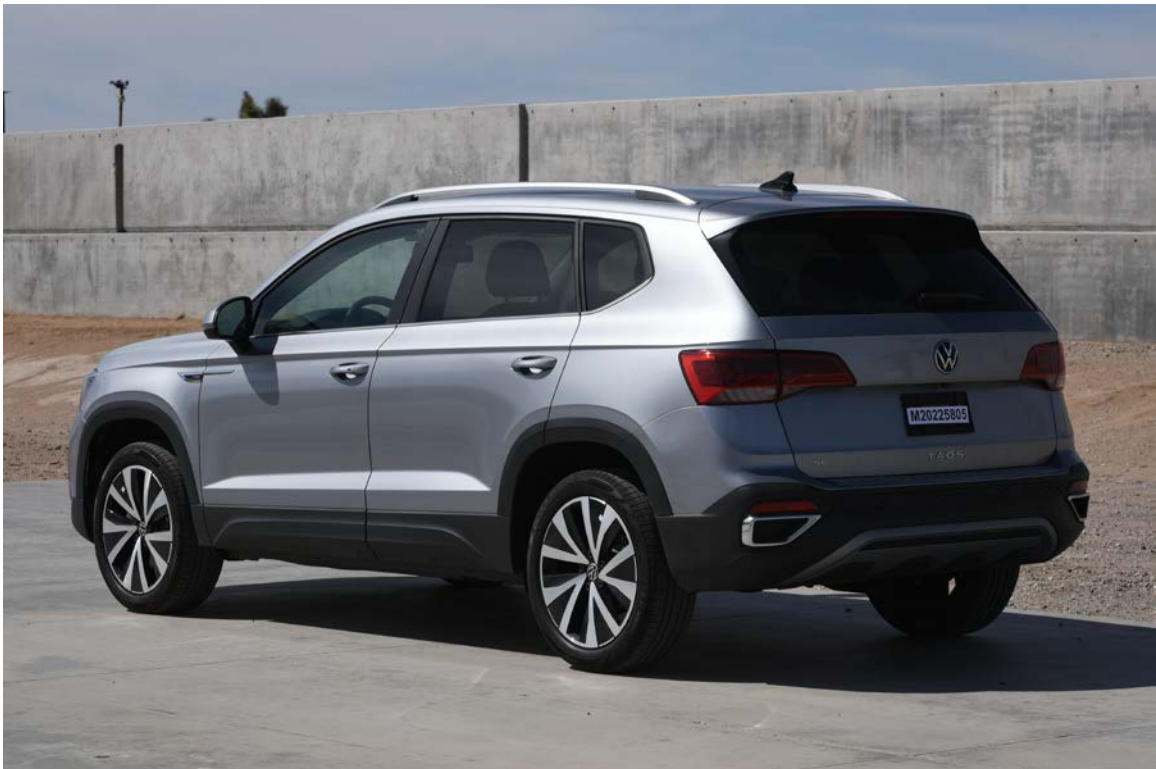
FIGURE 2. As-Delivered Left Rear  $\frac{3}{4}$  View of Test Vehicle

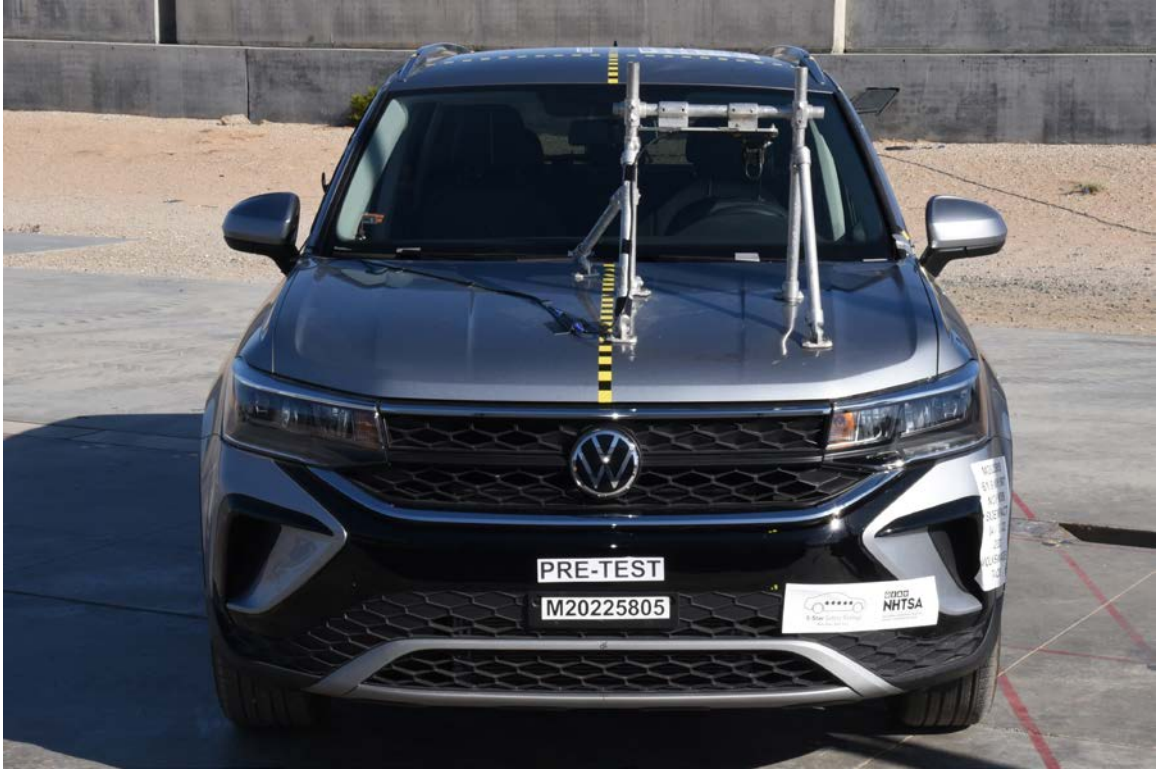
FIGURE 3. Pre-Test Frontal View of Test Vehicle

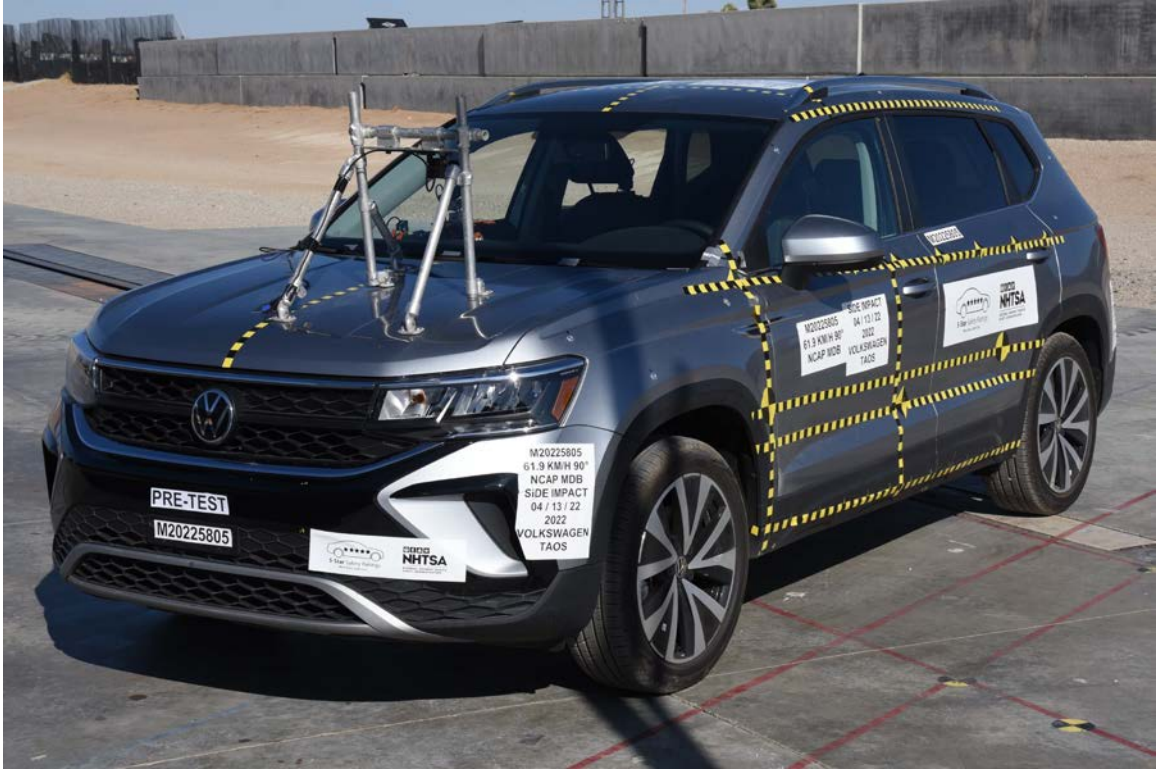
FIGURE 5. Pre-Test Left Front  $\frac{3}{4}$  View of Test Vehicle

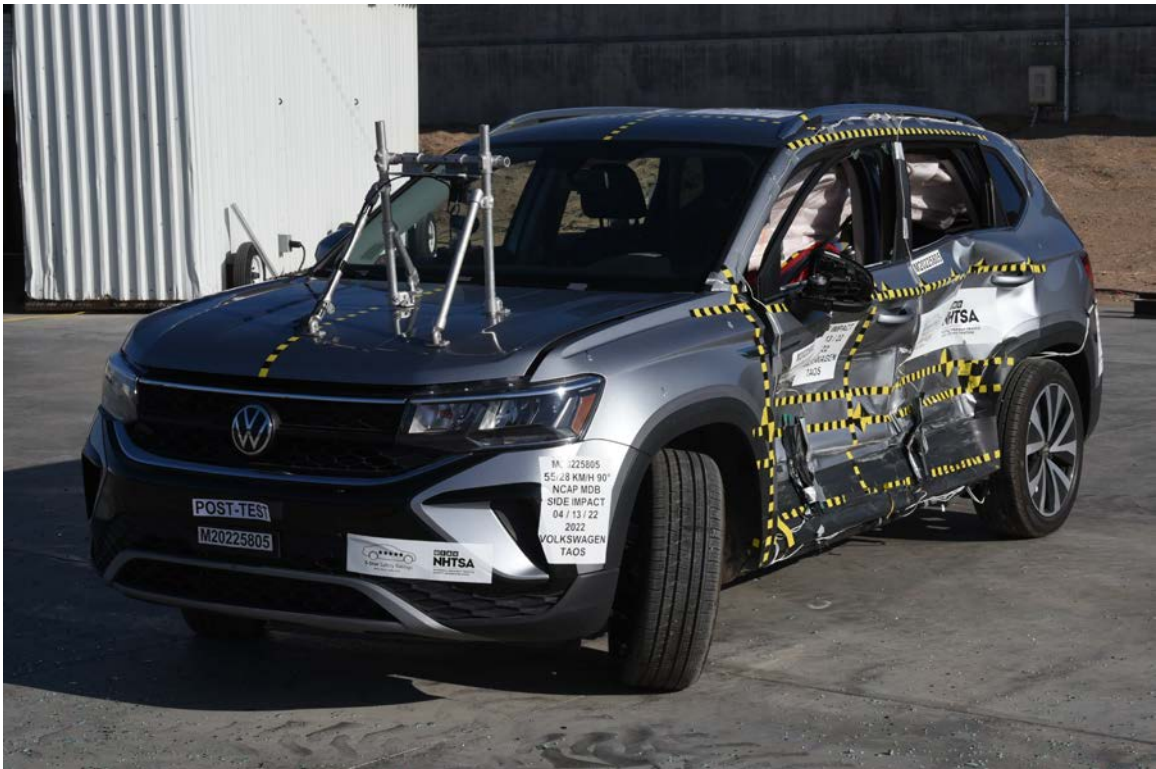
FIGURE 6. Post-Test Left Front  $\frac{3}{4}$  View of Test Vehicle

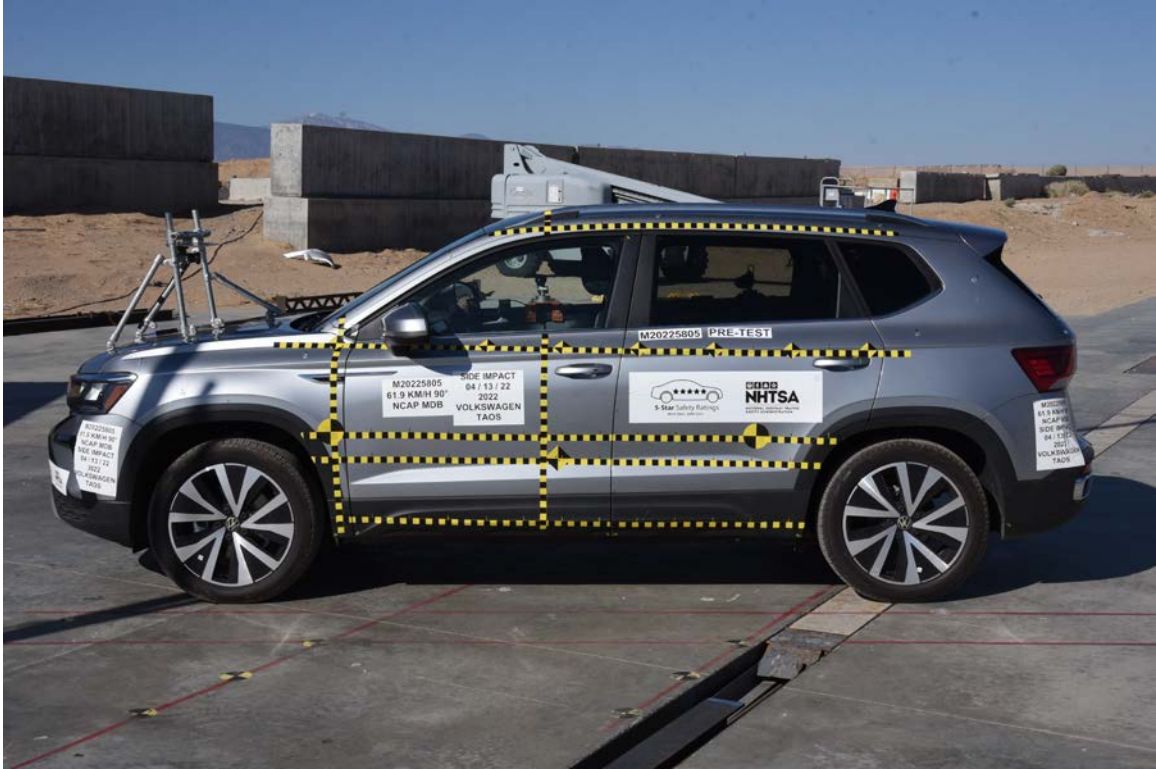
FIGURE 7. Pre-Test Left Side View of Test Vehicle

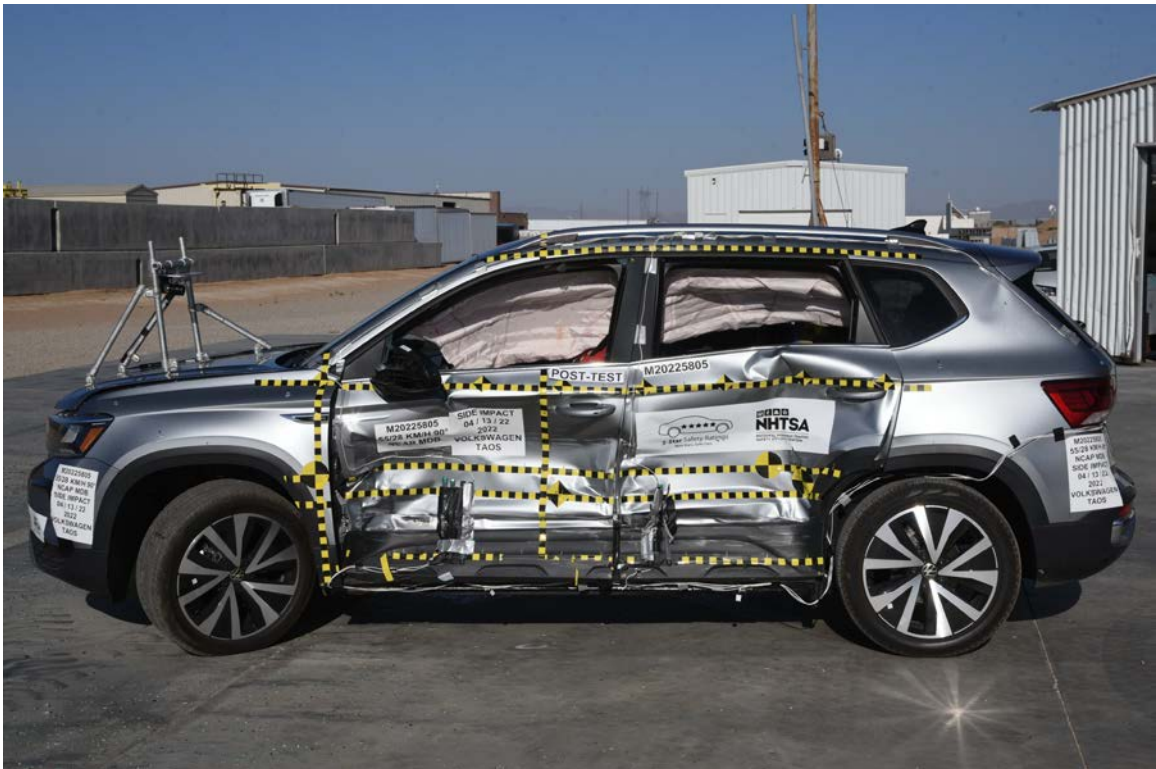
FIGURE 8. Post-Test Left Side View of Test Vehicle

| Critical Areas of Performance | Observations and Conclusions |
|---|---|
| Side Window Damage | Broken |

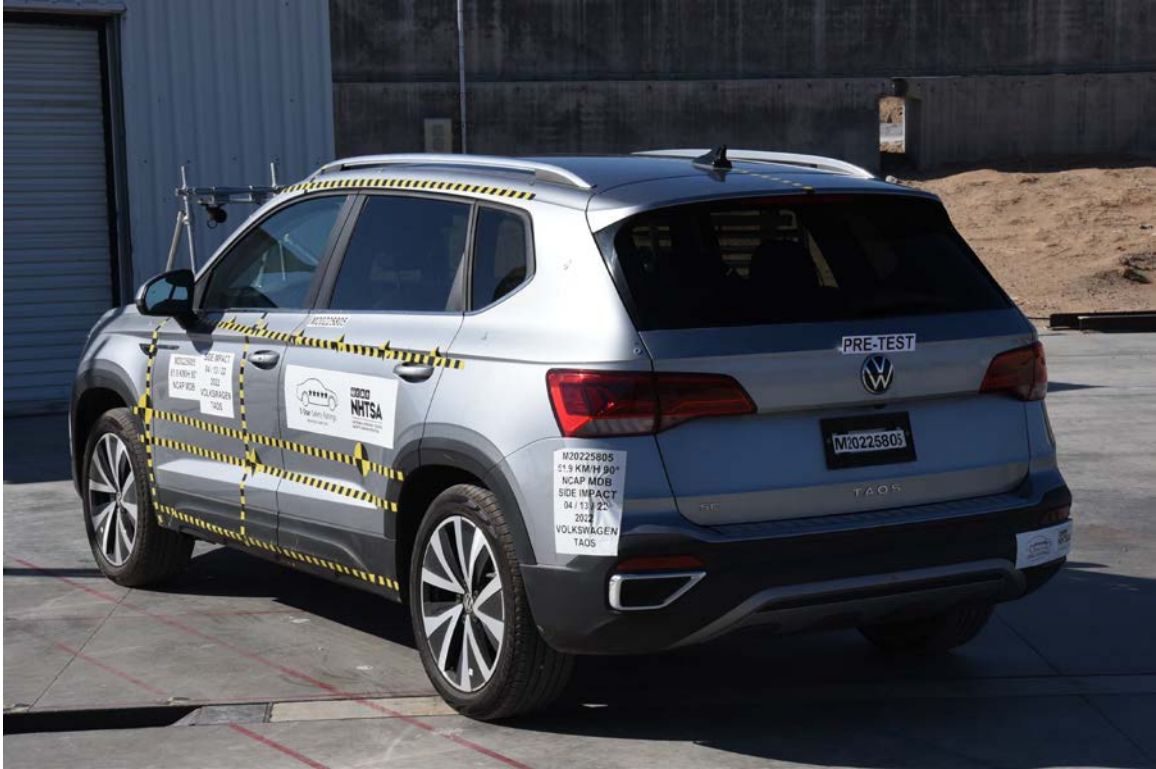
FIGURE 9. Pre-Test Left Rear  $\frac{3}{4}$  View of Test Vehicle

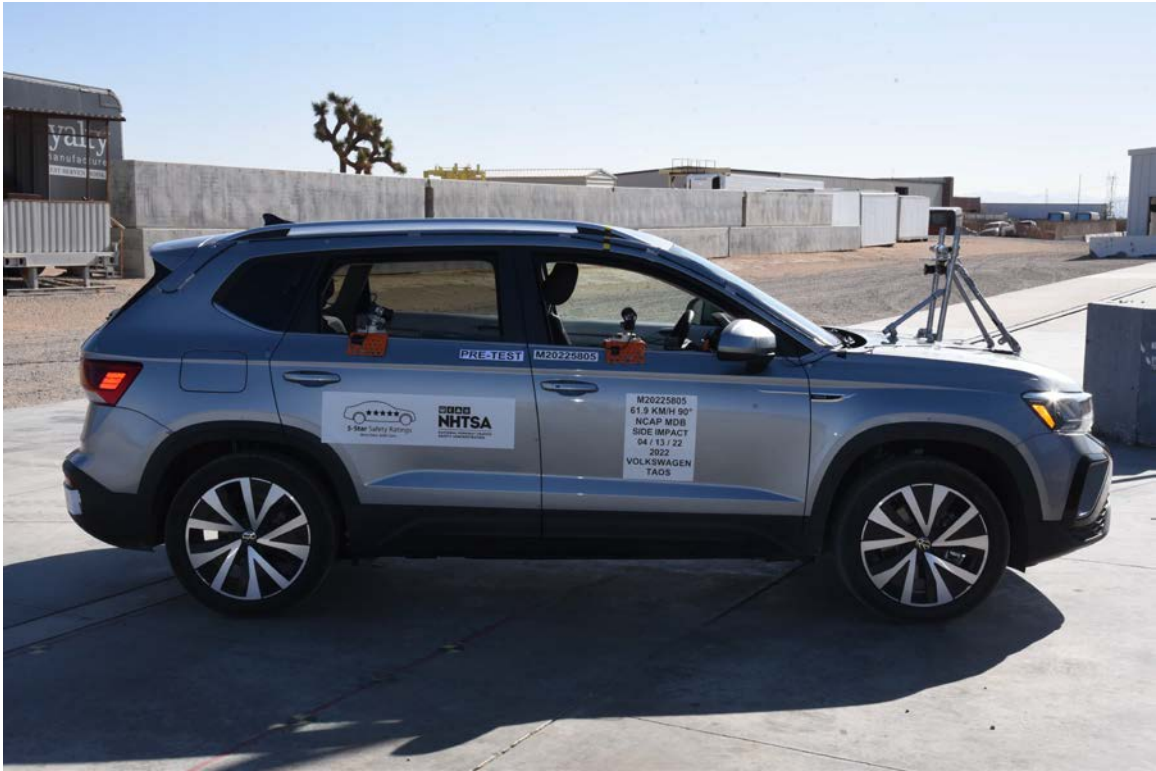
FIGURE 13. Pre-Test Right Side View of Test Vehicle

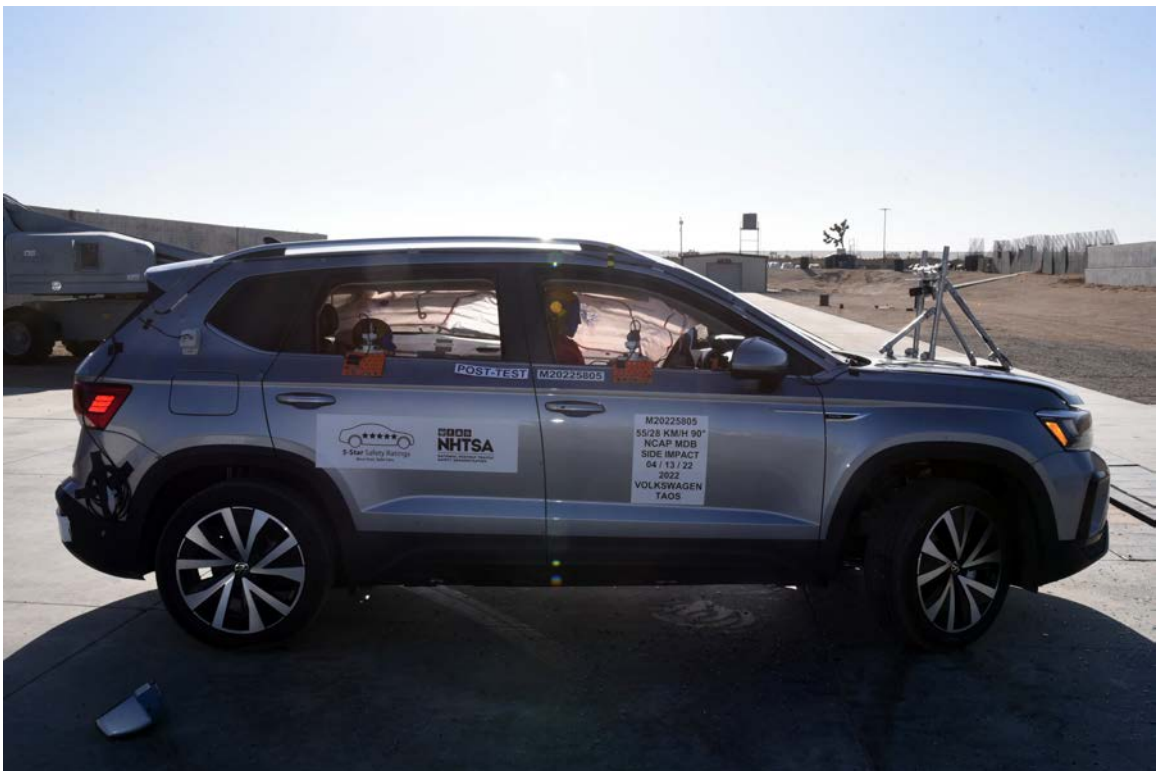
FIGURE 14. Post-Test Right Side View of Test Vehicle

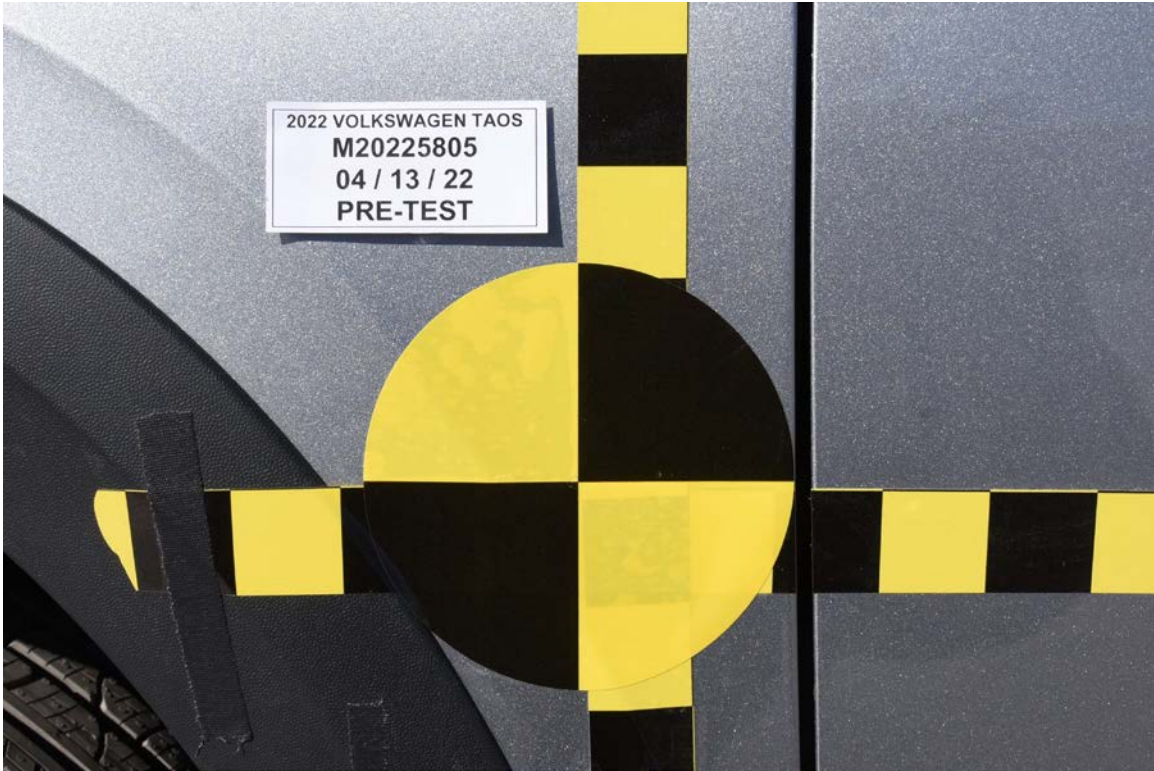
FIGURE 19. Pre-Test Close-Up View of Impact Point Target

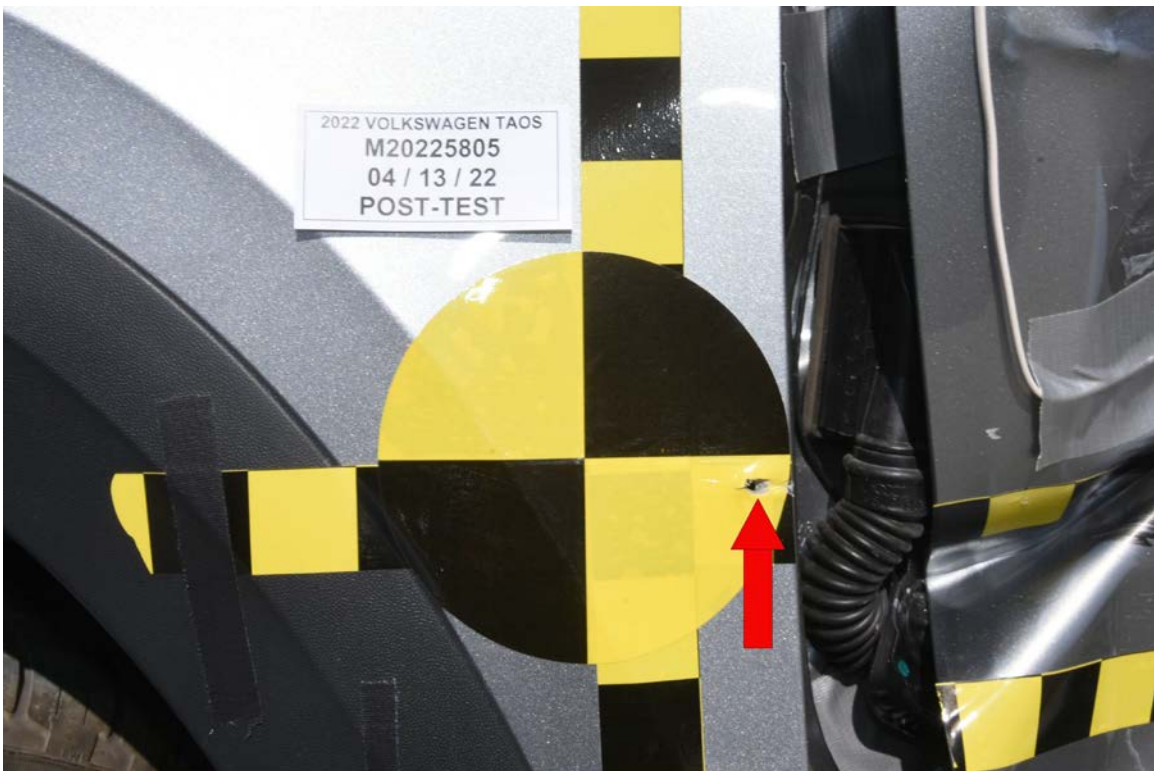
FIGURE 20. Post-Test Close-Up View of Impact Point Target

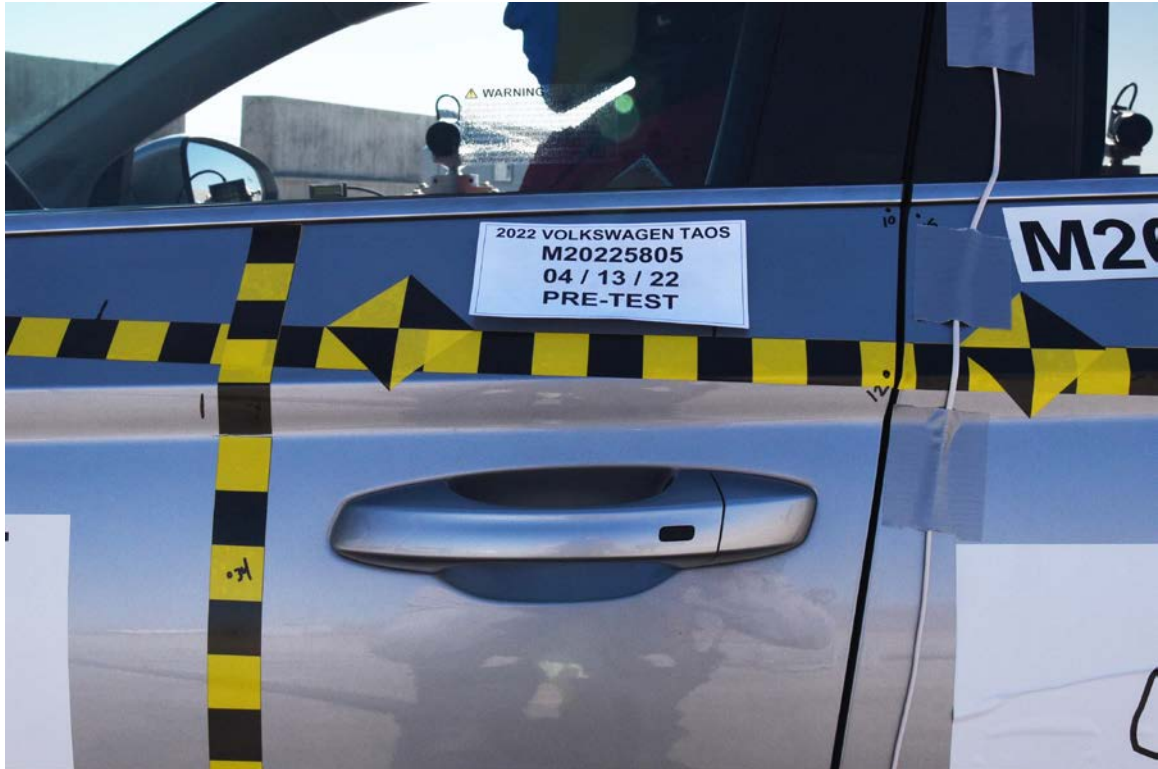
FIGURE 21. Pre-Test Left Front Door Latch Close-Up

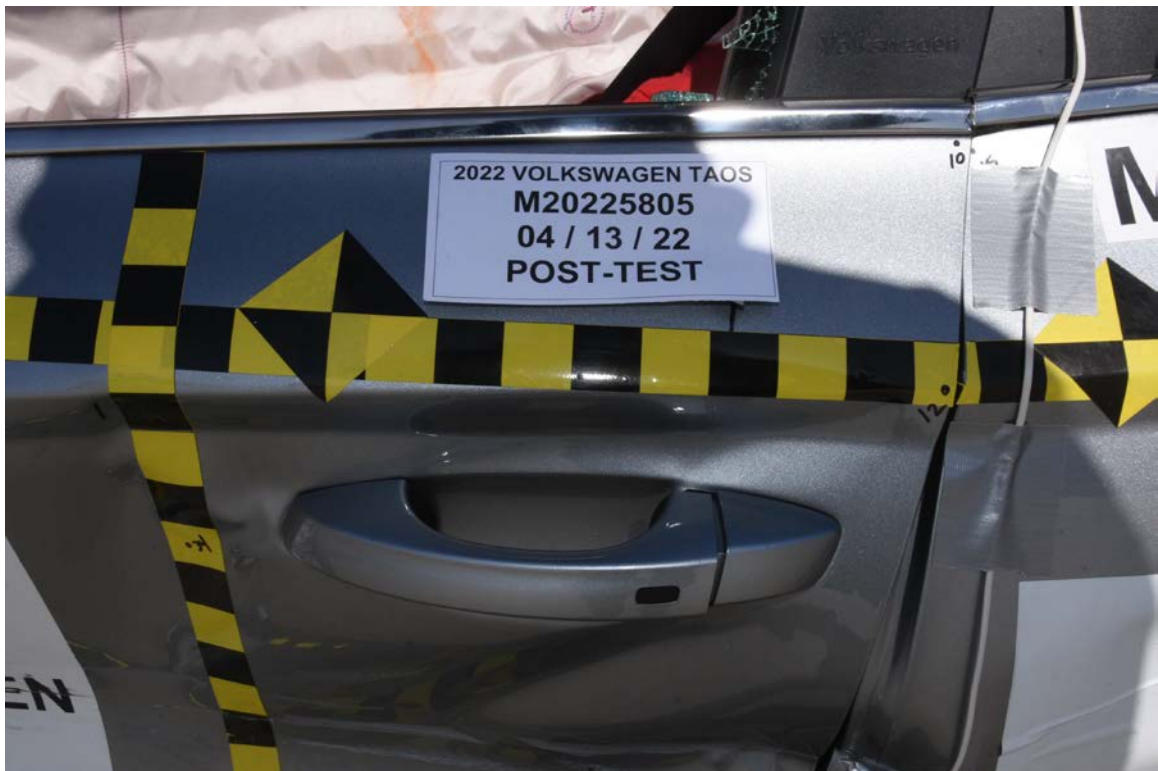
FIGURE 22. Post-Test Left Front Door Latch Close-Up

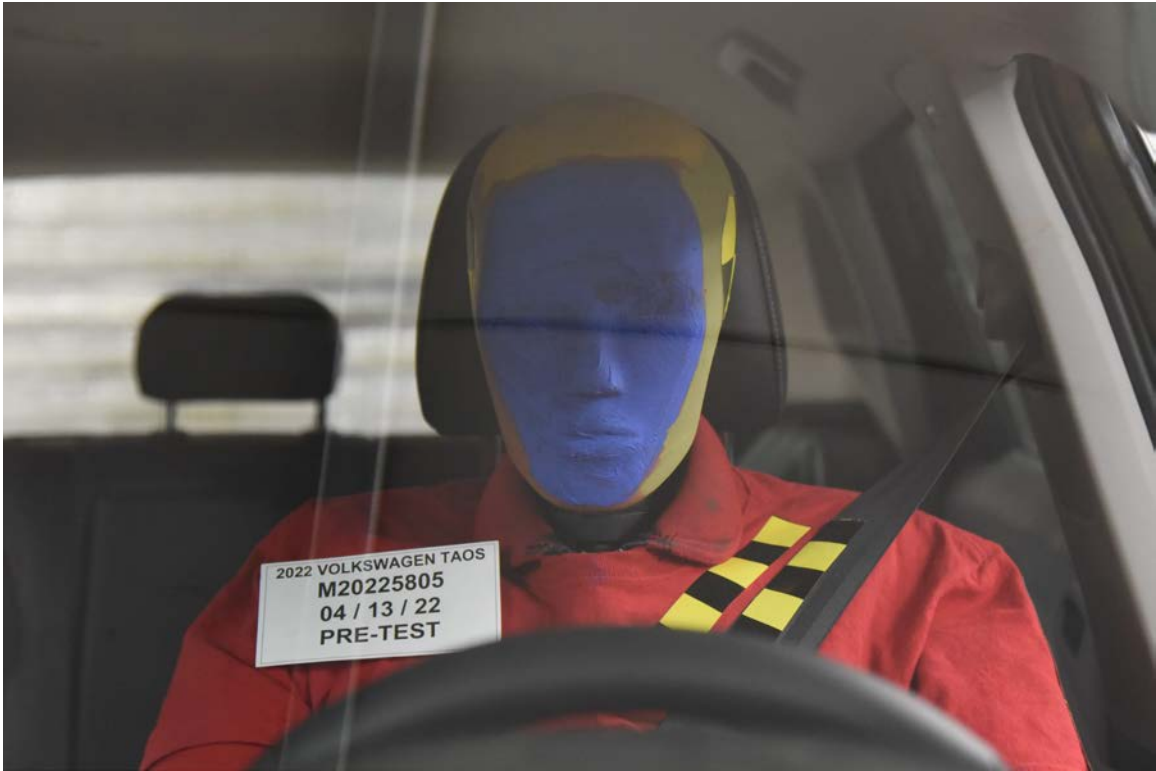
FIGURE 25. Pre-Test Front Close-Up View of Driver Dummy

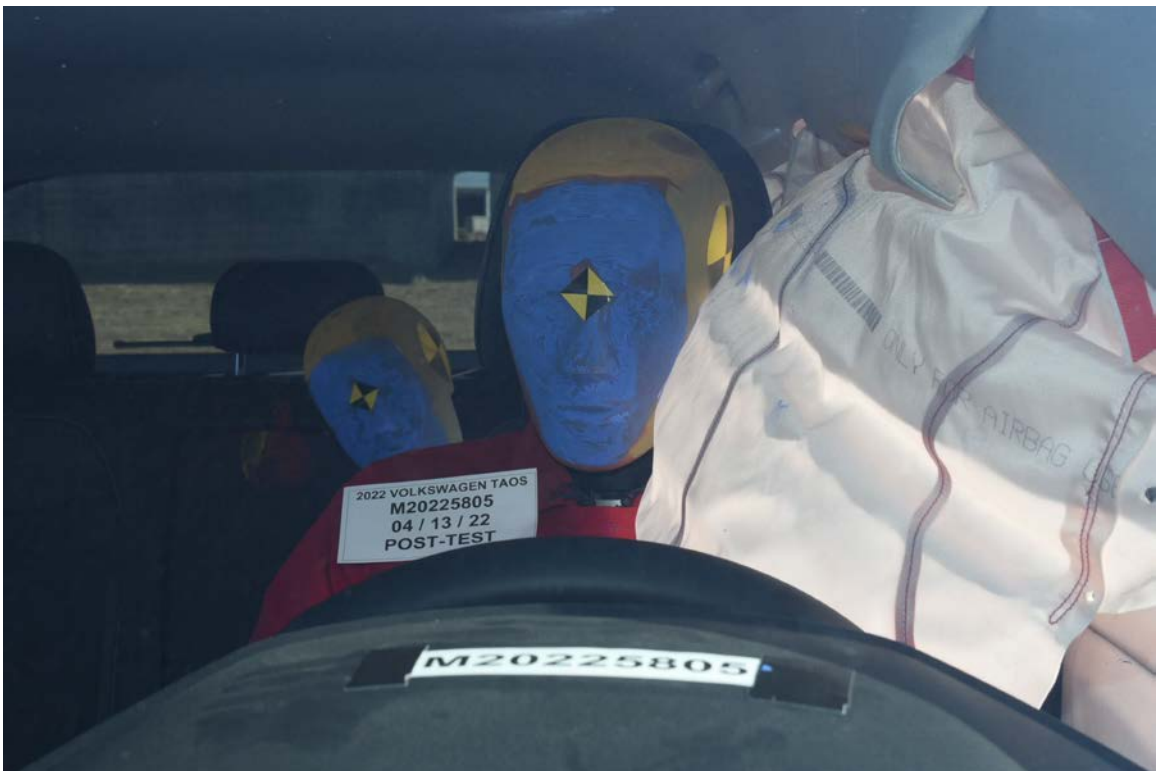
FIGURE 26. Post-Test Front Close-Up View of Driver Dummy

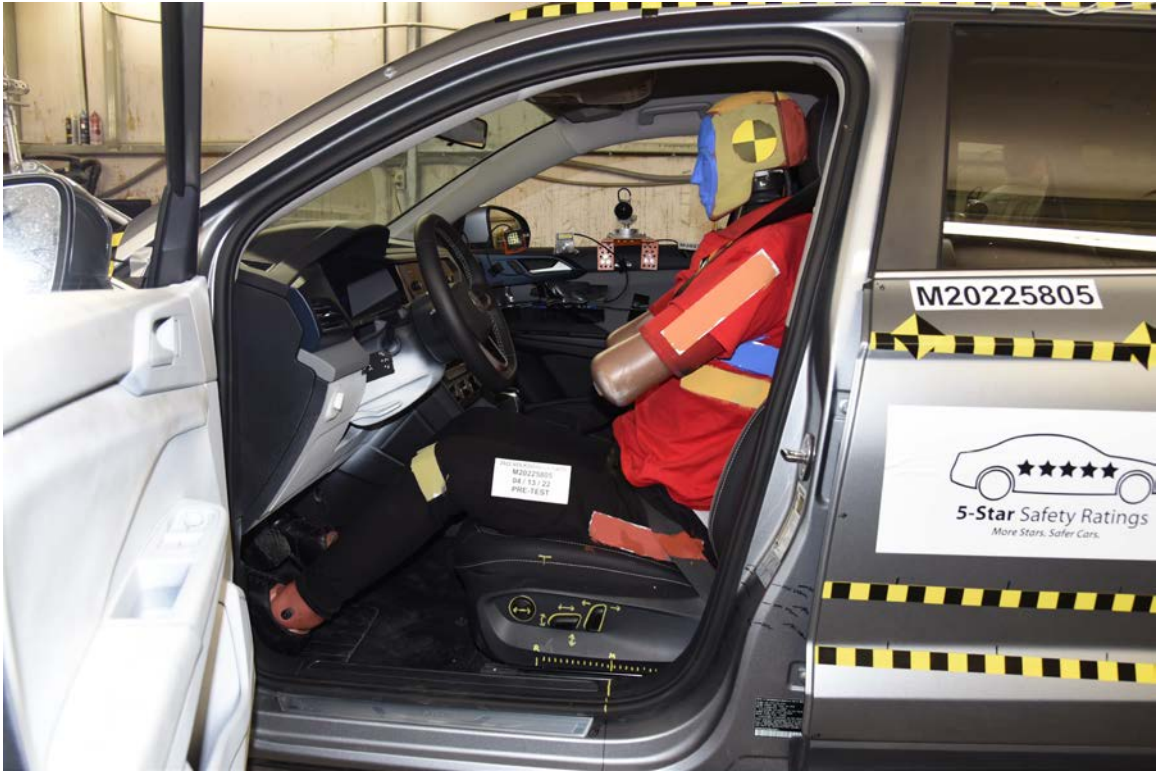
FIGURE 27. Pre-Test Left Side View of Driver Dummy  
Showing Belt and Chalking

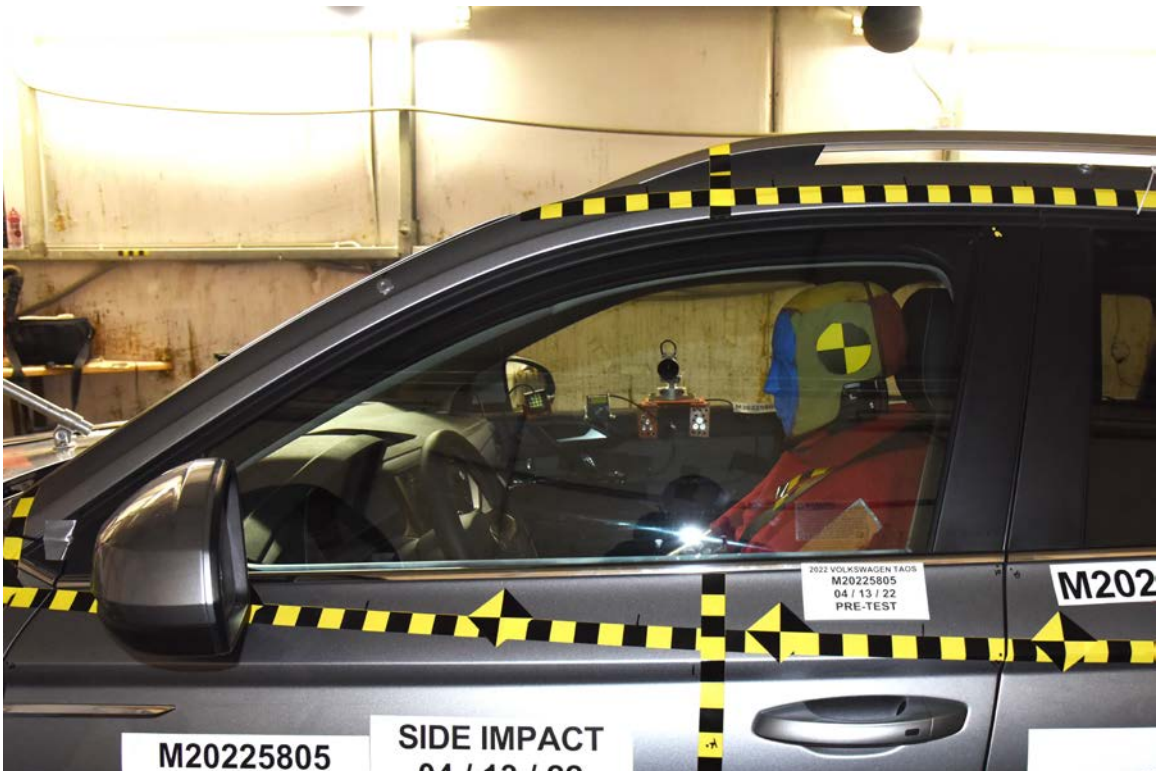
FIGURE 28. Pre-Test Left Side View of Driver Dummy Shoulder and Door Top View

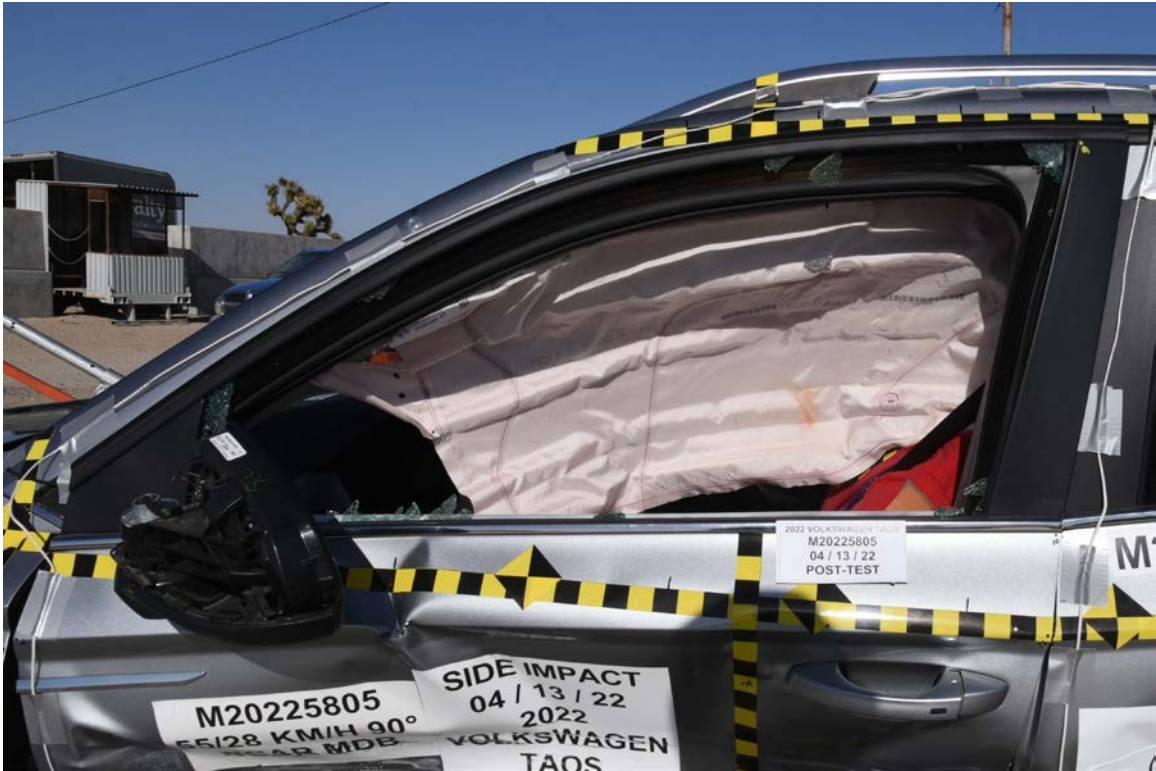
FIGURE 29. Post-Test Left Side View of Driver Dummy Shoulder and Door Top View

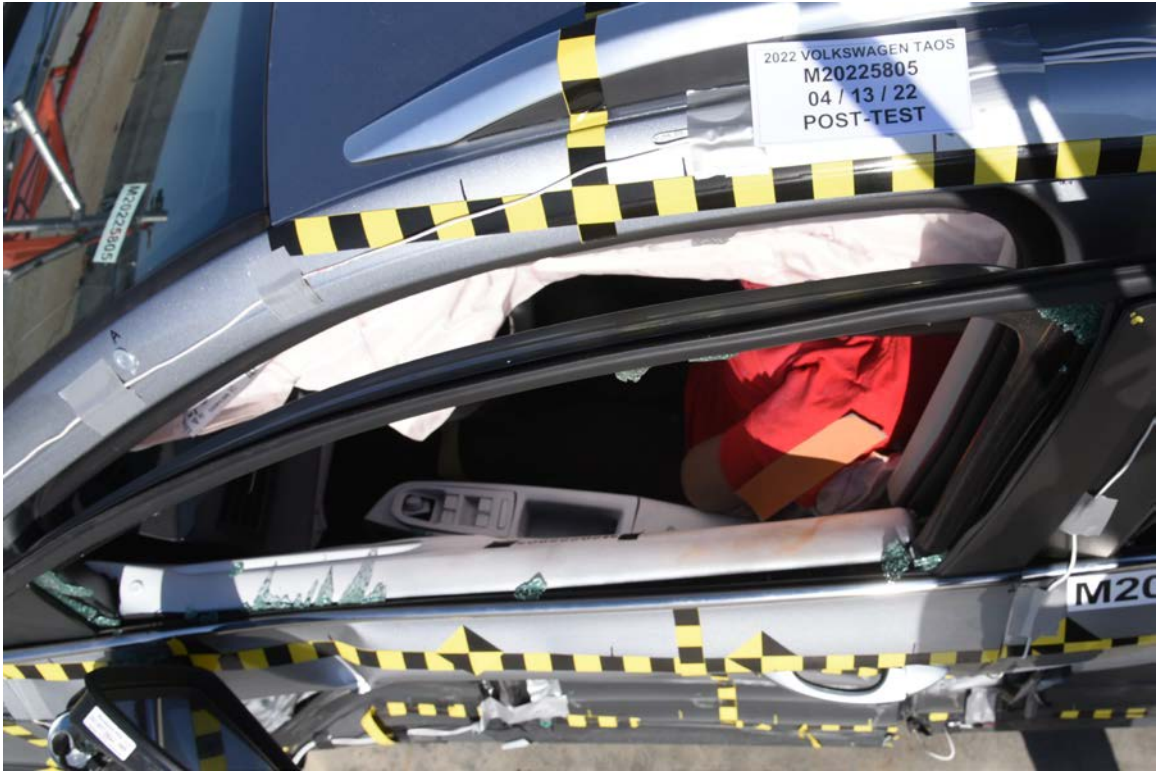
FIGURE 43. Post-Test Driver Dummy and Door Clearance View

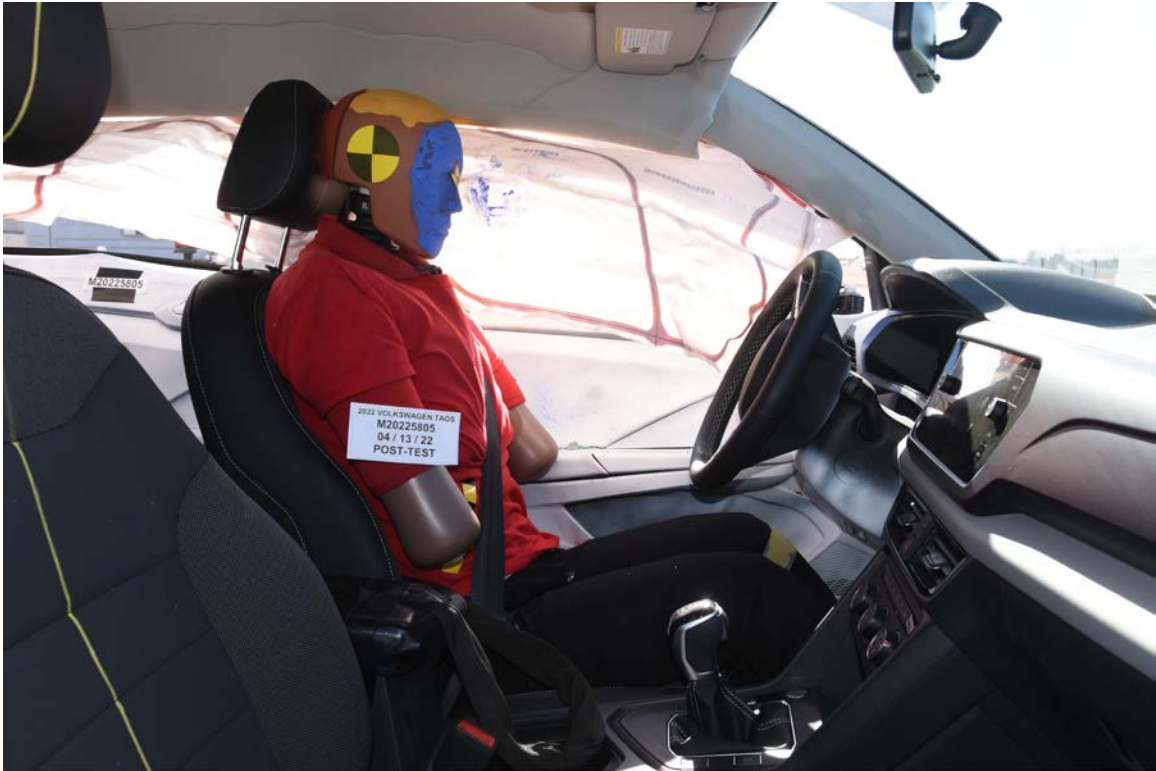
FIGURE 45. Post-Test Right Side View of Driver Dummy and Front Seat Occupant Compartment

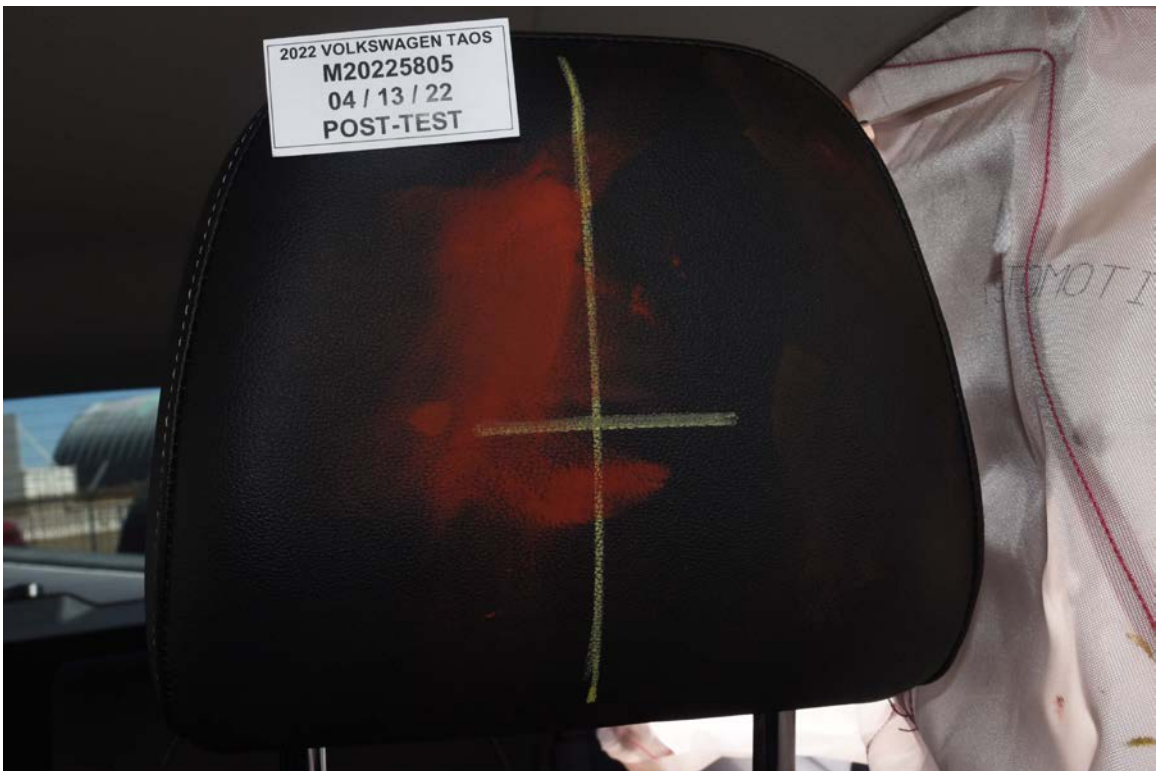
FIGURE 48. Post-Test Driver Dummy Close-Up Head Contact  
with Vehicle Interior View

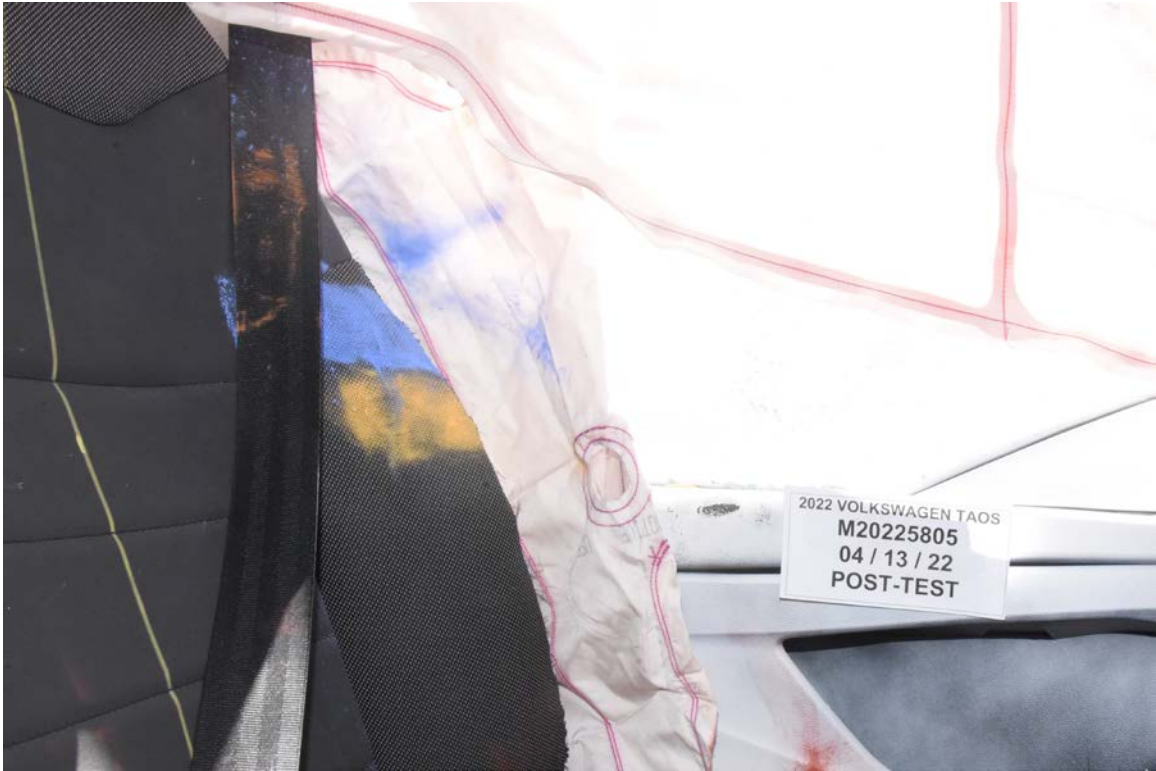
FIGURE 51. Post-Test Driver Dummy Close-Up Torso Contact with Side Airbag View

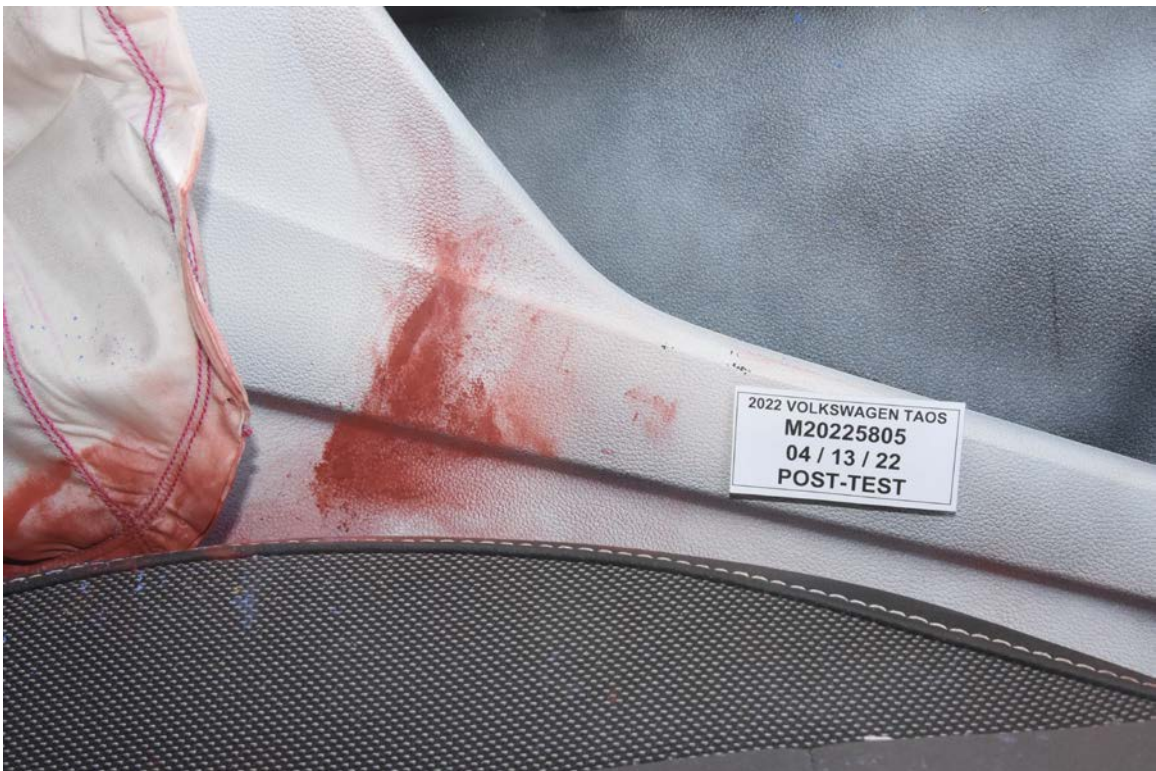
FIGURE 52. Post-Test Driver Dummy Close-Up Pelvis Contact  
with Vehicle Interior View

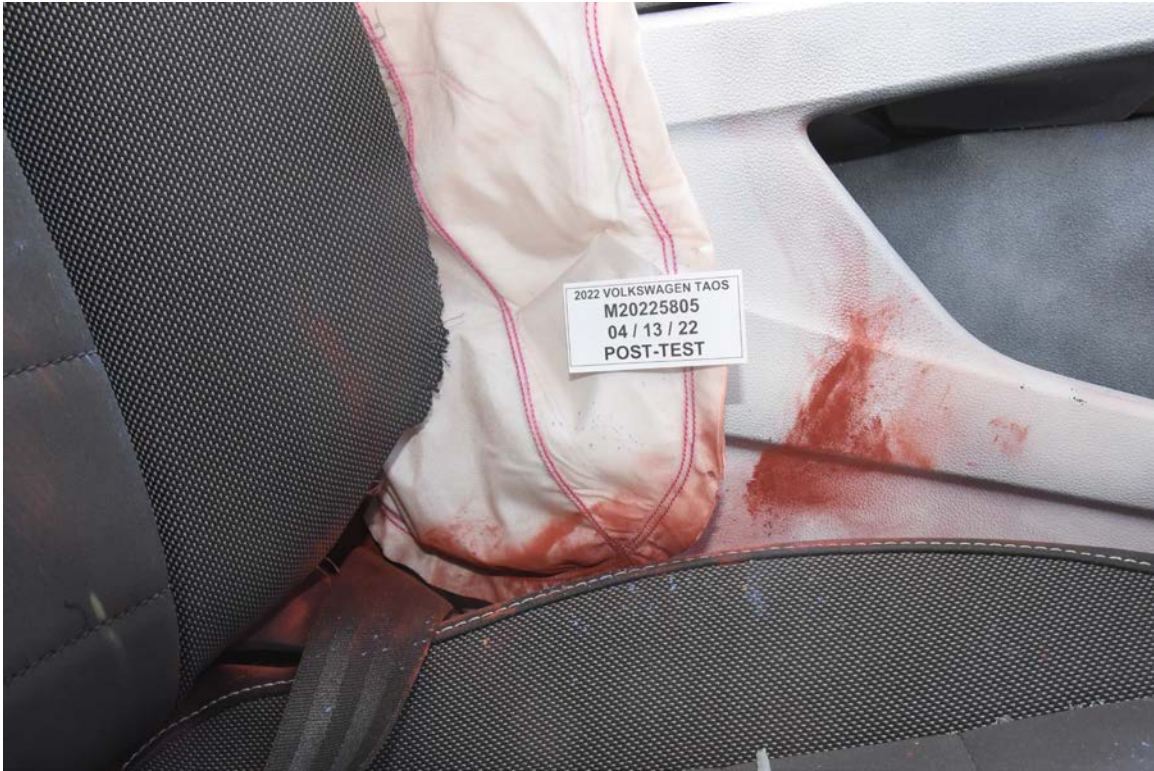
FIGURE 53. Post-Test Driver Dummy Close-Up Pelvis Contact with Side Airbag View
