**REPORT NUMBER: SideNCAPMDB-KAR-22-001**

**NEW CAR ASSESSMENT PROGRAM (NCAP)  
MOVING DEFORMABLE BARRIER SIDE IMPACT TEST**

**VOLKSWAGEN DE MEXICO  
2022 VOLKSWAGEN TAOS 5-DOOR MPV**

**NHTSA No: M20225805**

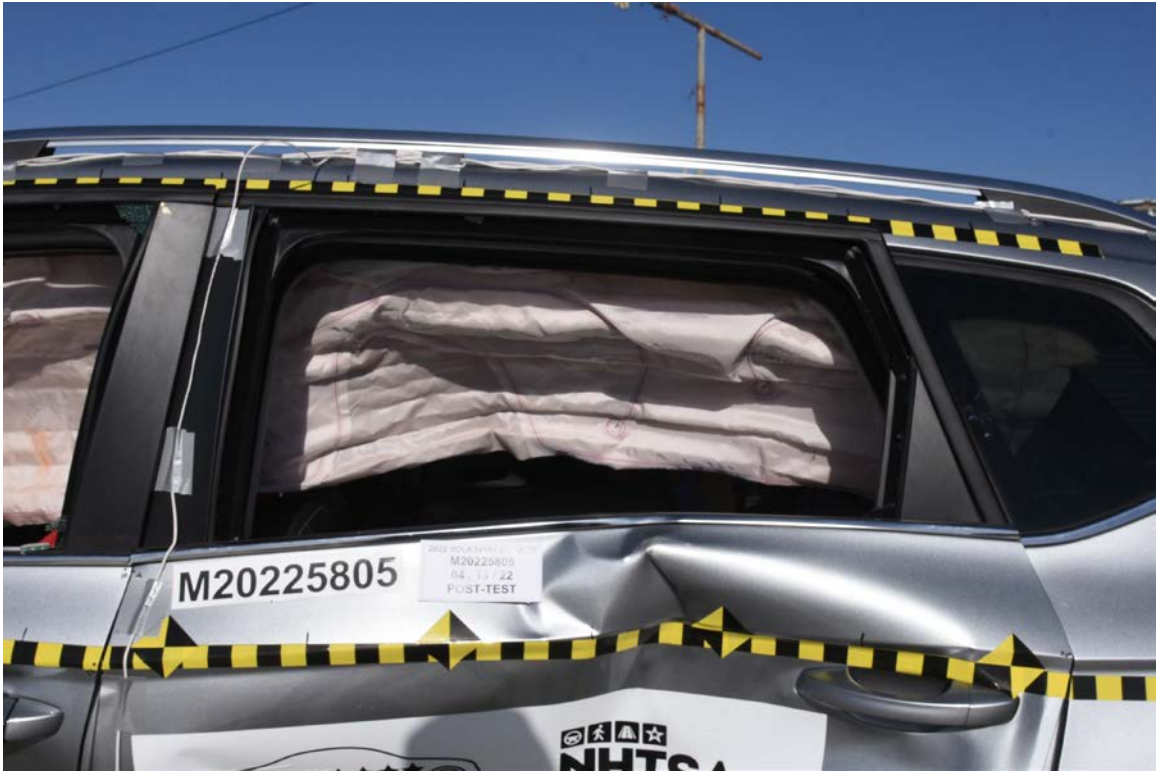
FIGURE 57. Post-Test Left Side View of Rear Passenger Dummy Shoulder and Door Top View

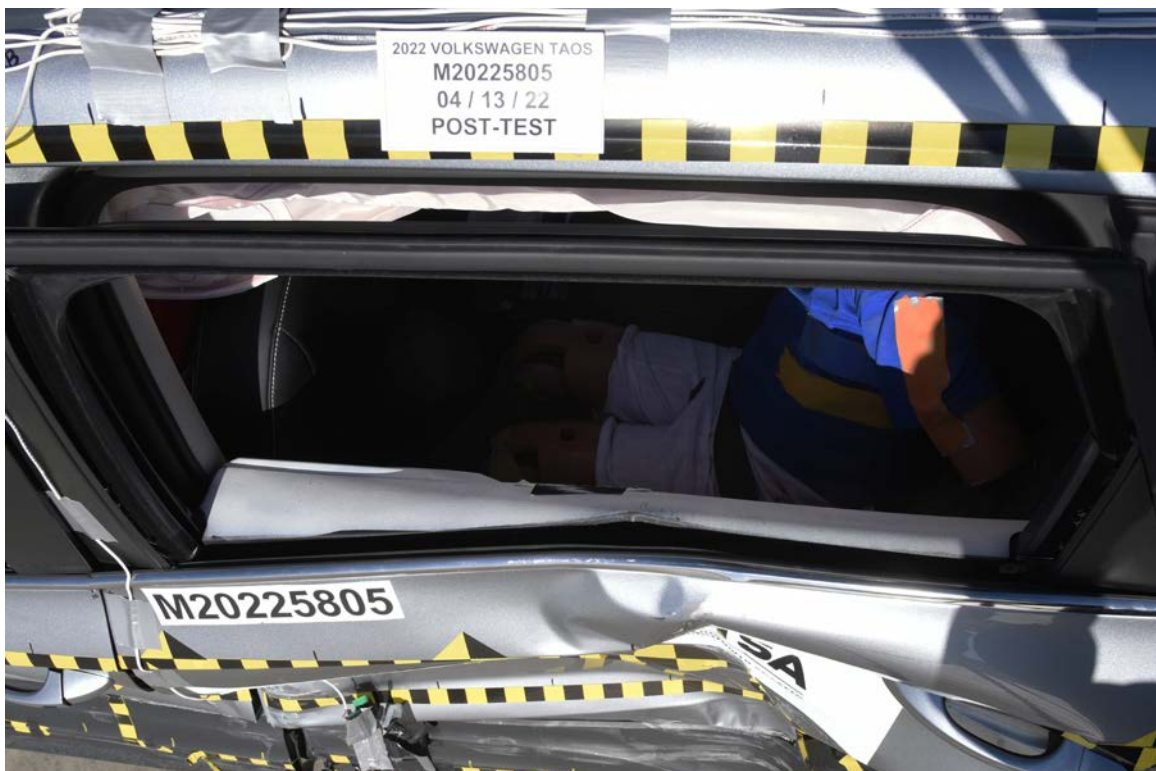
FIGURE 70. Post-Test Rear Passenger Dummy and Door Clearance View
