REPORT NUMBER: NCAP-MGA-22-024

**NEW CAR ASSESSMENT PROGRAM (NCAP)
Frontal Barrier Impact Test**

**NISSAN MOTOR CO., LTD.
2022 Nissan Rogue S AWD 5-Door SUV
NHTSA No.: O20225200**

**MGA RESEARCH CORPORATION
5000 Warren Road
Burlington, WI 53105**

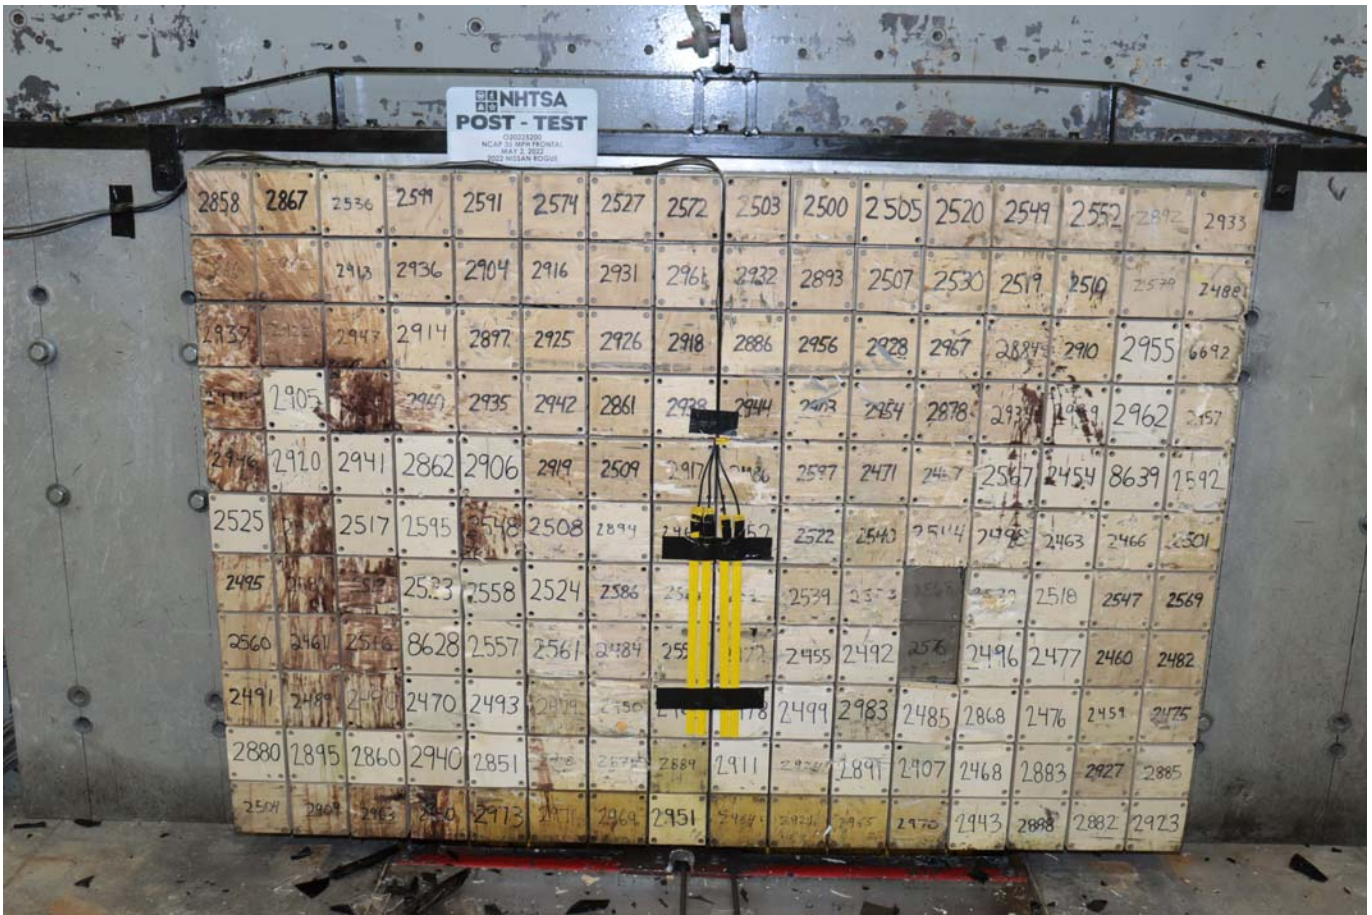
Photo No. 003 - Post-Test Load Cell Wall

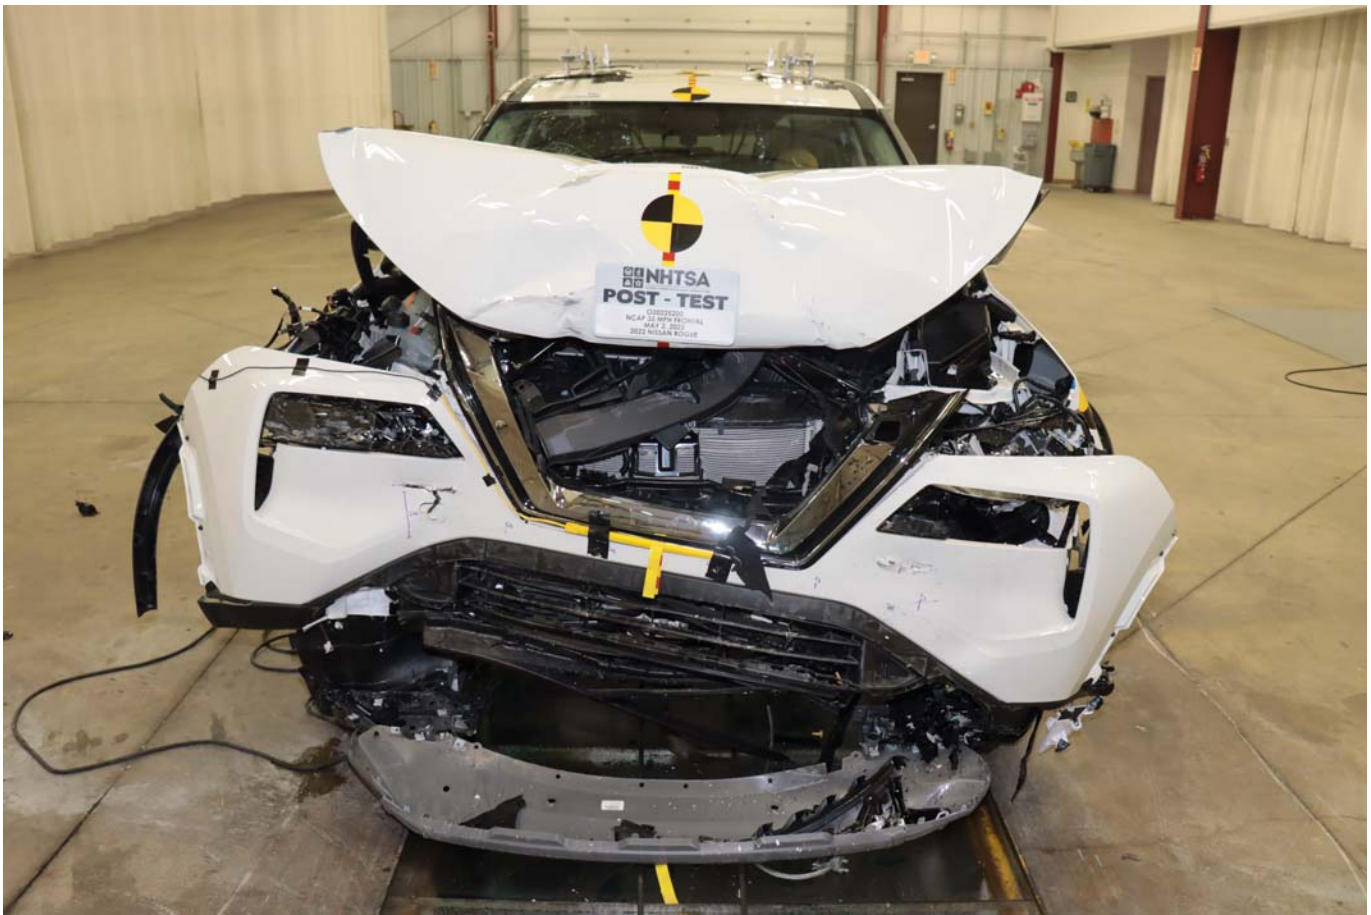
Photo No. 009 - Post-Test Front View of Test Vehicle

The maximum static crush of the vehicle was 523 mm located to the right of the vehicle centerline and both the driver and passenger side doors remained closed during the impact event and were operable after the impact.

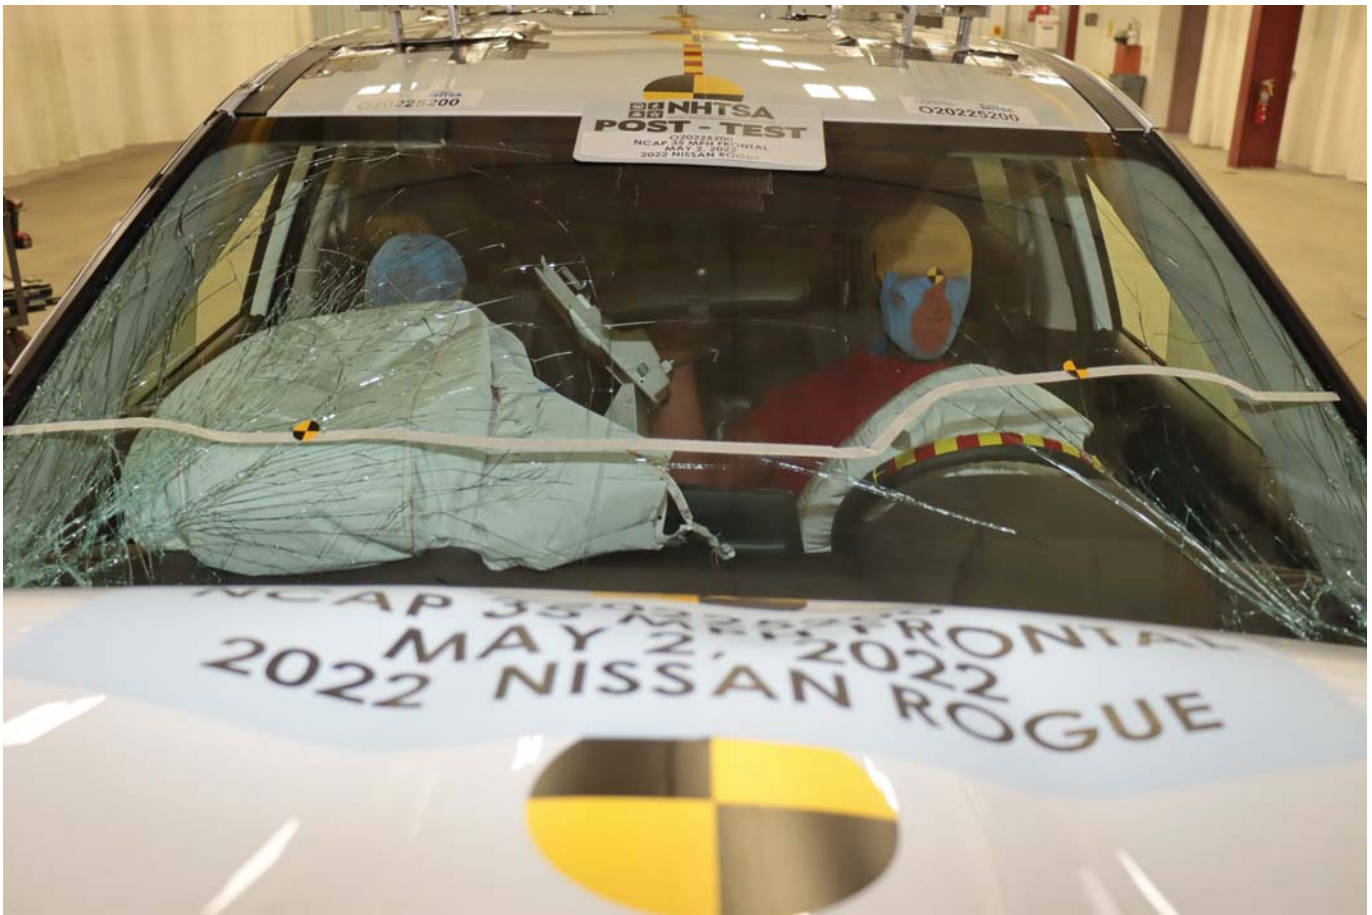
Photo No. 019 - Post-Test Windshield View

There was 100 percent windshield retention and no intrusion into the protected zone of the windshield during the event. There was no Stoddard Solvent leakage after the event or during any phase of the static rollover.

Critical Areas of Performance	Observations and Conclusions
Windshield Damage	Cracked along lower edge
Window Damage	LF/RF window shifted from track
Other Notable Effects	None

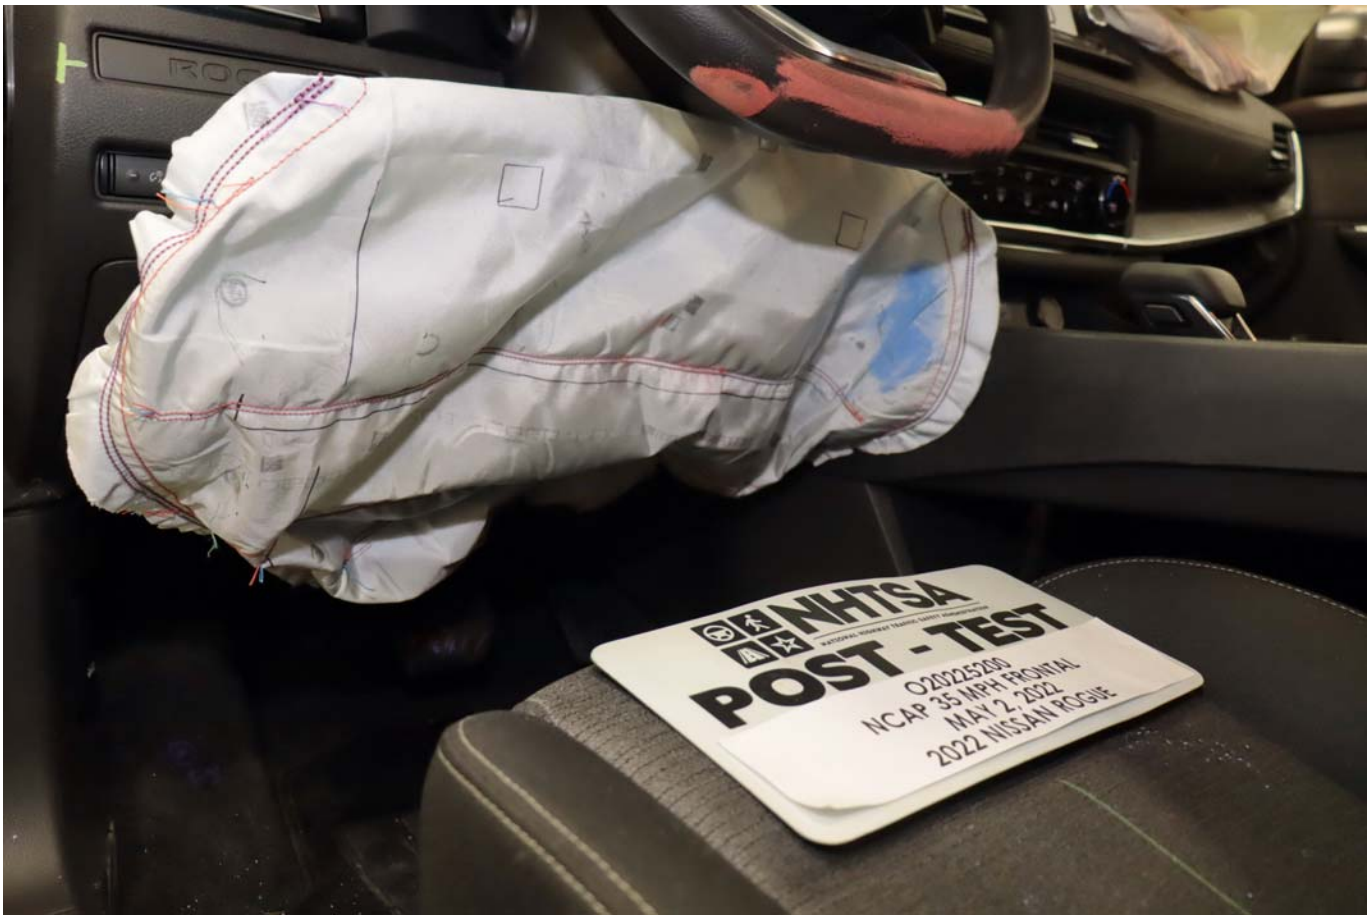
Photo No. 045 - Post-Test Driver's Side Knee Bolster

The driver's visible contact points were as follows: The driver's head contacted the airbag. The driver's head also contacted the headrest. The driver's left knee contacted the knee bolster and right knee contacted the knee airbag.

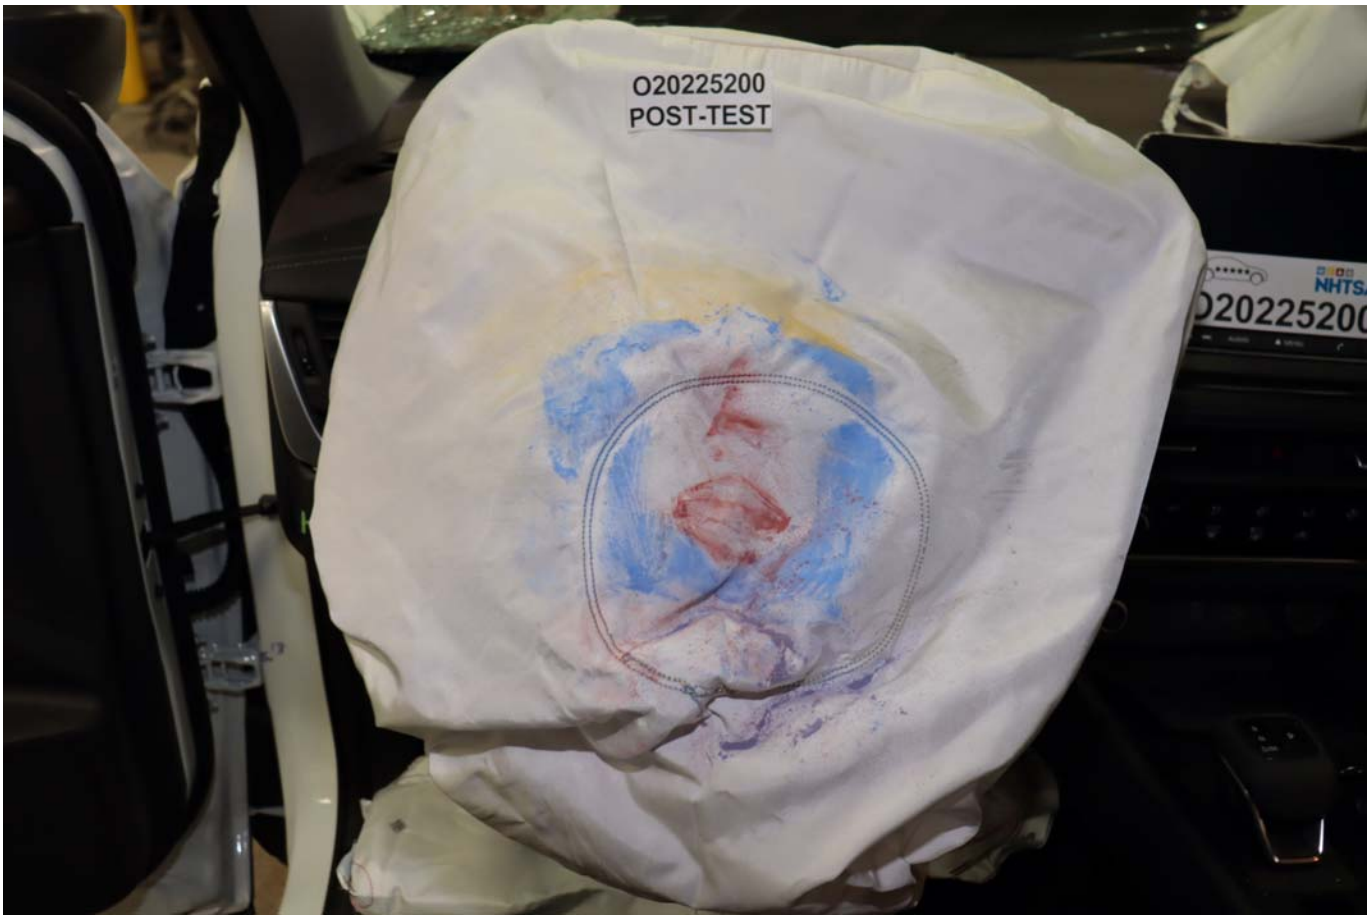
Photo No. 049 - Post-Test Driver Dummy Contact with Airbag

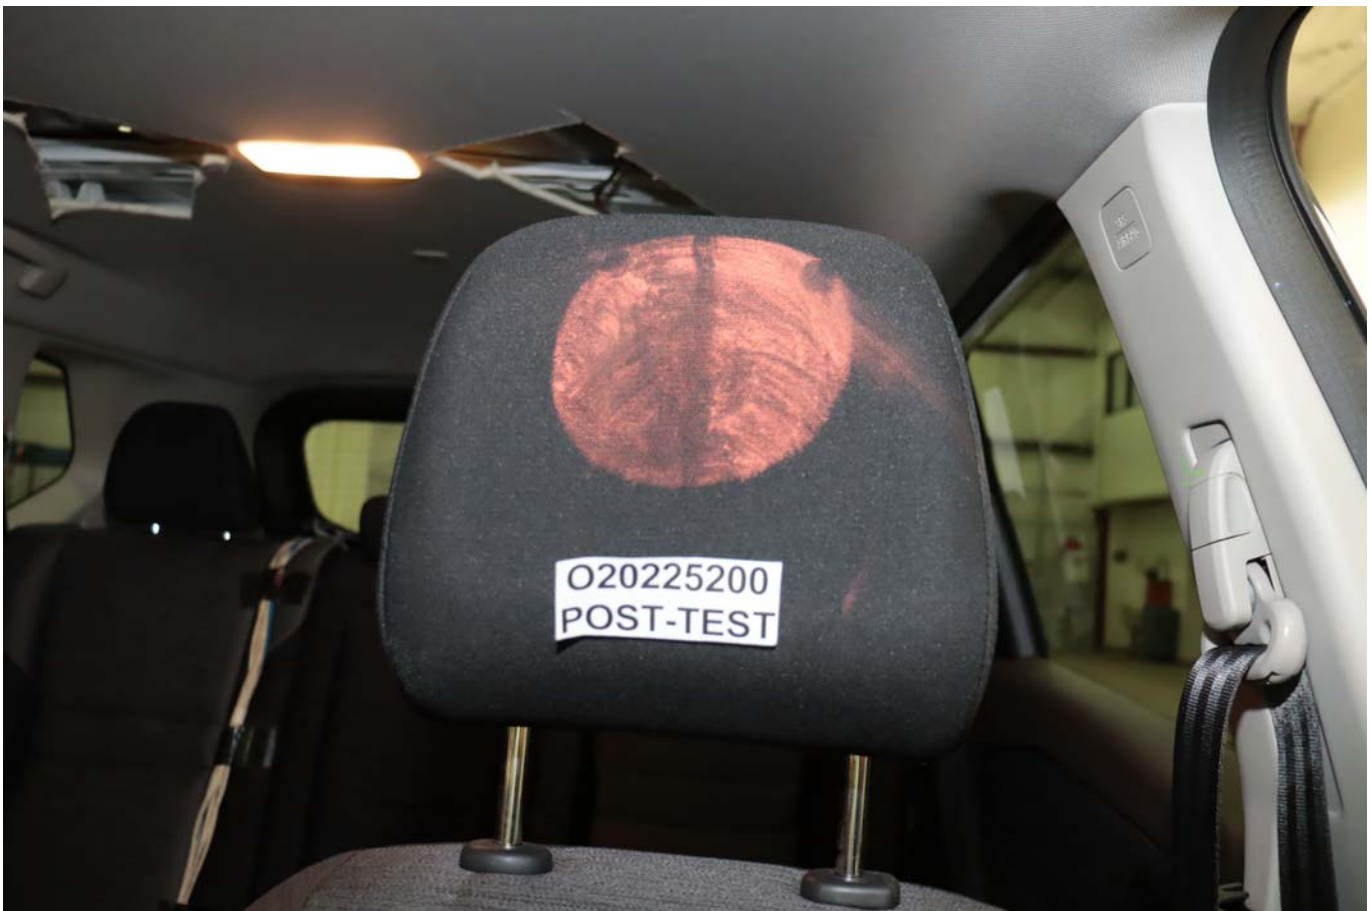
Photo No. 050 - Post-Test Driver Dummy Contact with Headrest

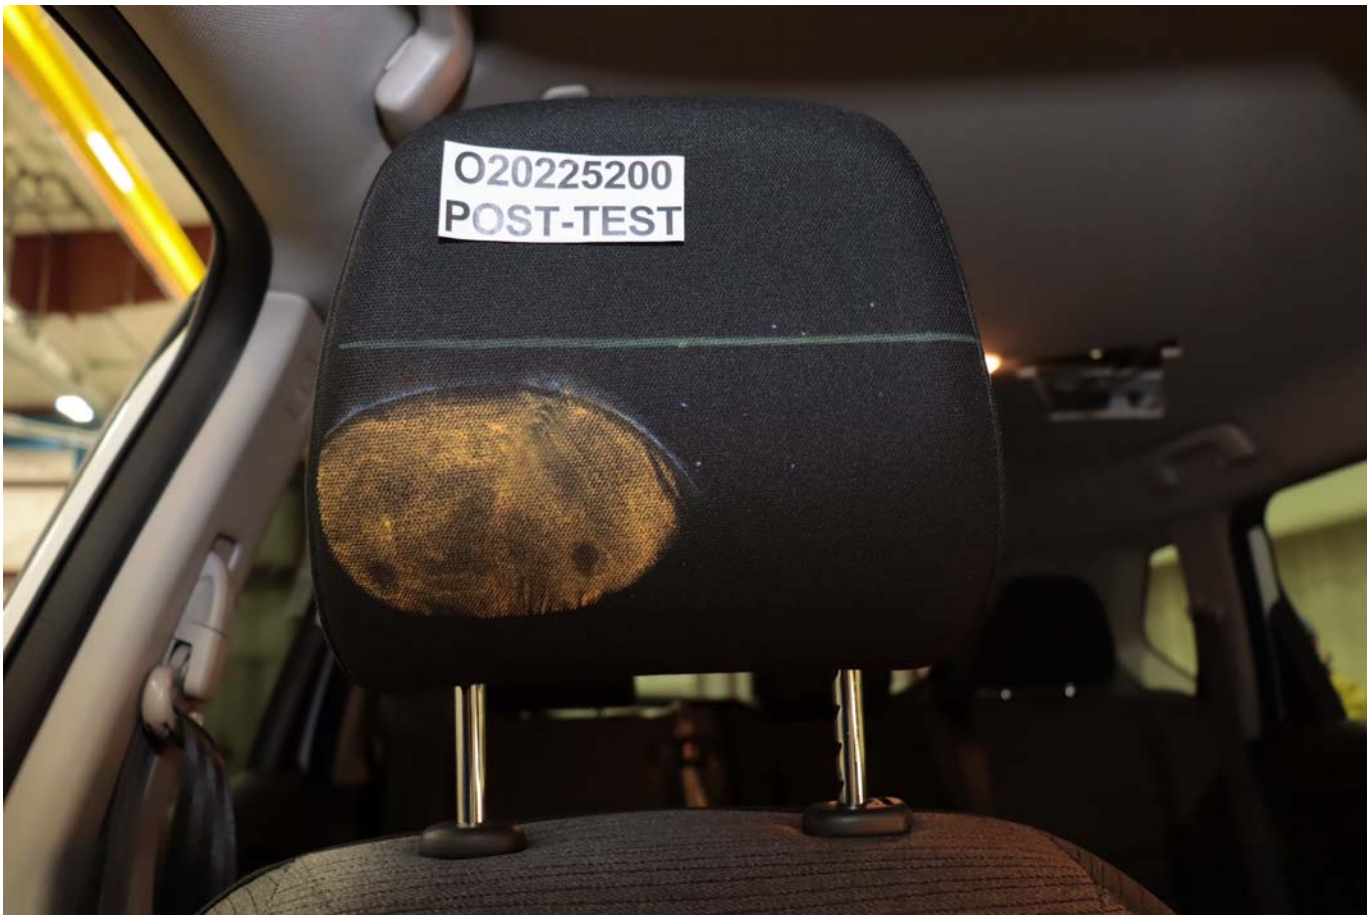
Photo No. 073 - Post-Test Passenger Dummy Contact with Headrest

The passenger's visible contact points were as follows: The passenger's head contacted the airbag. The passenger's head also contacted the headrest. The passenger's knees contacted the knee airbag and left knee contacted the glovebox.
