**REPORT NUMBER: SideNCAPPole-KAR-22-003**  
**NEW CAR ASSESSMENT PROGRAM (NCAP)**  
**SIDE IMPACT POLE TEST**

**VOLKSWAGEN DE MEXICO**  
**2022 VOLKSWAGEN TAOS 5 DOOR MPV**

**NHTSA No: M20225804**

**FINAL REPORT**

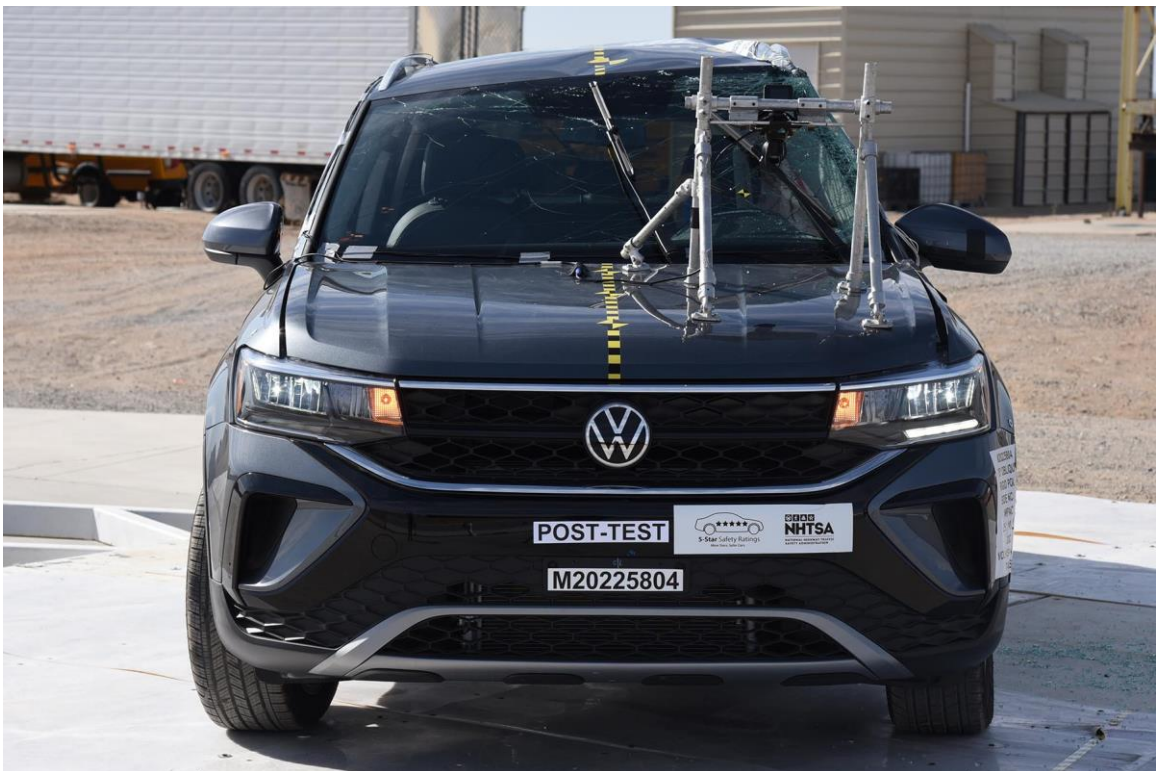
FIGURE 4. Post-Test Frontal View of Test Vehicle

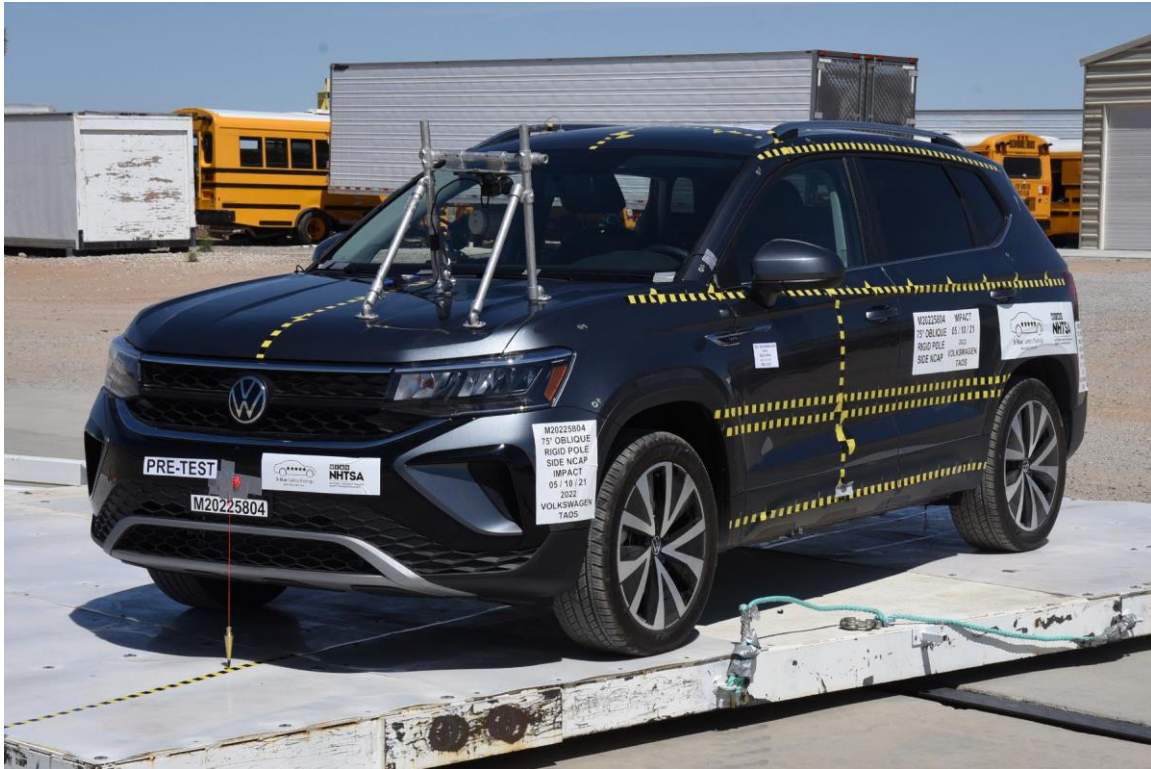
FIGURE 5. Pre-Test Left Front  $\frac{3}{4}$  View of Test Vehicle

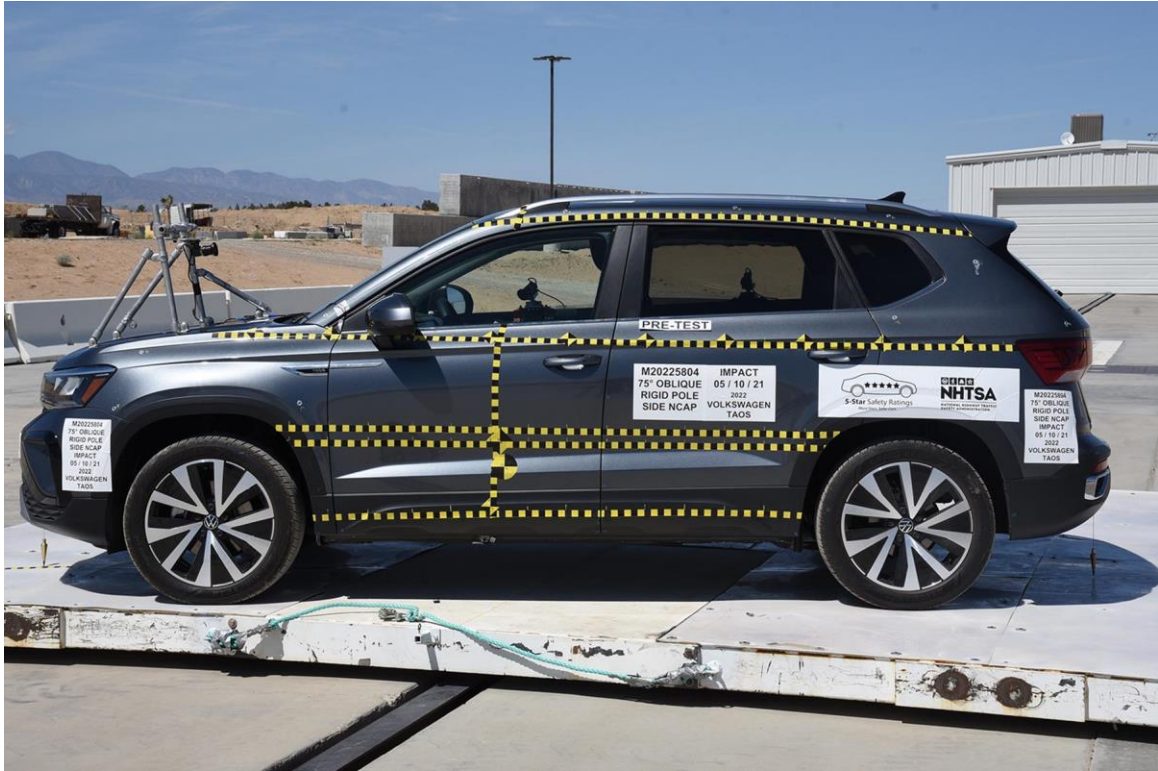
FIGURE 7. Pre-Test Left Side View of Test Vehicle

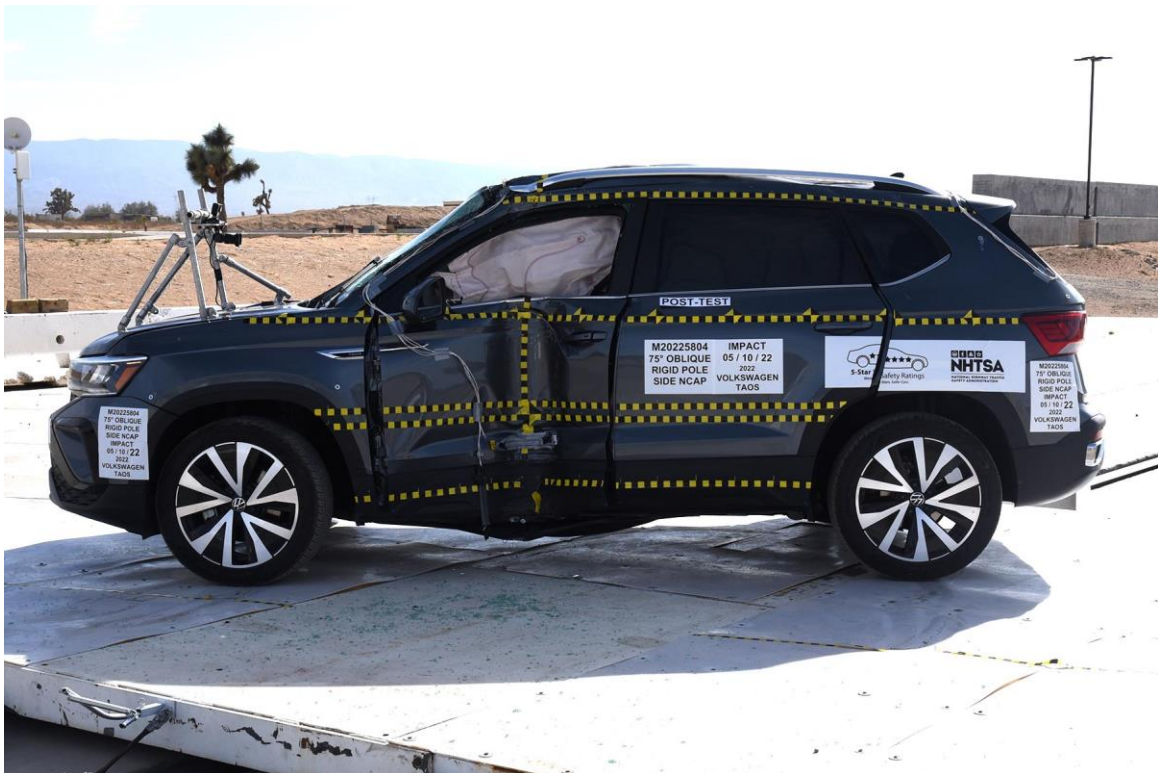
FIGURE 8. Post-Test Left Side View of Test Vehicle

The struck side doors of the vehicle were jammed shut. There was no separation at the hinges or latches. The remaining doors remained closed and latched. There were no ATD values that exceeded limits.

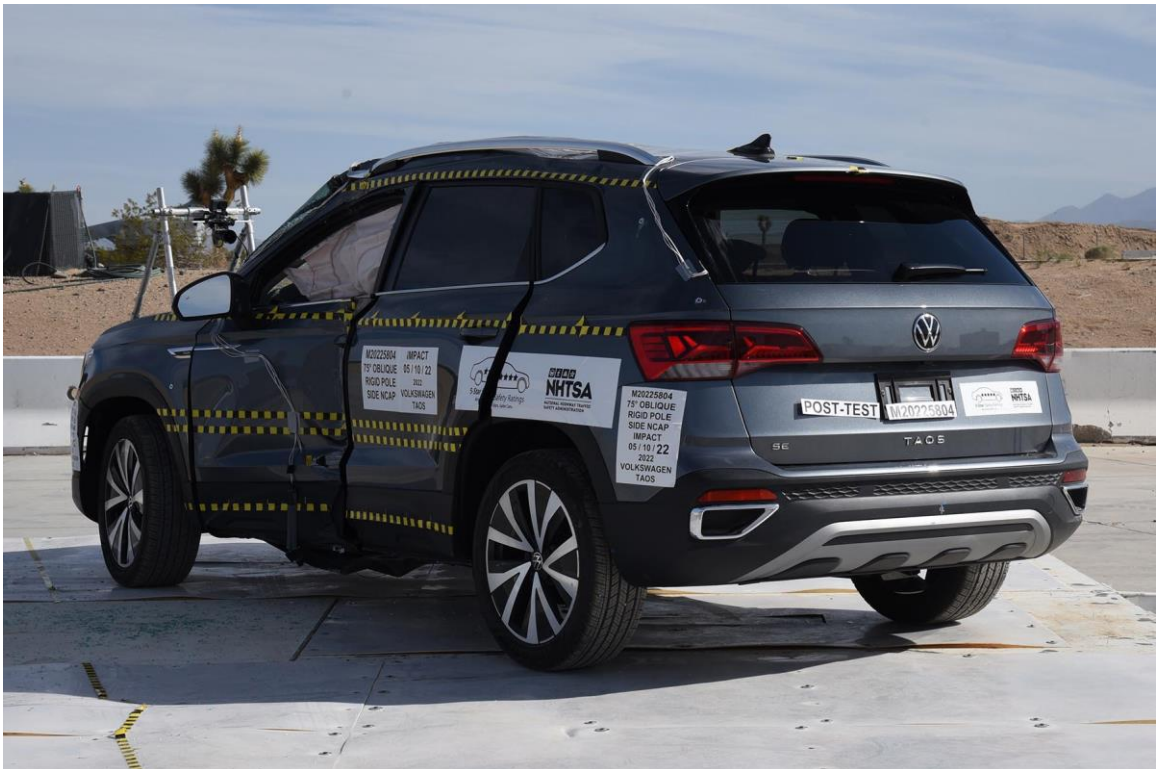
FIGURE 10. Post-Test Left Rear  $\frac{3}{4}$  View of Test Vehicle

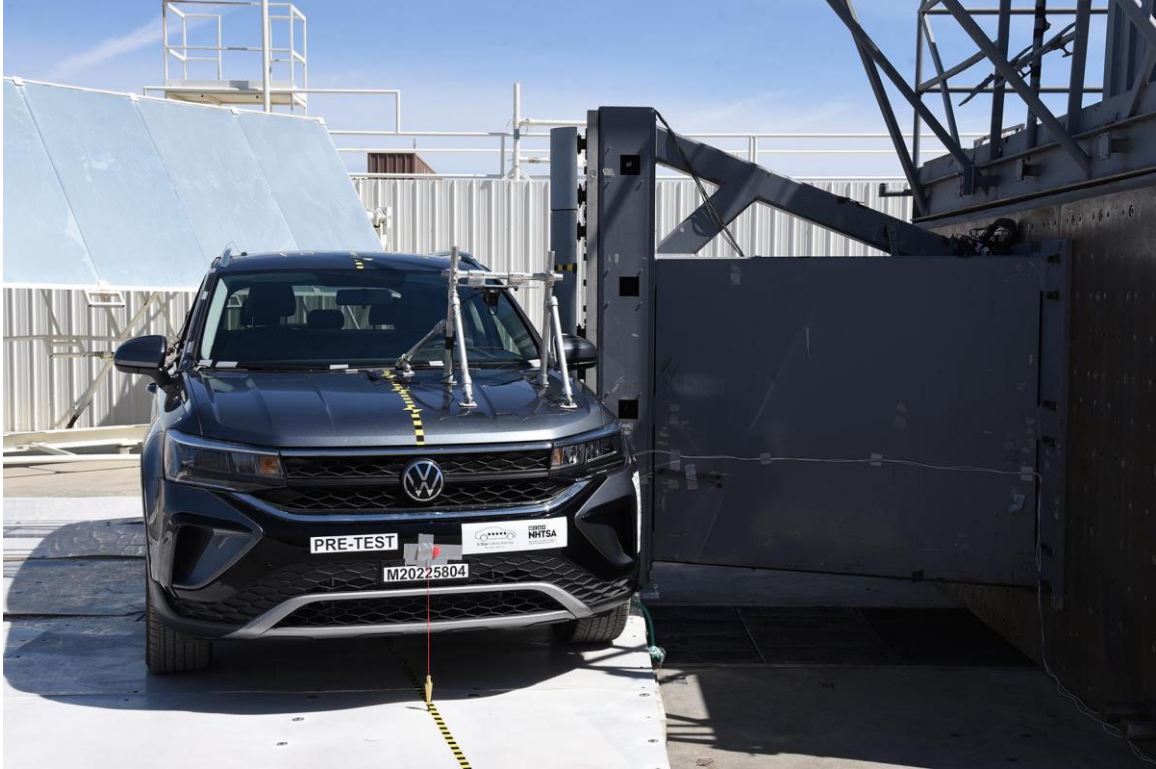
FIGURE 17. Pre-Test Left Side View of Pole Positioned Against Side of Vehicle

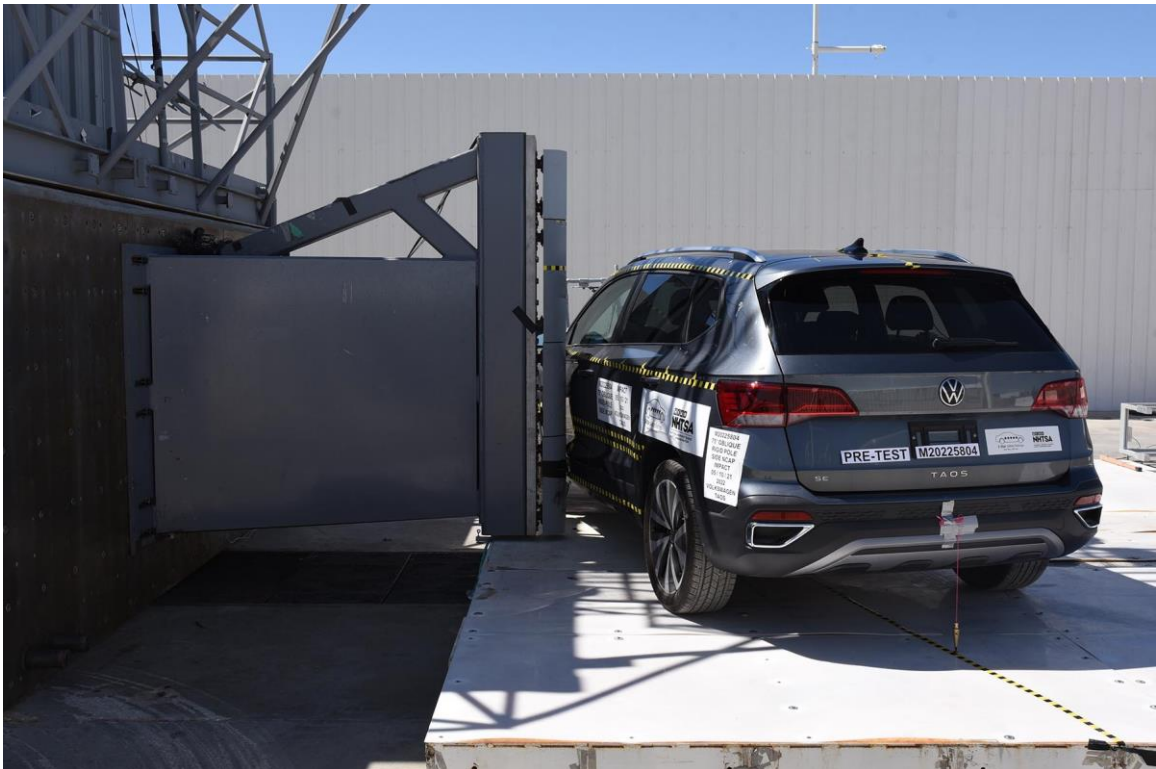
FIGURE 18. Pre-Test Right Side View of Pole Positioned Against Side of Vehicle

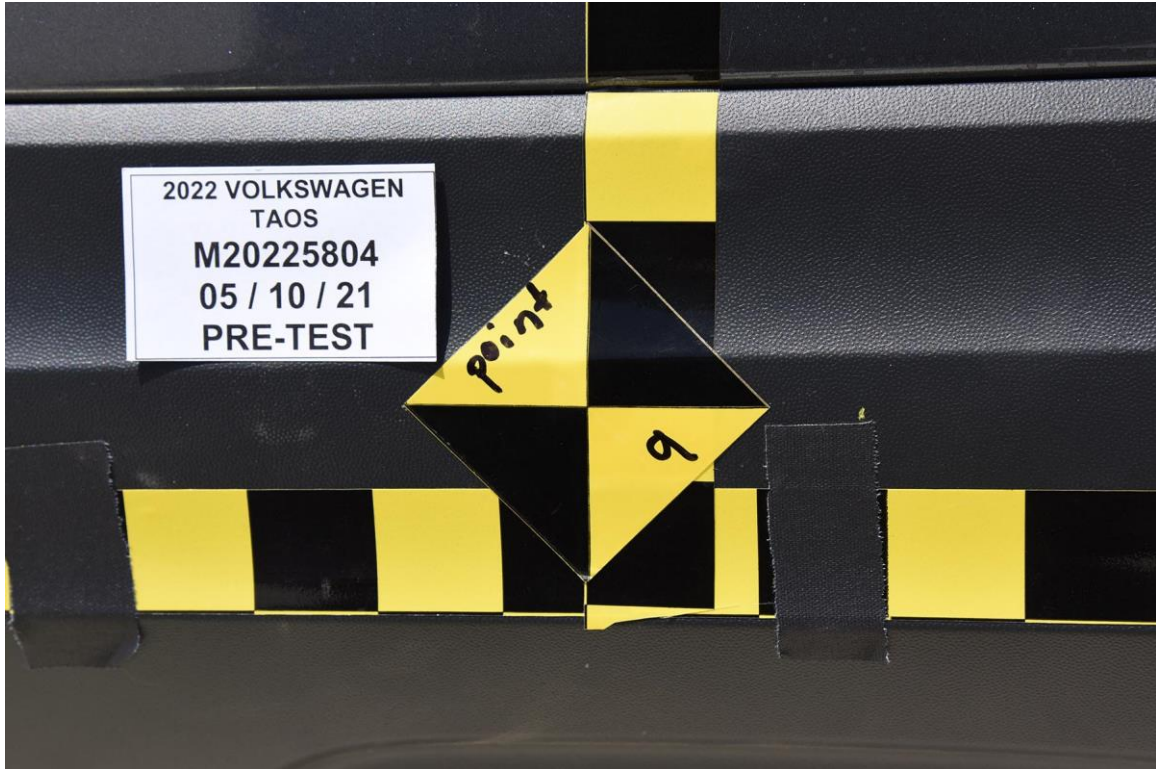
FIGURE 19. Pre-Test Close-Up View of Impact Point Target

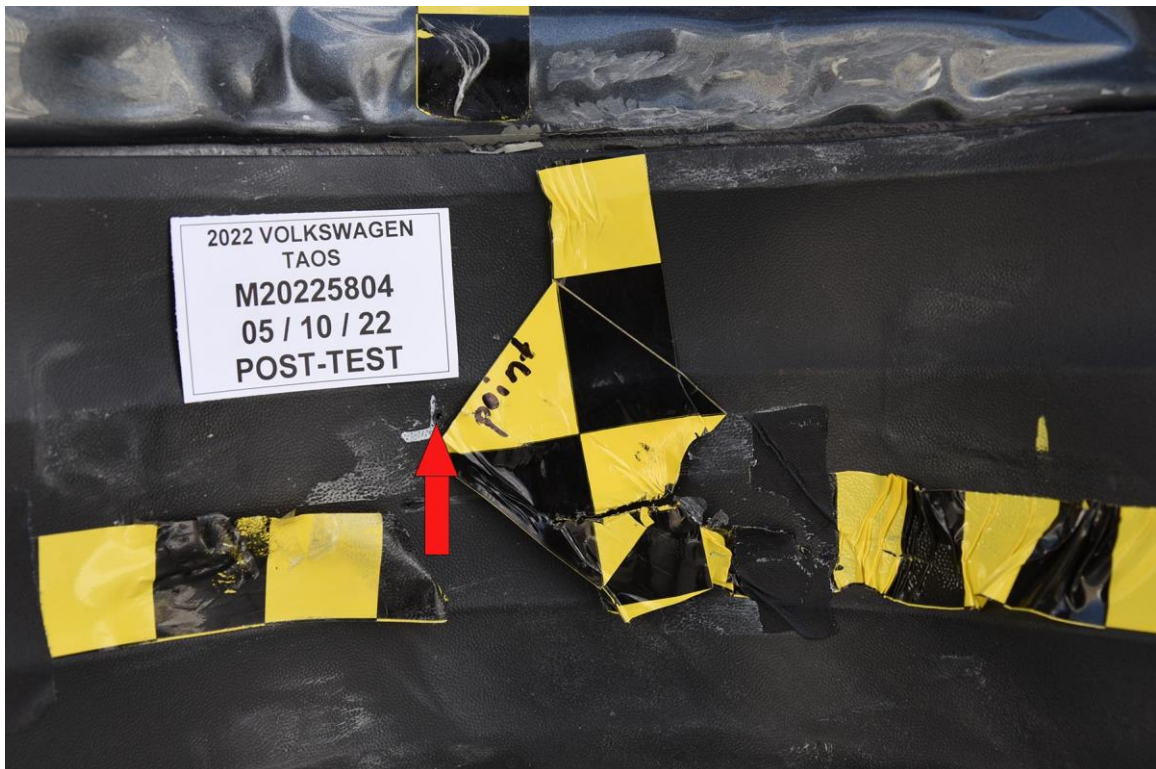
FIGURE 20. Post-Test Close-Up View of Impact Point Target Showing Impact Location

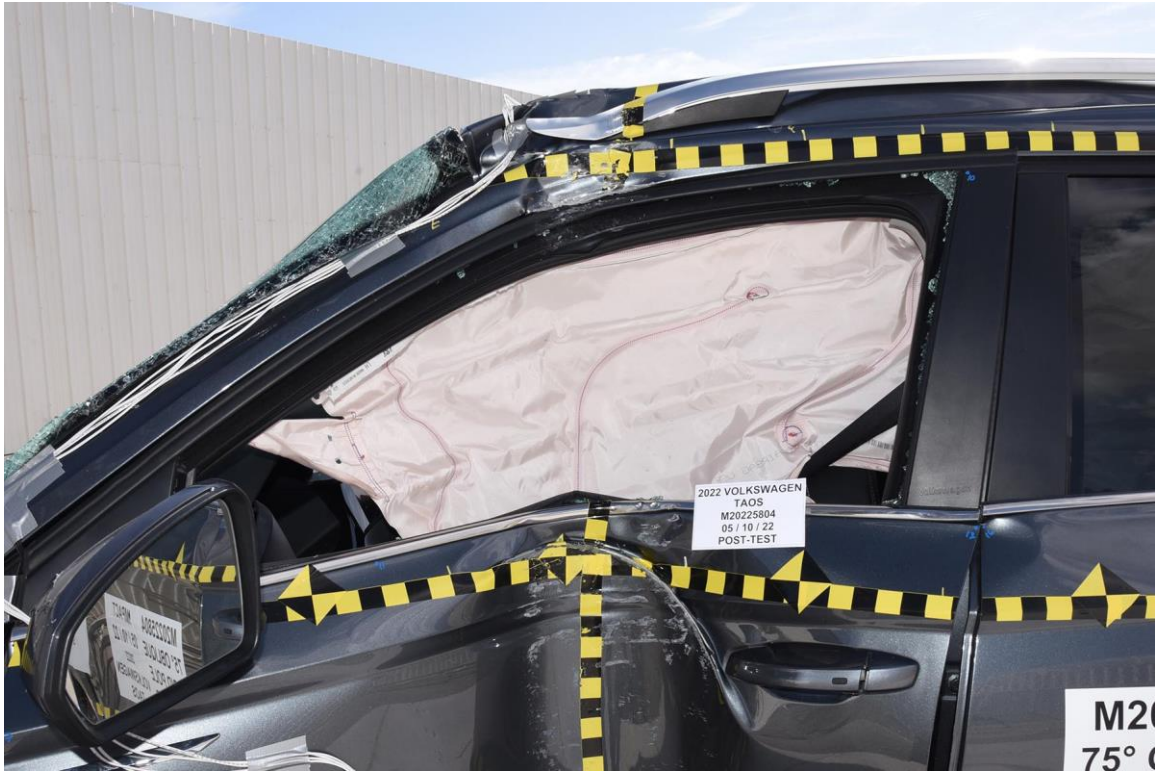
FIGURE 25. Post-Test Left Side View of Dummy Shoulder and Door Top View

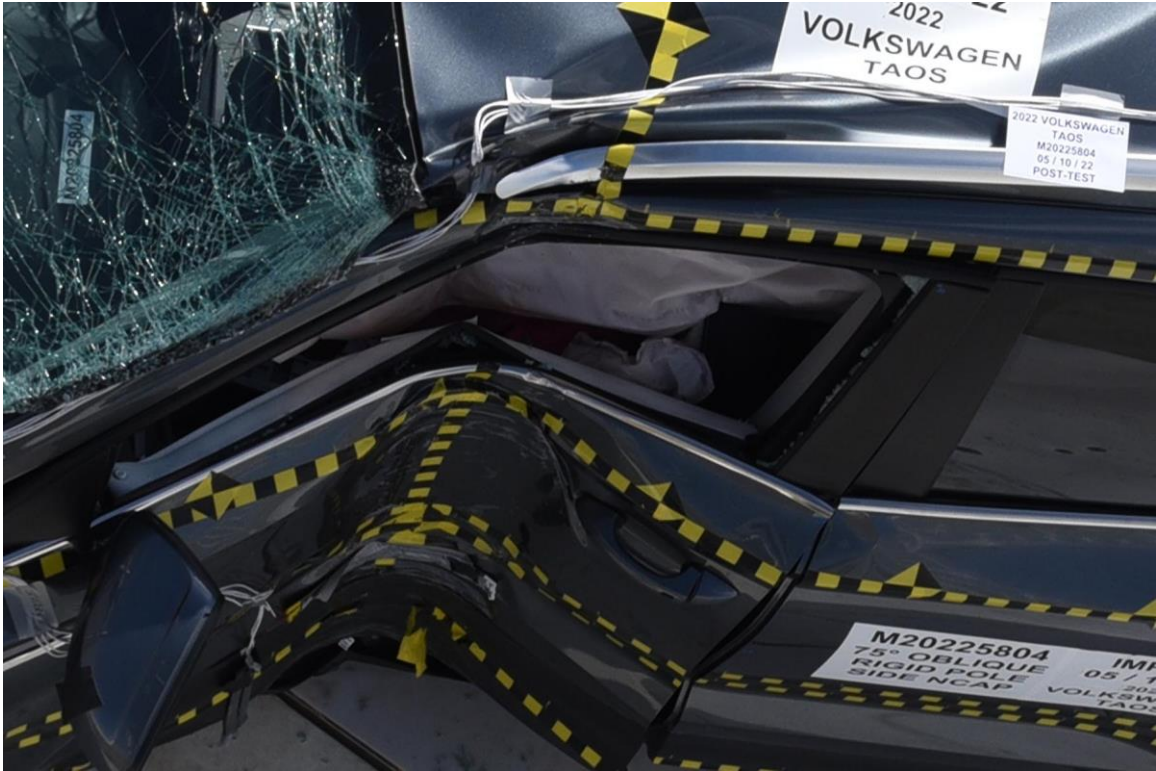
FIGURE 41. Post-Test Dummy and Door Clearance View

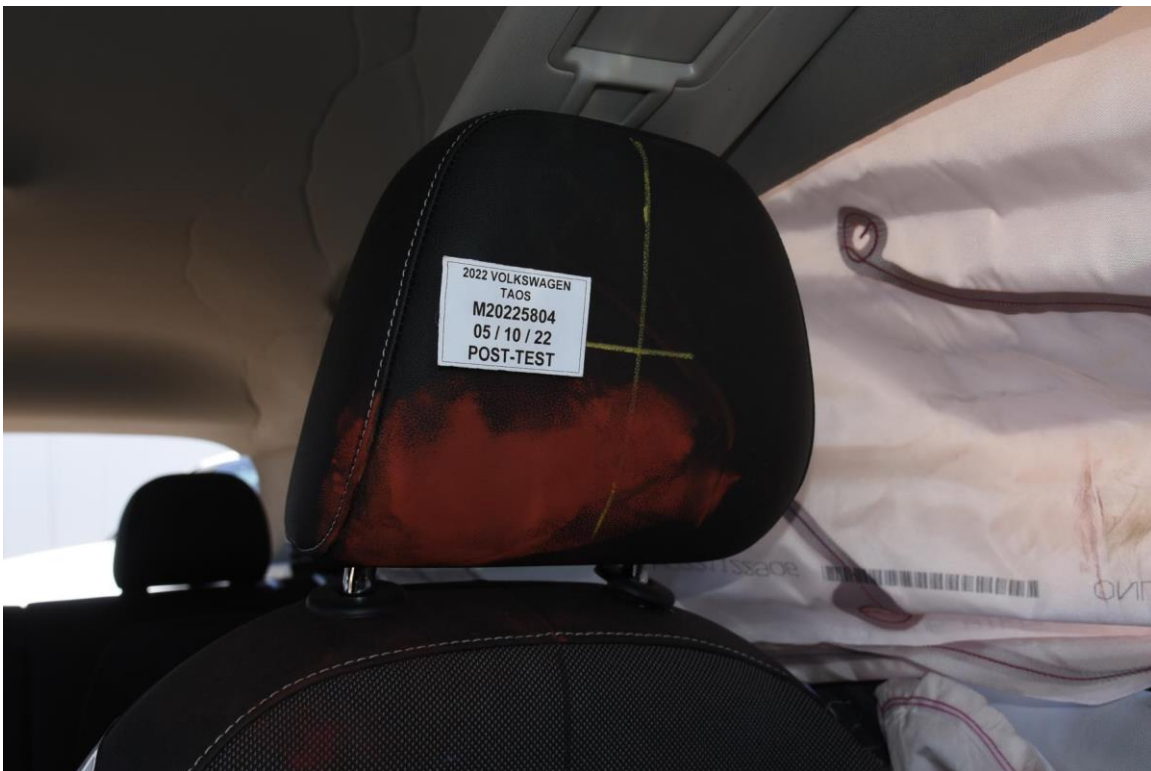
FIGURE 46. Post-Test Dummy Close-Up Head Contact with Vehicle Interior View

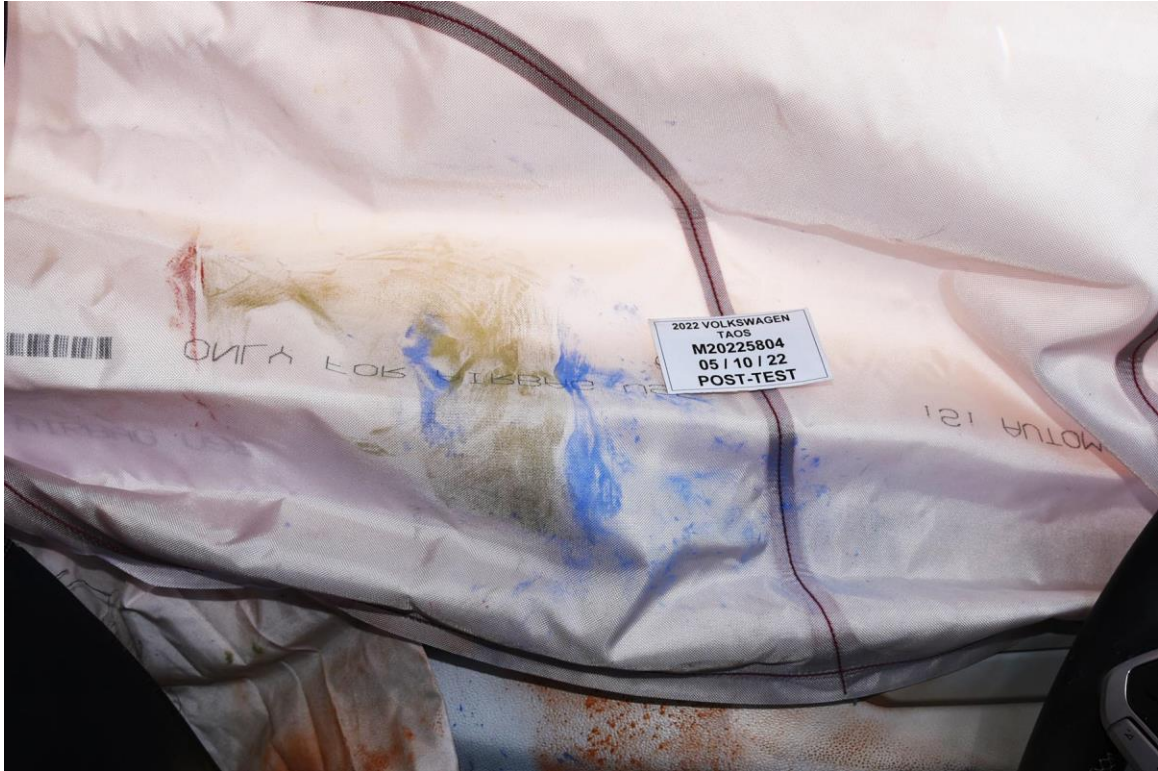
FIGURE 47. Post-Test Dummy Close-Up Head Contact With Side Airbag View

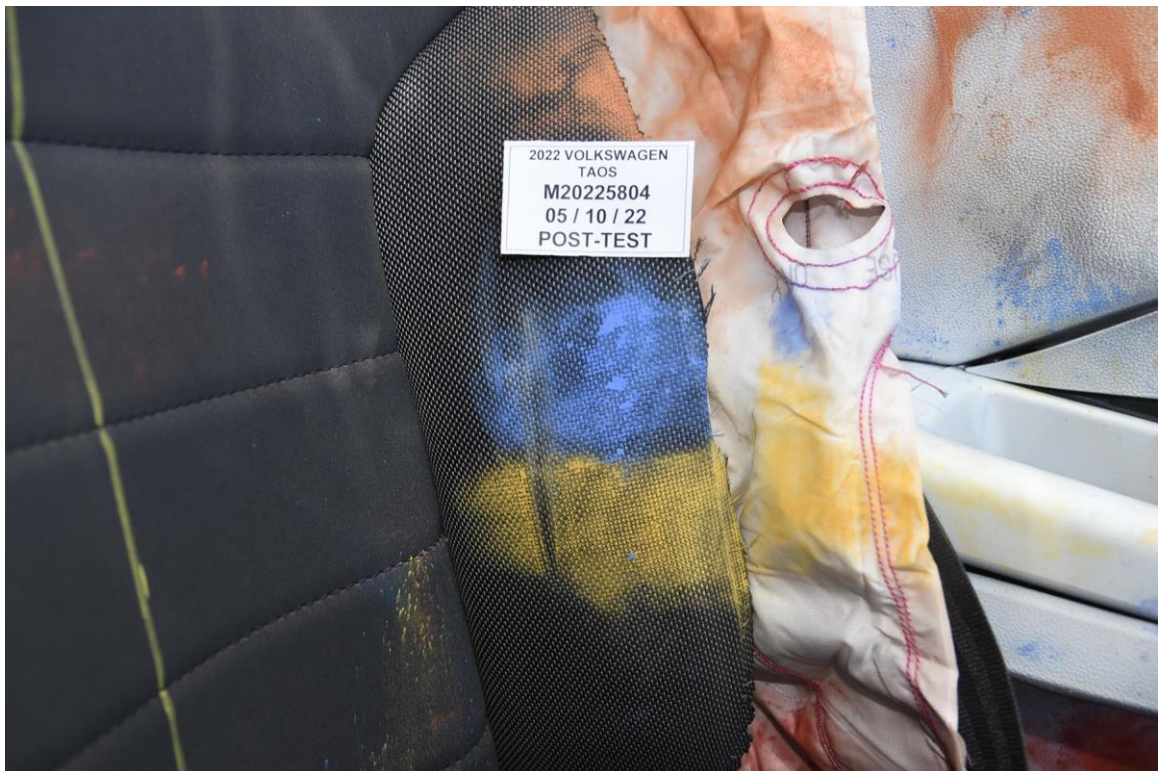
FIGURE 48. Post-Test Dummy Close-Up Torso Contact With Vehicle Interior View

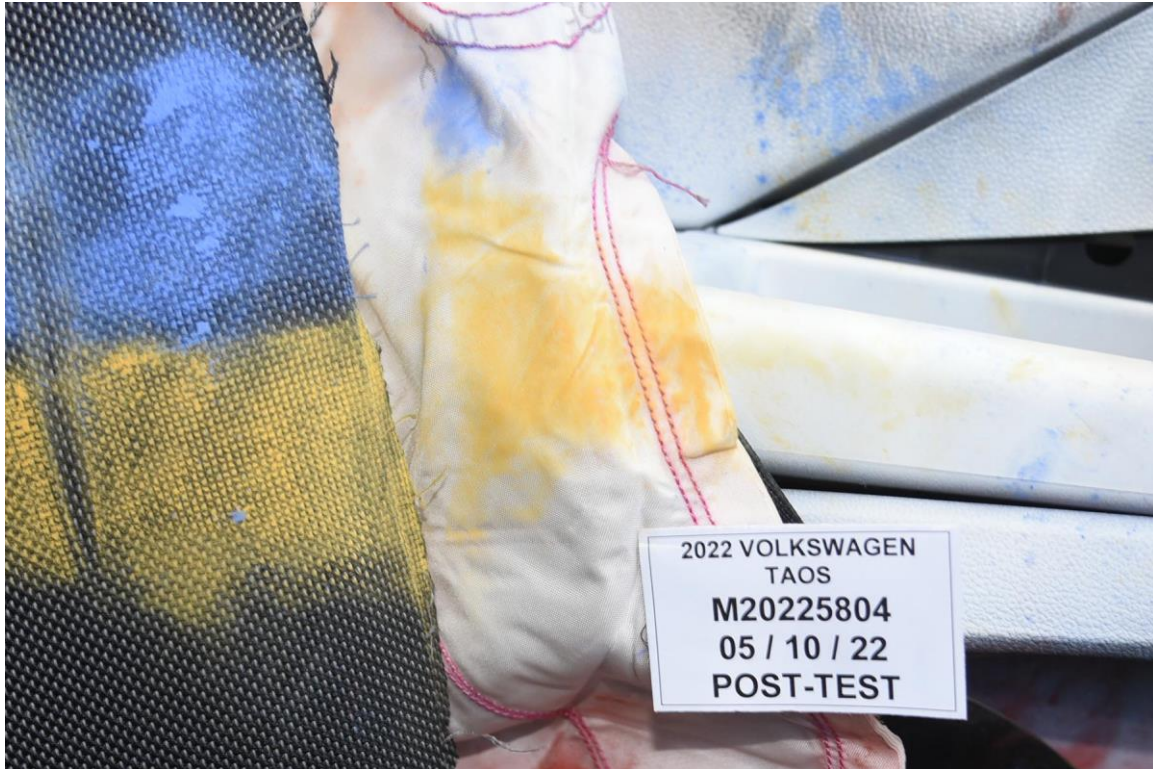
FIGURE 49. Post-Test Dummy Close-Up Torso Contact With Side Airbag View

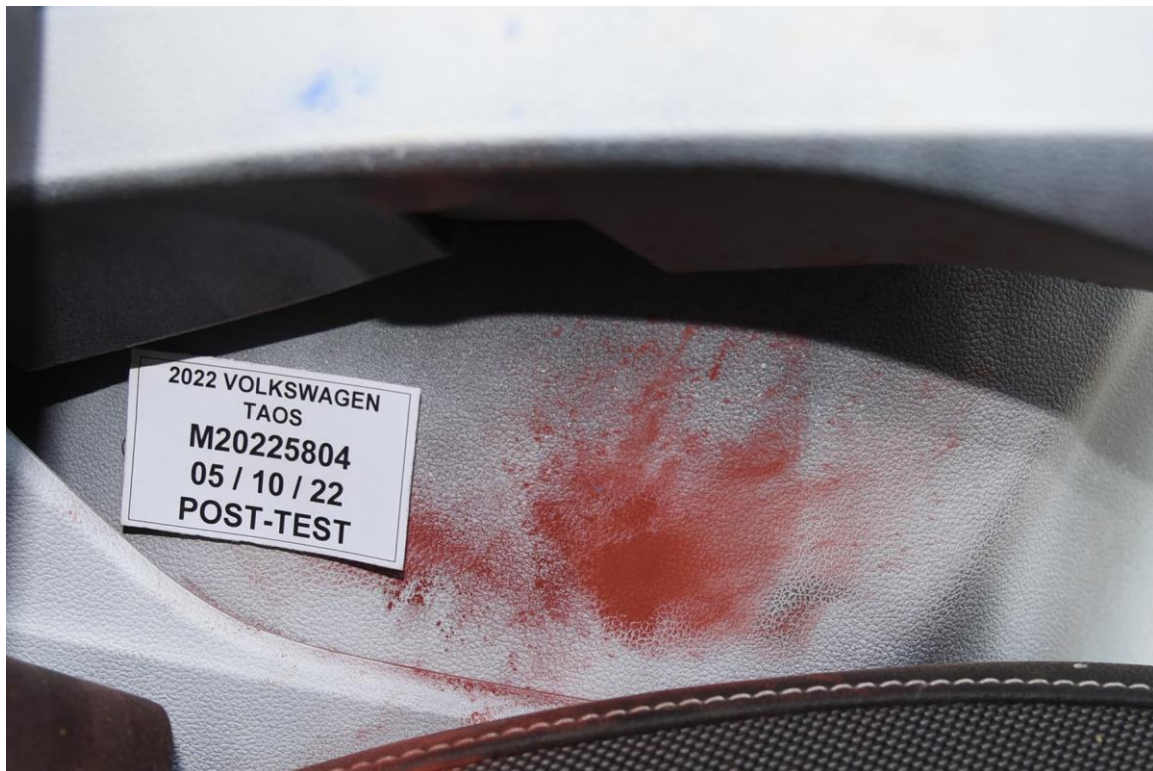
FIGURE 50. Post-Test Dummy Close-Up Pelvis Contact With Vehicle Interior View

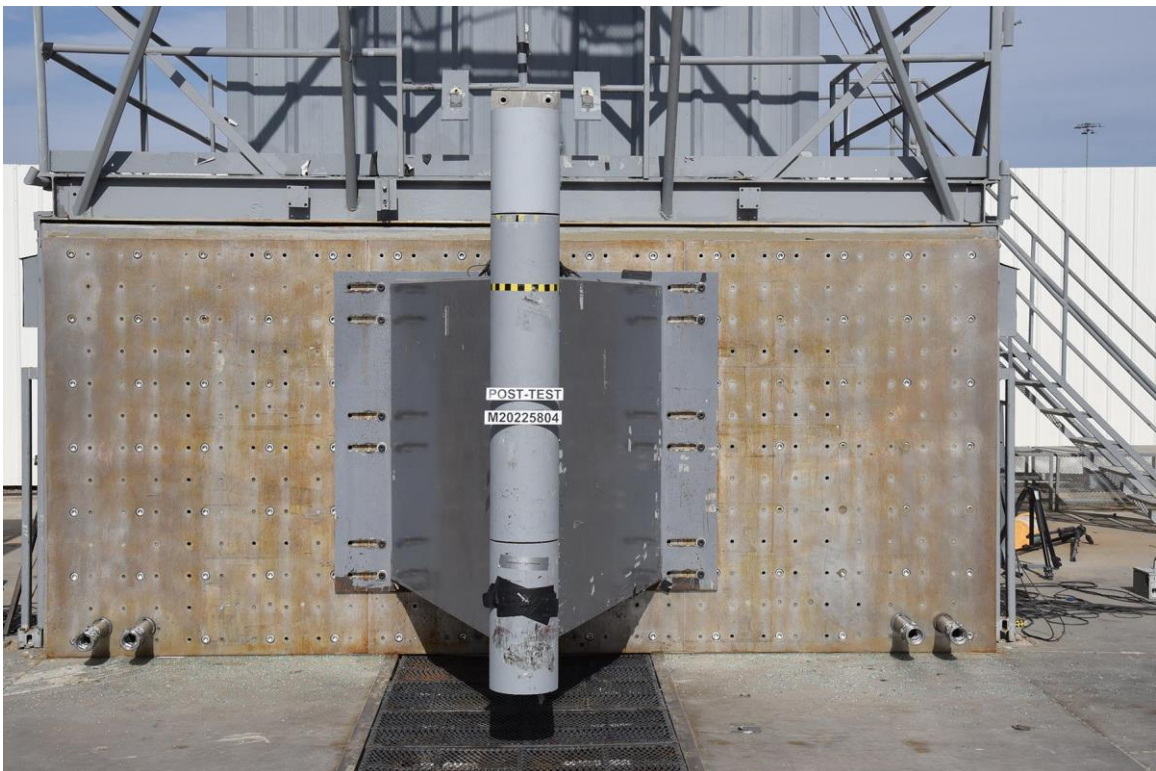
FIGURE 60. Post-Test Pole Barrier Front View

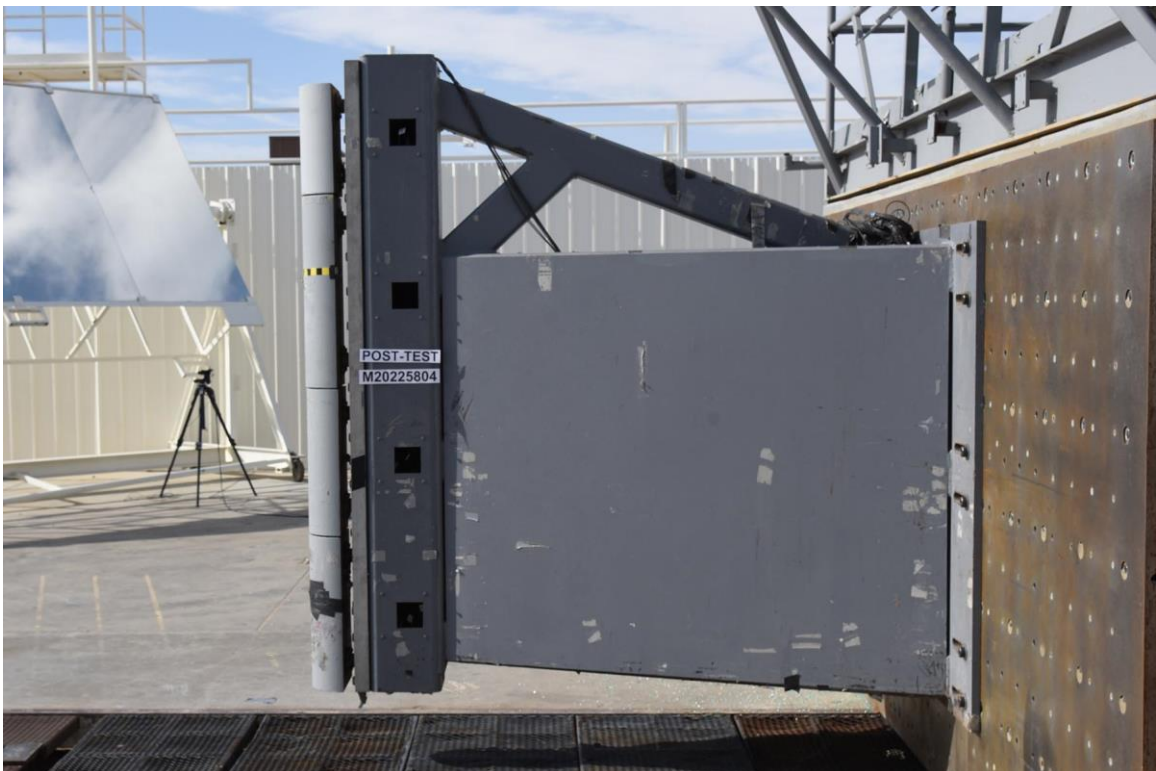
FIGURE 62. Post-Test Pole Barrier Side View
