REPORT NUMBER: NCAP-MGA-22-025

**NEW CAR ASSESSMENT PROGRAM (NCAP)
Frontal Barrier Impact Test**

**FORD MOTOR CO.
2022 Ford Expedition MAX XLT 4x4 5-Door SUV
NHTSA No.: M20220203**

**MGA RESEARCH CORPORATION
5000 Warren Road
Burlington, WI 53105**

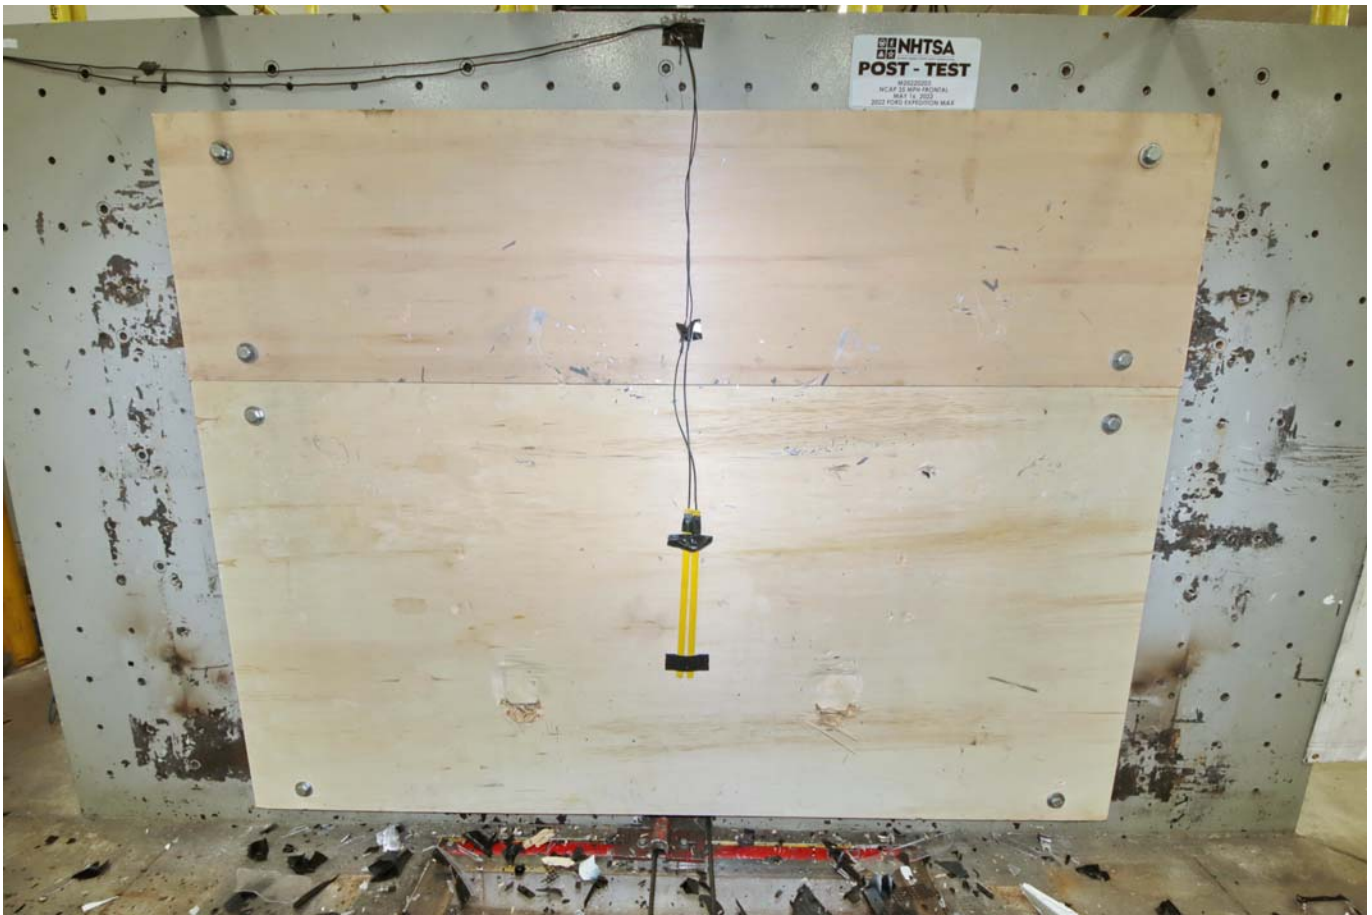
Photo No. 003 - Post-Test Load Cell Wall

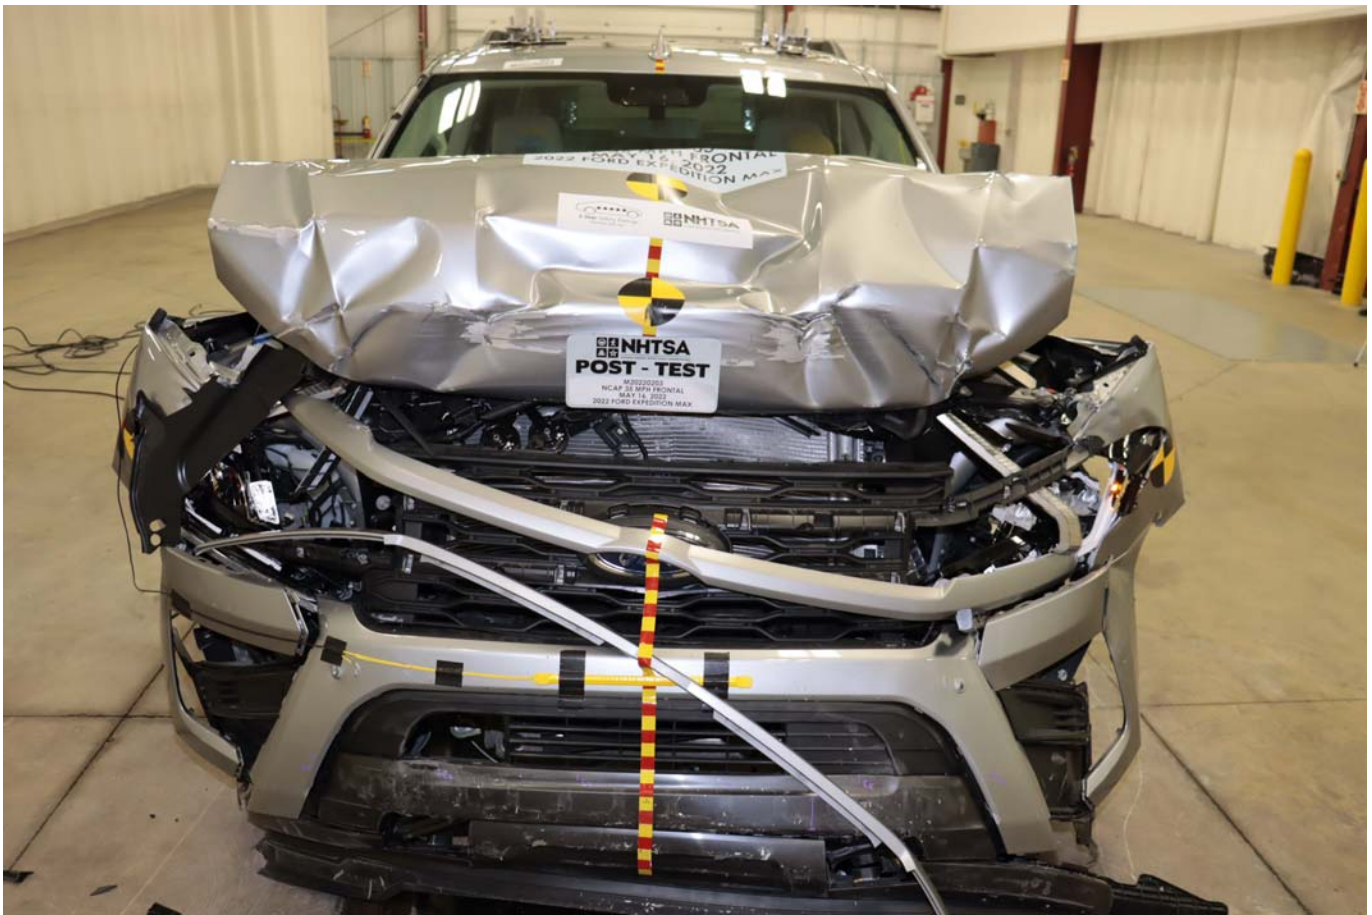
Photo No. 009 - Post-Test Front View of Test Vehicle

The maximum static crush of the vehicle was 626 mm located to the left of the vehicle centerline and both the driver and passenger side doors remained closed during the impact event and were operable after the impact.

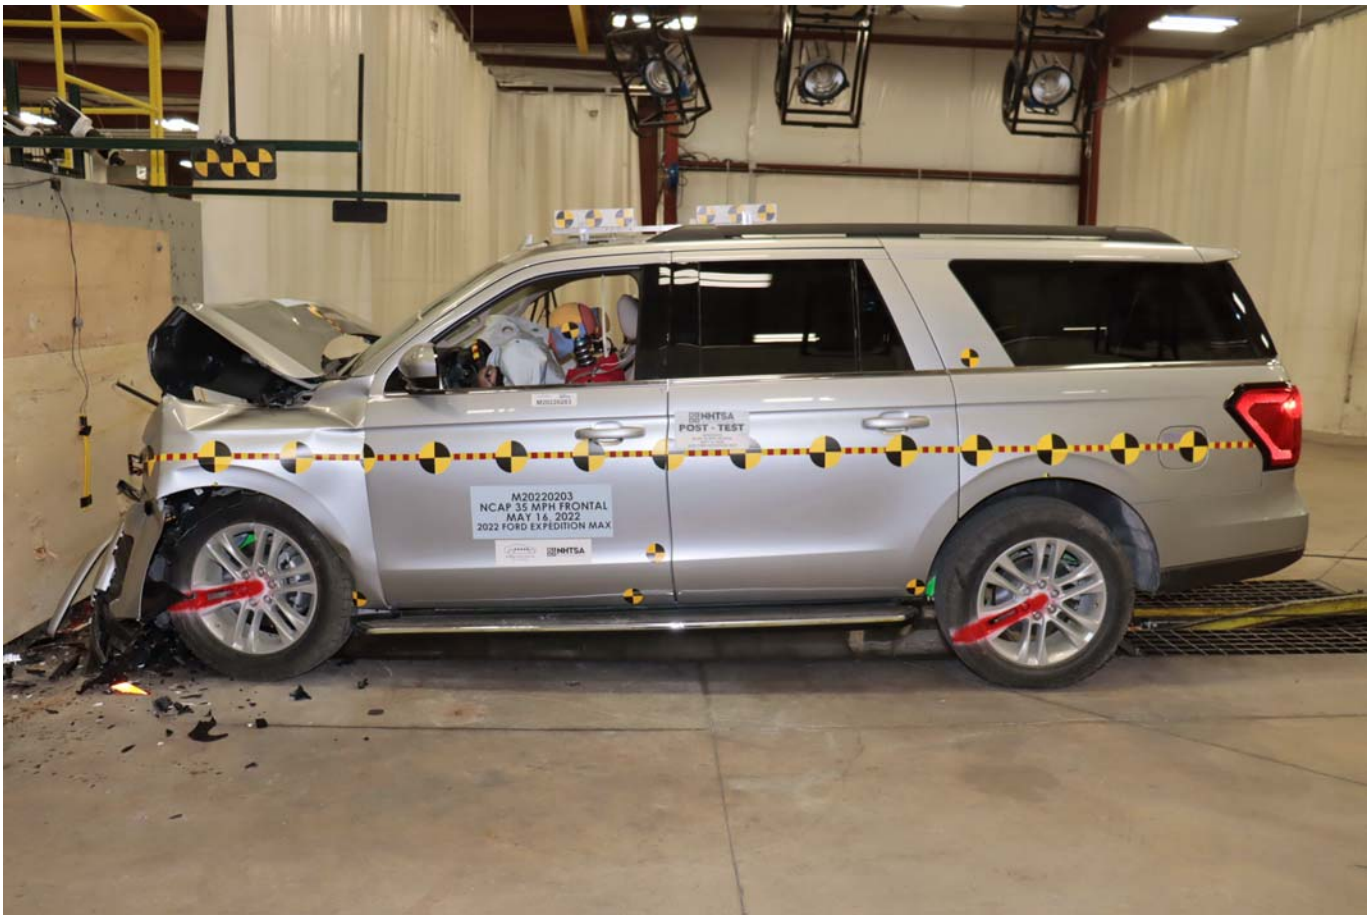
Photo No. 011 - Post-Test Left View of Test Vehicle

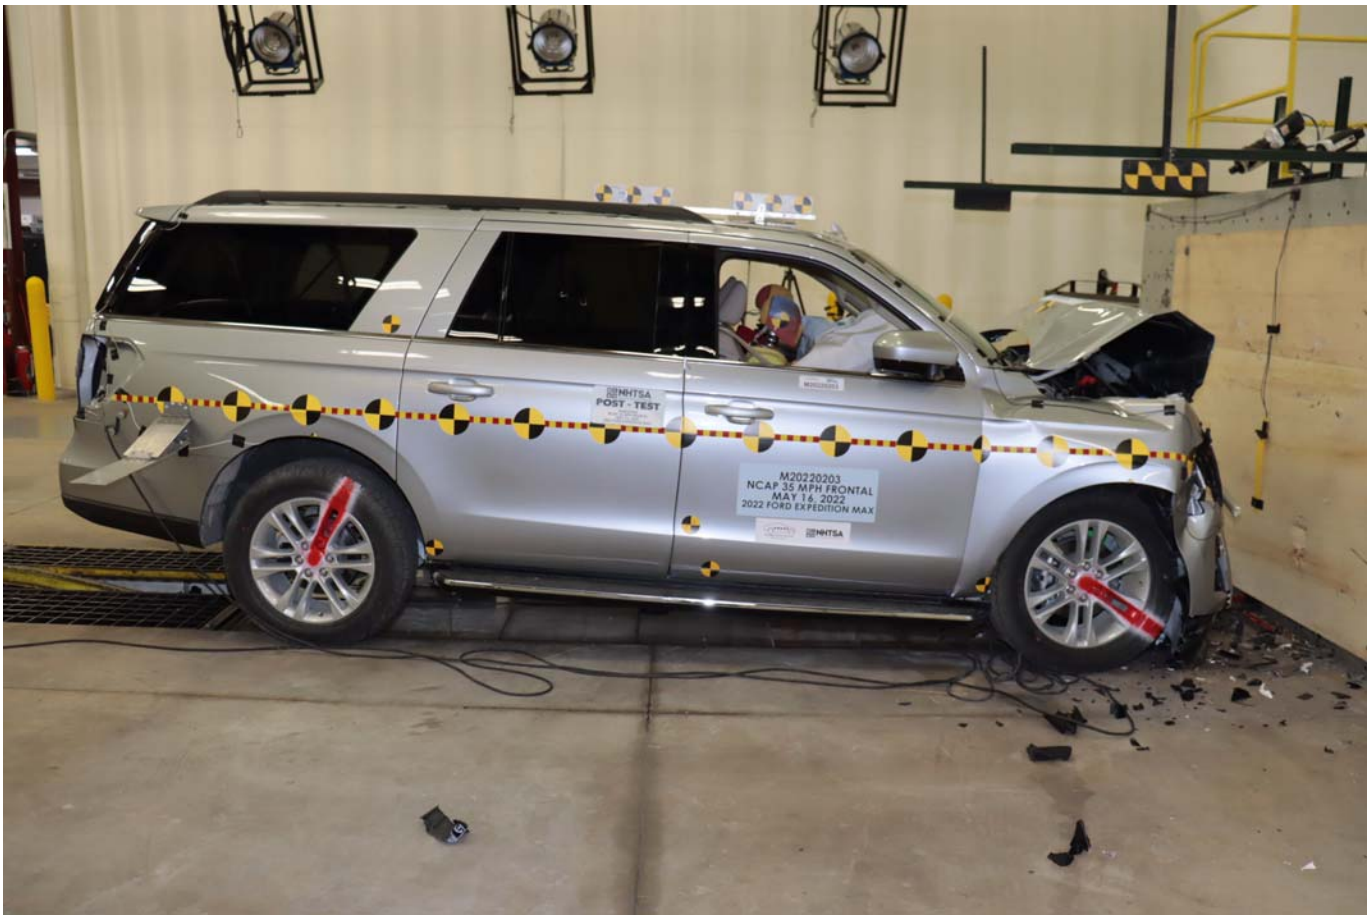
Photo No. 013 - Post-Test Right View of Test Vehicle

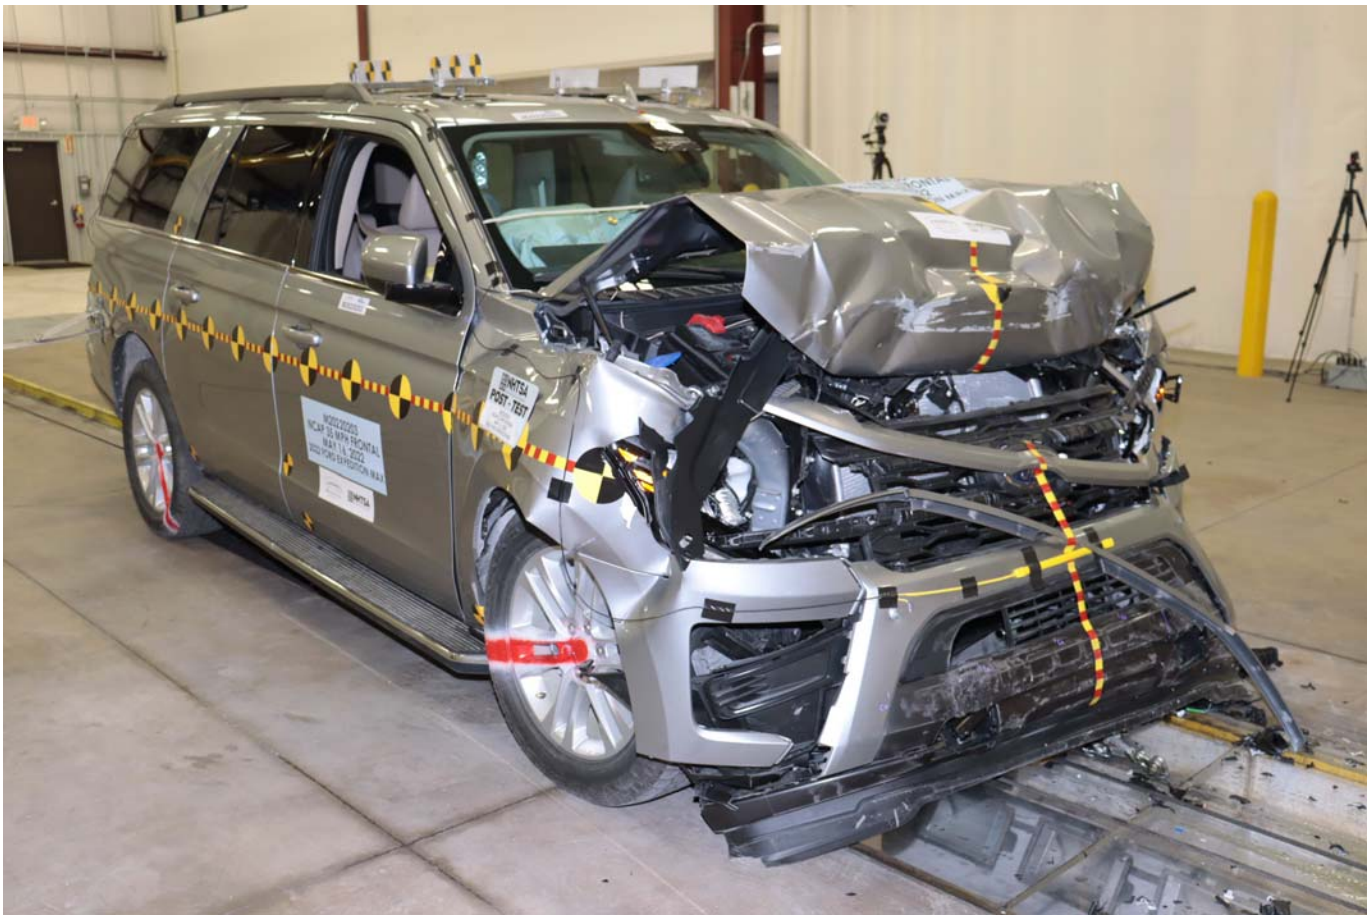
Photo No. 015 - Post-Test Right Front 3-4 View

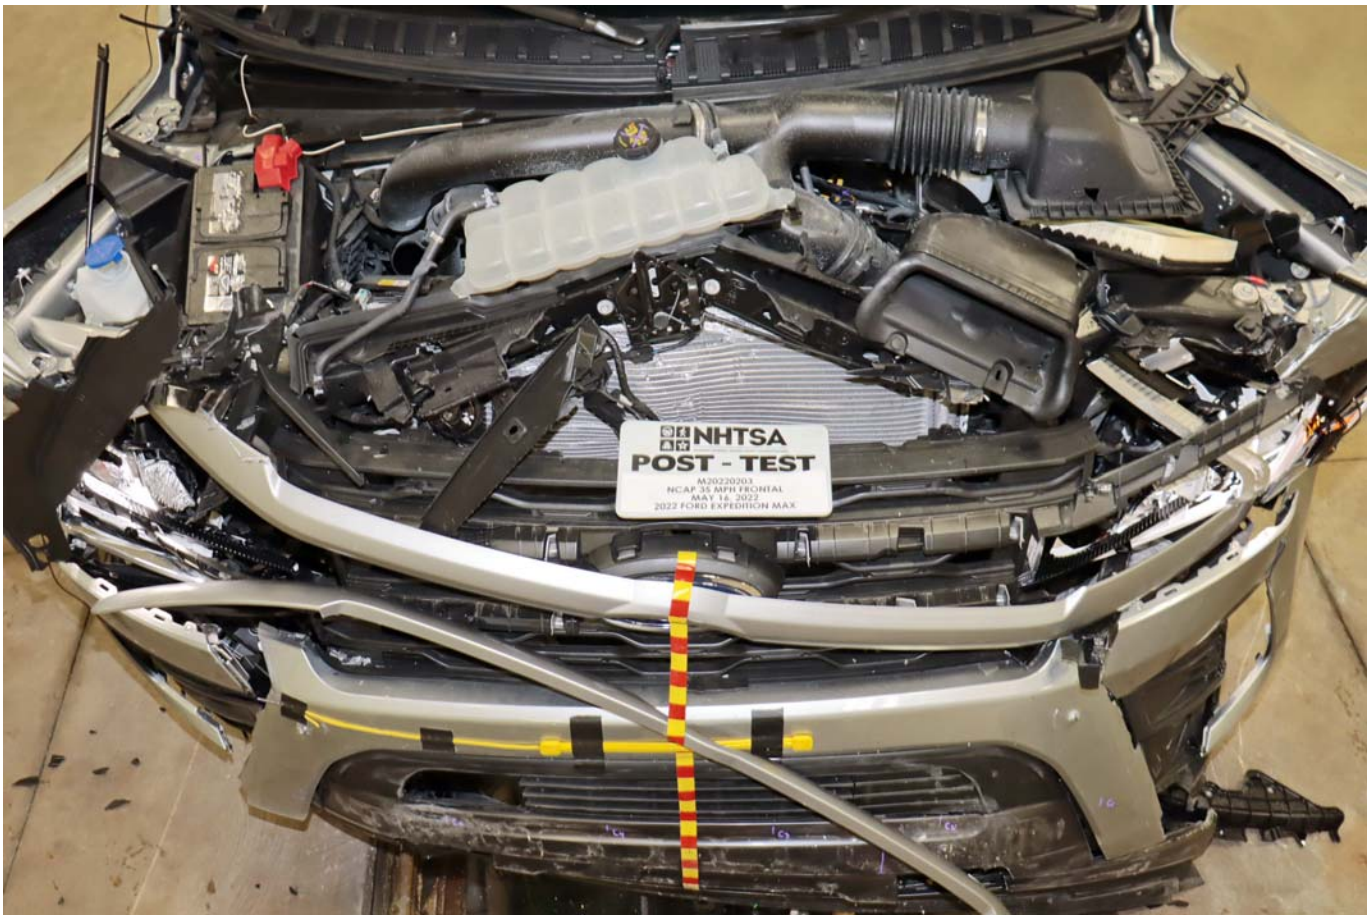
Photo No. 021 - Post-Test Engine Compartment View

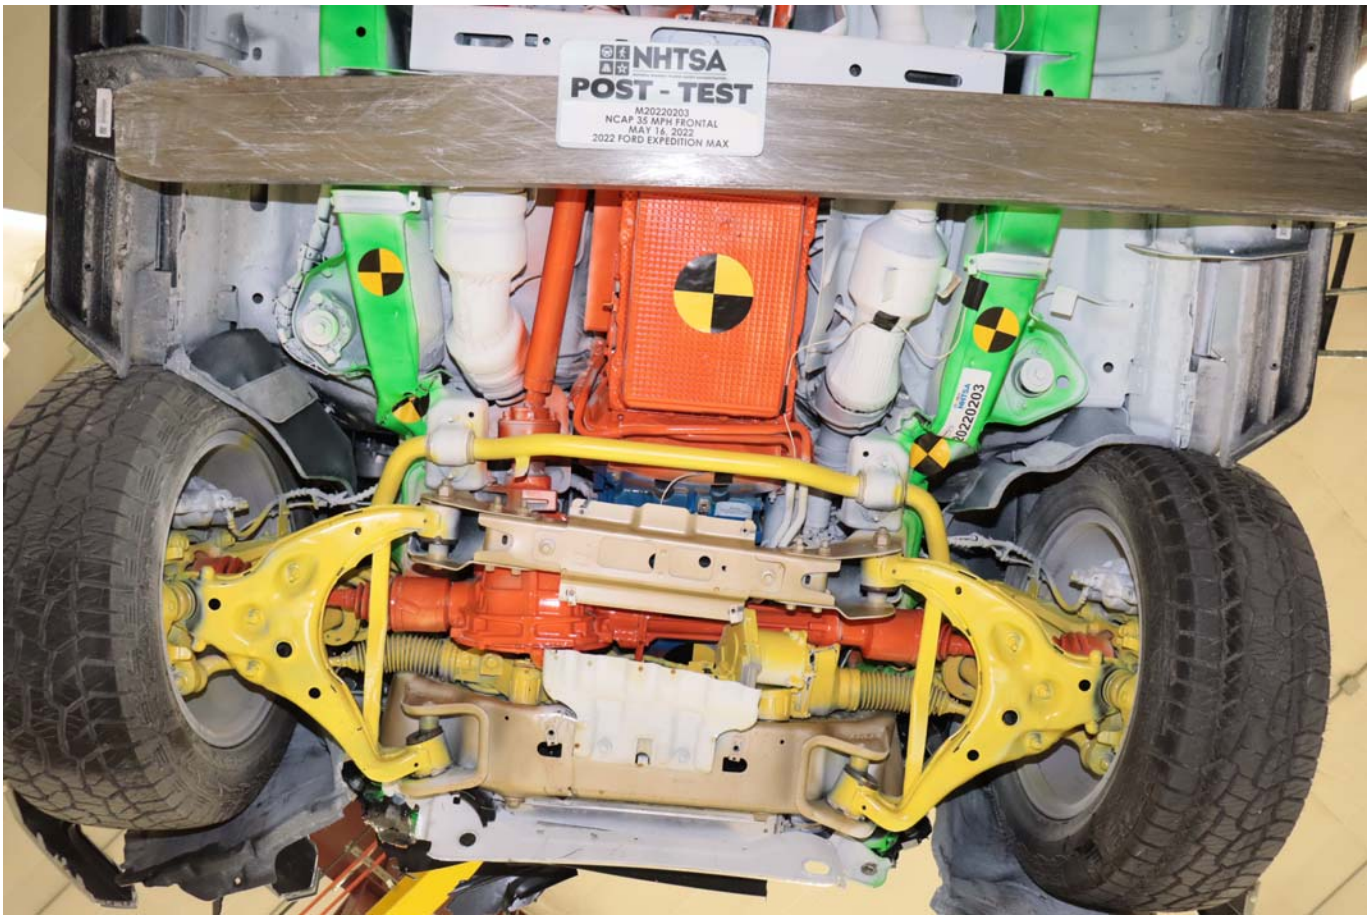
Photo No. 025 - Post-Test Front Underbody View

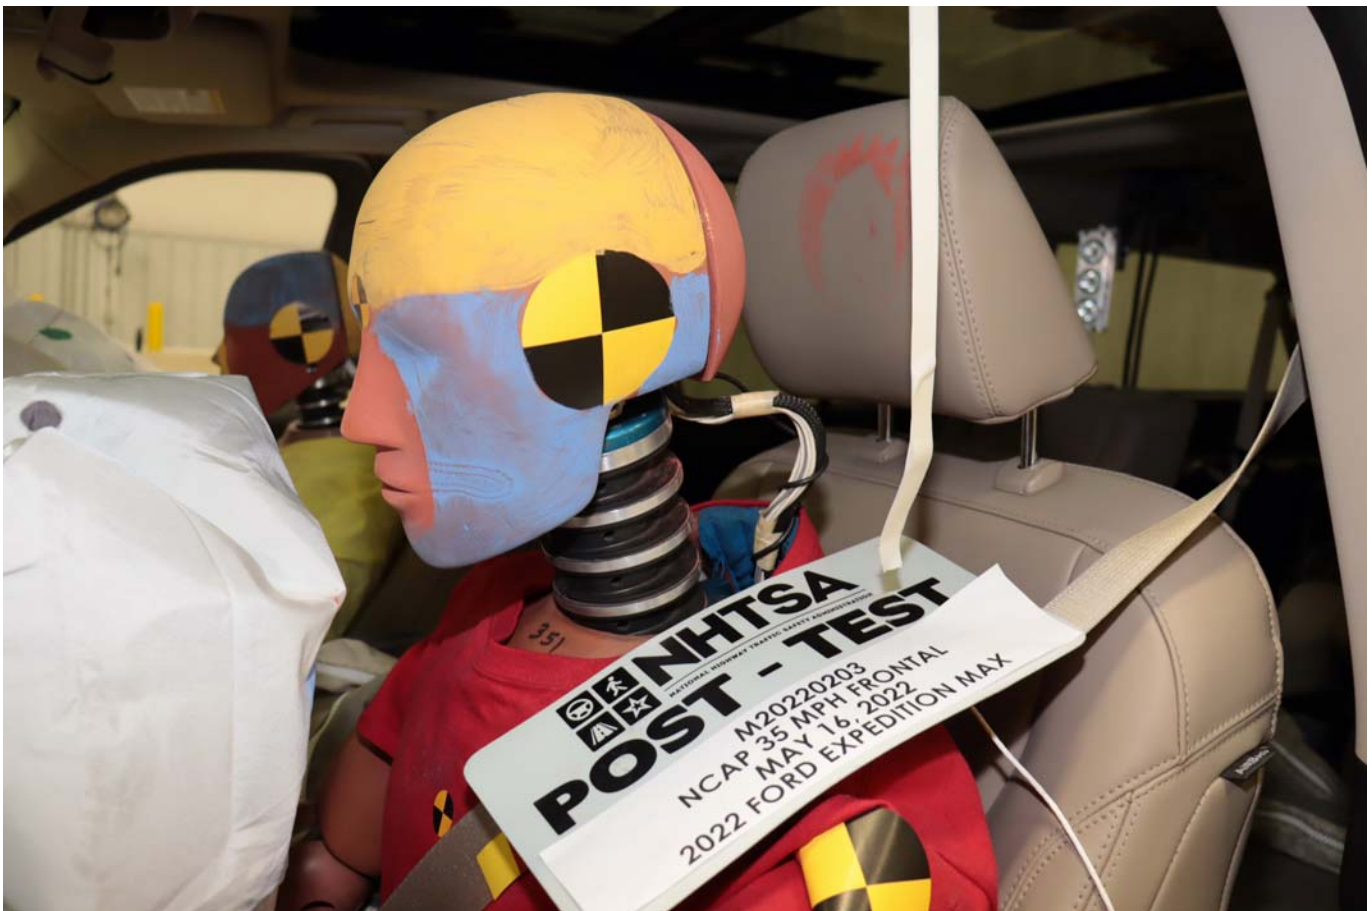
Photo No. 048 - Post-Test Driver Dummy Face

The driver's visible contact points were as follows: The driver's head contacted the airbag. The driver's head also contacted the headrest. The driver's knees contacted the knee airbag.
 The passenger's visible contact points were as follows: The passenger's head contacted the airbag. The passenger's head also contacted the headrest.

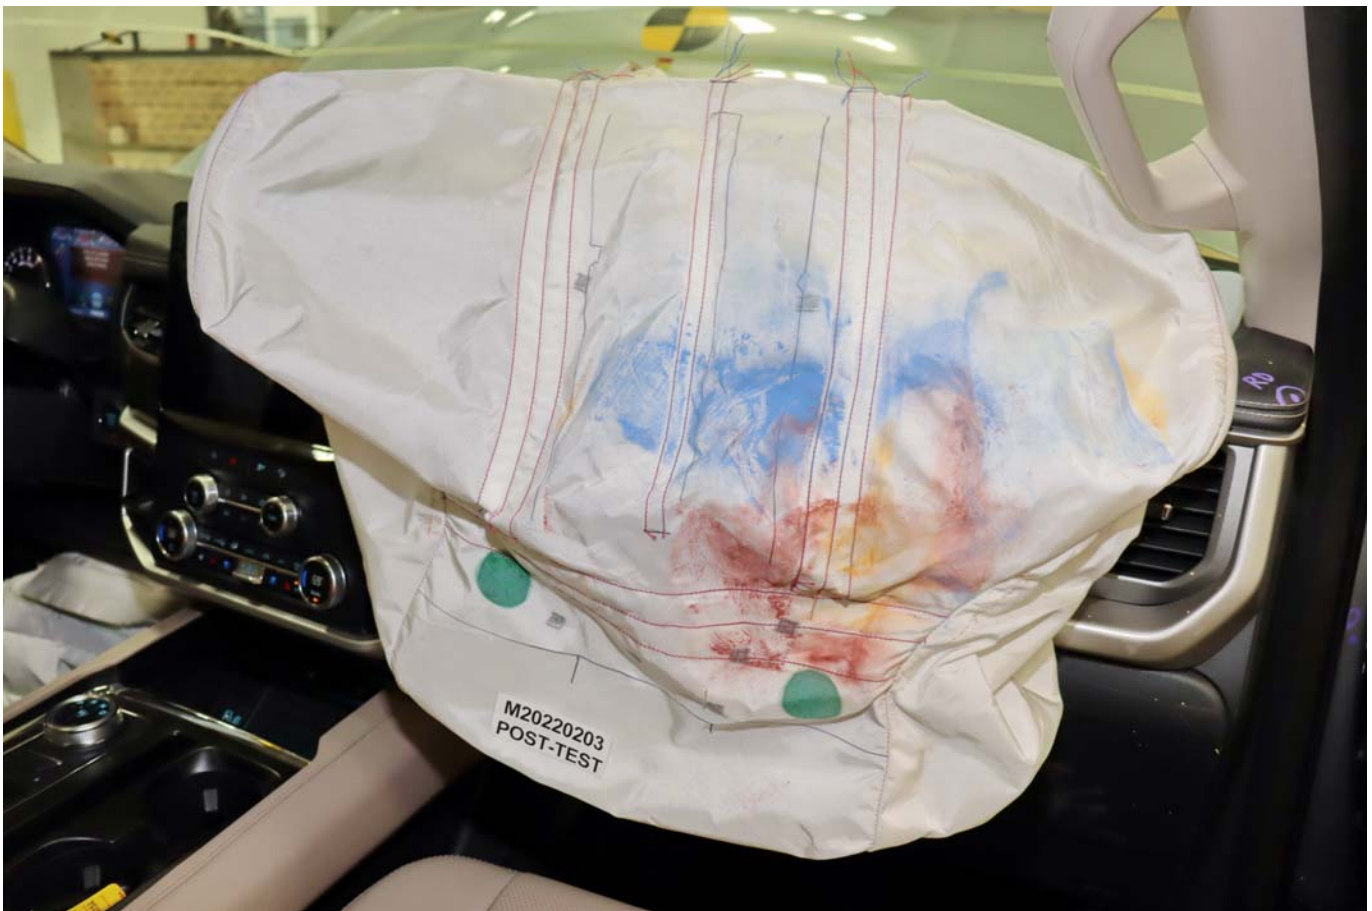
Photo No. 072 - Post-Test Passenger Dummy Contact with Airbag

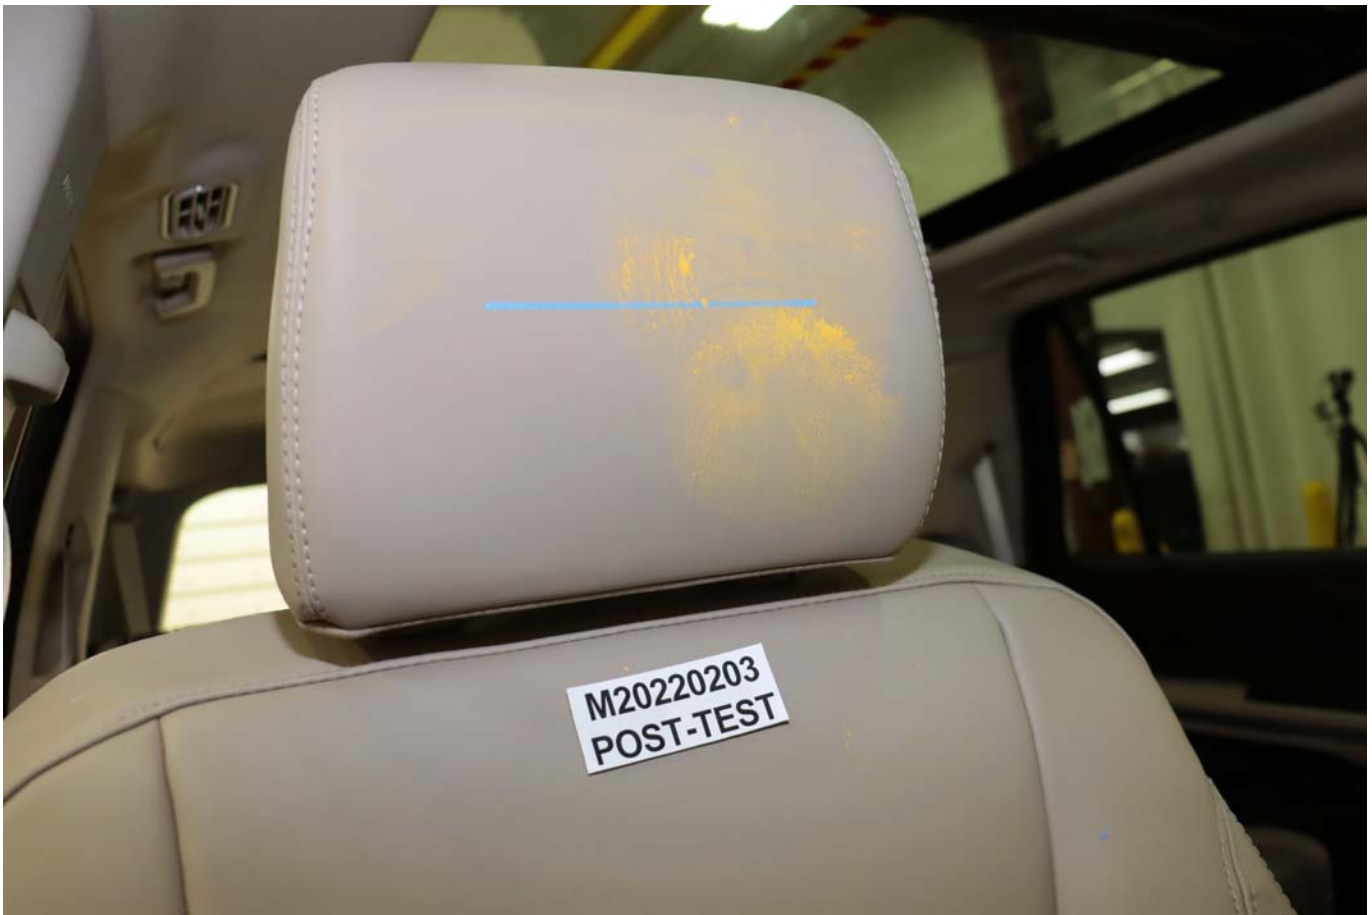
Photo No. 073 - Post-Test Passenger Dummy Contact with Headrest
