**REPORT NUMBER: SPNCAP-CAL-22-002**

**NEW CAR ASSESSMENT PROGRAM (NCAP)  
SIDE IMPACT POLE TEST**

**Nissan Motor CO. LTD  
2022 Nissan Pathfinder  
SUV**

**FINAL REPORT**

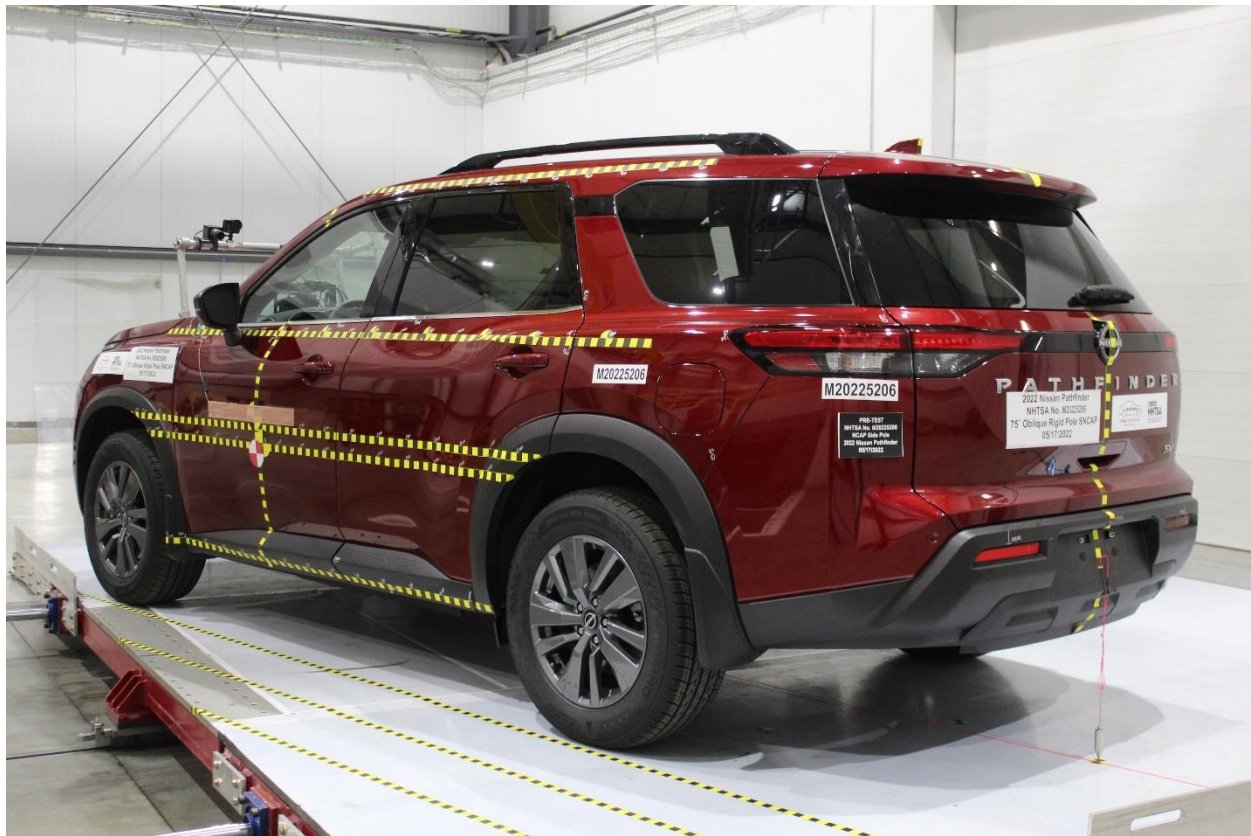
**Figure A-9: Pre-Test Left Rear  $\frac{3}{4}$  View of Test Vehicle**

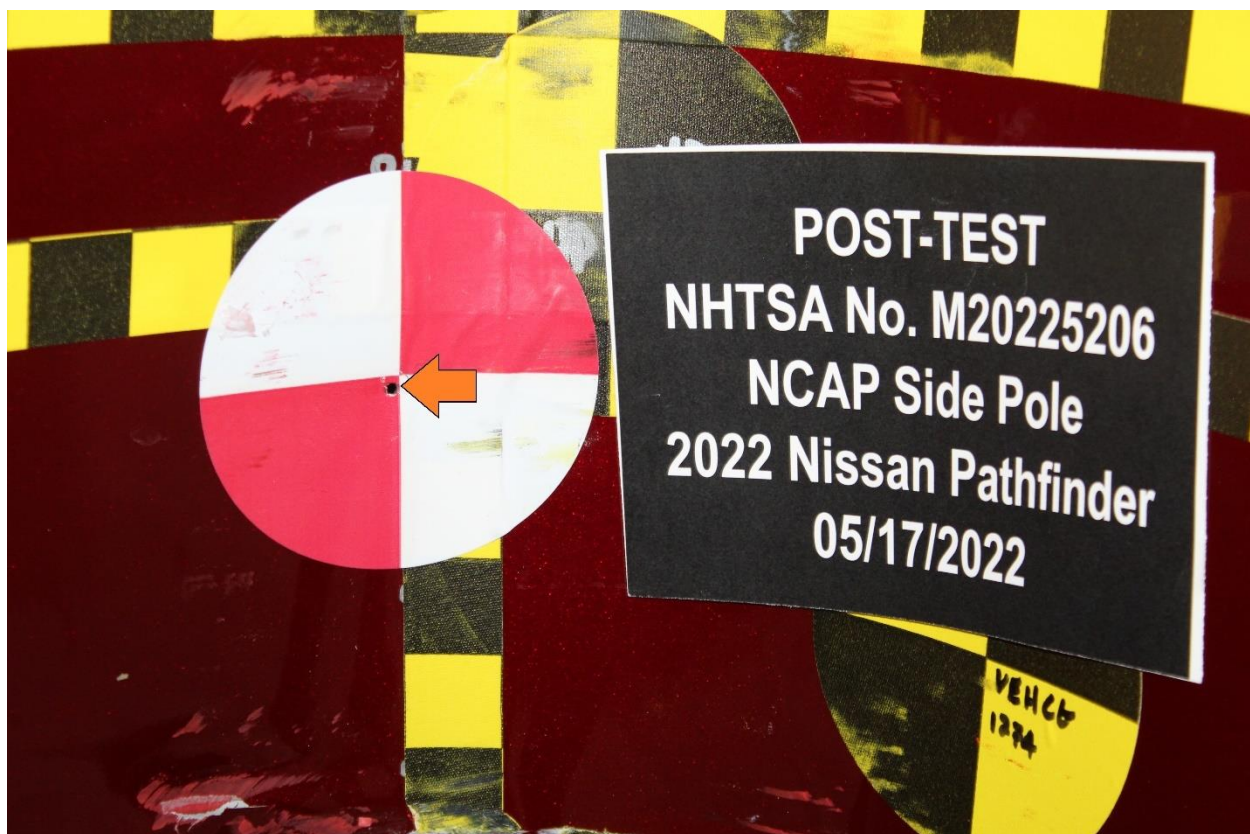
Figure A-20: Post-Test Close-Up View of Impact Point Target Showing Impact Location

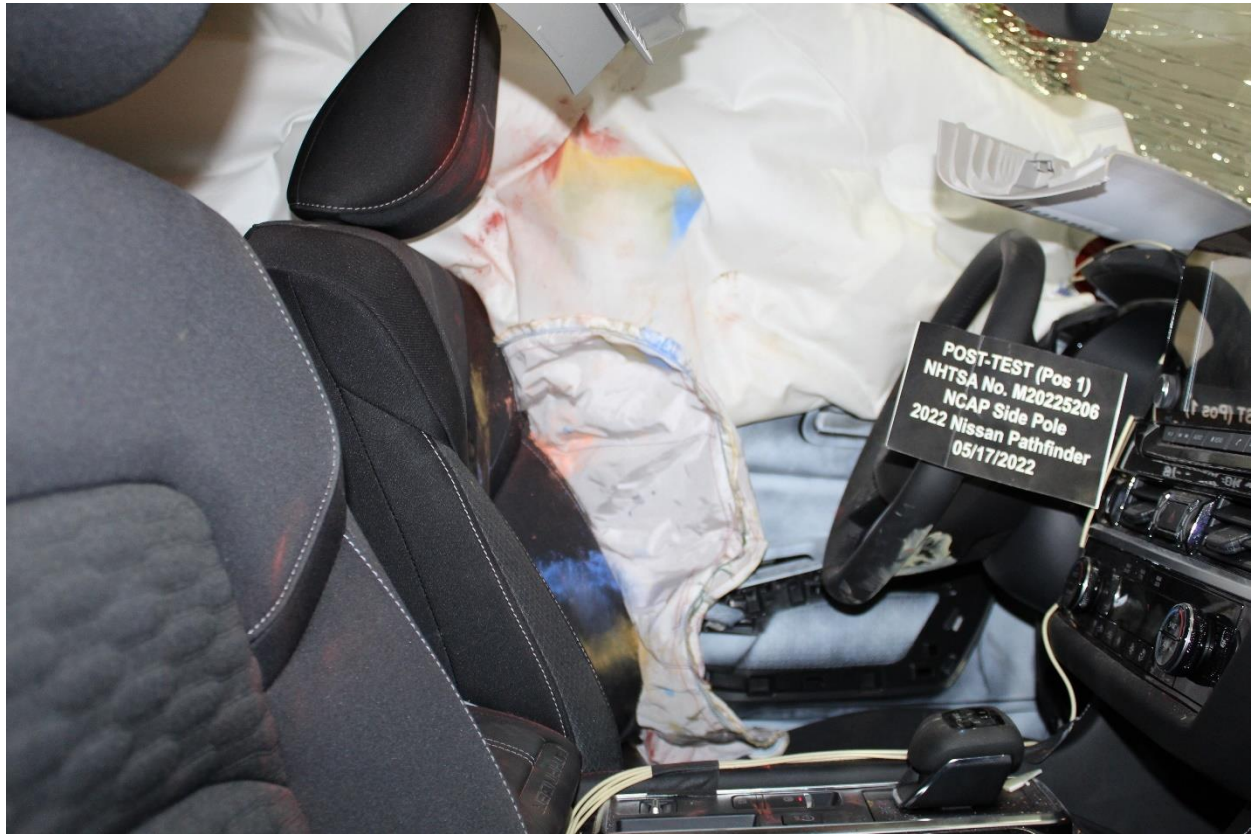
**Figure A-45: Post-Test Inner Door Panel View Showing Dummy Contact Location**

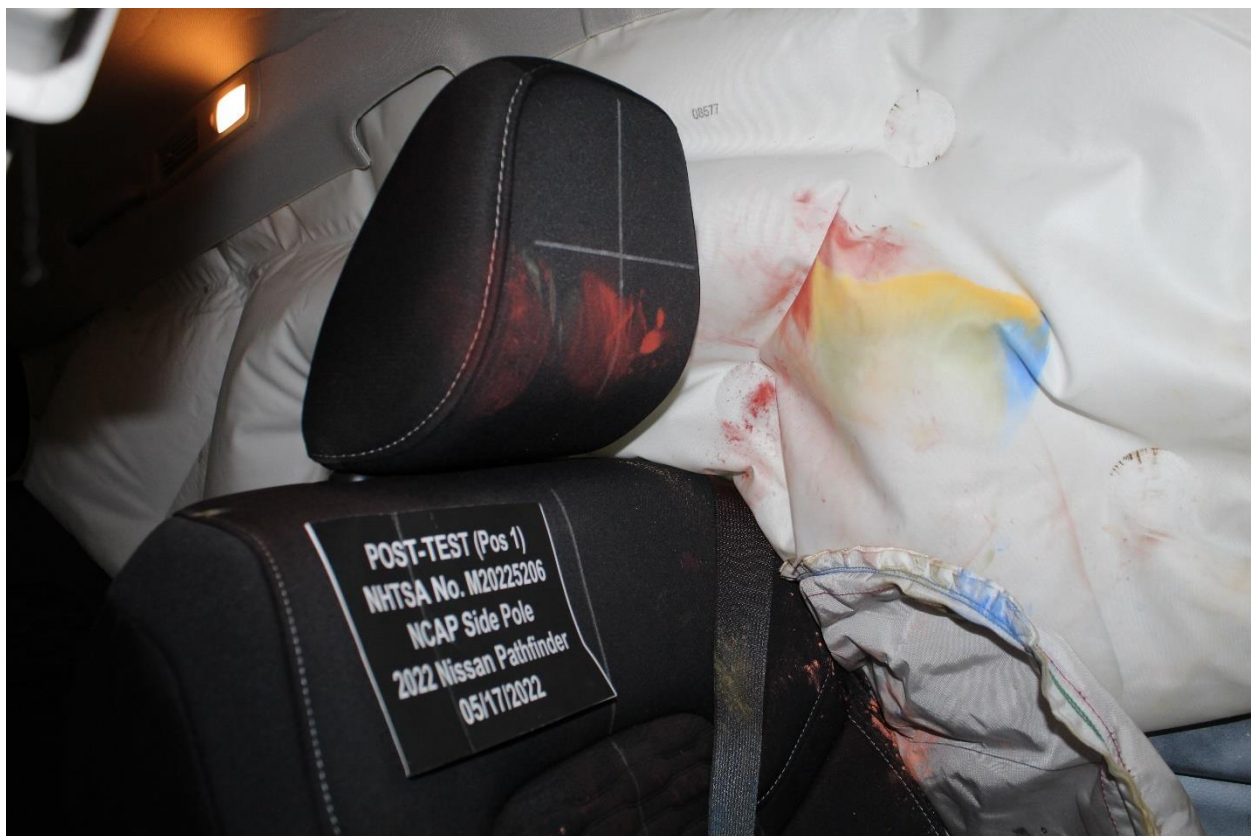
**Figure A-46: Post-Test Dummy Close-Up Head Contact with Vehicle Interior View**

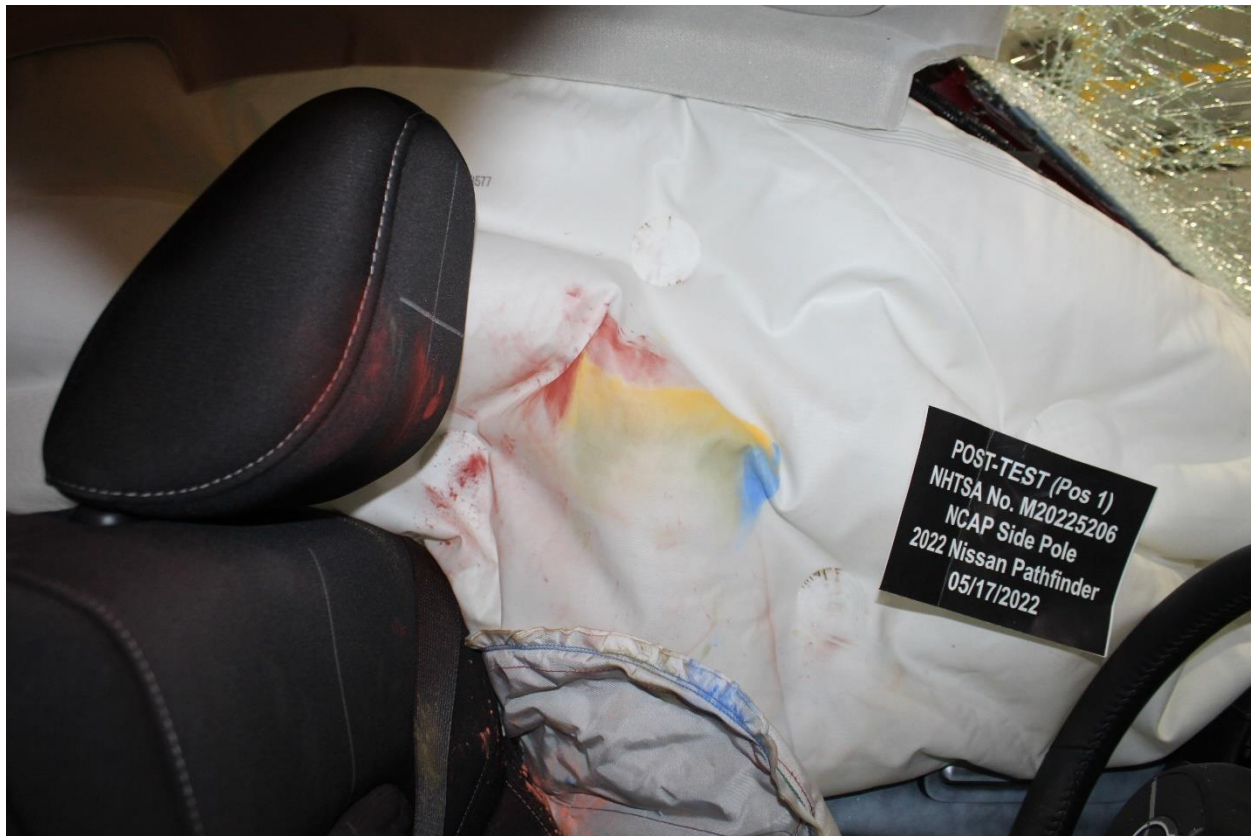
**Figure A-47: Post-Test Dummy Close-Up Head Contact with Side Airbag View**

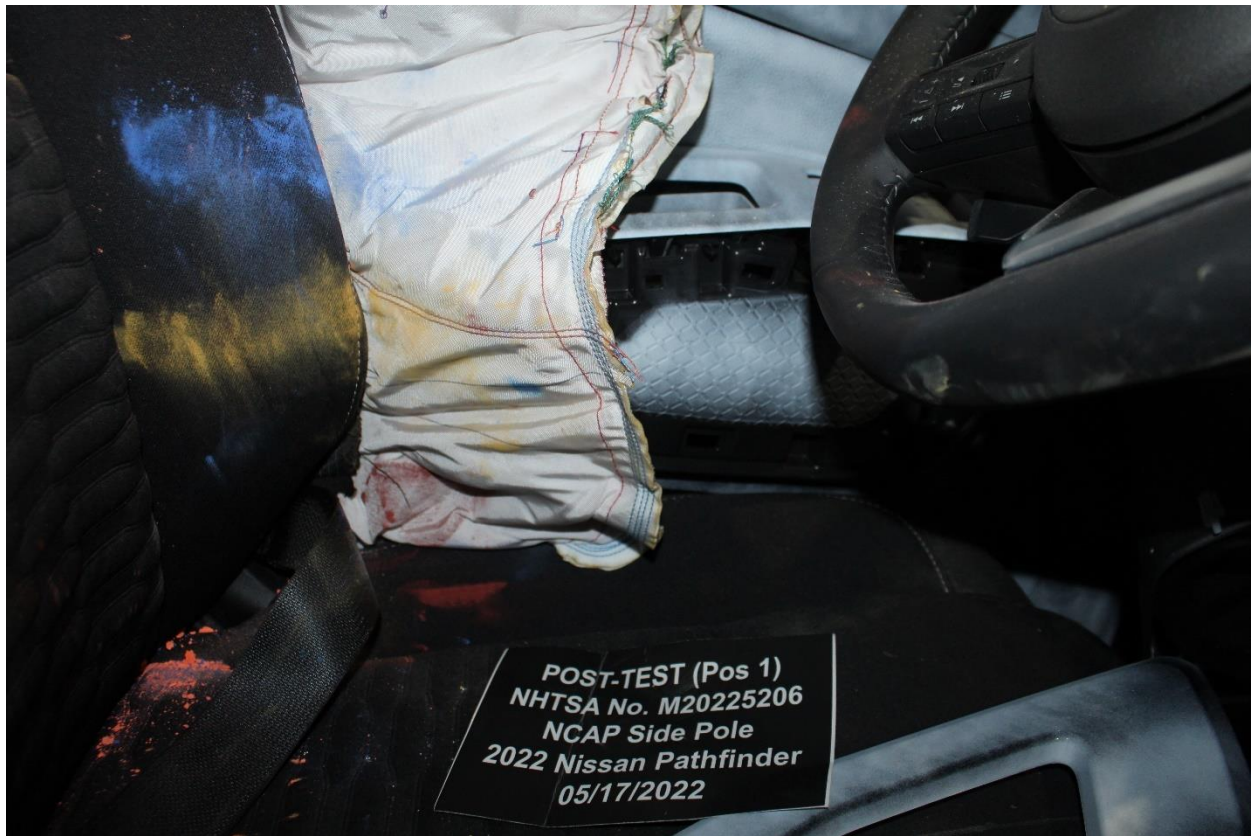
**Figure A-49: Post-Test Dummy Close-Up Torso Contact with Side Airbag View**

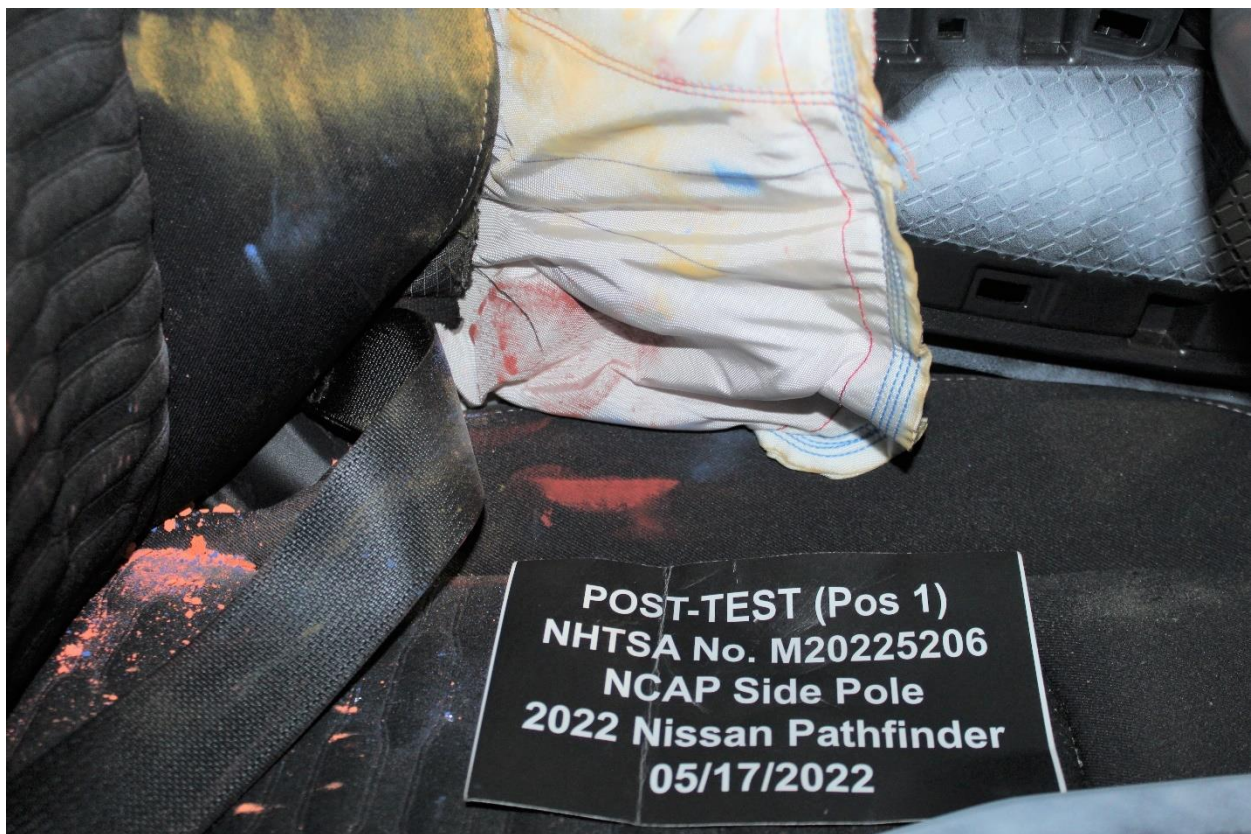
**Figure A-50: Post-Test Dummy Close-Up Pelvis Contact with Vehicle Interior View**

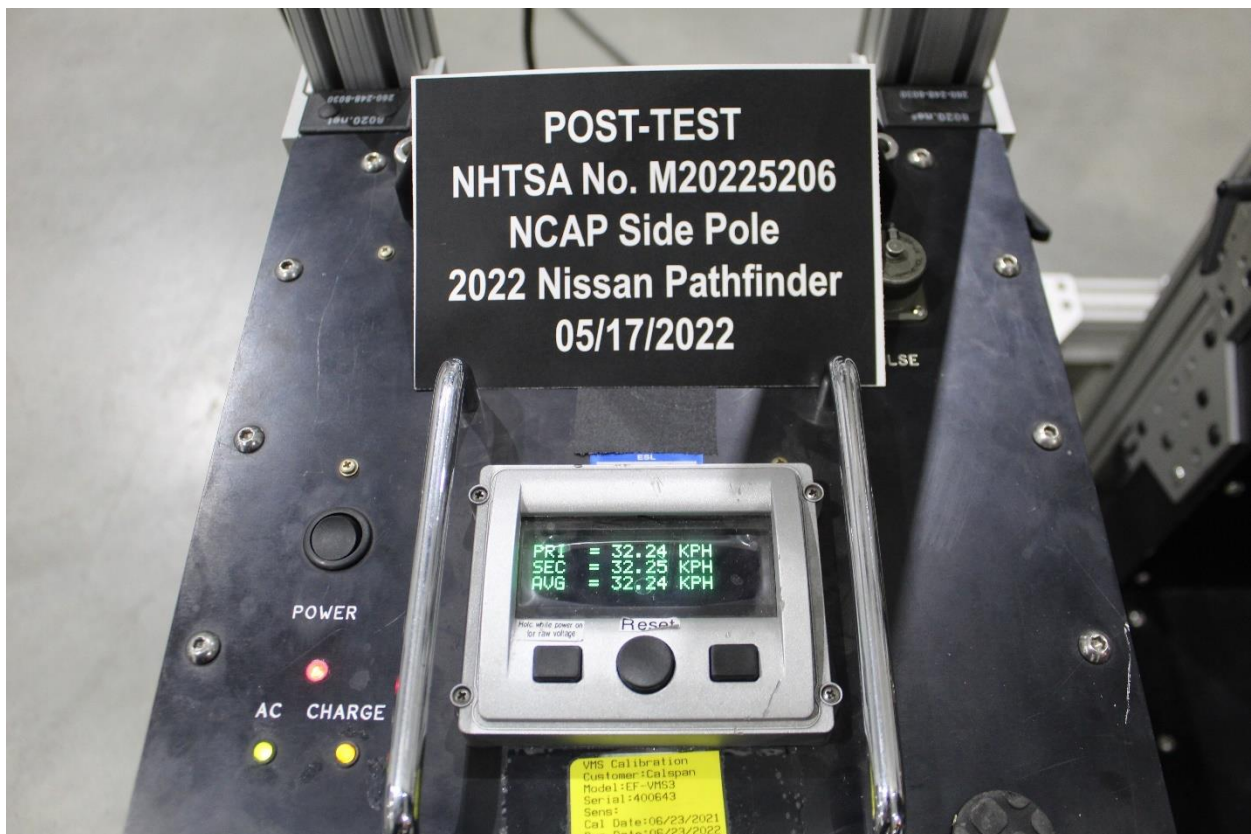
**Figure A-64: Post-Test Primary and Redundant Speed Trap Read-Out**
